**FY15 Final Technical Report for DOE SunShot
Sandia National Laboratories*
Agreement # 24372, 25538, 25539
PV Regional Test Centers**

Introduction

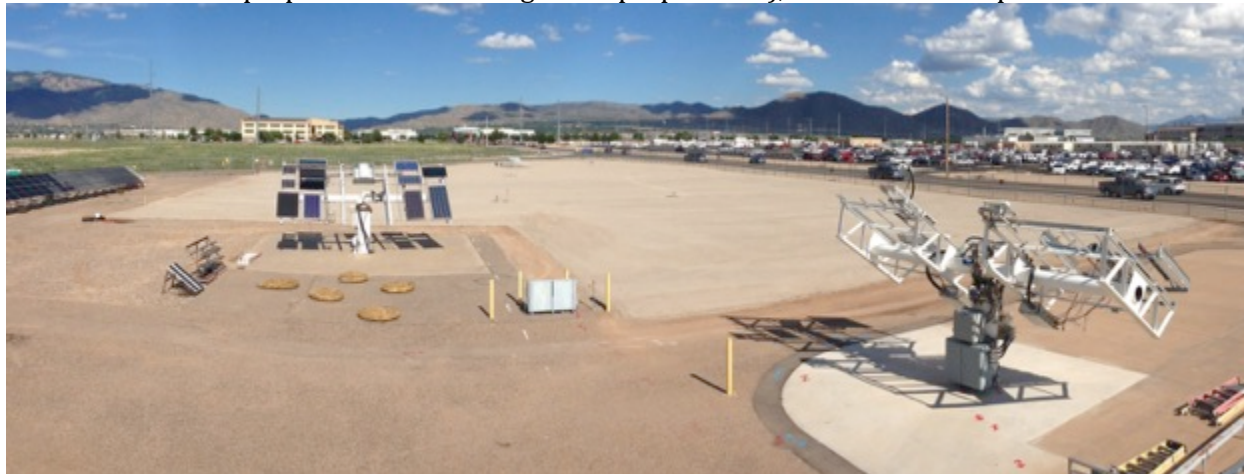
Figure 3. Ground preparations for the New Mexico RTC-North site, which is co-located with Sandia's PSEL, were completed in early FY15.

between 50 kW and 250 kW. The infrastructure at PSEL required some site upgrades (including installation of a step-up transformer and ground preparation), which were completed in FY14.

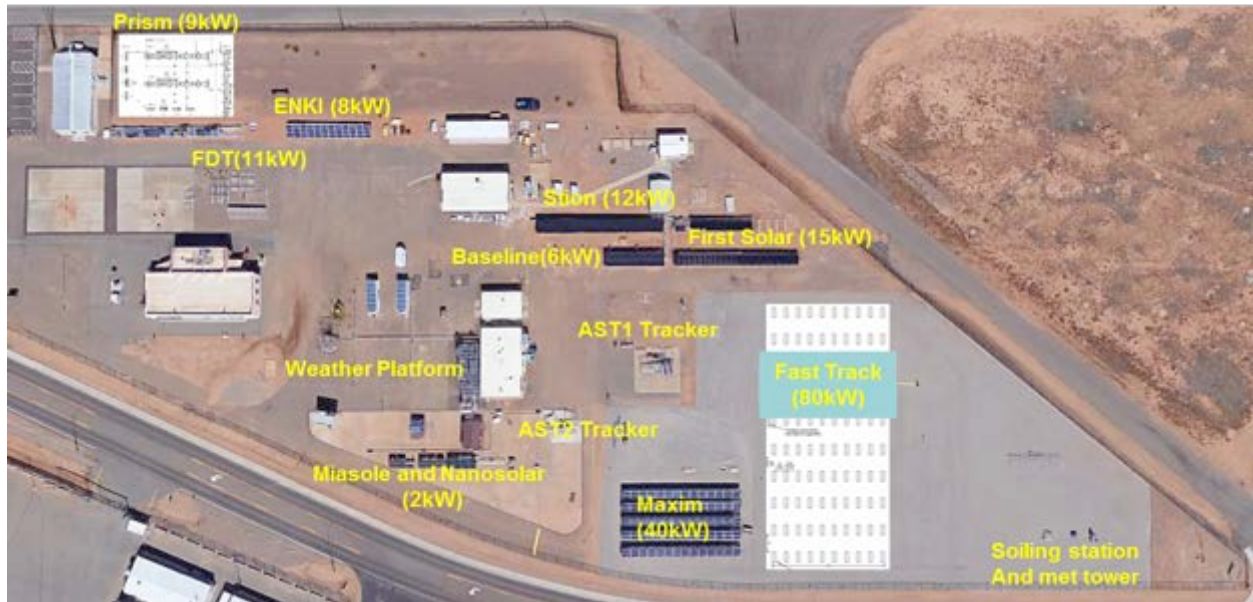
Figure 4. Site plan for the New Mexico RTC-South site showing the locations of various systems located at the PSEL.

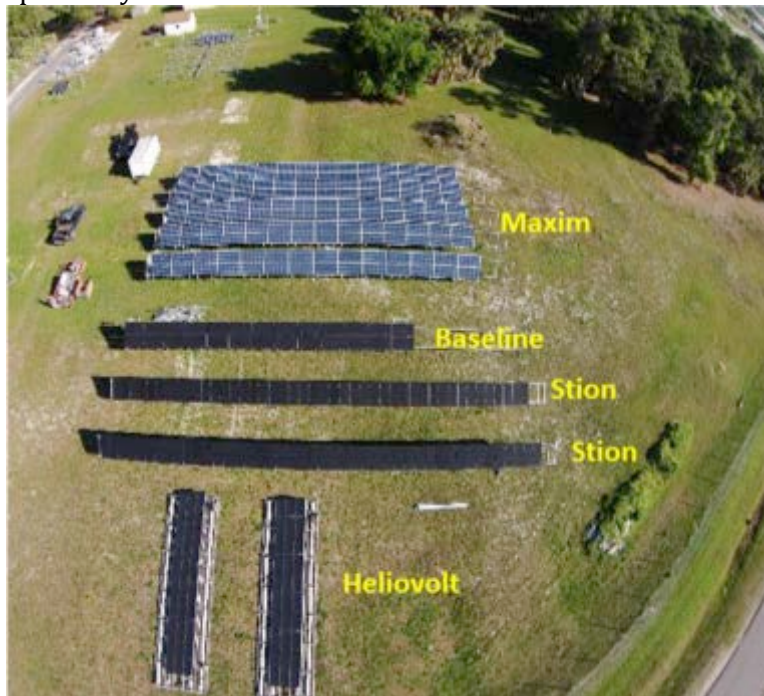
Figure 6. Current RTC systems installed at the Florida RTC. Does not include the ENKI project, which is located at a nearby site.

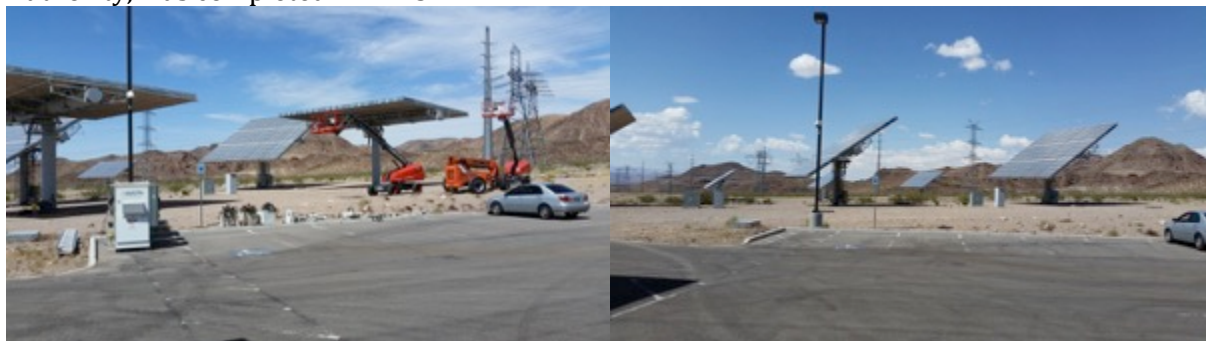
Figure 7. Left: Two Amonix trackers in foreground before removal. Right: site after all three trackers were removed and the site graded.

In FY15, the major activity at the Nevada RTC focused on the removal of three non-operational Amonix trackers to expand the site and allow for a significant increase in future RTC installations. The removal, which required the legal approval and oversight of the Southern Nevada Water Authority, was completed in FY15.

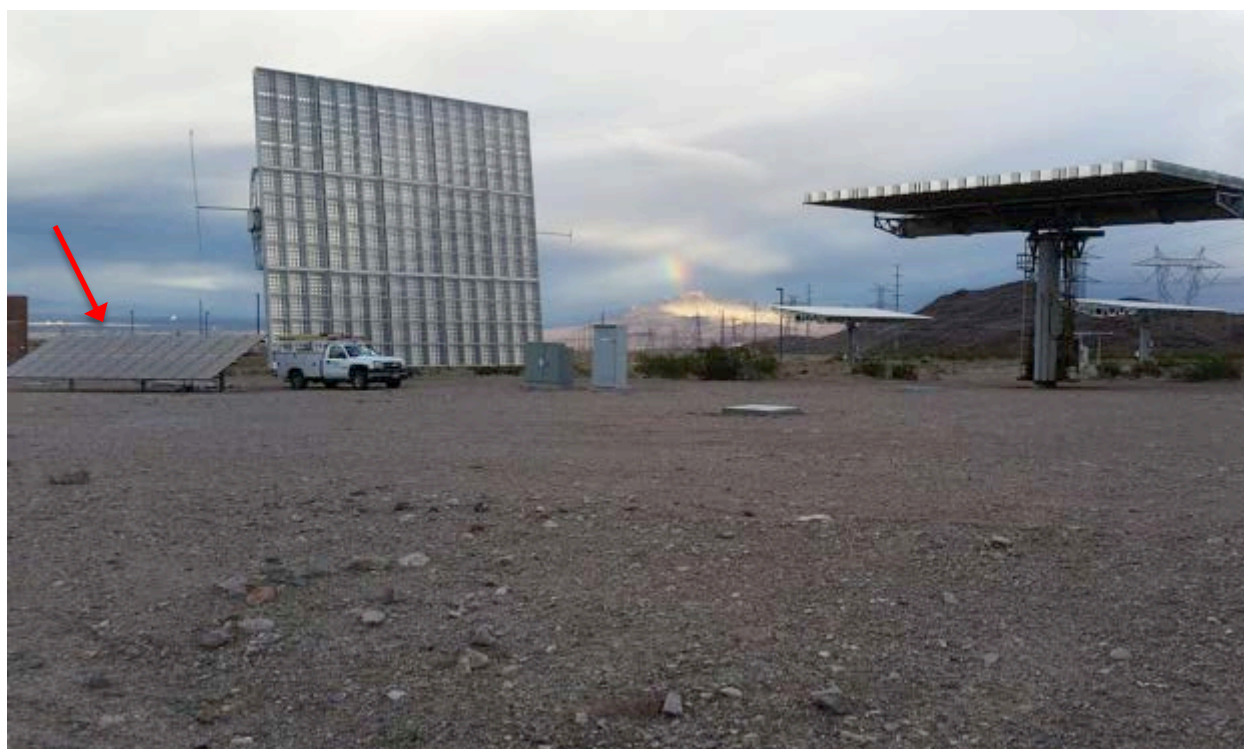
Figure 9. Nearly complete 6-kW baseline system (*see red arrow*) at the Nevada RTC, Amonix and Soitec trackers are to the north.

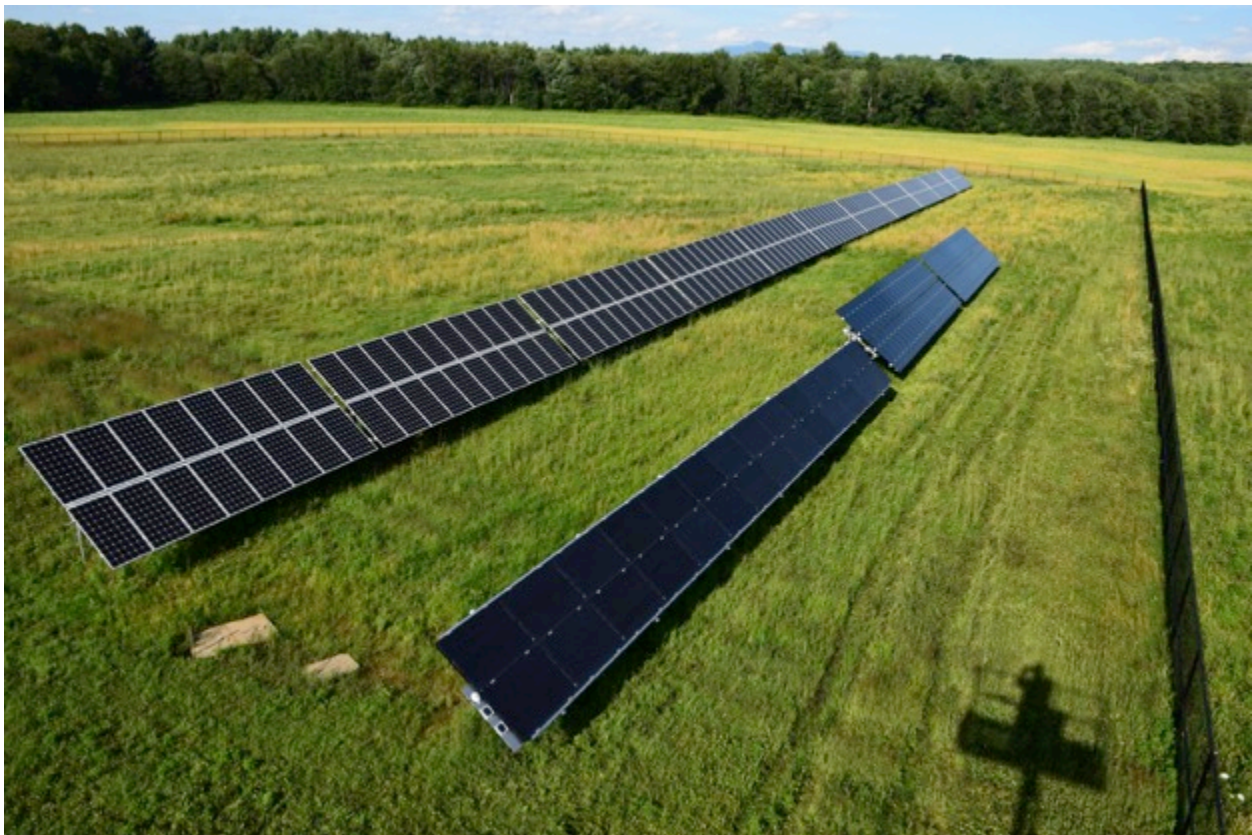
Figure 10. View of the PV arrays installed at the Vermont RTC as of the end of FY15. Array in back row is the 60-kW c-Si array. In the front row is the 6-kW baseline system in the foreground and the Stion systems in the background.

The baseline array, while operational, is scheduled to have one of its inverters (from Fronius) replaced and a transformer installed in early FY16. Until then, as described earlier in this report, the data is not being released to the public. This system was commissioned in August 2014; the 60 kW c-Si system in the next row north (see figure 10) was commissioned in September 2014.

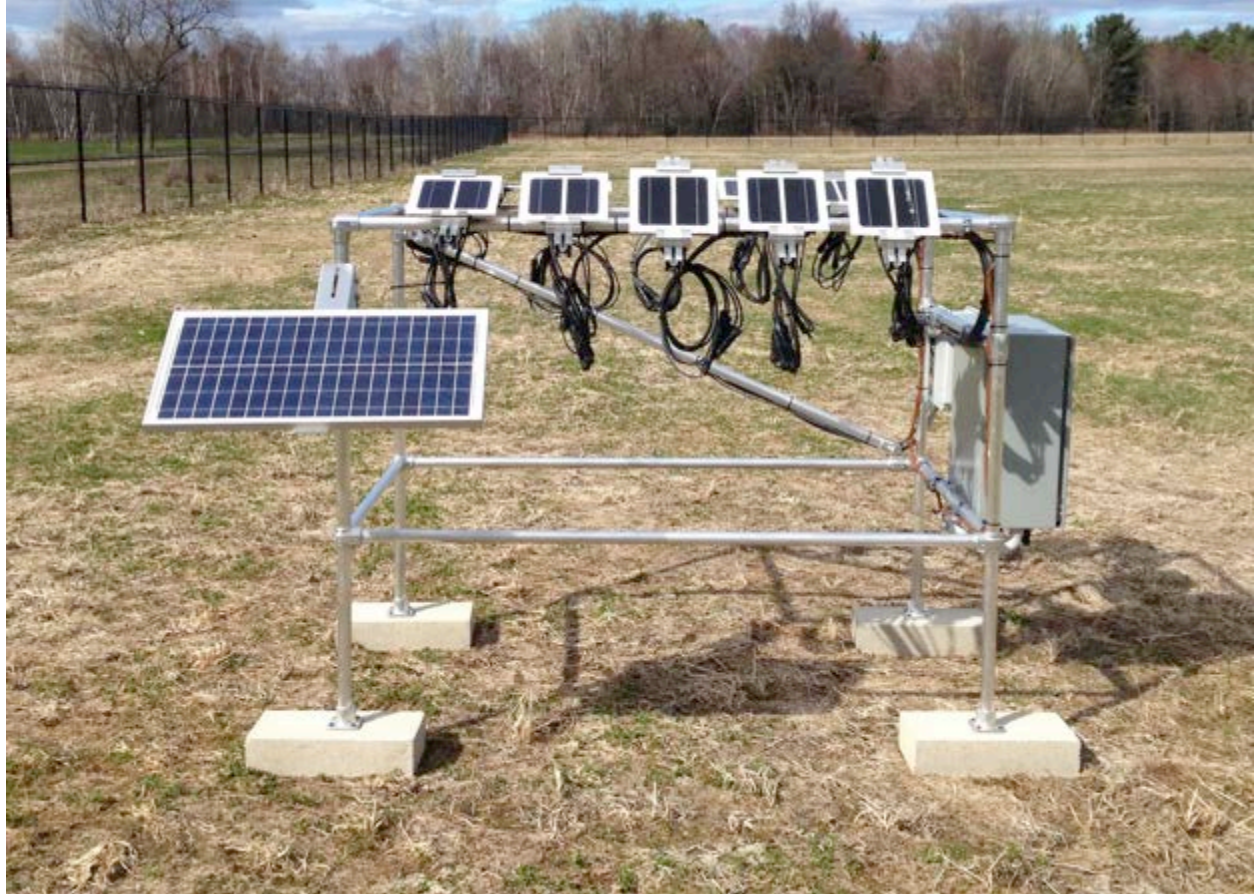
Figure 16. Soiling station at the VR RTC is measuring the effect of particulate accumulation on the energy output of split reference cells set at different tilt angles. The data logger (*grey box to the right*) is powered by the module mounted on the vertical post.

Soiling stations have been installed at the New Mexico, Florida, Vermont, and Colorado RTC sites during FY15. These stations include a series of ten split reference cells that are attached at a variety of tilt angles. Approximately twice per week, one half of each cell is cleaned while allowing the other half to collect dust and dirt at a natural rate. The short circuit current is measured on both halves of each cell and the change in the ratio of the dirty to the clean side after each cleaning event can be used to quantify the soiling rate on the dirty side. When there is sufficient rain, both sides are cleaned and the ratios are reset. Below is a figure of the soiling station at the Vermont RTC.

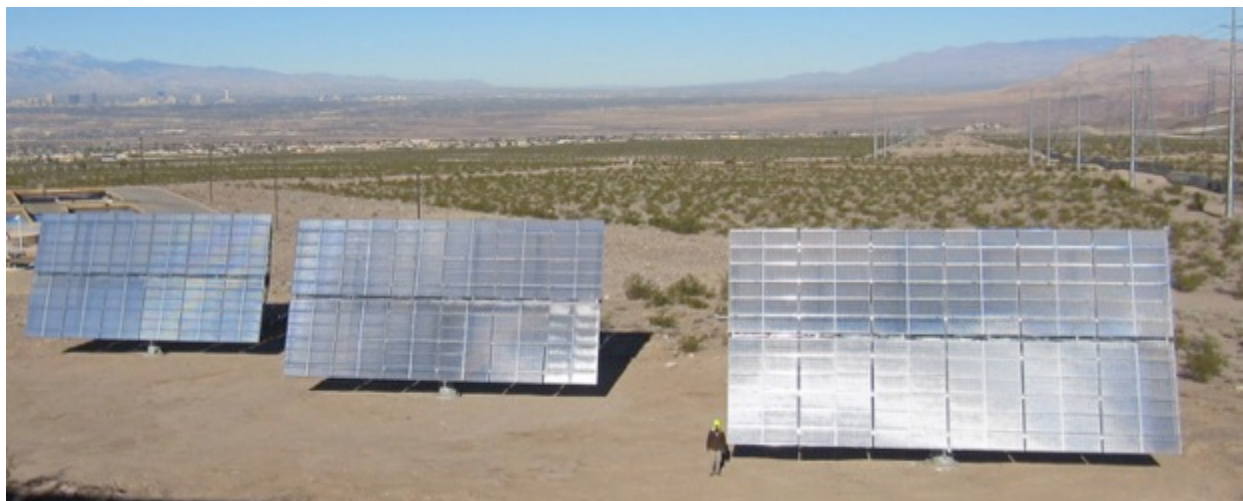
Figure 18. Soitec trackers installed at the Nevada RTC.

Soitec – A three-tracker concentrating photovoltaic (CPV) system totaling 84 kW was installed at the Nevada RTC in March 2014. Data from the system is transmitted daily to Sandia, where it is automatically stored in the PV Data Management System (PVDMS) and available for analysis. During this 20-month period, the trackers have had various technical issues, including bent encoder shafts and multiple popped inverter fuses, but Soitec has worked with UNLV to fix those problems and is now confident the systems are structurally sound.

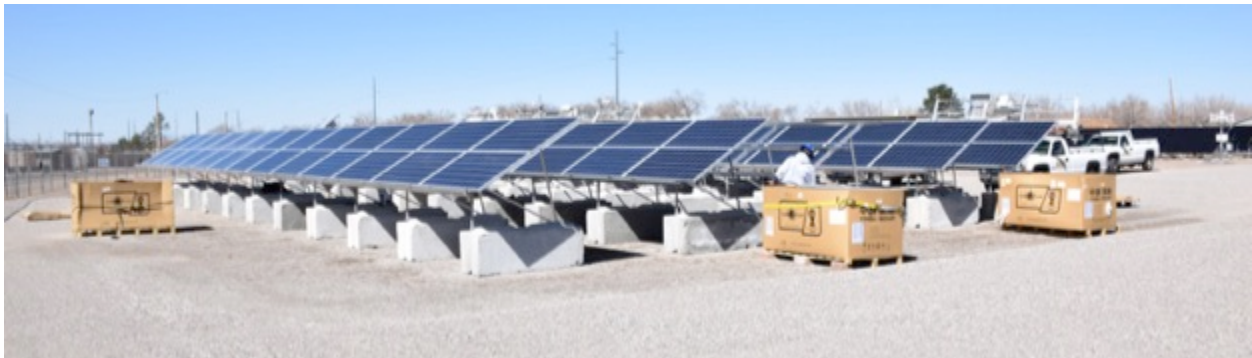
Figure 19. Maxim Integrated array in New Mexico.

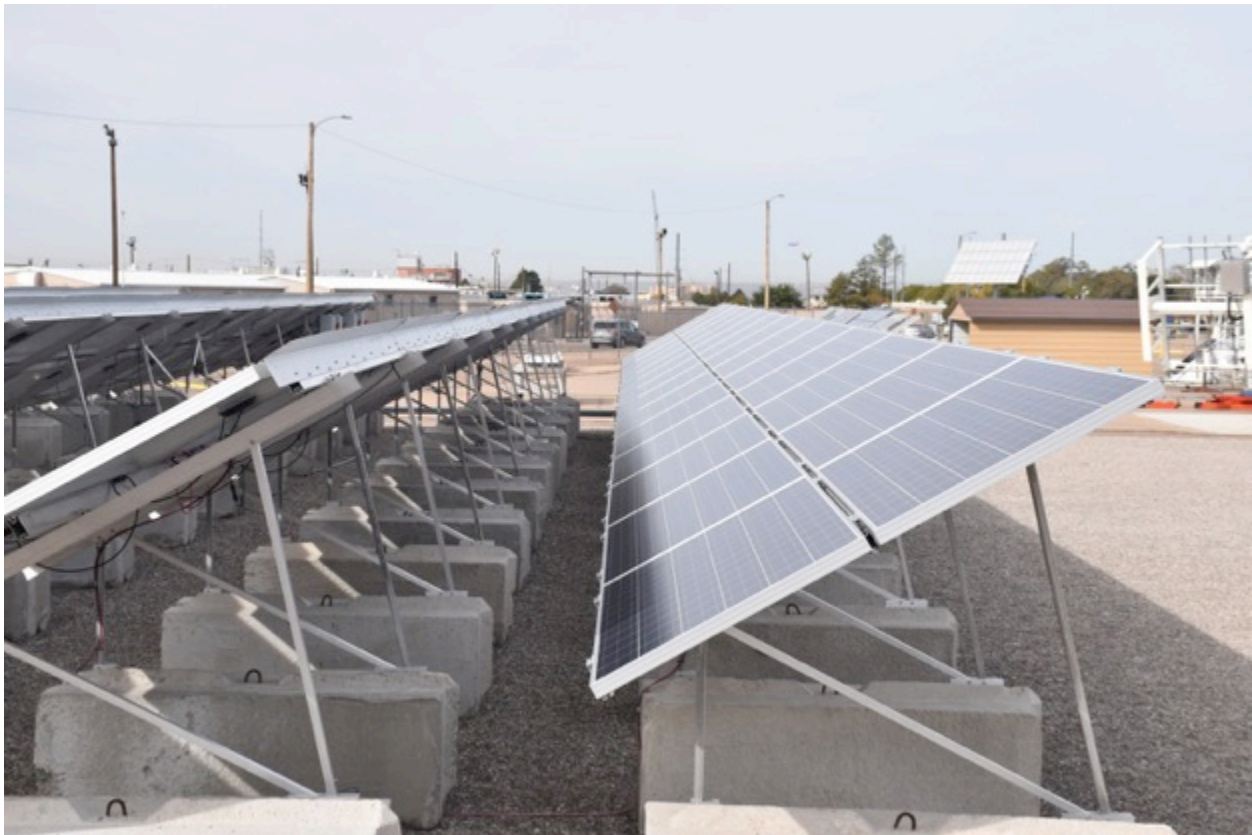
Figure 20. Testing of intentional row-to-row shading on the back row of Maxim's RTC array in New Mexico began in October 2015.

Maxim Integrated – 40-kW systems were installed in Colorado, New Mexico, and Florida in FY14-15. The main purpose of this partnership is to quantify and validate the effectiveness of the Maxim Integrated dc-dc optimizer chips to provide energy gains from systems designed with row-to-row shading in order to fit more PV in less space. The systems are designed with variable row spacing and modules/strings with and without the Maxim chips installed. Performance comparisons between these strings are used for the validation. Unfortunately, these Maxim chips seem to

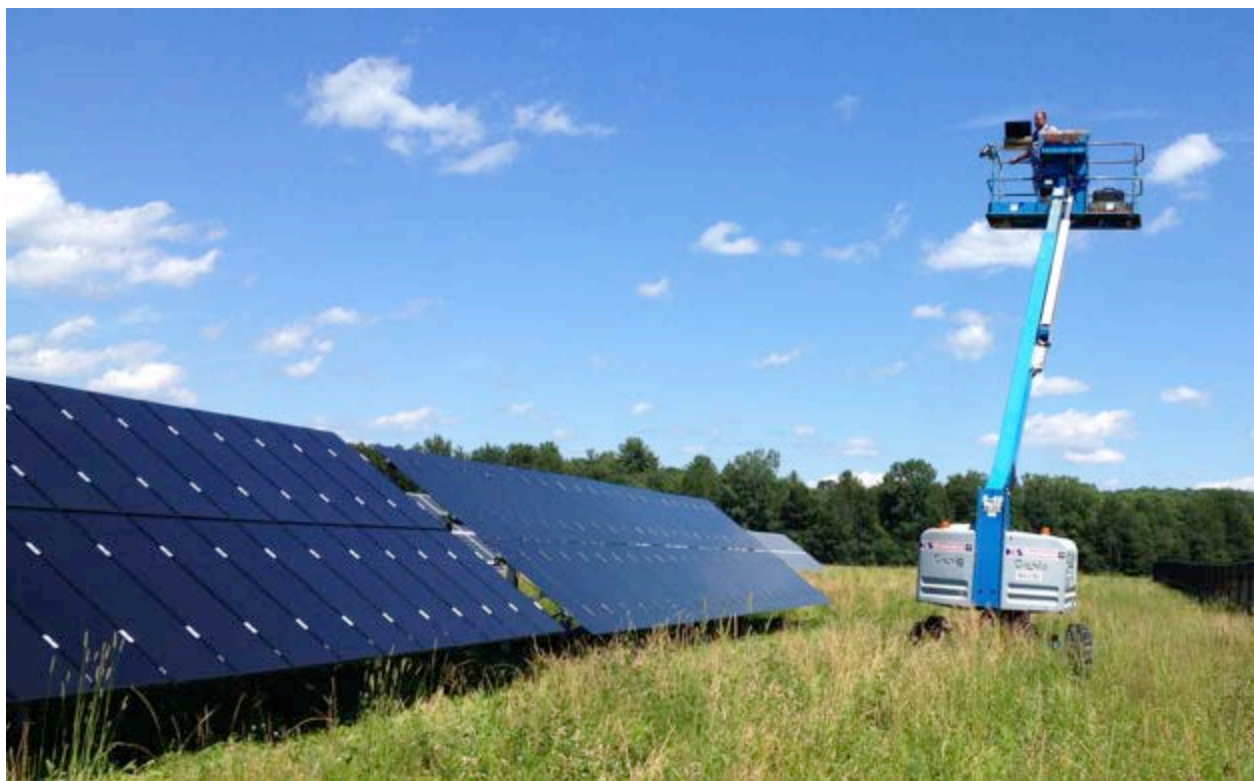
Figure 23. Sandia takes IR images of the Stion modules at the Vermont RTC.

In the months since the Stion systems have been installed, Sandia has observed a high rate of module failure, correlated with cracking. Sandia prepared and delivered a report to Stion detailing when and where broken modules were discovered[‡]. This report also provided thermal and electroluminescence images of module hot spots that may have developed following moisture ingress into the module through the cracked glass. The table below lists the number of cracked modules of each type at each site. Cracked modules were discovered at all three sites and have been removed and replaced. A subset of the most badly damaged modules has been sent to Sandia for further analysis.

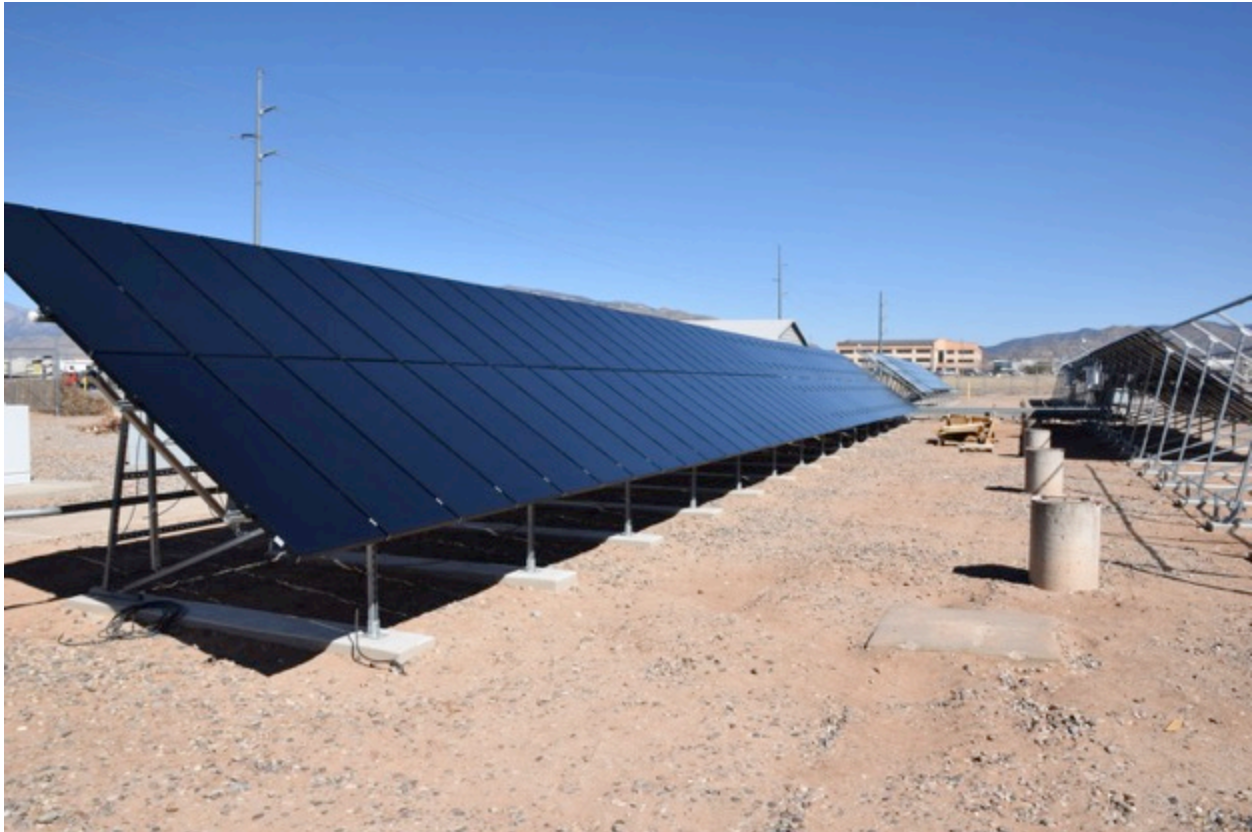
Figure 24. Stion system in New Mexico. Framed subarray in the foreground and frameless in the background.

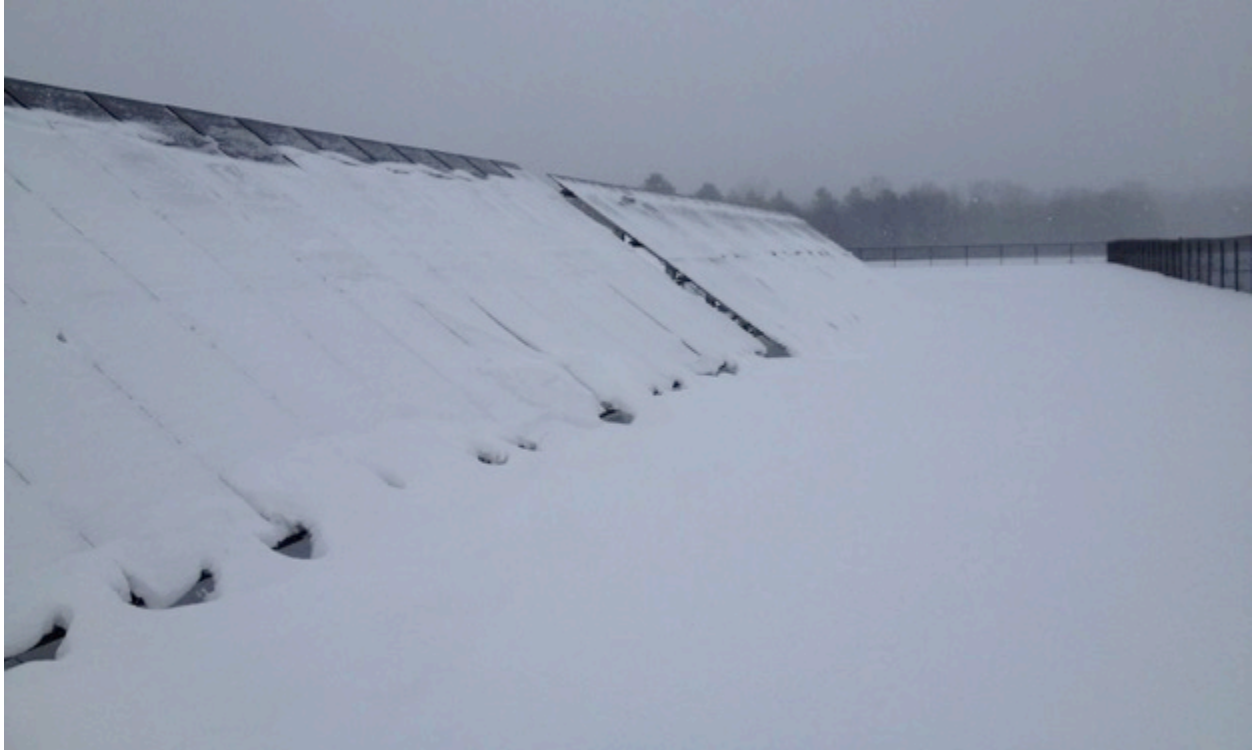
Figure 25. Snow nearly covered the Stion array during the winter of 2014-15.

Vermont: This system was completed and commissioned in November, 2014. This system experienced a lot of snow during the winter of 2014-15 and by spring six modules had cracked and needed to be replaced. It is not yet clear what caused the module cracking.

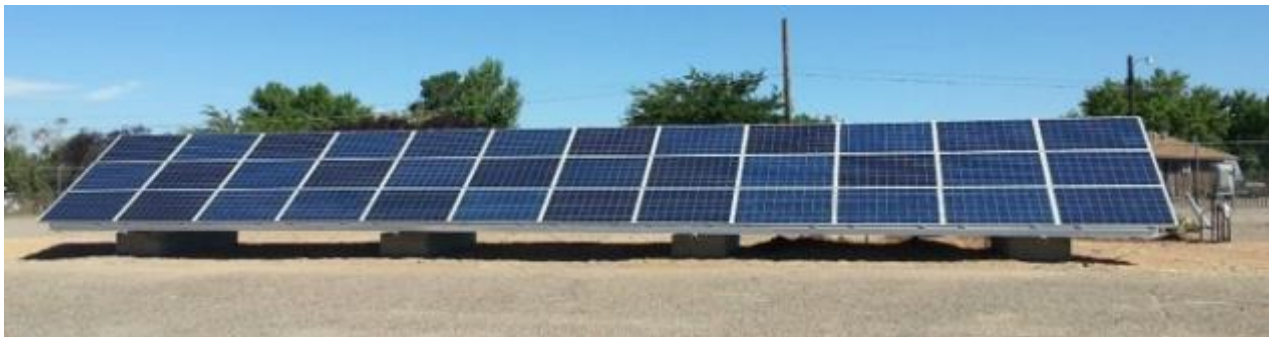
Figure 26. New Mexico: ENKI system was installed in August and is operational.

ENKI - 8kW systems in New Mexico and Florida testing the effectiveness of anti-reflection and soiling coatings compared with uncoated modules. This partner was brought into the RTC after already installing a system in Florida. ENKI is currently doing the analysis of the data delivered to them by the RTCs.

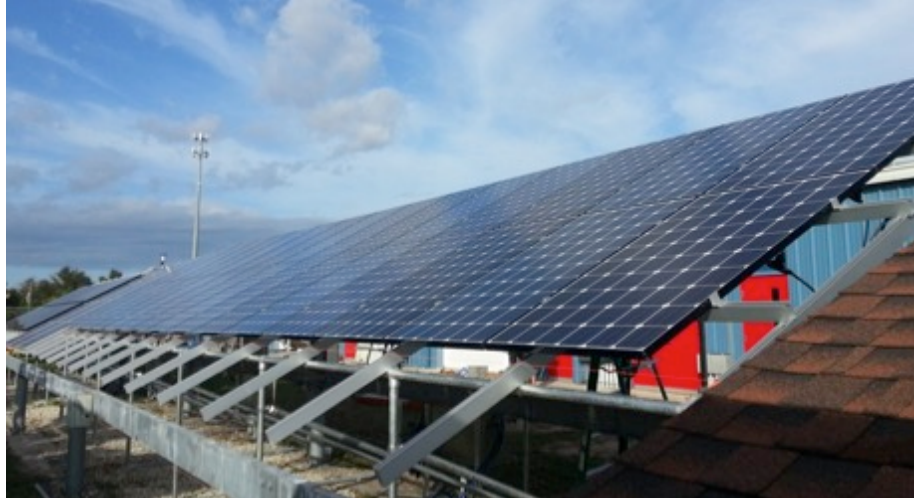
Figure 27. ENKI system in Florida.

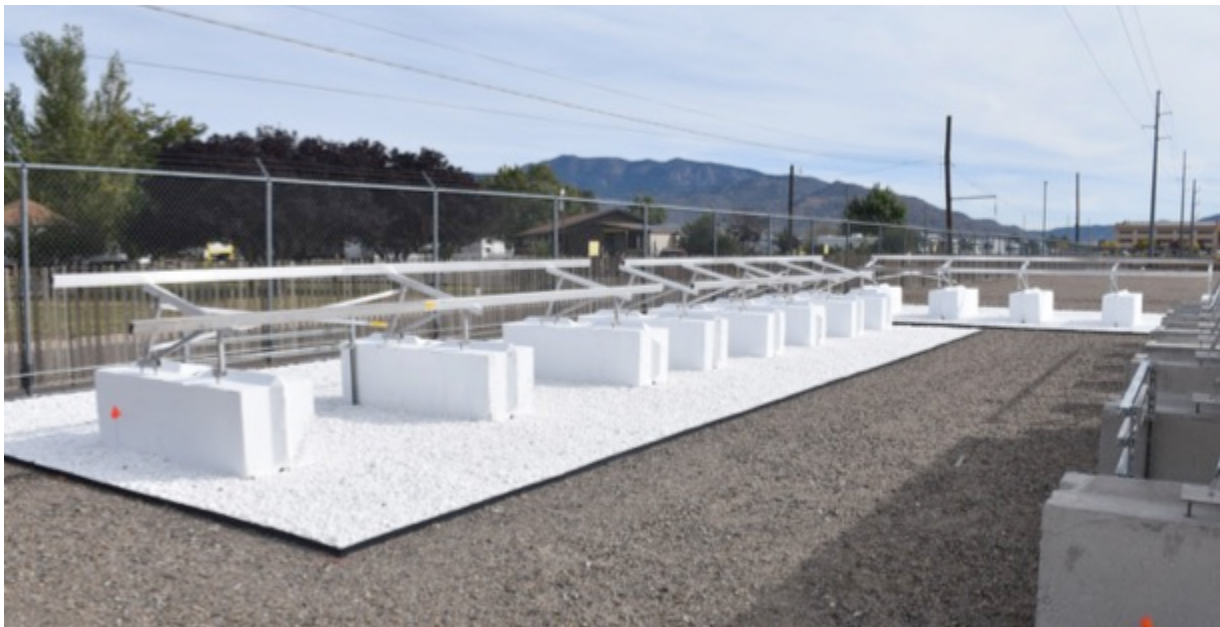
Figure 28. Portion of the Prism installation in New Mexico. Some of the racks are placed on a highly reflective white background to enhance the light available on the back of the arrays.

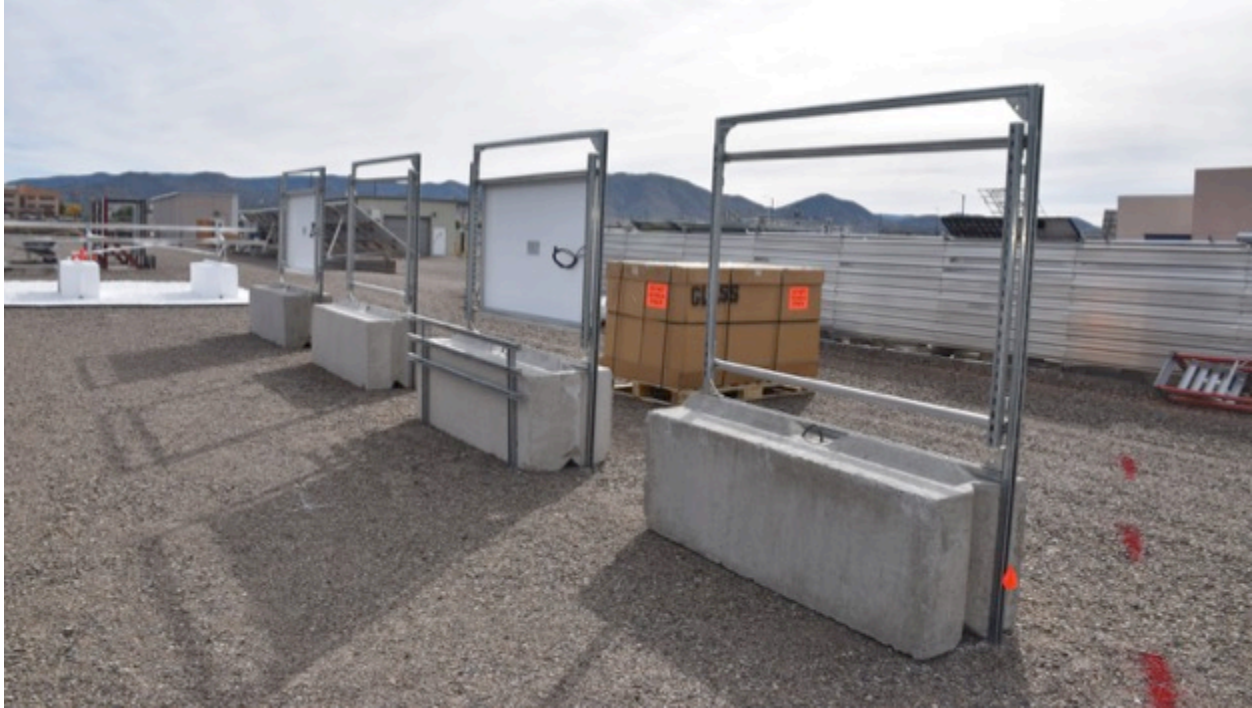
Figure 29. Prism array in New Mexico. Vertical modules oriented E-W and N-S are included in the test array.

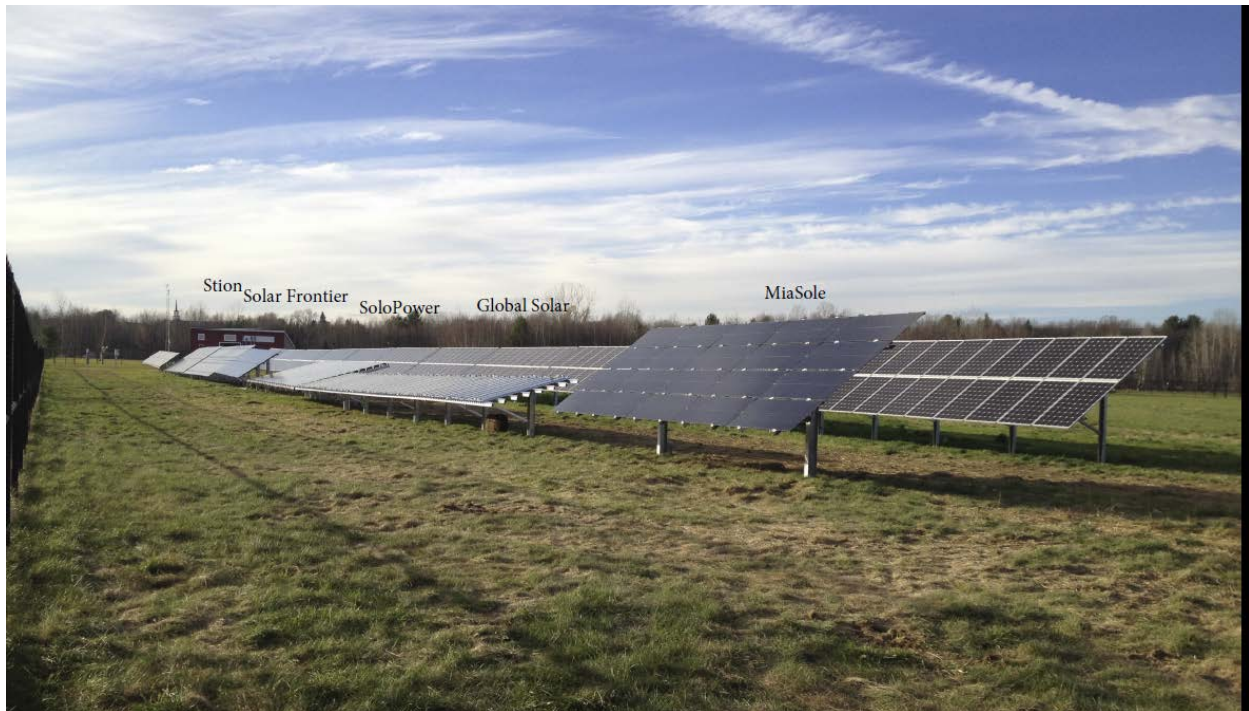
Figure 30. PVMC arrays installed--but not yet commissioned--at the Vermont RTC. Five of the six CIGS arrays (including Stion) are visible in the first row above (see labels).

Photovoltaic Manufacturers Consortium (PVMC) is installing five different systems representing four CIGS module manufacturers at the Vermont RTC, adjacent to the Stion CIGS arrays. PVMC is installing the arrays and the monitoring systems, with guidance and technical support from Sandia. Sandia has provided PVMC access to the site, reviewed the design and provided detailed specifications for the monitoring systems. The five arrays will be commissioned in early FY16, in accordance with the RTC commissioning procedure.

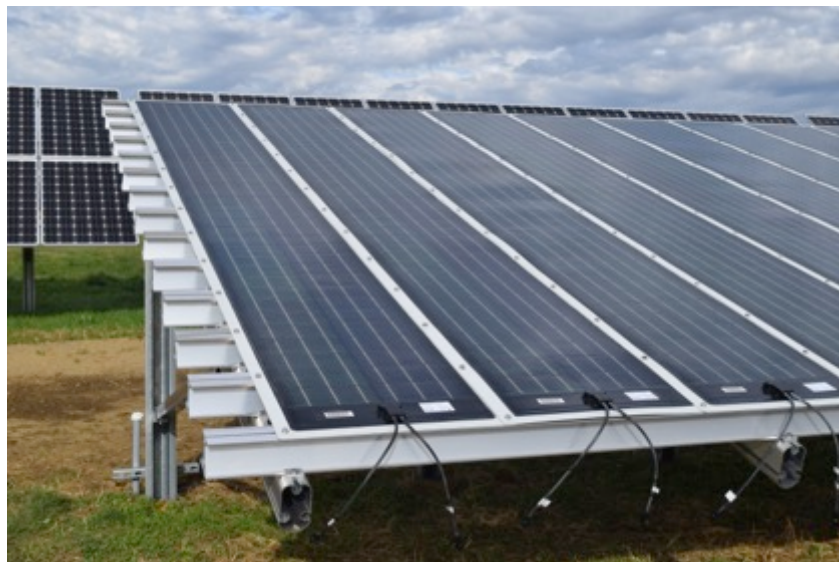
Figure 31. Global Solar CIGS modules at the Vermont RTC that are being installed by PVMC.

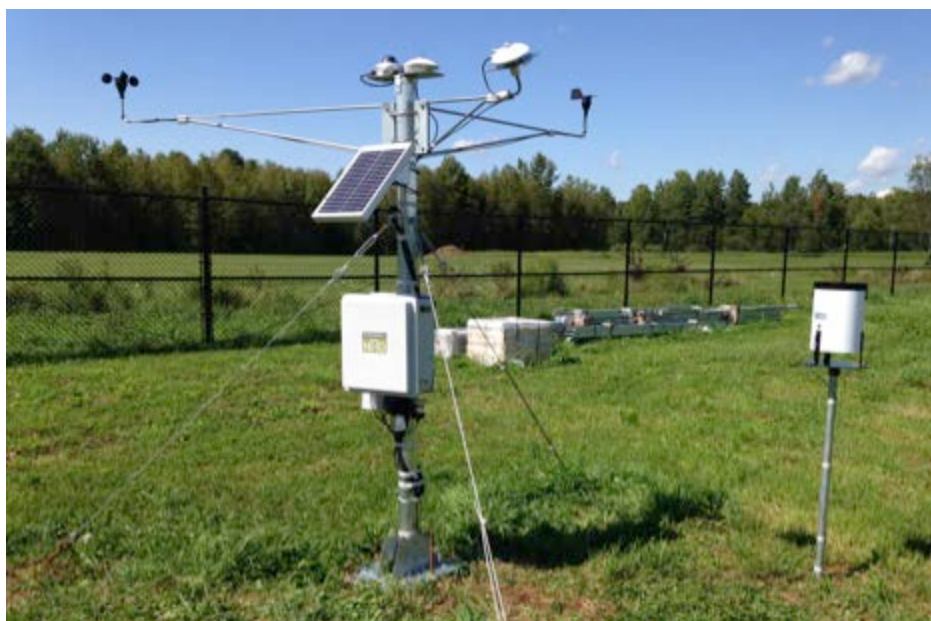
Figure 32. Solar resource assessment system installed at the Vermont RTC. The data logger (white box on tower) is powered by the solar module; irradiance and wind instruments are mounted at the top of the tower on booms; the rain gauge is to the right.

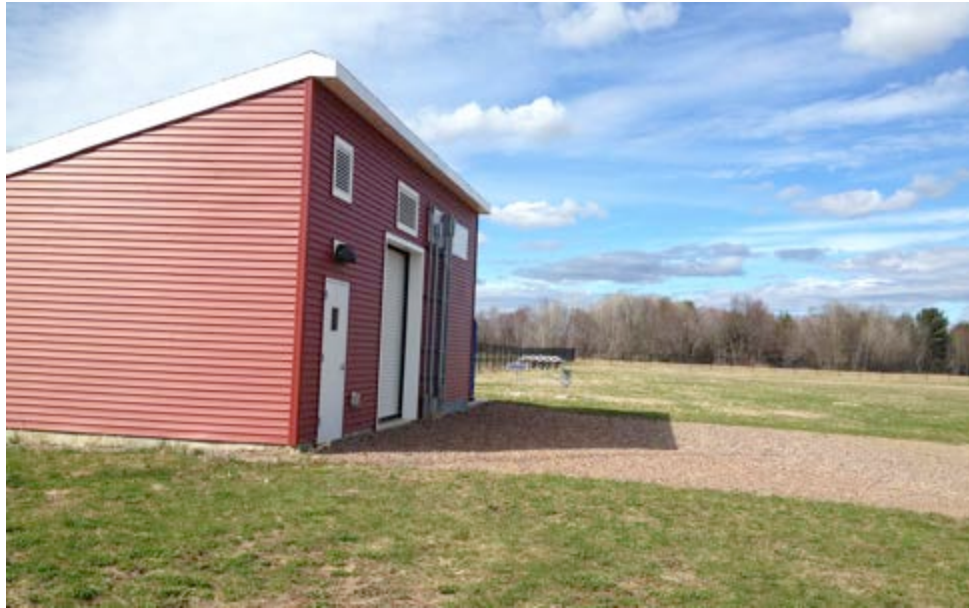
Figure 33. The Norwich/Chilicon/SolarWorld rooftop PV system will be installed on the roof of the Vermont RTC equipment shed.

Norwich Technologies/Chilicon Power/SolarWorld is the first multiple-company, all-American partnership for the RTCs. Norwich Technologies has developed a modular racking solution, called EZ-PV, which is pre-assembled at a plant in White River Junction, Vermont and then transported to a job site, where it can be installed and fully operational in less than a day. Chilicon is a start-up company manufacturing microinverters in California interested in gaining bankability data to enable market expansion. SolarWorld is a US module manufacturer interested in the comparative performance of two module types (mono- and poly-crystalline) on a west-facing roof. Each partner has donated equipment and time; together they have collaborated on a system design that Norwich will implement. Sandia will provide the monitoring system, collecting AC data from sensors and current transformers, and DC data from the Chilicon micro-inverters. The system is scheduled for installation in early FY16.

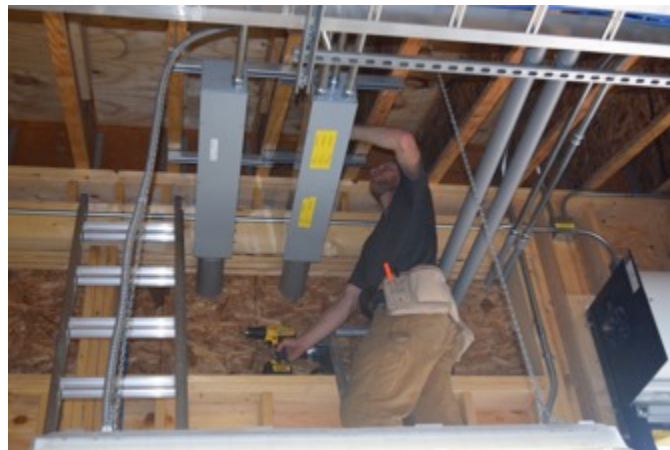
Figure 34. Norwich Technologies reinforces the rafters in preparation for the EZ-PV installation.
