ACCELERATED AGING AND TESTING OF THIN FILMS ON LTCC TEST VEHICLES

**The Rio Grande Symposium on Advanced Materials
October 6th, 2014.**

- ◆ Explore accelerated aging of thin films with presence of Sn-Pb solder on 9K7 low temperature co-fired ceramic (LTCC).

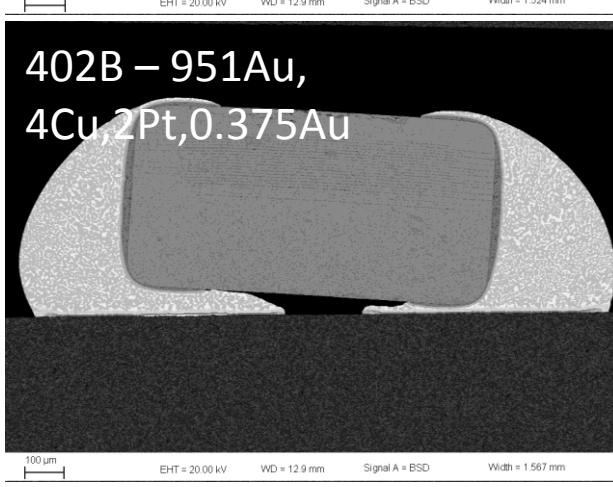
402B – 951Au,
4Cu,2Pt,0.375Au

Solder fillets are intact.
Pb-rich particles coarsened.
Pt-Sn IMC layer above Pt layer is prevalent.

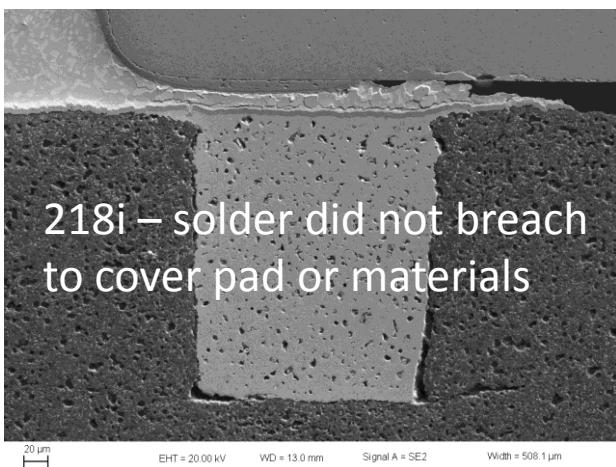
In solder region, Au-Sn IMC laths and discrete layer above Pt layer.
Pt and Cu layers showed NO signs of dissolution. There are creases.

Au-Sn IMC layer prevented solder breach to thin films, via caps, and via materials.

*Cracks in LTCC near fillet toes and cover pad. Clear separation of Cu layer from LTCC in 402i.
