ACCELERATED AGING AND TESTING OF THIN FILMS ON LTCC TEST VEHICLES

Sandia National Laboratories, Albuquerque, NM

**The Rio Grande Symposium on Advanced Materials
October 6th, 2014.**

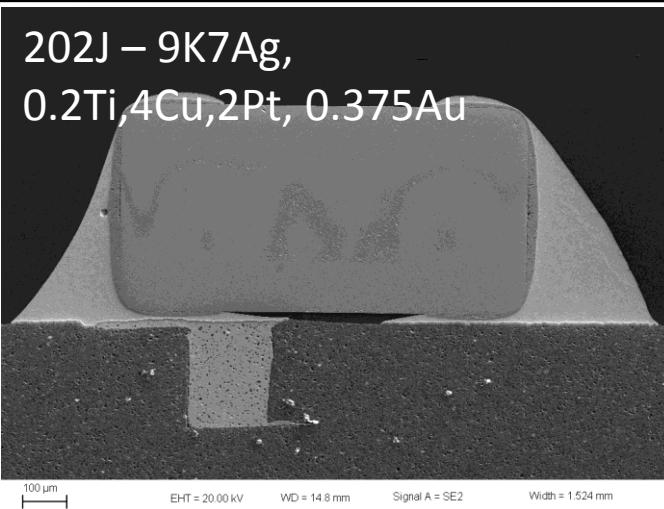
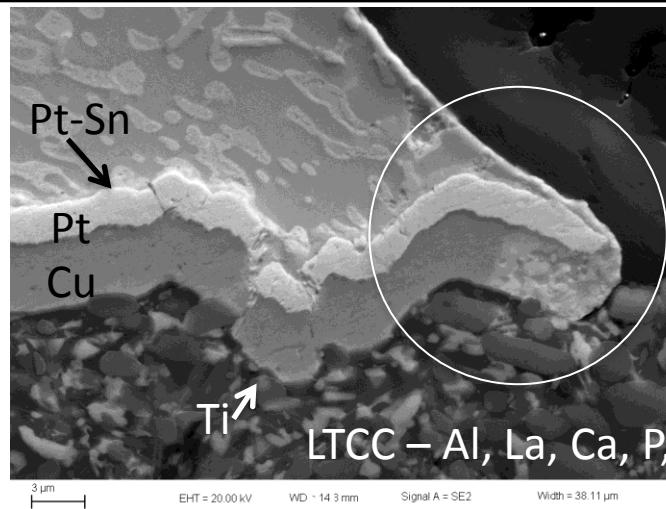
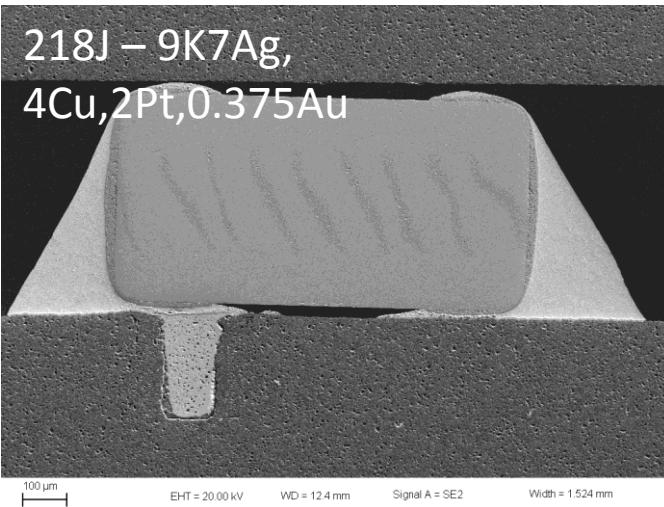
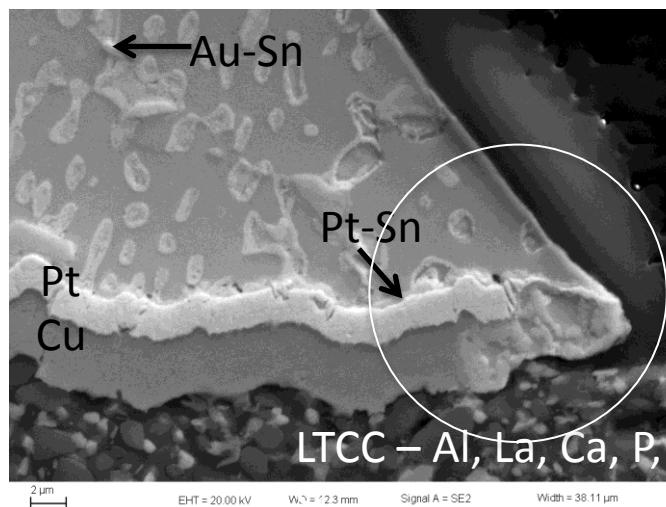
RT Baseline

Solder wetted pad corners during fabrication and continues to react with thin film layers.
Without Ti adhesion layer, solder can undermine the Cu layer.

These accelerate aging degradation.

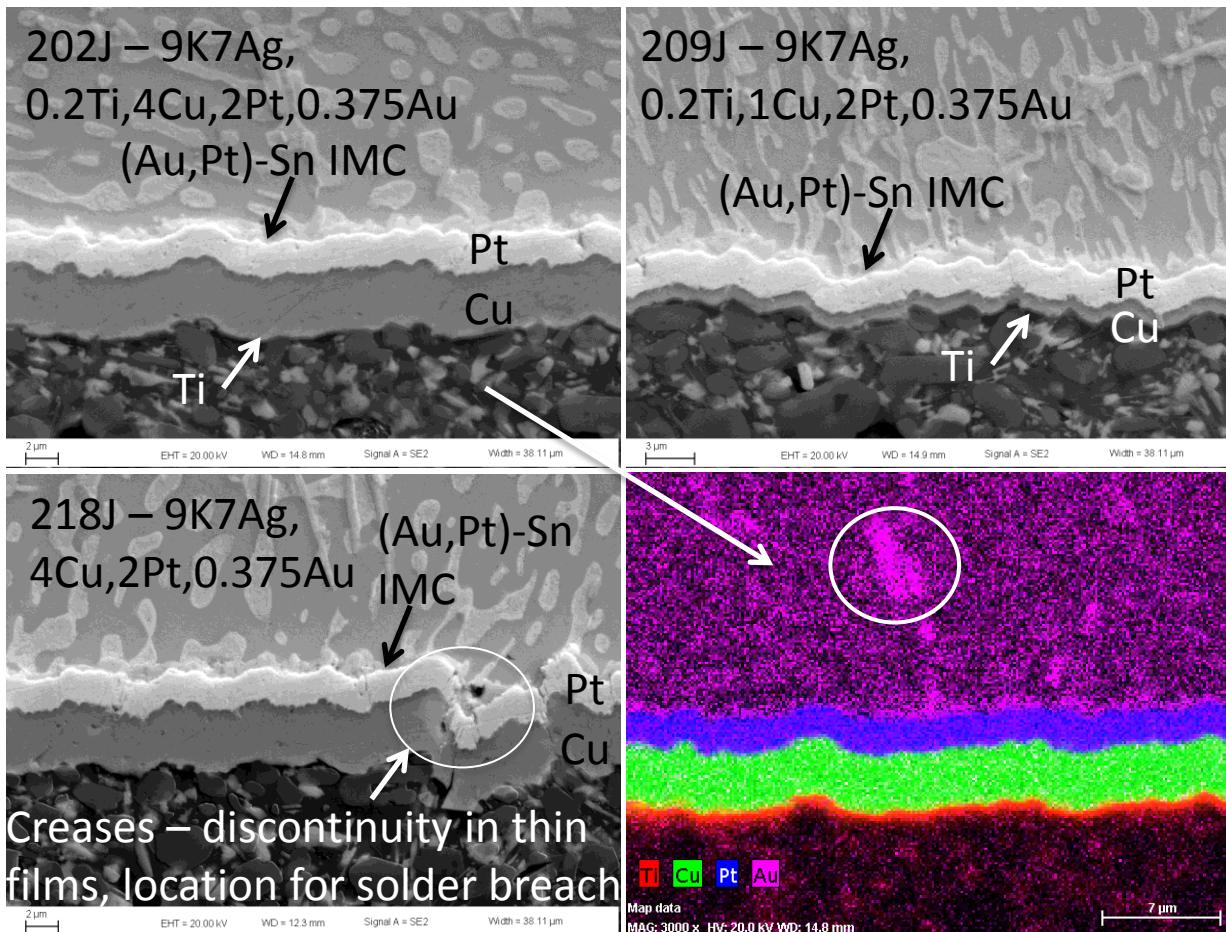
RT Baseline

- Images taken at the solder fillet. Dispersed Pb-rich particles & Au-Sn IMC laths in Sn-Pb solder.
- 9K7 surface roughness provides creases in the film stacks.
- Substrate surface topography can cause **thinned regions** and other **discontinuity defects** in the films *that accelerate aging degradation*.

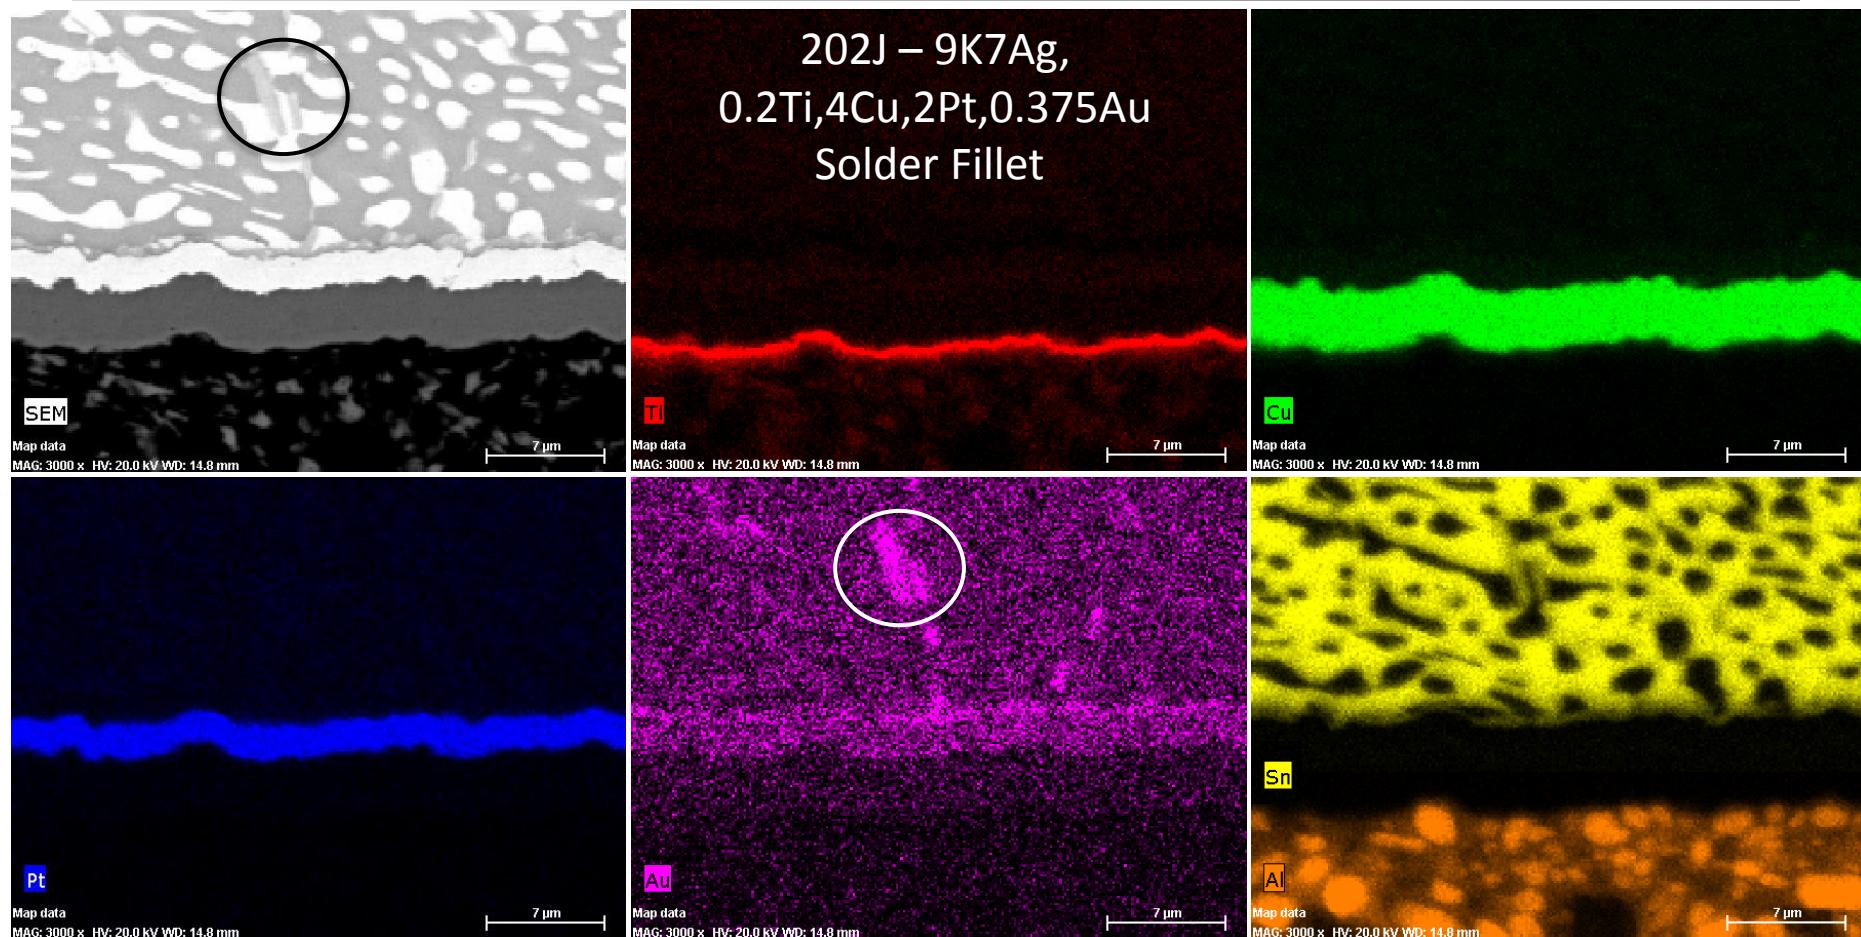
RT Baseline

- Au-Sn IMCs found in Sn-Pb solder fillet. Very thin Au-Sn IMC layer above the Pt layer.
- Discrete layers (LTCC → Solder) ~0.2um Ti, ~0.4um Cu, ~0.2um Pt, and ~0.5um Au-Pt-Sn IMC.
- Au and Pt peaks almost overlap.

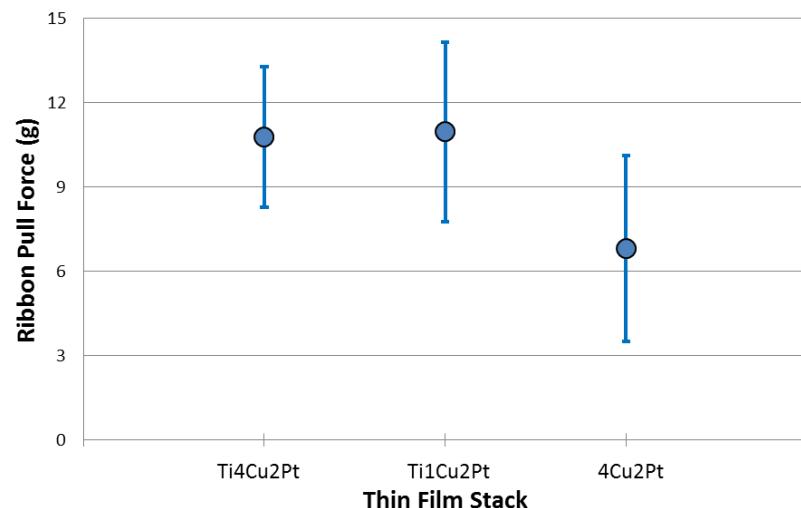
Ribbon Pull Forces, Room Temp Aging

- With Ti → failed in solders
- Without Ti → thin film/LTCC separation

- All samples failed in the ribbons.

- Ti layer needed for higher pin pull and ribbon pull forces.

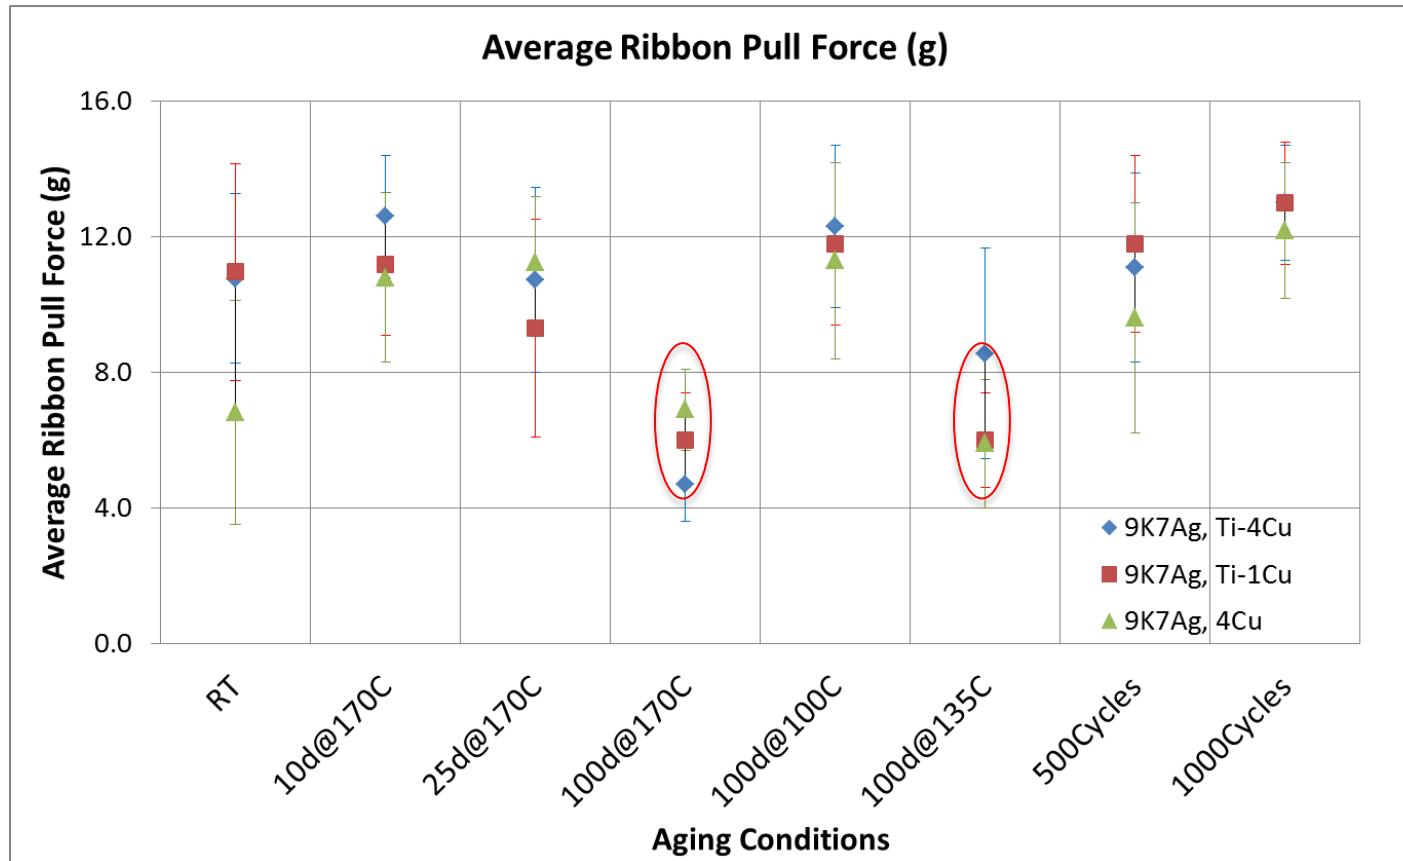
◆ Average Ribbon Pull Forces

- All failures were in the ribbons.
- Annealed ribbons have lower strengths (100days @ 135°C and 170°C).

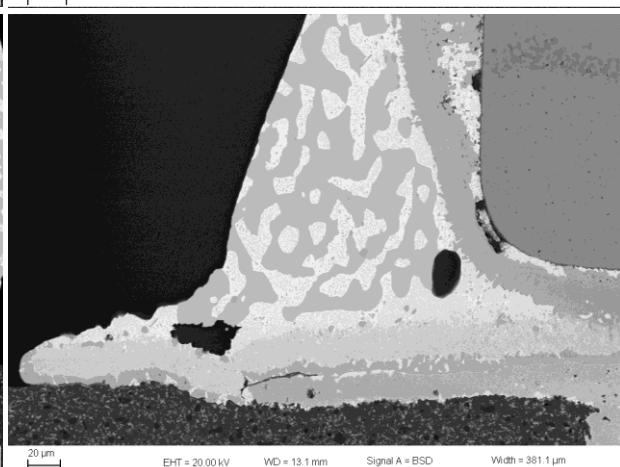
Solder interaction with thin films → increasing intermetallic compound (IMC) formation.
Pb-rich particles coarsened in the solder fillets.

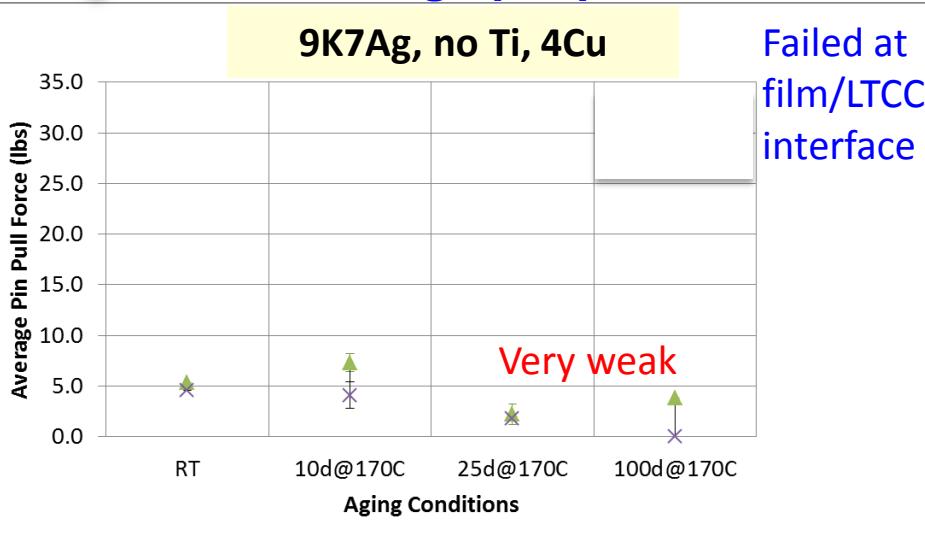
Average pin pull forces, 10, 25, 100 days at 170°C, 9K7Ag 4Cu.

*Separation between film stack/LTCC at RT.
Pin pull forces were weak.

- **10d**: IMCs formed above/below Pt layer. Cu layer was compromised.
- **25d**: Pt and Cu almost completely consumed. Significant IMC in solder.
- **100d**: significant IMCs, Solder reacted with all thin film layers. Cracks found in IMCs.

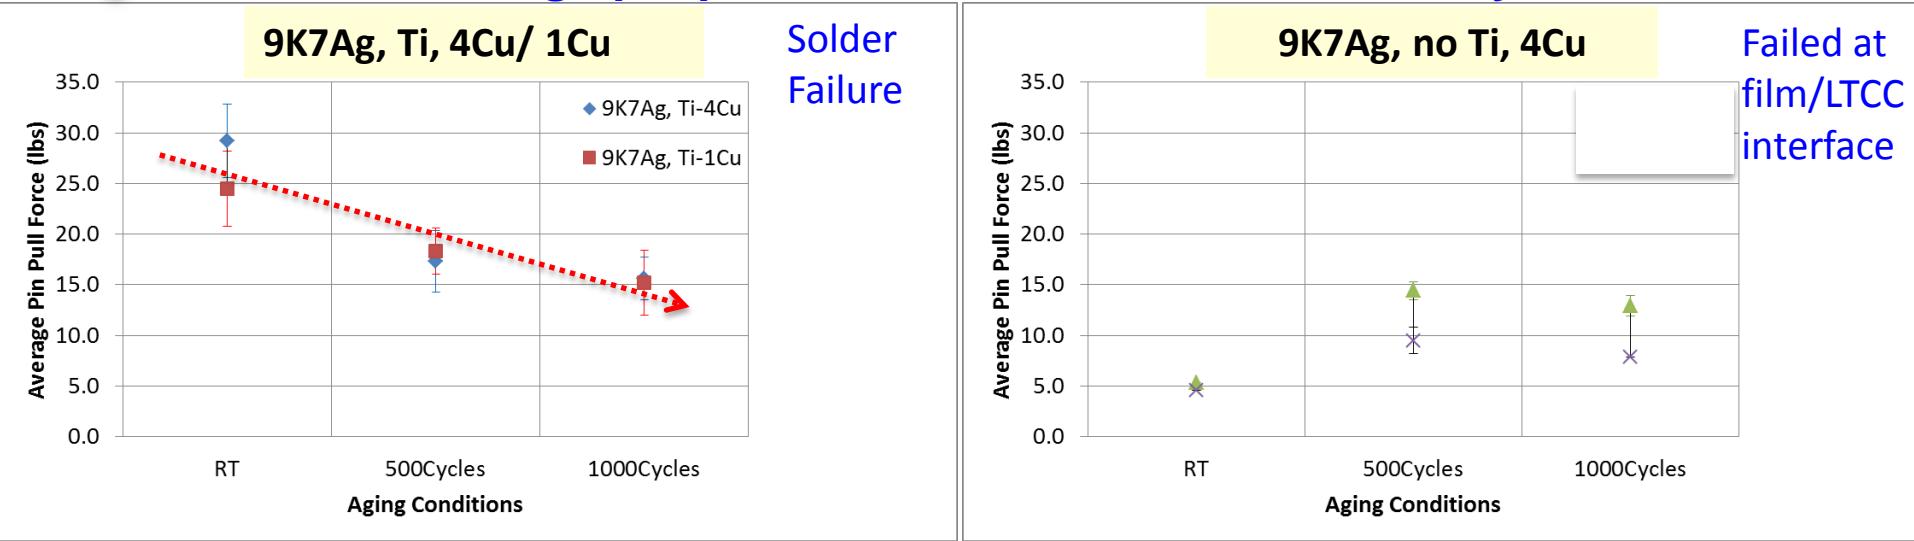
Average pin pull forces, 500 and 1000 thermal cycles.

- Pin pull forces:
 - Little effects from Cu thickness
 - Large effects from presence/absence of Ti
- Thermal cycling induces thermomechanical fatigue (TMF) between the pin, solder, and 9K7 LTCC caused drop in pin pull forces.
- Without Ti, adhesion between thin film and LTCC is poor. Little effects from thermal cycling on pin pull forces were observed.

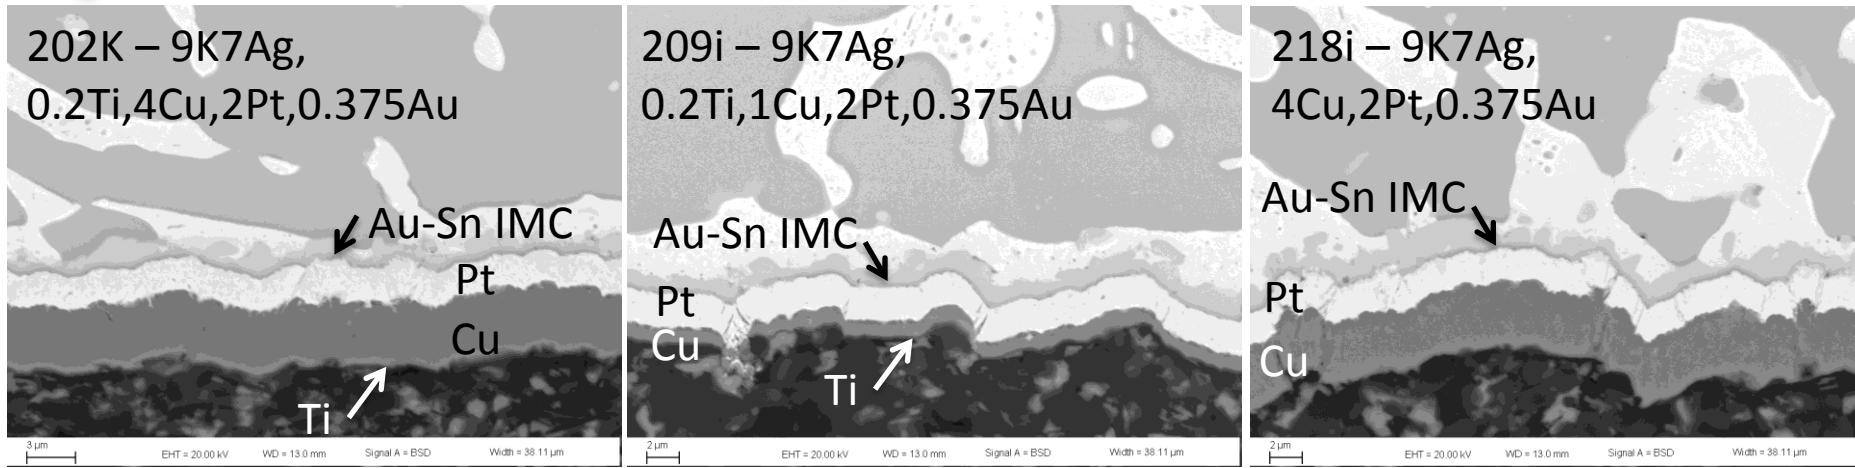
Microstructures at 1000 thermal cycles.

- Microstructural examination of 1000 thermal cycle samples revealed:
 - Pt and Cu layers showed NO signs of dissolution.
 - Au-Sn IMC formed above Pt layer. This IMC layer helped retard solder – Pt interaction and decreased likelihood of solder breaching/interaction with thin film stack.
- Due to low IMC volumes, pin pull forces did not appear to decrease much with thermal cycling.

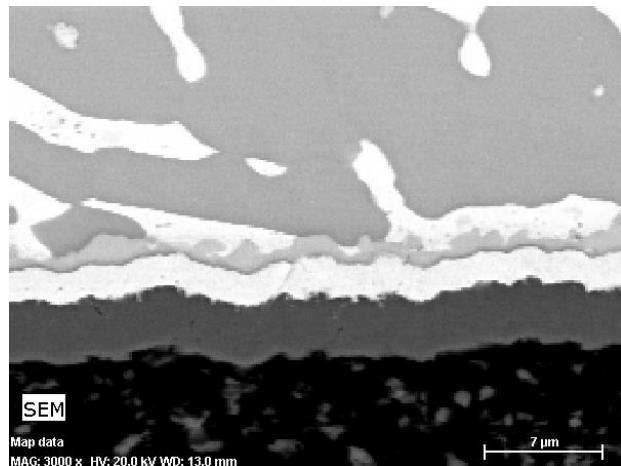
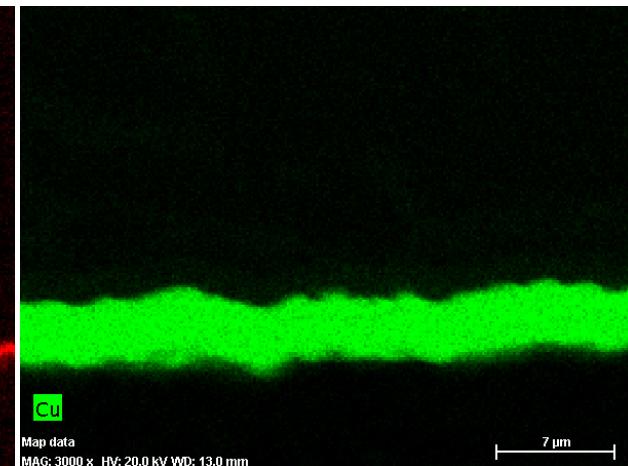
LTCC Solid-State Aging – 1000 Thermal Cycles

Discrete layers (LTCC → Solder) Ti, ~0.4um Cu, ~0.2um Pt and [~1.7um Au-Sn IMC](#).
Pt and Cu layers appeared to be undisturbed.

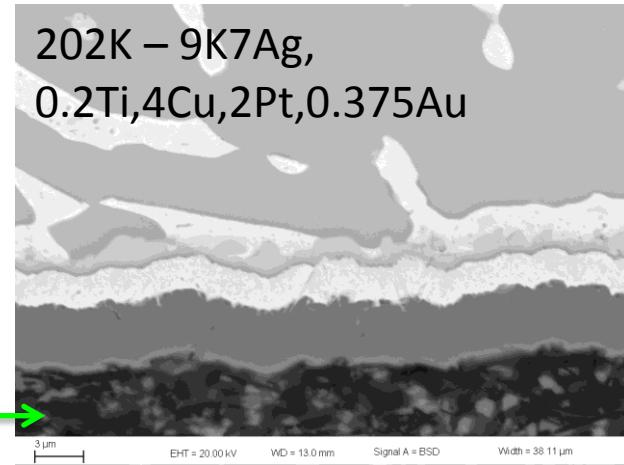
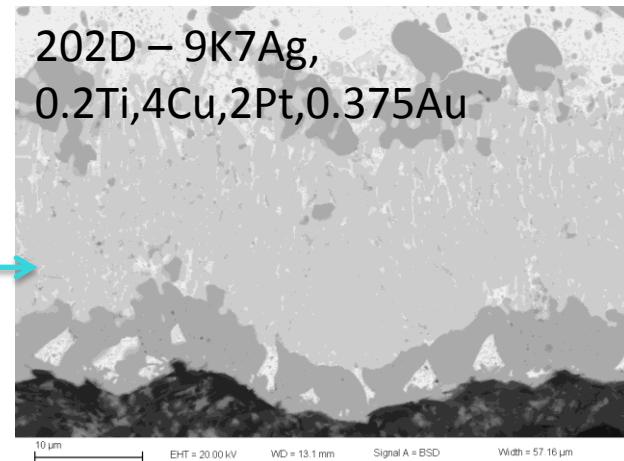
Au-Sn IMC layer formed above Pt layer, providing a barrier layer between solder and Pt. Thermomechanical fatigue from thermal cycling reduced pin pull forces.

Solder breached and interacted completely with all thin film layers, forming large volume of IMCs (brittle phases), degrading the mechanical integrity of solder joins (>75% drop in pin pull forces).

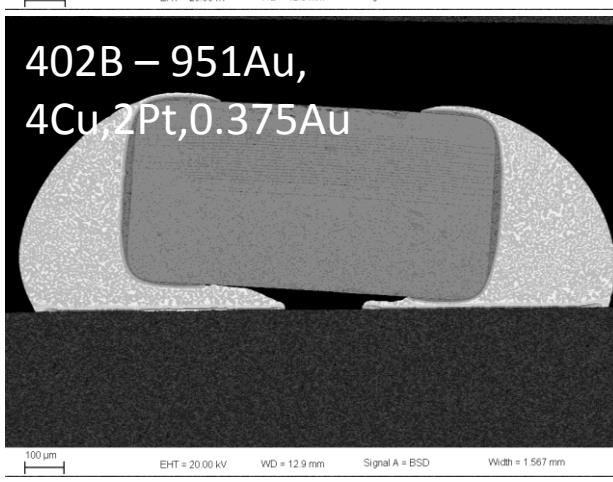
Solder fillets are intact.
Pb-rich particles coarsened.
Pt-Sn IMC layer above Pt layer is prevalent.

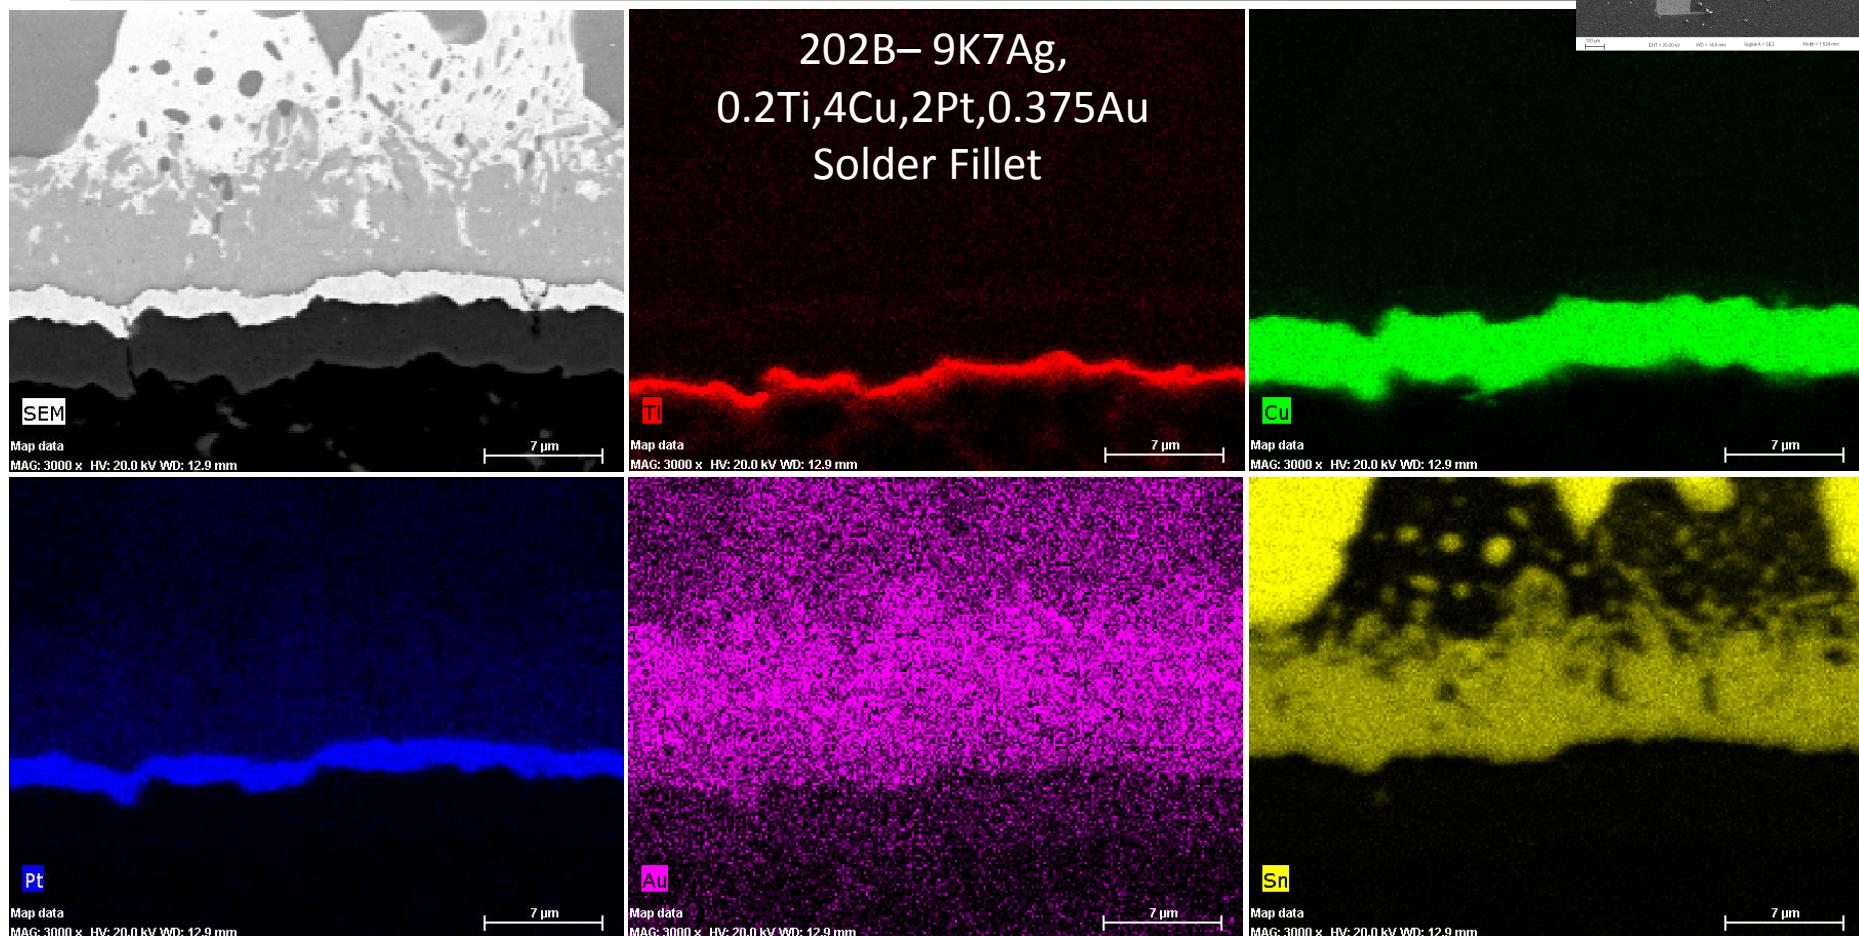
Discrete layers (LTCC → Solder) ~0.2um Ti, ~0.4um Cu, ~0.2um Pt.
Pt-Sn IMC above the Pt layer. Cu layer was not disturbed.
Note that Au and Pt peaks almost overlap.

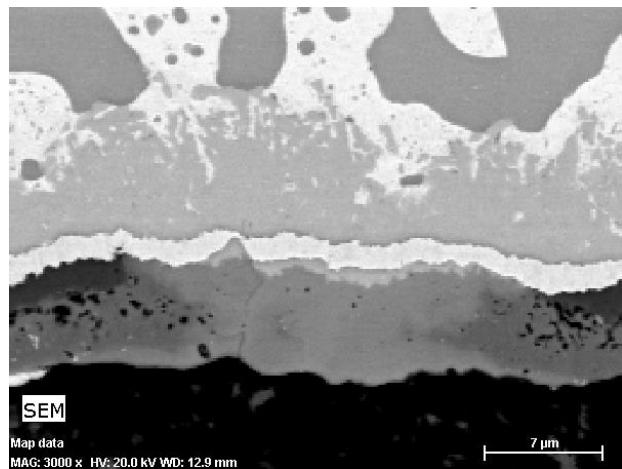
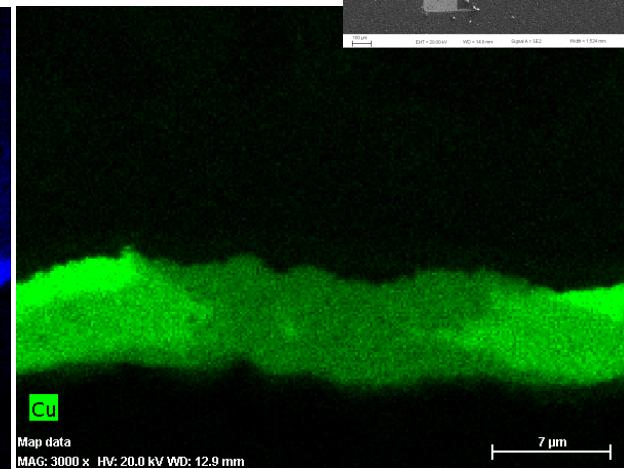
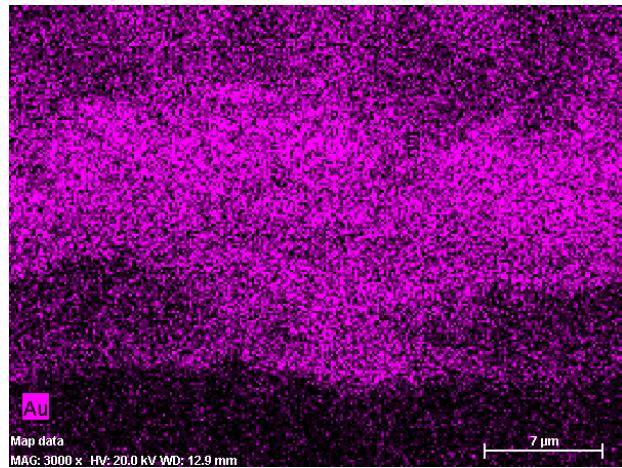
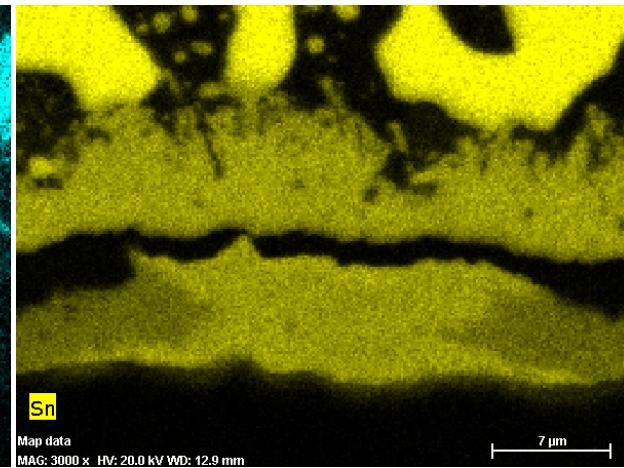
Solder breached through creases in Pt to LTCC.
Pt-Sn, Au-Sn, Cu-Sn IMC present.

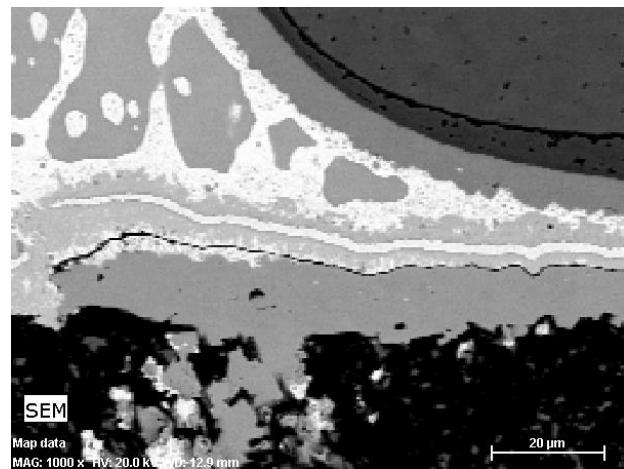
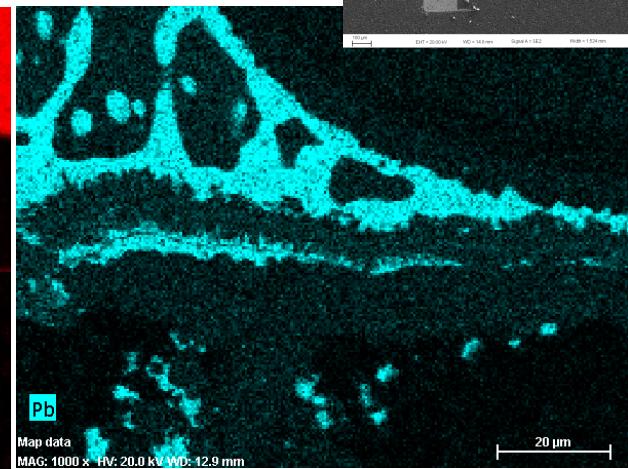
Ni-Sn IMC under capacitor Ni outer layer.
Ti layer lifted. Cu-Sn IMC not seen?

Via breached. Pb-rich particles segregated in Ag. Presence of Ag-Sn IMC and Sn-Pt IMC.

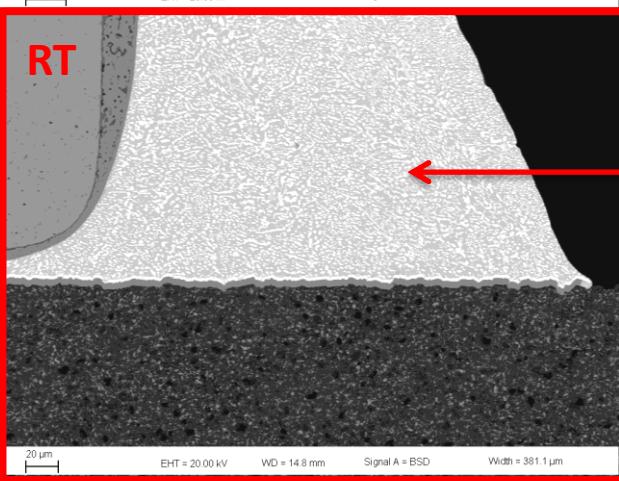
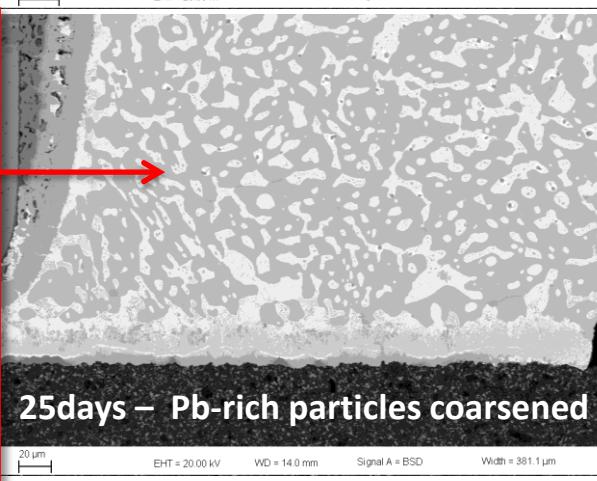
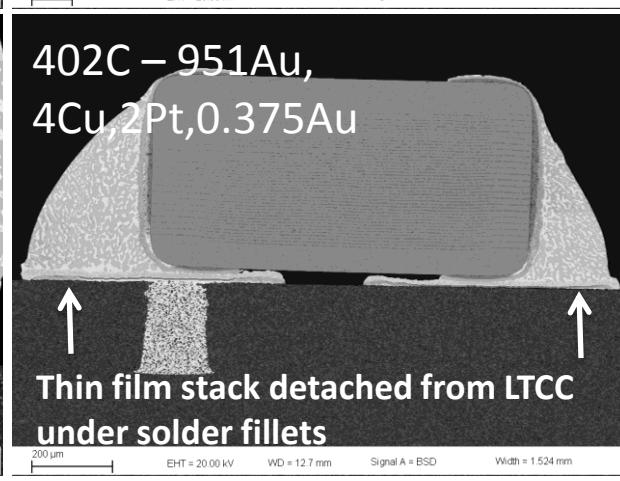
Solder fillets are intact.
Pb-rich particles coarsened.

Without Ti adhesion layer, thin films delaminated from LTCC under solder fillets.
Solder breached and interacted with Pt and Cu almost completely at the fillets.

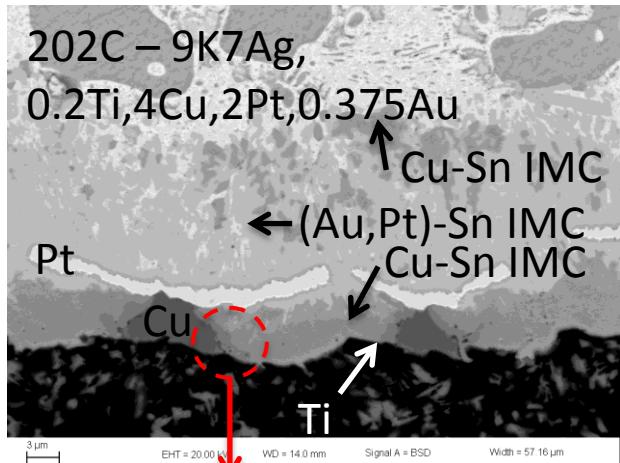
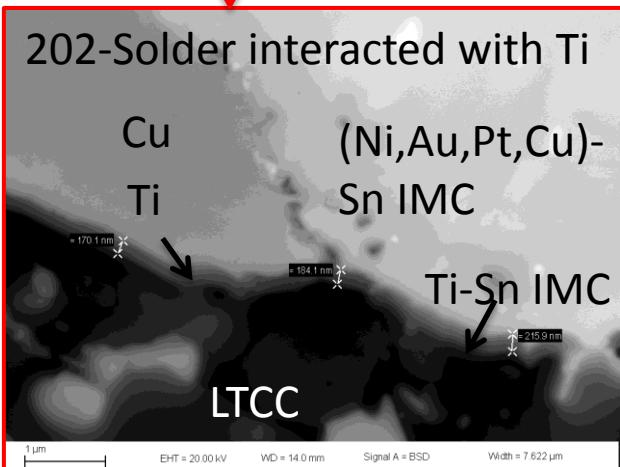
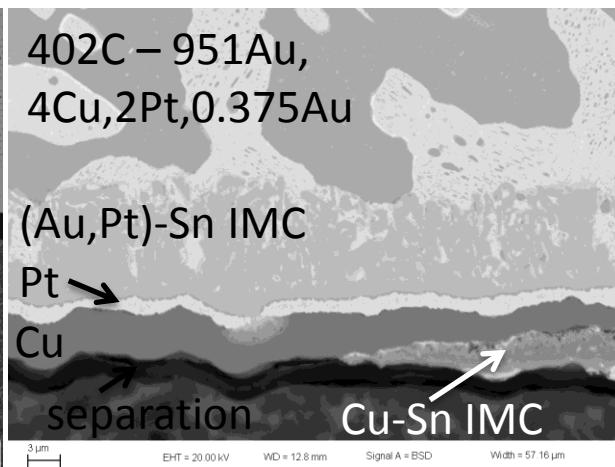
Solder reacted with Pt, breached through and reacted with Cu to great extent
402B appeared to have the least Sn-Cu interaction.

Observed signs of Sn reacted with Ti.

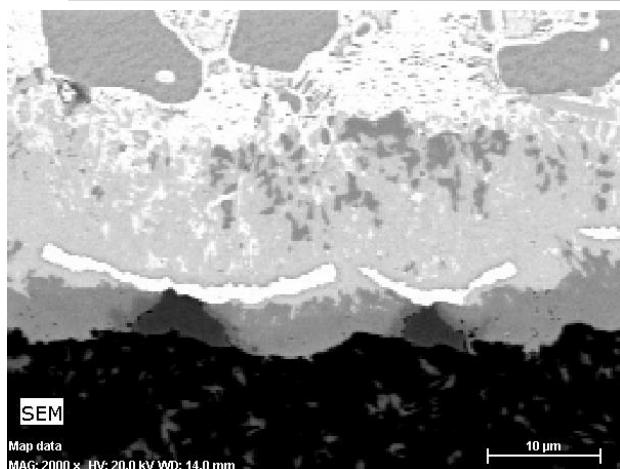
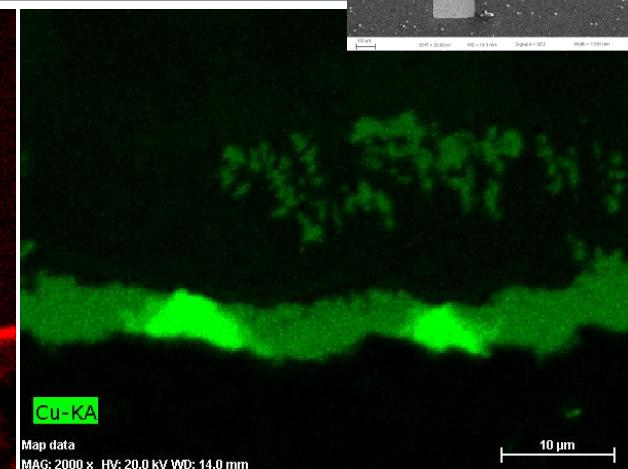
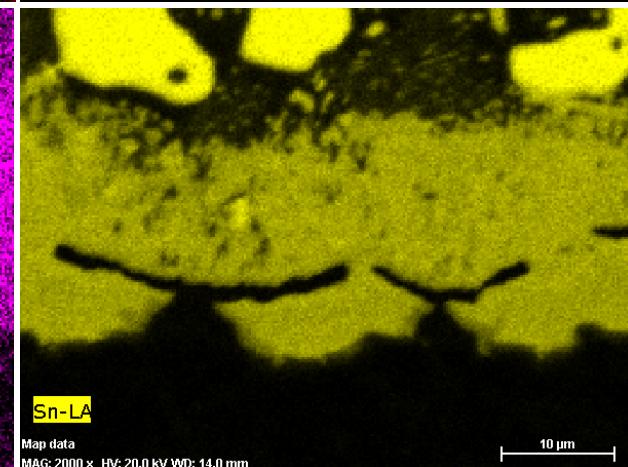
Solder breached through Pt layer from top.
Sn reacted with all elements- Au, Pt, Cu, Ti-in film stack.
Islands of unreacted Cu in film stack.

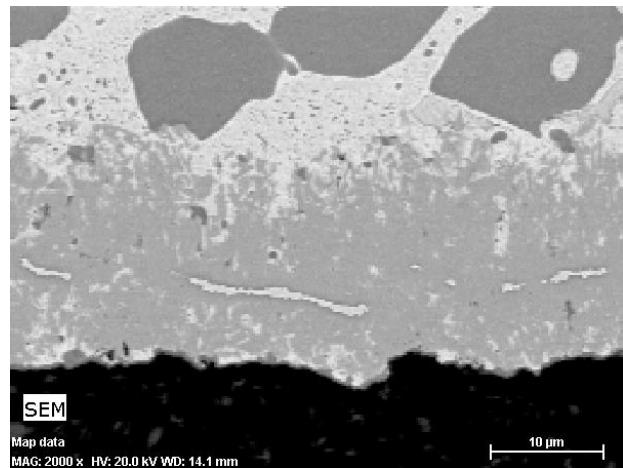
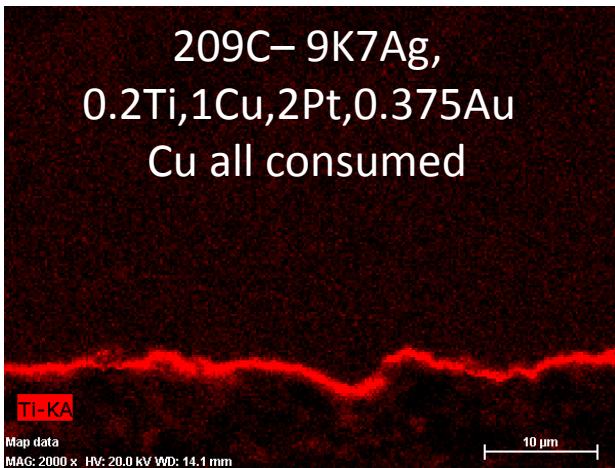
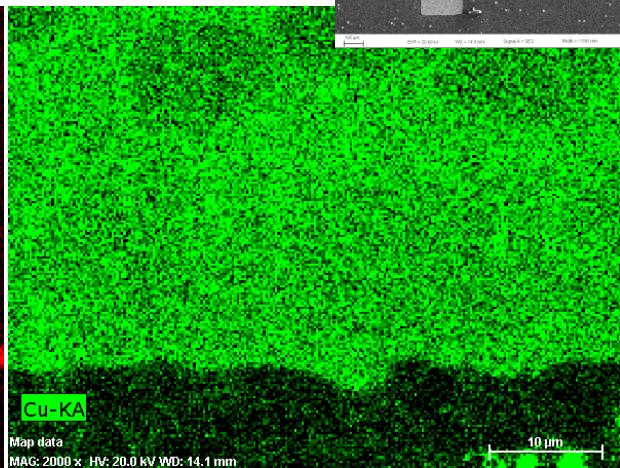
Sn reacted with all elements in thin film stack - Au, Pt, Cu, Ti.
All Cu in the film stack is consumed. Pt in the film stack is almost all consumed.

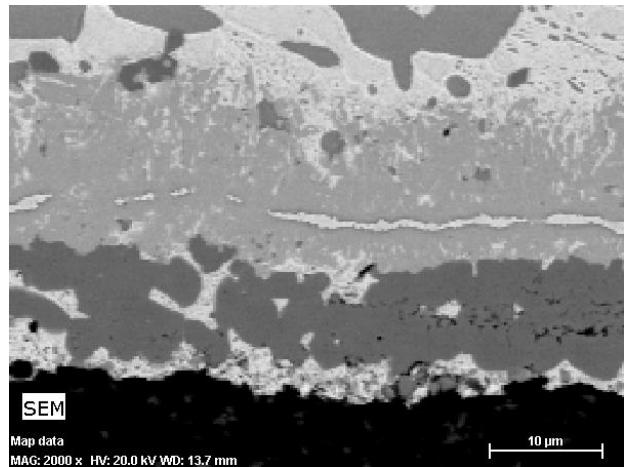
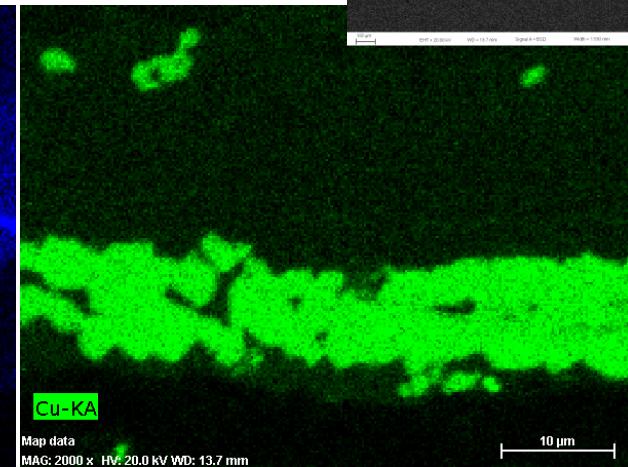
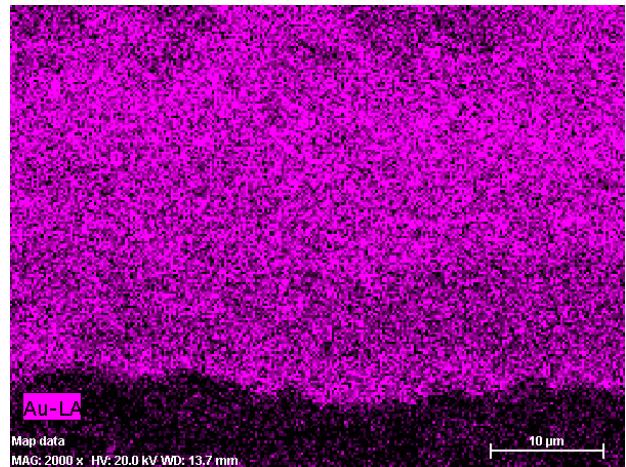
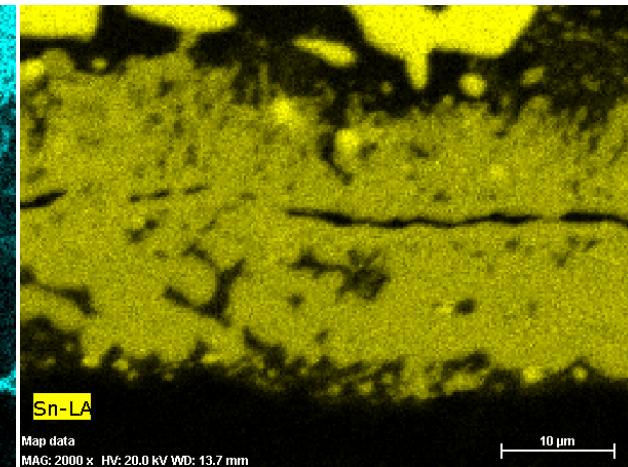
Sn reacted with all elements in thin film stack - Au, Pt, Cu and in the capacitor shells – Ni, Cu.

All Cu in the film stack is consumed. Pt in the film stack is almost all consumed.

Pb rich particles found at the thin film/LTCC interface were possibly due to molten solder undermining film stack during the time the joint was made because there was no Ti adhesion layer.

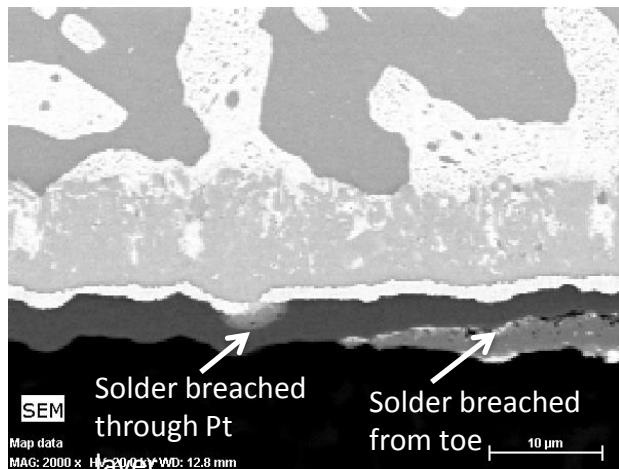
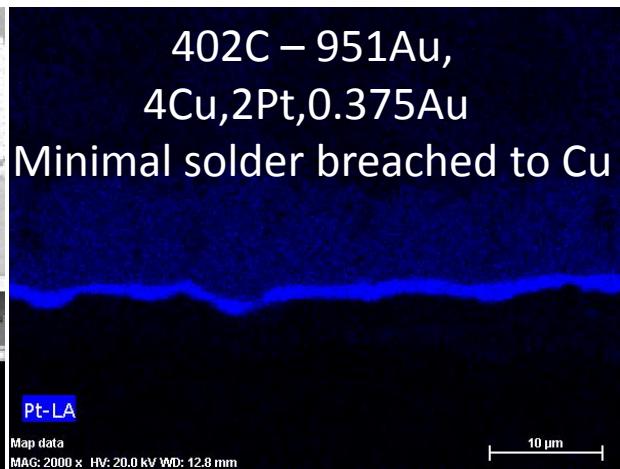
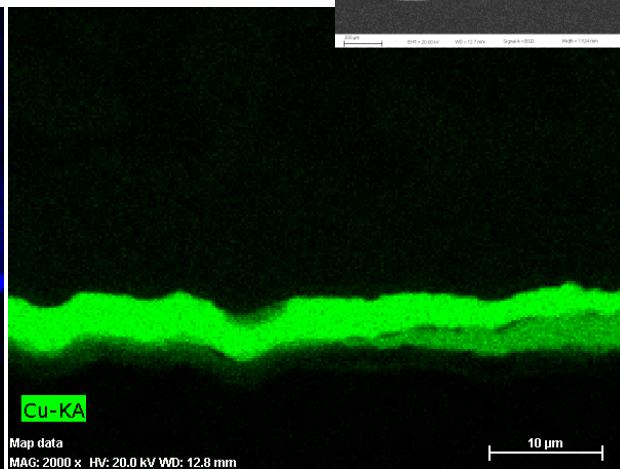
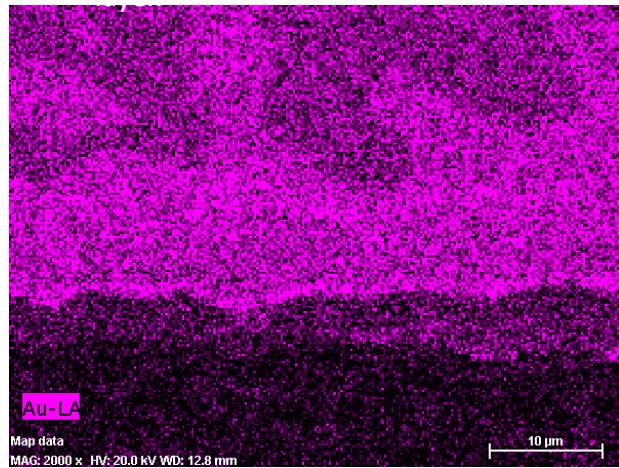
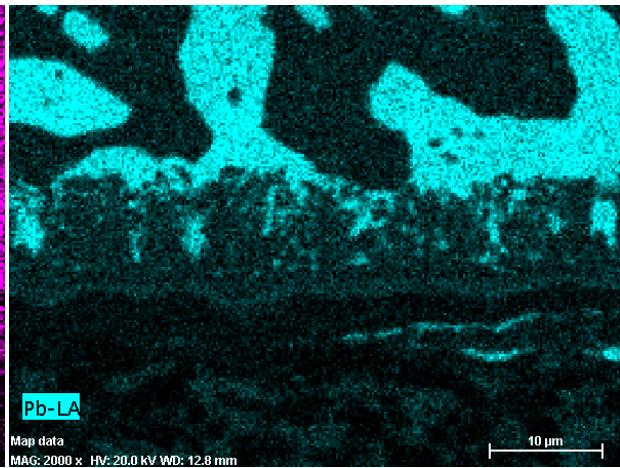
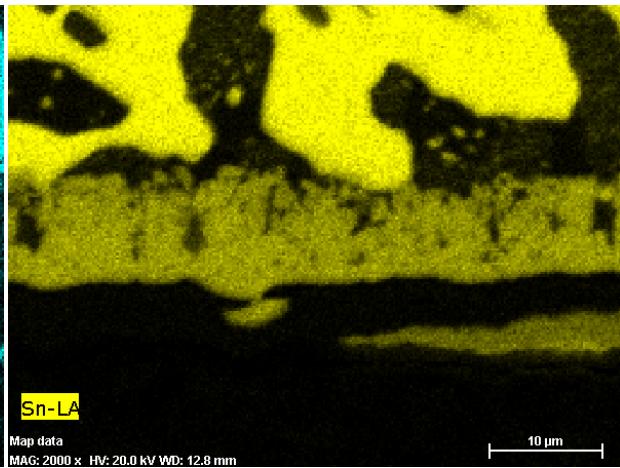
Solder breached from toe, reacted with Cu layer more quickly than solder breached through Pt from top.
Pt layer is mostly intact.

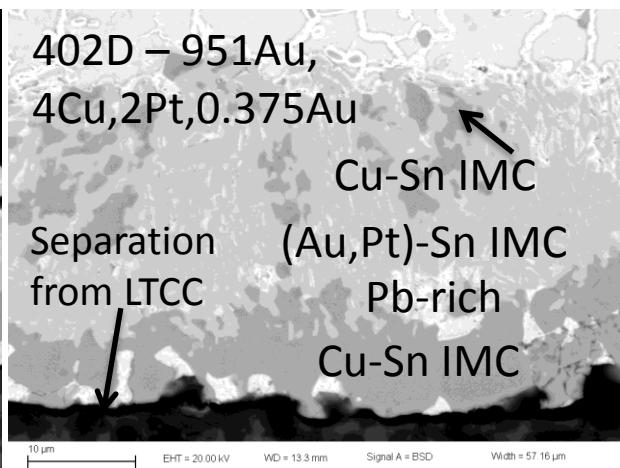
All joints composed of Pt-Sn, Sn-Cu, and Ti-Sn IMCs with many segregated Pb-rich particles.
Micro-cracks in regions near or in Cu-Sn IMCs.
Clear separations from LTCC.

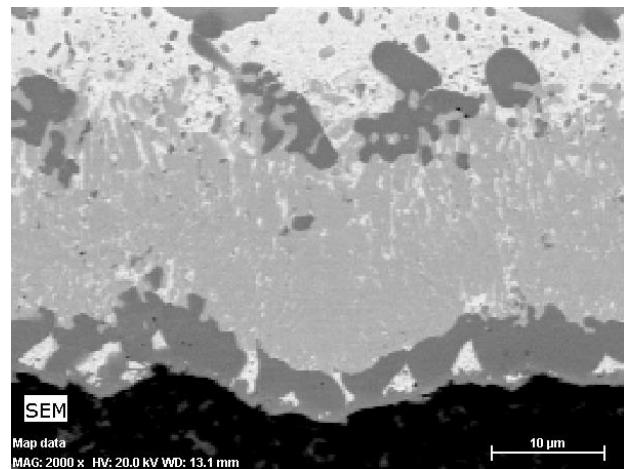
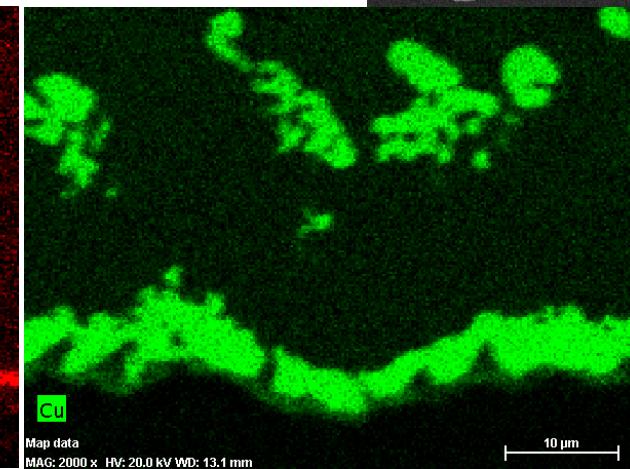
Sn reacted with all elements in thin film stack - Au, Pt, Cu, Ti.
The Cu-Sn IMCs appeared scalloped with Pb-rich pockets between them.

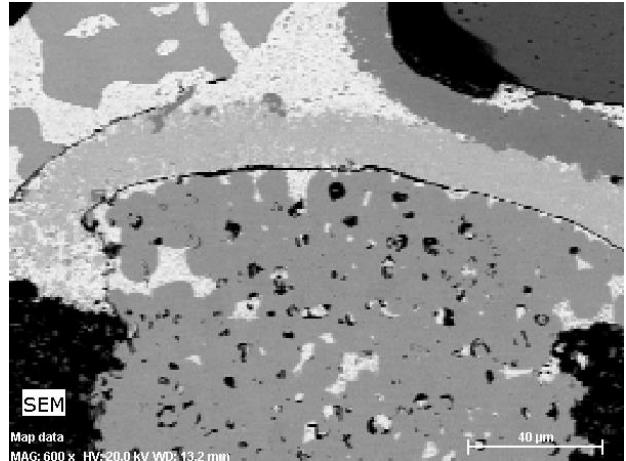
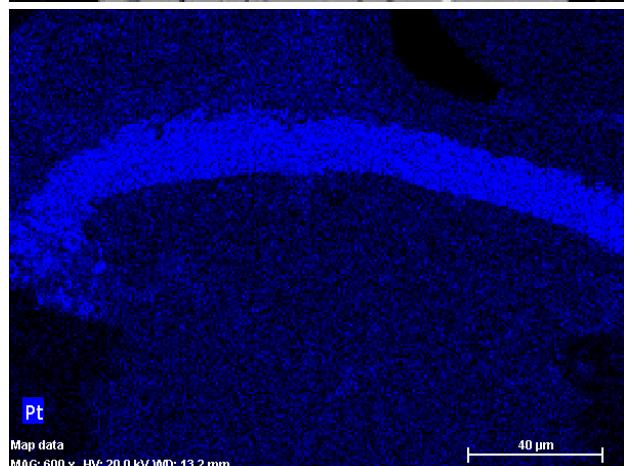
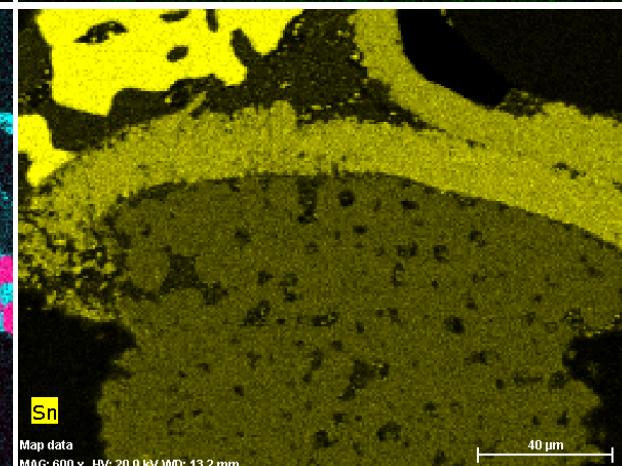
Ti layer lifted. Cu-Sn IMC at capacitor shell location and pockets in the solder.
Via breached. Pb-rich particles segregated in Ag. Presence of Ag-Sn IMC and Sn-Pt IMC.
