ACCELERATED AGING AND TESTING OF THIN FILMS ON LTCC TEST VEHICLES

Sandia National Laboratories, Albuquerque, NM

**The Rio Grande Symposium on Advanced Materials
October 6th, 2014.**

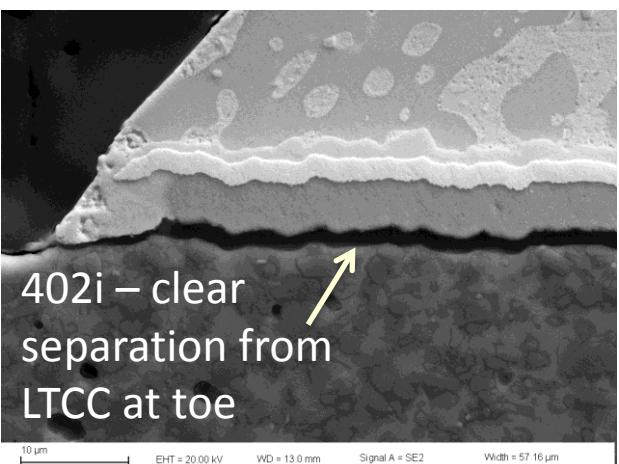
Solder fillets are intact. Films adhered to LTCC in samples with Ti layers.

All samples have long cracks starting from fillet toes in LTCC.

Pb-rich particles coarsened.

Discrete Au-Sn IMC layer above Pt layer, less laths dispersed in solder as in RT samples.

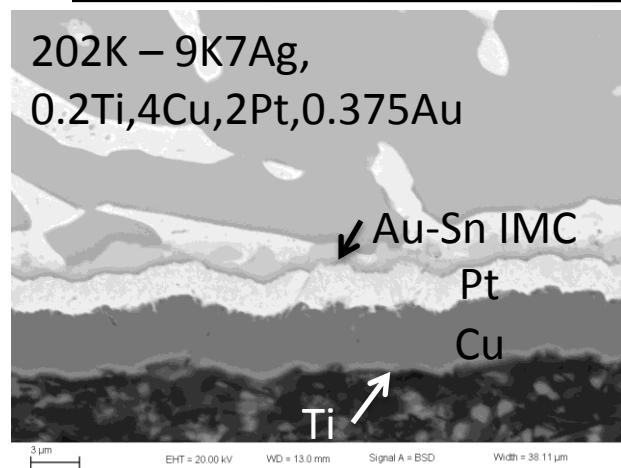
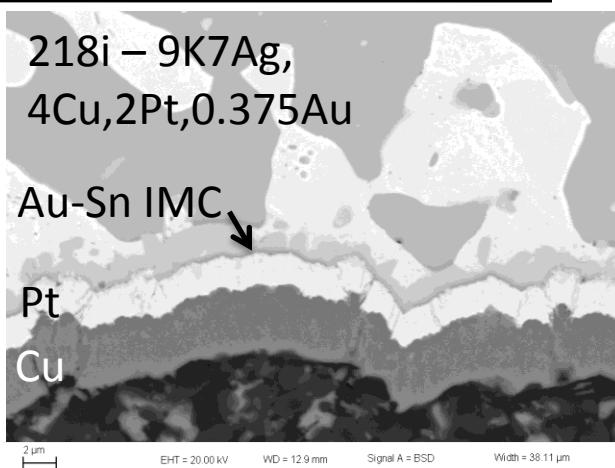
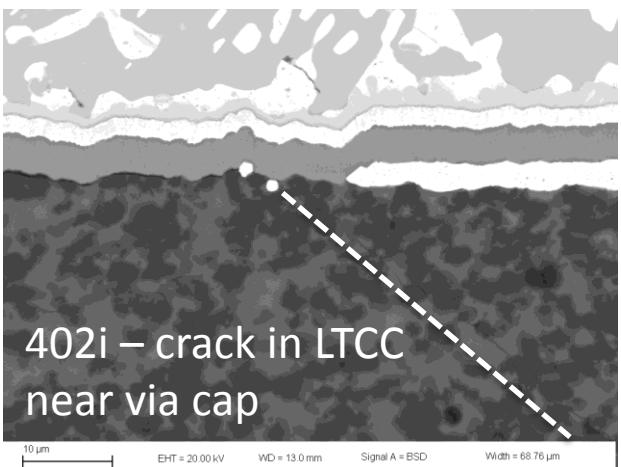
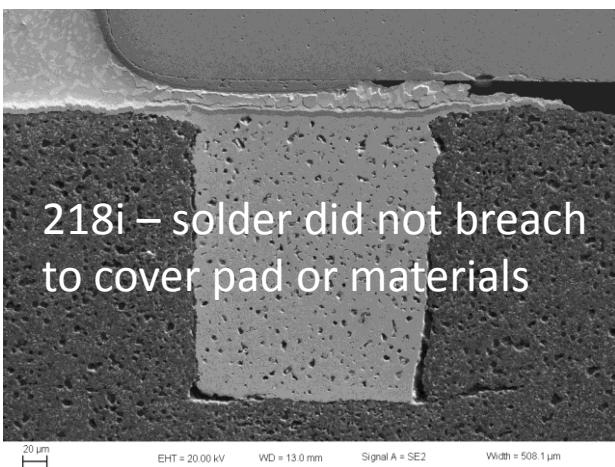
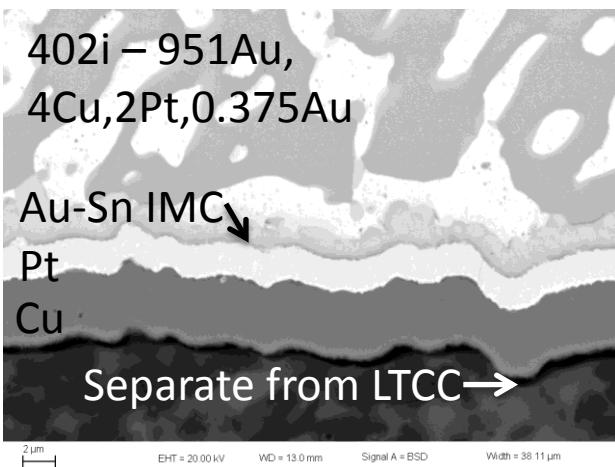
In solder region, Au-Sn IMC laths and discrete layer above Pt layer.
Pt and Cu layers showed NO signs of dissolution. There are creases.

Au-Sn IMC layer prevented solder breach to thin films, via caps, and via materials.

*Cracks in LTCC near fillet toes and cover pad. Clear separation of Cu layer from LTCC in 402i.

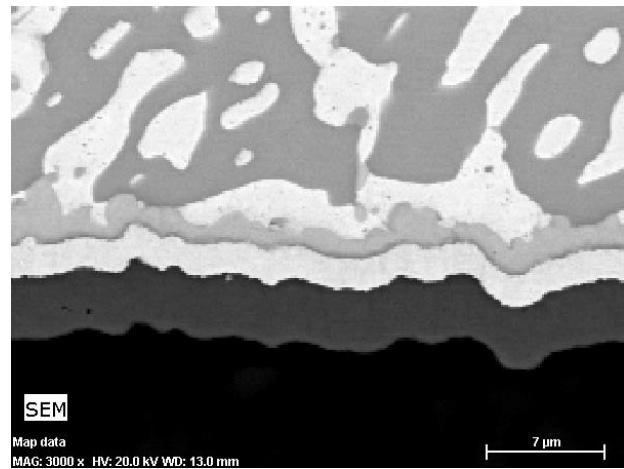
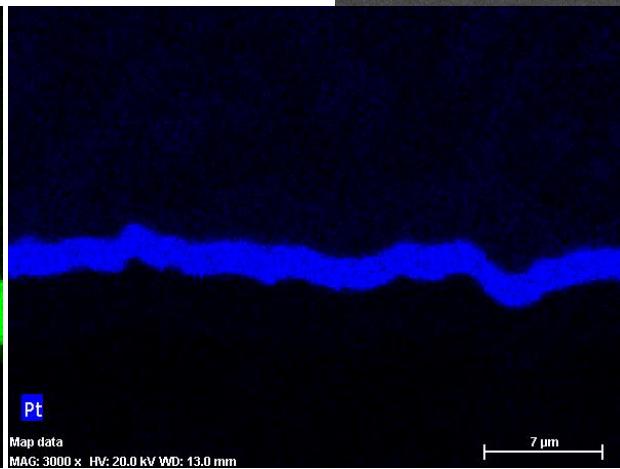
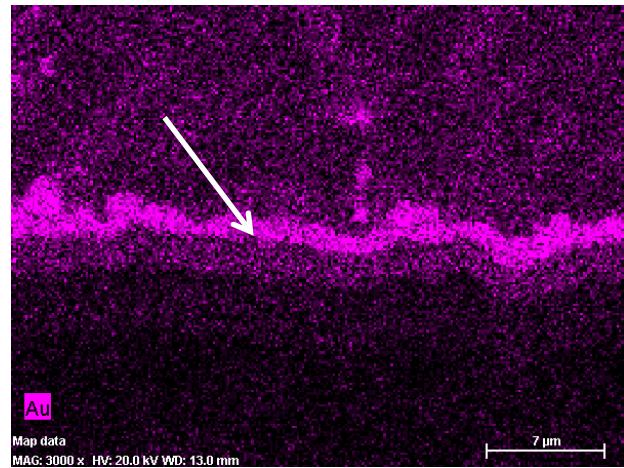
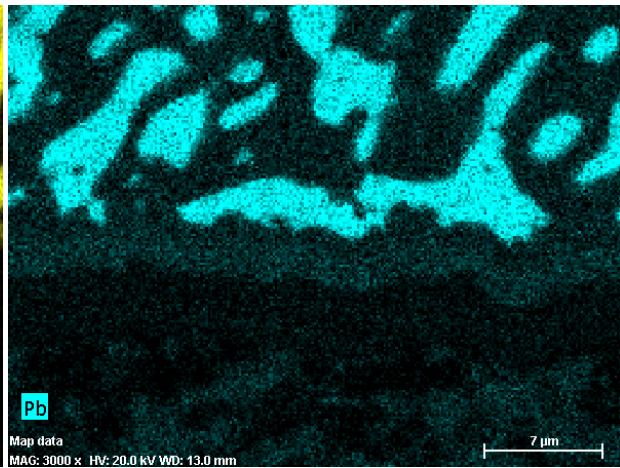
402i – 951Au,
4Cu,2Pt,0.375Au
Solder Fillet

Discrete layers (LTCC → Solder) ~0.4um Cu, ~0.2um Pt and ~1.7um Au-Sn IMC.
Sn only reacted slightly with Pt layer.
Cu layer appeared to be undisturbed.

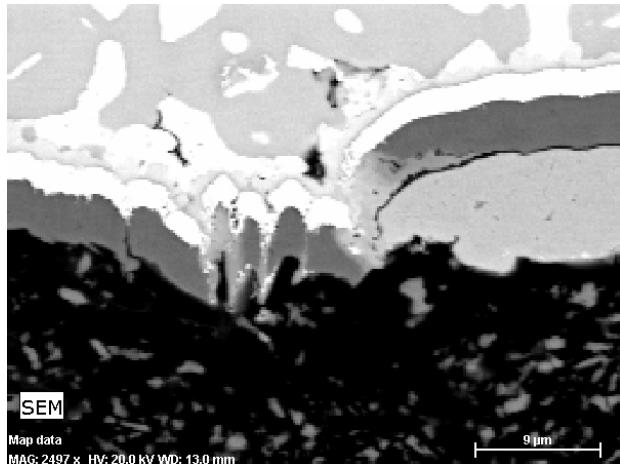
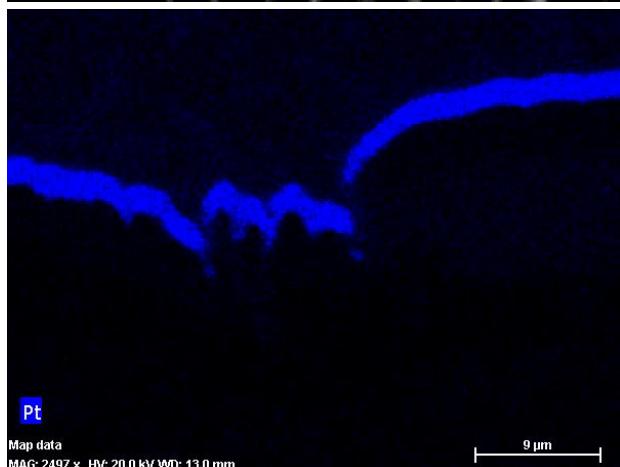
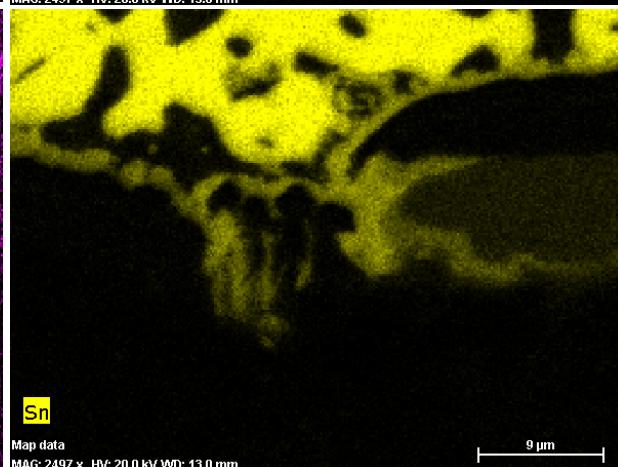
Creases in thin film stack provided discontinuity in the Pt.
Sn reacted with Pt, Cu, Ti and Au to form IMCs.
Via breached. Sn reacted with Ag via material to form Ag-Sn IMC.
