Recipe for Insulating a Noble Metal Alloy Electrical Contact:  
Stick it in an “Inert” Lubricant, Rub and Shake it

B.L. Nation, M.T. Dugger, and N. Argibay

# The Problem

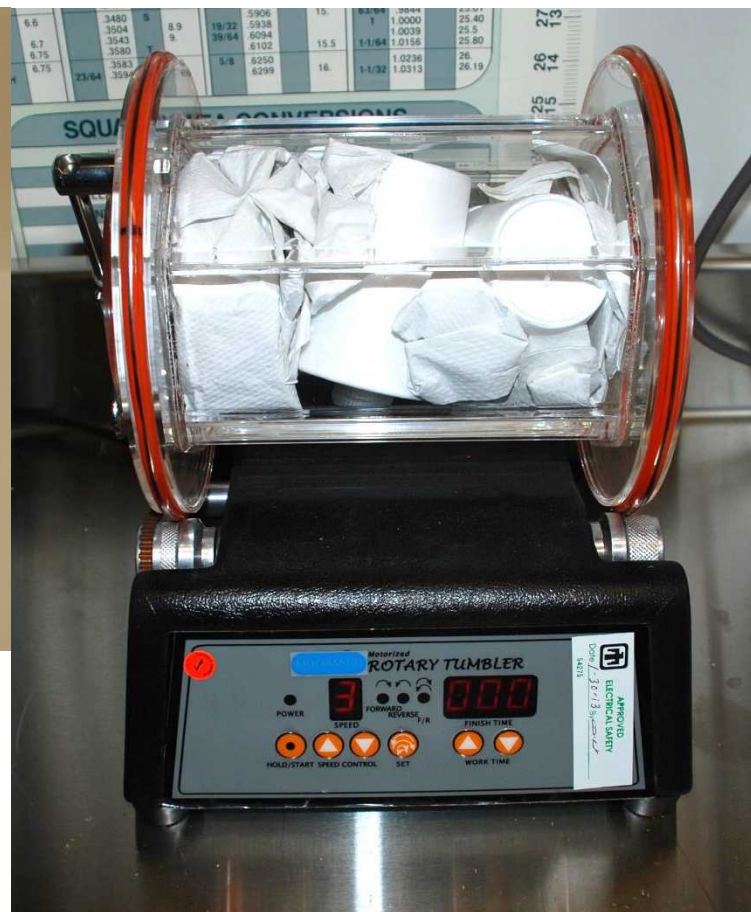
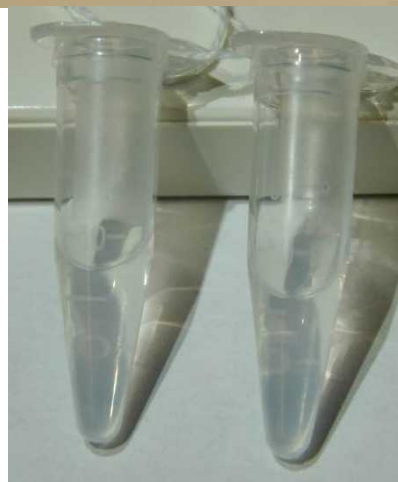
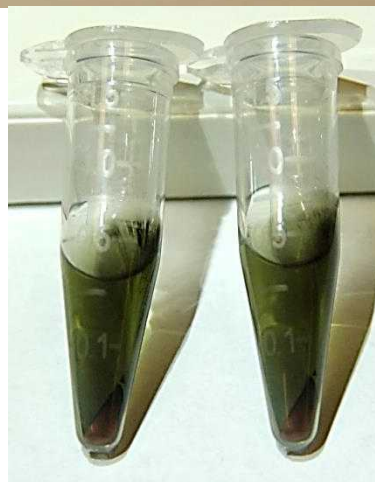
# Mechanism Investigation

Since 440C has higher mass and lower thermal conductivity we can rule out shear and thermal degradation because it did not produce reaction product
