# Temperature-dependent deformation behavior of highly nanotwinned Cu

Timothy A. Furnish<sup>†‡</sup>  
Andrea M. Hodge<sup>†</sup>

<sup>†</sup>University of Southern California  
Dept. of Aerospace & Mechanical Engineering, Los Angeles, CA 90089

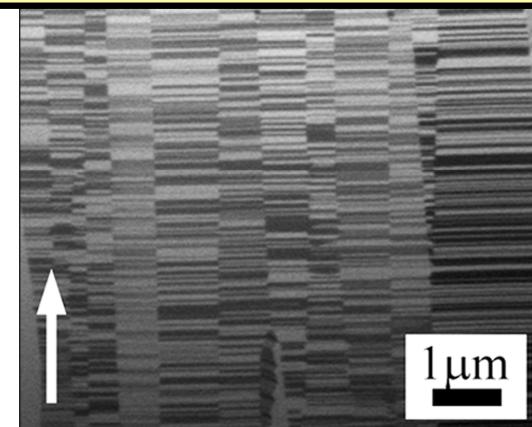
- The typical resulting microstructure:

- Highly aligned columnar grains
- High density of nanotwins parallel to substrate

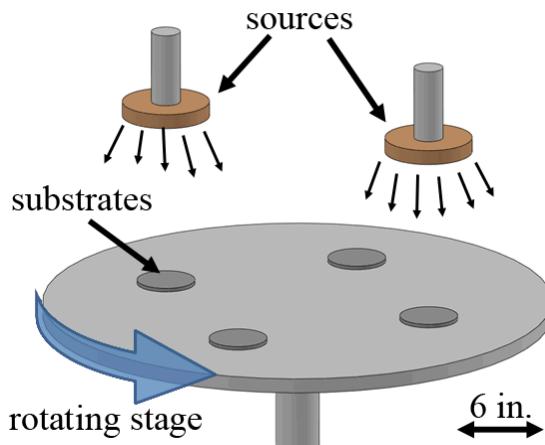
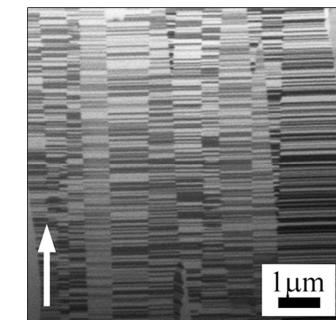
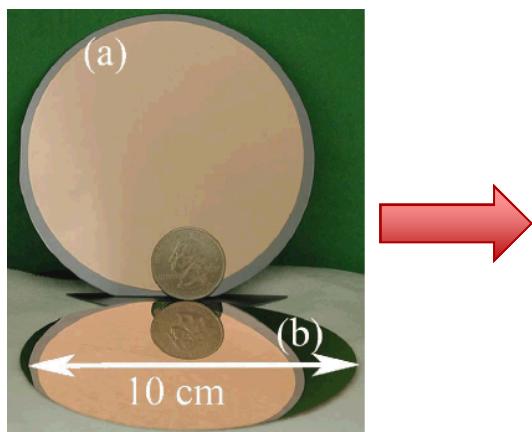
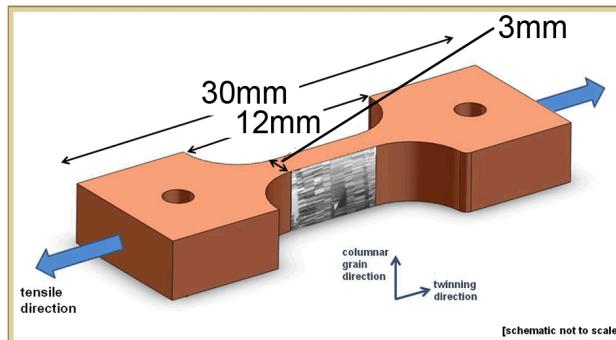
# Magnetron sputtering was used to produce highly nanotwinned “thick” foils

- A modified multilayer sputtering approach was developed at LLNL for the synthesis of highly nanotwinned Cu
- Cu-Cu layers (99.99+ % purity) were deposited onto 10 cm diameter Si wafers
- Cu foils (170  $\mu$ m thick) were removed from the substrates to be free-standing
- Microstructural features:
  - 500-800 nm columnar grain widths
  - 40 nm average twin thickness

- Tensile dogbones were die-cut
  - Gauge width: 3mm
  - Gauge length: 6mm (measured using non-contact laser extensometer)

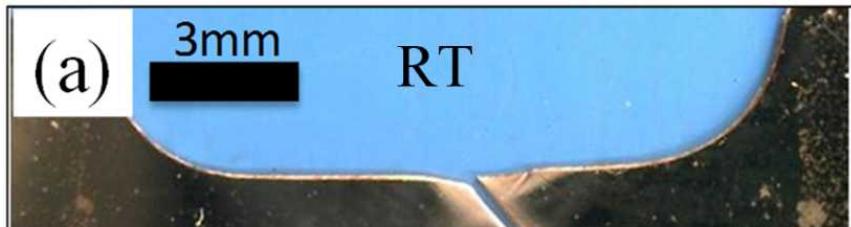
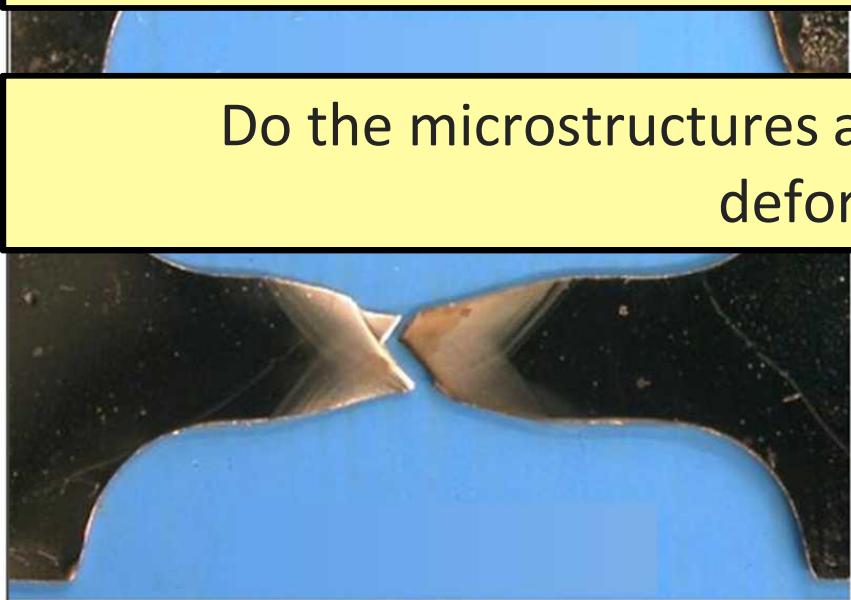
# Shear band formation was observed to be the primary deformation mechanism at both temperatures

RT:

- Two predominant bands with fracture occurring along the primary band (first)

throughout gauge section

- Much more necking
- Cup-and-cone fracture profile

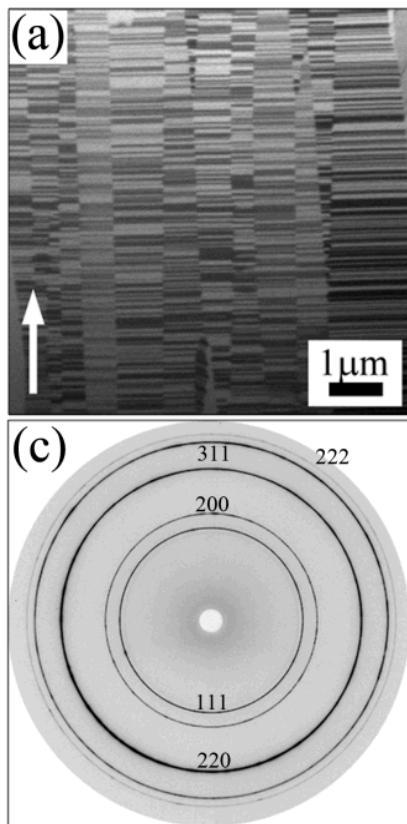
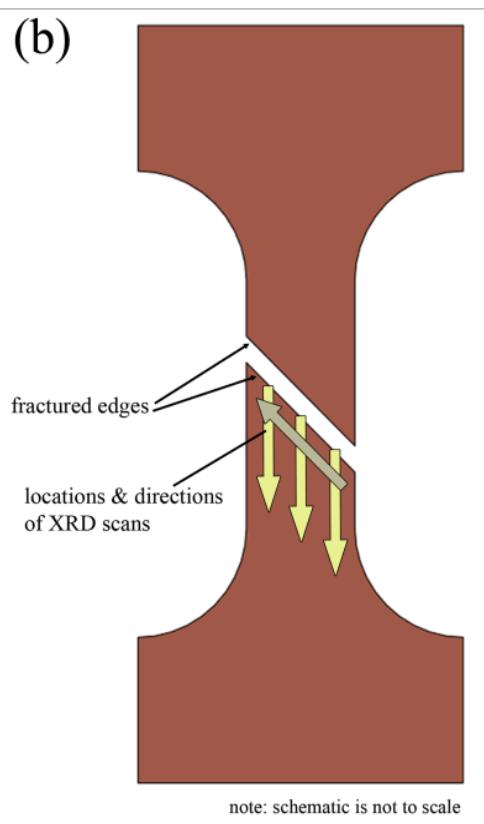
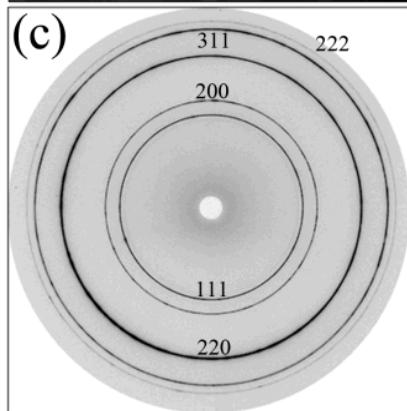
# High energy microdiffraction and focused-ion beam cross-section imaging was used for microstructural investigation

- High Energy Microdiffraction (HEMD) using synchrotron X-ray was used at the ESRF (Grenoble, France)
- High energy (69.7keV) beam was used to transmit the sample thickness and produce full diffraction patterns
- Scans using a microfocused X-ray beam ( $8 \mu\text{m} \times 20 \mu\text{m}$ ) were performed across and along the shear banded regions
- FIB cross-sectional imaging was performed at select locations

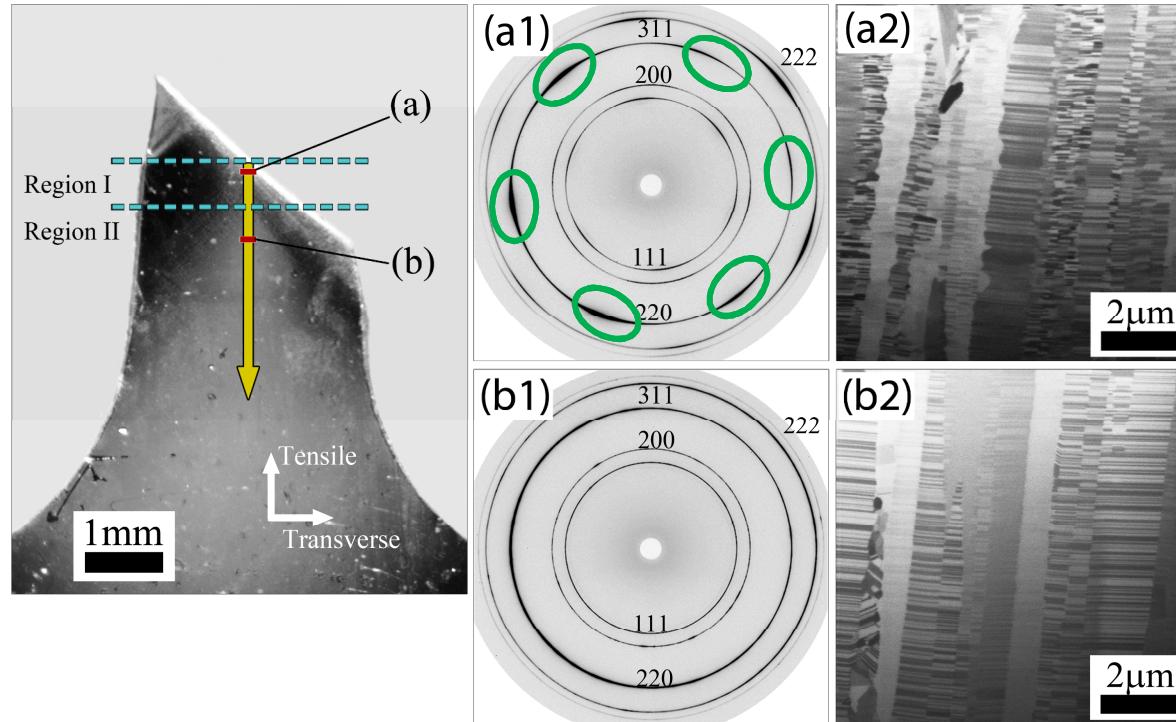
# HEMD & FIB of the RT samples highlight grain-rotation and deformation-texturing within shear-banded regions

Two distinct regions where the DPs change:

- $d < 500 \mu\text{m}$  : DPs show a deformation texture indicative of in-plane grain rotation (likely dislocation-induced)
- $d > 500 \mu\text{m}$  : DPs and microstructure similar to as-prepared case

The HEMD results reveal that dislocation-mediated grain rotation accompanies the shear band formation

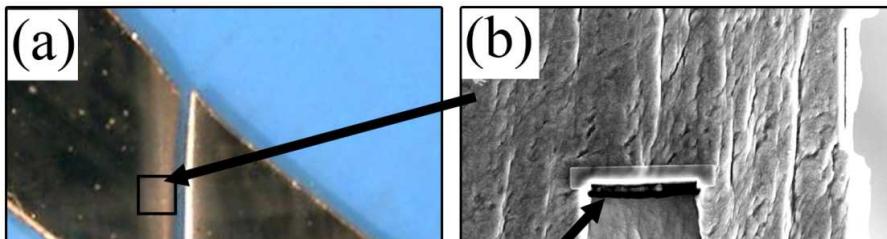
# Additional FIB analysis in the RT samples revealed severe detwinning near and along the fracture sites

Upon initial shear band formation, all strain is then localized within one region, leading to a strain-induced structure transformation and subsequent fracture

- Fracture in the RT samples occur by first transforming the microstructure into a less mechanically stable detwinned structure – we hypothesize that these are strain-induced grain boundary transport mechanisms, but this requires further work

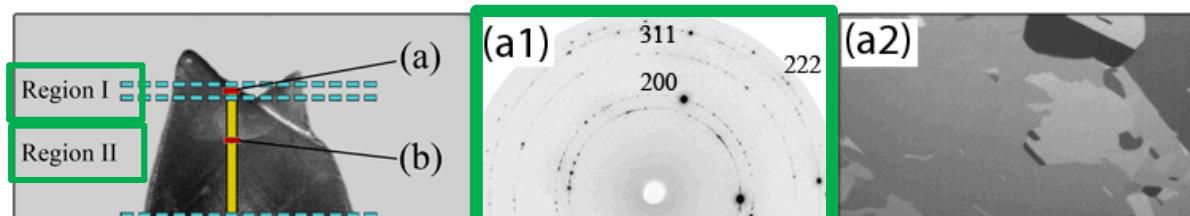
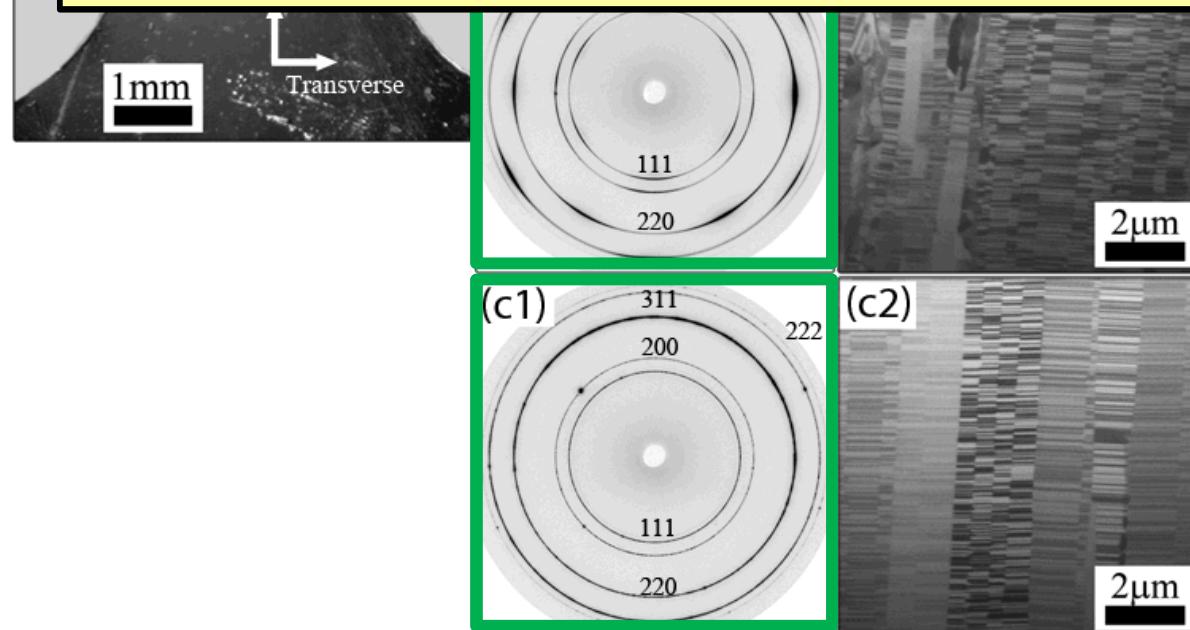
77K results showed the same texture within the shear band regions and *additional plasticity by abnormal grain growth*

Three distinct regions :

- $d < 120 \mu\text{m}$  : “spotty” DP  
(~~as structured revealed~~)

The region that underwent grain growth experienced much more necking (more plasticity!) – thus, the higher elongation at 77K may be partially due to the abnormal grain growth

same deformation texture  
as for the RT sample (in-plane grain rotation)

- $d > 1550 \mu\text{m}$  : DP and microstructure similar to as-prepared case

- (ii) the activation of additional thermo-mechanical mechanisms [i.e. the combination of adiabatic temperature rises and an increased dislocation debris (often found during low-temperature deformation) that promotes abnormal grain growth]
