Development and Assessment of Advanced Inspection Methods for Wind Turbine Blades Using a Focused WINDIE Experiment

Dennis Roach¹, Stephen Neidigk², Tom Rice², Randy Duvall³, Josh Paquette⁴
Sandia National Labs
Albuquerque, NM 87185 U.S.A.

I. Wind Inspection NDI Experiment (WINDIE)

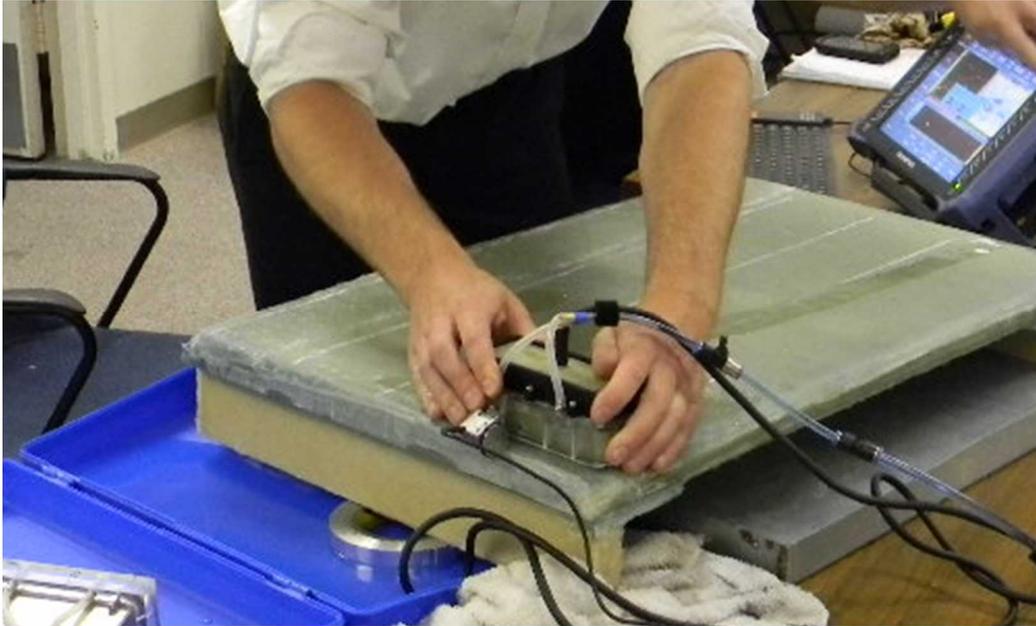
Figure 7. Phased Array Ultrasonics Inspection with OmniScan System.

from which to assess structural integrity. Three probe and wedge combinations were used with the majority of the tests performed with the two large aperture combinations. The 25 mm water column (WC) shoe used a contained water column to provide the UT coupling between the probe and the part. The contact wedge used a solid block of an impedance-matching plastic material with a thin film of base water to provide the offset and coupling to the part. The Aqualene wedge used a delay line block made from Aqualene along with a wetted surface to provide the offset and coupling to the part. Figure 7 shows the OmniScan equipment set-up and deployment for these phased array UT inspections.

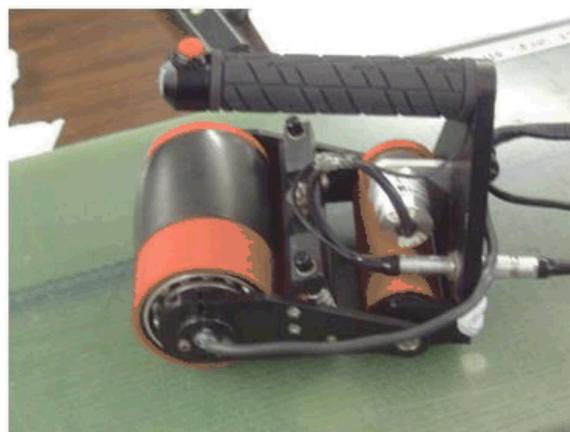
Figure 12. Sonatest RapidScan 2 – Linear Array UT WheelProbe Design.

In order to evaluate a different method for deploying PA-UT, the *Sonatest Linear Array WheelProbe (RapidScan 2 Device)* was applied to a series of WINDIE panels. Figure 12 shows the RapidScan along with the rolling Array WheelProbe deployed on a wind NDI test specimen. The Sonatest RapidScan 2 instrument used a modified receive amplifier with dedicated low bandwidth response for enhanced sensitivity to defect detection in attenuating composites. The low frequency WheelProbe designed for inspection of thick fiberglass composites, utilizing a 100 mm long array with 20 mm element elevation and 1MHz center frequency for optimum coupling, area coverage and penetration. Figure 13 shows the flaw profile of wind NDI test specimen REF-STD-2-127-173-SNL-1 along with labels for the set of line scans that were completed by the RapidScan 2 WheelProbe to produce the overall C-scan image of the part. Time-of-Flight information was used to arrive at depths associated with each reflection. The calibration color code used to relate indications to depth within the part is shown in Figure 14.

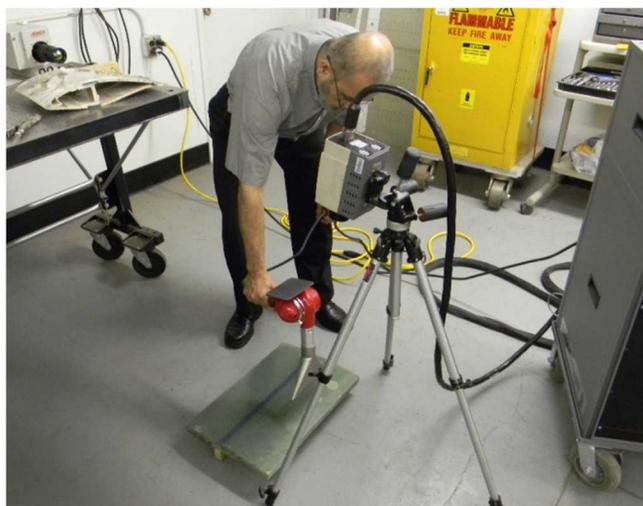
Figure 21. TWI Thermography System Inspecting a Wind Blade NDI Specimen.

Initial investigations to evaluate the viability of thermography for wind blade inspections were conducted using the *Thermal Wave Imaging EchoTherm Pulsed Thermography* system. Figure 21 shows the deployment of the EchoTherm system to the set of WINDIE test specimens. Normal pulsed thermography operation uses very brief flashes of quartz lamps to produce the temperature differential (heat flow) through the part. However, in thick composite sections, such as those used in wind blades, more heat energy needs to be applied in order to observe damage corresponding to heat flow variations through the part thickness. Thus, a heat gun was used on the thick WINDIE specimens in order to induce a sufficient heat differential for detecting deeply embedded flaws.
