## **Design and Construction of the Paddys Run Streambank Stabilization Project at the Fernald Preserve, Harrison, Ohio - 16165**

Gwendolyn Hooten\*, Bill Hertel\*\*, John Homer\*\*

\*US DOE, Office of Legacy Management, Harrison, Ohio

\*\*Navarro Research and Engineering, Inc., Harrison, Ohio

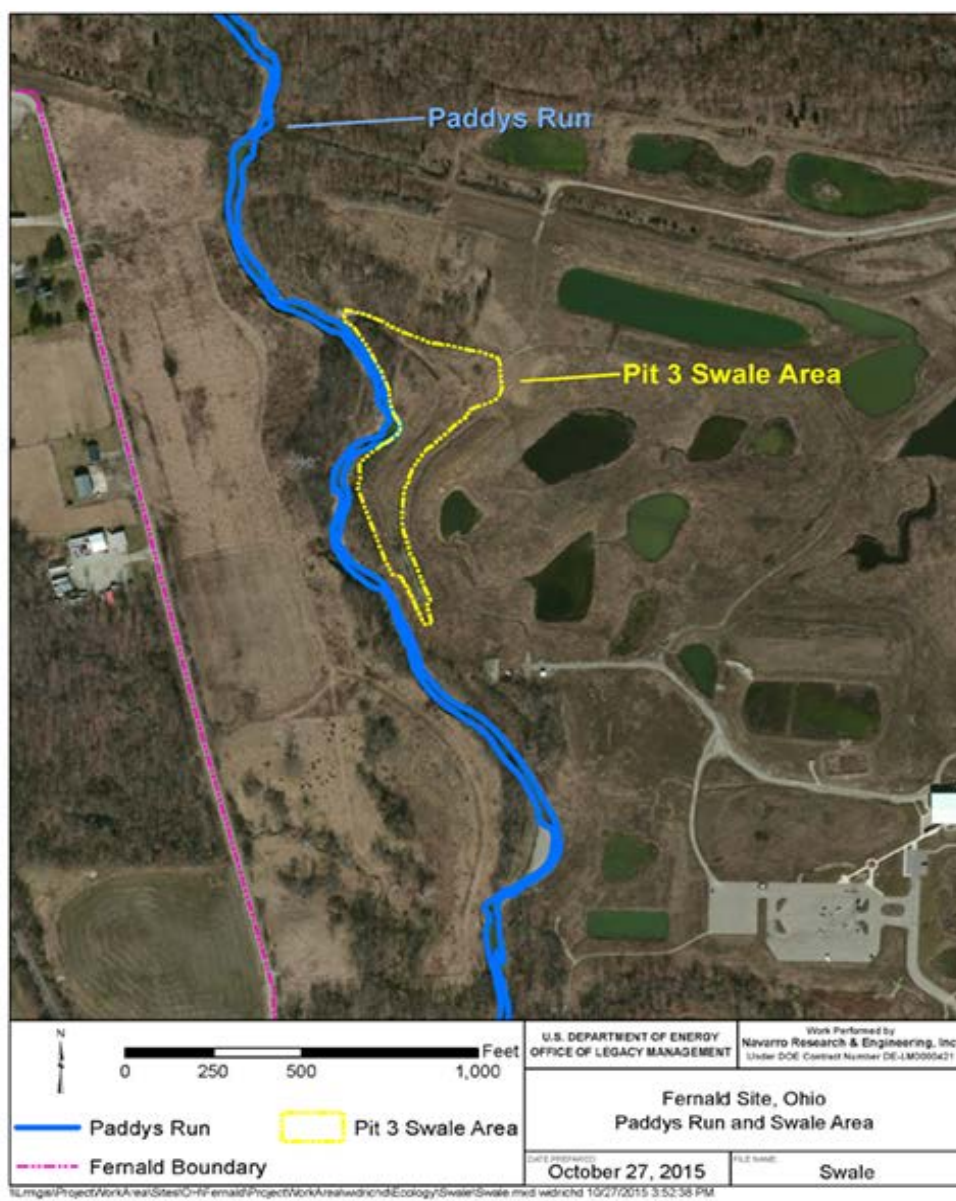
Fig. 3. Pit 3 Swale area located between Paddys Run and the former Waste Pits

Personnel conducting routine site inspections observed that Paddys Run was migrating east via bank erosion into the Pit 3 Swale area, specifically Sample Location SWD-09 (Fig. 4). Paddys Run had migrated east approximately 4 m (13 ft) in 2 years and was approximately 29 m (95 ft) from the sample location. The recent erosion also resulted in a reduction of the bank height by approximately 1 m (3 ft), thereby reducing the freeboard elevation above Sample Location SWD-09 (Fig. 5). This rapid migration threatened the current conditions that allowed for continued monitoring of the swale area. Additionally, there was concern that continued erosion would result in the contamination of Paddys Run. Therefore, DOE and regulators determined that the east bank of Paddys Run required stabilization.

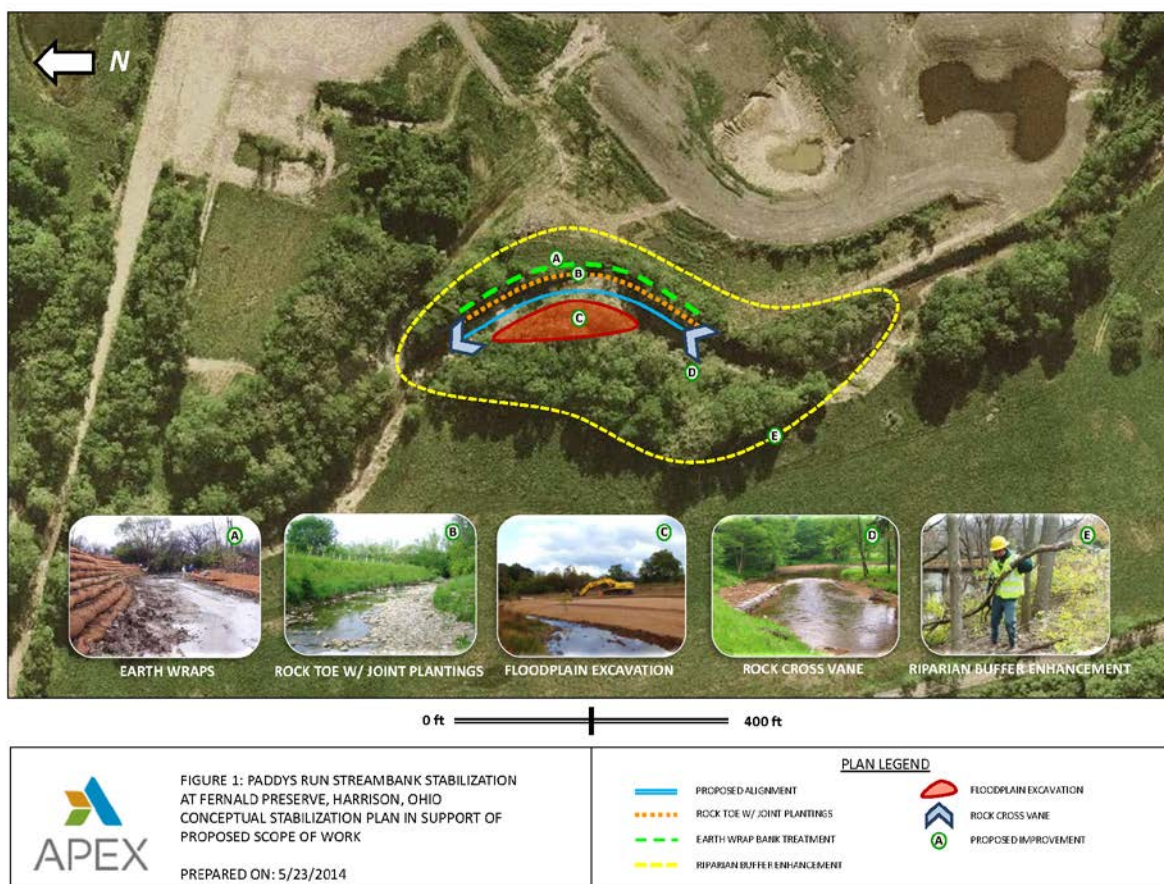
Fig. 6. Concept Plan for the Paddys Run Streambank Stabilization Project [Figure prepared for DOE by Apex Companies, LLC, (5)]

These options represented a range of approaches from traditional hard armoring to bioengineering control. Each option was evaluated against cost, constructability, durability, risk, and probability of successfully meeting project goals and objectives. Regulators and other stakeholders were afforded an opportunity to review and comment on the alternatives analysis, and a consensus approach was reached to use a combination of riprap, soil encapsulated lifts, and regrade, fabric and plant (Fig. 6).

The final design included the following components: temporary relocation of approximately 145 m (475 ft) of streambed 9 m (30 ft) west, installation of a rock toe along the east bank, installation of two cross-vane in-stream grade control structures, stabilization of a portion of the east bank using soil encapsulated lifts, and regrading, seeding, and planting within remaining disturbed areas.
