Cyclic Loading of Nanocrystalline FCC Metals *In Situ* in the TEM

10 April 2015

Daniel Bufford¹, John Sharon^{1,2}, William Mook¹, Brad Boyce¹, and Khalid Hattar¹

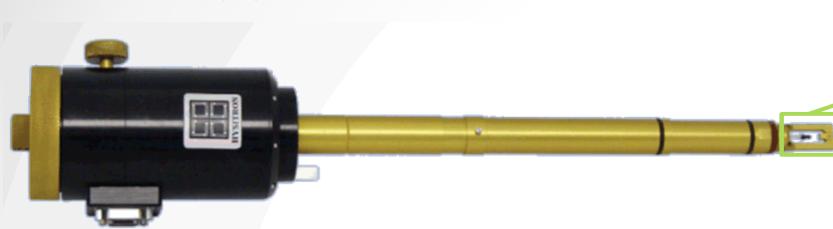
Hysitron PI95 *In Situ* Nanoindentation TEM Holder

- Sub nanometer displacement resolution
- Quantitative force information with μN resolution
- Concurrent real-time imaging by TEM

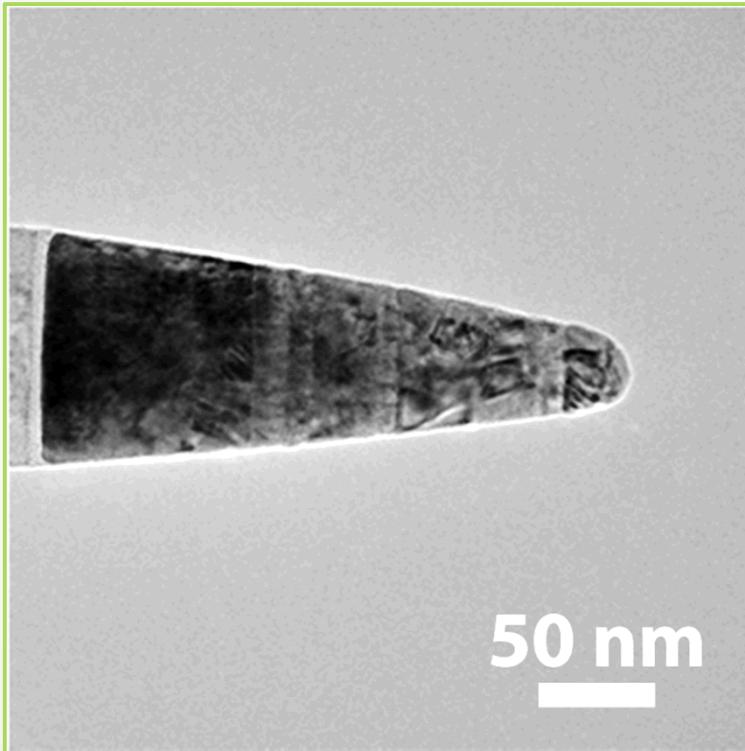
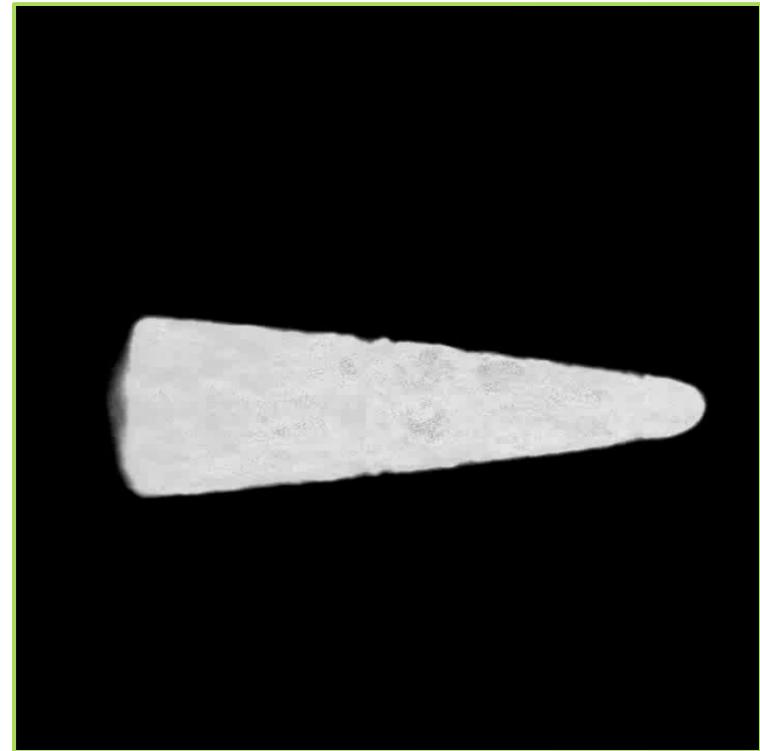
Nanopillar Fabrication

- FIB-milled from 500 nm PLD Ni on Si
 - ~100 nm base diameter
 - Conical geometry

- Mostly electron-transparent, easy geometry for stress calculations
- Small volume, susceptible to vibration and shear

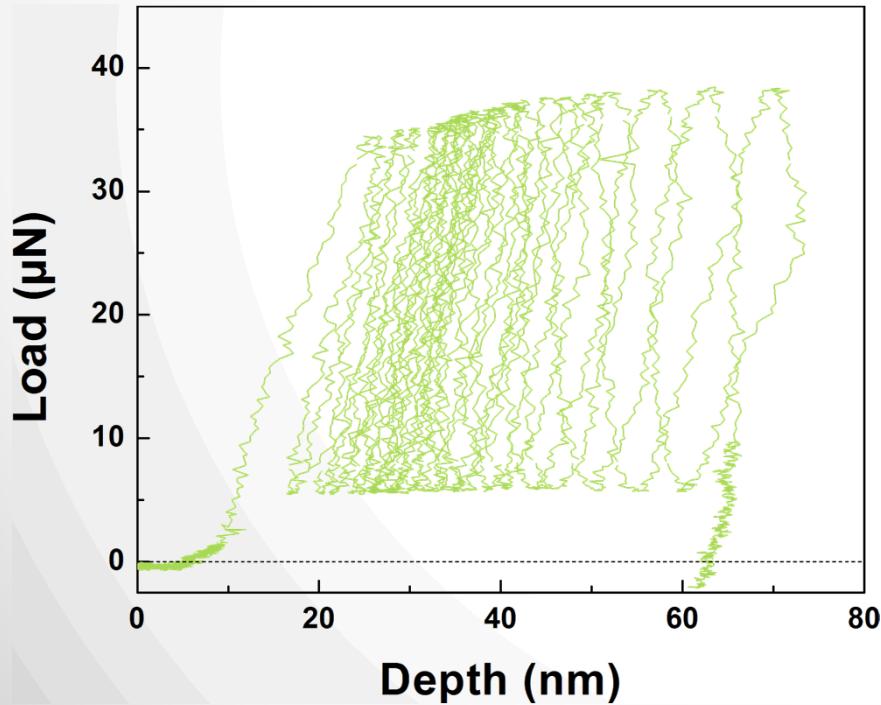
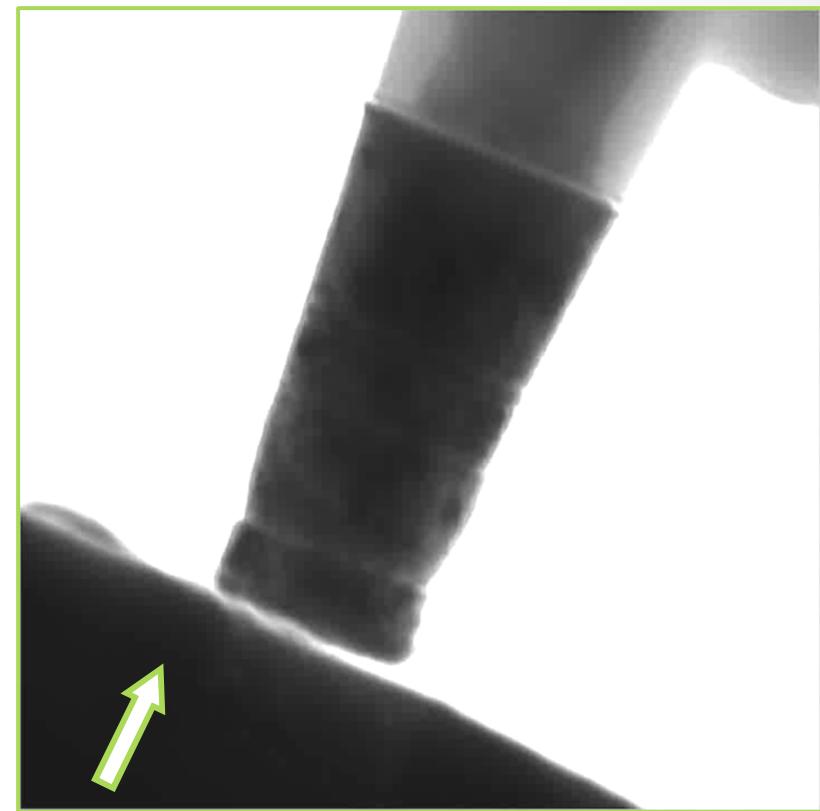
Pillar Compression

- Cyclic loading with increasing force amplitude
 - After a previous monotonic compression
 - 23 cycles to failure
- Failure initiated at notches

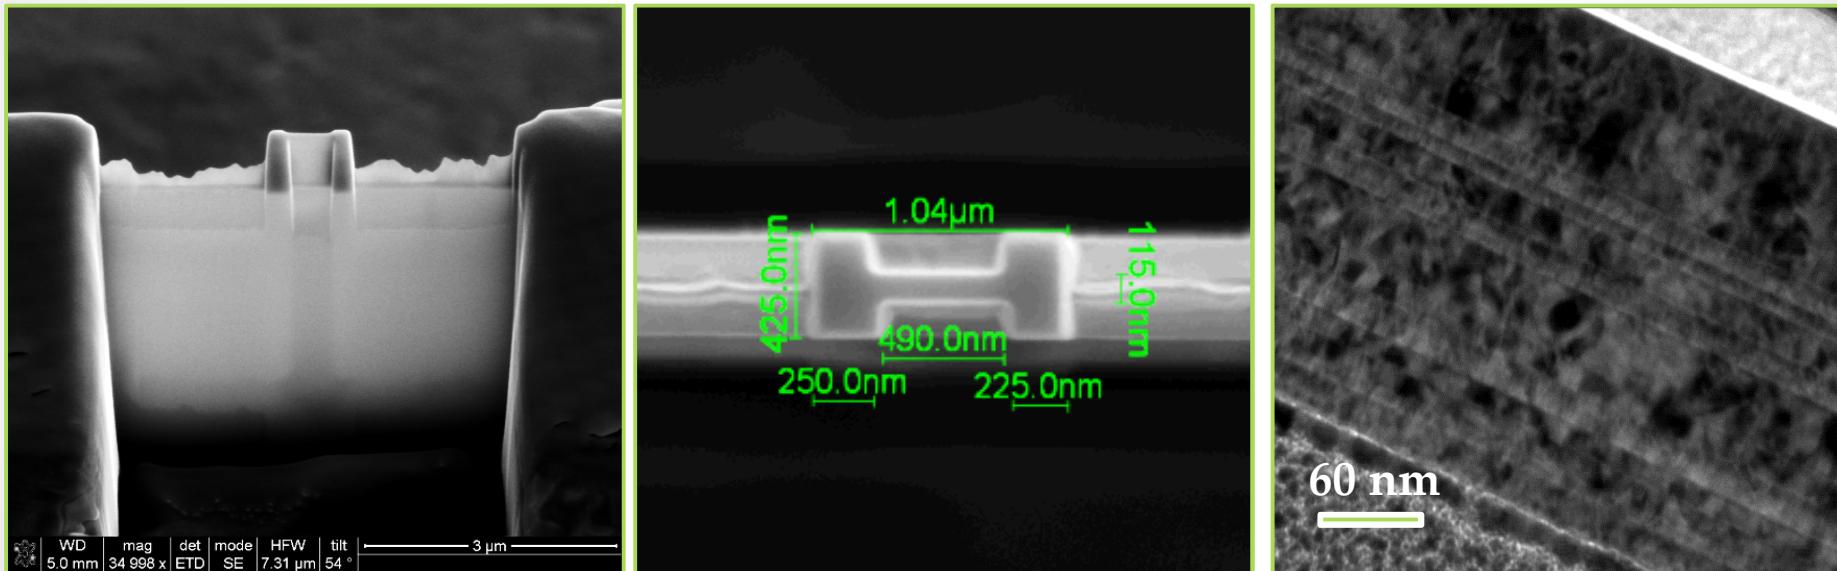
“I-Beam” Fabrication

- Wide pillars with transparent center and thicker side supports
- FIB-milled from same 500 nm PLD Ni on Si

- Enhanced mechanical stability and larger viewable area
- More complicated force-displacement interpretation

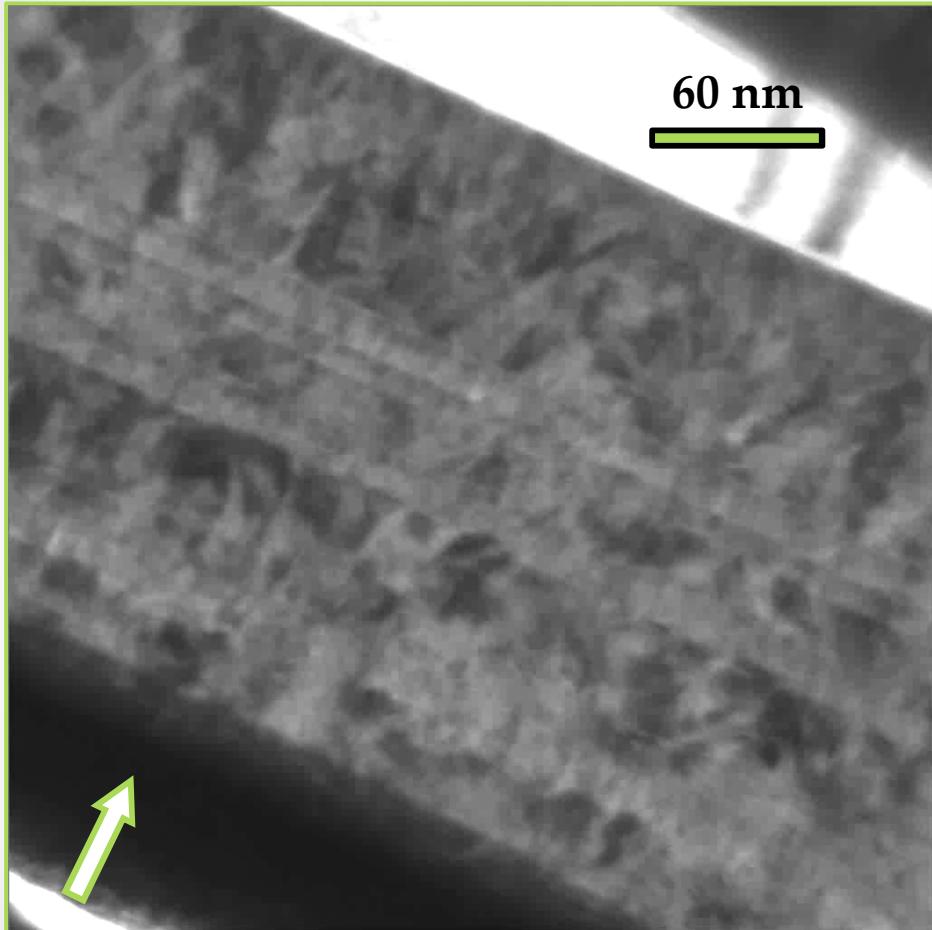
I Beam Compression

- Improved visualization
- Evidence of grain growth

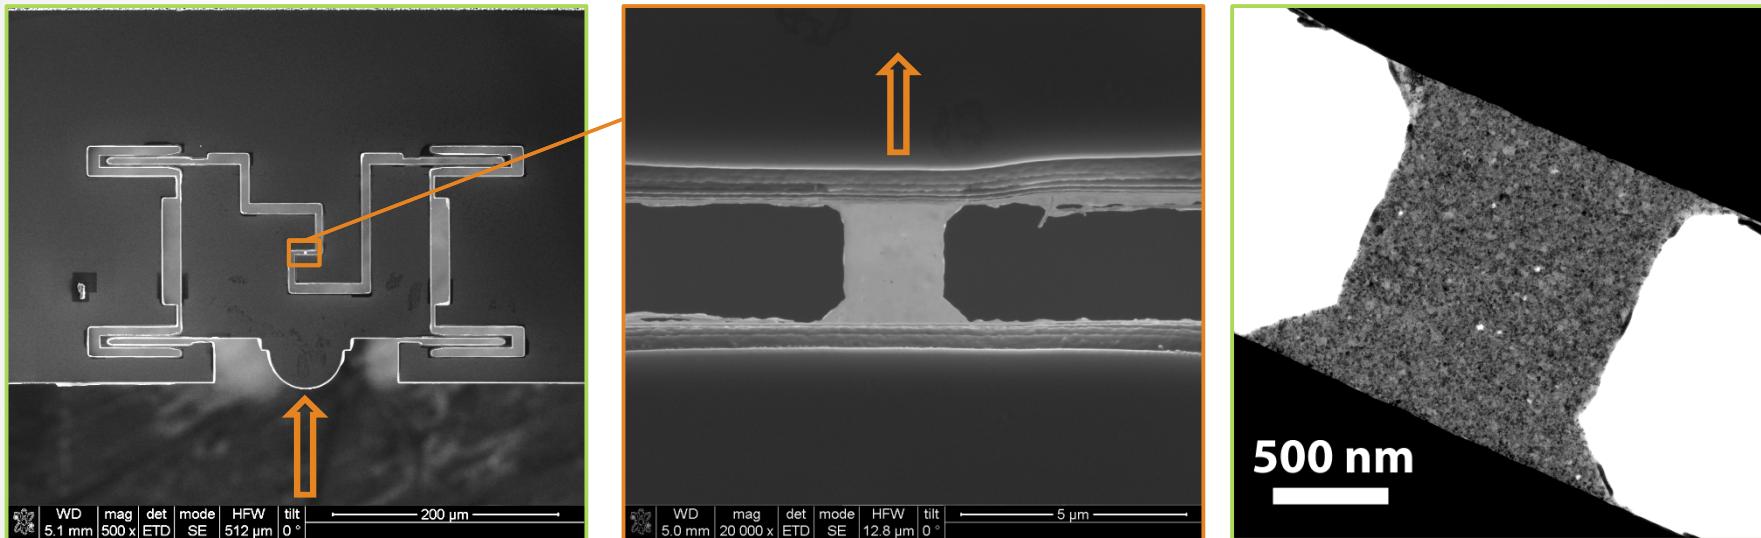
Tension Specimen Fabrication

- Hysitron “Push-to-Pull” devices
 - Microfabricated Si test frame
 - Cu film (75 nm) floated onto device, then FIB milled

- Nearly pure tension, uniform cross sectional area, stable load frame
- Fragile, sensitive to shape of edges, issues with magnetic materials

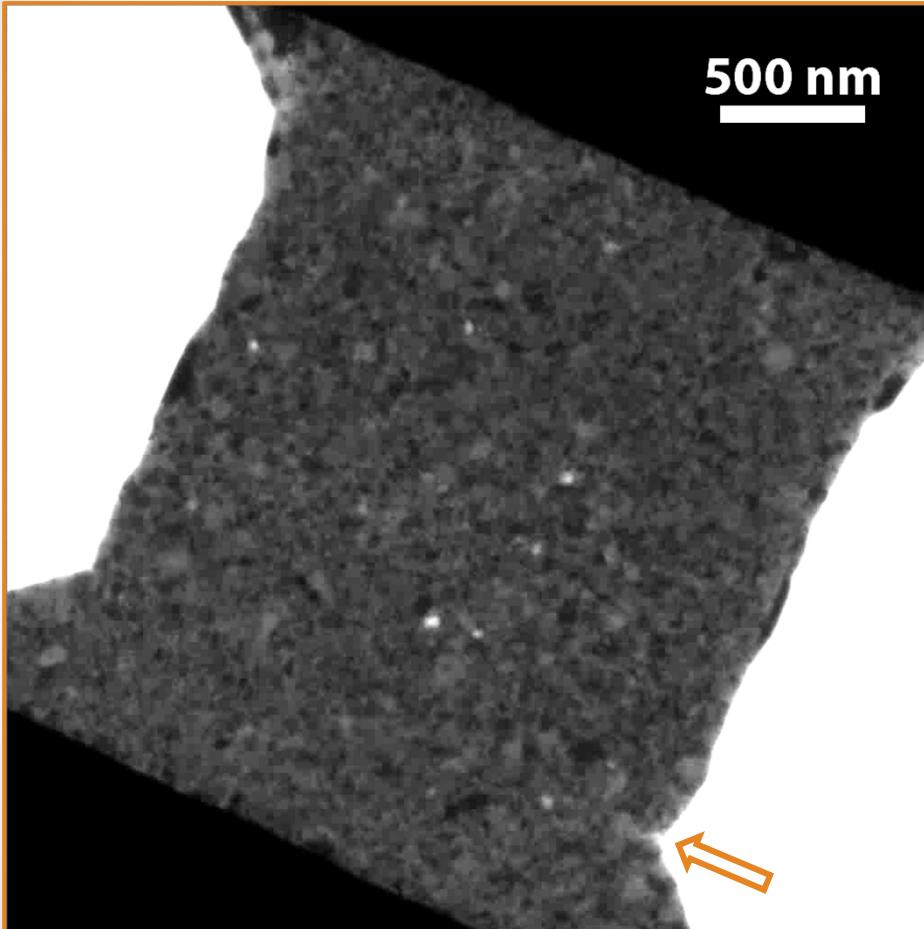
Tension Testing

- Slow crack propagation
- Evidence of grain growth

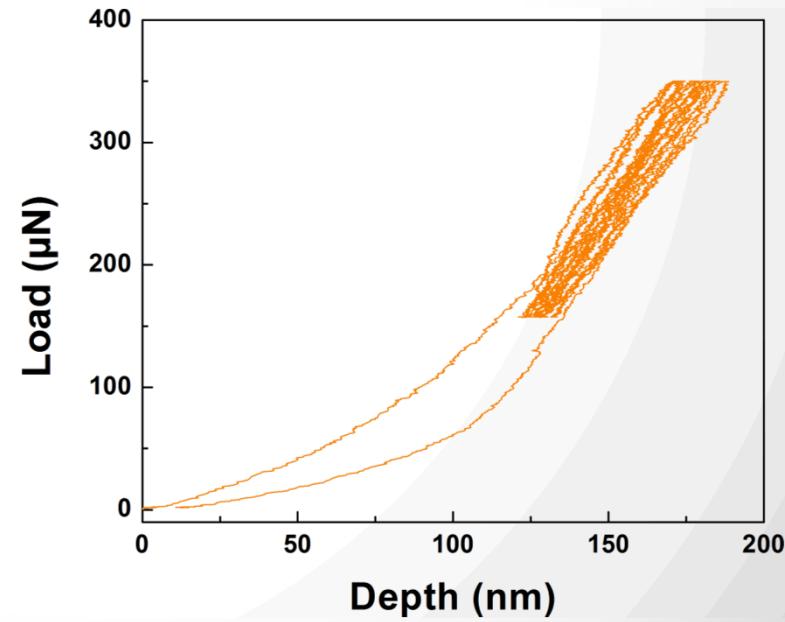
- Cyclic loading:
 - Crack initiated in previous monotonic test
 - 9 cycles to $\sim 87.5\%$ of that load
 - 50 % unloading
 - Slow crack propagation

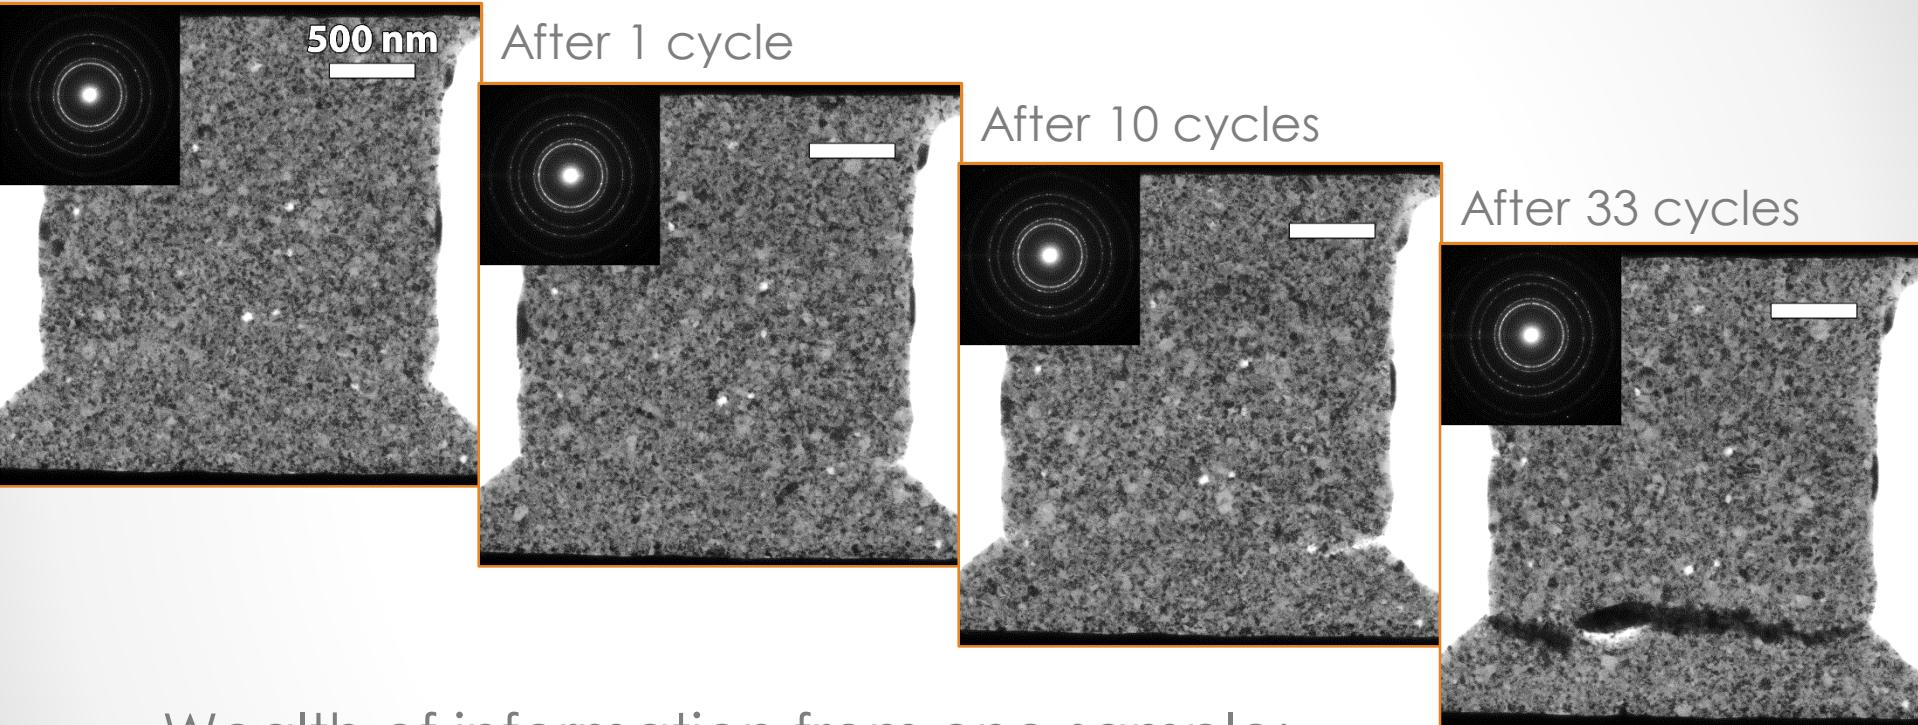
Cyclic Tension *In Situ*

Before

(Post-failure)

- Wealth of information from one sample:
 - Images and electron diffraction at each stage
 - Video and force/displacement during load cycles
- Microstructural change still elusive
 - Difficult to confirm and quantify

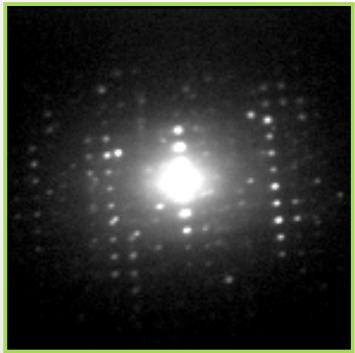
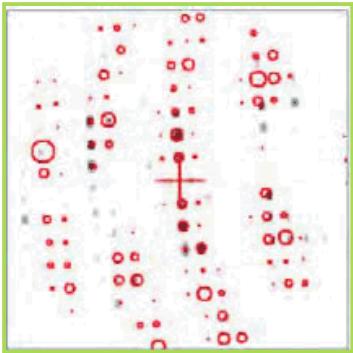
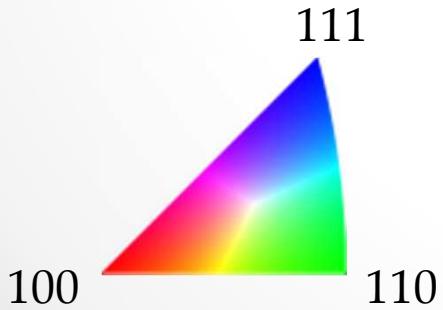
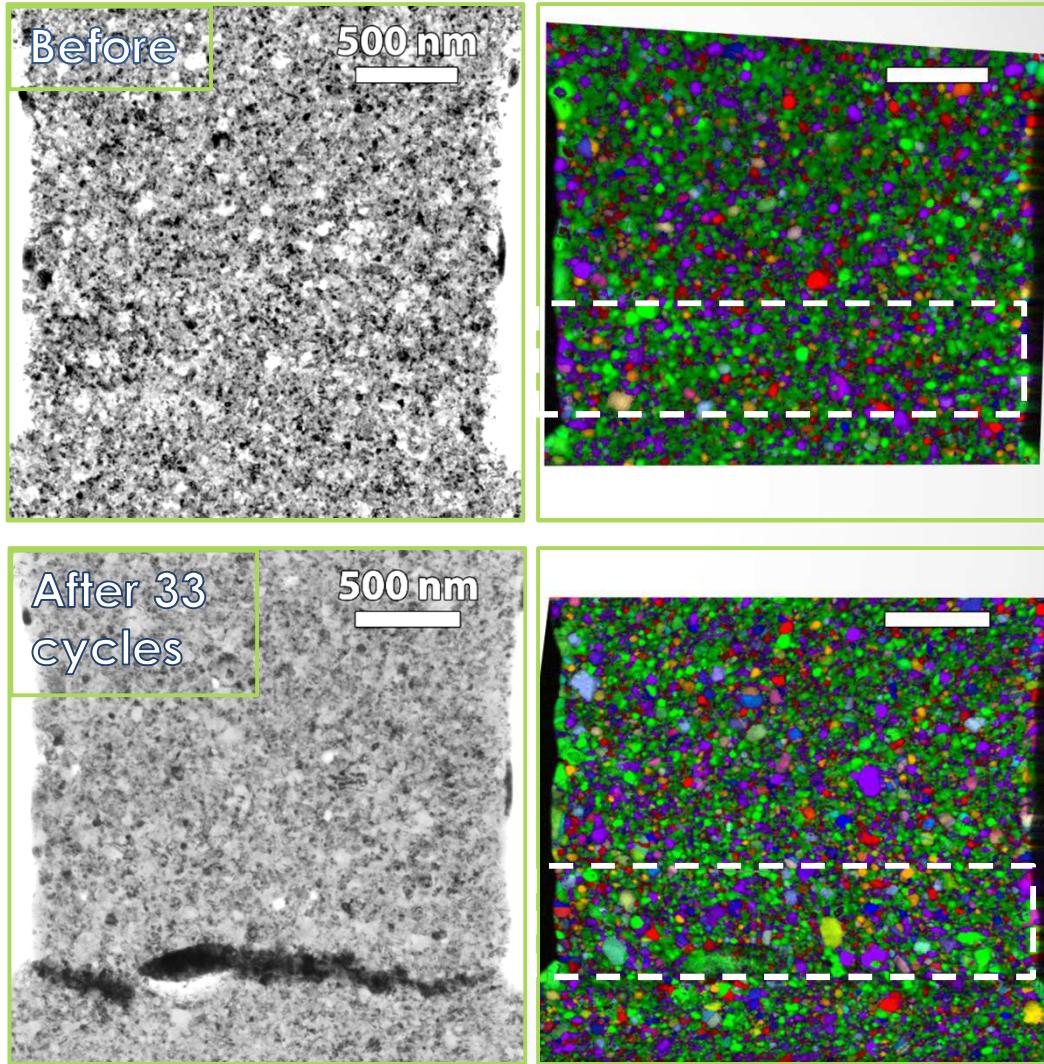
Quantifying Microstructural Change

- Combining orientation mapping with deformation
- EBSD-like capability in the TEM
 - Powerful analytical tools available
