ANL-FF-55a

Metallurgical Tests on Zirconium-Clad Zr-U Alloy Plates
Submitted to Hanford for Irradiation
Program 6.1.2a

S. H. Paine, Jr., J. E. Draley, W. F. Murphy, F. L. Brown
EC RESEARCH AND DEVELOPMENT REPORT

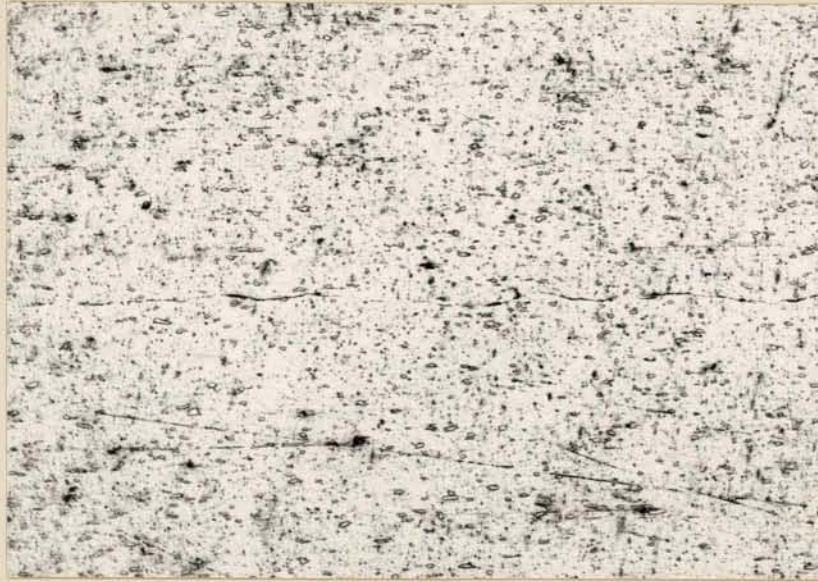
Figure 1. Specimen No. 2124-1

Macro #6631 0.5% HF etch 100-X

View of Bureau of Mines clad specimen bond, showing extensive inclusions supposed to be carbides. Structure is very similar to arc-melted crystal bar material used for the Hanford and Oak Ridge test specimens. (Compare with Figure 3.)

²In general, the bonds were all made visible by an intermittent line of inclusions along a wavy interface, (see Figures 1, 2 and 3). The zirconium cladding material was not completely sound, but small voids and rolling defects were observed in the surface of the specimens, the largest of which is recorded in Figure 3. All visible defects in bonds and in cover material were marked with a needle scratch for reference after autoclave tests. /end

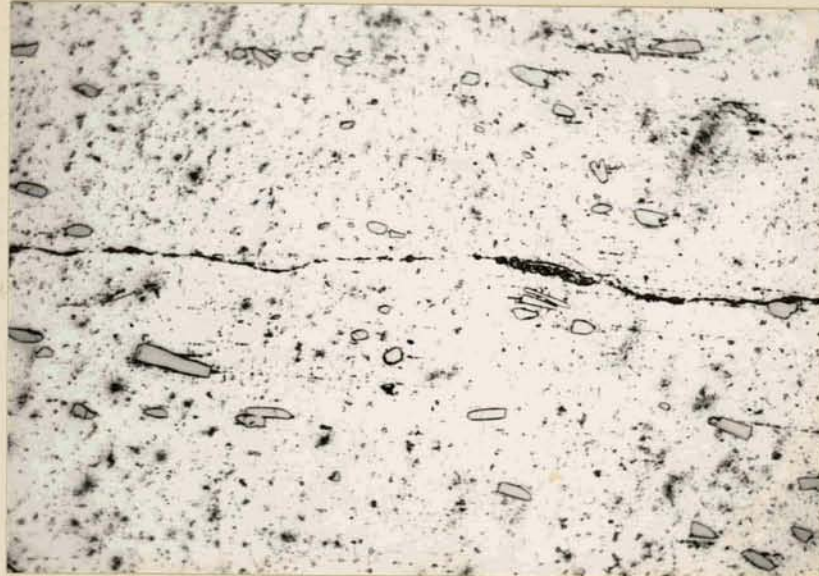
Figure 2. Specimen No. 2124-1

Macro #6630 0.5% HF etch 500-X

Higher magnification of area shown in Figure 1. Note rather vigorous attack of HF on bond inclusions, as compared with negligible attack on matrix carbides.

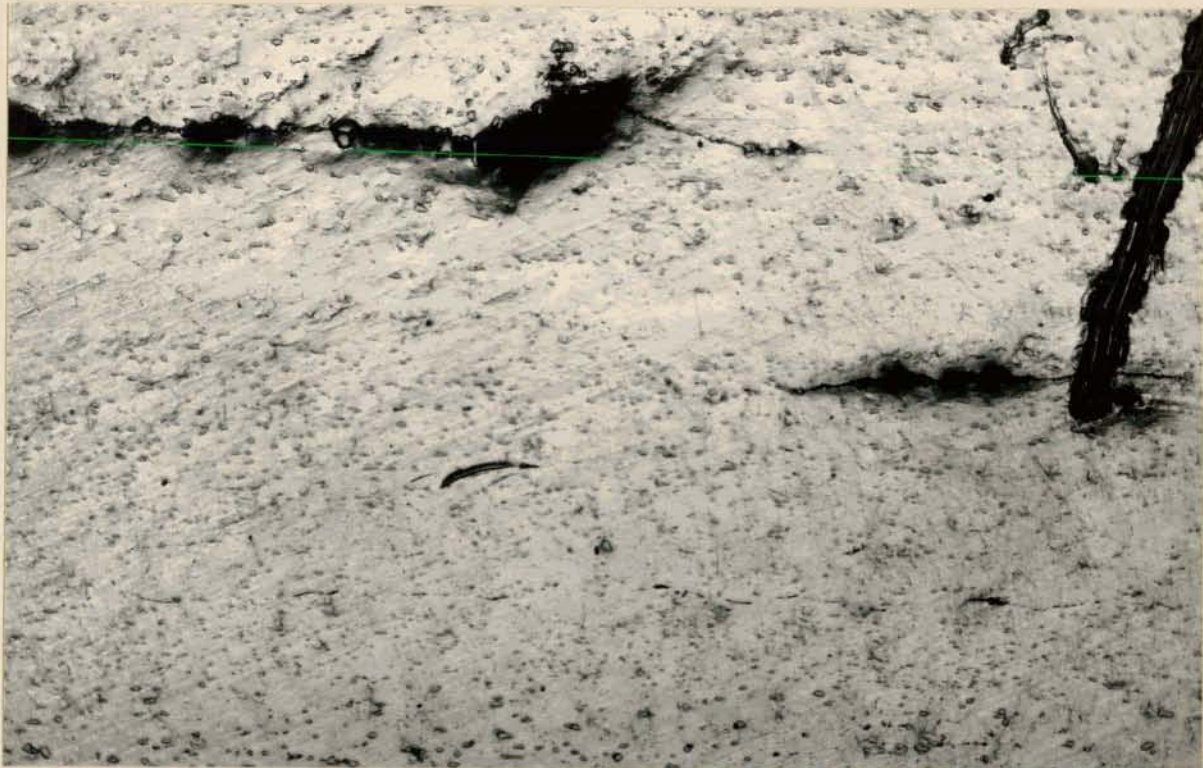
Figure 3. Specimen No. 2124-10

Macro #6591

As Polished

100-X

View of polished edge on Hanford test specimen #10, fabricated from arc-melted Foote crystal bar. Polishing is not optimum, due to awkward shape and size of piece, but matrix inclusions (carbides) are visible as well as a discontinuous line of inclusions at bond. Note macro voids visible in the edge of cover material above (diagonal mark at upper right is a needle scratch). These are rolling defects, the only serious ones observed on any of the Hanford specimens. Recent tests indicate that they contain a black material which is not yet identified.

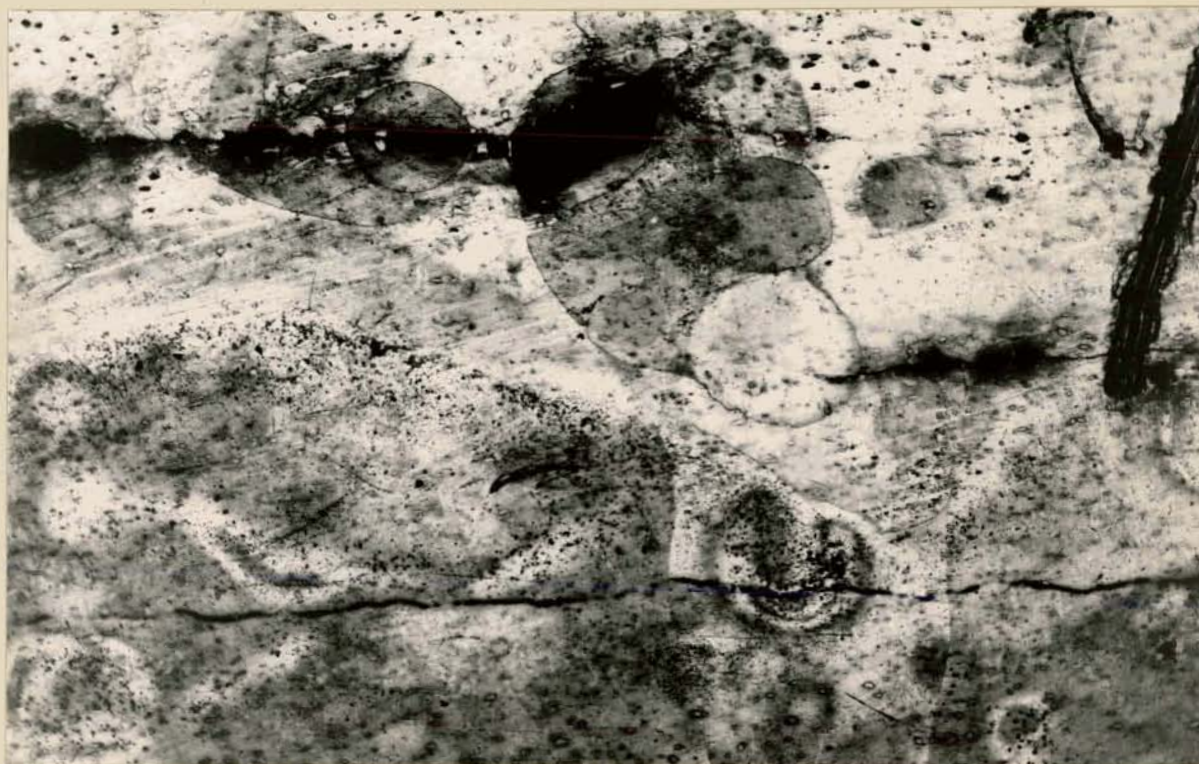
Figure 4. Specimen No. 2124-10

Micro #6592

As water autoclaved

100-X

Micro of area shown in Figure 3 after water autoclave test in contact with aluminum. General staining is alumina. Water seepage from macro defects is noted. Staining along bond is further analyzed in Figures 7 to 9.

The stainless steel autoclave was contaminated at the beginning of the test with a white material presumed to be alumina. This doubtless accounts for general superficial staining of the specimens shown in Figures 4 and 5. In addition, all samples showed a thin tannish film probably indicating the presence of a slight oxide film. The aluminum holders showed considerable pitting attack, particularly adjacent to areas of contact with the stainless steel and in some

No pitting was observed on any of the sandwich specimens. The bond lines proved to be stained by the test (Figures 4, 7). Some boundary attack around bond inclusions seems to be responsible for this condition; however, penetration was not great (Figures 7, 8 and 9).

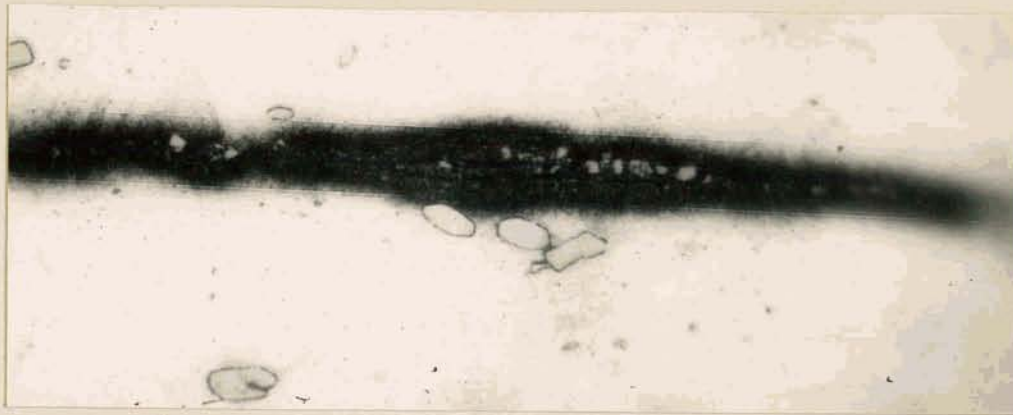
Figure 7. Specimen No. 2124-10

Micro #6593

1500-X

Bond staining after autoclave test, shown at high magnification. This area is characteristic of the maximum effect observed.

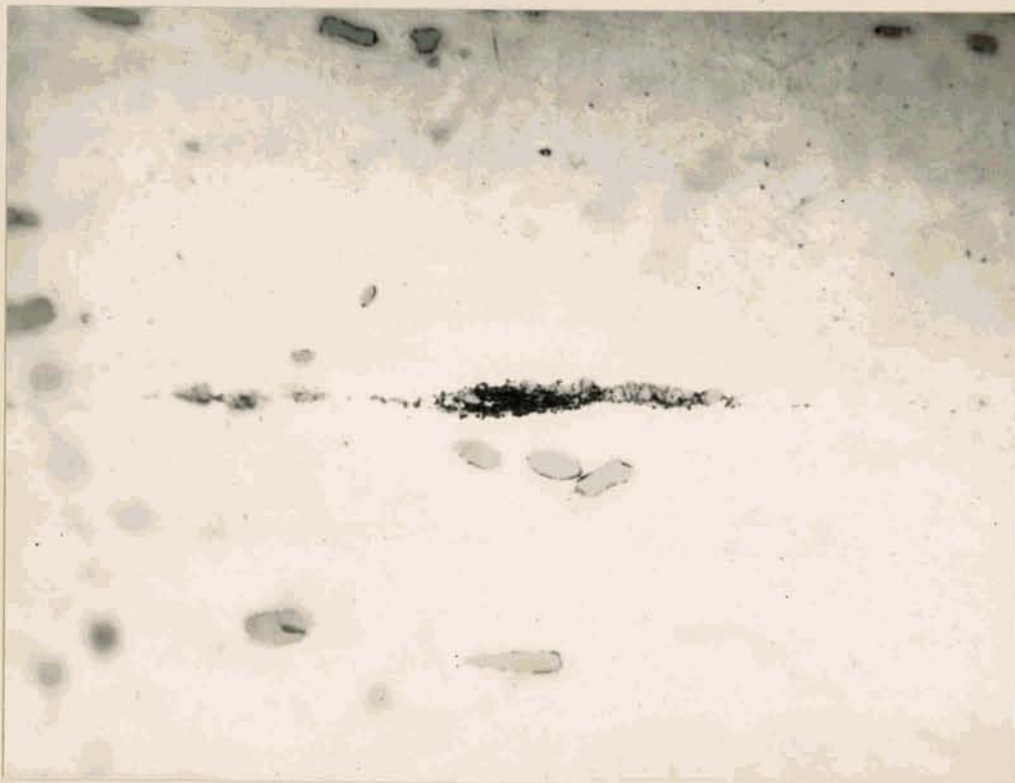
Figure 8. Specimen No. 2124-10

Micro #6622

1500-X

Same area as Figure 7 after 3 minutes of light polishing with Linde B (.1 micron) powder on AB Microcloth. Staining has disappeared but boundary corrosion at all inclusions is still visible. Loosened inclusions at bond have been pulled out.

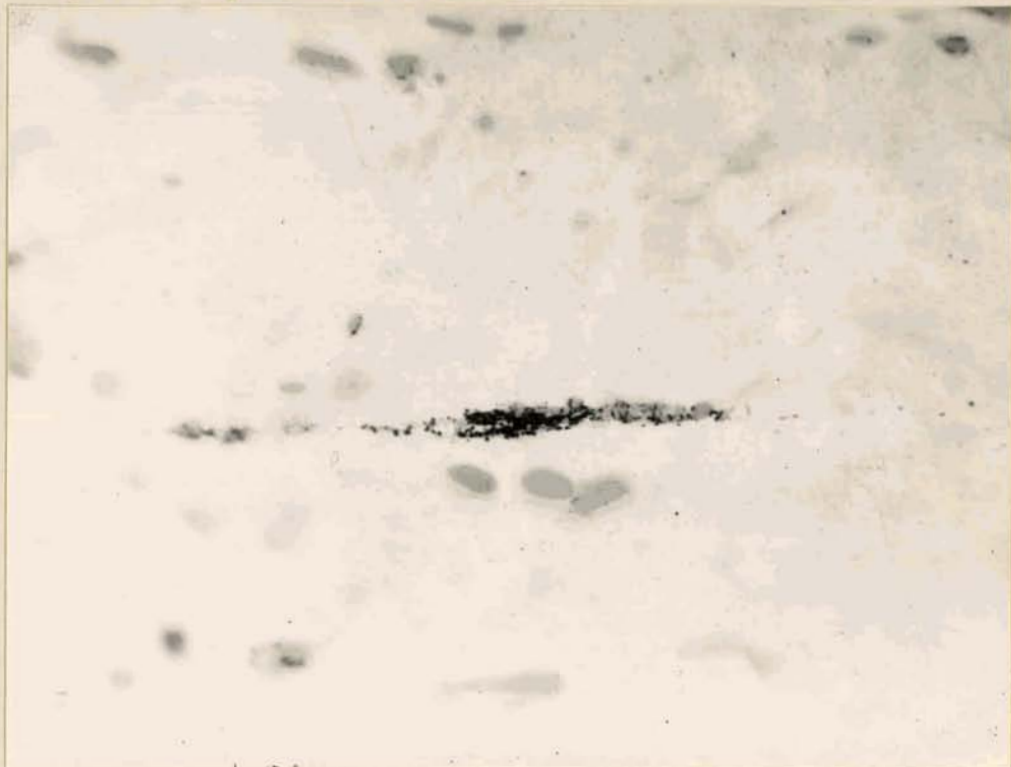
Figure 9. Specimen No. 2124-10

Micro #6621

As polished

1500-X

Same area as Figures 7 and 8 after additional polishing totalling 10 minutes. Boundary corrosion at inclusions has disappeared in areas away from bond. It is beginning to disappear around bond inclusions, but a void appears where particles have been pulled out. Total depth of metal removed is less than a micron. Total length of main defect is approximately 25 microns.
