Safety testing of electrochemical cells and systems

Joshua Lamb

Next Generation Batteries 2015, La Jolla, CA

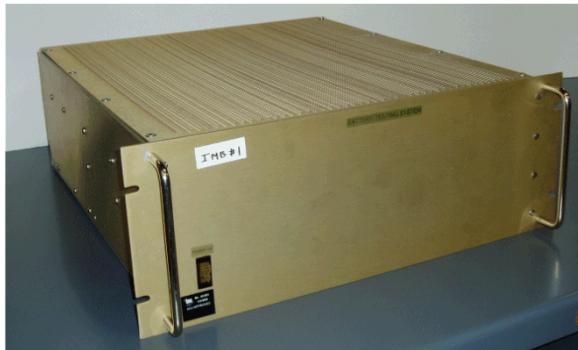
Impedance measurement box developed by INL

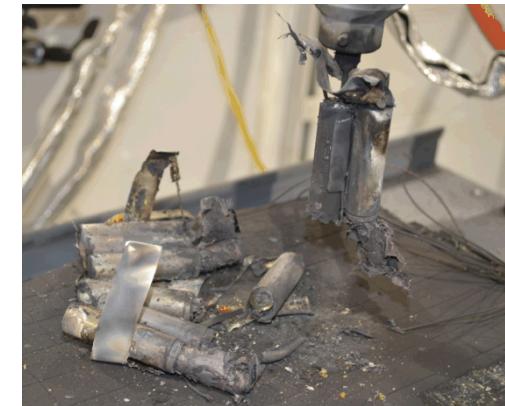
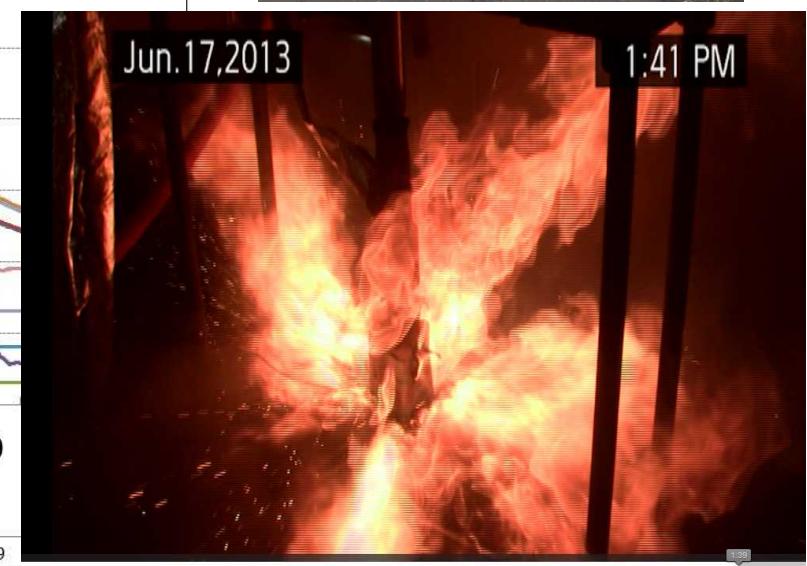
10S1P and 1S10P configurations

2.2 Ah 18650 cell packs (92 Wh at 100% SOC)

Failures initiated by mechanical insult to the center cell (#6)

Complete propagation of a single point failure in the 1S10P pack
