**Environmental Restoration of Diesel-Range Organics from Project Chariot,
Cape Thompson, Alaska - 16147**

Mark Kautsky*, Rick Hutton**, Judy Miller**

*US DOE, Office of Legacy Management

**Navarro Research and Engineering, Inc.

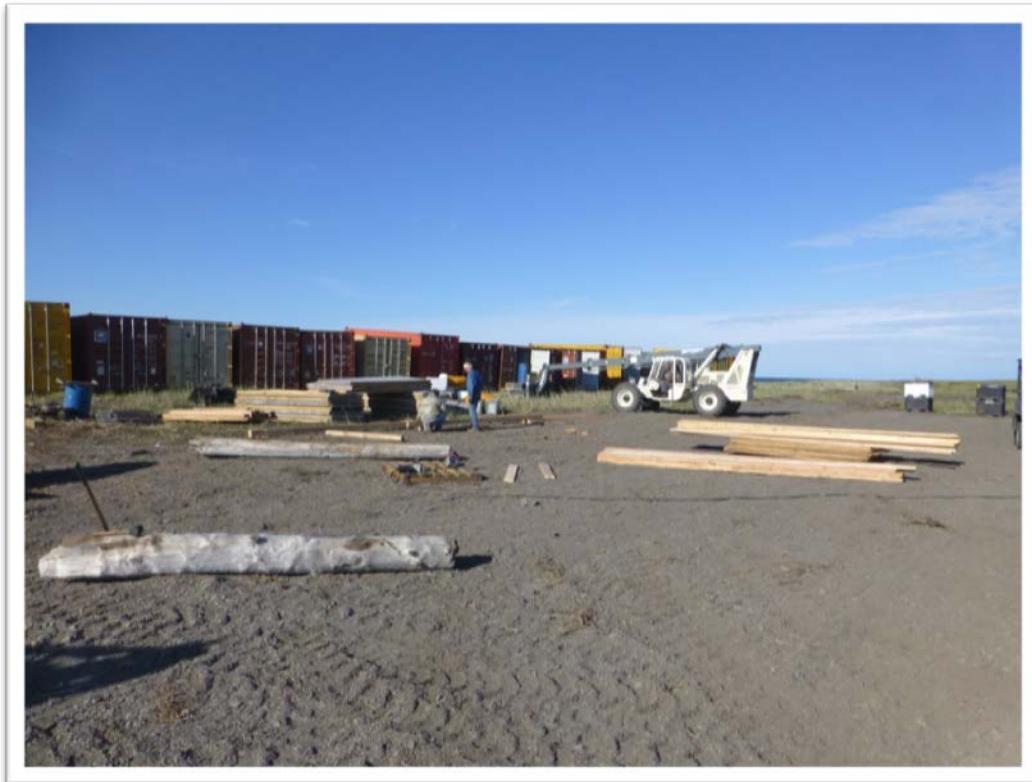
Figure 4. Setting Up Camp on July 12

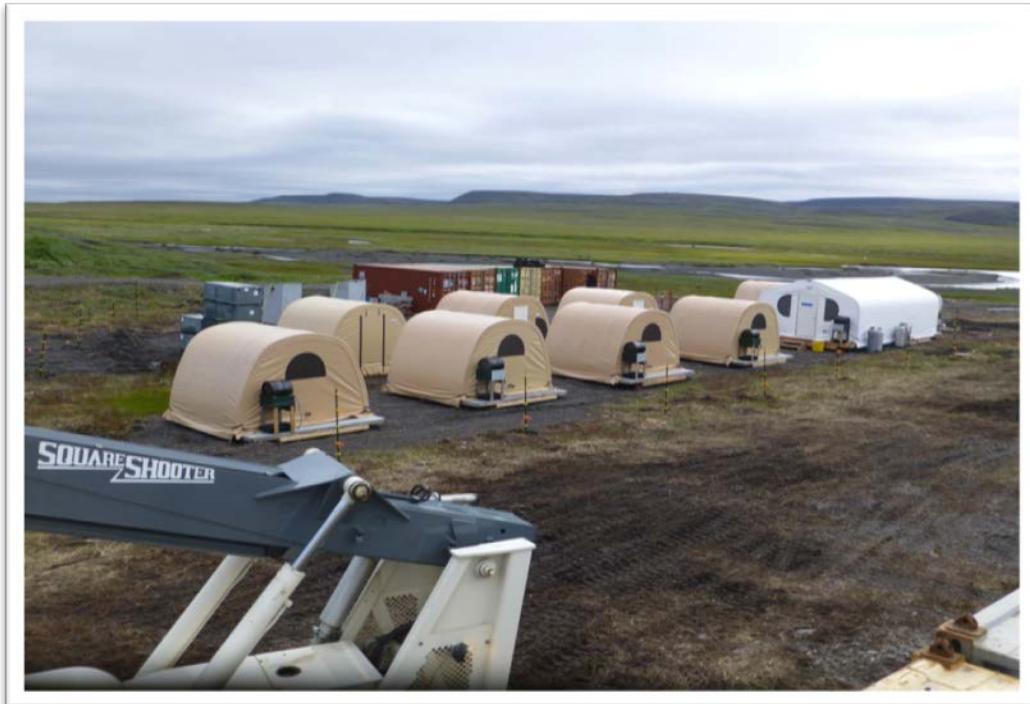
Figure 5. View of Finished Camp from West Staging Area

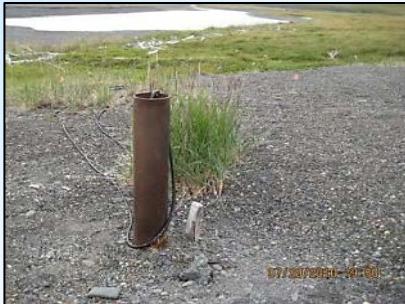
Test hole Able and down-hole-temperature cable

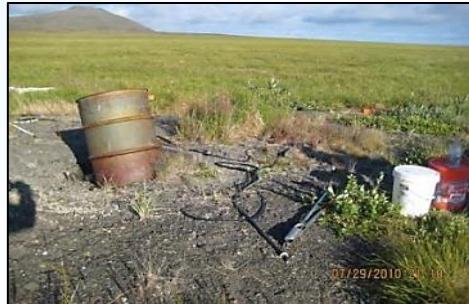
Test hole Baker with down-hole-temperature cable and sampling equipment

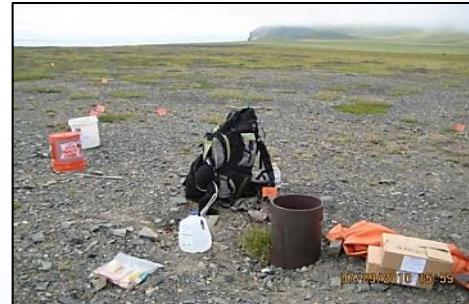
Test hole X-1 with sampling equipment

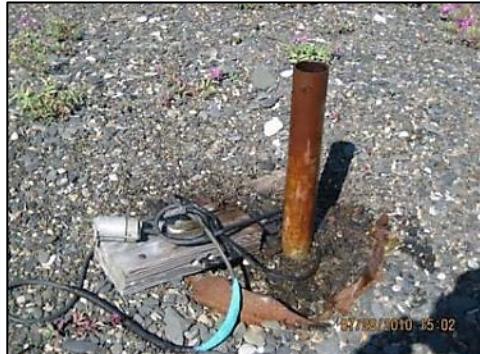
Test hole Charlie with down-hole-temperature cable, block of wood, and cylinder on ground

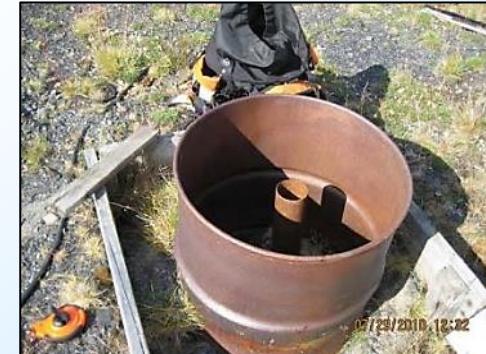
Test hole Dog with steel drum protective casing and wood structure

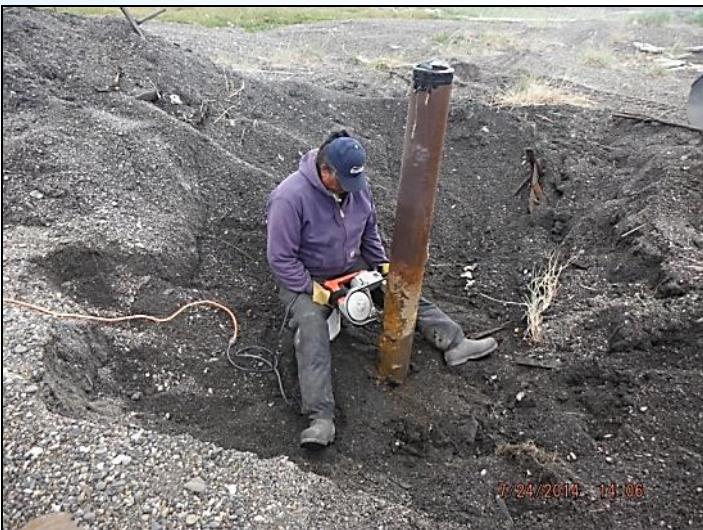
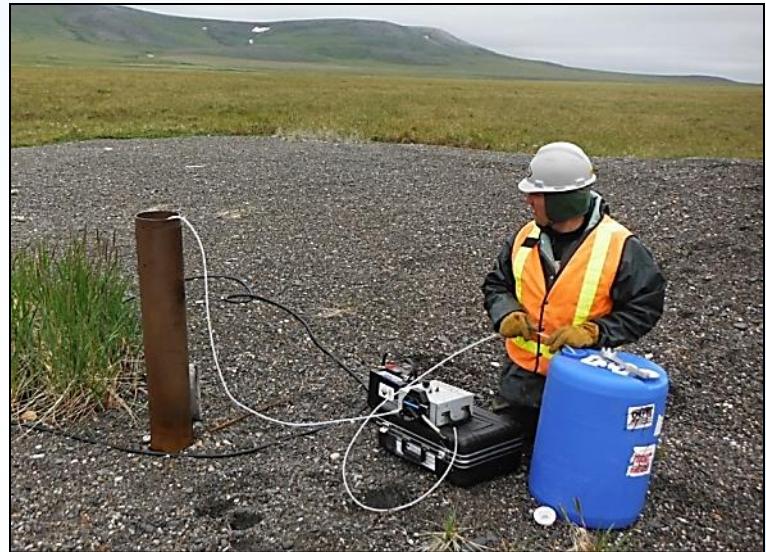
- Water removed from test hole casings
 - 9 gallons
 - Treated with carbon filter
 - Sampled
 - Discharged onsite per approved work plan

- Casings cut off below grade
 - Plugged
 - Welded shut
- Exception: Casing at test hole X-1
 - Removed completely

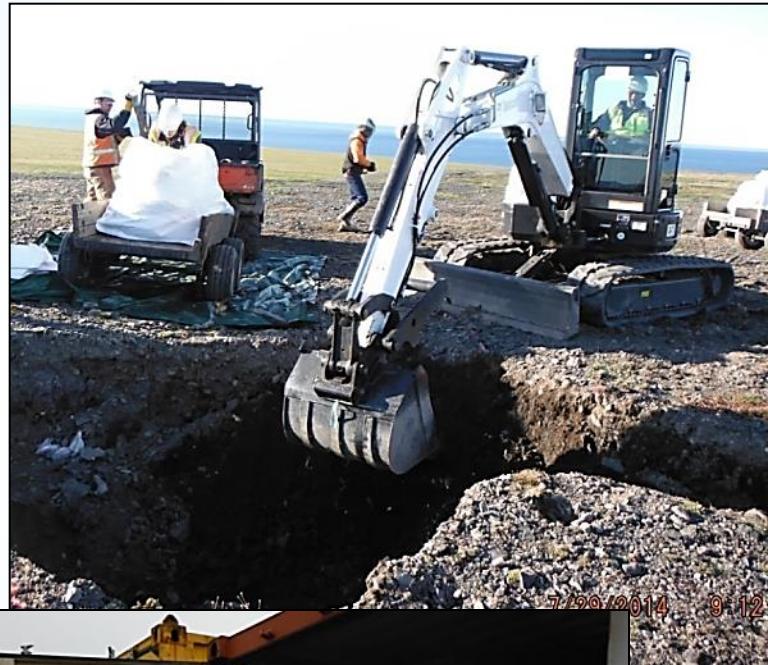
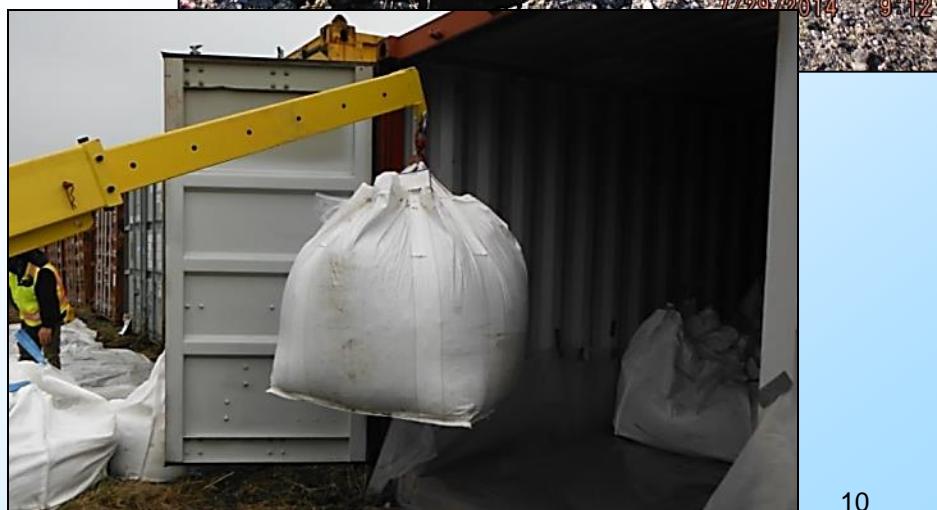
- Contaminated soil excavated and containerized in super sacks
 - Guided by field screening
 - Excavations stopped vertically at permafrost and/or bedrock
 - Per approved work plan
- Filled sacks transported to staging areas
 - Weighed
 - Loaded into shipping containers

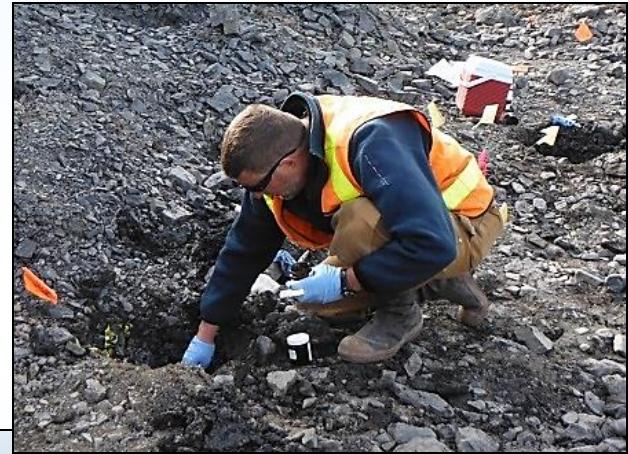
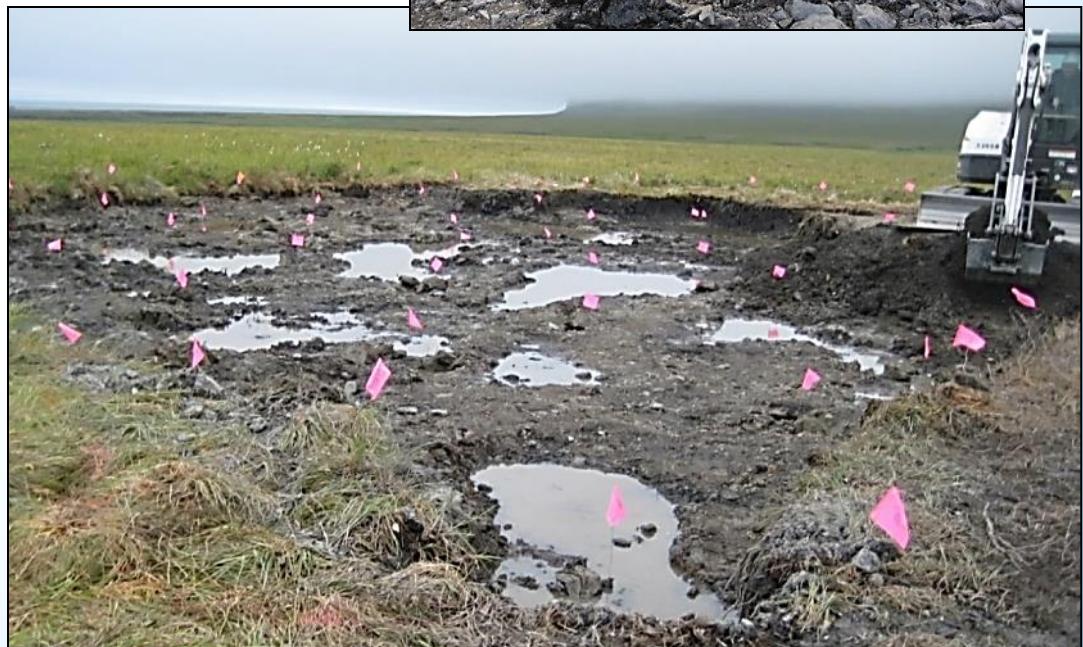
- After excavation completion:
 - Additional screening and laboratory samples collected from floor and walls
 - Confirmation that cleanup work completed
- Sample results:
 - All below state limits or;
 - permafrost/bedrock prevented further excavation
- Results forwarded to Alaska State
 - Review prior to backfilling

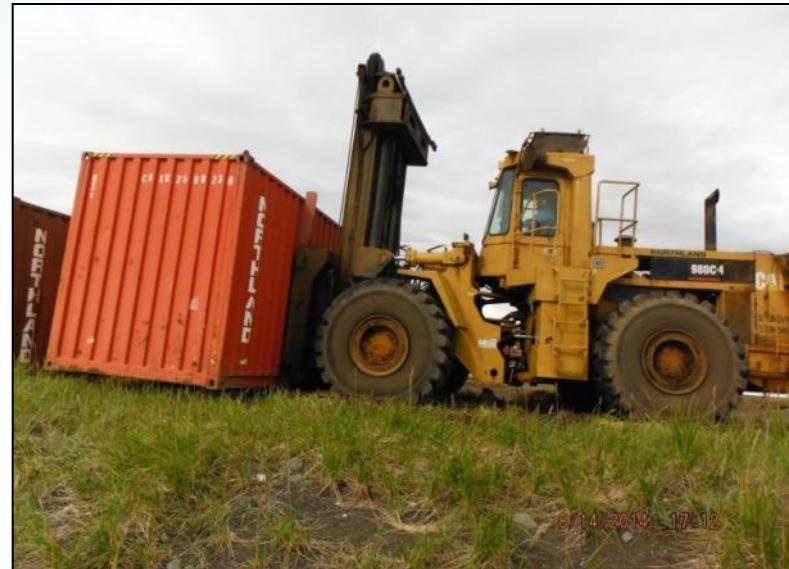
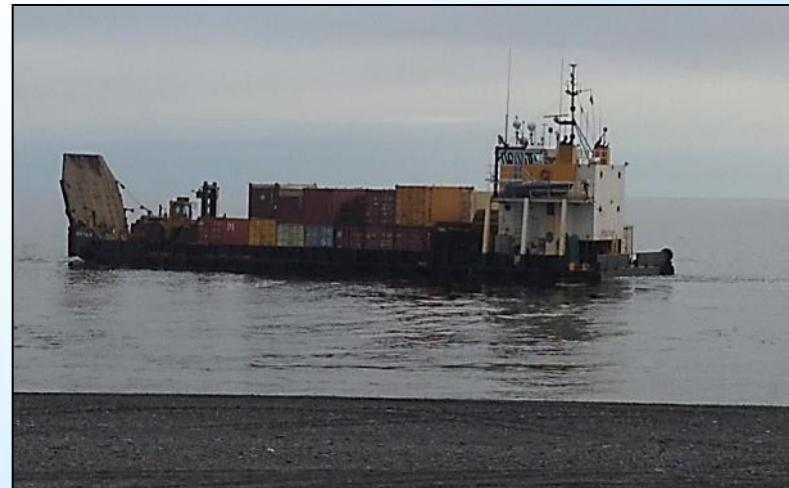
- Super sacks loaded into shipping containers
 - Quantity: 12 to 15 (20 tons)
- Shipping containers loaded onto landing craft
 - Transported from cleanup site to Kotzebue and Nome
- Containers loaded onto barges
 - Shipped to Seattle, Washington
- Containers transported overland to Columbia Ridge Landfill in Arlington, Oregon

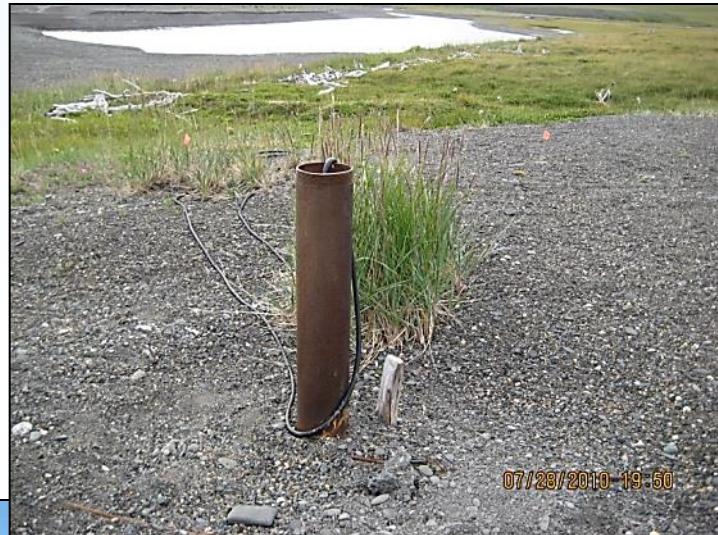
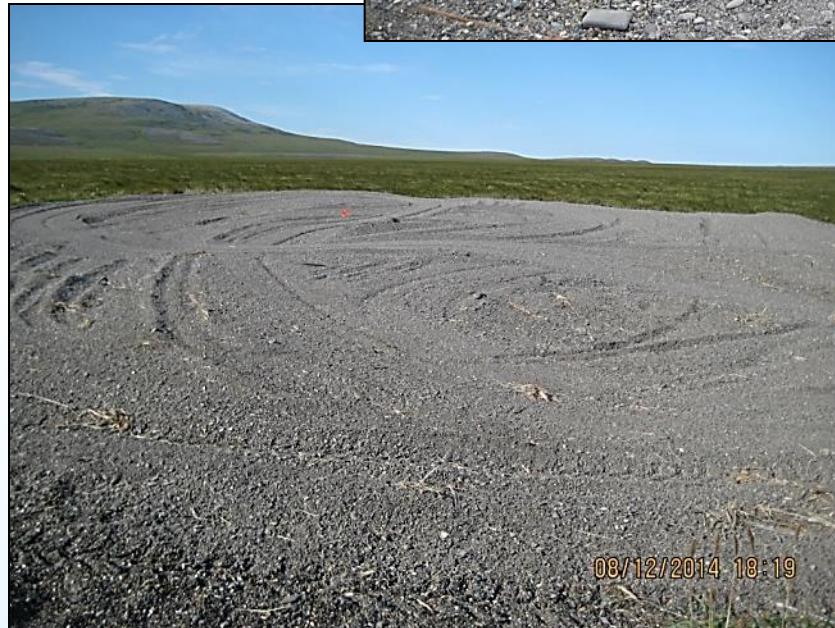
- No contamination identified
- Casing cut, sealed, and capped
- Site contoured and reseeded
