## **Filter Component Assessment**

Westinghouse Electric Corporation  
Science and Technology Center  
1310 Beulah Road  
Pittsburgh, Pennsylvania 15235-5098

Advanced Coal-Fired Power Systems '95 Review Meeting

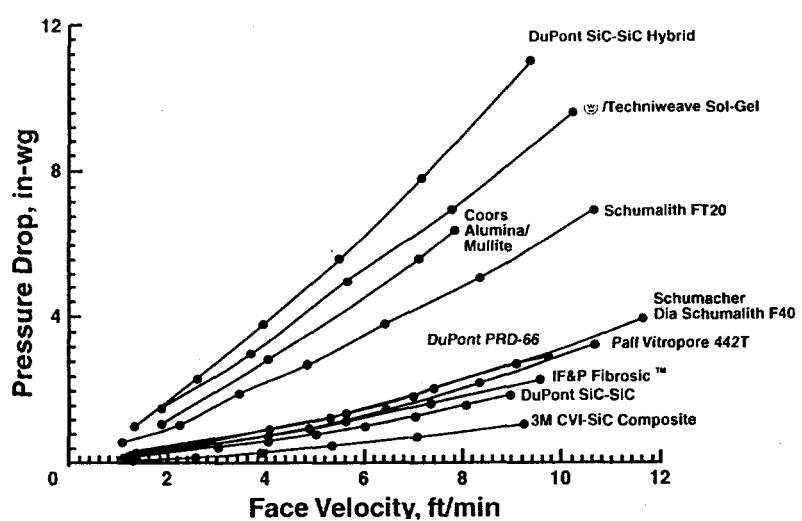
Figure 1. Room Temperature Gas Flow Resistance of the First Generation Monolithic and Advanced Second Generation Candle Filters

Manufacture of 1.4-1.5 m advanced, second generation candle filters has been achieved within the past two years. The room temperature, gas flow resistance of the as-manufactured 3M CVI-SiC composite, DuPont PRD-66, DuPont SiC-SiC, and IF&P Fibrosic™ candle filters is shown in Figure 1 in conjunction with first generation,

monolithic filter elements. These data indicate the relatively high initial permeability of the porous, light weight, second generation filter elements.

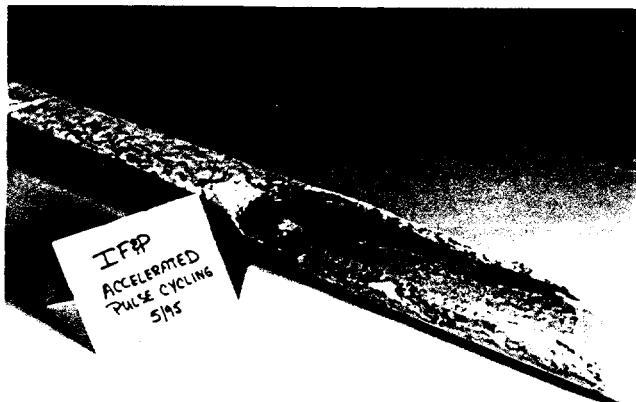
**Figure 3. Fractured IF&P Fibrosic™ Candle Filter After 1645 Accelerated Pulse Cycles Under HTHP Conditions**

HTHP testing was conducted at temperatures of 843°C and pressures of 100 psig, with a pulse cycle delivered every 2.5 minutes. After 1645 pulse cycles, dust was detected in the off-gas, indicating that a breach had occurred within the filter system. Upon disassembly, the IF&P Fibrosic™ candle was observed to have fractured along the mid-body (Figure 3). A large hole (~75 mm long; ~40 mm wide) was evident below the flange, and a smaller through-wall hole (i.e., ~10 mm) was evident along the filter body. The longitudinal fractured surface of the Fibrosic™ matrix followed what appeared to be the "bark-like" or matrix texture lines that were apparent along the outer surface of the filter element. Striated layers of the chopped fiber matrix were evident throughout the fractured IF&P Fibrosic™ filter wall.

Gas flow "stream" lines were evident along the ID wall of the fractured IF&P Fibrosic™ candle. These lines which were approximately 180° from the large hole that resulted below the flange, were considered to have resulted from repeated pulse cycling. Further inspection of the ID surface near the flange indicated that the surface of the infiltrate

that was used to provide additional strength along the flange had partially separated from the support matrix.

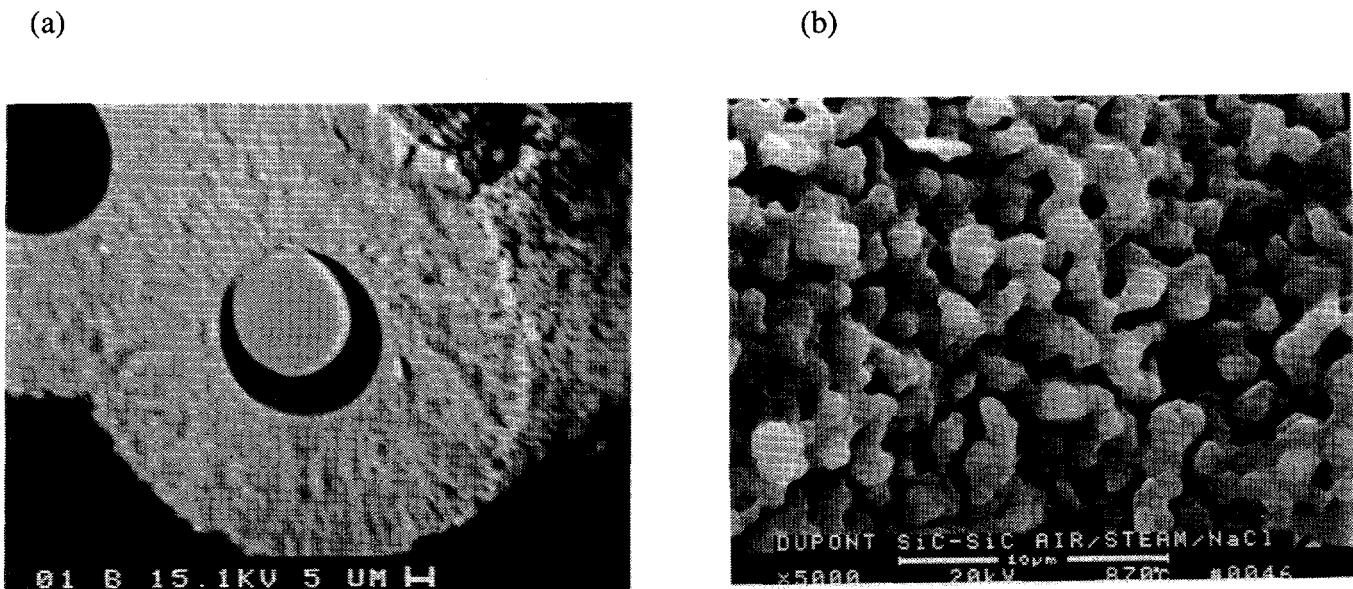
**Figure 5. DuPont SiC-SiC Composite Matrix After 400 Hours of Exposure at 870°C to the 20 ppm NaCl/5-7% Steam/Air Flow-Through Test Environment**  
 (a) Depletion of the Interface Coating; (b) Oxidation of the CVI-SiC Surface

**DuPont SiC-SiC Composite Matrix.** The DuPont SiC-SiC composite matrix consists of an ~10-20  $\mu\text{m}$  silicon carbide layer which is chemically vapor infiltrated (CVI) along an ~2-5  $\mu\text{m}$  interface coating layer which encapsulates ~15  $\mu\text{m}$  Nicalon<sup>TM</sup> fibers. Several issues have been raised as to the oxidative stability of the dual single-ply felt or hybrid (i.e., single-ply felt; single-ply open mesh screen) DuPont SiC-SiC composite matrix, and in particular the stability of the interface coating and Nicalon<sup>TM</sup> fibers.

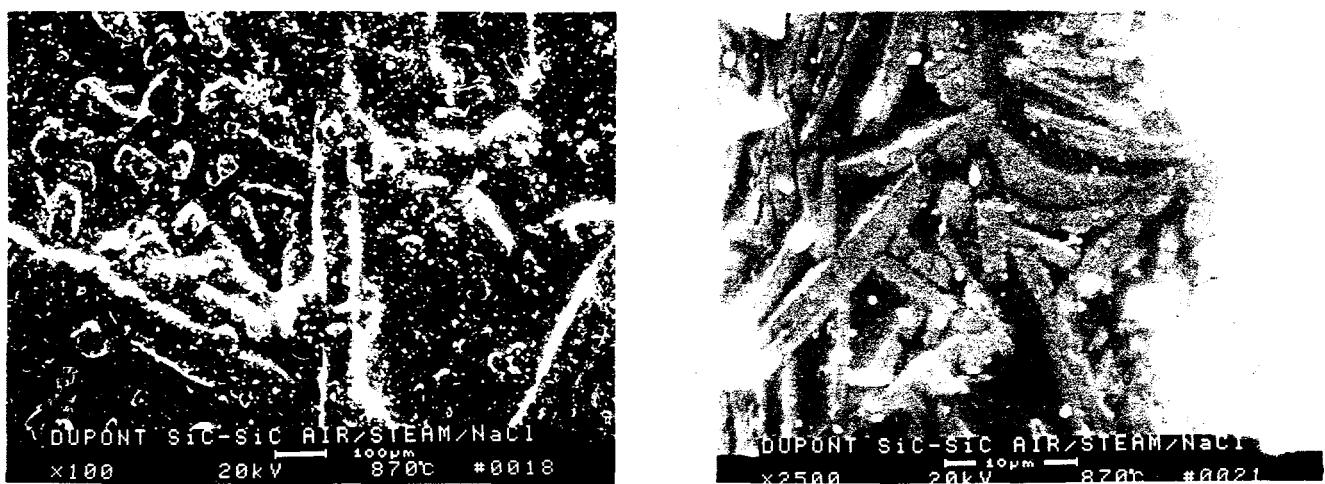
**Figure 6. Glazed Sodium-Enriched Surface Membrane of the DuPont SiC-SiC Composite Candle Filter Matrix After 400 Hours of Exposure to 870°C, 20 ppm NaCl/5-7% Steam/Air Flow-Through Test Environment**

In contrast, the fine grained SiC membrane coating of the DuPont matrix tended to form a glaze during the high temperature, alkali/steam/air exposure, which reduced gas flow permeability through the filter disc (Figure 6). The glazed surface which was enriched with sodium could conceivably serve as a potential site for collection and adherence of ash fines at process operating temperatures, which may ultimately cause blinding of the filter element surface.

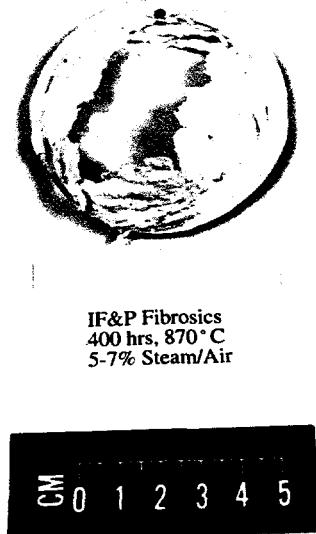
**Figure 7. IF&P Fibrosic™ Filter Disc After 400 Hours of Exposure at 870°C to the 5-7% Steam/Air Flow-Through Test Environment**

**IF&P Fibrosic™ Filter Matrix.** The vacuum infiltrated alumina and aluminosilicate chopped fiber IF&P Fibrosic™ matrix was similarly subjected to 400 hours of flow-through testing at 870°C in both the steam/air and alkali/steam/air environment. After 400 hours of exposure in the 870°C steam/air environment, the membrane coated IF&P Fibrosic™ disc was torn as the result of repeated pulse cycling (Figure 7). In contrast, the IF&P Fibrosic™ disc which had been exposed for 400 hours at 870°C to the alkali/steam/air environment remained intact, and appeared to have

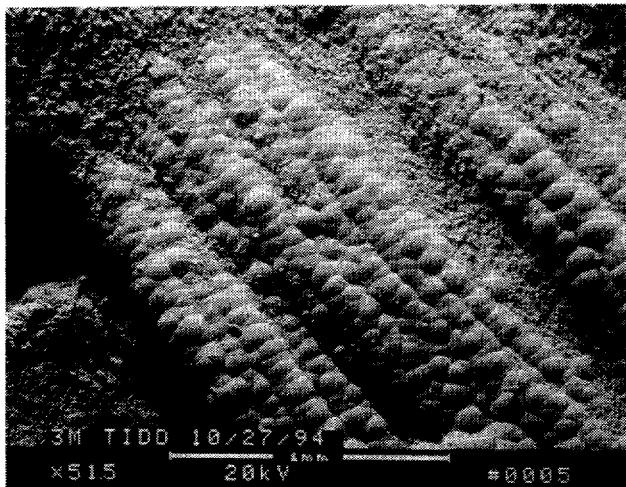
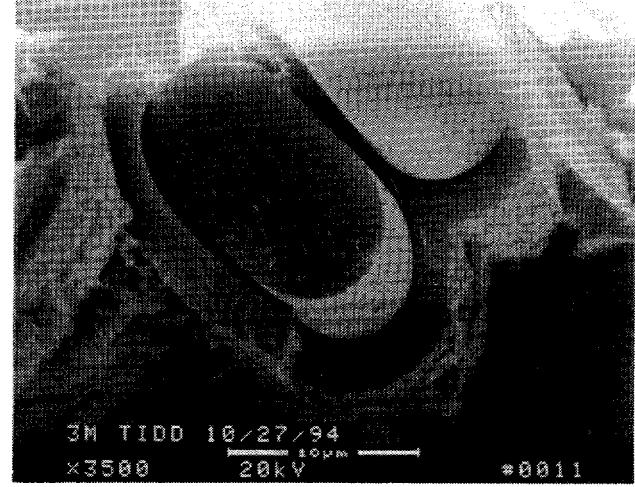
**Figure 8. Morphology of the 3M CVI-SiC Composite Matrix after 1705 Hours of Operation in the 660-760°C PFBC Environment**

PFBC environment, oxidation of the interface coating is expected to occur.

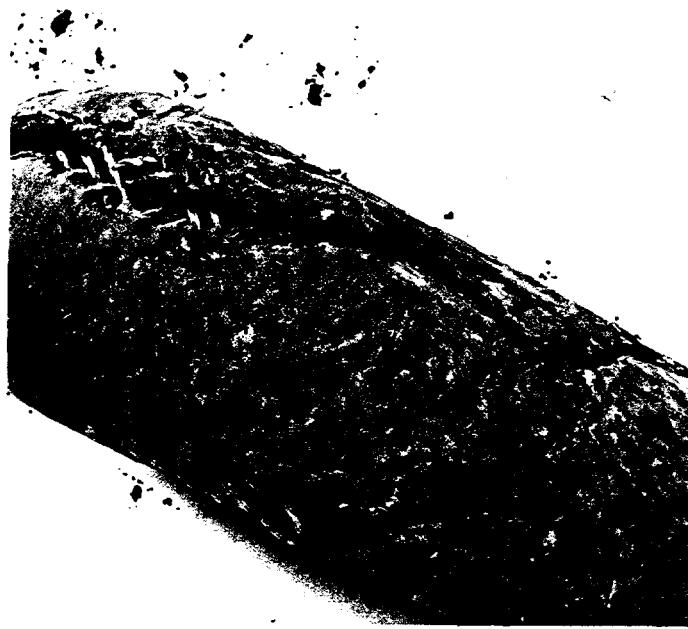
**Figure 9. Fractured 3M CVI-SiC Composite Filter End Cap After 1110 Hours of Operation in the W-APF System at AEP in Test Segment #5**

CVI-SiC composite filters were installed in the W-APF system. After 1110 hours of filter operation at temperatures ranging between 760 and 845°C, testing was terminated. Post-test inspection of the filter cluster indicated that all ten of the 3M CVI-SiC composite filter elements were intact. Further inspection of the 3M candles indicated that ash had been carried into the ID bore of the elements due to a breach within an alternate filter array. As a result, ash fines became tightly packed in the bottom of several of the filter elements. After cool-down of the W-APF, cracks were evident along the internally ash plugged section of at least one filter element (Figure 9). Along an alternate 3M filter element, a 25.4 mm diameter hole was evident along the outer confinement layer. The location of the removed confinement layer was ~75 mm below the flange.
