Final 2014 Remedial Action Report

Project Chariot Cape Thompson, Alaska

March 2015

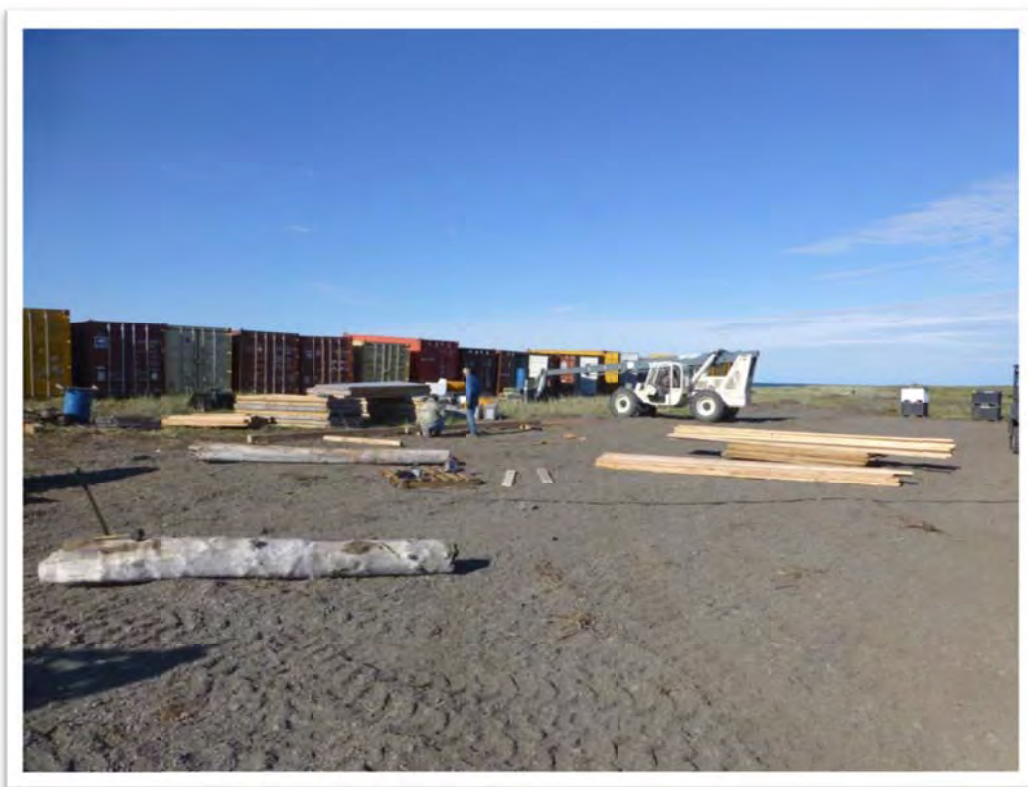
Photograph 1 – Setting up camp on July 12; West Staging Area in background. Camp materials and equipment arrived via barge on July 8. View to the southwest.

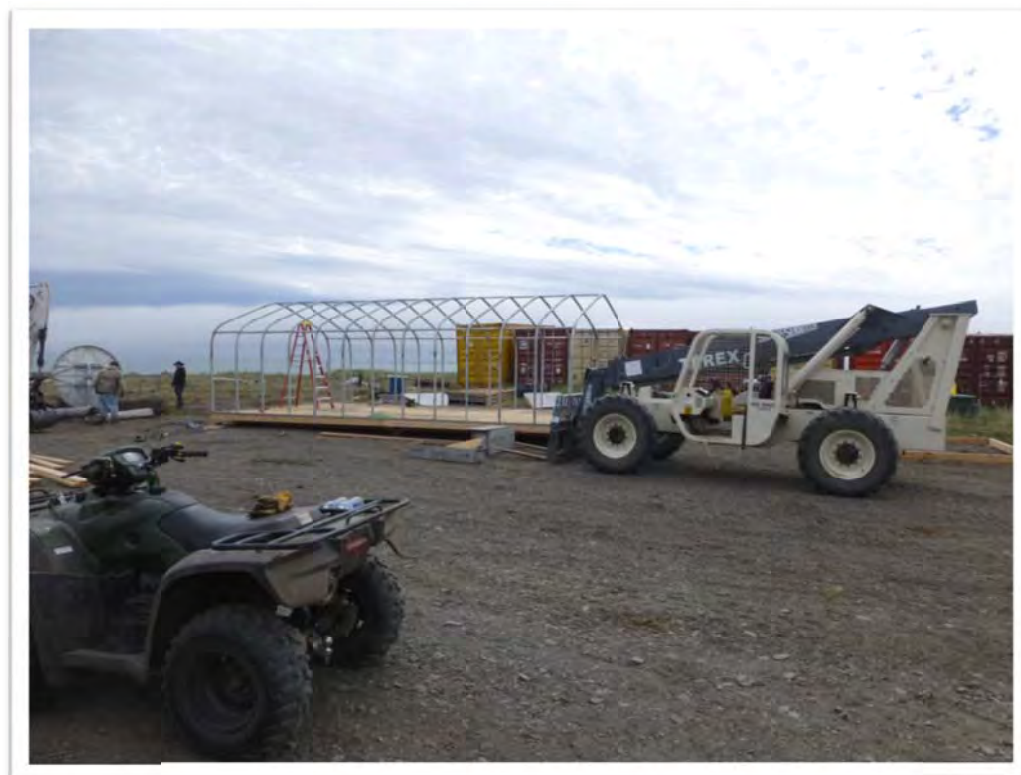
Photograph 2 – The main tent shown being erected housed the kitchen and dining room on the east side, and the laundry and showers on the west side. View to the southeast.

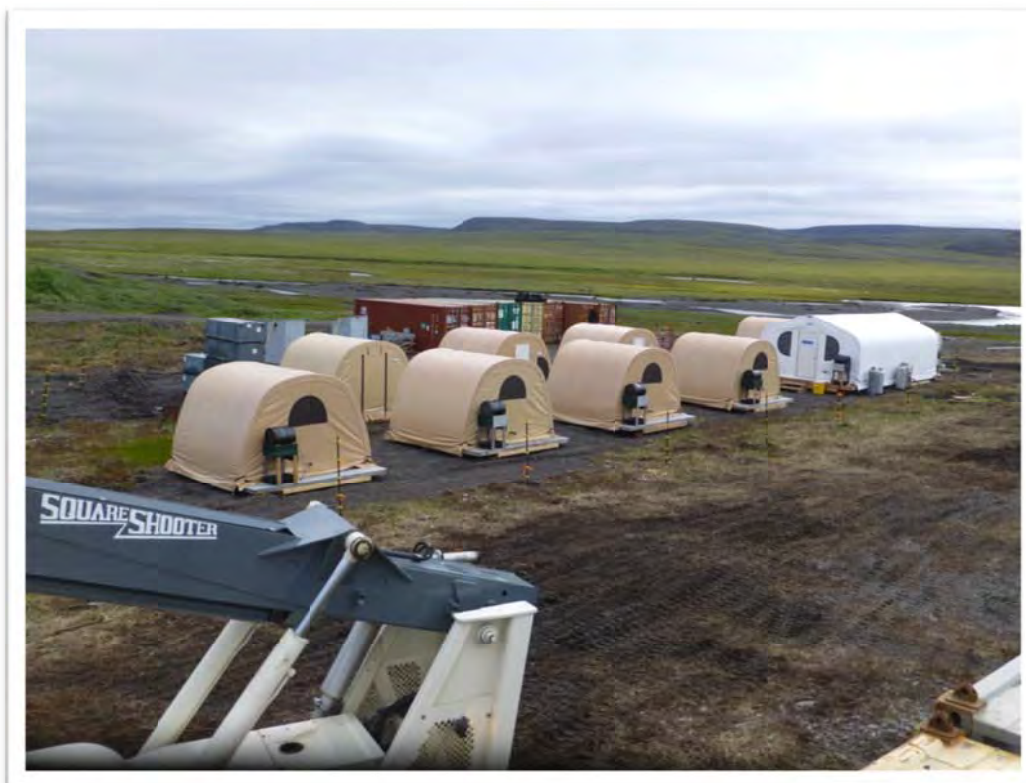
Photograph 3 – View of finished camp from West Staging Area. Tan tents were sleeping quarters. Food, tools, and parts were stored in the connex shipping containers in background. View to the northeast.

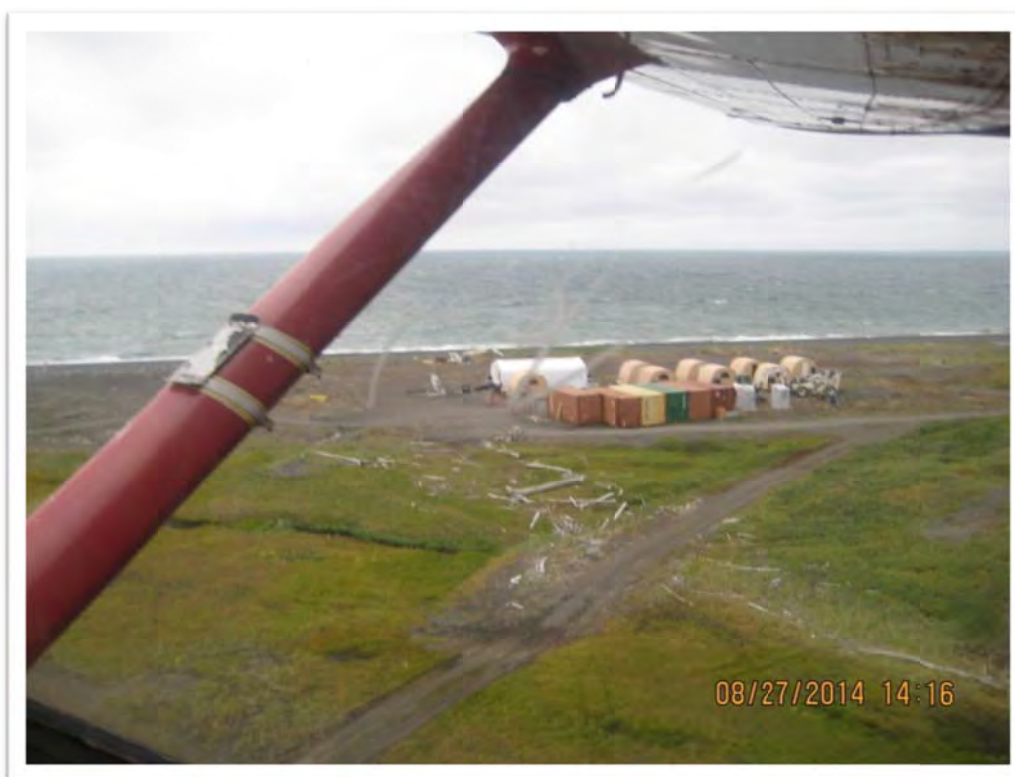
Photograph 4 – View of camp from the airplane window. View to the south.

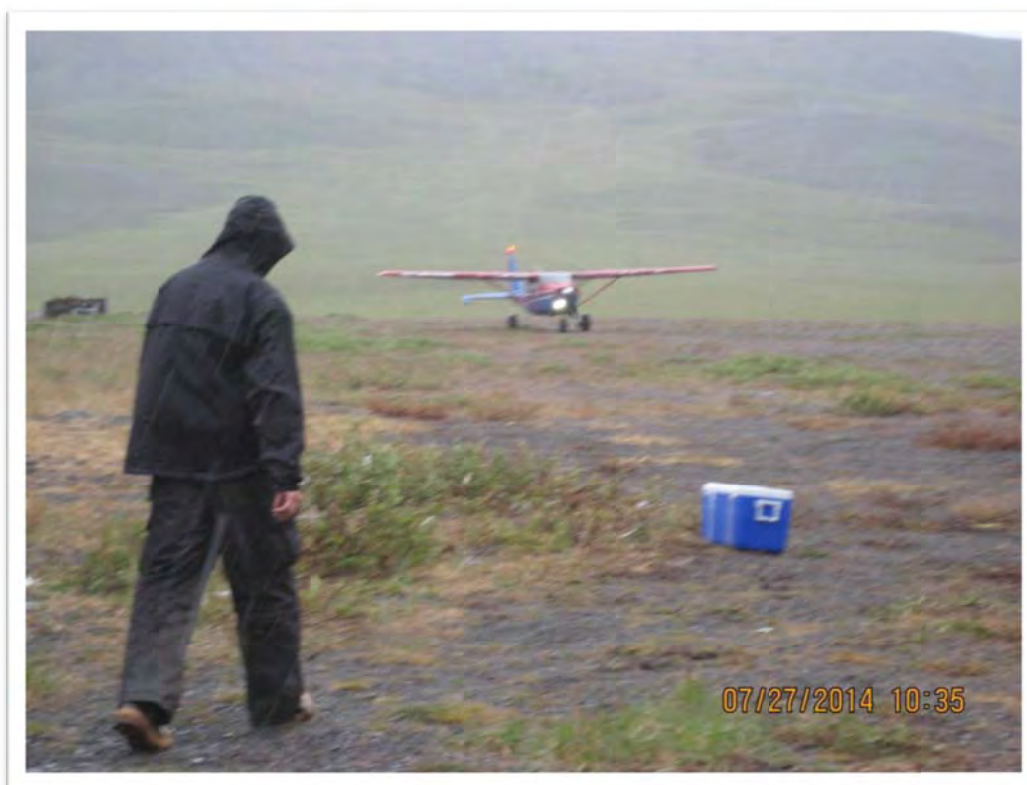
Photograph 5 – Sample coolers were shipped from the site to Kotzebue via fixed-wing plane, where they were put on a commercial flight to the project laboratory in Anchorage. View to the northwest.

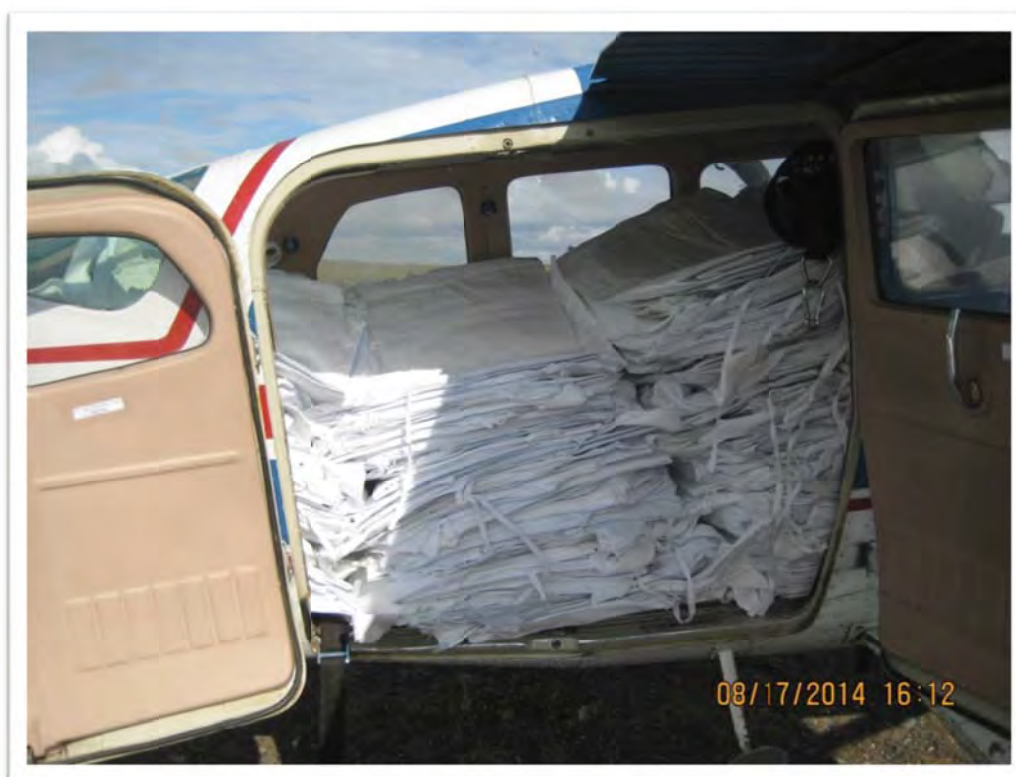
Photograph 6 – Field personnel and gear were transported to the site via fixed-wing plane capable of carrying 800 pounds. Additional super sacks are shown in this photograph.

Field personnel and site visitors accessed the site via small fixed wing aircraft from Kotzebue, Alaska. Northwestern Aviation utilized modified Cessna 206 aircraft capable of transporting up to four passengers or up to 800 pounds of freight to the remote site. Most takeoffs and landings occurred on the West Airstrip. However, during periods of strong north-south winds, an alternate airstrip (Airstrip 3) located northeast of the East Airstrip was used. The East Airstrip was in bad condition and was not used by aircraft.

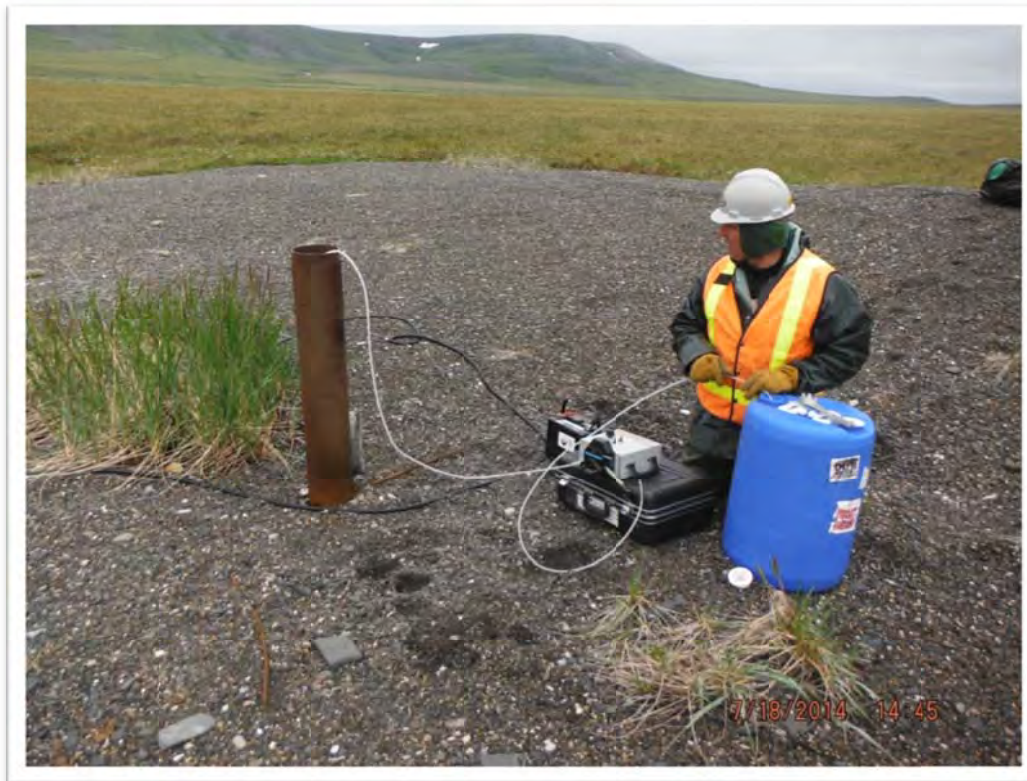
Photograph 7 – Approximately 4.5 gallons of water were pumped from the Test Hole Able casing. View to the northwest.

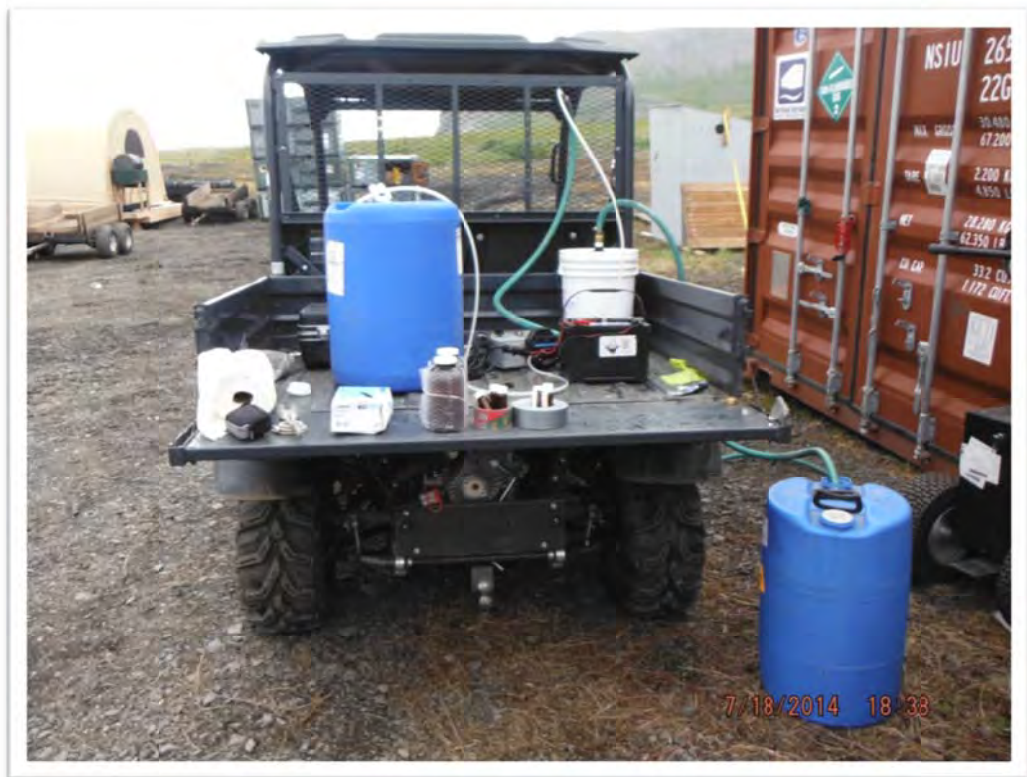
Photograph 8 – Approximately 9 gallons of casing water was treated collectively with granular activated carbon prior to surface discharge. Representative samples were collected pre- and post-treatment. View to the west.

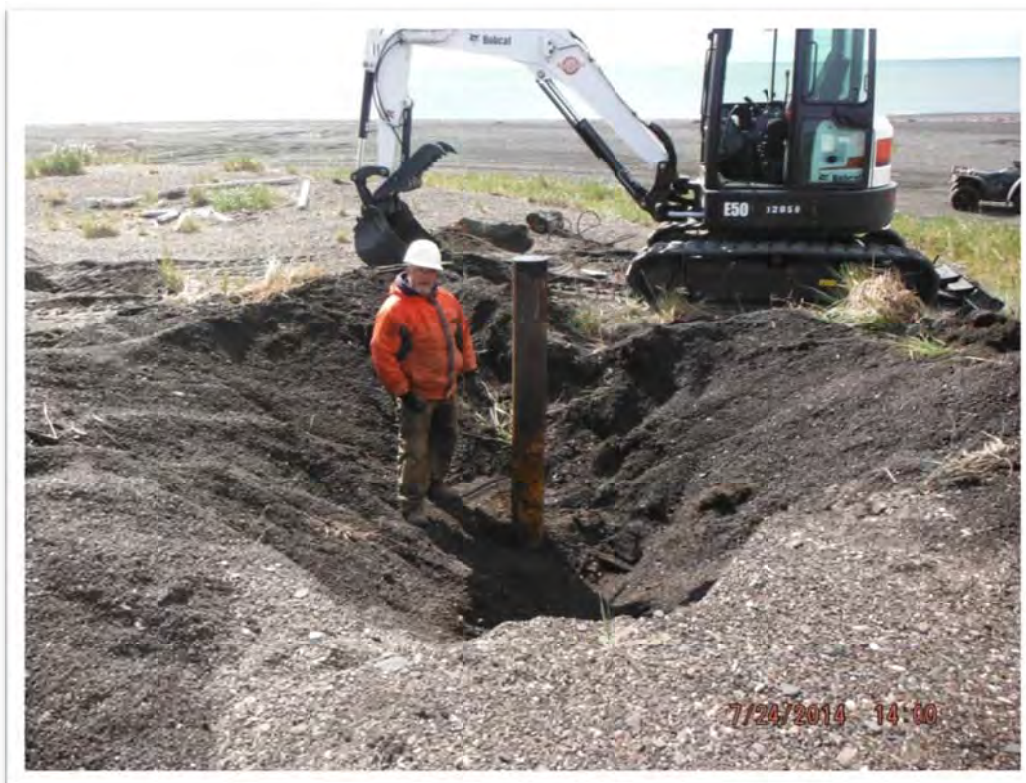
Photograph 9 – The area surrounding Test Hole Able casing was excavated so it could be cut and capped below grade.
View to the south.

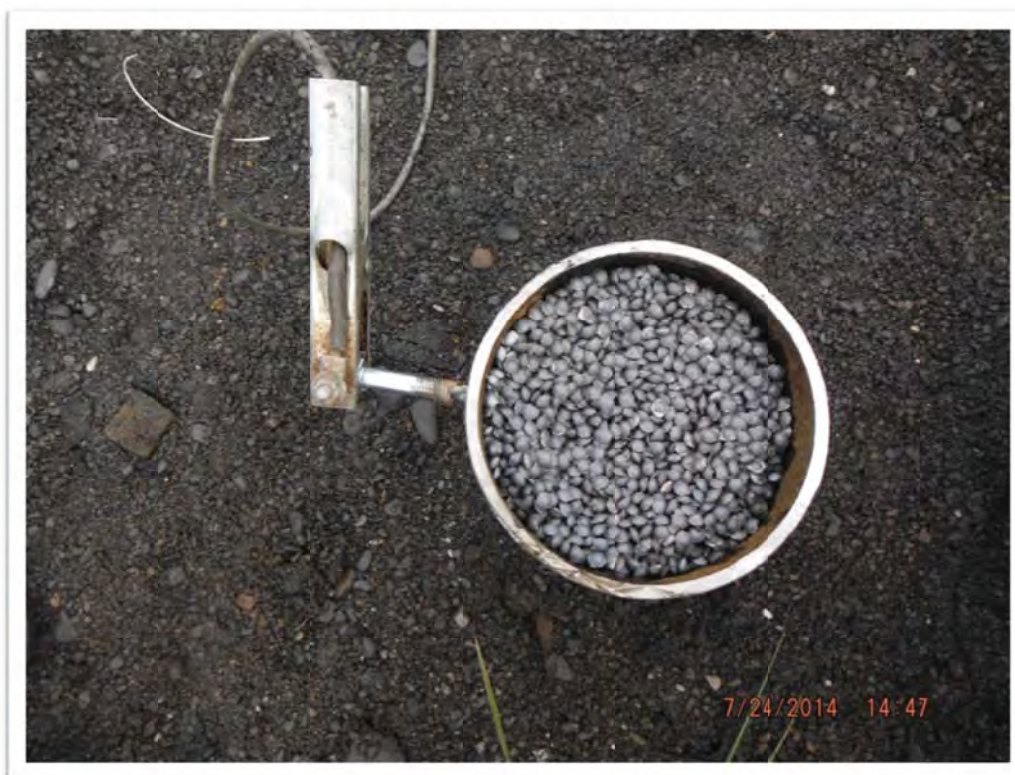
Photograph 10 – The casing interiors were sealed with a bentonite plug. A ground wire was attached to a bolt welded onto the left side of casing to allow welding of cap.

After water was removed and treated, the steel casings were cut below grade with an electric handheld band saw, sampled if possible, then sealed with hydrated bentonite and welded shut. An effort to remove the Test Hole Charlie casing by attaching a chain from the well casing to the mini-excavator and extracting the casing from the ground was attempted but failed, likely due to the presence of shallow permafrost. The casing at Test Hole X-1 was completely removed; the casing was only buried to a depth of 5 feet and was not installed in permafrost.

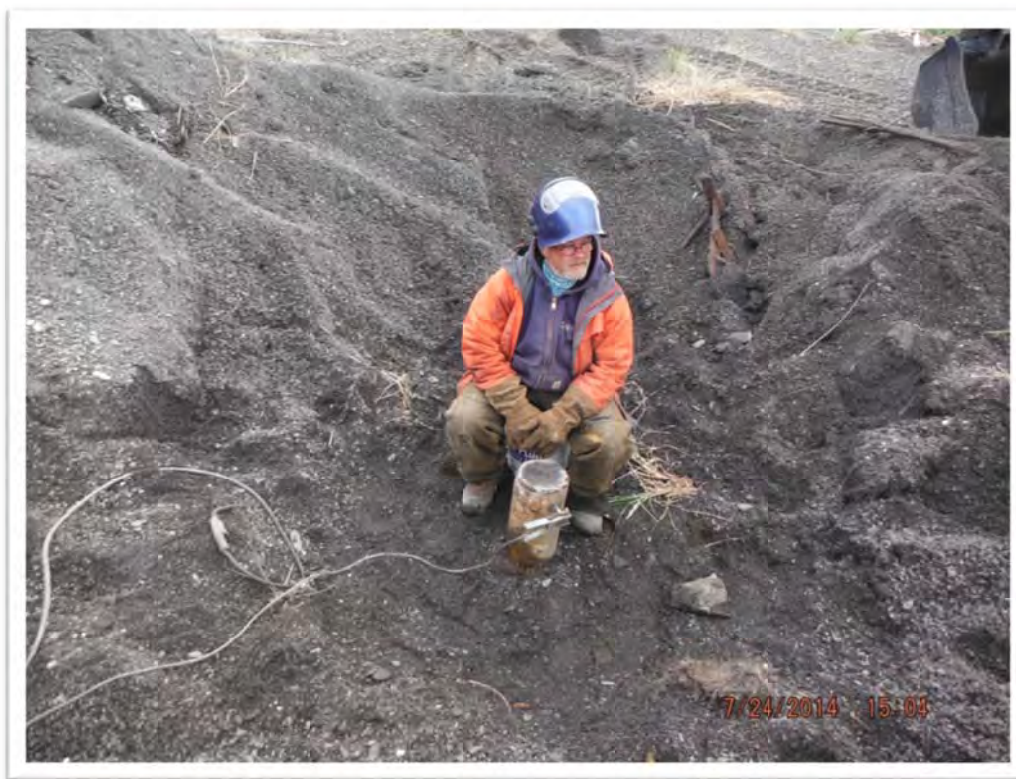
Photograph 11 – Caps were welded onto the top of the cut casings. View to the southeast.

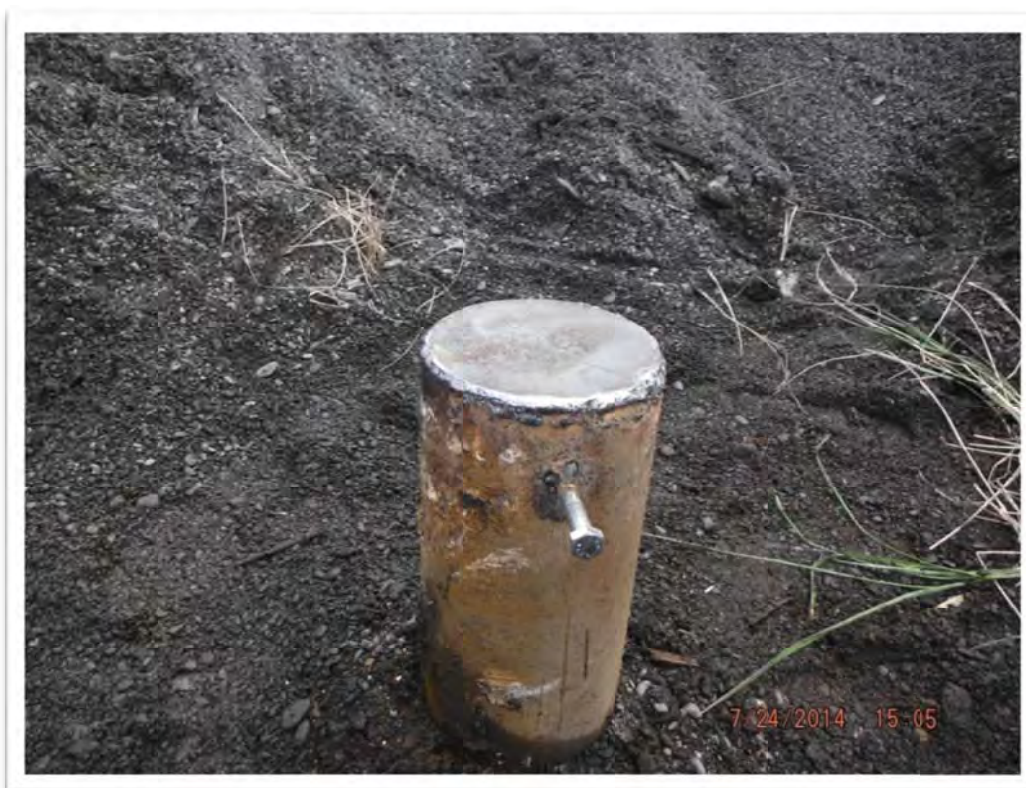
Photograph 12 – Close-up of Test Hole Able before it was buried.

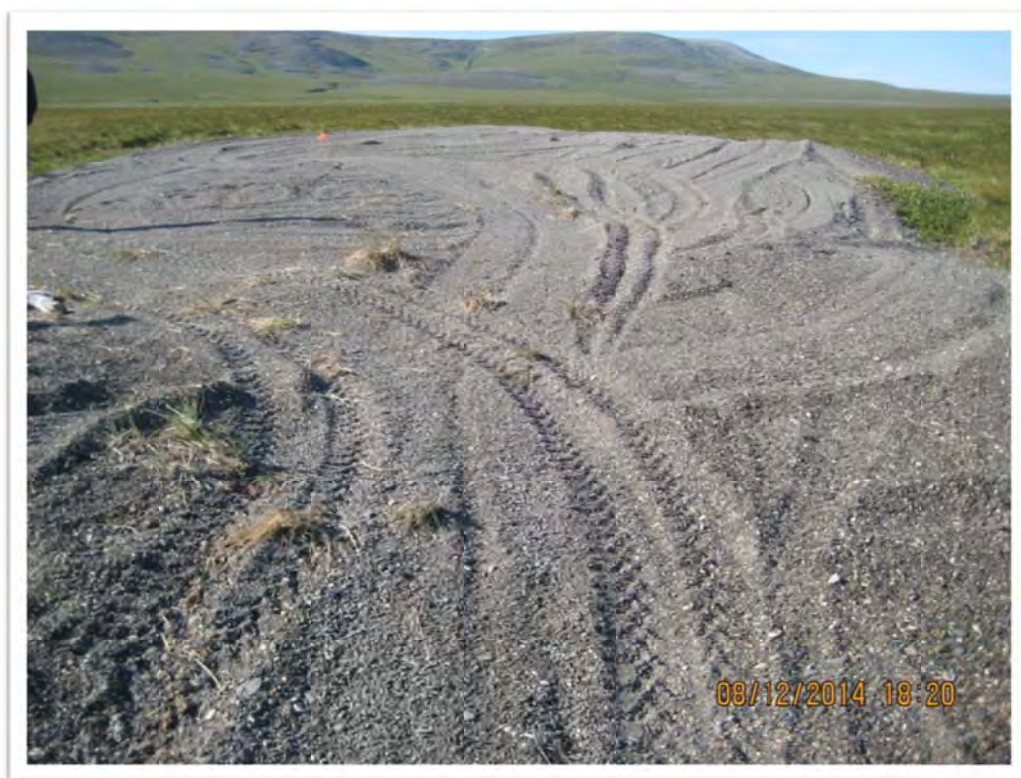
Photograph 13 – Test Hole Able pad was re-contoured following the decommissioning of the casing. Orange pin flag represents the casing location. View to the northwest.

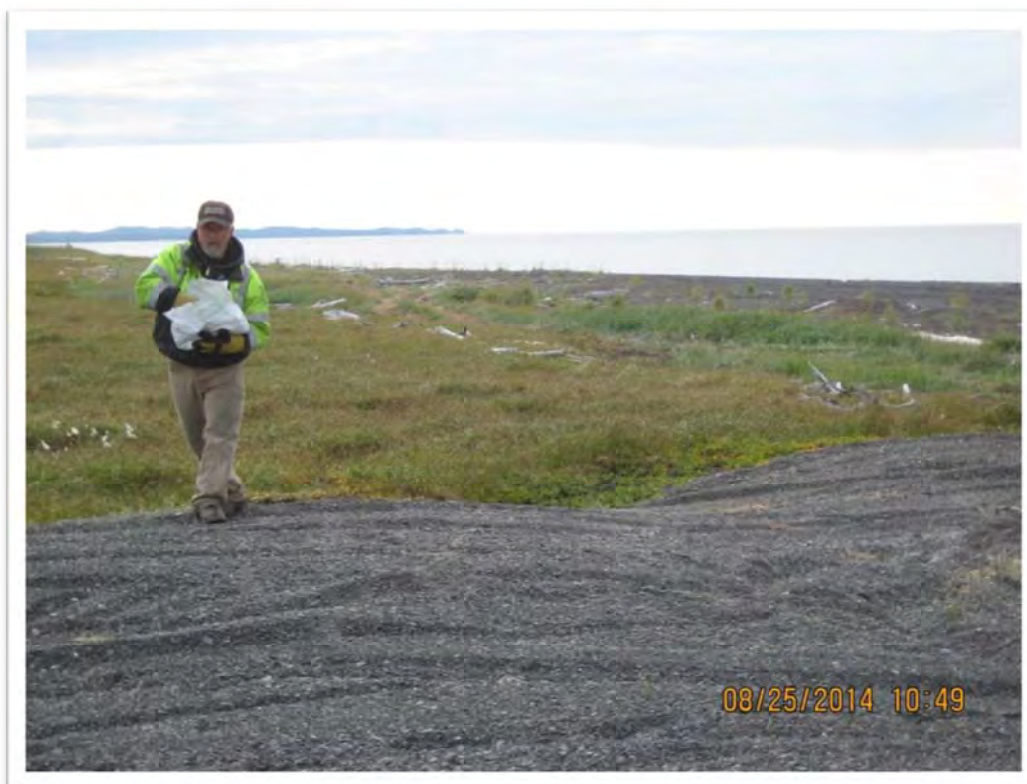
Photograph 14 – The pads were fertilized and re-seeded at the end of the project.

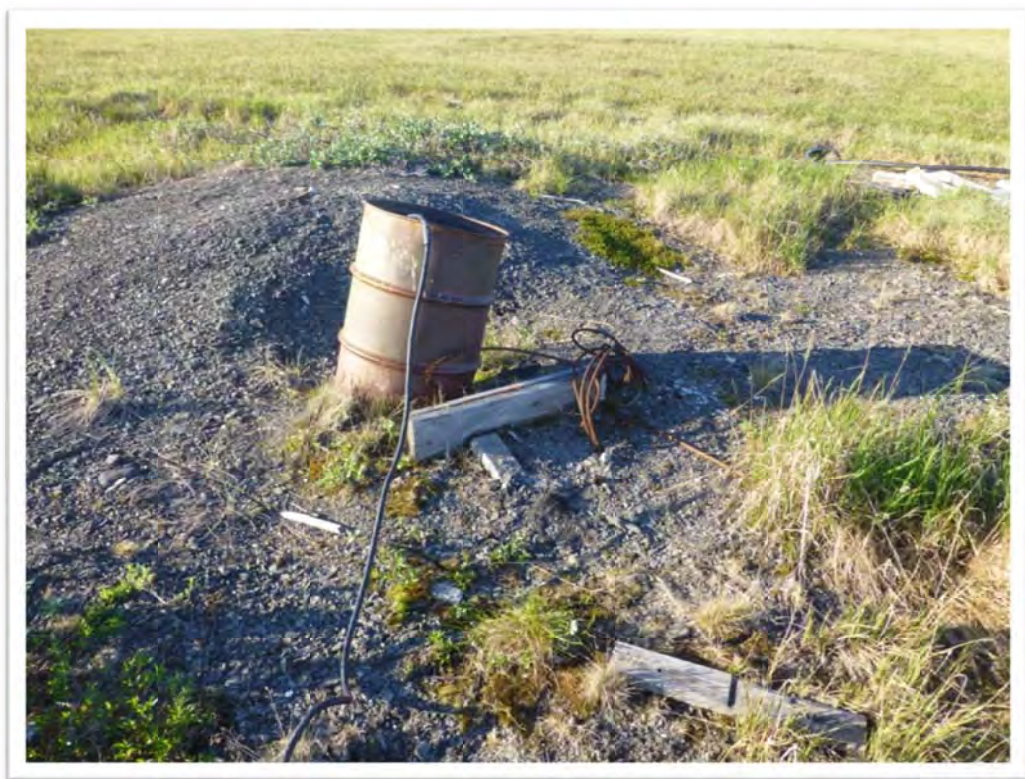
Photograph 15 – Test Hole Baker prior to decommissioning. View to northeast

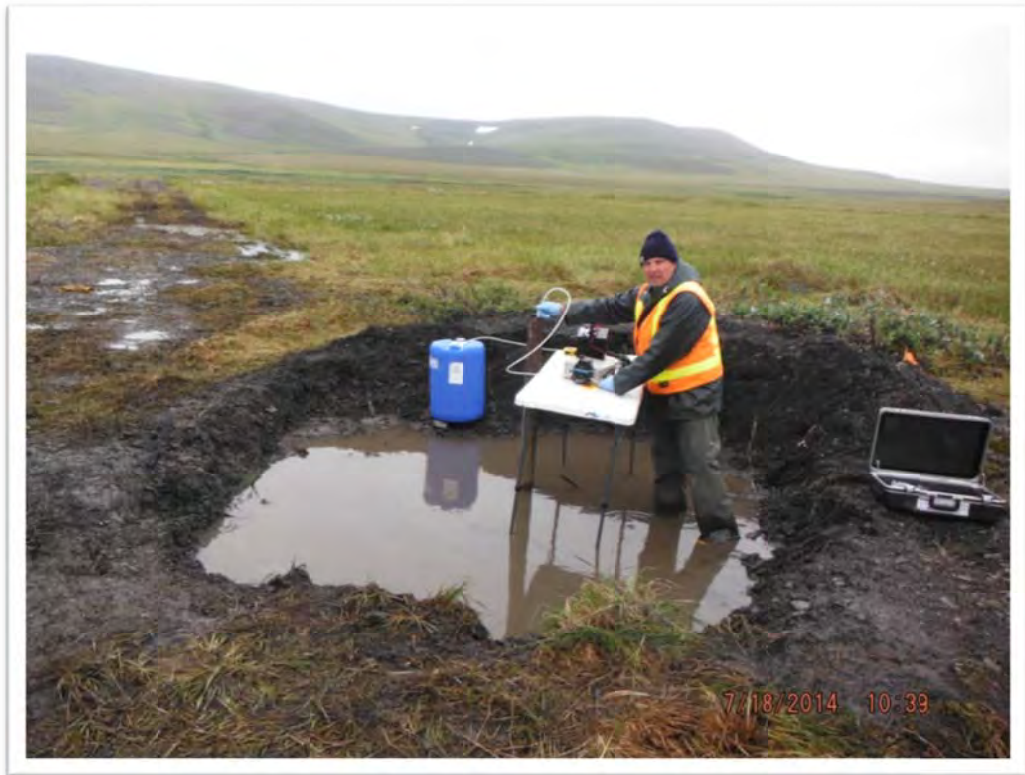
Photograph 16 – Water was pumped from the casing prior to decommissioning.
View to the northwest.

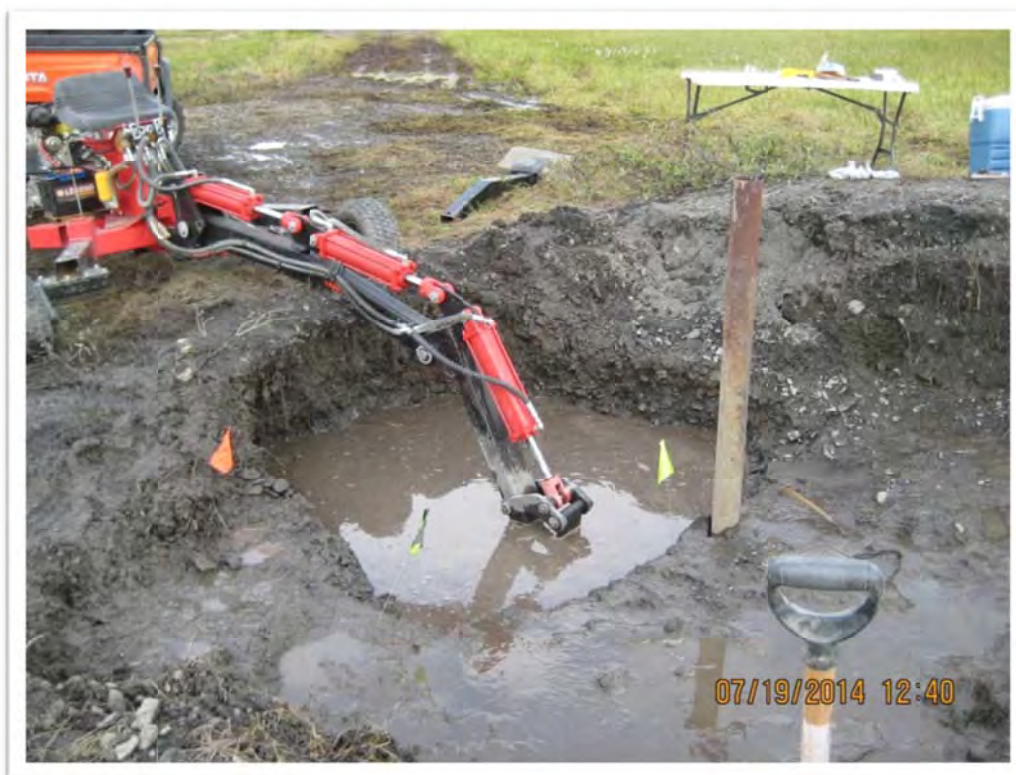
Photograph 17 – The northwest corner of the Test Hole Baker was excavated to a depth of 40 inches. A small, towable backhoe was used due to site access and small excavation size. View to the northwest.

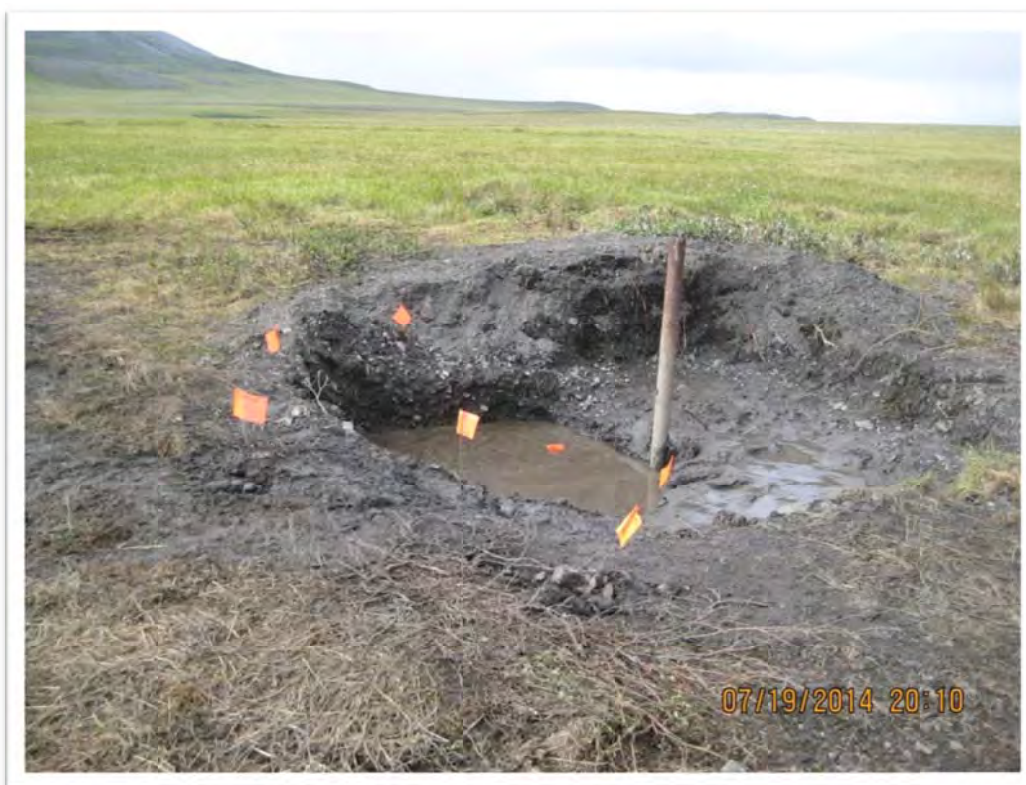
Photograph 18 – Confirmation and footprint sample locations were marked with orange pin flags so they could be surveyed. View to the north.

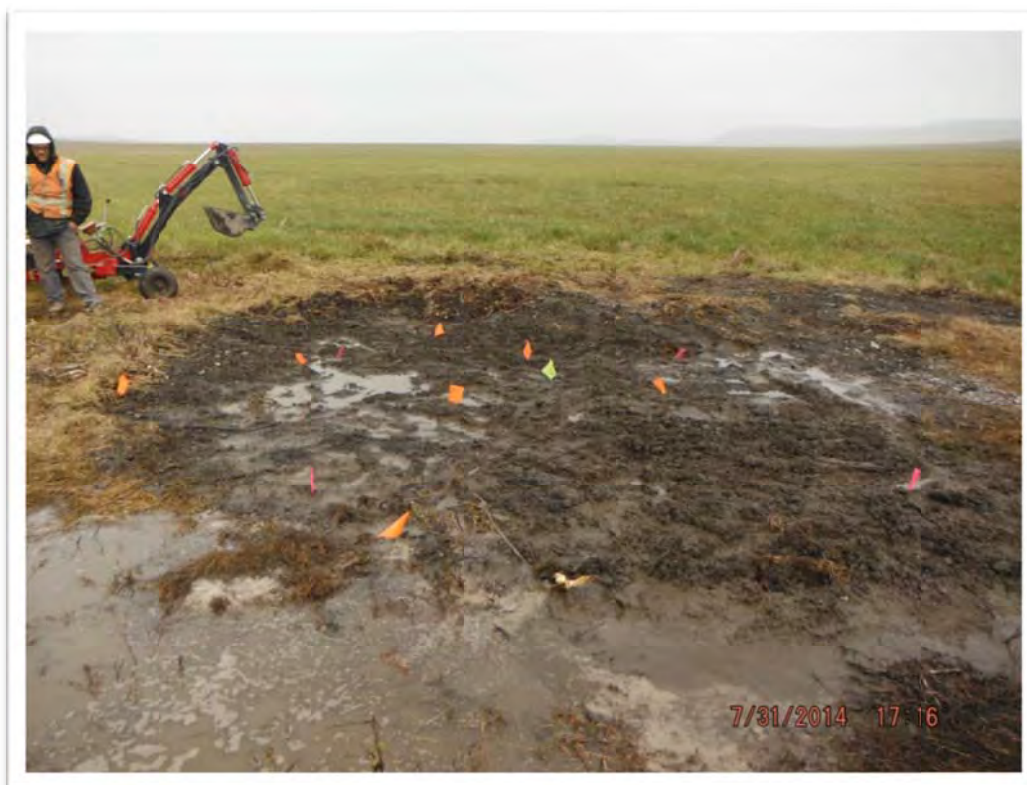
Photograph 19 – View of Test Hole Baker excavation immediately after backfilling and re-contouring. Casing was cut and capped below grade. View to northeast.

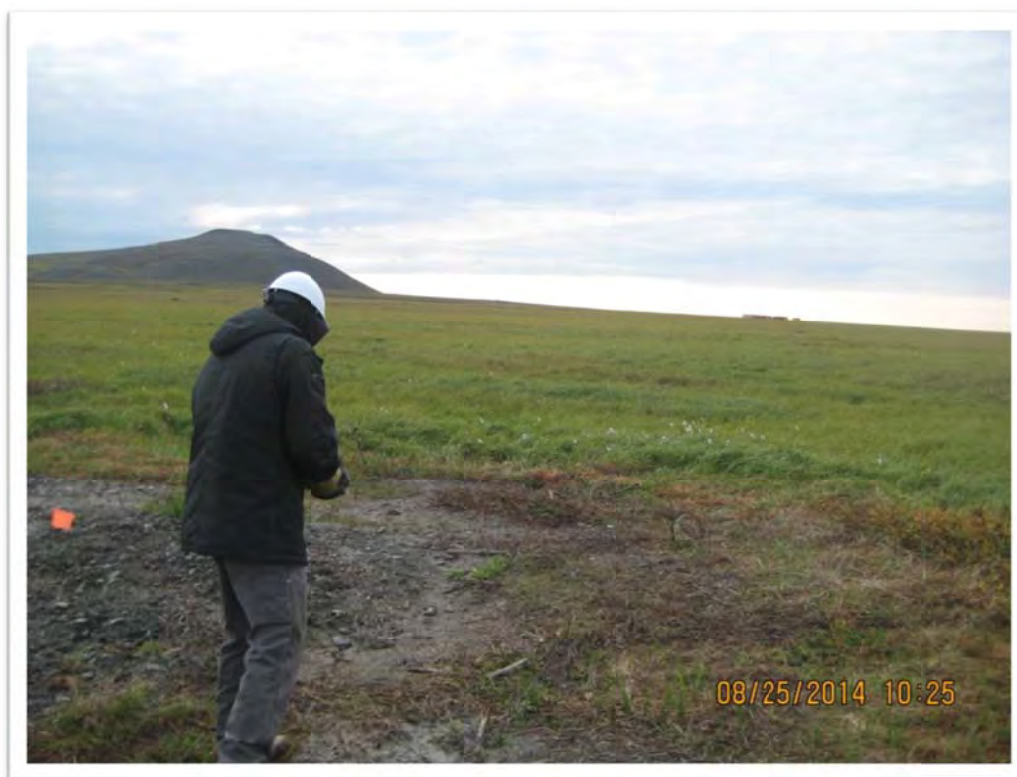
Photograph 20 – The Test Hole Baker pad was fertilized and re-seeded on August 25. View to the southeast.

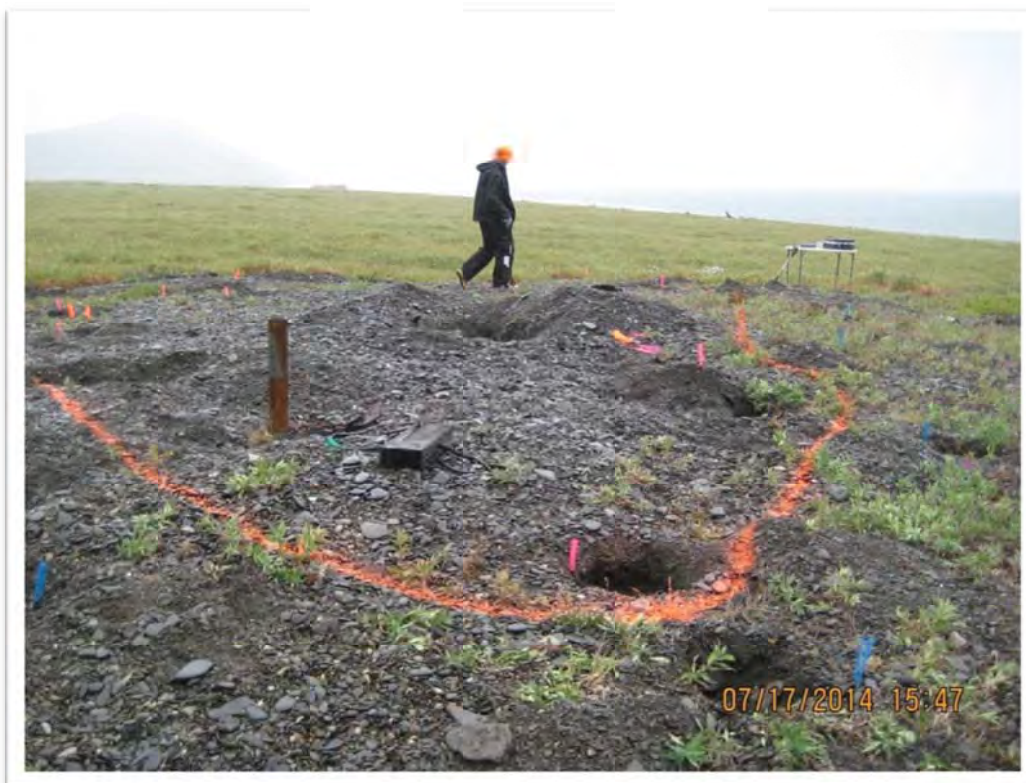
Photograph 21 – Surface soils at Test Hole Charlie were screened with a PID to estimate the area with POL-contamination (marked with spray paint). Casing is shown on left. View to the southeast.

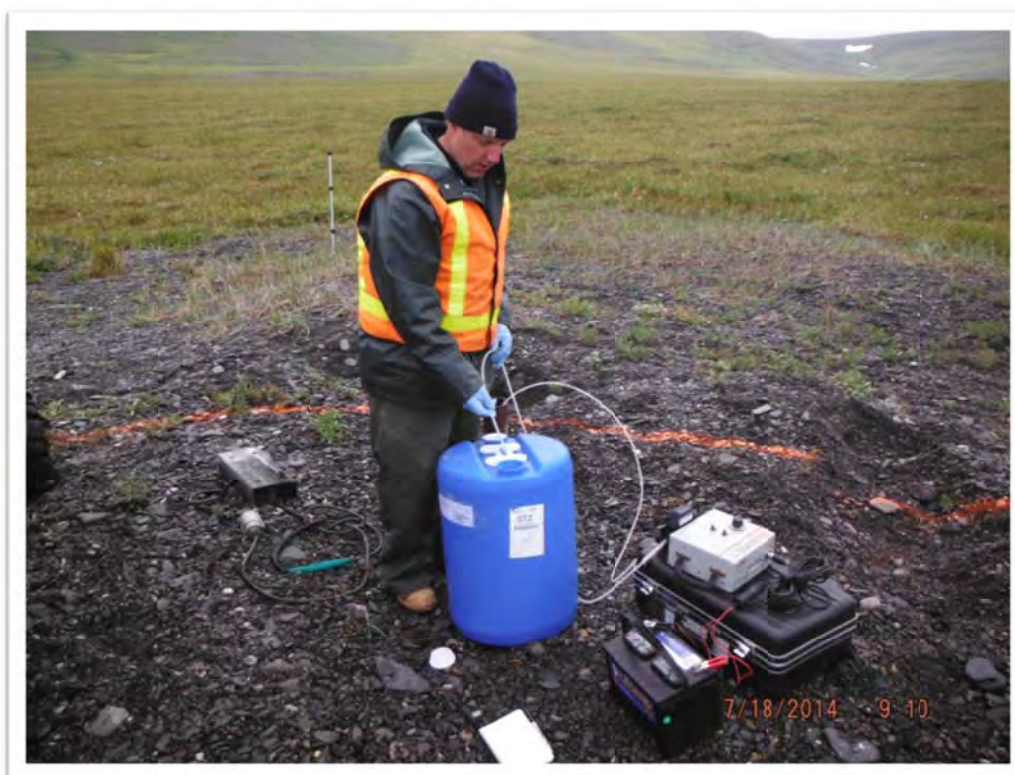
Photograph 22 – Standing water was pumped from the Test Hole Charlie casing prior to decommissioning and excavation activities. View to northwest.

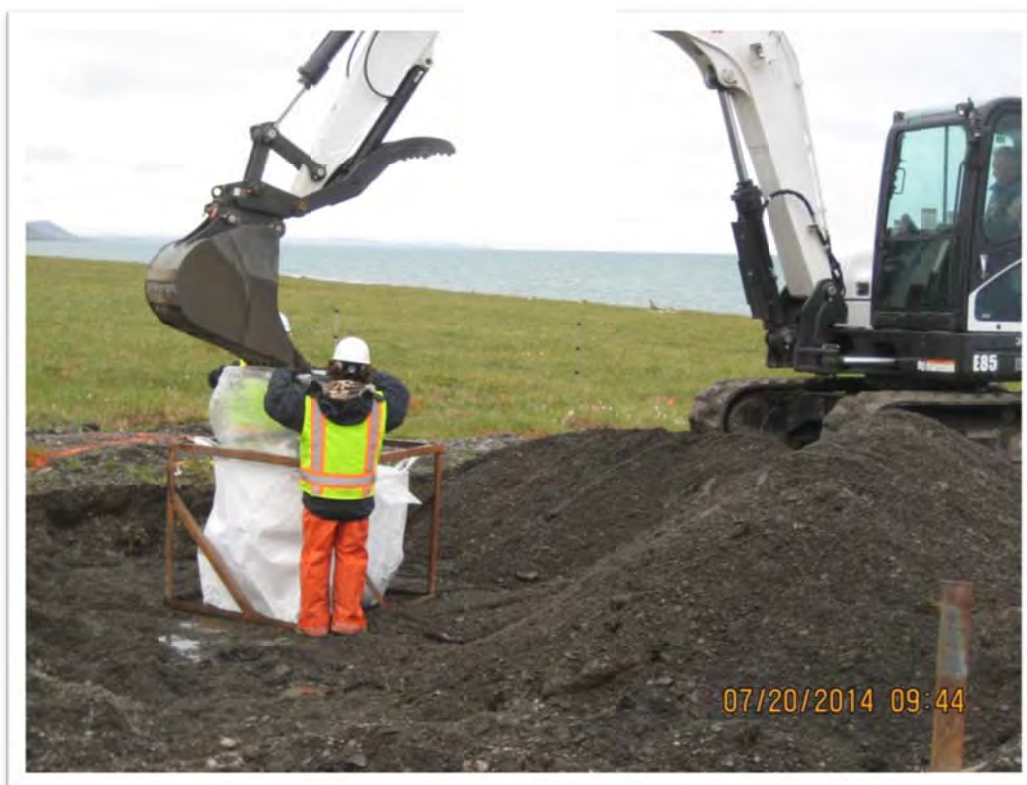
Photograph 23 – POL-contaminated soil was placed in super sacks. View to the southeast.

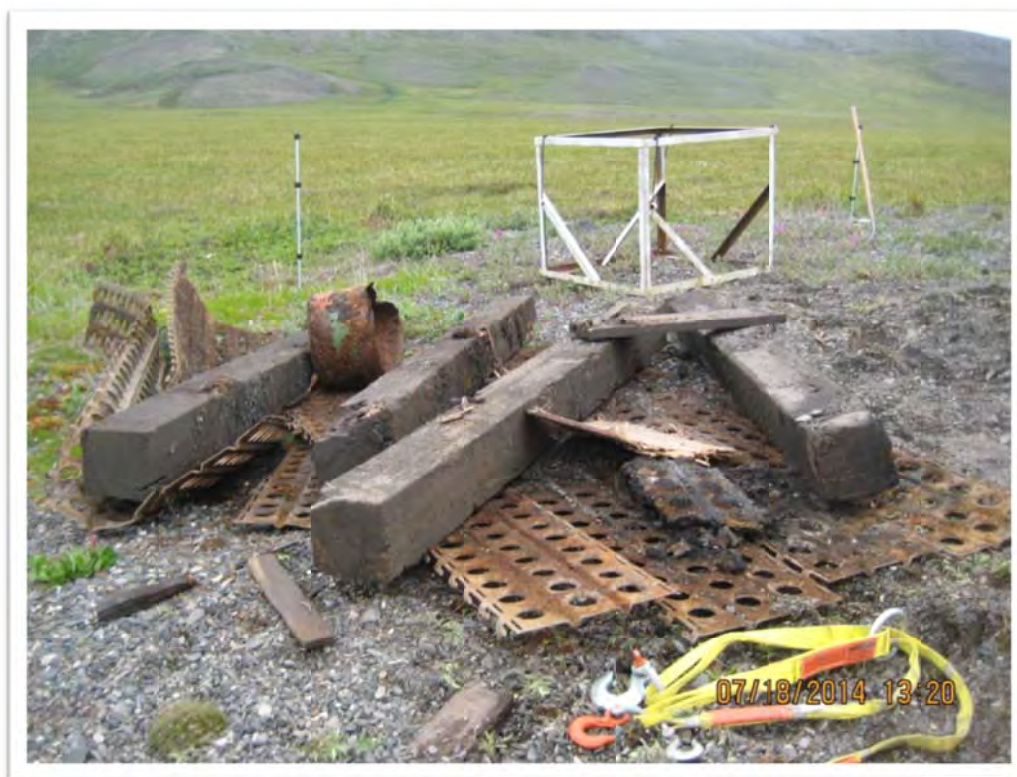
Photograph 24 – View of buried items (overcasing, timbers, and Marsden mats) removed during the Test Hole Charlie excavation. View to the northwest.

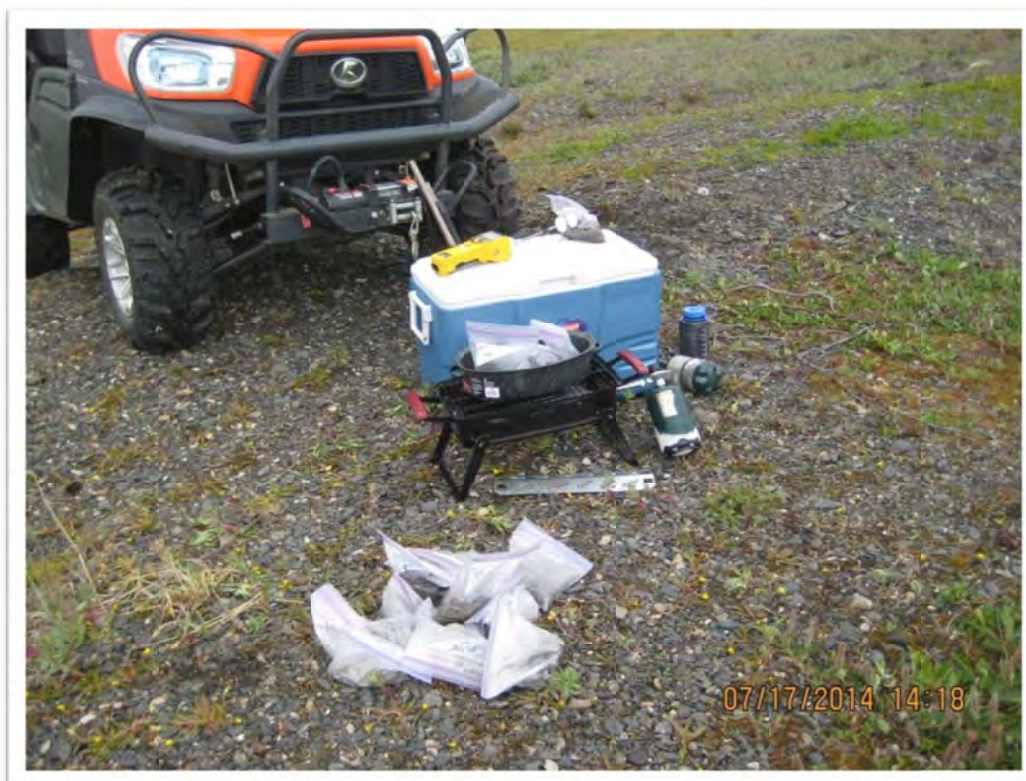
Photograph 25 – Screening samples in sealable plastic bags were heated in a water bath prior to measuring headspace with a PID. Excavations were guided using PID screening results.

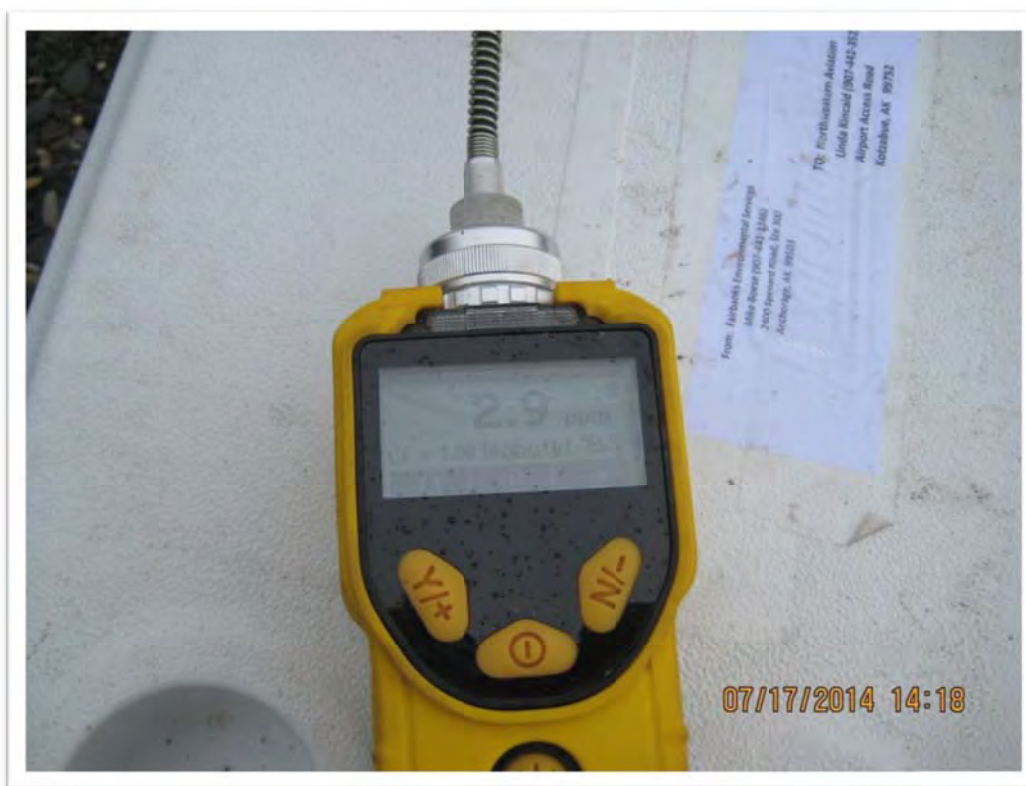
Photograph 26 – Close up of PID shown in the Photograph 25.

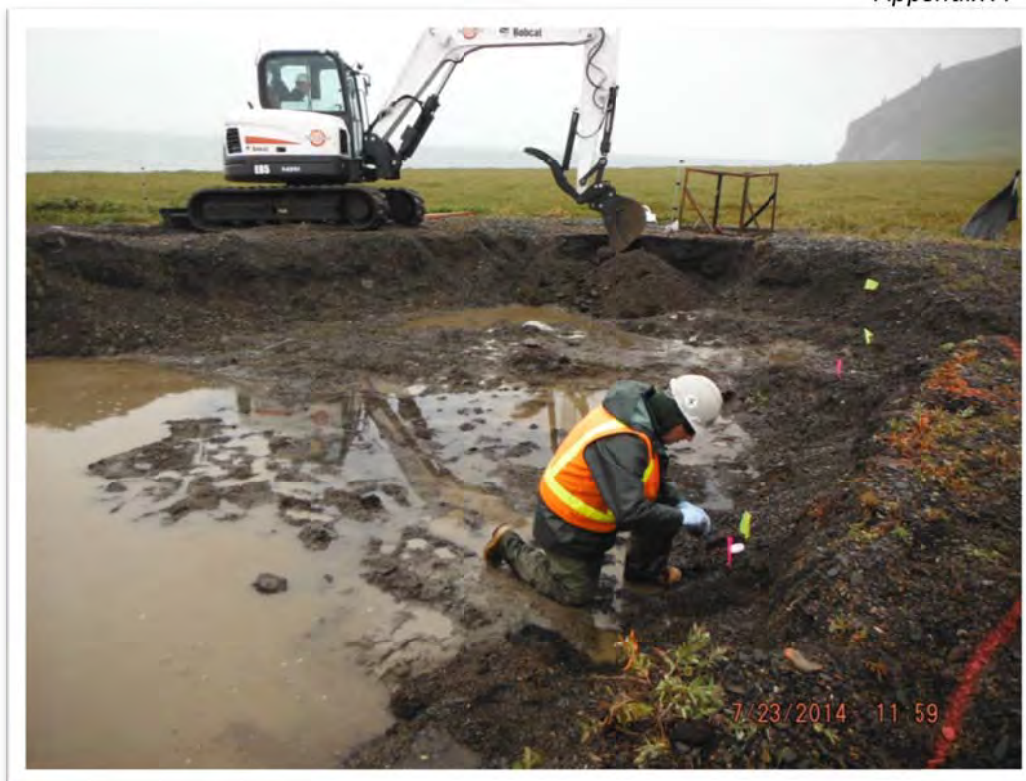
Photograph 27 – Sampler collecting excavation guidance sample 14PCC026SO and field duplicate 14PCC027SO. Laboratory results were below ADEC Method One cleanup levels and excavation activities were curtailed to the north. View to the west.
