Final 2014 Remedial Action Report

Project Chariot Cape Thompson, Alaska

March 2015

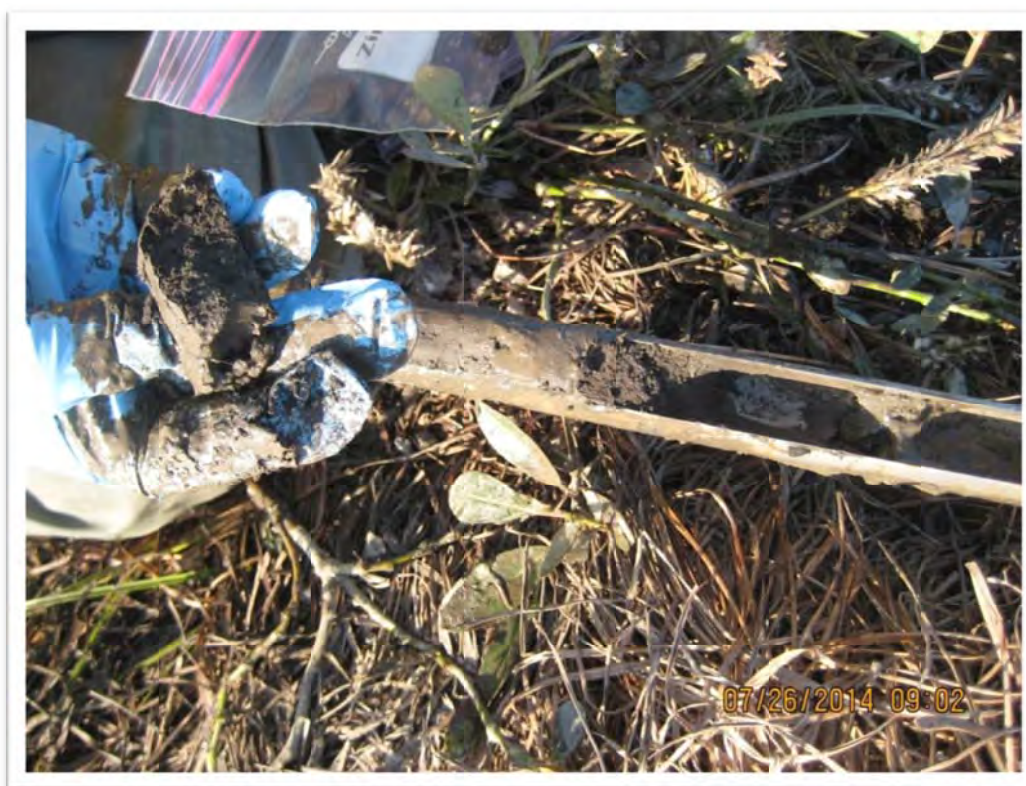
Photograph 28 – Due to frozen soils and standing water, several floor samples on the southern side of Test Hole Charlie were collected with a hand-driven probe as shown in this photograph. View to southeast.

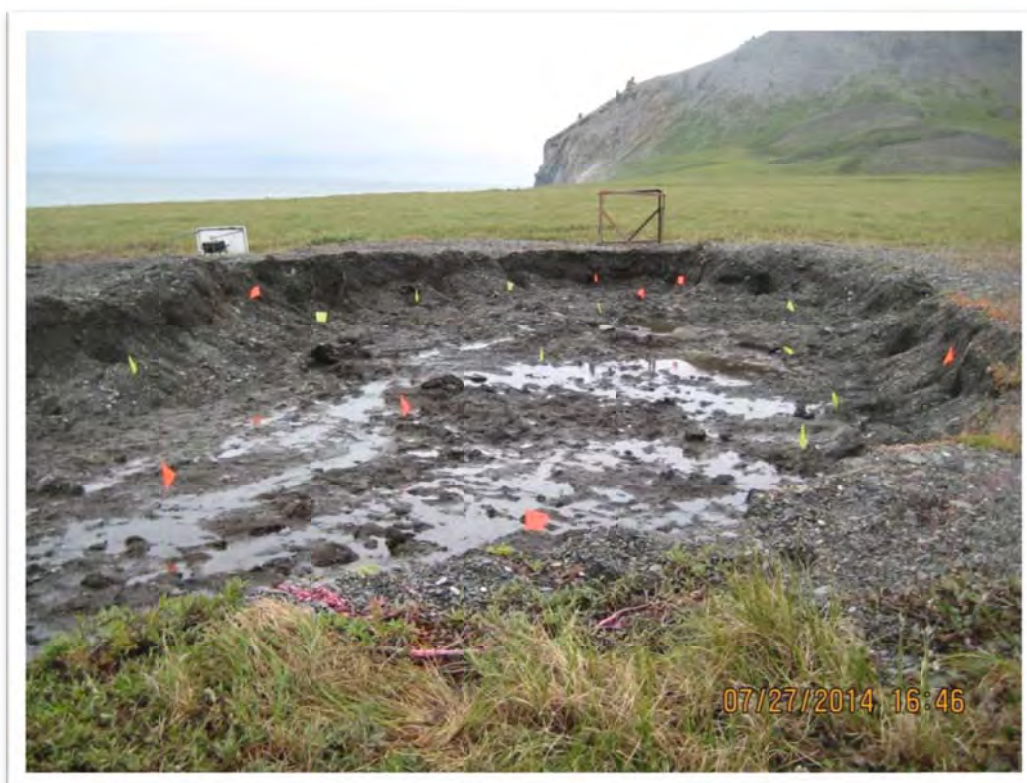
Photograph 29 – Northern half of Test Hole Charlie excavation. Yellow flags represent PID screening locations. Orange flags represent PID screening and laboratory sample locations. View to the west.

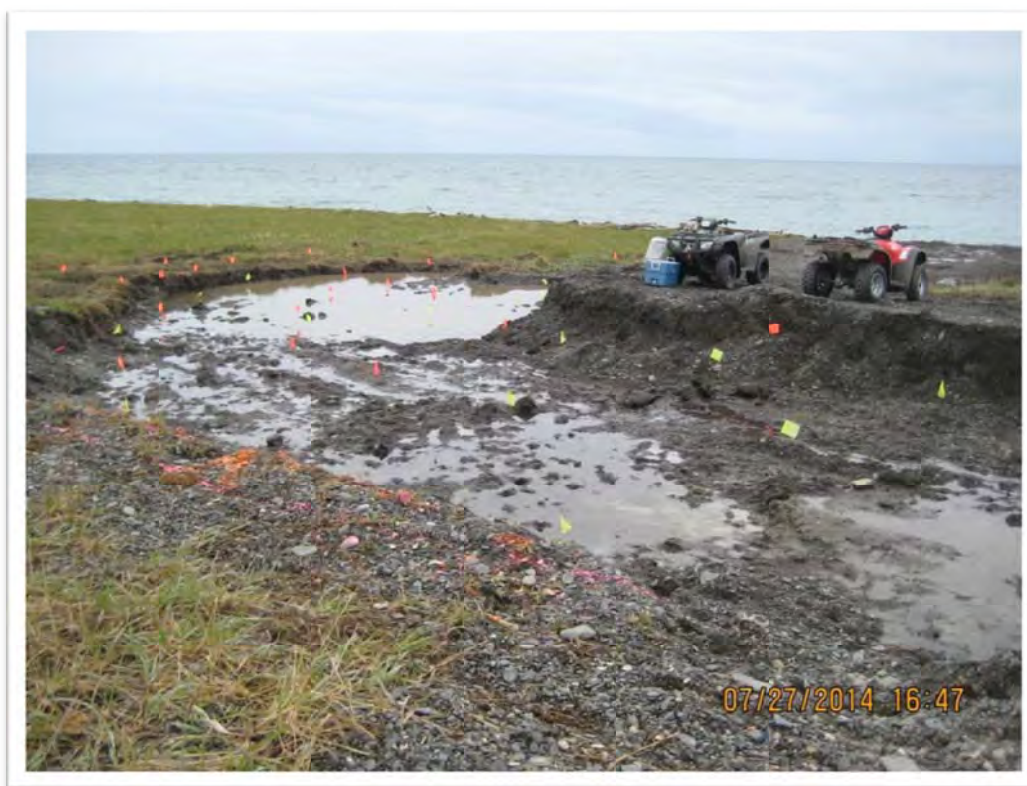
Photograph 30 – Test Hole Charlie excavation looking southeast. Yellow flags represent PID screening locations. Orange flags represent PID screening and laboratory sample locations. Casing is to the right of photograph.

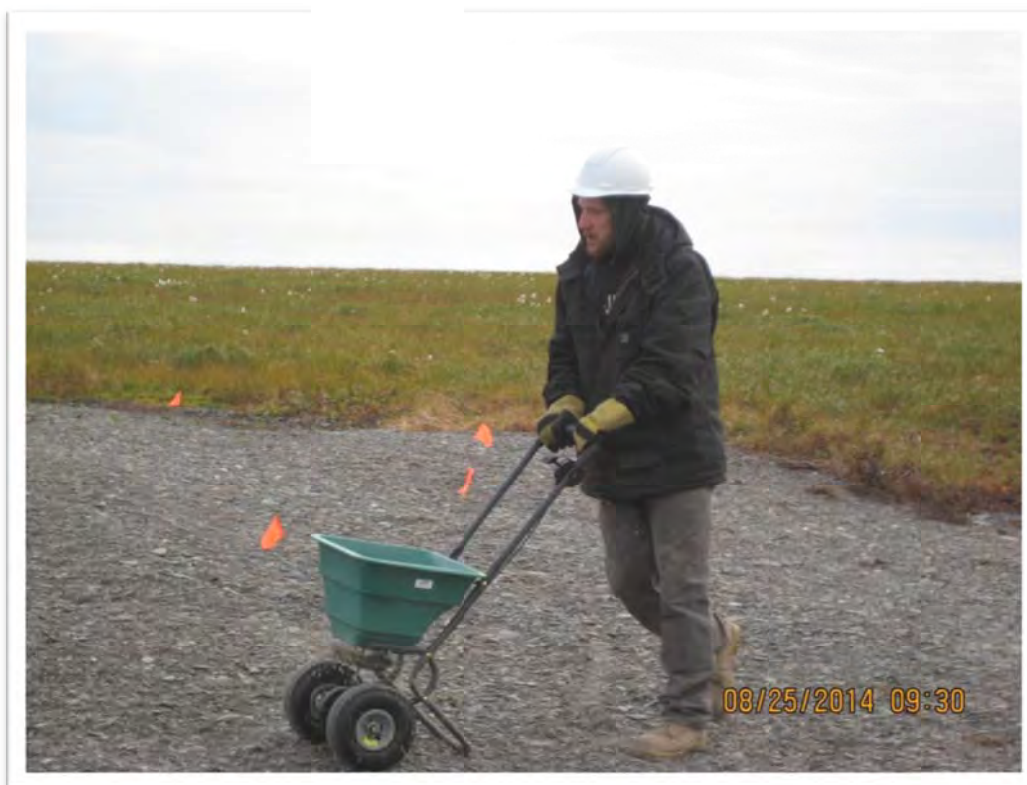
Photograph 31 – Seed and fertilizer were spread on test hole pads following re-contouring. Orange pin flags denote laboratory sample locations with were surveyed on August 27. View to the northeast.

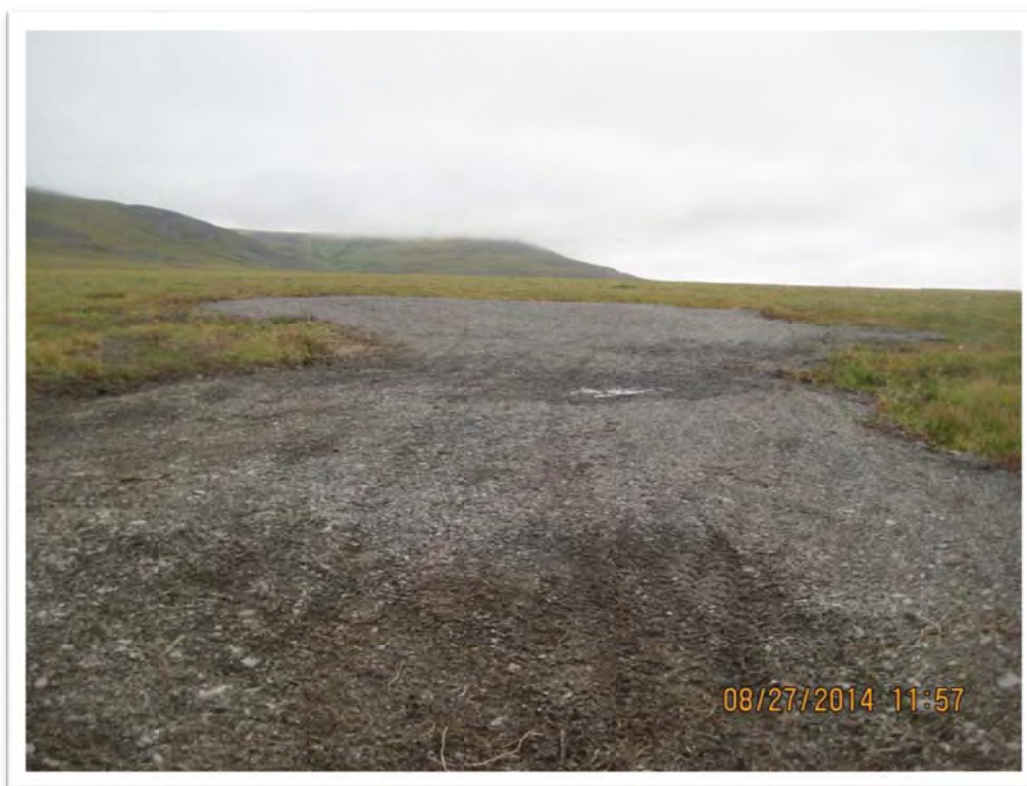
Photograph 32 – View of Test Hole Charlie following Remedial Action. View to north.

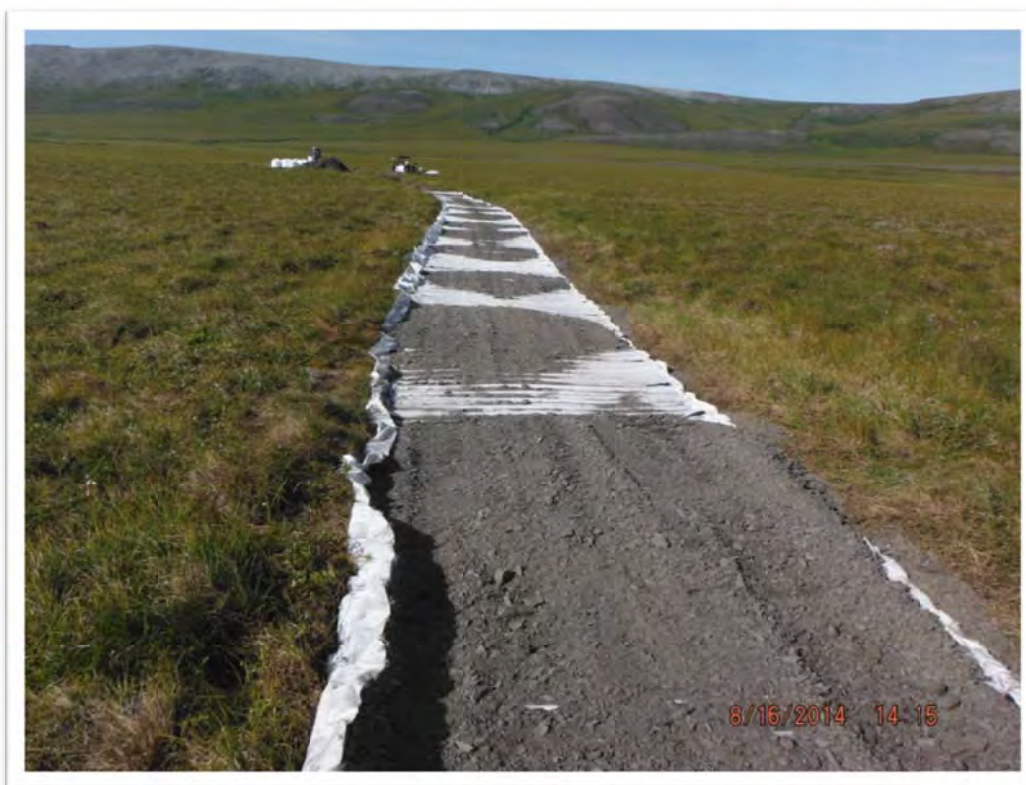
Photograph 34 – Improvements, including the addition of gravel and mud mats, were required to access and remove the filled super sacks from the Test Hole Dog site (site shown in distance). View to the west.

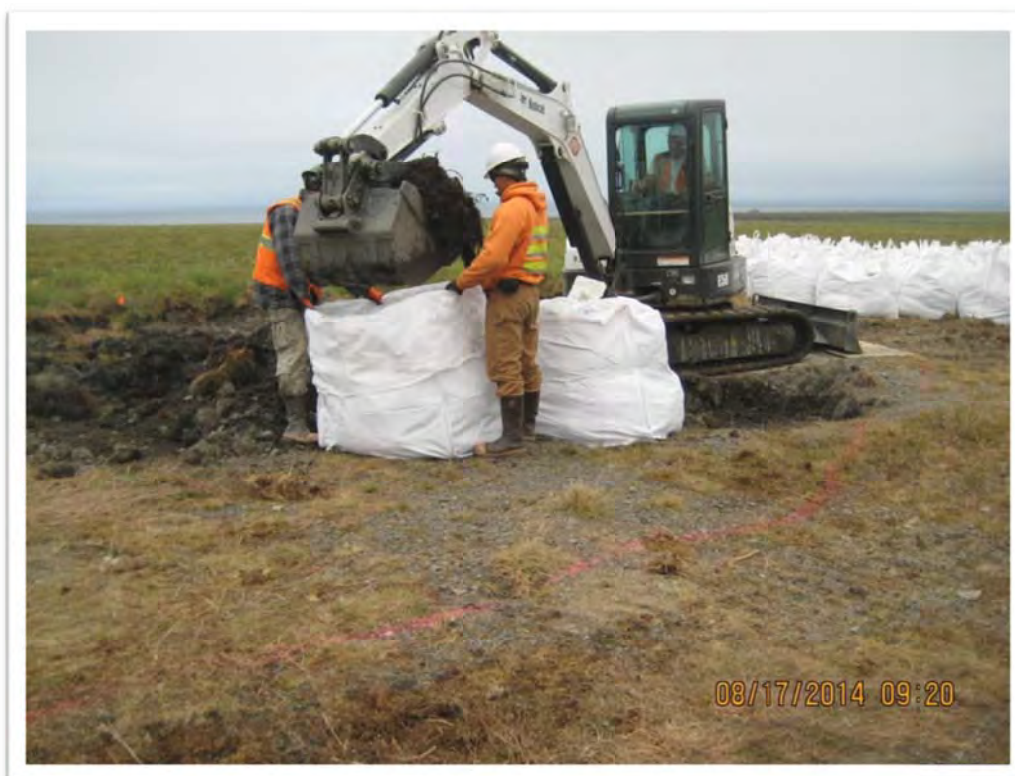
Photograph 35 – Loading super sacks within the Test Hole Dog excavation (see pink spray paint). Note excavator on mats to reduce contact with POL-contaminated soil within excavation. View to the south.

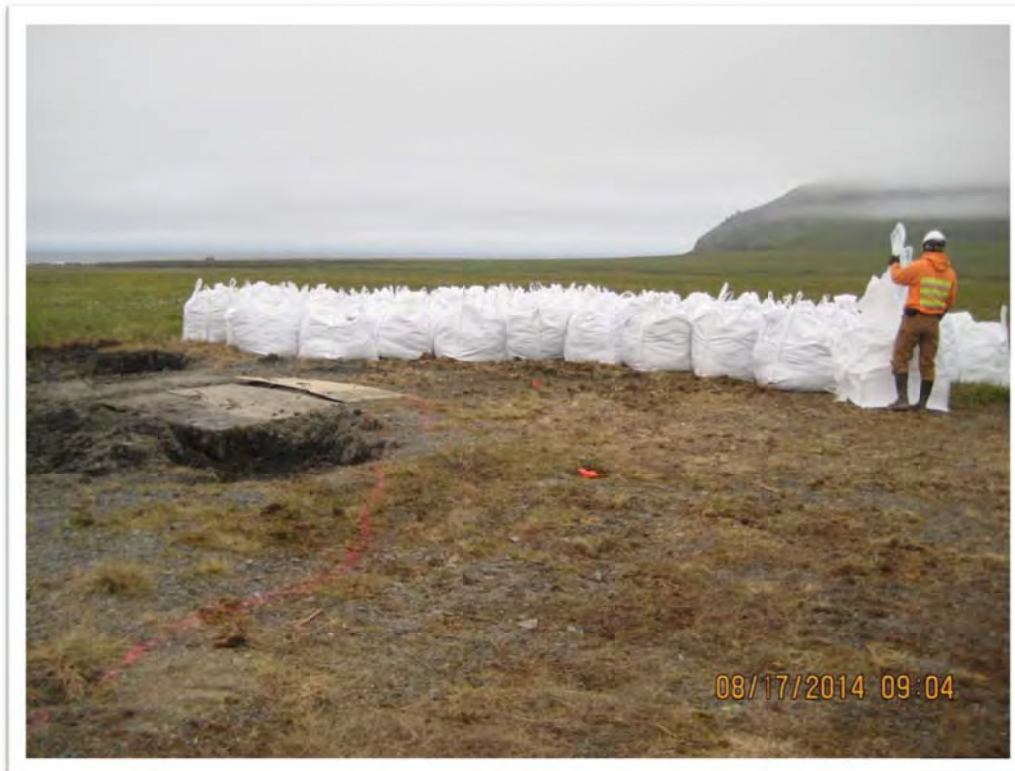
Photograph 36 – Filled super sacks were stockpiled adjacent the Test Hole Dog excavation prior to arrival of additional mud mats. View to the southwest.

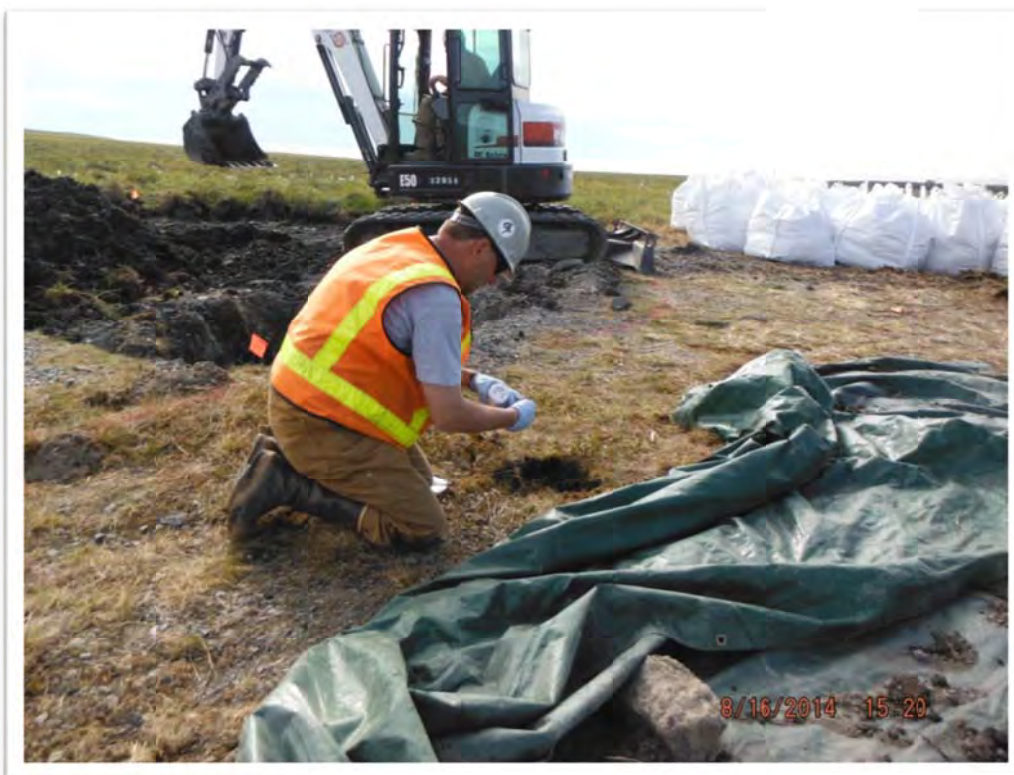
Photograph 37 – Sampler collecting a pre-loading area footprint sample 14PCD019SO located outside the limits of the Test Hole Dog excavation. View to the south

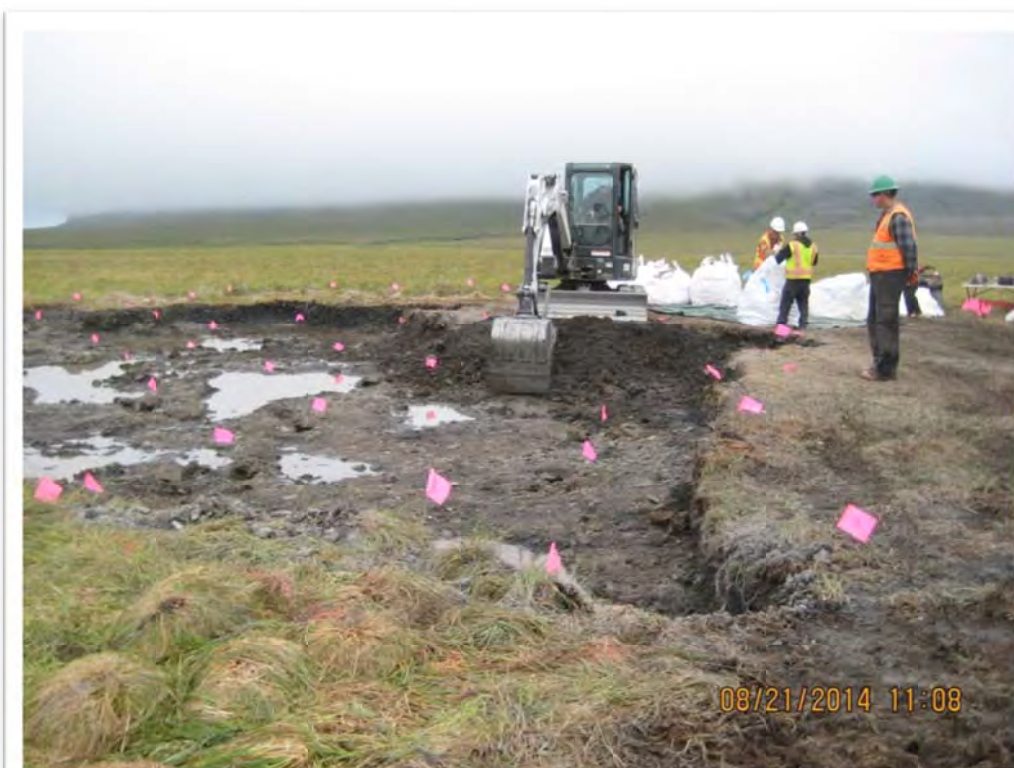
Photograph 38 – Limits of Test Hole Dog excavation with pin flags marking the floor and wall PID screening locations. View to the west.

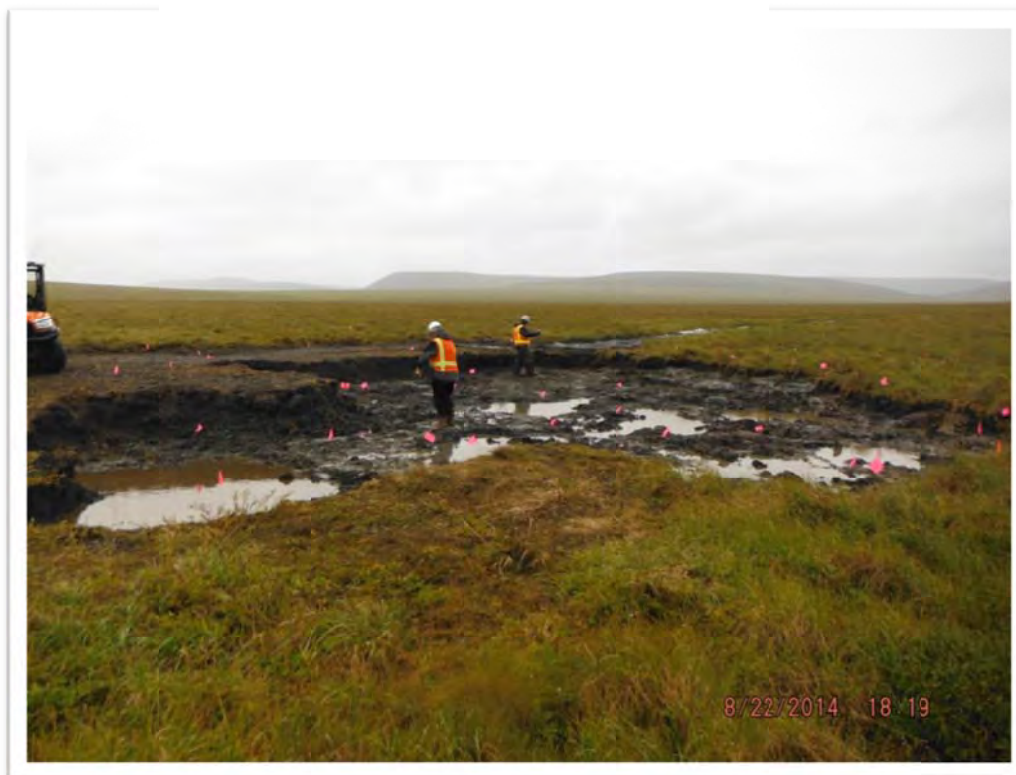
Photograph 40 – Final limits of Test Hole Dog excavation. Pin flags denote laboratory confirmation sample locations to be surveyed. View to the northeast.

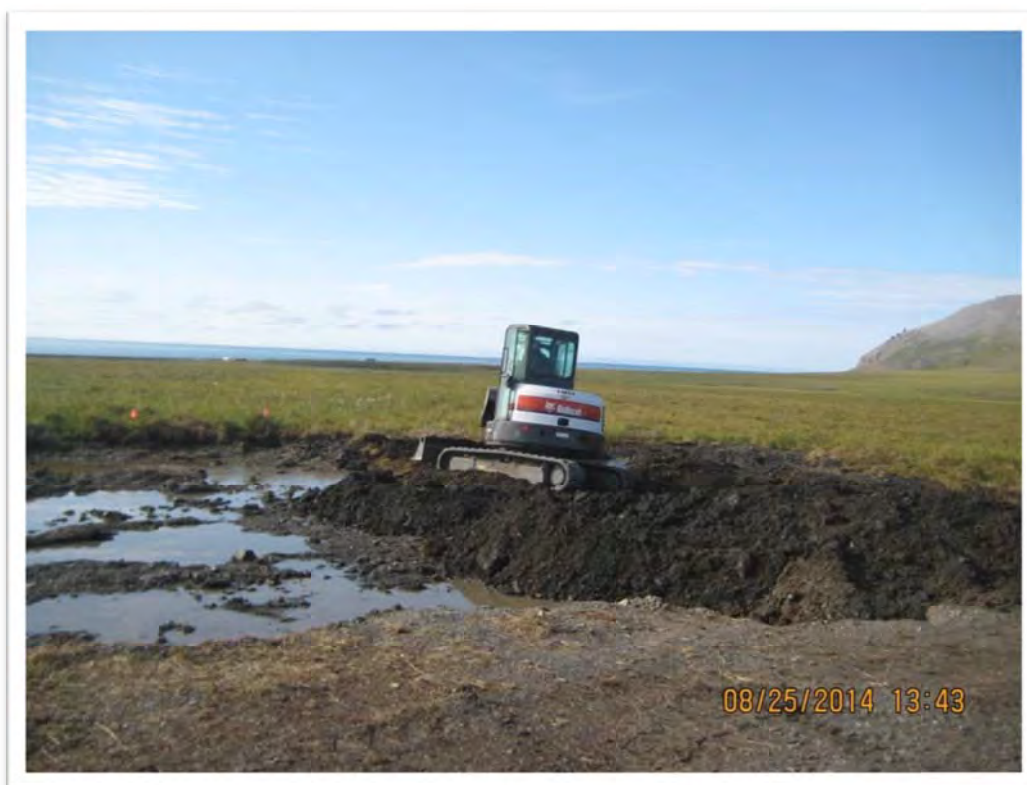
Photograph 41 – Re-contouring of Test Hole Dog excavation following ADEC approval. View to the southwest.

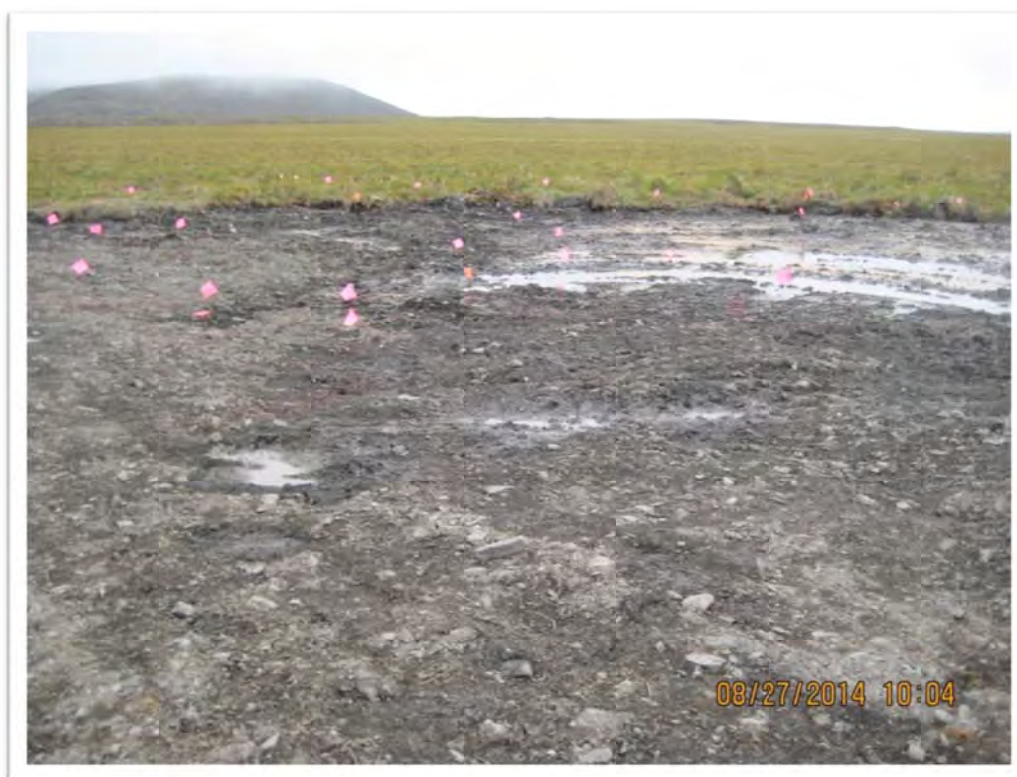
Photograph 42 – Test Hole Dog site following fertilization and re-seeding and just prior to surveying confirmation sample locations marked by pin flags. View to the southeast.

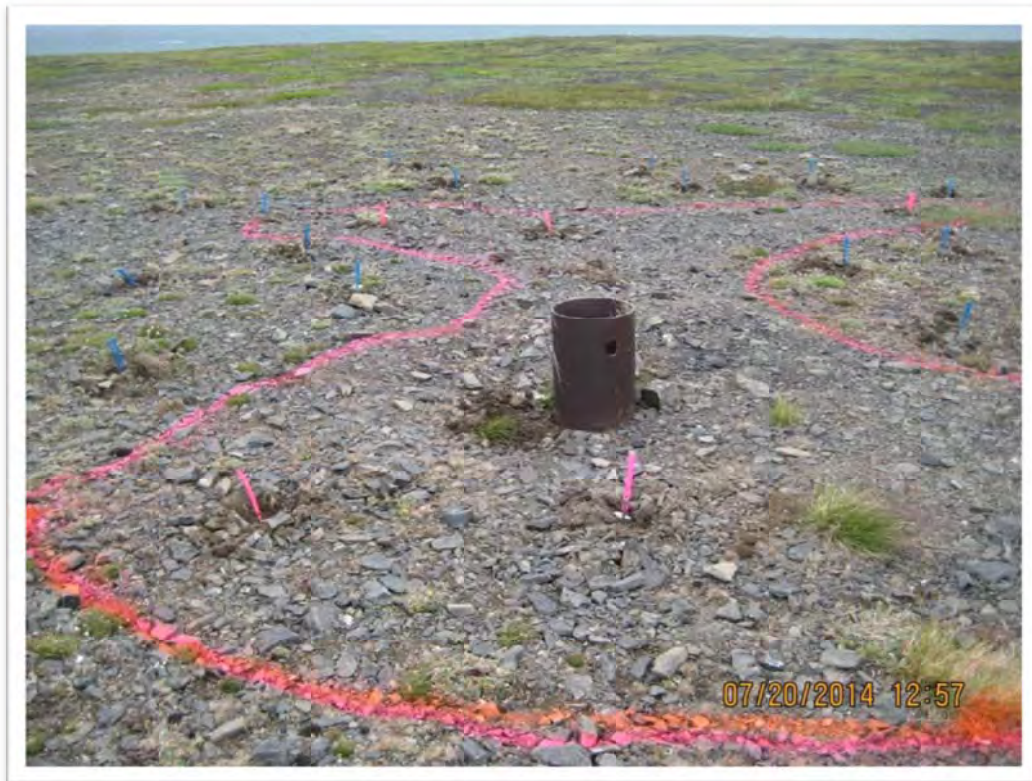
Photograph 43 – POL-contamination in surface soil at Test Hole X-1 was marked with spray paint. The actual excavation extended further than the surface contamination. The site is located on a sparsely vegetated hilltop. View to south.

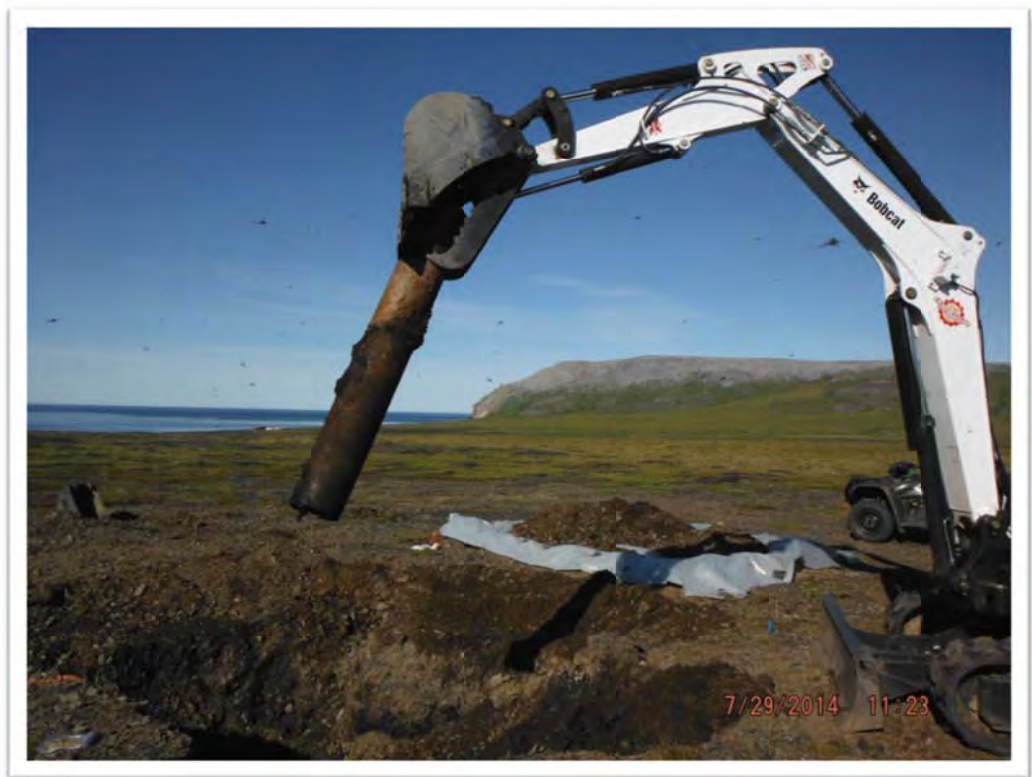
Photograph 44 – The 6-foot-long Test Hole X-1 casing was completely removed. Stockpiled surface soils are shown on far side of excavation. View to the west.

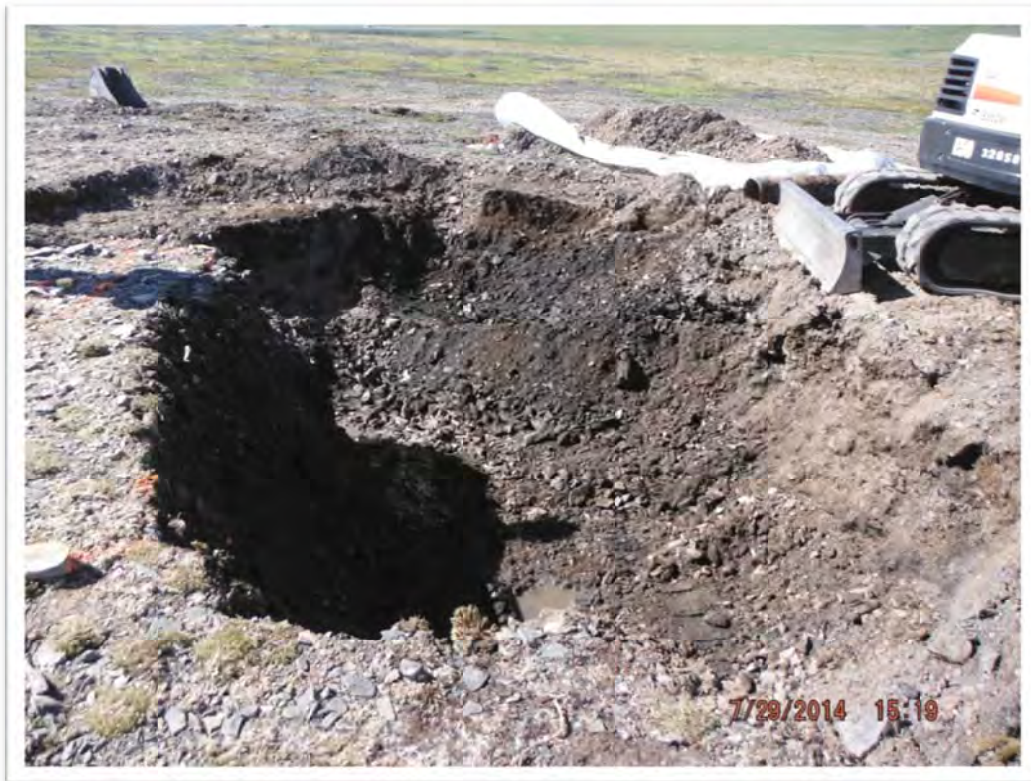
Photograph 45 – Soils closest to the Test Hole X-1 casing appeared to have been previously disturbed. A soil screen, wood debris, gasket and plug were unearthed. View to south.

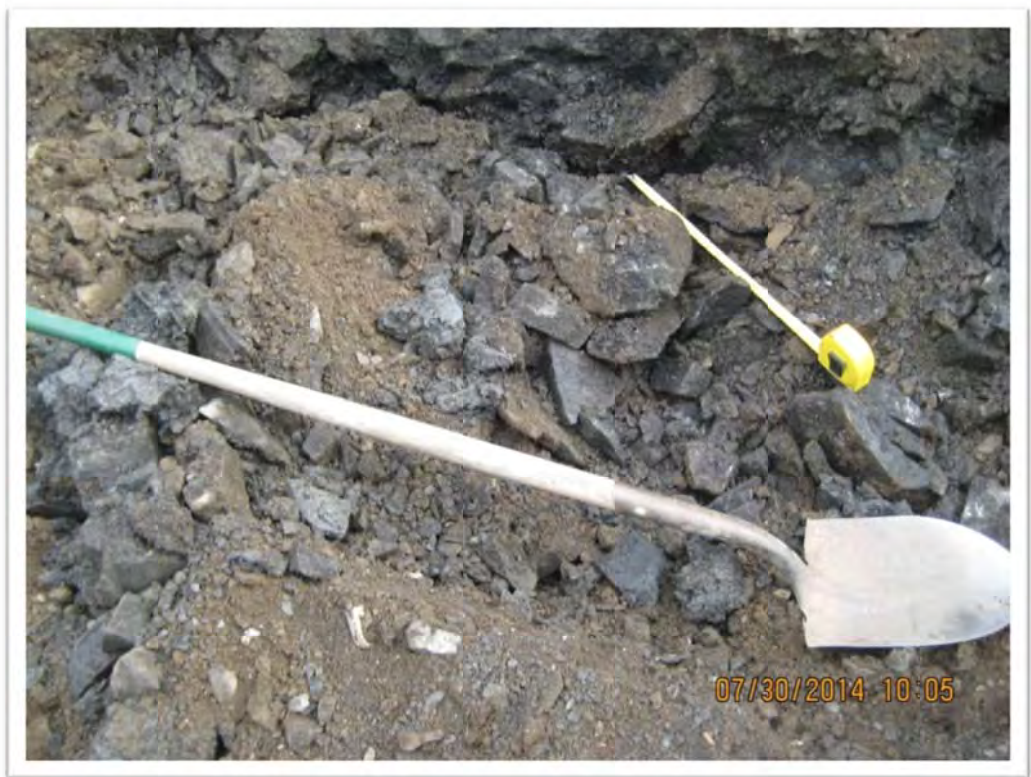
Photograph 46 – Rock size increased with depth of excavation; rocks up to 10 inches in diameter were encountered. Permafrost was encountered at approximately 5 feet below ground surface and limited vertical excavation.

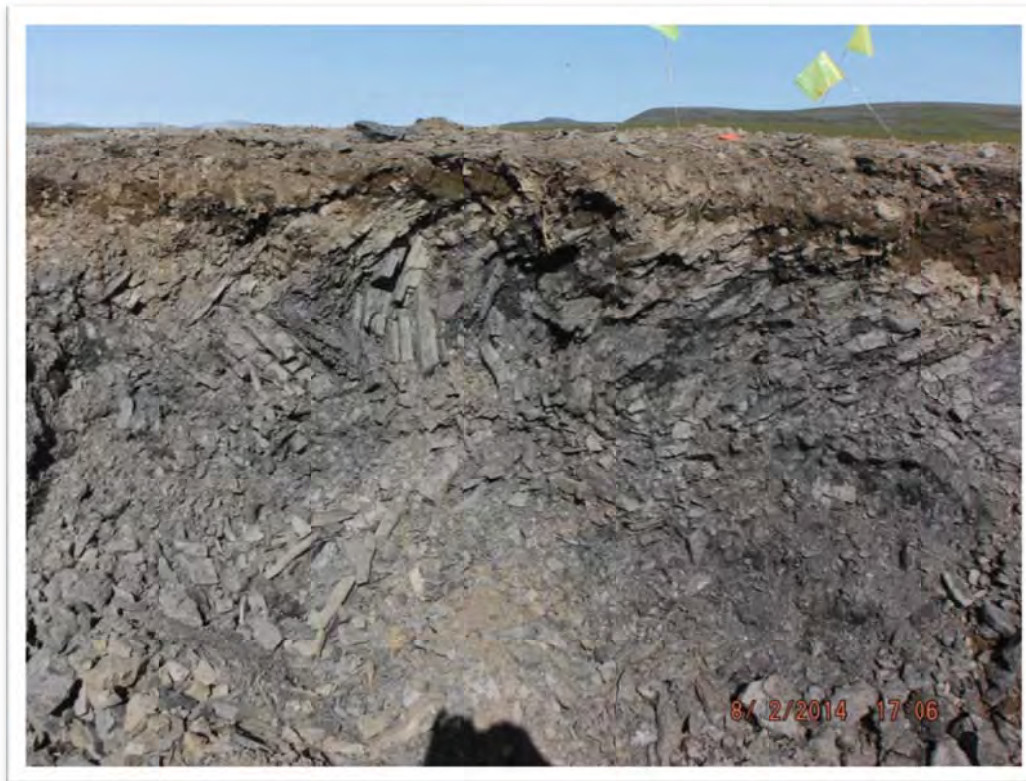
Photograph 47 – The northwestern sidewall (fractured bedrock) was previously undisturbed as shown in this photograph. View to west.

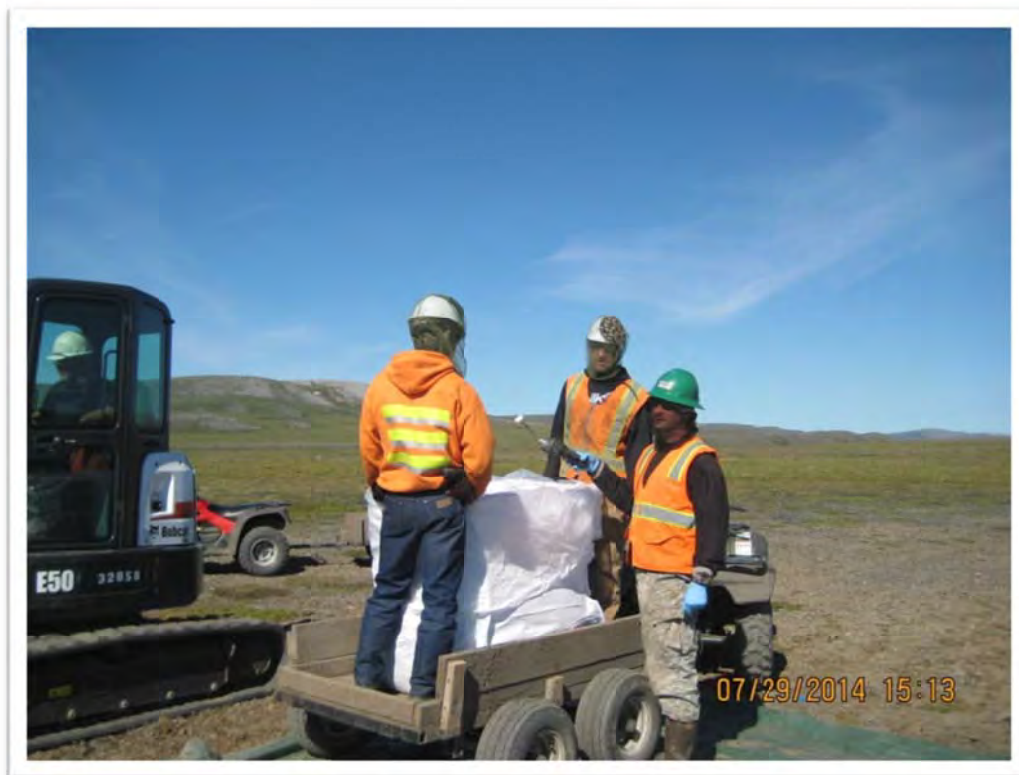
Photograph 48 – Breathing air was monitored with a PID during excavation activities. The Test Hole X-1 excavation had the highest PID readings, but breathing air never exceeded the 15 part per million safety limit. View to the northwest.

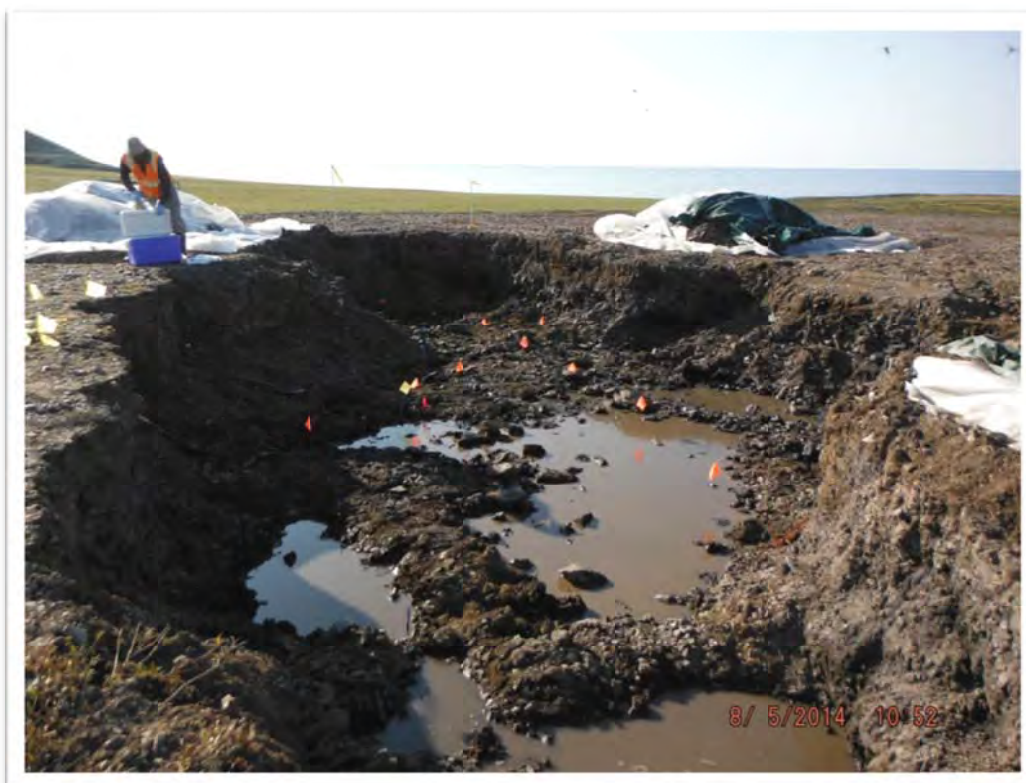
Photograph 49 – Final limits of the Test Hole X-1 excavation. Pin flags mark confirmation sample locations. A total of four stockpiles were constructed around the excavation. View to south.

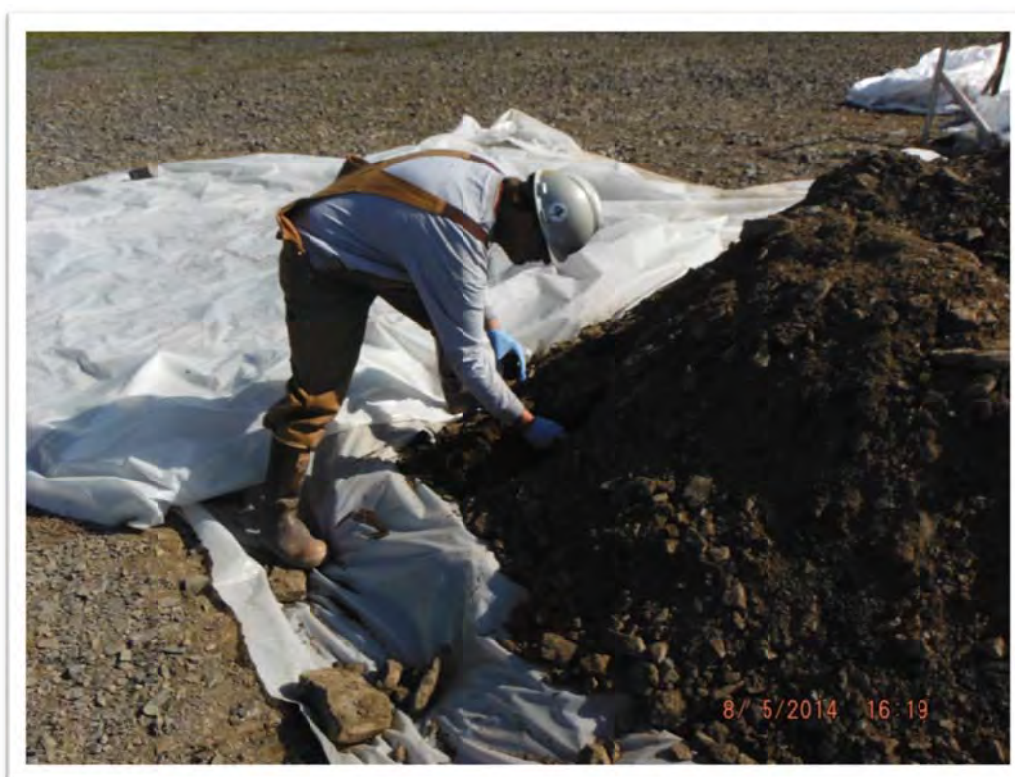
Photograph 50 – Sampler collecting soil samples from a stockpile. Five locations from each stockpile were field screened, and laboratory samples were collected from the location with the highest PID result.

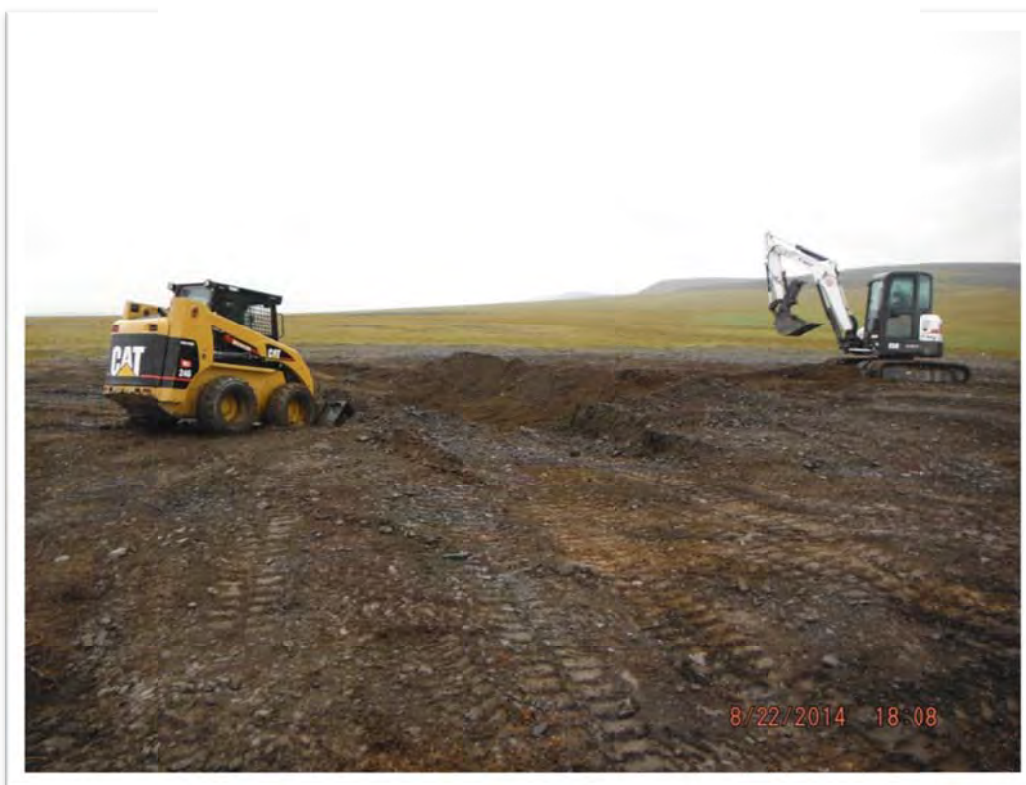
Photograph 51 – Test Hole X-1 was backfilled and contoured to match the existing grade using both excavators and the skid steer and local material. View to northeast.

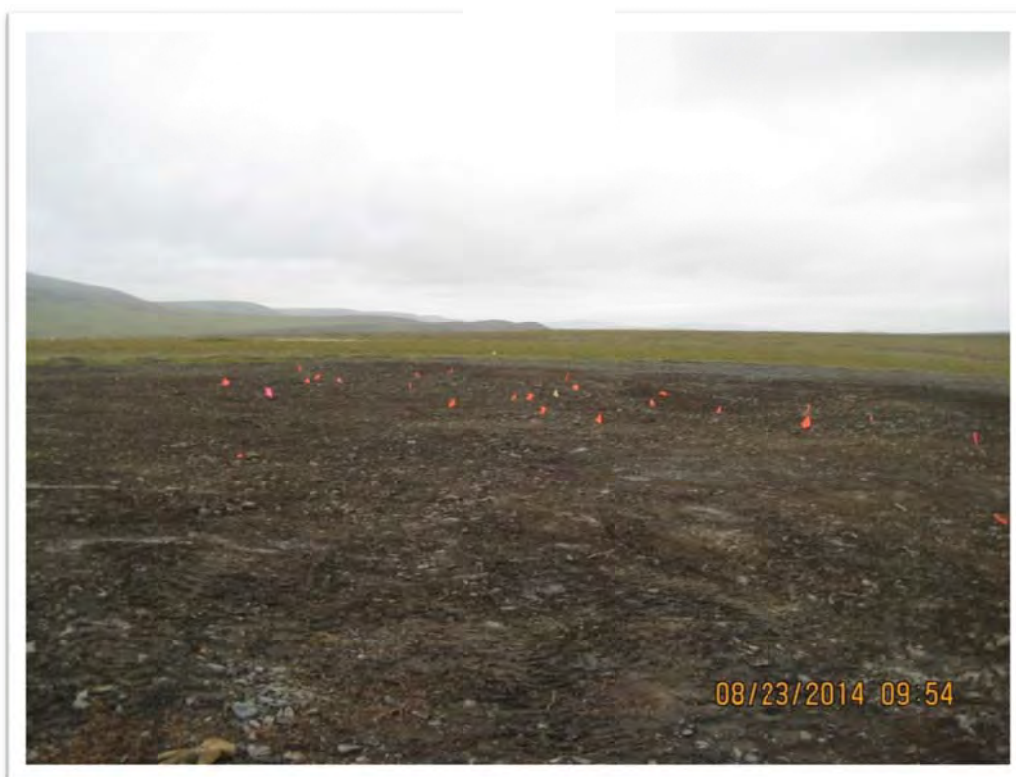
Photograph 52 – Test Hole X-1 following remedial action efforts. Pin flags marking confirmation samples locations were re-installed using swing-ties. View to southeast.

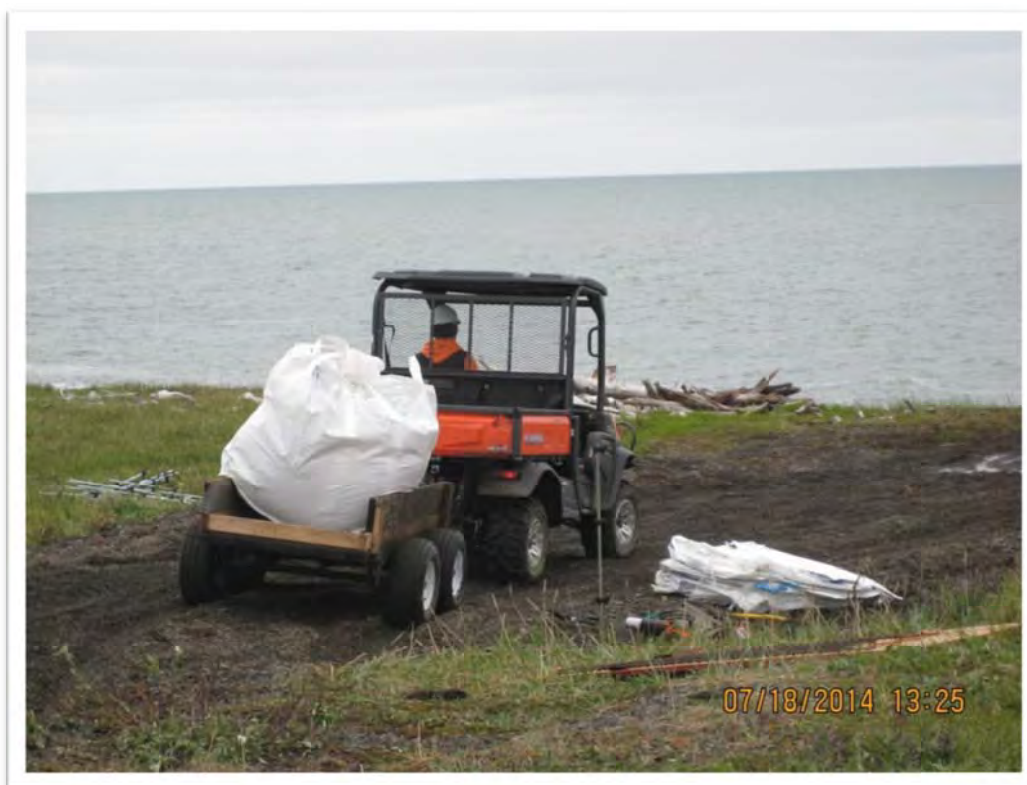
Photograph 53 – Filled super sacks were transported to staging area on trailers pulled by ATVs or UTVs (shown here).
View to south.

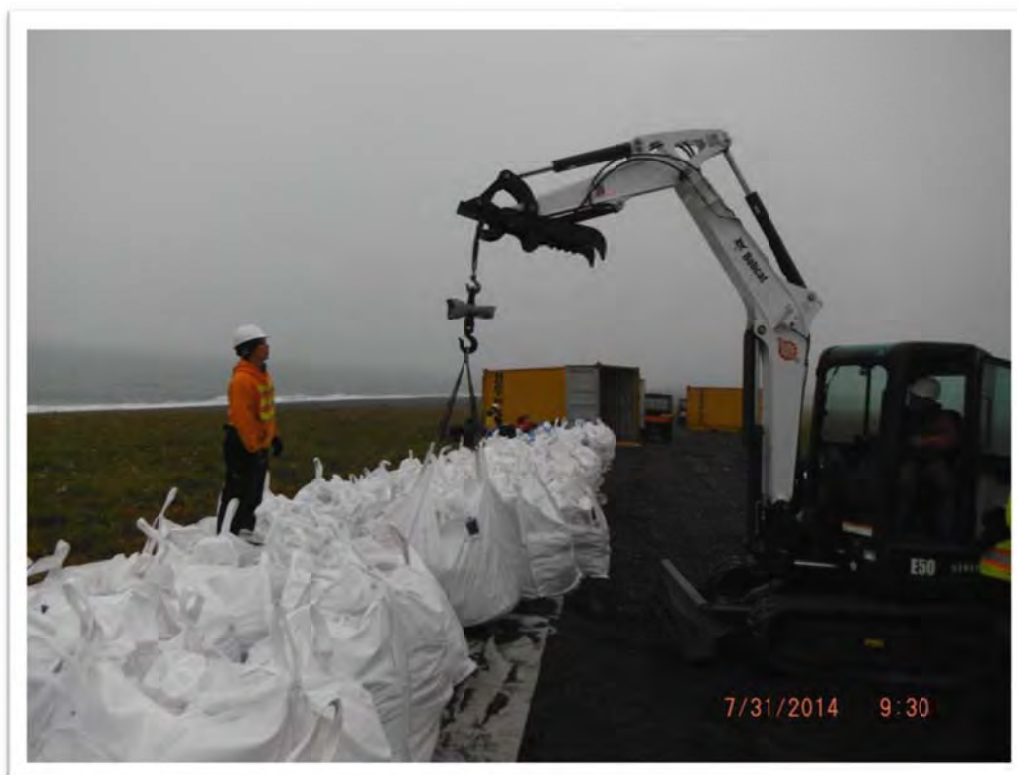
Photograph 54 – Filled super sacks were weighed using a crane scale suspended from an excavator at the staging areas.
View to the southwest.

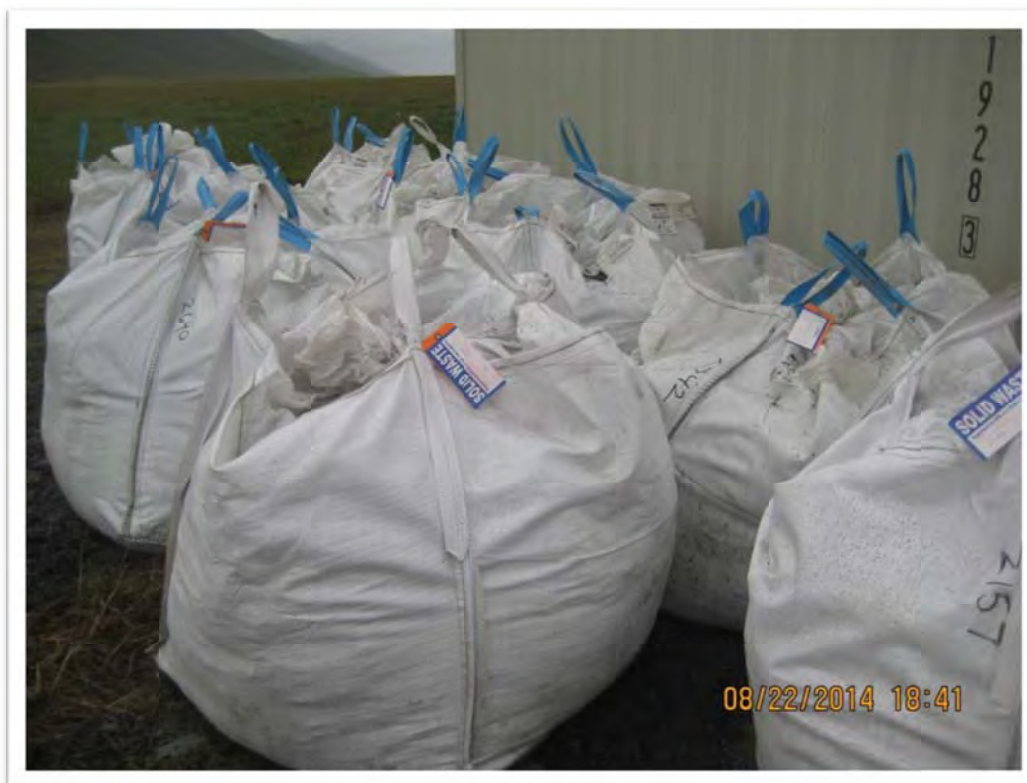
Photograph 55 – View of labeled and weighed super sacks at the East Staging Area. View to southeast.

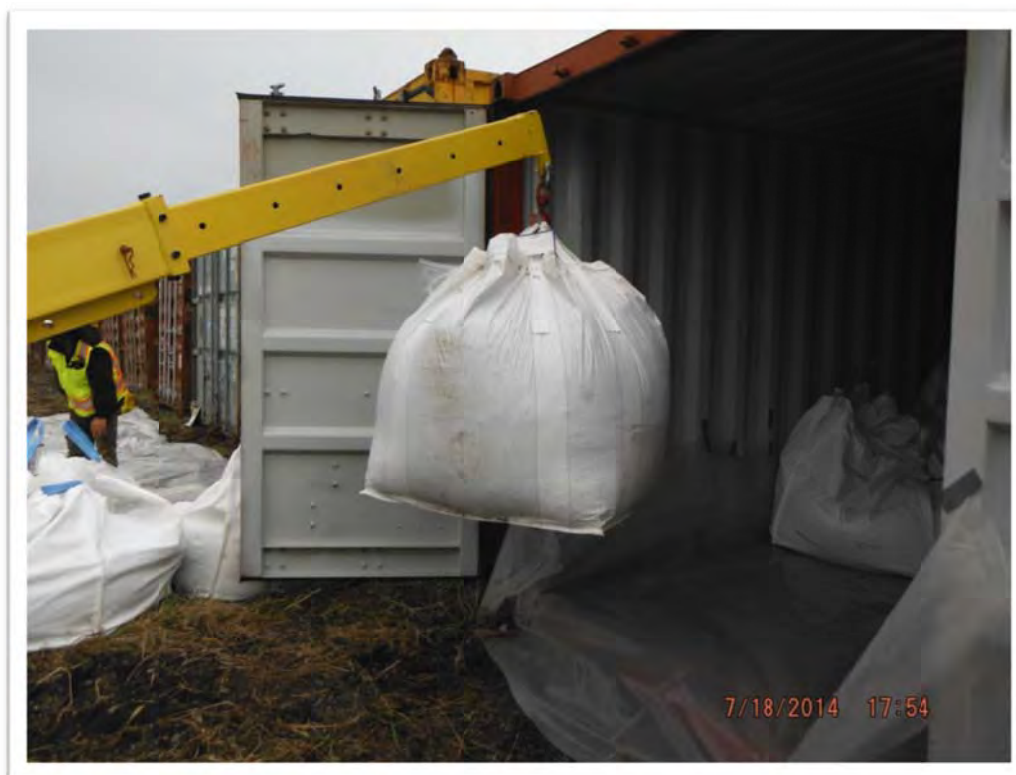
Photograph 56 – Filled super sacks being loaded into the connex shipping containers using an extended boom forklift. Approximately 20 tons of POL-contaminated soil was loaded into each connex.
