Final 2014 Remedial Action Report

Project Chariot Cape Thompson, Alaska

March 2015

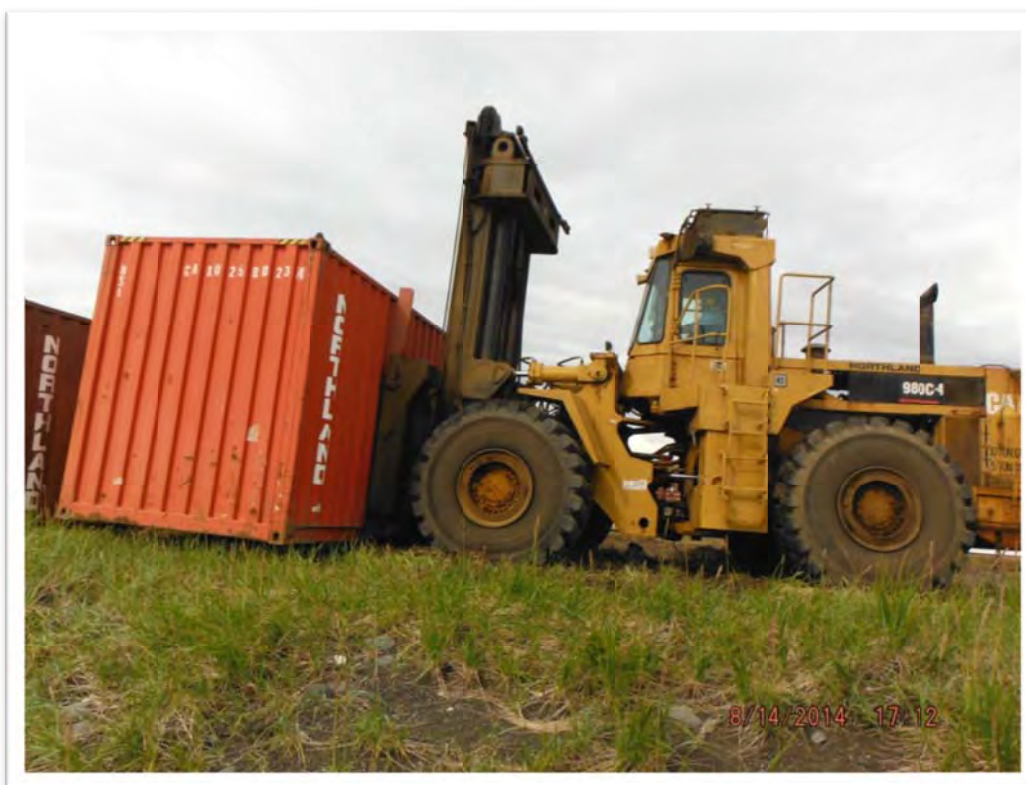
Photograph 57 – A 980C-4 Caterpillar equipped with forks was used to move this container from the West Staging Area onto the landing craft. View to north.

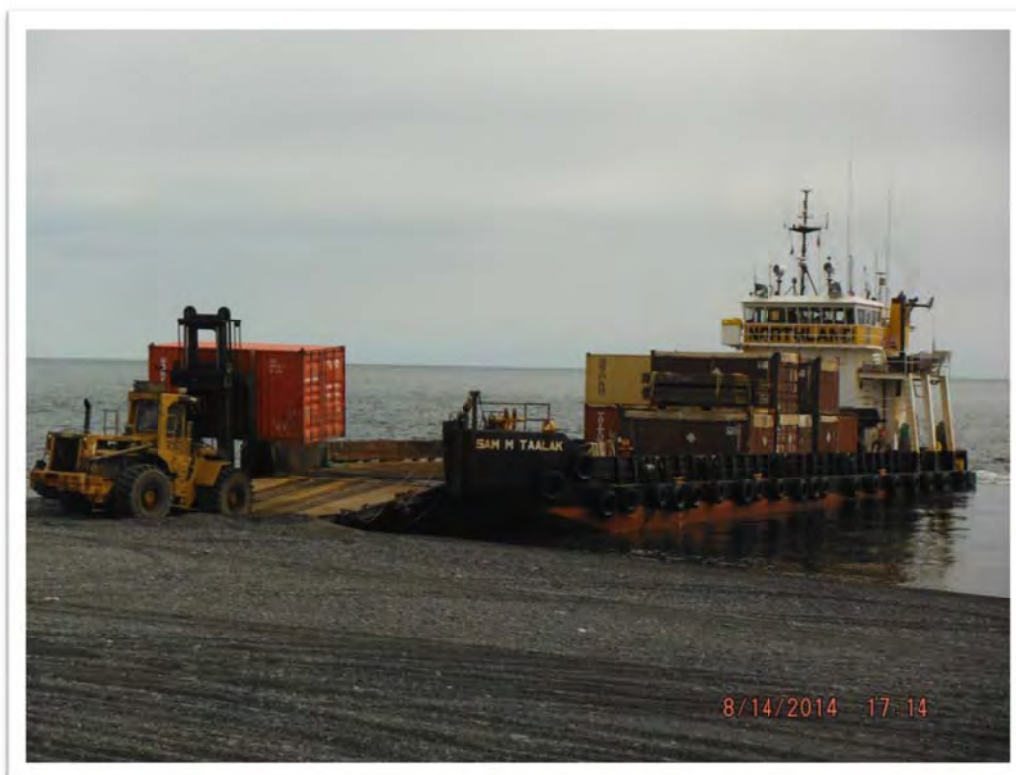
Photograph 58 – Loading connex boxes onto 140-foot landing craft. A total of 41 connexes filled with POL-contaminated soil were removed from the site. View to southeast.
