Investigations of Zirconium Fires during Spent Fuel Pool LOCAs

Sam Durbin and Eric Lindgren

Funded by
USNRC and OECD
JCN# N6777 and F6898

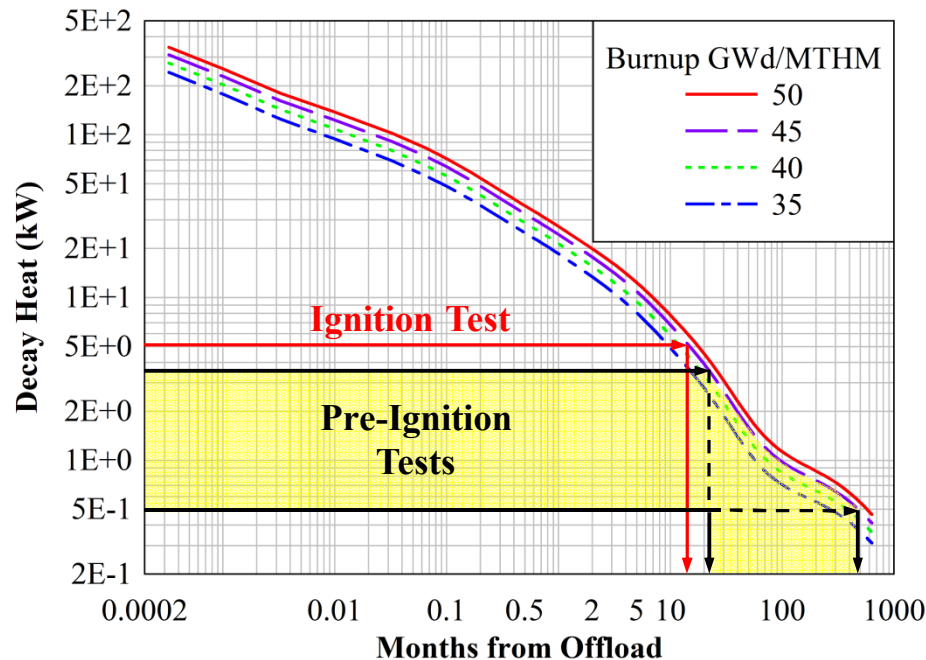
Phase 1 Simulated Decay Heat

- Pre-ignition tests
 - Decay heats 0.5 to 3.5 kW
 - Simulate 45 GWd/MTHM fuel 23 mo. to 40 yrs from offload
- Ignition test
 - Decay heat = 5 kW
 - Fuel age 15 months (457 days) at 45 GWd/MTHM

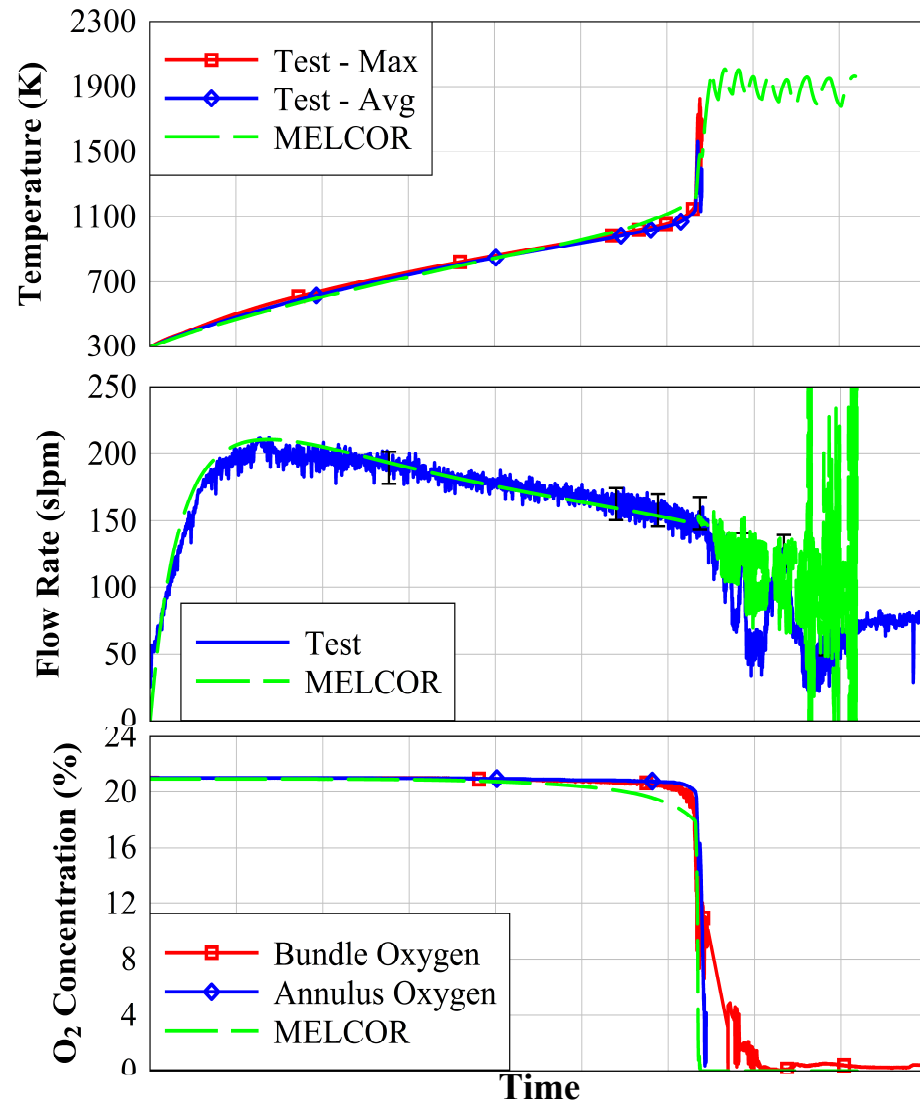
Phase 1 Ignition Test Results

- Assembly power 5000 W
 - Situational equivalent of a cluster of 15 month-old assemblies (hot neighbor BC)
- Modeling predicts ignition within 10 minutes
 - Based on Peak Cladding Temp. = 1200 K
 - PCT within 40 K of test max at all times up to ignition
- Thermocouples failed after ignition
 - Sharp transition to breakaway oxidation
 - Oxygen depletion at time of ignition
- Predicted flow rate within experimental uncertainty
- Interesting dynamics on burn-front movement
 - Usually downward to follow oxygen and fresh Zr

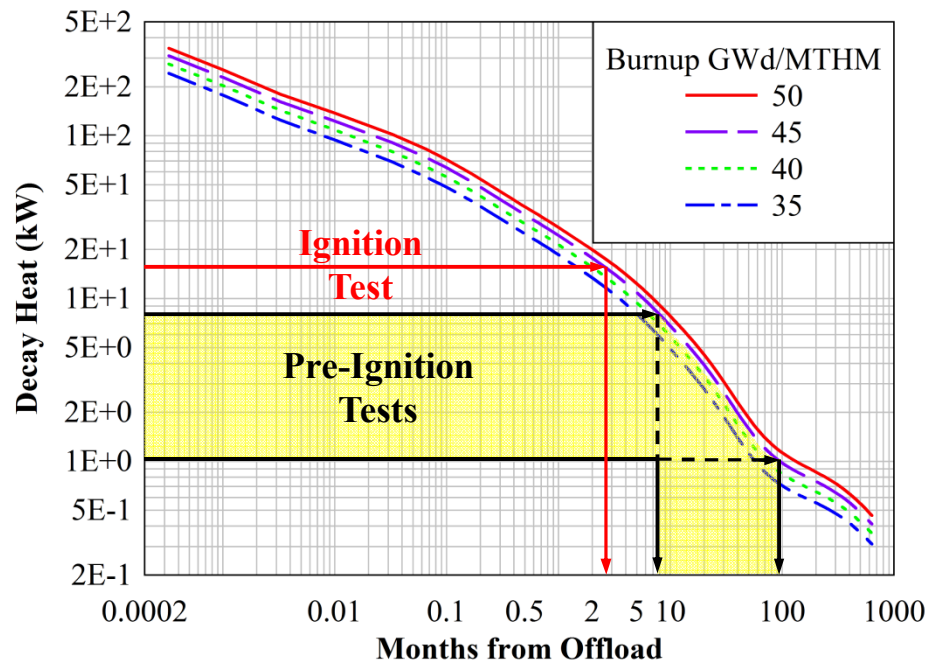
Phase 2 Simulated Decay Heat

- Pre-ignition tests
 - Decay heats 1 to 8 kW
 - Simulate 45 GWd/MTHM fuel 8 mo. to 8 yrs from offload
 - Transient data to $t = 12$ hrs
 - For 1 and 4 kW, up to $t = 24$ hrs
- Ignition test
 - Decay heat = 15 kW
 - Fuel age 2.8 months (86 days) at 45 GWd/MTHM

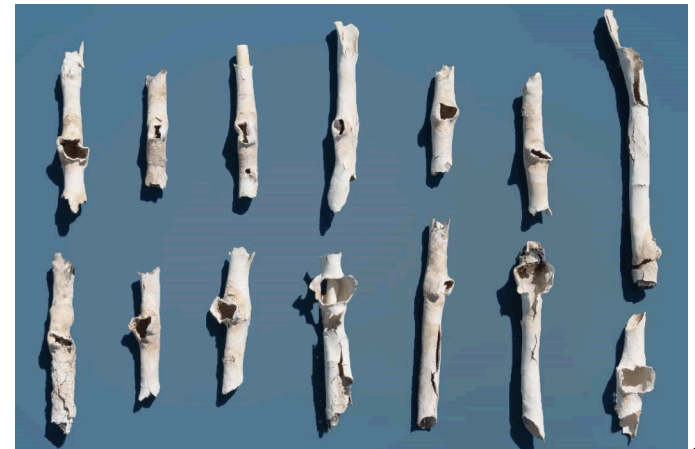
Clad Ballooning

- First ballooning event shortly after ignition in center
- Initial pressure not significant
 - Within 3 minutes of each other
- No measureable difference between assemblies w/ and w/o ballooning
- Ballooning likely between $z = 2.692$ and 3.302 m

- All Sandia Fuel Project testing successfully completed
 - Phase 1 (Uniform loading) – Sixteen pre-ignition (Feb. 2011) and one ignition test (March 2011)
 - Phase 2 (1×4 loading) – Nine pre-ignition (May 2012) and one ignition test (June 2012)
 - Ignition tests broadcasted live on web to project members
- Successfully demonstrated and quantified phenomena dominant during spent fuel pool complete LOCAs
 - Burn initially propagated near the top of the fuel assemblies
 - Primarily burned down to the assembly inlet
 - Cladding fire breached the pool rack and propagated into the peripheral assemblies
 - Significant depletion of nitrogen during initial stage of ignition
 - More energetic burn than previously modeled
 - Severe thermal environment caused all pressurized fuel pins to balloon
 - No measureable thermal-hydraulic impact from ballooning

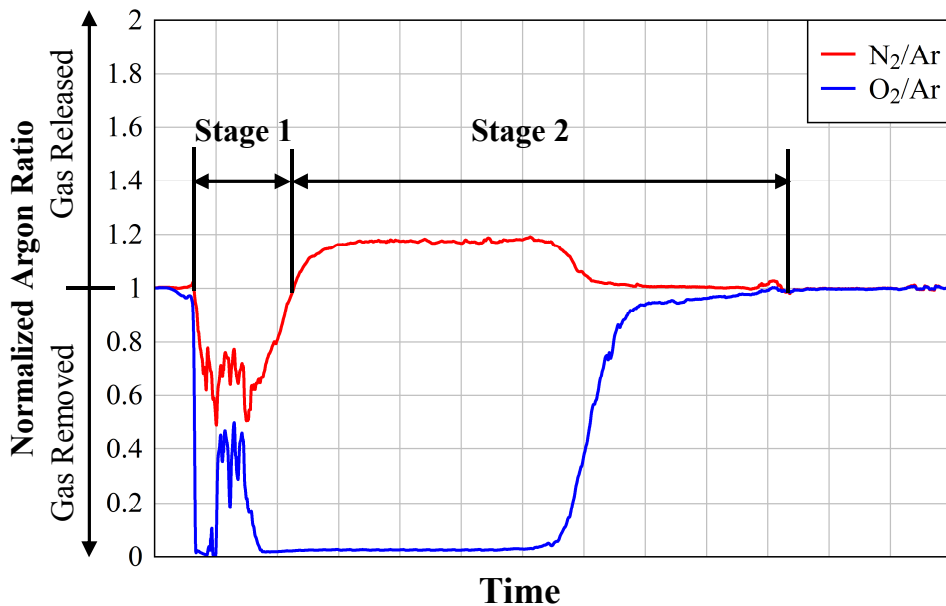
Exhaust Gas Analysis by Mass Spectrometry

Stage 1 Oxidation

Stage 2 Oxidation

- Substantial conversion to ZrN
 - After Stage 1 Oxidation
 - ~22% ZrO₂
 - ~78% ZrN
 - Doubles the energy release
- Models must incorporate the nitrogen reactions
 - Greater propensity for burn propagation to adjacent assemblies
 - Higher temperatures
 - More energetic burn
