Application and Certification of Comparative Vacuum Monitoring Sensors For In-Situ Crack Detection

In-Situ Health Monitoring for Aircraft Using Comparative Vacuum Monitoring Sensors

Application and Certification of Comparative Vacuum Monitoring Sensors for In-Situ Crack Detection

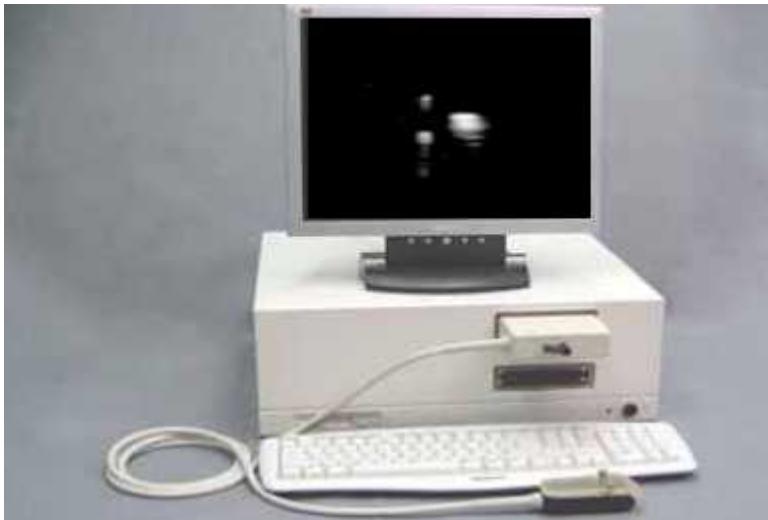
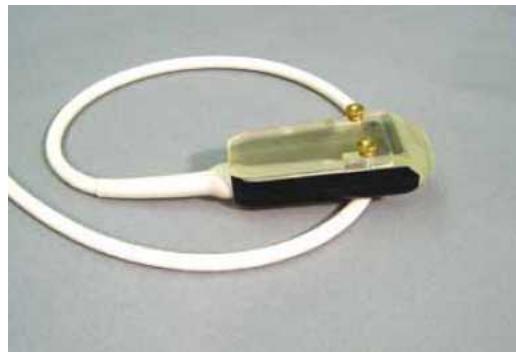
Supplemental NDI Crack Monitoring

Crack

Rivet

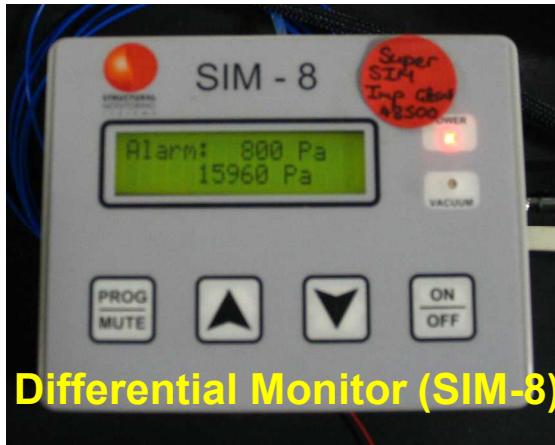
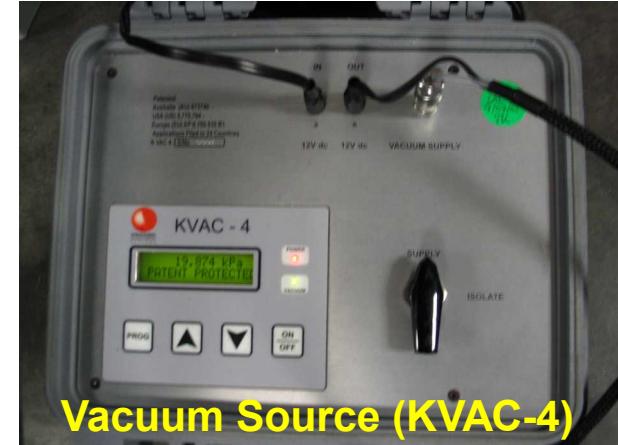
Test Procedure – Lab Monitoring with SIM-8 Followed by Check with Field PM-4 Device

- Panels loaded into fixtures
- Baseline images of fasteners taken with optical microscope camera and USUT ultrasound
- Sample fatigued at R-ratio of 0.1 at 17 ksi until crack visually detected by CCD camera
- Sensor monitored to check for crack detection
- Crack growth closely measured while CVM sensors are periodically monitored to determine permanent alarm threshold

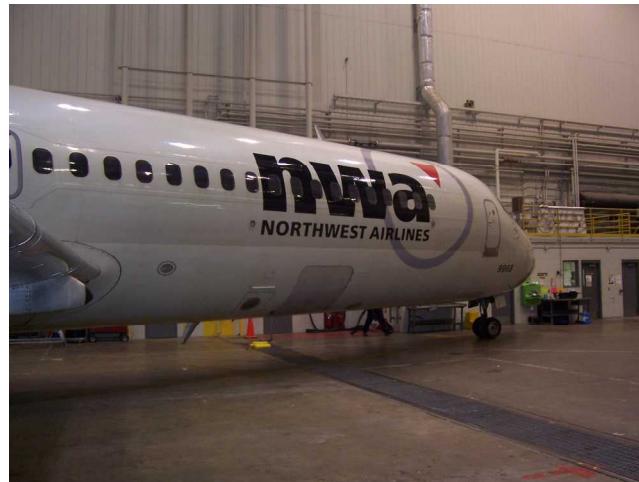
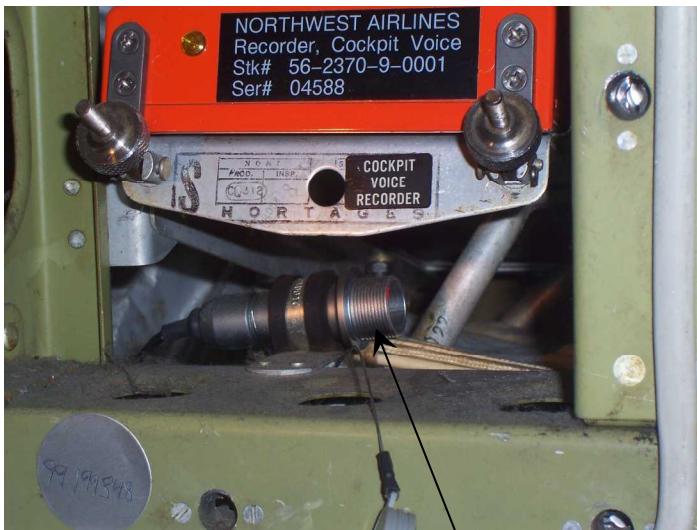
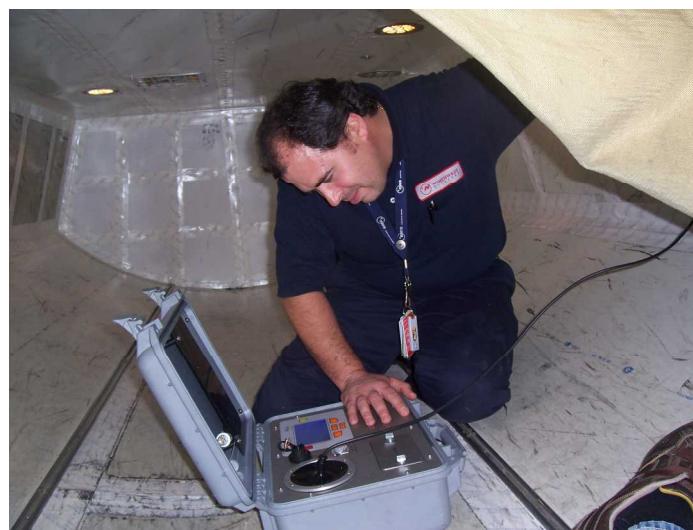
NWA Aft Baggage Compartment Sensor (A/C 9968)

TPS connector routed to access panel
