Historical Review of Oak Ridge National Laboratory Grout Injection Program

Oct. 27, 2006

ORNL Hydrofract Program

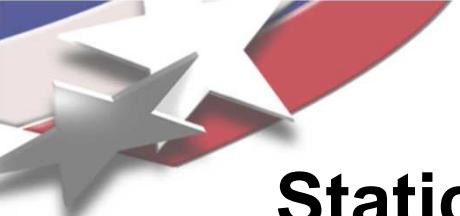
MCC-1 Leach Procedure: Static leaching with solutions analyzed after 4, 7, 14, 28, 56, 94, 112 and 140 days

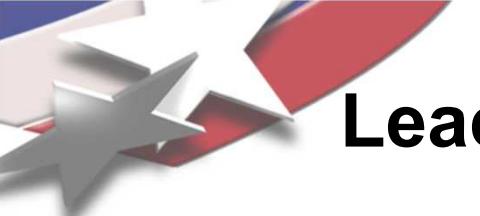
Leachability Index, L_i , for ORNL Grout (24 day cure time)

Distilled Water	Shallow Water	Deep Brine
^{137}Cs	10.6	10.5	8.8
^{85}Sr	10.6	11.7	8.6
As	13.6	12.7	11.3
Ba	13.1	12.1	8.9
Cd	17.3	17.1	10.9
Co	13.9	13.9	10.5
Cr	13.8	13.4	11.4
Cu	15.1	14.3	10.7
Hg	13.4	13.3	8.1
Ni	15	15.1	11.1
Pb	15.3	15.3	10.3
Sb	13.1	12.1	9.7
