Importance of Understanding Sedimentation for Tamarisk Control Efforts

Tamarisk Research Conference

October 3, 2006

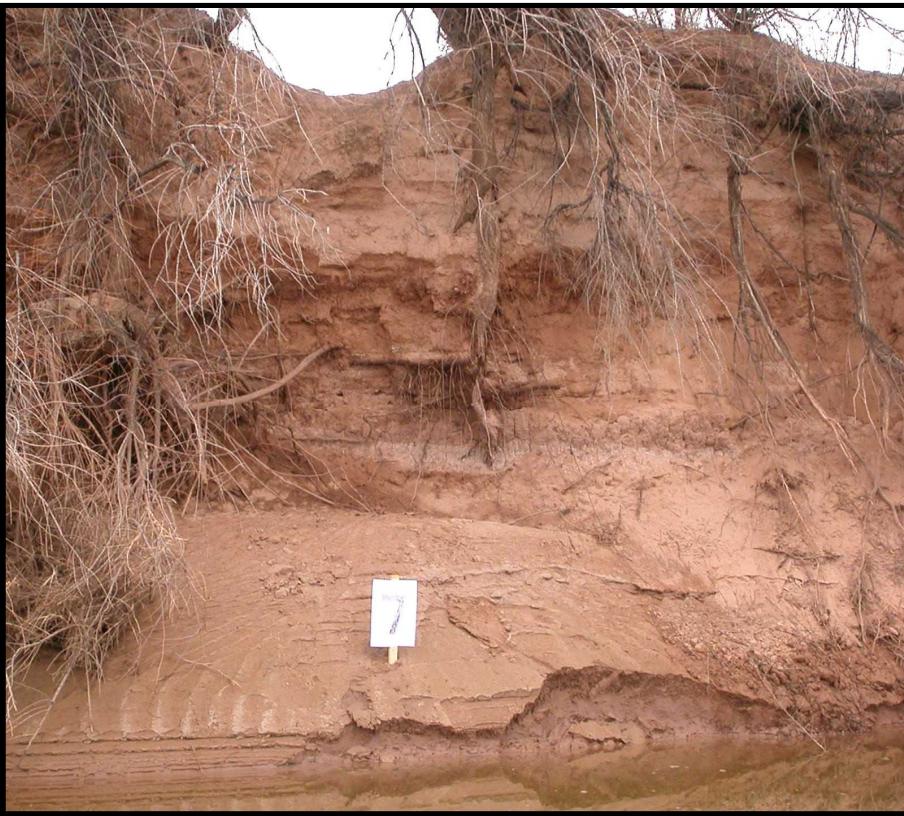
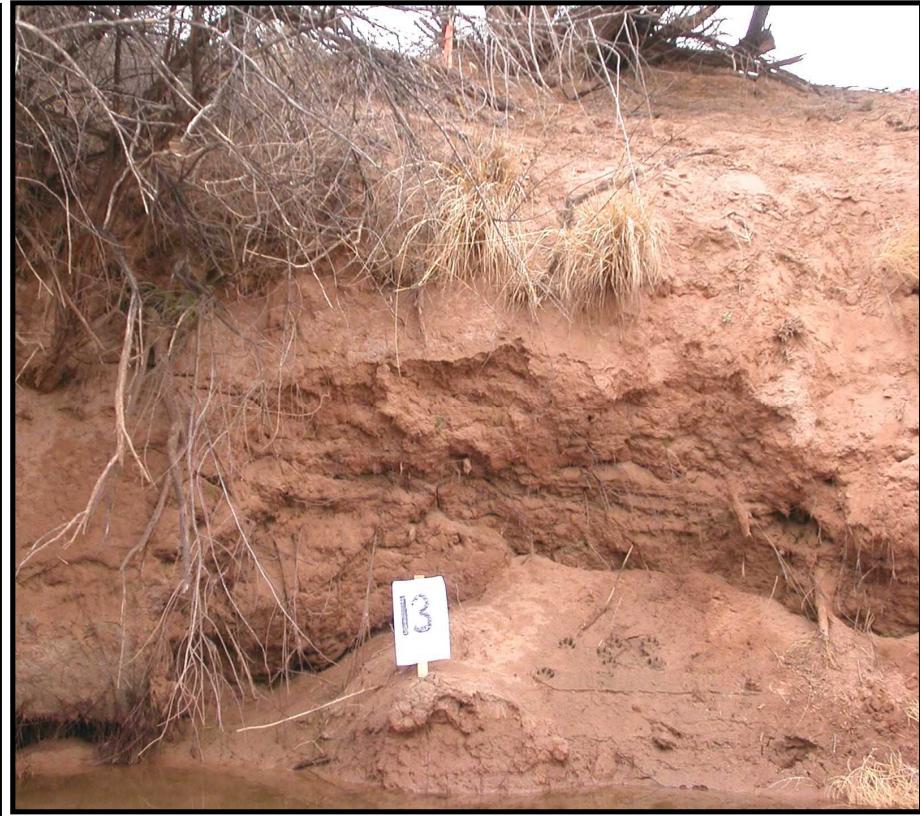
- Dead saltcedar root systems provide little stability

- Sediments will accumulate in and reduce life span of Brantley Reservoir

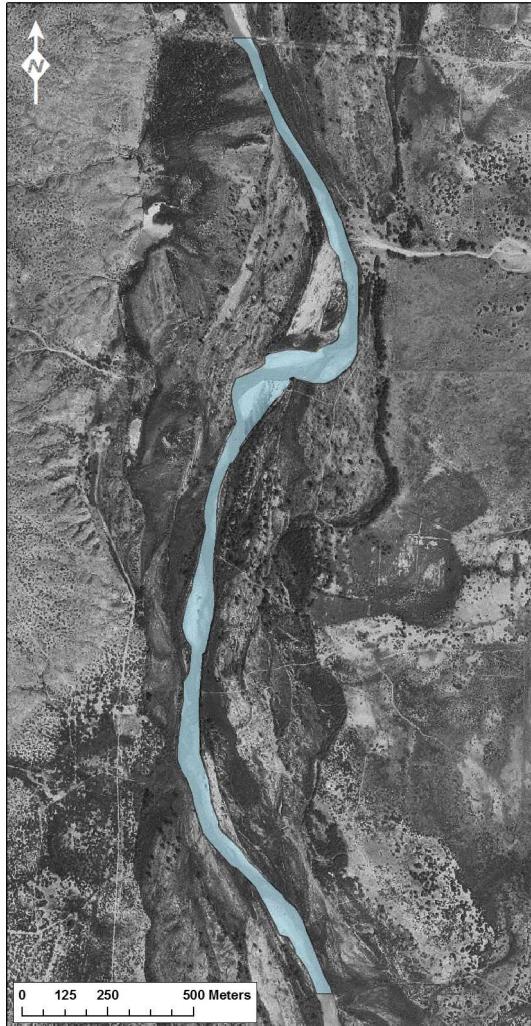
1998

- Images recently made available
- Determine temporal changes in river characteristic
- Pre/post tamarisk control

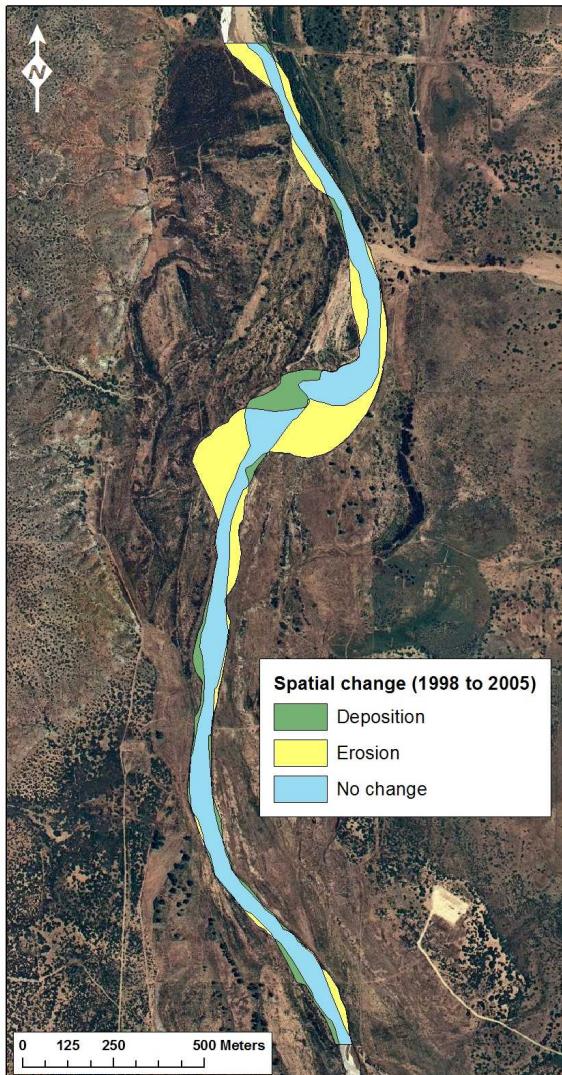
Change	Square meters	% change
Deposition	28,000	11
Erosion	90,000	34
No change	143,000	55
Total	261,000	100

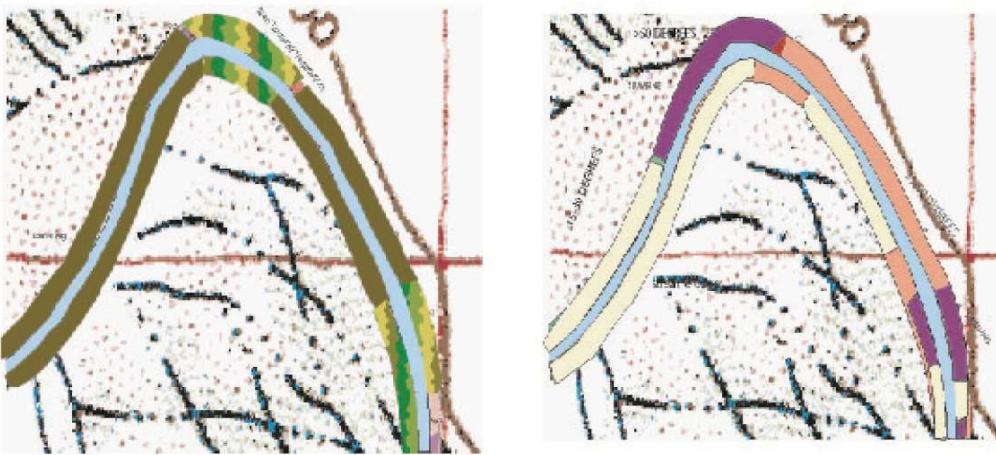
SITE B (lynnette and candyland)

Vegetation type

- Non Salt Cedar Vegetation
- Live Salt Cedar
- No Vegetation
- Sparse Vegetation

Erosion process and Slope

- Slumping, caving(>50 deg)
- Stream erosion (31-50 deg)
- >50 deg slope
- 15-30 degree slope

FIGURE SHOWING RELATIONSHIP BETWEEN CHANNEL MORPHOLOGY AND MAPPED PARAMETERS AT SITE B

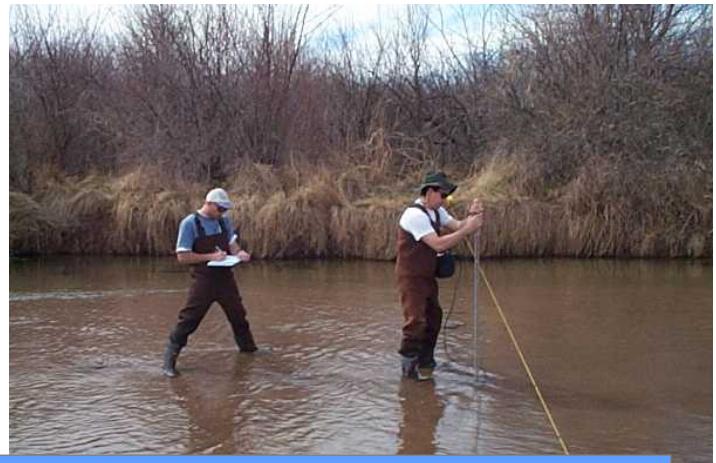
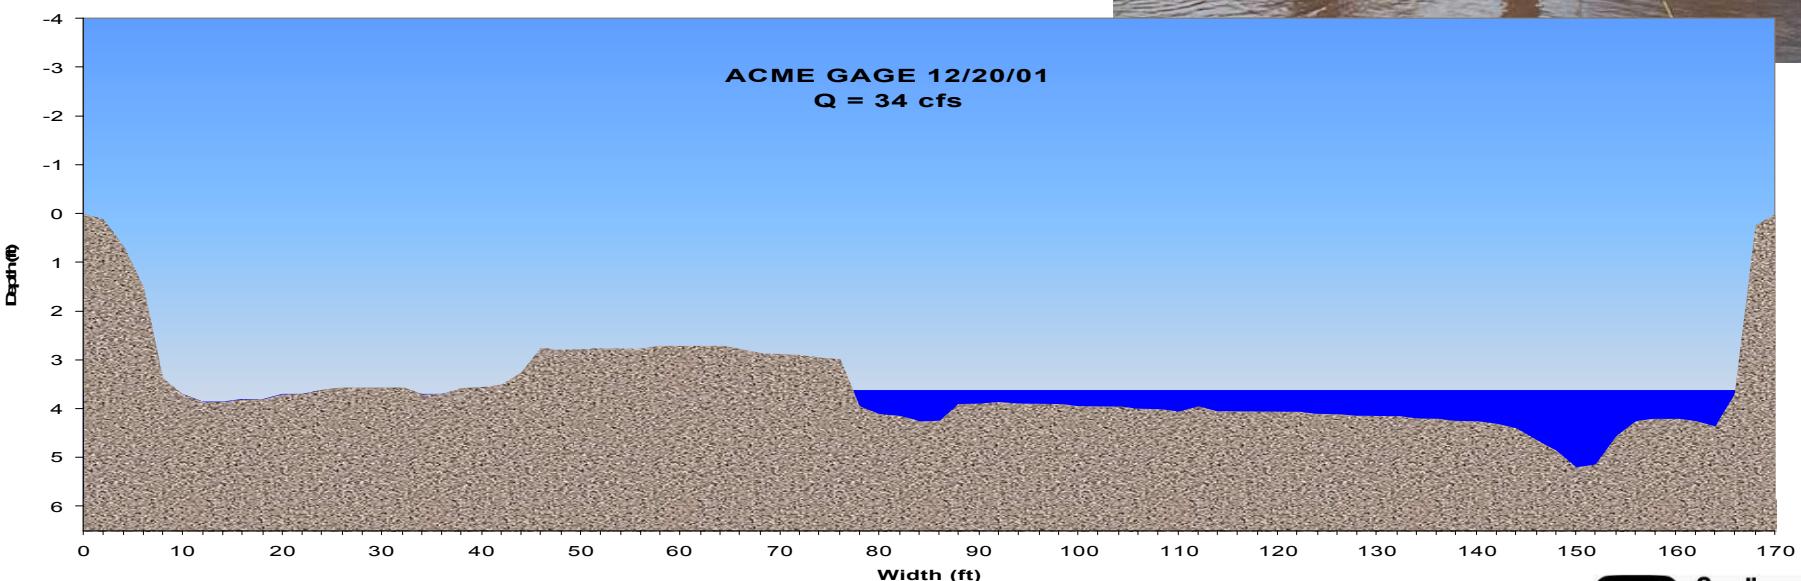
- Semi-permanent monitoring stations
 - 11 single-sites North of Roswell (2001-2004)
 - ❖ Flow rate and cross-section data
 - ❖ bed form geometry and migration rates
 - 5 multi-sites South of Roswell (2005-present)
 - ❖ Cross section data only

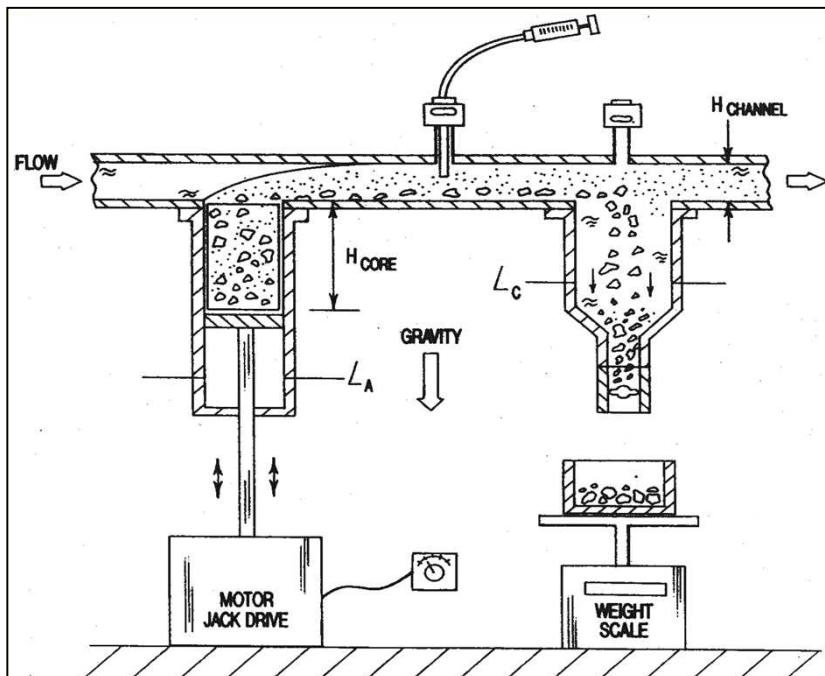
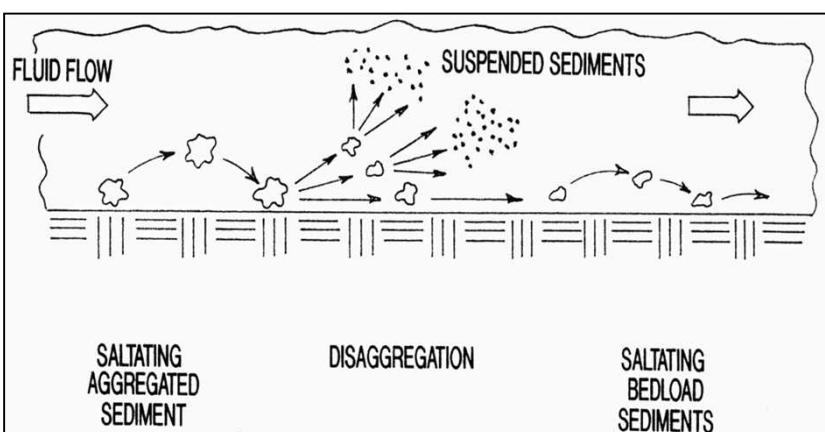
- Uses SEDflume/ASSET flume data to quantify bed stability
- Uses multiple size classes
- Incorporates bedload and coarsening
- Incorporates cohesive bedload and consolidation

o Making improvements to include bank erosion

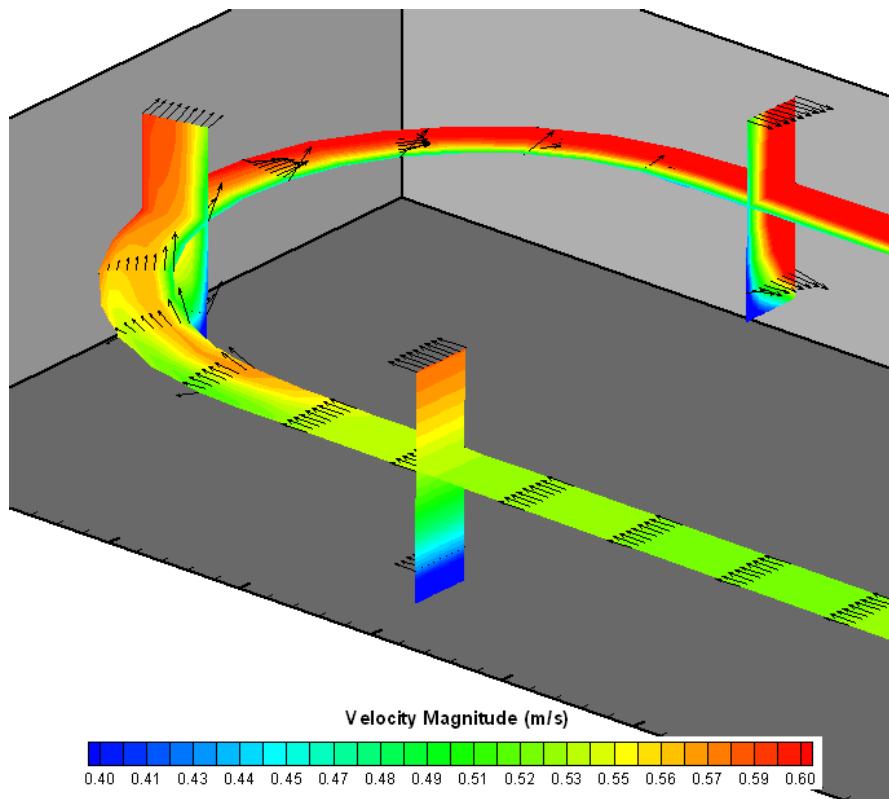
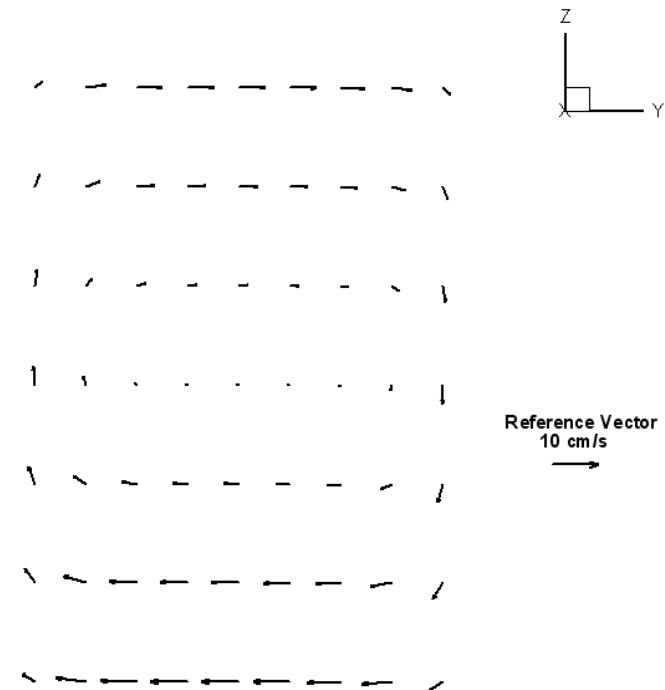
- Experiments were conducted in a 180° bend flow channel with graded non-cohesive sediments and unsteady flow to investigate sediment sorting.

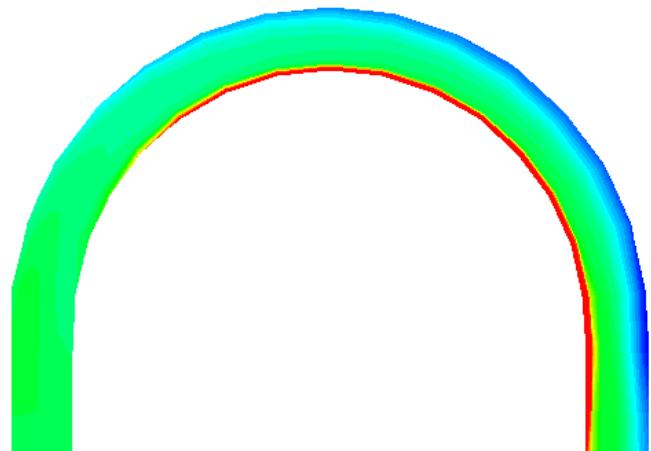
Change in Bed Thickness

- Results are consistent with laboratory measurements of bed thickness and particle size distribution after the experiments.

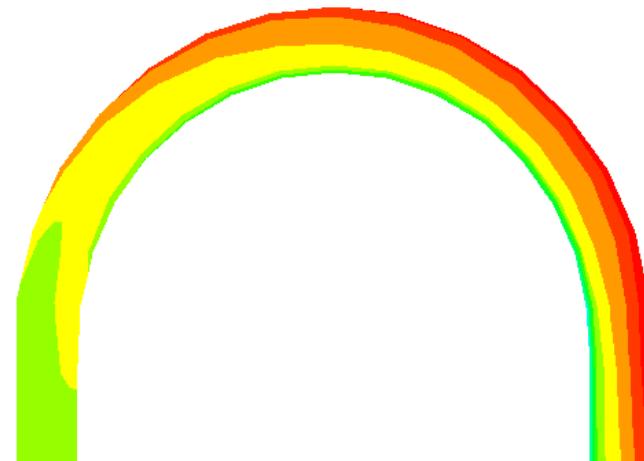
Distribution of Particle Size
