# **NDT Comparison of In-service Cracks, Manufactured Cracks and EDM Notches**

**Quantitative Nondestructive Evaluation  
Conference**

**August 4, 2006**

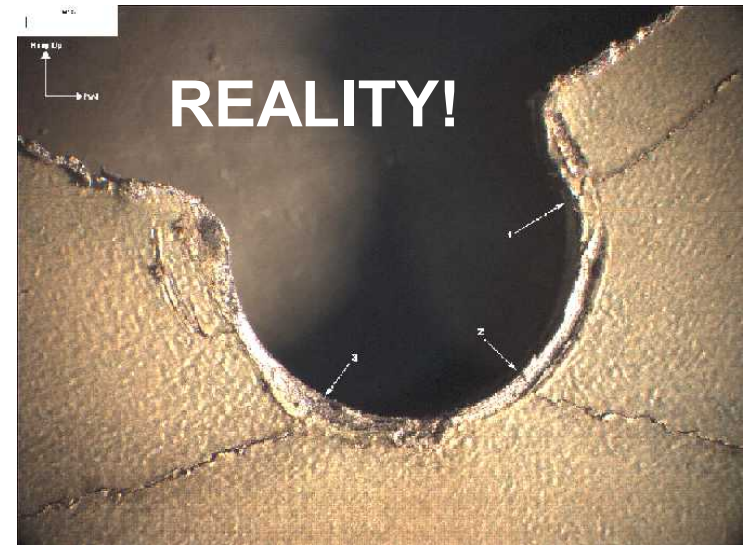
**EDM Notch**

# Crack Differences Can Affect Signals

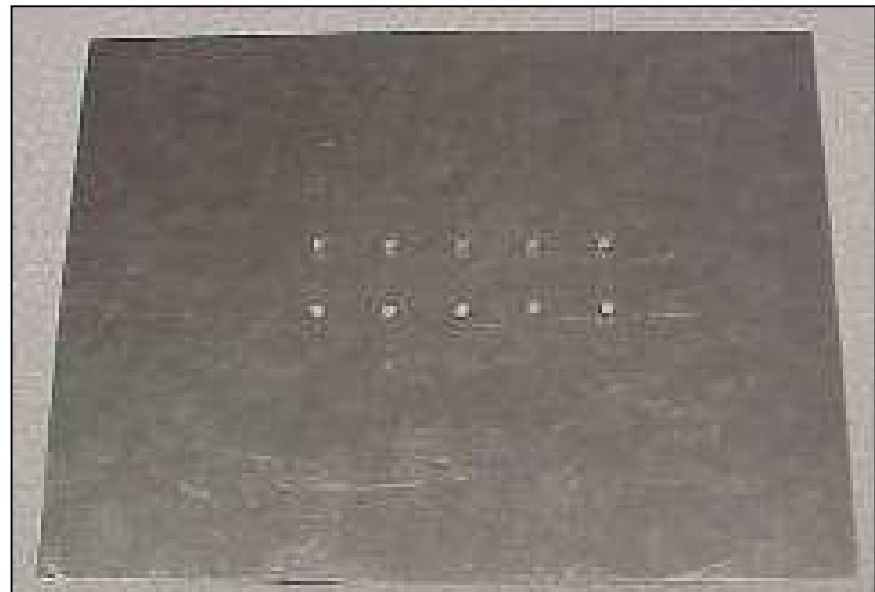
# EDM Notch Reference Standard

2 EDM NOTCH LENGTHS (SEE VIEW 1 AND 2 ABOVE):

- L1 0.030 INCH (0.76)
- L2 0.040 INCH (1.00)
- L3 0.050 INCH (1.27)
- L4 0.050 INCH (1.27)
- L5 0.100 INCH (2.54)
- L6 0.150 INCH (3.81)

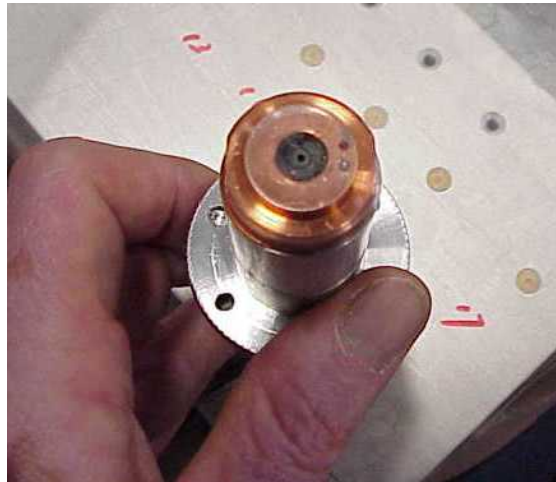
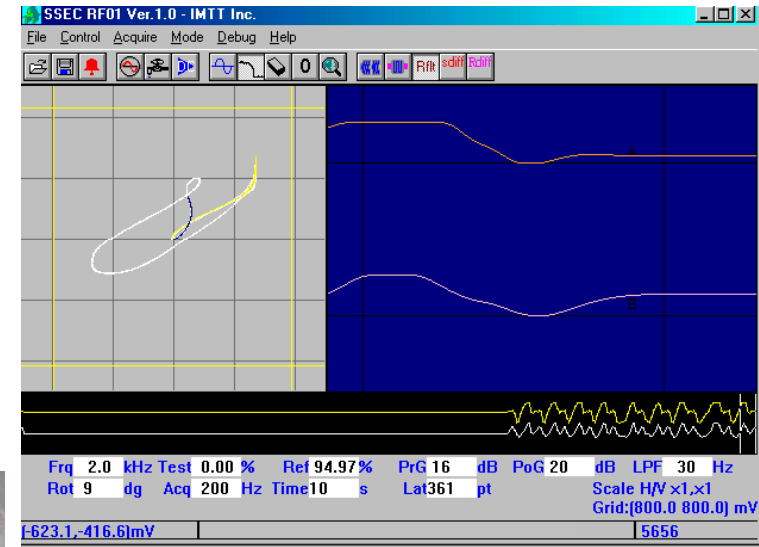
- IMTT
- Super Sensitive Eddy Current (SSEC)
- Recent Improvements to auto-centering and signal processing algorithms
