# SANDIA REPORT

SAND99-2017  
Unlimited Release  
Printed August 1999

## Advanced Blade Manufacturing Project Final Report

Robert Z. Poore

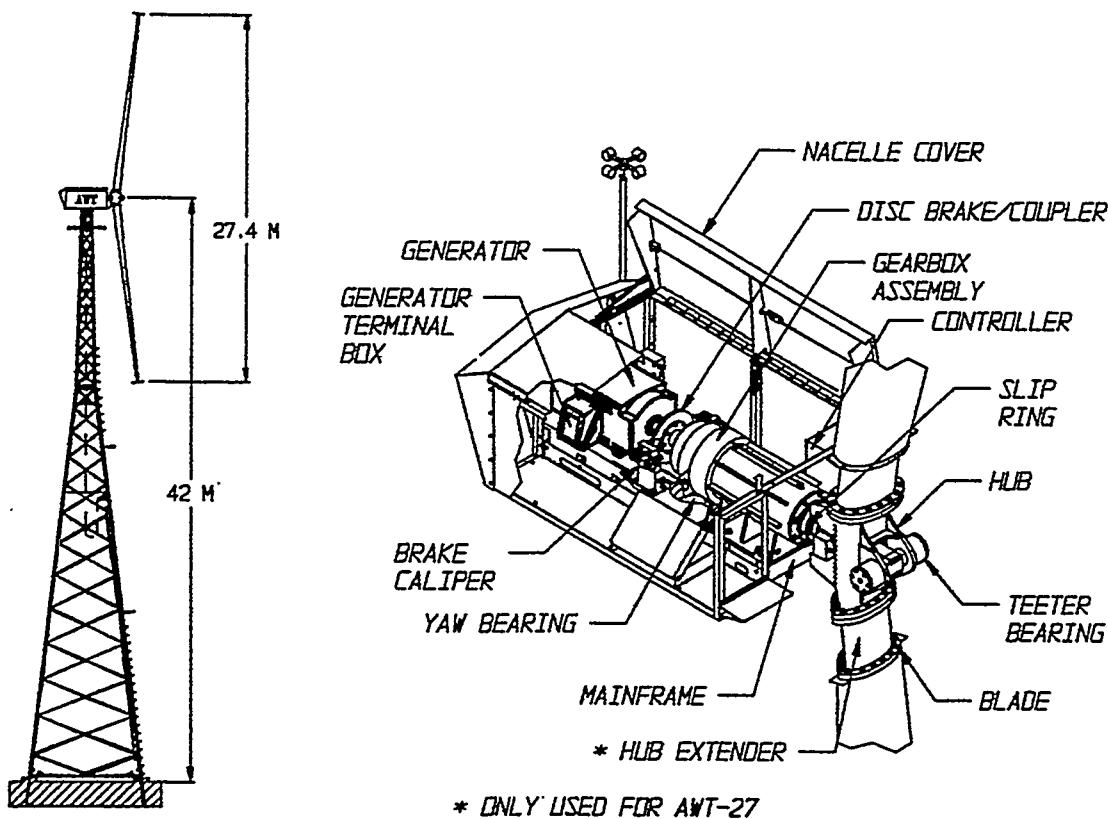
The configuration of the AWT-27 wind turbine is shown in Figure 2-1. The turbine is a downwind, free-yaw, fixed-pitch machine. Rotational energy is converted to electrical power in the nacelle, which contains a speed increaser (gearbox), generator, and a programmable logic controller (PLC).

Figure 2-1 General Configuration of AWT-27 Turbine

The blades are lofted from NREL S825/S809/S810 thick-airfoil sections, and are made of wood-epoxy laminates, reinforced with carbon fiber. The AWT-27 rotor is a teetered, two-bladed, fixed-pitch, stall-regulated design. It has a diameter of 27.4 m (90 ft) and has a nominal speed of 53 rpm. The rotor is connected directly to the gearbox mainshaft, and the gearbox increases the mainshaft speed to 1800 rpm, driving a three-phase, 60 Hz, 480 volt, induction generator.

The tower is a 42.7 m (140 ft) high free-standing, steel lattice structure. The machine is controlled by a PLC that is located in a control house adjacent to the tower. This PLC communicates with the PLC in the nacelle and also provides performance and maintenance diagnostic information. Connection to the grid is made at the switchboard enclosure in the control house.

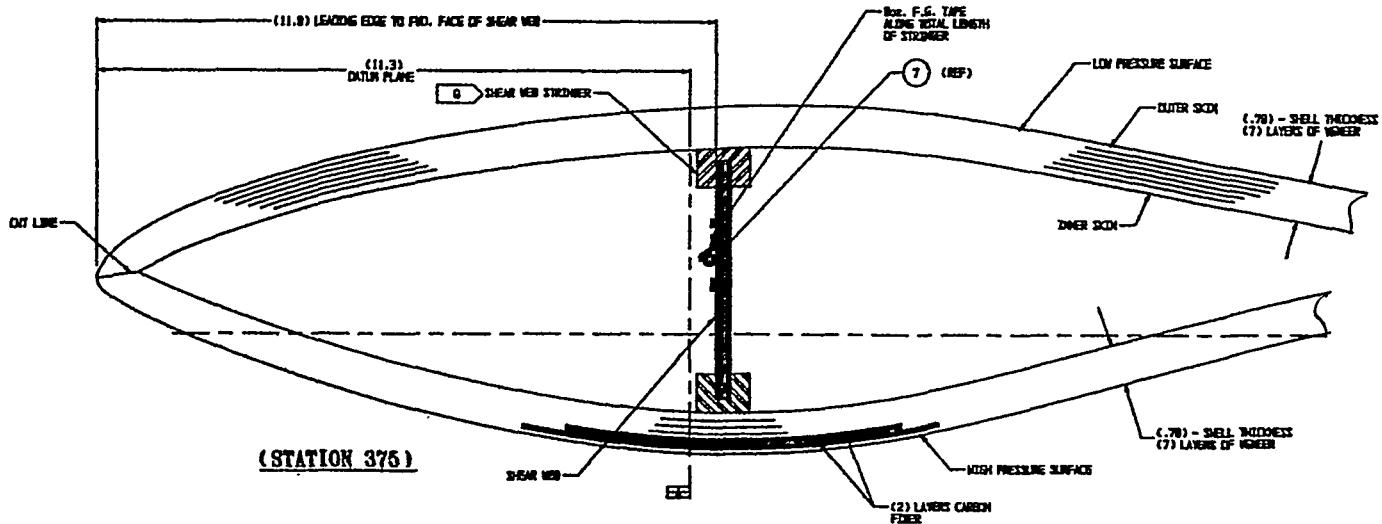
**Figure 2-2 Typical Blade Cross Section**

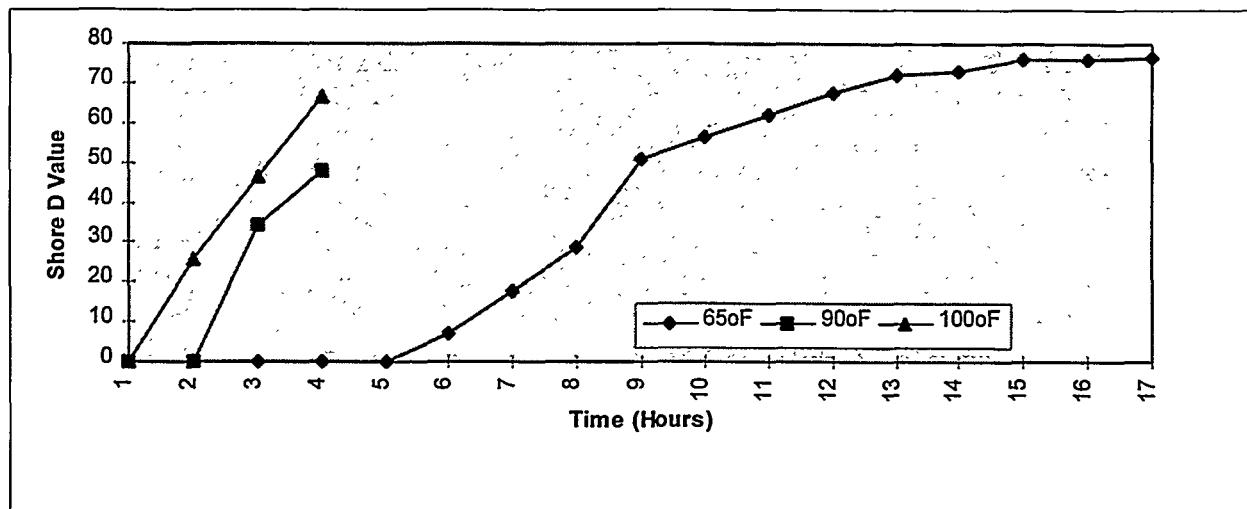
Three series of laboratory tests were completed, one at 65°F, one at 90°F, and one at 100°F. The tests performed at 65°F were used as the base case, duplicating the conditions normally found in the factory during the colder winter months. The tests were performed at ABM using existing temperature controlled refrigerators and ovens. Hardness was measured utilizing a Durometer to obtain values on the Shore D hardness scale. Special sample containers were fabricated for testing purposes to insure that the test results modeled the isothermal conditions experienced in the curing cycle of the blade laminate. The sample containers were constructed from 1 1/2 inch thick aluminum plate six inches square. These plates had a 3/16" Garolite sheet containing a 3" diameter hole bonded to the top surface of the aluminum plate. The large aluminum plate served as a heat sink to assure isothermal conditions and the Garolite formed platen cavity contained the epoxy sample. Data (temperature and Shore D hardness) were recorded at one hour elapsed time intervals. The results of these tests are shown in Figure 3-2.

Figure 3-2 Shore D Hardness Testing Results

Examination of the data in Figure 3-2 for 65°F result in the following observations:

- Between 2.5 and 3 hours were required with the 90 °F samples before they reached a Shore D hardness value of approximately 30. Upon rapid cool-down the sample hardness increased to 70+. This would reduce the blade vacuum forming cycle time from eight hours to 3 hours if Shore D harnesses at the time of removal of the vacuum are maintained. Since the heat-up and cool-down cycles of the blade and mold fixture are estimated to require a minimum of 1/2 hour each, the elevated temperature of 90 °F would require at least a 4 hour cycle, which was determined to be inadequate to achieve a 12 hour cycle time.

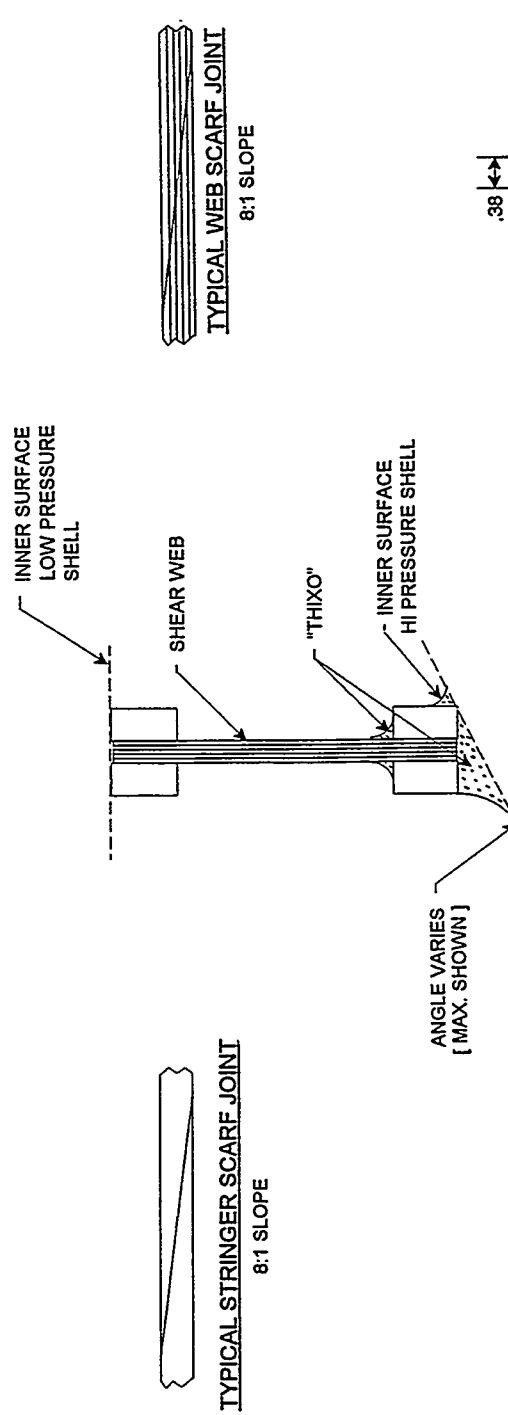
TYPICAL STRINGER DETAIL

PART NO.		DESCRIPTION	
ADVANCED BLADE		MANUFACTURING	
MANUFACTURED WEB		MODIFIED WEB	
DETAILS		DETAILS	
SCARF A		SCARF A	
BMP-008		BMP-008	
REV A		REV A	
SHT. 1 OF 1		SHT. 1 OF 1

1. The shear web stringer design, employing 5/4" Douglas fir board stock that is fabricated into 1" x 3/4" strips with 1/4" dado grooves had to be redesigned for use with a mold. A new design was developed which replaced each stringer with two (2) 3/8" x 3/4" strips. Figure 3-3 shows the proposed configuration.
2. Replacement of the scarfed joints in the shear web and stringer with "butt" joints was proposed.
3. A new molding fixture would be designed and constructed to allow fabrication of a pre-molded shear web. This would create shear web units that were identical to one another. This would reduce the time required to fit shear webs into blades and allow a reduction in the tolerance allowed between the shear web and blade shell. The reduced tolerance will result in a better fit and an improved quality blade.

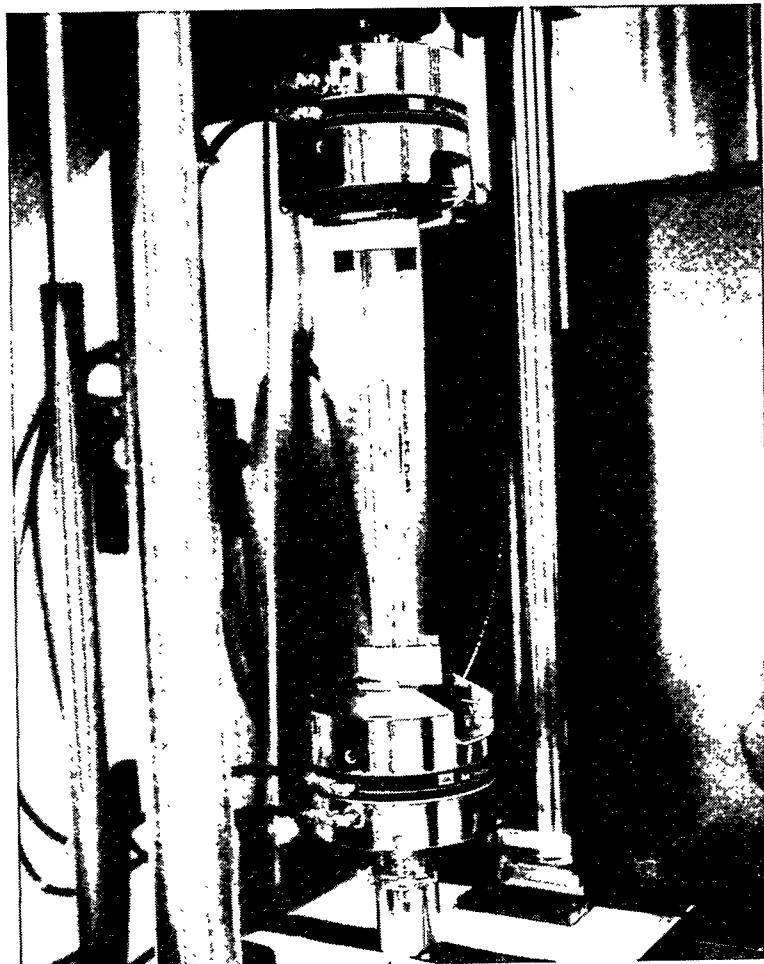
**Figure 1**

Setup for progressive tension fatigue tests  
showing specimen NG-039 installed in 22-kip MTS  
with wedge-action grips.

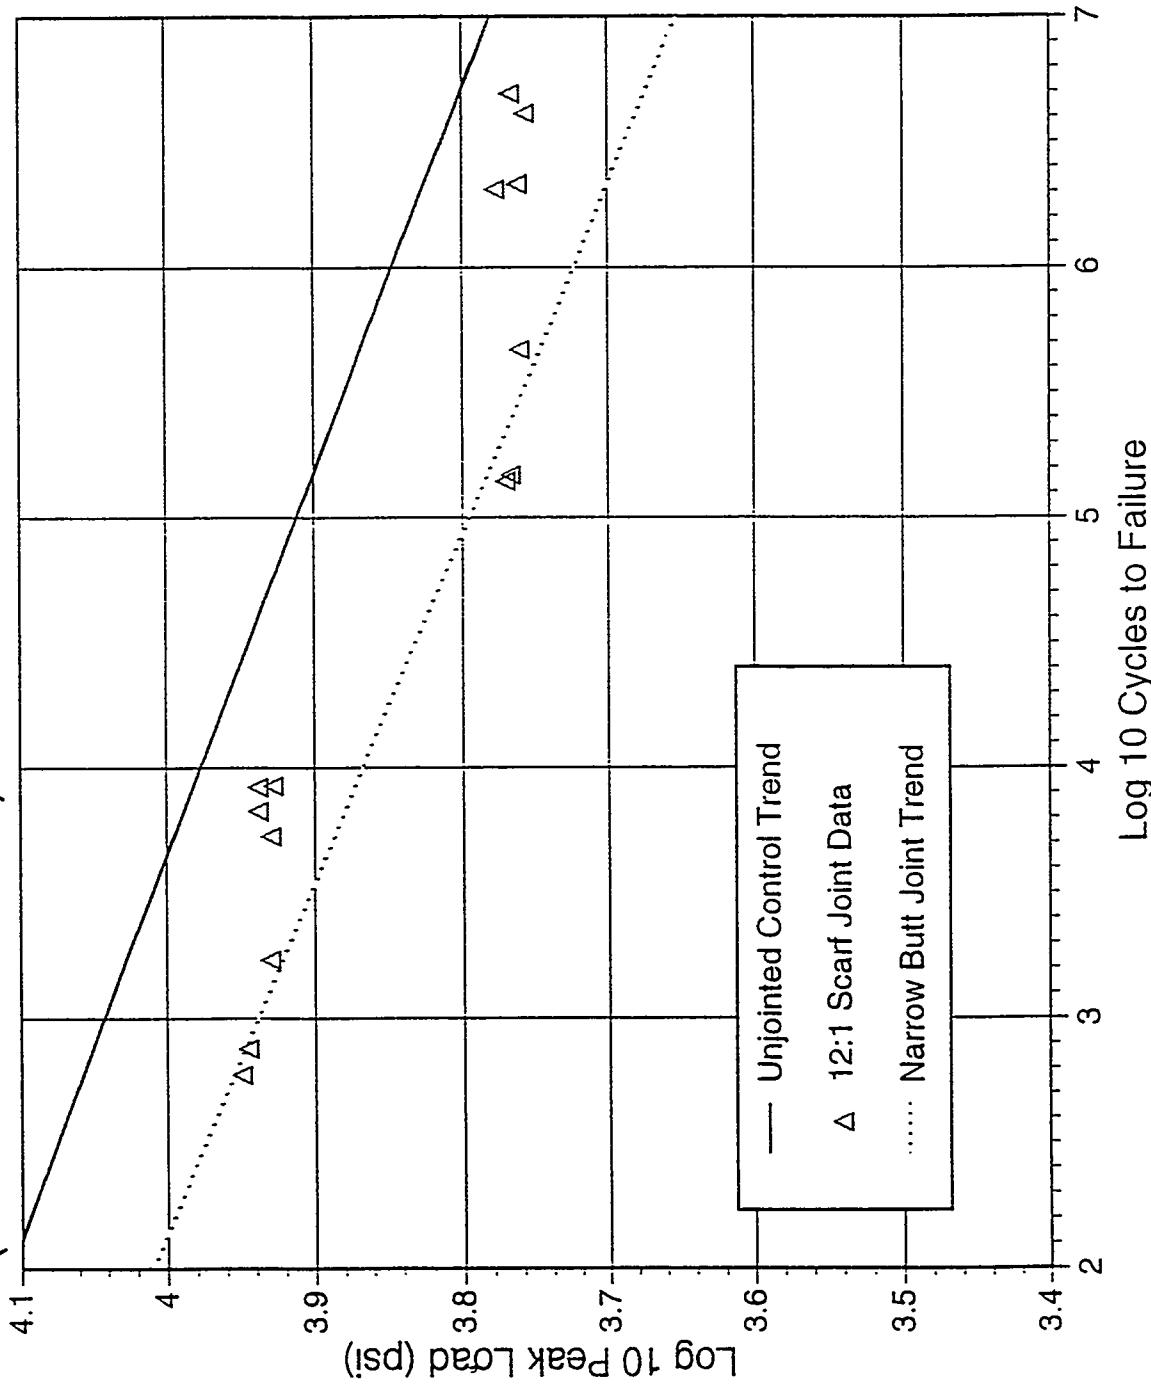
Figure 1

DOE/SBIR Classical Tension Fatigue Data  $R = 0.1$   
 (Corrected to 12% W.M.C.)
