Low Voltage E-Beam Diagnostics

March 6, 2007

Background

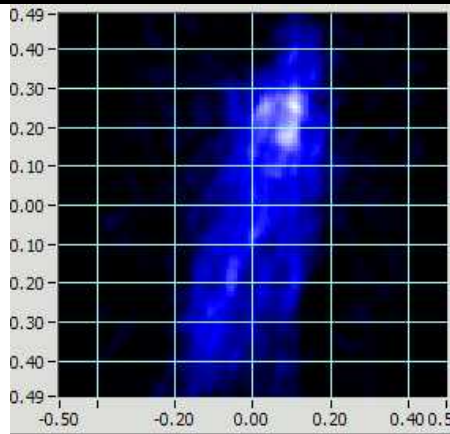
Focus -10 mA

Low Voltage
Ribbon Gun
Ribbon Fil.
60kV, 5mA?
"Old Coil" CR

- Image scales are consistent
- Faraday cup profiles using LLNL MFC
- Initial concern for LV was 90° rotation

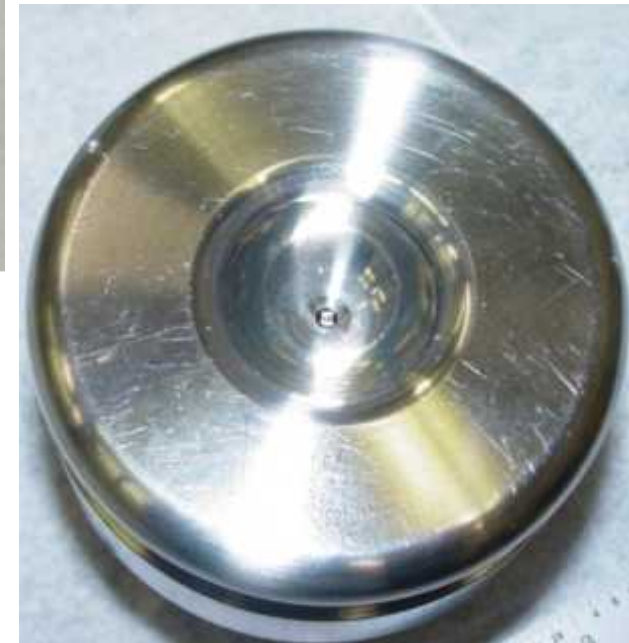
Low Voltage
Hairpin Gun w/
Ribbon Filament
Hole ϕ .100"
Diagonal 0.093"

Ribbon – LV
Up to 150mA

Ribbon – HV
Up to 60 mA

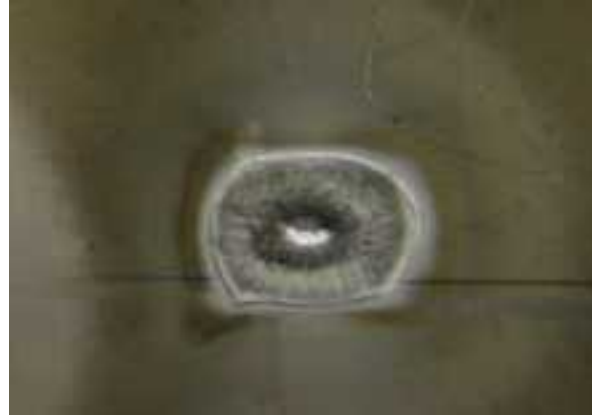
LV Machine
Ribbon filament
“Ribbon gun”
60kV, 10’s mA

Concluded that any issues that may exist with our LV guns were not root cause issues

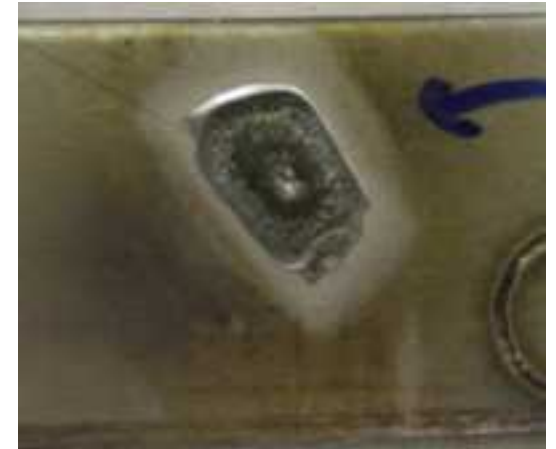
HV Machine
Ribbon filament
120kV, 30 mA

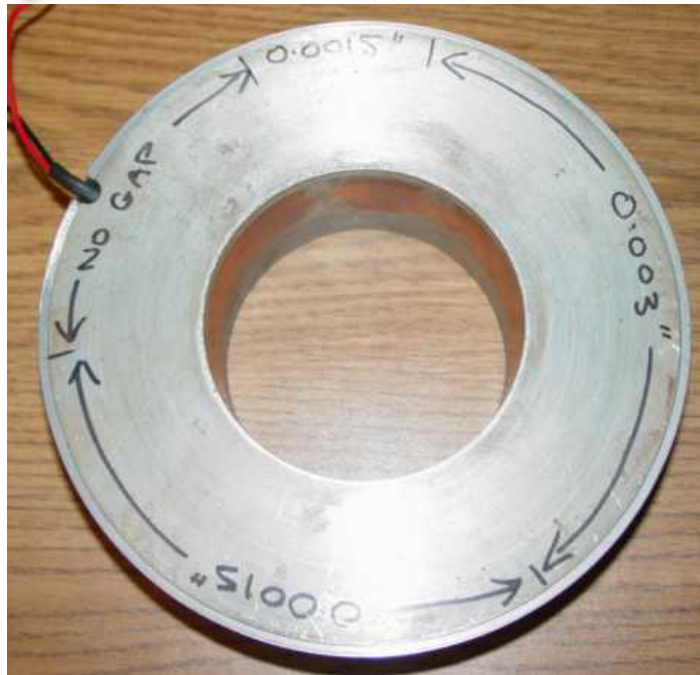
Original Coil (Left) Replacement (Right)

- Initial thought was focus coil issue
- Original coil may have hysteresis
- Received second coil with "improved" ferromagnetic alloy – but had sizeable gaps
- Coil fabrication not trivial
- Top and bottom

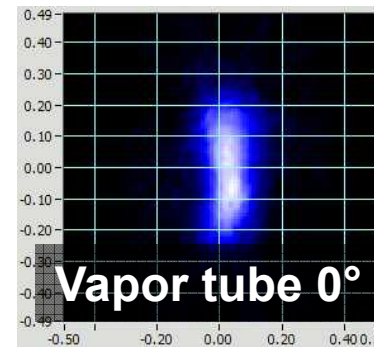
Low Voltage
Hairpin Gun
Ribbon Fil.
60kV, 5mA?
New Coil
553 mA focus
