Radiological Threats in the Gulf

Practical Workshop on Radiological Emergency Response

Bahrain
February 18, 2007

Dr. Amir H. Mohagheghi
Program Manager, CMC Middle East Program
Sandia National Laboratories
Phone: +1-505-844-6910 Fax: +1-505-284-5055
Email: ahmohag@sandia.gov

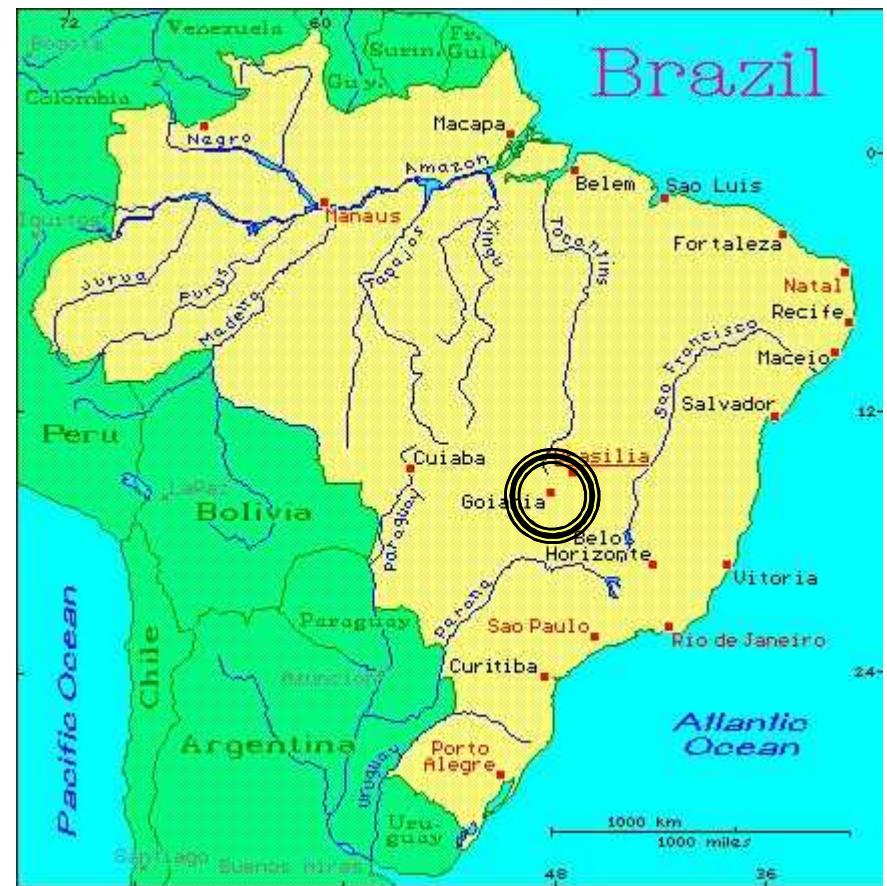
- The accident occurred in September 1987 in Goiania involving a Cs-137 medical teletherapy source
- Goiania had a population of about 800,000 at the time of the accident
- In 1985, the Goiania Institute of Radiotherapy moved to a new location leaving behind an obsolete Cesium-137 teletherapy unit in a partially demolished building

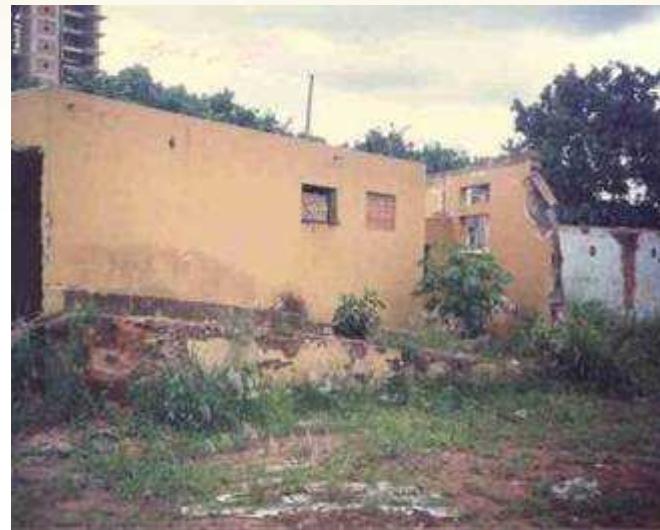
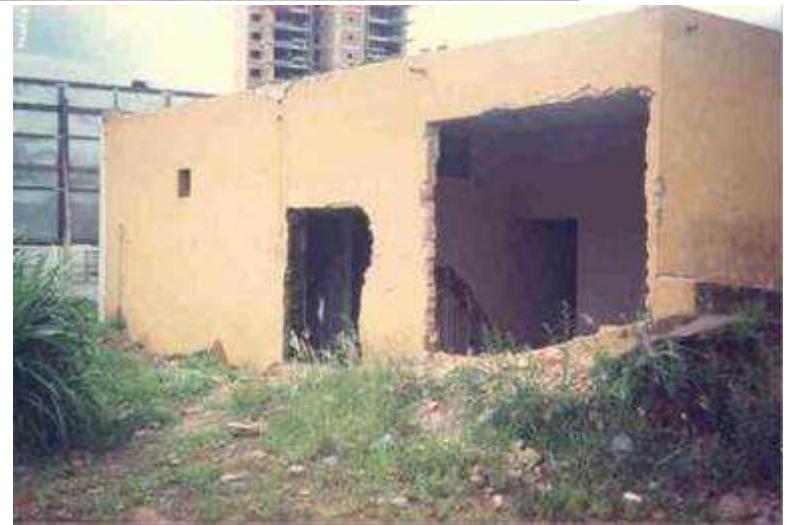
How did it happen?

- Two young men learned that there was a heavy equipment at an abandoned hospital building in downtown Goiania (Sep. 13)
- They removed the shielding head of the teletherapy unit and sold it to a junk yard
- The two men, the owner of the junk yard and his two employees initiated attempts to dismantle the equipment
- A capsule containing about 1400 Curies of Cesium-137 (Cs-Chloride powder) was dismantled and ruptured (Sep. 18)
- Pieces of the source were distributed among the junk yard owner's relatives, neighbors and most close friends

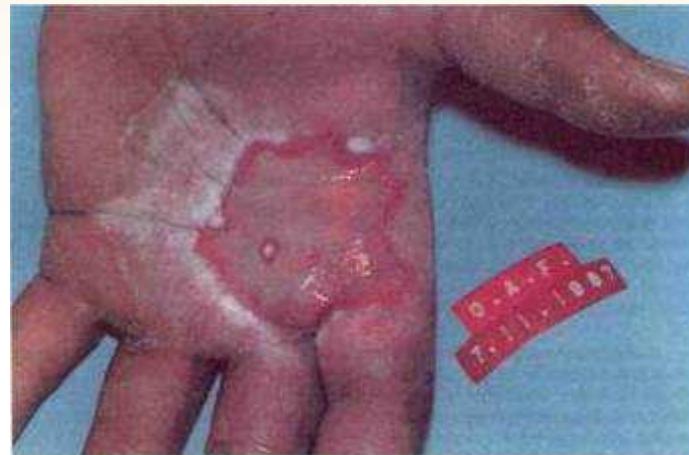
FIG. 9.3. 3-30 days after exposure. The skin was excised. A raw reddish surface is covered with a delicate layer of fibrinous exudate. Note the centripetal character of the healing process and the attempt of re-epithelialization.

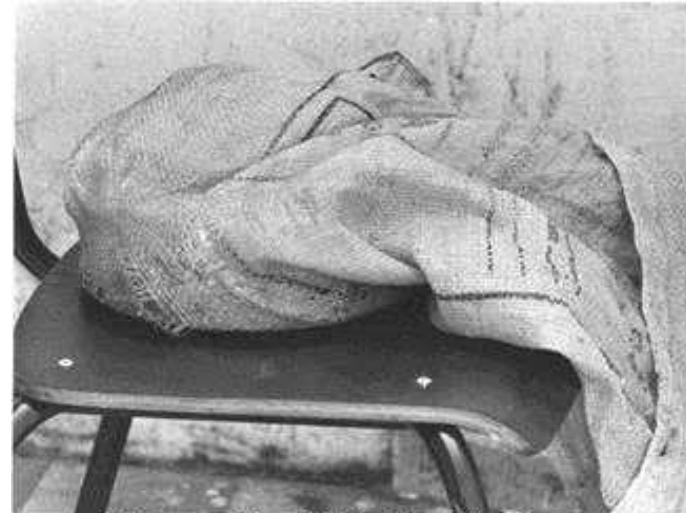
source assembly that was removed from the shielding of the radiation head. It was enveloped by a cloth bag and placed on a chair, which was taken to the corner of the Health Department courtyard. OSEGO.

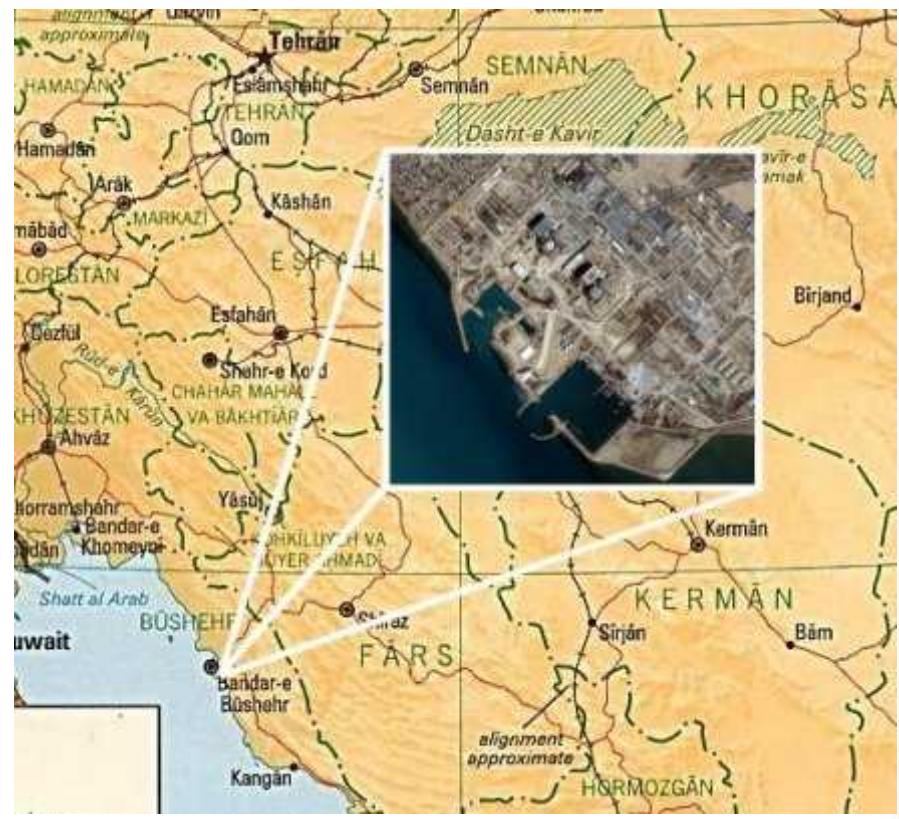
-The Bushehr nuclear facility is located near Halileh which is about a dozen kilometers to the south of Bushehr proper, along the Gulf coast.

-1974: Siemens began construction of two 1200 MW PWR reactors

- 1979: Work stopped due to Iranian revolution and opposition by Ayatollah Khomeini

- 1995: Russia agrees to provide one VVER-1000 light water reactor

- Agreement includes supply of fresh fuel and take back of spent fuel

- Most work on Bushehr I completed, ready for fueling by late 2007

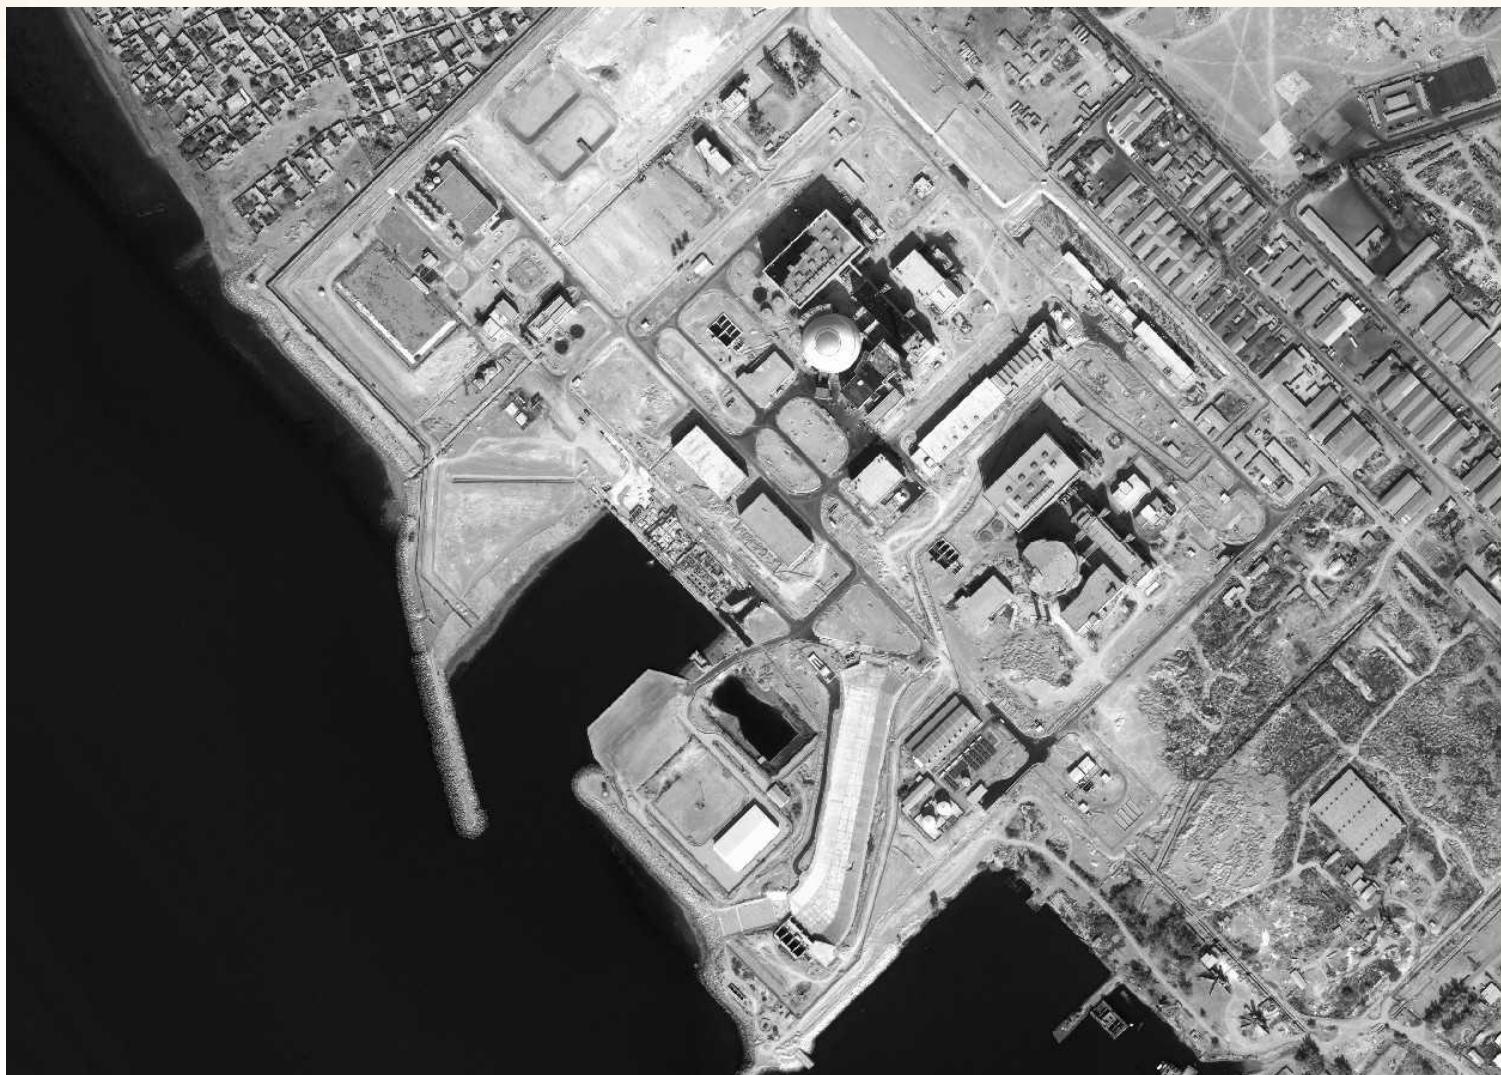
Bushehr Reactor Site, 16 November 2006, QuickBird Image, 0.62 Meter Resolution

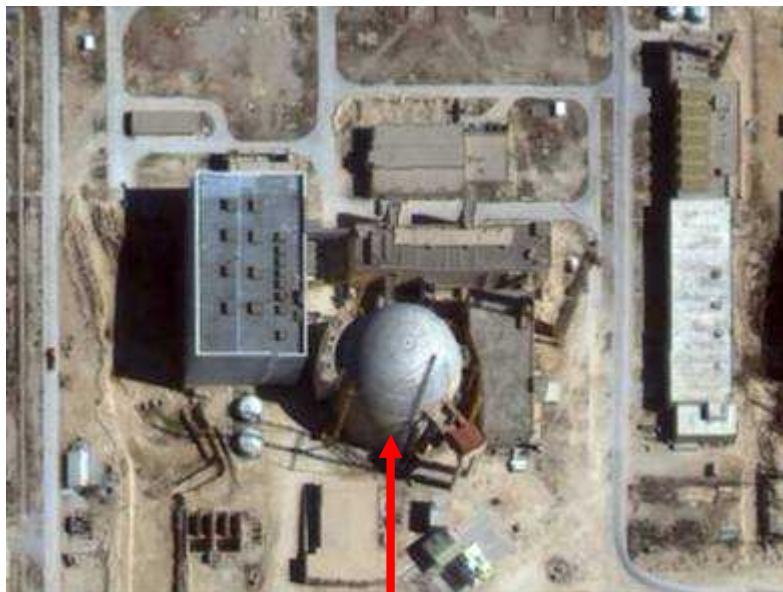
Containment Buildings

If a reactor core is severely damaged / melted (1st barrier) and the primary cooling system fails (2nd barrier), there should be only small releases to the atmosphere because of the last barrier, the containment.

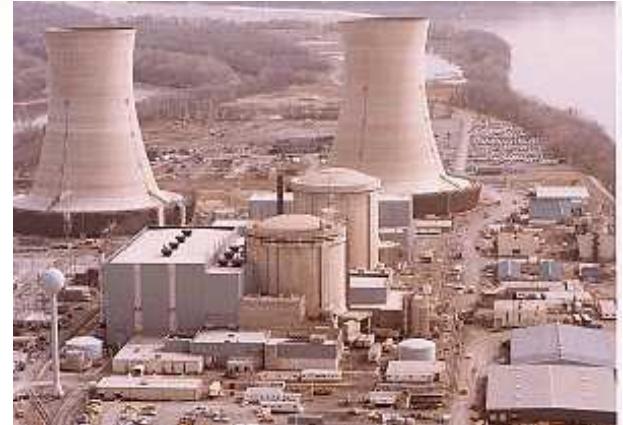
Power Plant Accidents - TMI

- Caused by equipment failures and human operator errors: the water level in the reactor core decreased to the point that the fuel was no longer submerged in water,
- Without the cooling normally provided by this water, the cladding and some of the fuel pellets melted,
- Large quantities of radioactive materials were released into the containment building,
- Radioactive releases to the atmosphere that occurred during the accident were very small,
- **The containment worked**: No fatalities, injuries, or large scale contamination.

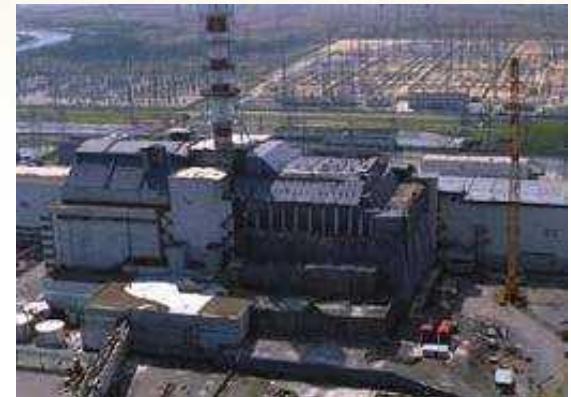
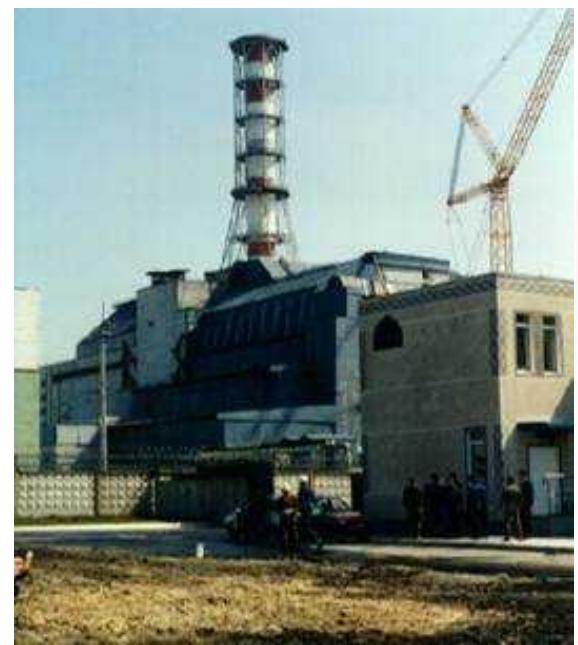
Power Plant Accidents - Chernobyl

- Caused by a combination of human errors, deliberate failure to follow procedures, and poor reactor design,
- Design of the reactor resulted in a very rapid increase in power after the water used to cool the core was lost,
- Pressure increased to the point that the reactor was blown apart,
- Resulted in multiple fatalities, injuries, exposed public to long term radiation effects.
