# Effect of proppant on maintaining permeability in fractured shale

MD Ingraham, SJ Bauer, EC Quintana, DS Bolintineanu, RR Rao,  
JB Lechman

Sandia National Laboratories, Albuquerque, NM  
June 9, 2015

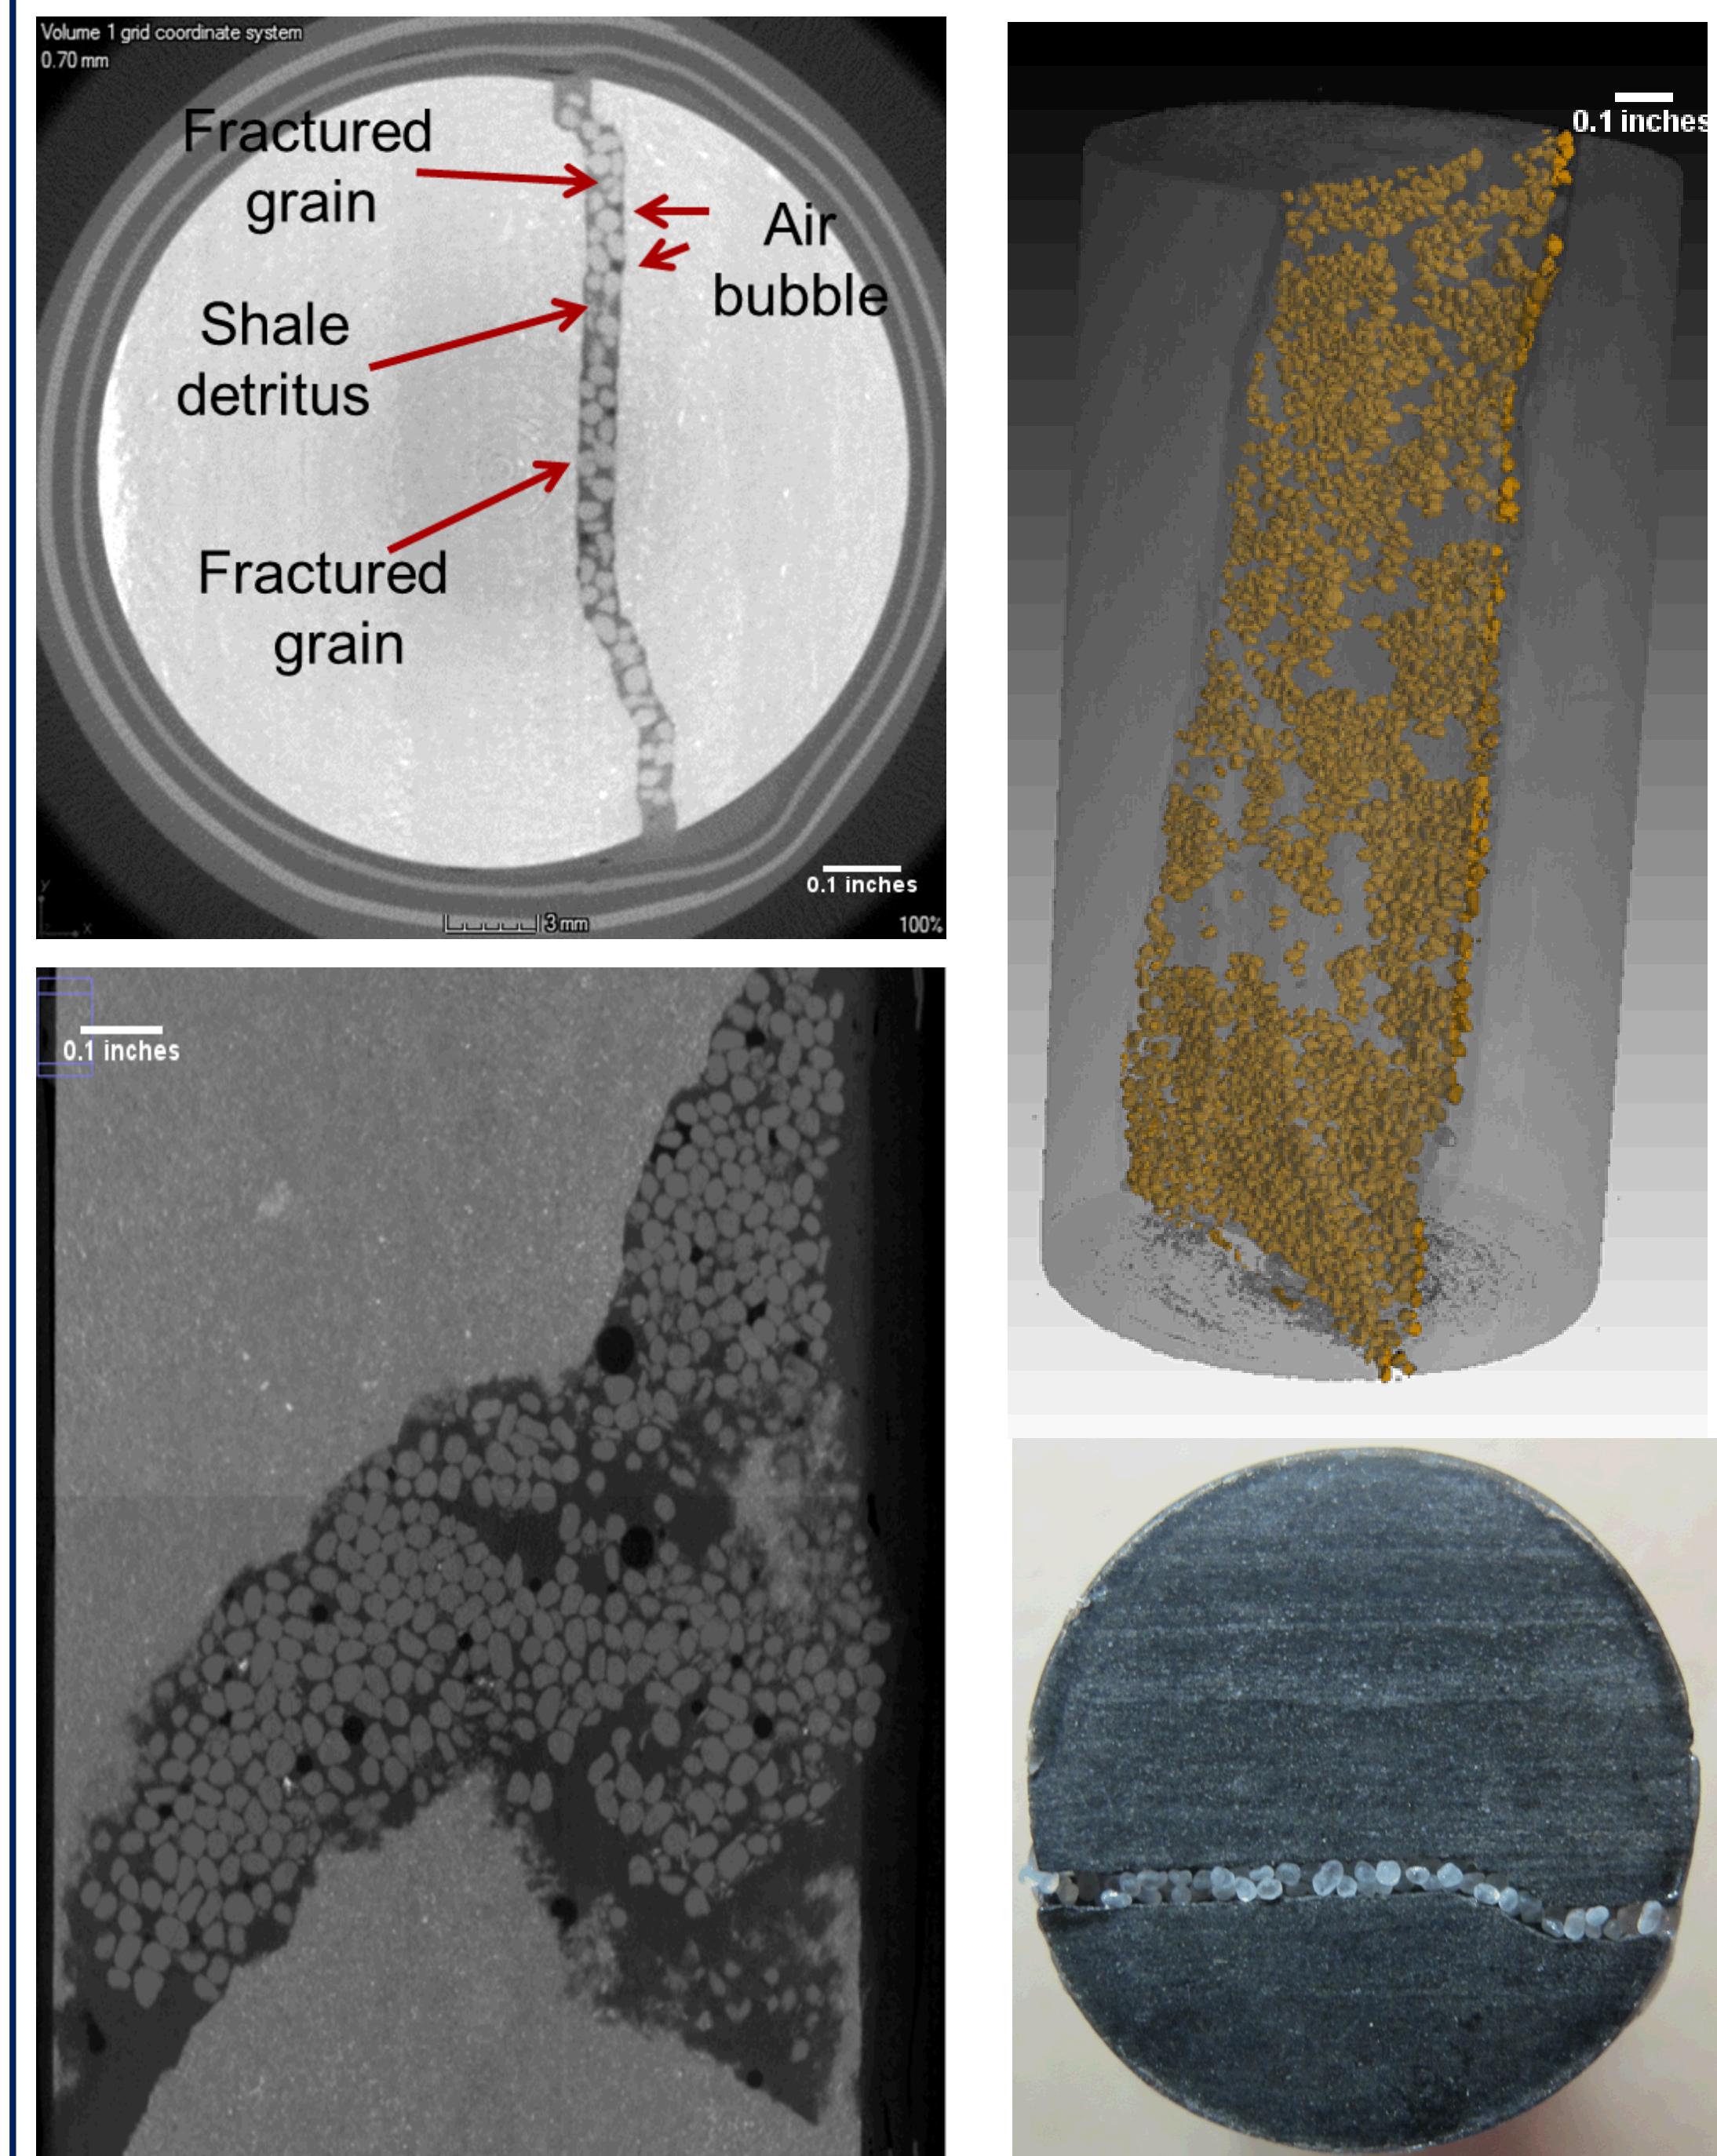
- Monitoring the crack space with X-Ray CT proved to be invaluable in terms of determining what was affecting the permeability of the fracture.
  - Grain fracture was observed, and transport of the fractured grains caused clogging of flow paths.

- Some grain embedment was observed, but it did not appear to be significant.
  - Fractured grains tended to be isolated, while embedded grains tended to be located in a pack of proppant.

- Whole grains showed little to no motion after specimen was assembled
  - Fracture walls sloughed resulting in transport of shale detritus which also clogged flow paths.

- Air bubbles were present in the fracture, even after multiple flow cycles, and a bottom up flow path. This indicates that the surface tension effects of the proppants and the shale fracture surface can trap gas within the fracture, but these should not affect permeability significantly.

- The clays in the specimen did not appear to adsorb significant water, nor did they swell significantly.
- The first images were taken after only 18 hours under reservoir conditions, at which point all of the above features were visible in the fracture, indicating that deterioration of the proppant/fracture interface begins immediately after proppant injection.

- Average fracture aperture was reduced from 0.966mm to 0.914 mm over the duration of the entire test, approximately 90 hours.

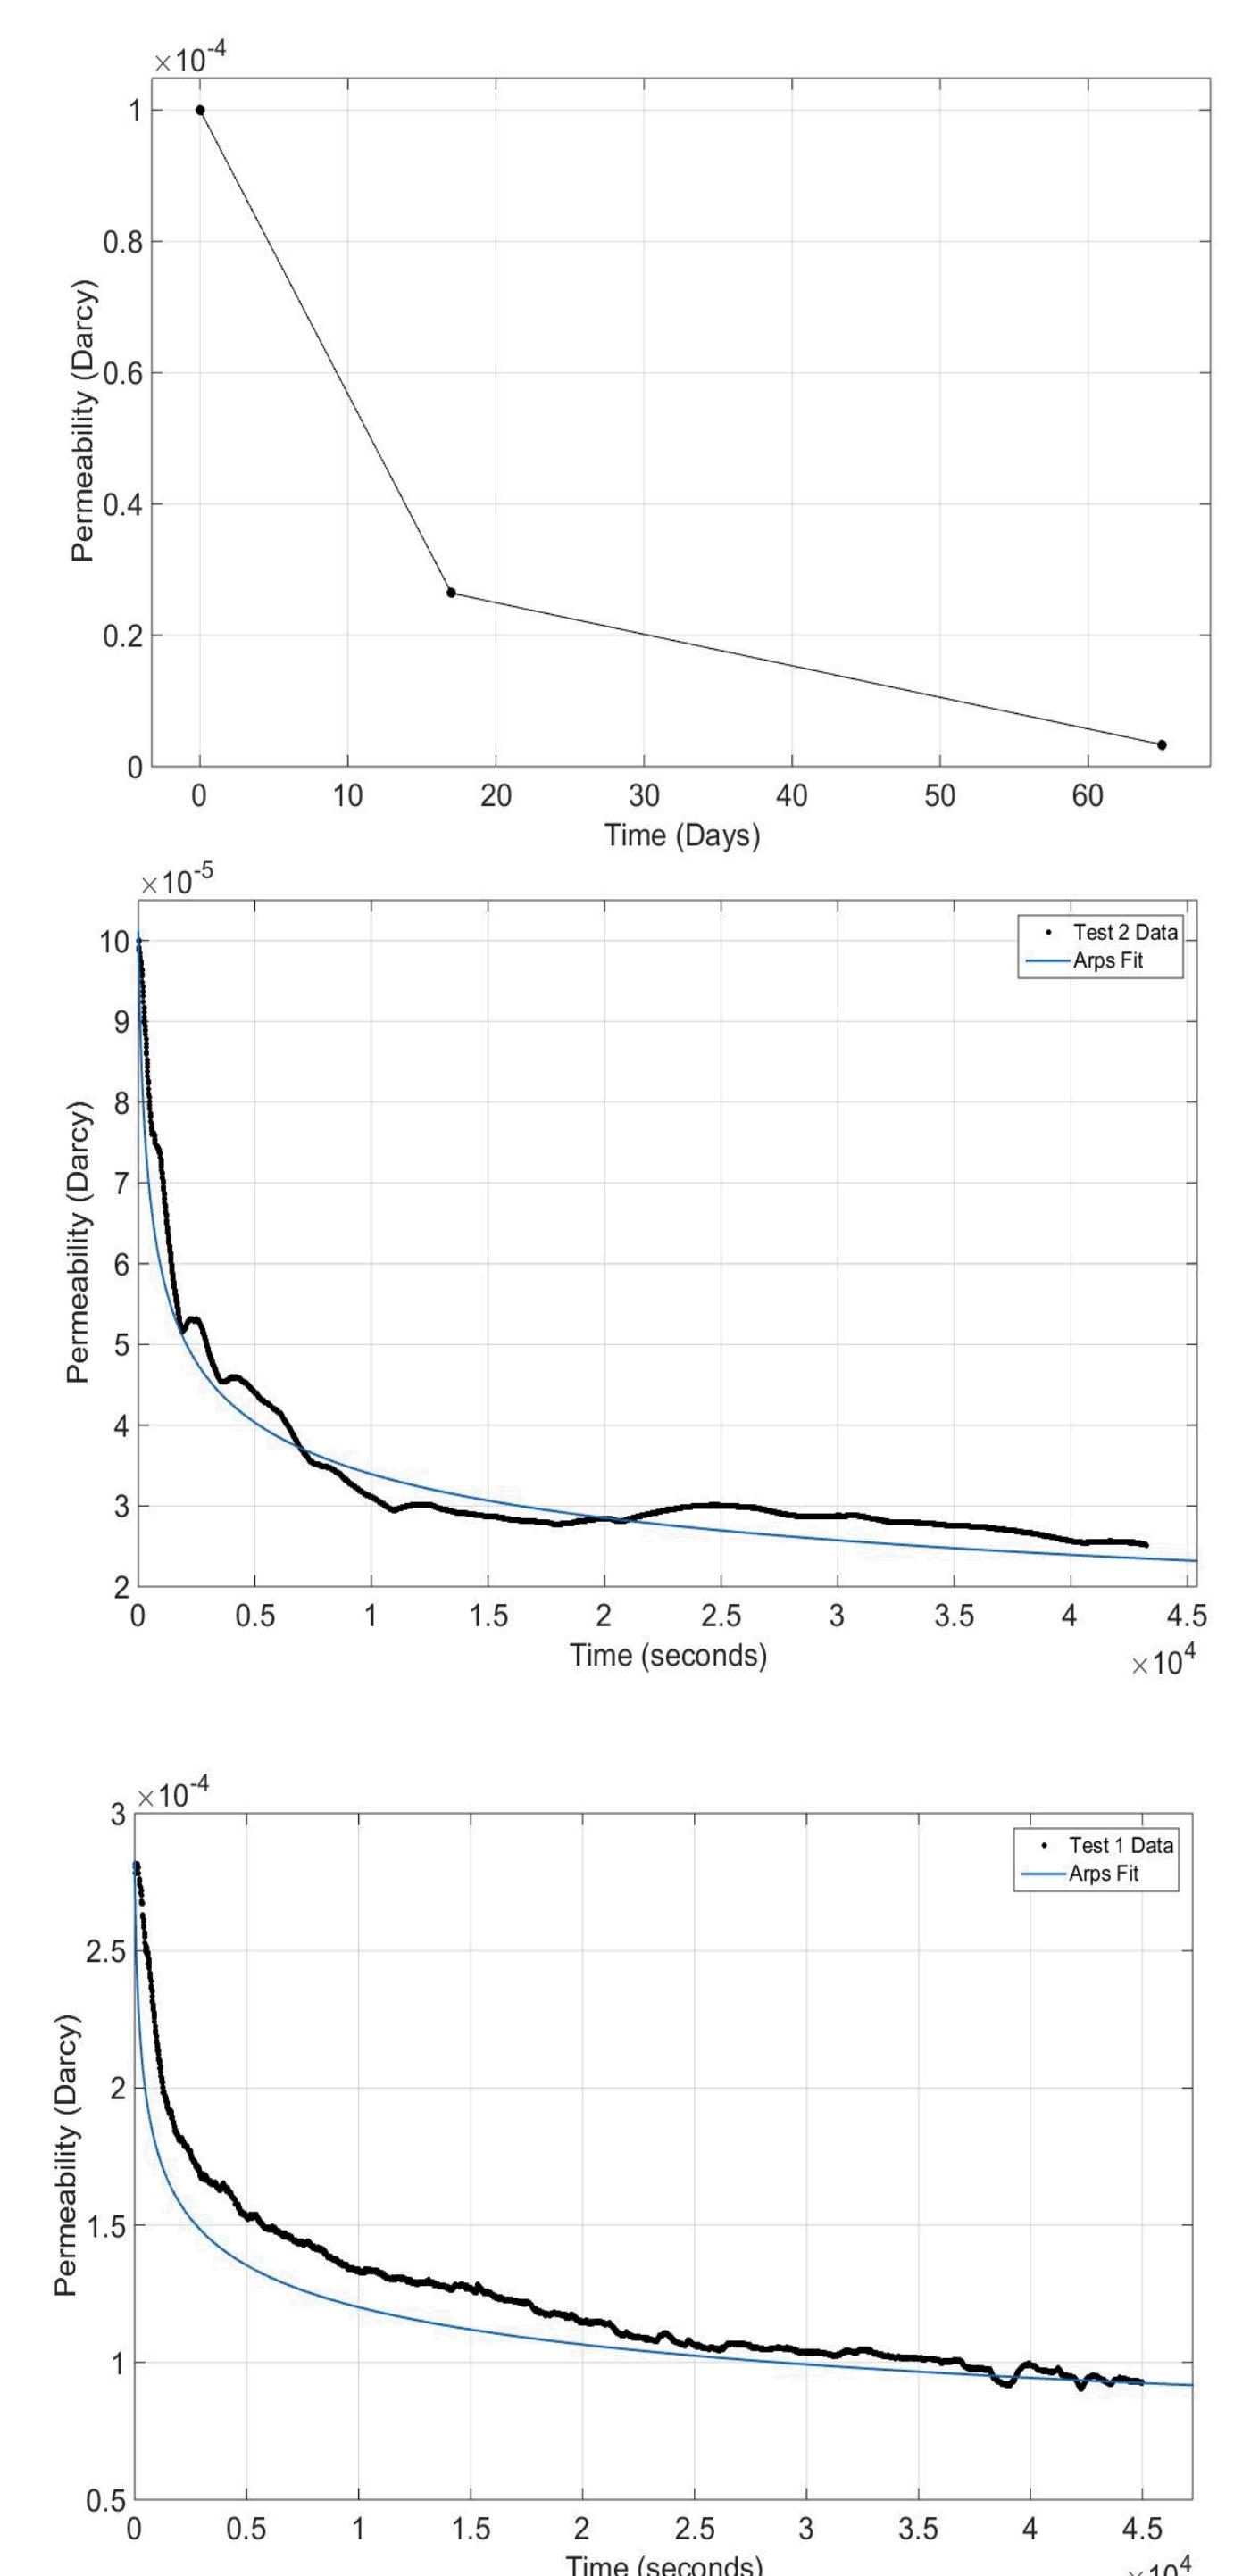
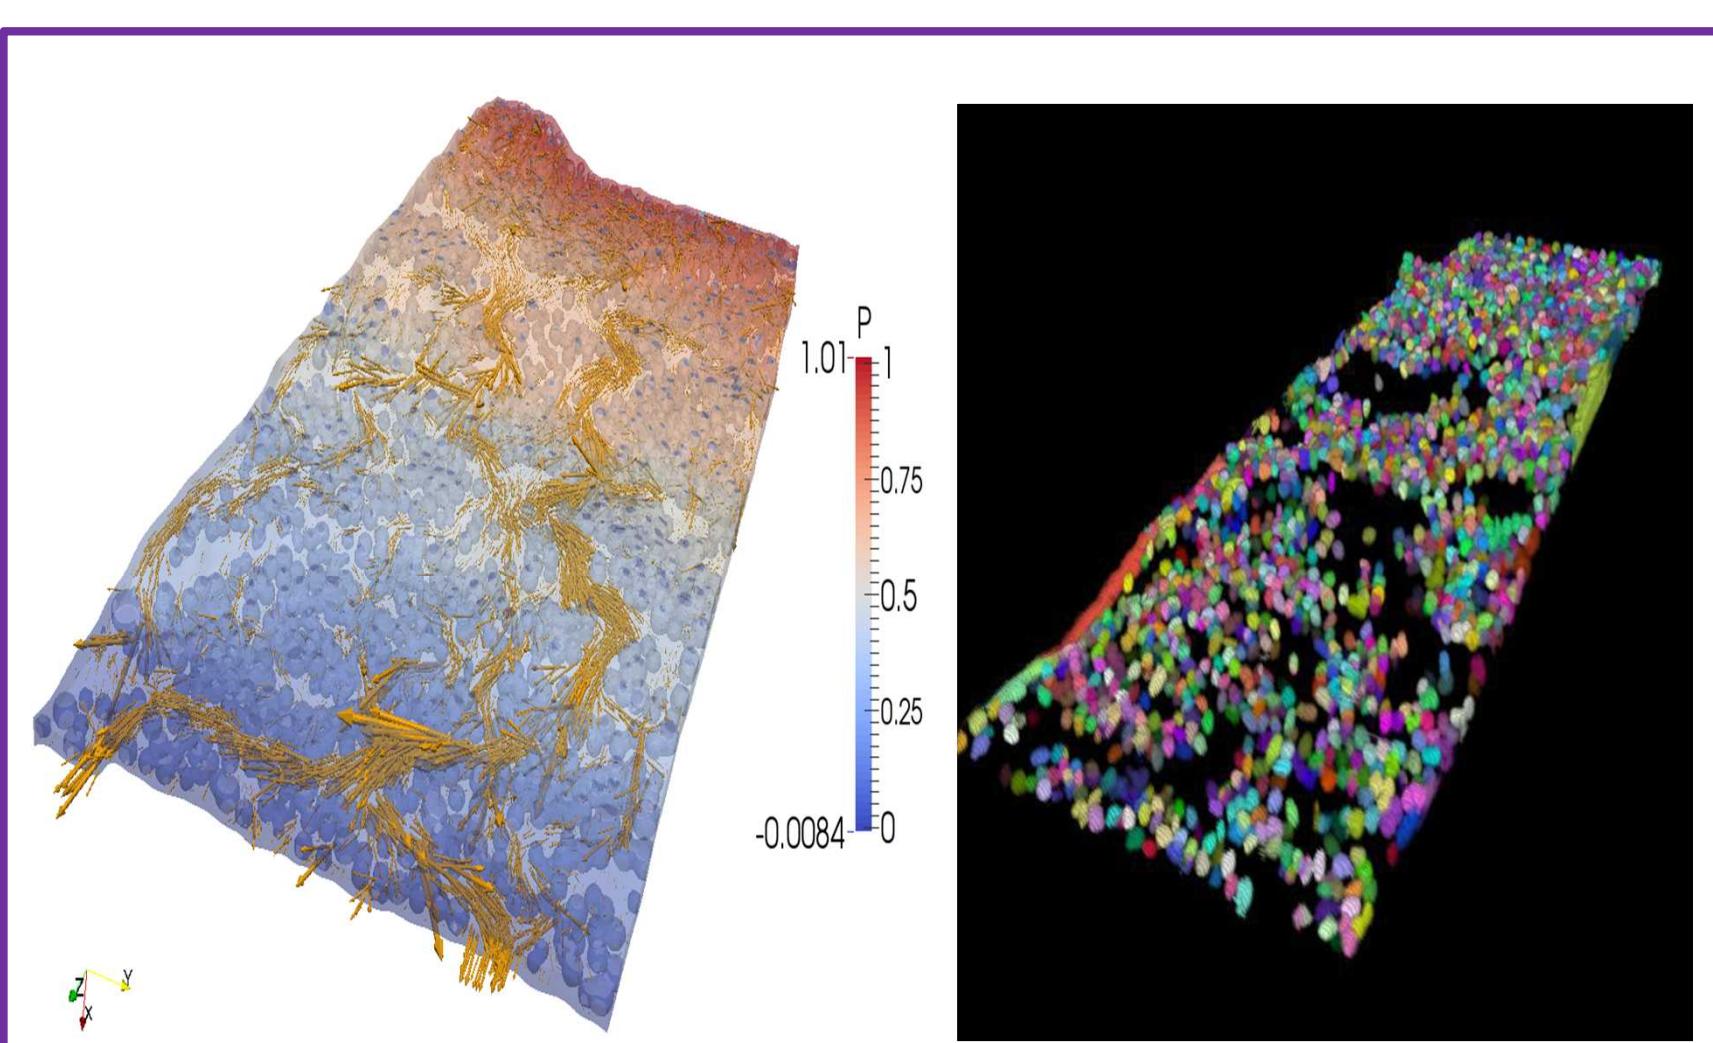
- Meshes were generated from CT data in order to model flow within the fracture and around the particles. This resulted in a high-quality mesh that still accounts for the particles.
