## Measurement of Surface Topography and Additive Manufacturing Process Characterization

Gabriela Barrera  
United States Military Academy  
Class of 2017

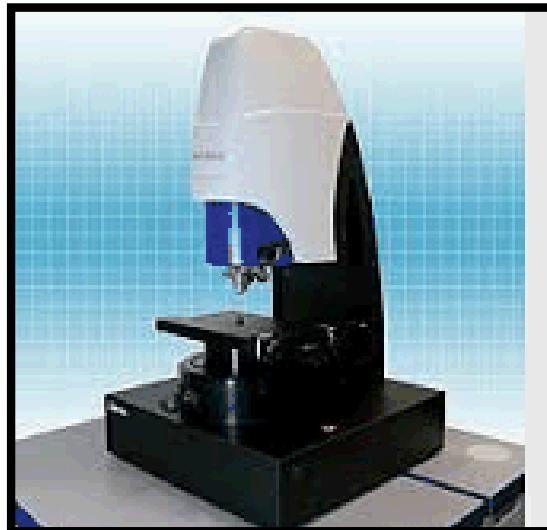
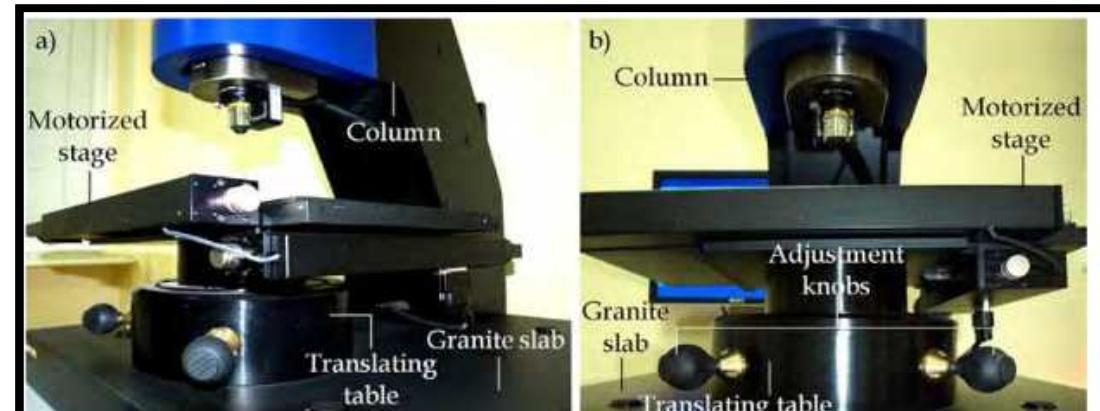
Fig. 3. White-light interference microscope Talysurf CCI 6000 produced by Taylor Hobson Ltd., (UK): a), b) front view and side view of the instrument with the main elements.

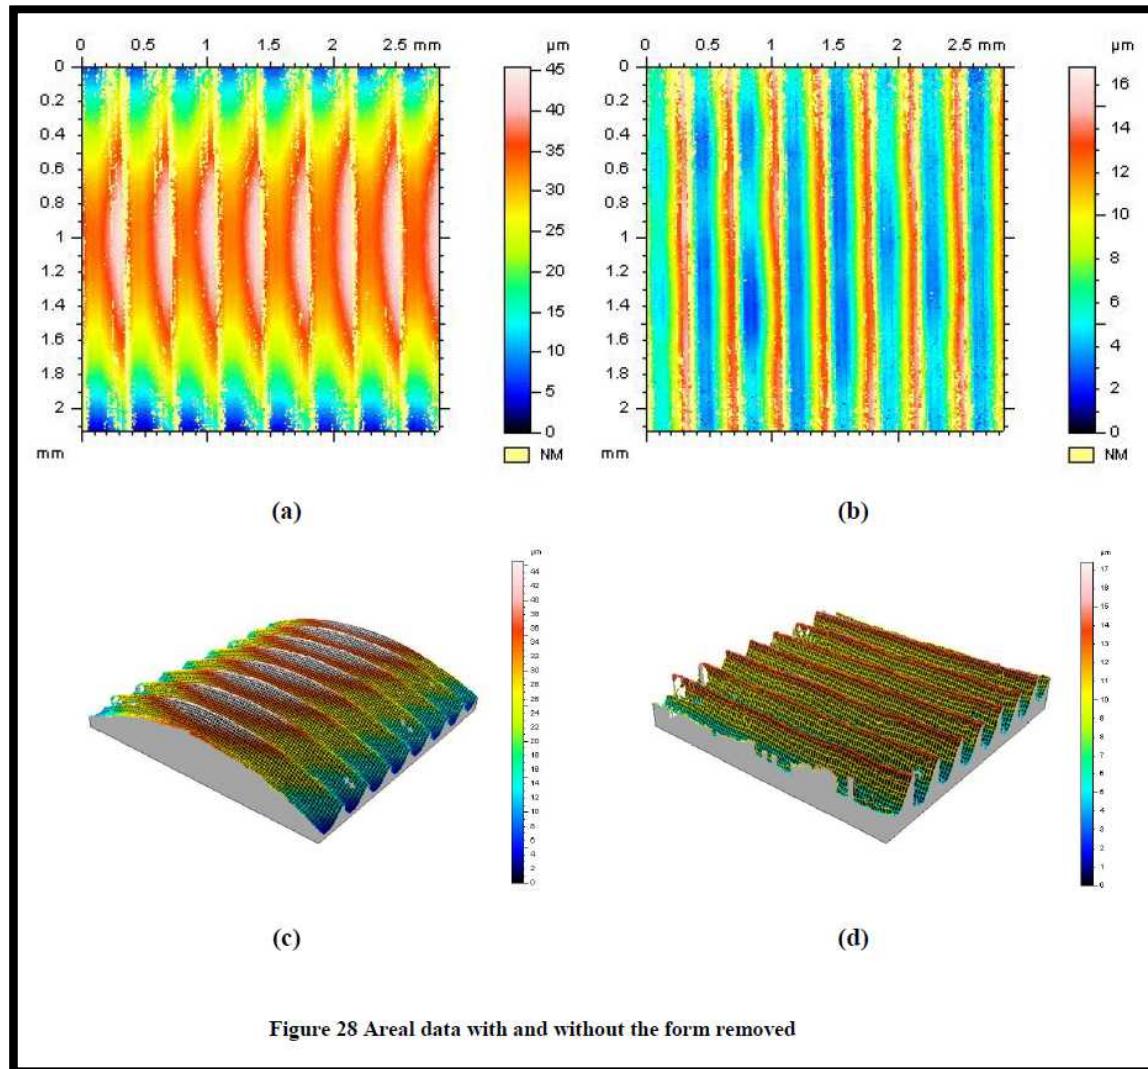
Figure 28 Areal data with and without the form removed

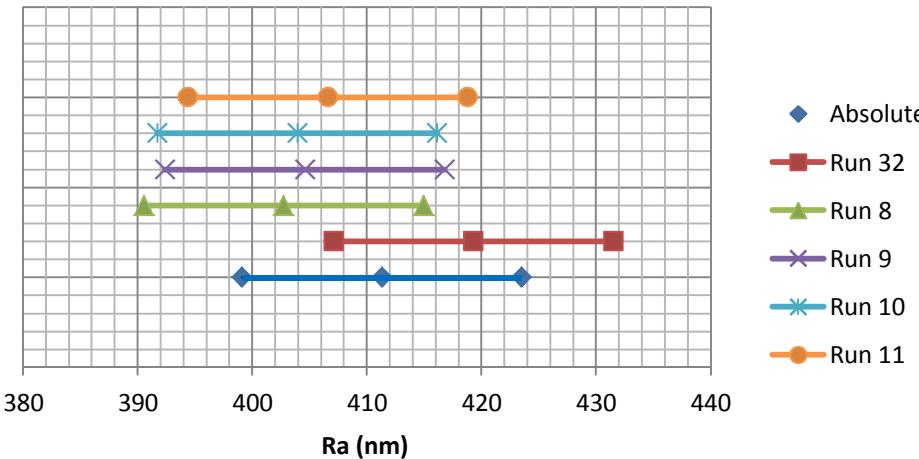
## P1D1: 50x and Smooth Surface Mode

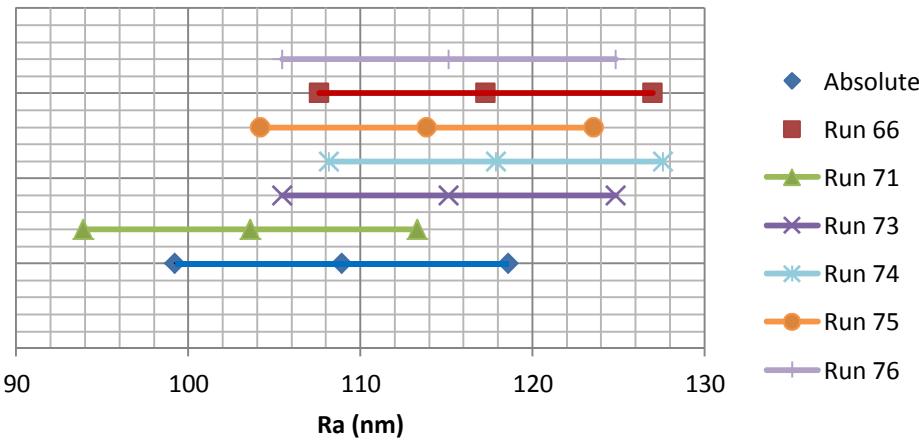
## P16T3: 50x and Rough Surface Mode

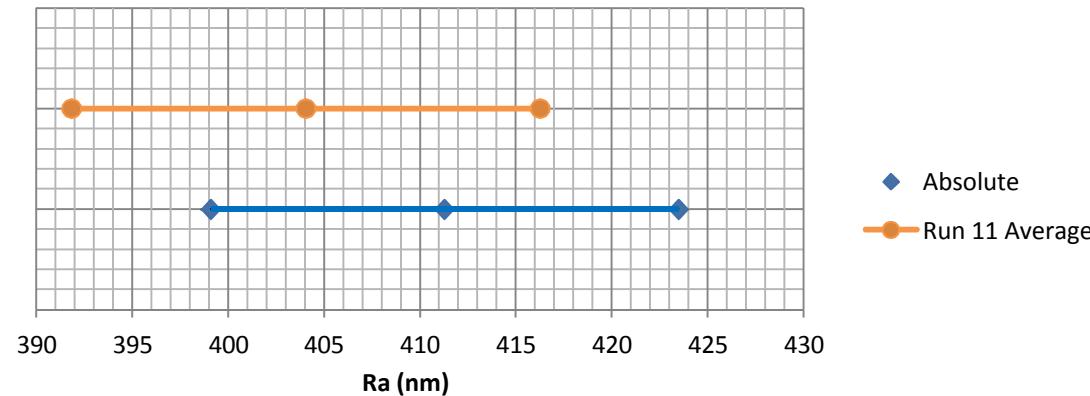
**P1D1: Run 11 Averaged  
50x and Smooth Surface Mode**

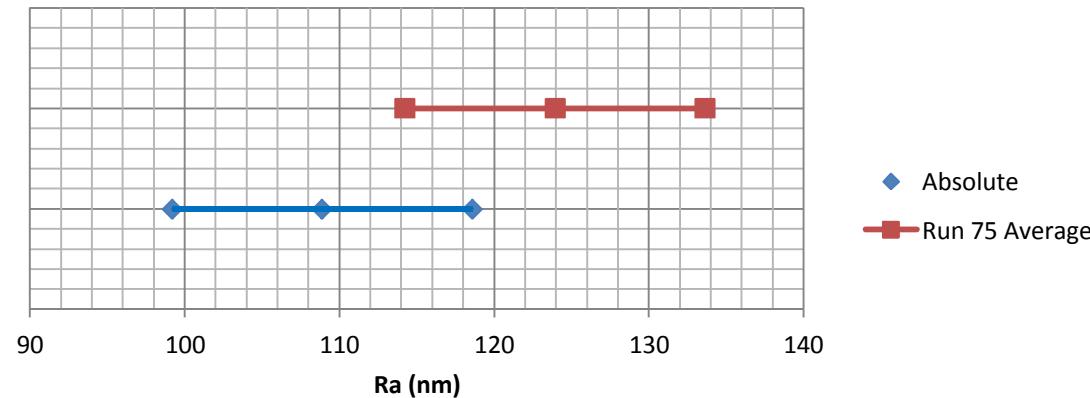
**P16T3: Run 75 Averaged  
50x and Rough Surface Mode**

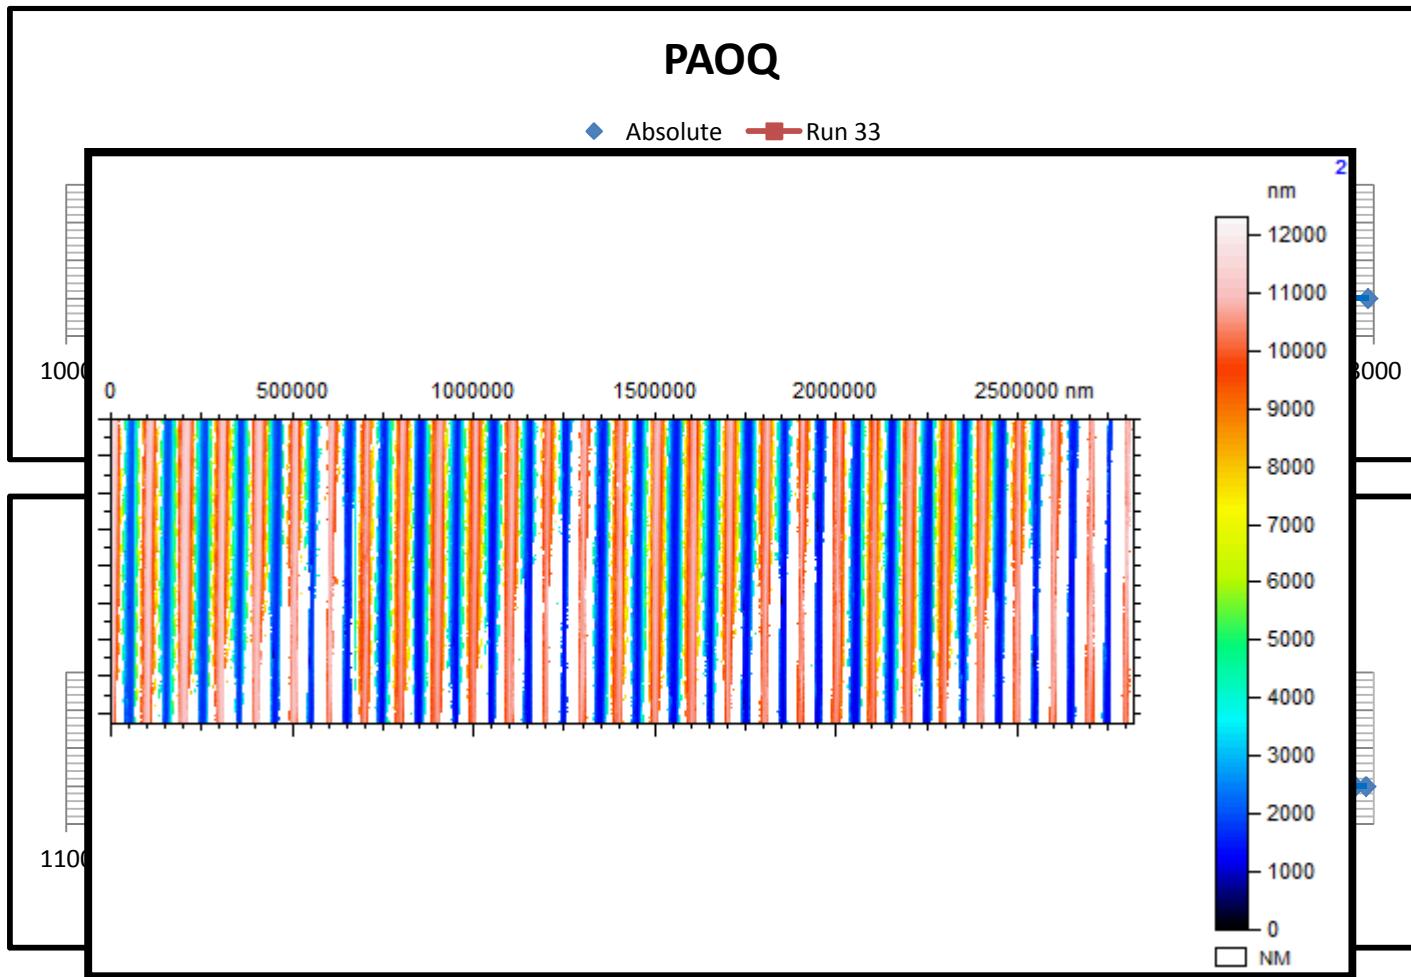
No signal in the interference microscope caused by irregularities of slope occurs when, the slope angles of inequality  $\theta$  exceed the maximum value  $\theta_{\max}$  given by the numerical aperture of the lens (Petzing et al., 2010):

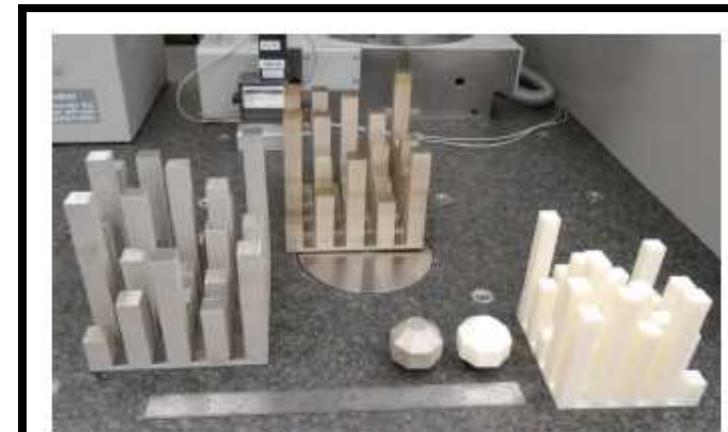
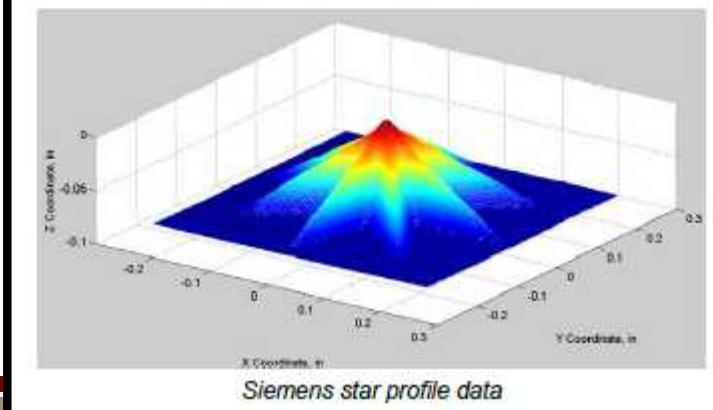
*artifacts ready for measurement*

- Small part in process characterization
- Investigate size, location, form, & orientation
- Find Minimum Feature Size
  - Artifact Based
  - Siemens Star
