Thermal Degradation of Extension Springs

Brian T. Werner, Bonnie R. Antoun, George B. Sartor

Sandia National Laboratories, Livermore, CA

2015 SEM Annual Conference and Exposition on Experimental and Applied Mechanics,

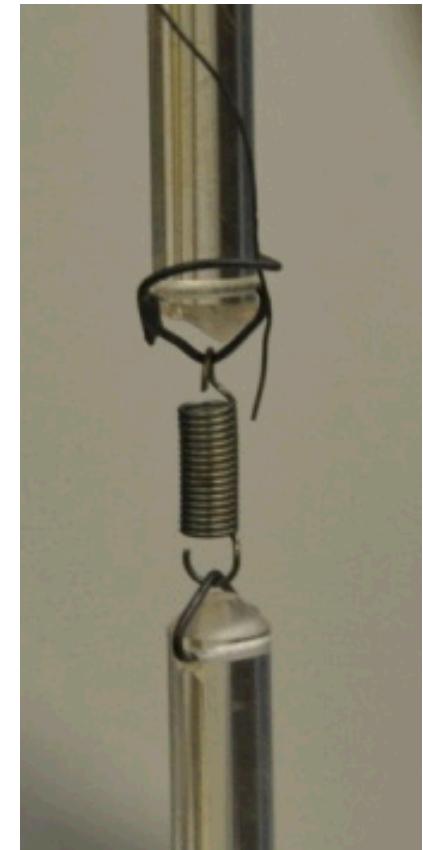
Dykhuisen and Robinho

- Shear modulus linear with temperature
- Spring constant bilinear with temperature
- Reduction in spring constant cannot be explained by wire response only
