*Title:* Full-scale fatigue tests of CX-100 wind turbine blades. Part II - analysis

# Full-scale fatigue tests of CX-100 wind turbine blades. Part II – analysis

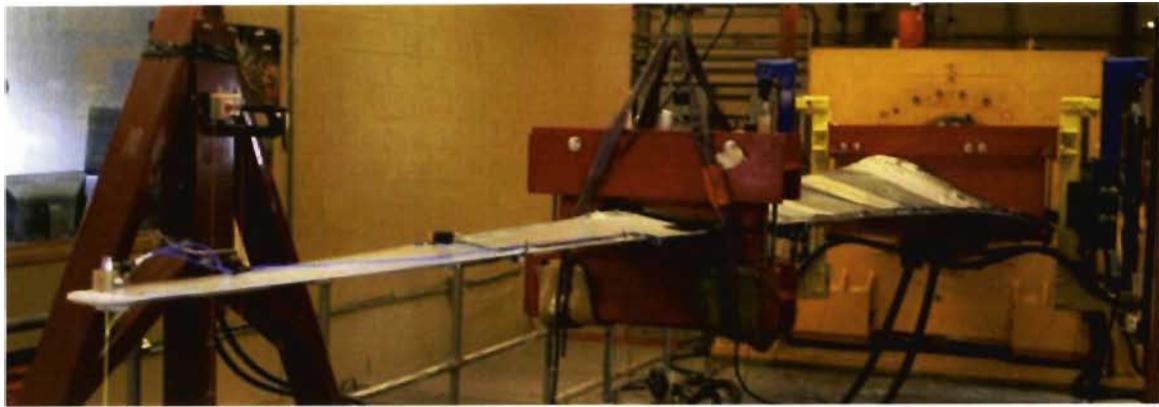
Figure 1. Test setup: a 9m CX-100 blade under a fixed-free condition

Two test structures were employed for fatigue testing. Each was a 9-m CX-100 blade [4], originally designed at Sandia National Laboratory. The first blade, dubbed the LANL blade, was manufactured according to standard specifications for the CX-100 blade. The LANL blade is shown mounted to the test fixture in Figure 1. The second blade, dubbed the University of Massachusetts, Lowell (UMass) blade, was manufactured with intentional defects. Each blade was mounted to a steel frame designed to approximate a fixed-free condition, and loads were introduced to the blade using a Universal Resonant EXcitation (UREX) system oscillating at the first resonant frequency of the blade.

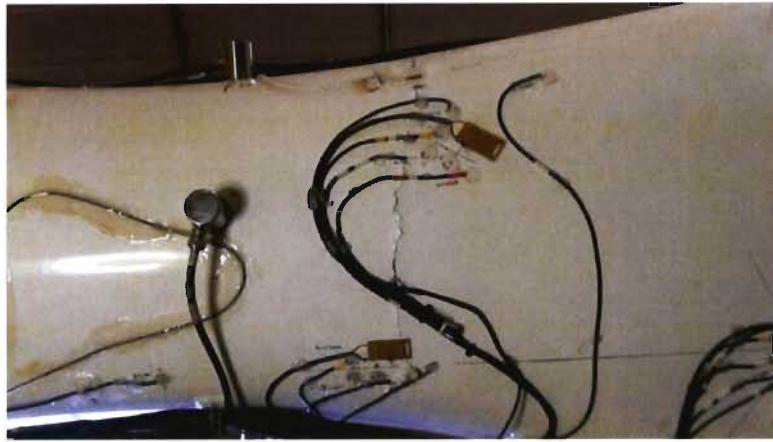
Figure 2. Photograph of fatigue crack in root area of blade.

The fatigue test began on 8/11/12, and it ran intermittently for approximately 8.5 million cycles until a fatigue crack became visible 11/8/12. The crack was a through-thickness crack that appeared on the surface of the blade in the root area on the leading edge. The area including the crack is shown in a photograph in Figure 2. The surfacing of this crack dramatically altered the dynamic characteristics of the blade, causing the blade's first resonance to vary as a function of loading. However, the authors believe that the damage that ultimately manifested itself as this externally visible crack was detectable using some of the methods applied in this paper as early as 10/20/12, approximately three weeks prior to the catastrophic failure. In the discussions to follow, the blade will be referred to as 'healthy' for the period prior to 10/20/12, 'transitionally damaged' for the period between 10/20/12 and 11/8/12, and 'catastrophically damaged' for the period after 11/8/12.

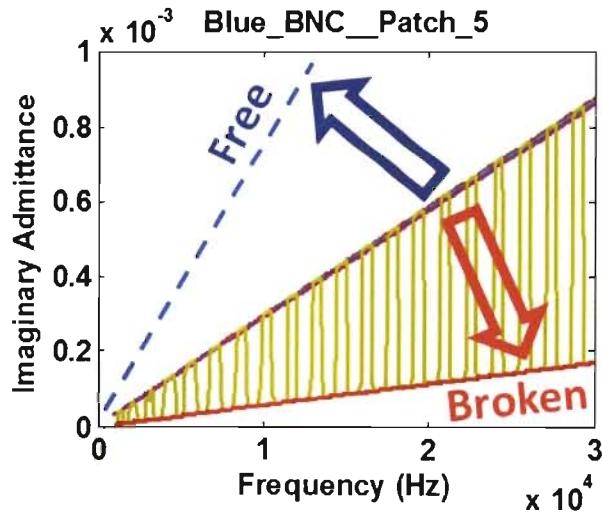
Figure 3. Depiction of sensor diagnostic measurement conclusions

The condition of a piezoelectric sensor mounted directly to a structure can be assessed by measuring the sensor's impedance over a relatively low frequency range, say from 5 kHz to 30 kHz, and computing the slope of the imaginary part of the admittance [6]. In this way, the health of the sensor can be assessed largely independently of the health of the underlying structure. Most active sensing methods focus on higher frequency ranges, say in the 50 kHz to 100 kHz range, because changes in structural behavior tend to be more pronounced at higher frequencies. Once a baseline has been established, or if there are enough sensors installed in the same configuration to act as an instantaneous baseline, this method permits a simple threshold algorithm to inform whether the sensor has broken, is becoming de-bonded from the structure, or its condition remains unchanged. An example measurement identifying the effect of each type of sensor failure is shown in Figure 3. Throughout the course of this fatigue test, the condition of the sensors was monitored using an HP 4291 impedance analyzer. However, more compact hardware can be utilized in order to perform this assessment, including low-power wireless devices [7].

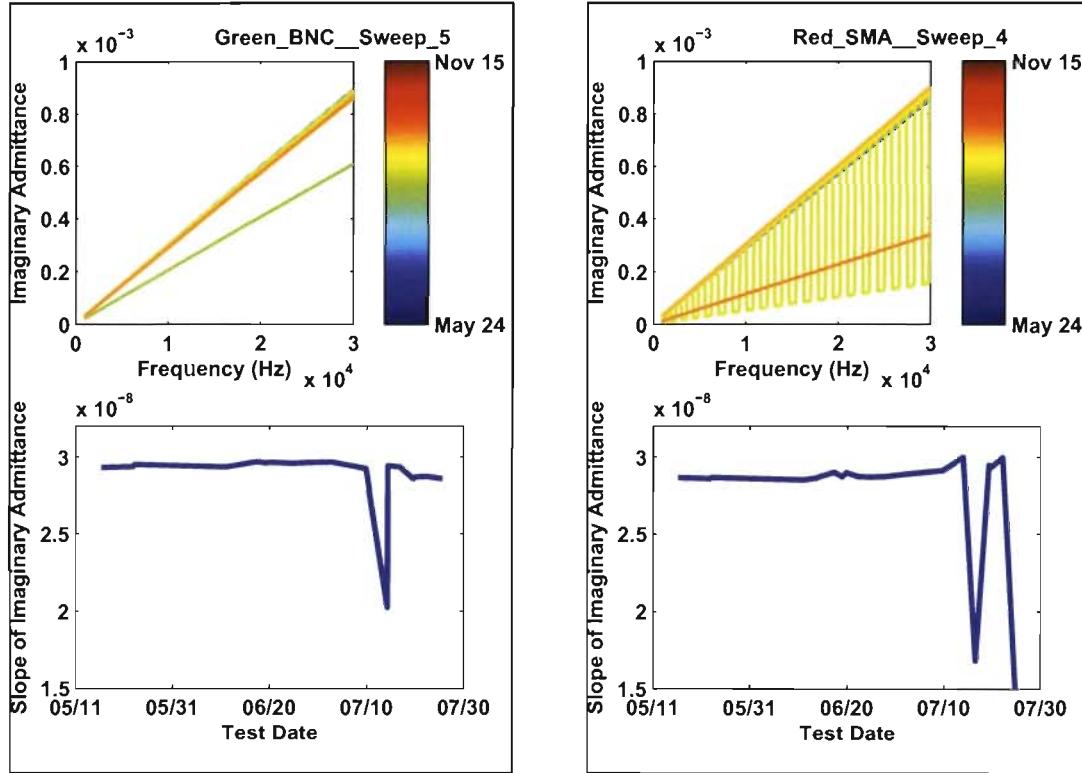
Figure 4. Sensor diagnostic measurement histories for sensors requiring either repair or replacement.

This section details some of the circumstances during the fatigue test in which sensors failed and required either repair or replacement. Figure 4 (left) shows the diagnostic data for a sensor that was replaced once near the end of the test. The replacement for this sensor survived through the end of the test. Figure 4 (right) shows a sensor that broke twice near the end of the test, possibly because of its close proximity to the site of the eventual catastrophic fatigue crack. This sensor was replaced once, but it was not replaced following its breaking at the end of the test.

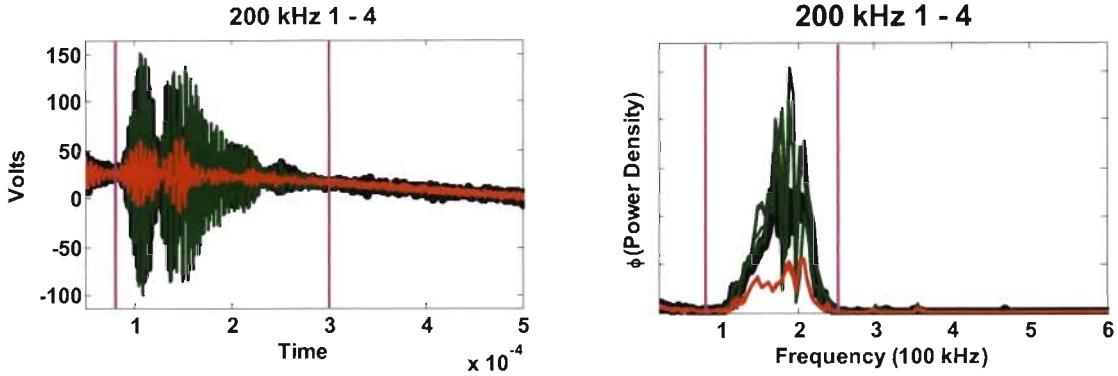
Figure 5. Raw and processed wave propagation data.

The method of applying principal component analysis (PCA) to the wave propagation data was first to isolate the received wave from the measured signal, and then transform that wave to the frequency domain by computing fast Fourier transform (FFT), so that the result is some function  $\phi$  of power density. Sample figures for one sensor path depicting this process are shown in Figure 5.

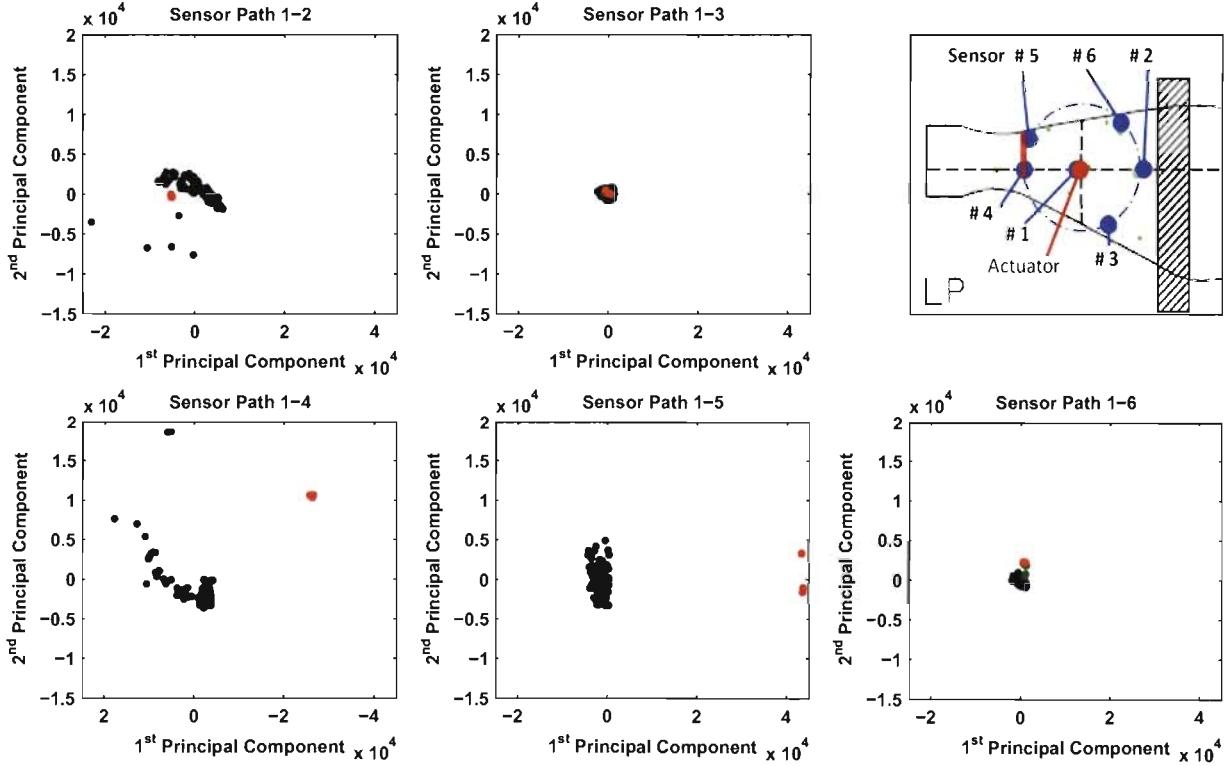
Figure 6. Wave propagation PCA results for the low-pressure side array.

Treating the values of the FFT at each frequency line as a sample from a multivariate random distribution, the sample covariance matrix was calculated, and principle component loads were computed as the dot products of each FFT vector with the eigenvectors of the sample covariance matrix. The first and second principal component loads were plotted versus each other. Data drawn from two different high-dimensional multivariate distributions can often be separated by projecting them onto a lower-dimensional subspace in this way. Plots showing the PCA results for the low-pressure and high-pressure side arrays are shown in Figure 6 and Figure 7, respectively. Each plot includes an inset identifying the sensor paths, as well as the location of the damage on the low-pressure side, shown with a red line between sensors 4 and 5. In each PCA plot, the second principal component load is plotted versus the first. The loads computed using data taken from the blade in a healthy state are plotted in black, loads computed using data taken from the blade in the transition state are shown in green, and loads computed using data collected from the damaged blade are shown in red.

On the low-pressure side, there is strong separation between the loads extracted from healthy blade data and those extracted from damaged blade data in sensor paths 1-4 and 1-5, correlating well with the actual location of the crack. The loads extracted from transitional blade data show moderate deviation from those for the healthy blade data, but not in a way that corresponds to the location of the developing damage. This method can successfully identify and locate the catastrophic damage, but does not seem effective in locating the transitional damage.

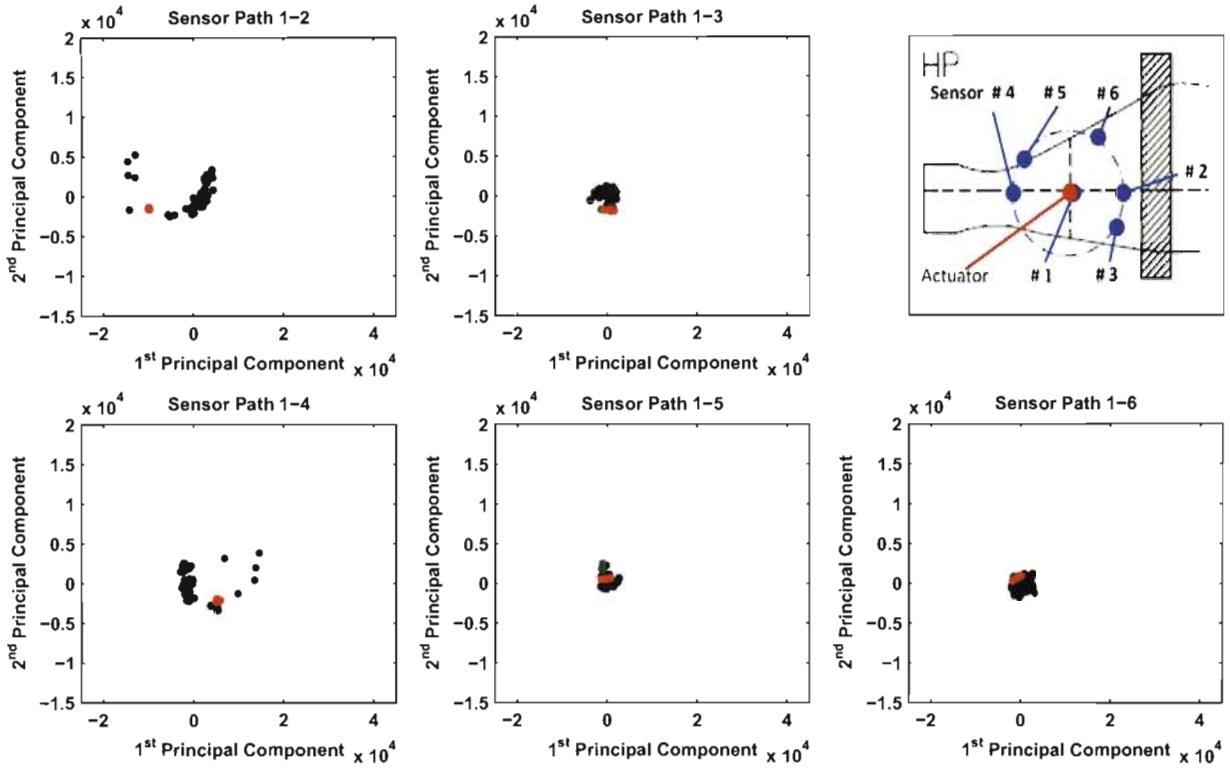
Figure 7. Wave propagation PCA results for the high-pressure side array.

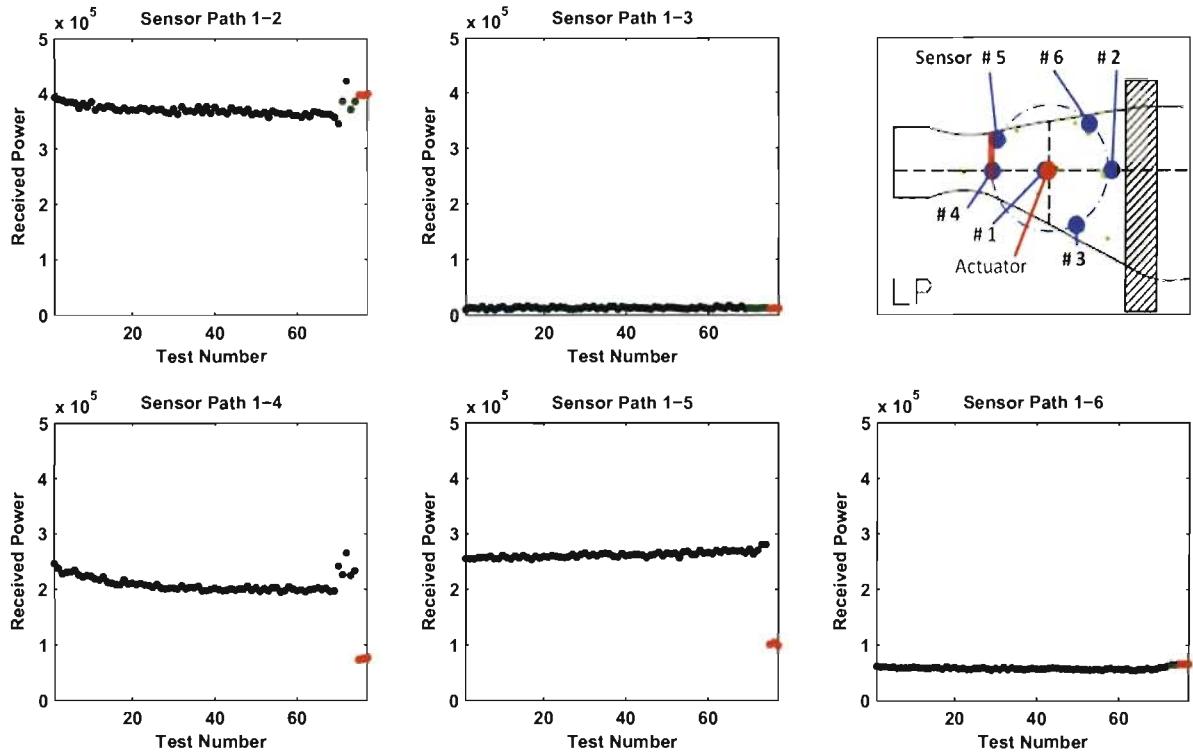
Figure 8. Received wave power results for the low-pressure side array.

In the second method applied to the wave propagation data, a monotonic function of the received wave power in the frequency range of excitation was estimated by calculating the area under the FFT curve between 100 kHz and 250 kHz. Although data was collected over multiple frequency ranges, only the data with 200 kHz excitation are considered here. The results from this computation are shown for the low-pressure side and the high-pressure side arrays in Figure 8 and Figure 9, respectively. In each figure, there is an inset diagram indicating the sensor locations by number, as well as an indication of the damage location on the low-pressure side, given by a red line between sensors 4 and 5 on the low-pressure side. Furthermore, the received power feature values are plotted in black for healthy blade data, green for transitionally damaged blade data, and red for data from the failed blade. In Figure 8, there is a noticeable drop change in the received wave power for sensors 4 and 5 beginning with tests corresponding to Nov 8, following the catastrophic failure. However, the baseline measurements exhibit some non-stationary behavior prior to that point, making this feature somewhat difficult to use in detecting the transitionally damaged state.

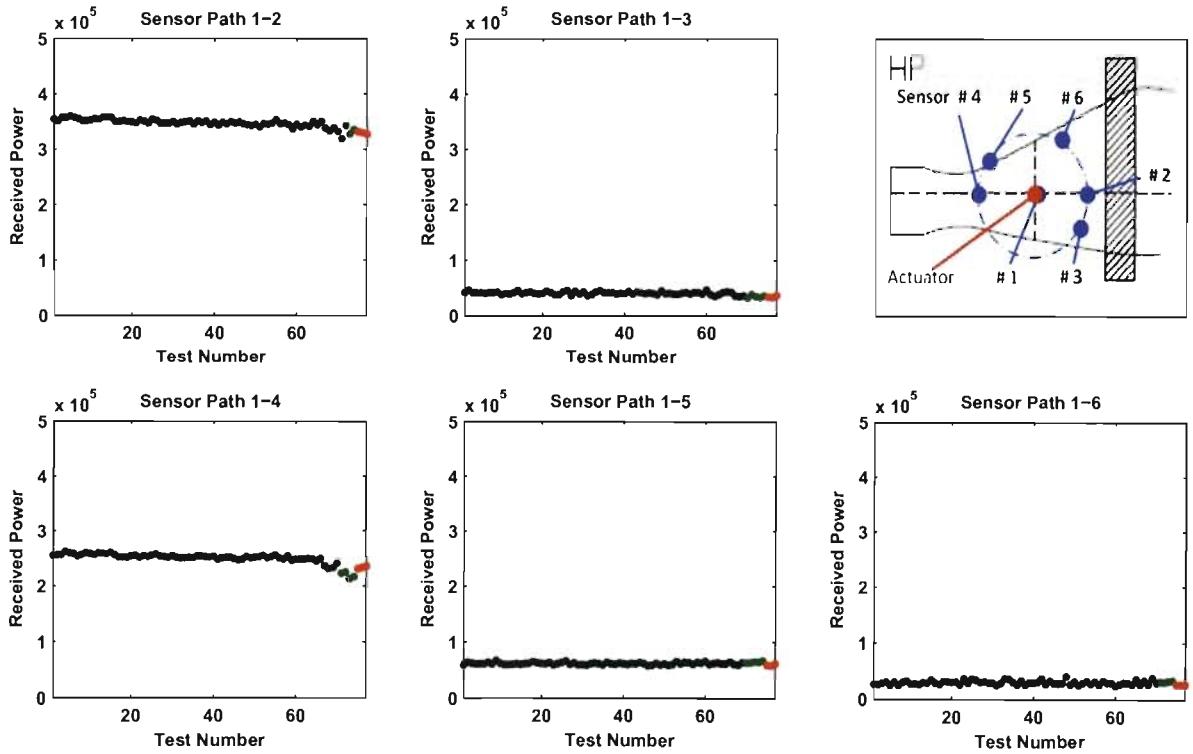
Figure 9. Received wave power results for the high-pressure side array.

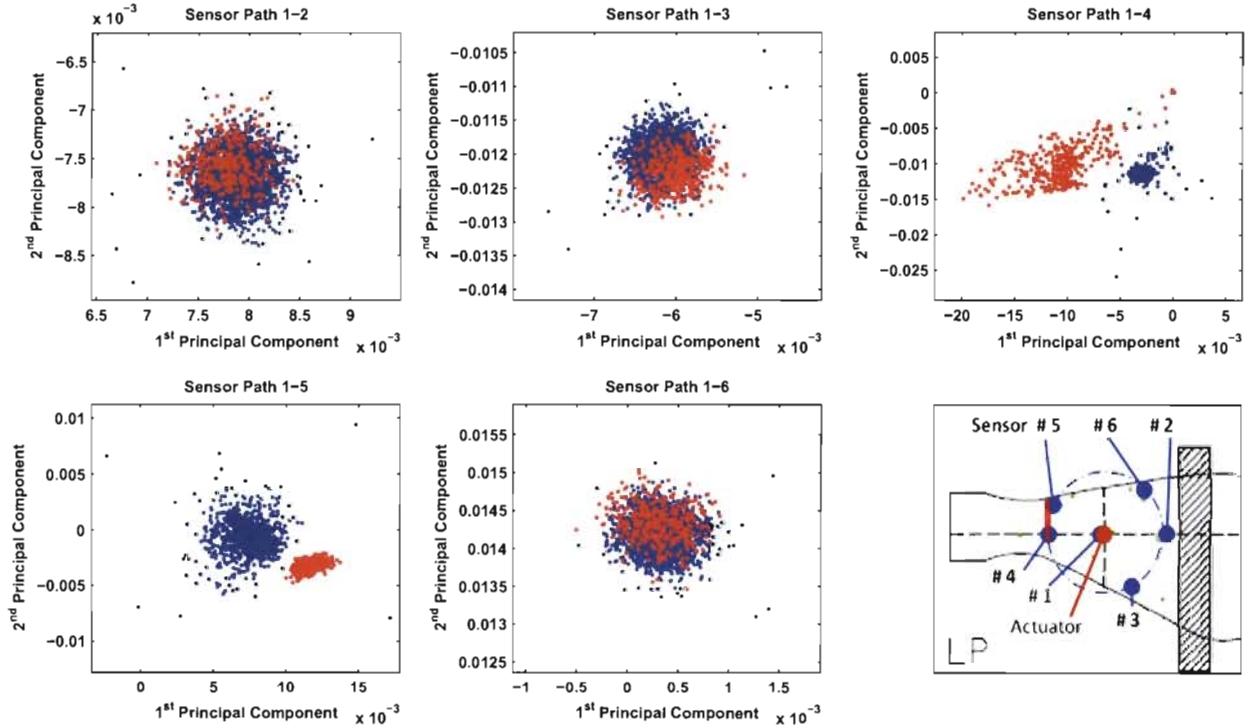
Figure 10. WASP ARX-PCA results for the low-pressure side array.

Plots showing the PCA results for the WASP data on the low-pressure side are shown in Figure 10, along with an inset identifying the sensor paths and the location of the fatigue crack, which was between sensors 4 and 5. In each plot, the blue dots were computed from data taken prior to Oct. 20, and the red dots were computed from data taken after Oct. 20. There is very little separation in the data for paths 1-2, 1-3, and 1-6, but there is near complete separation in the data for paths 1-4 and 1-5, which were physically nearest the crack. This method appears as though it is sensitive to local structural changes while still permitting localization.

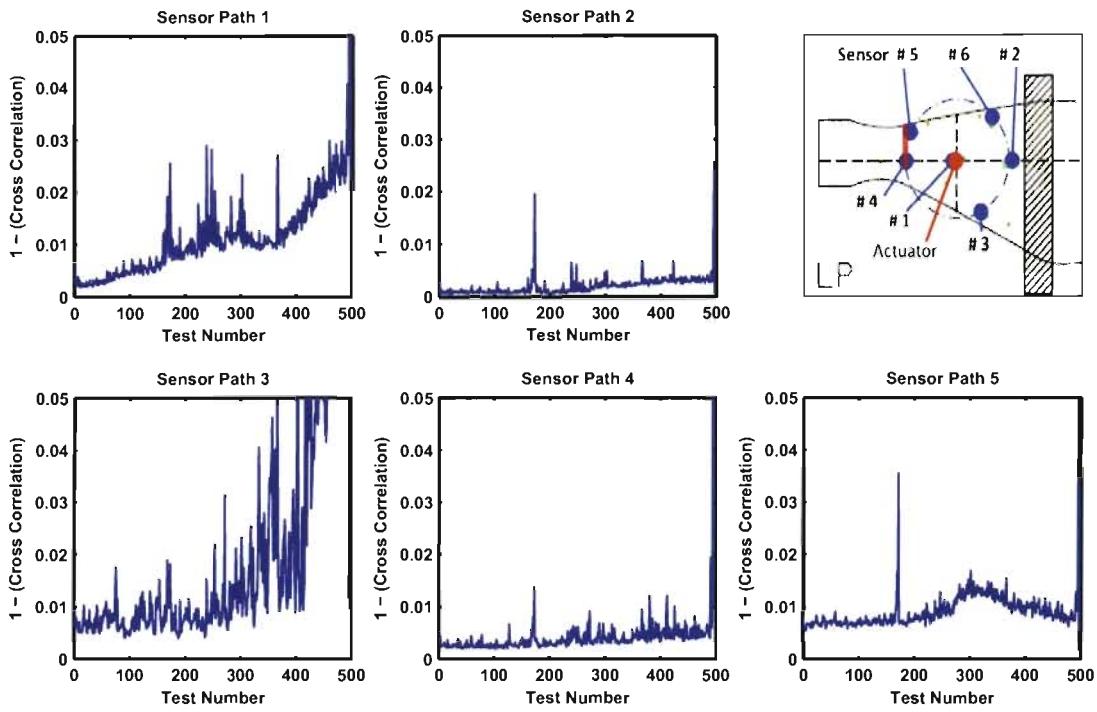
Figure 11. Cross correlation-based feature results for the LASER inner array.

Using the LASER system, diffuse wave-field frequency response functions were measured from 0.5 kHz to 40 kHz, with a sampling rate of 96 kHz. The cross-correlation (CC) between a newly measured FRF and a baseline FRF was computed, and the feature was taken as unity minus this CC value ( $1 - CC$ ). If the newly measured FRF is the same as the baseline, the value  $1 - CC$  will be zero, but if the underlying structure has changed (e.g. if damage occurs), the value will increase. The values of the  $1 - CC$  feature are plotted versus test number in Figure 11 for the LASER Inner array, and in Figure 12 for the LASER Outer array. There are noticeable increases in the  $(1 - CC)$  feature for all sensor paths in the inner array after 10/20/12 (corresponding to test 280 in Figure 11 and Figure 12), but for the outer array, there appeared to be no significant change until the blade underwent catastrophic damage.

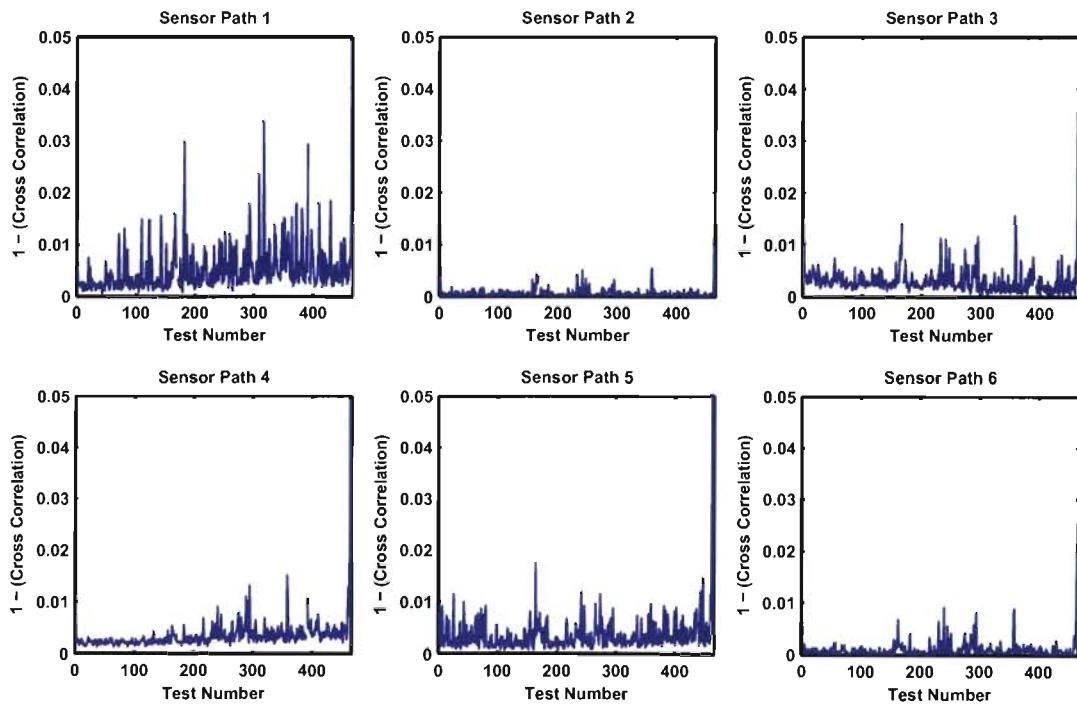
Figure 12. Cross correlation-based feature results for the LASER outer array.
