# Failure Analysis and Process Improvement for Superconducting Electronics

N. Missert, M. Jenkins, P. Tangyunyong,  
P. Kotula, J. Michael

Sandia National Laboratories is a multi-program laboratory managed and operated by Sandia Corporation, a wholly owned subsidiary of Lockheed Martin Corporation, for the U.S. Department of Energy's National Nuclear Security Administration under contract DE-AC04-94AL85000. SAND2011-0439P

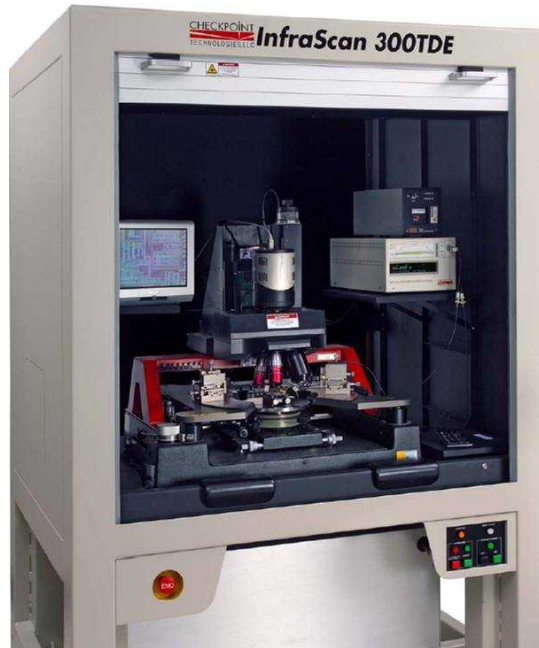
Checkpoint InfraScan 300TDE

# Thermally induced voltage alteration (TIVA) localizes shorts between layers on CMOS wafers

Overlay of reflected, TIVA and  
CAD images

**Scan laser to induce heat, activate defect, generates EMF**  
**Pulsed stimulus, lock-in detection eliminates spreading, 0.5  $\mu\text{m}$  resolution**

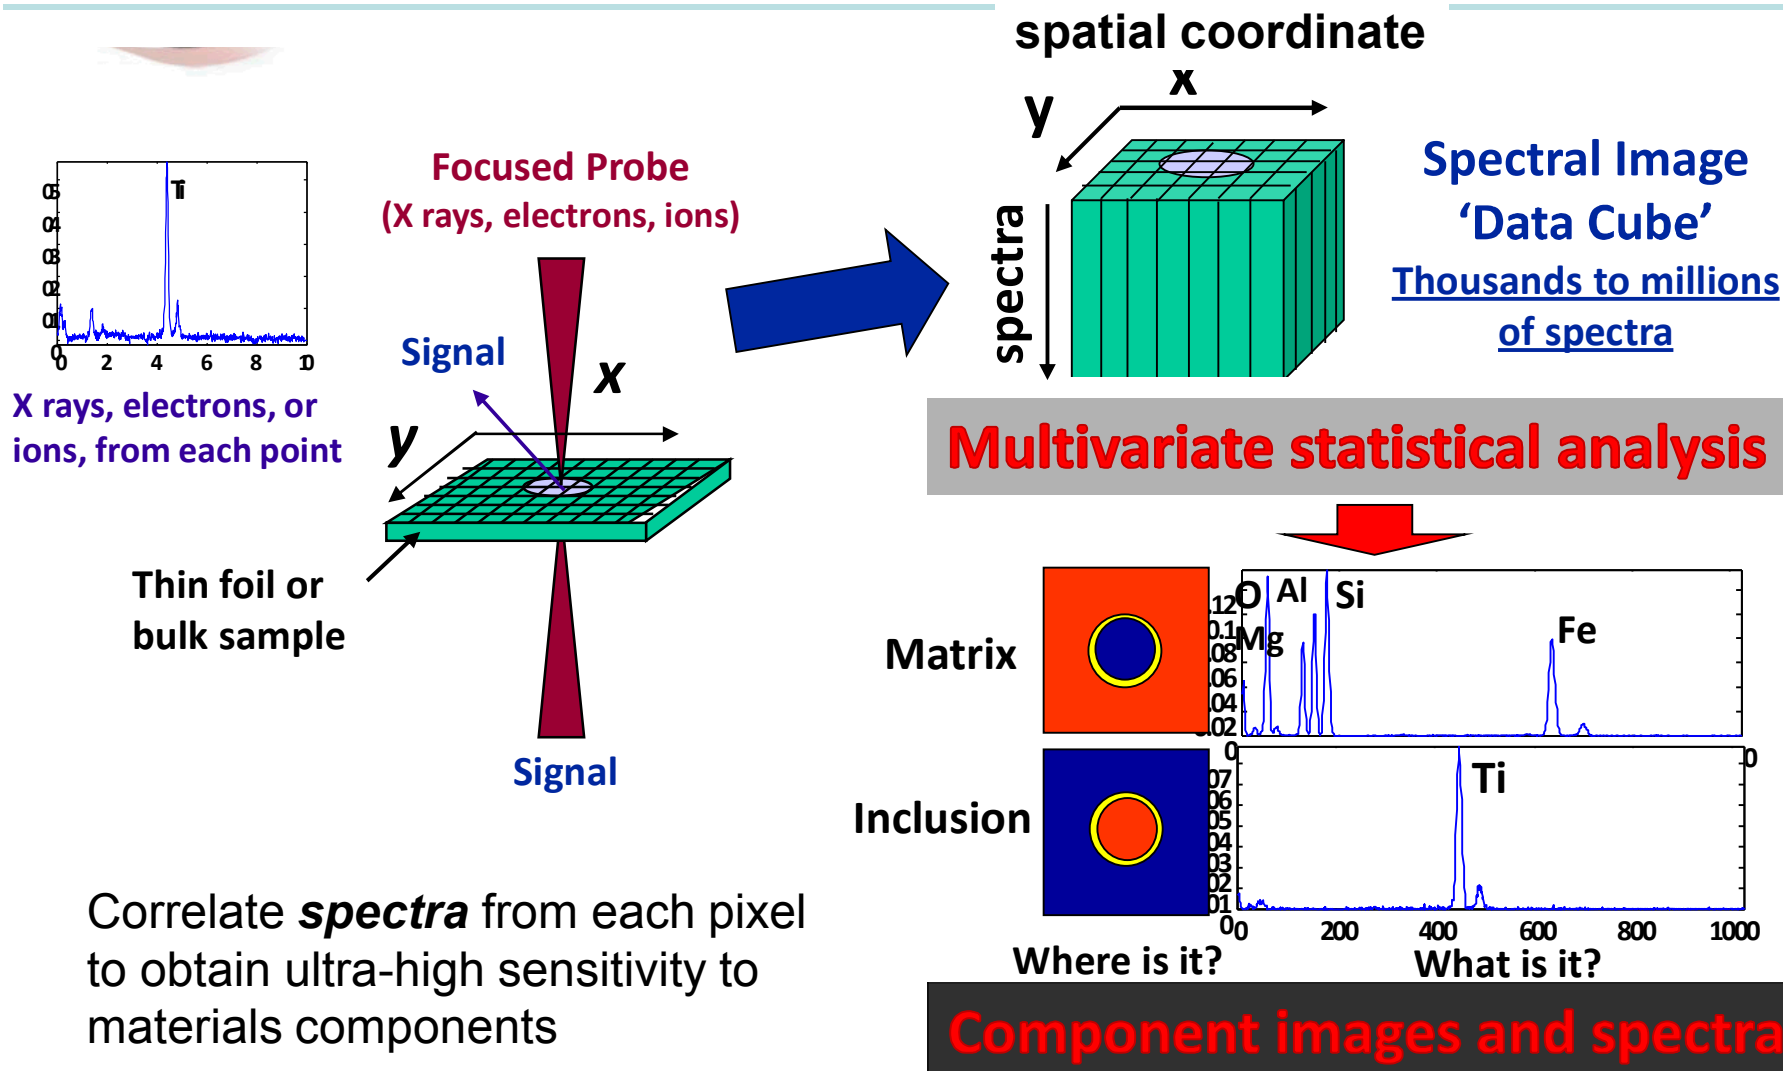
# Multivariate statistical analysis of spectra allows sensitive mapping of material components

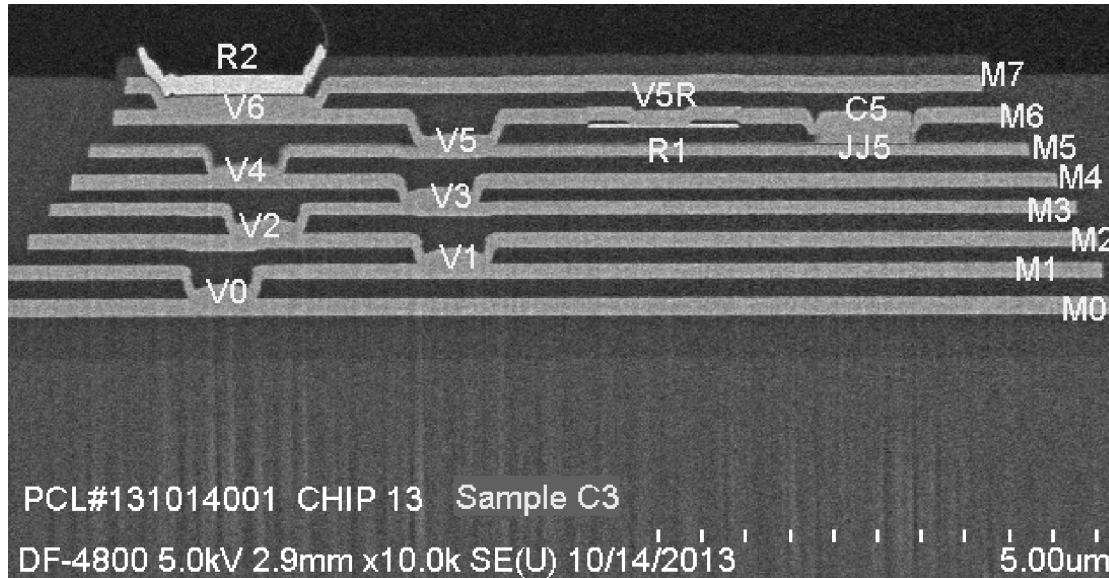
## MIT-LL 8 metal layer Nb process: Nb metal, resistor, Al/AlO<sub>x</sub> junction, SiO<sub>2</sub>

- Nb etch (SF<sub>6</sub>, Cl) - inactive layer at edges
- Hydrocarbon contamination
- Nb anodization uniformity
- Nb/SiO<sub>2</sub> interface interdiffusion
