Edward Matteo¹, John C. Stormont², Mahmoud Taha², and Thomas A. Dewers¹

1) Project Overview

This project involves the development and testing of polymer-cement nanocomposites for repairing flaws in annular wellbore seals. These materials will have superior characteristics compared to conventional materials, ensuring hydraulic isolation of the wellbore after closure. The technology contributes to the Program's effort of ensuring 99% CO₂ storage permanence.

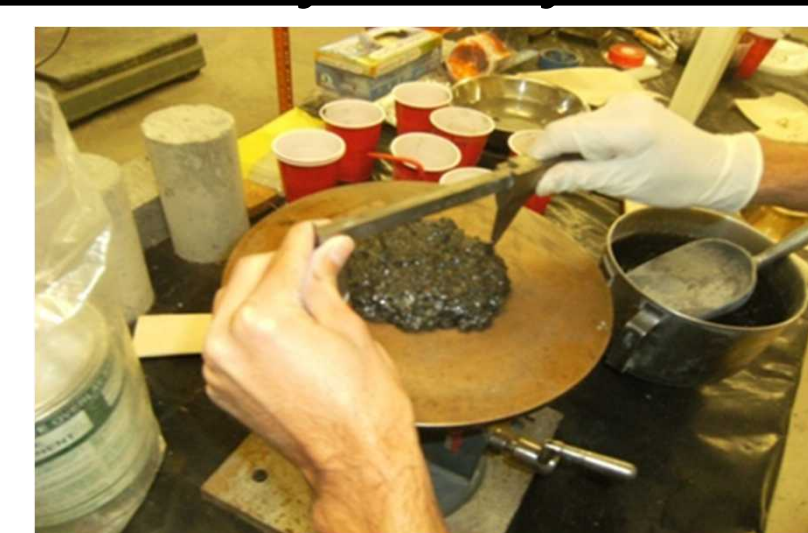
Figure 6. Flowability test performed according to ASTM C1437 and ASTM C1611 standards.

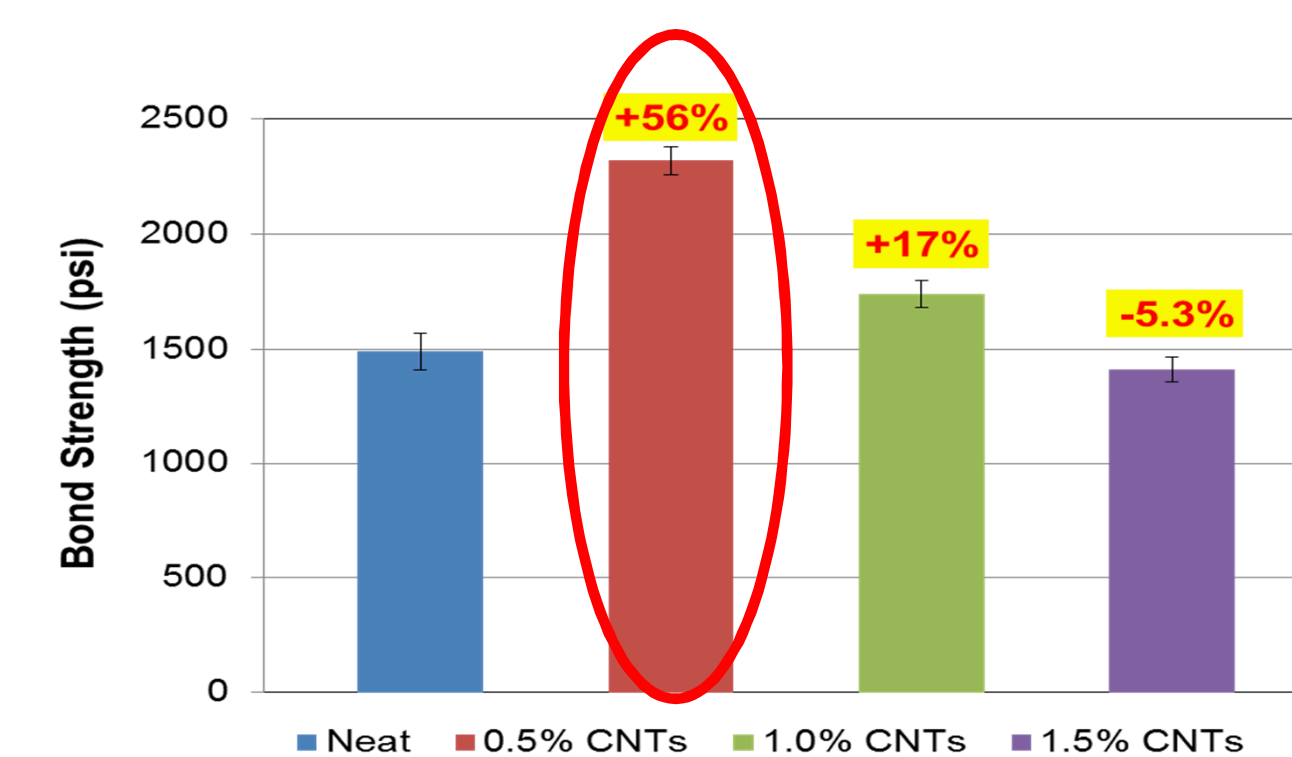
Figure 9. Slant shear test results show a remarkable improvement in bond strength for 0.5% CNT loading.
