Mechanically-Induced Degradation of Metallic Sliding Electrical Contacts in Silicone Fluid at Room Temperature

M.T. Dugger, D. Groysman, M.C. Celina, T.M. Alam, N. Argibay, B.L. Nation and S.V. Prasad

2014 IEEE Holm Conference, 13-15 October 2014, New Orleans, LA

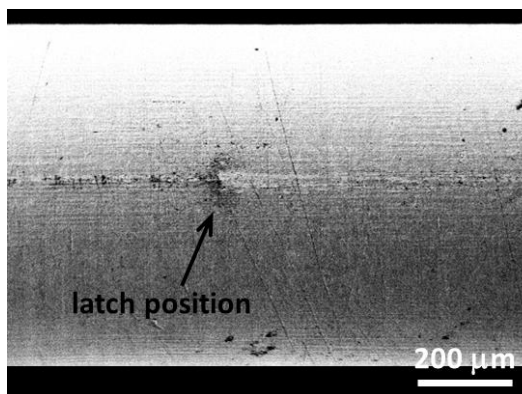
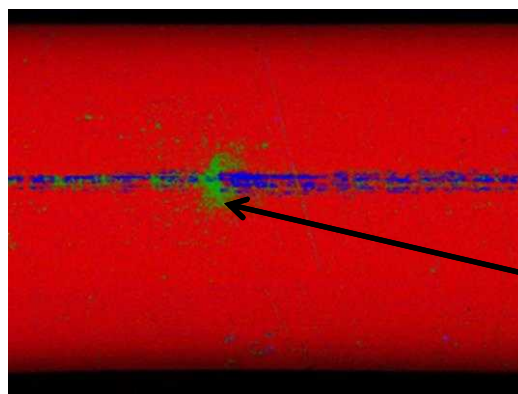
A fluid-damped accelerometer exhibits increased electrical contact resistance (ECR) after storage

- contacts are precipitation hardened electrical contact alloys; a Neyoro-G spring slides on the side of a Paliney-6 or -7 pin (Deringer-Ney Company)
- the device is filled with PDMS-200 silicone fluid (Dow Chemical Company)

Red = Paliney-7
Blue = Neyoro-G transfer
Green = Si-C-O deposit

EDS/AXSIA image of a focused ion beam (FIB) cross section through deposit

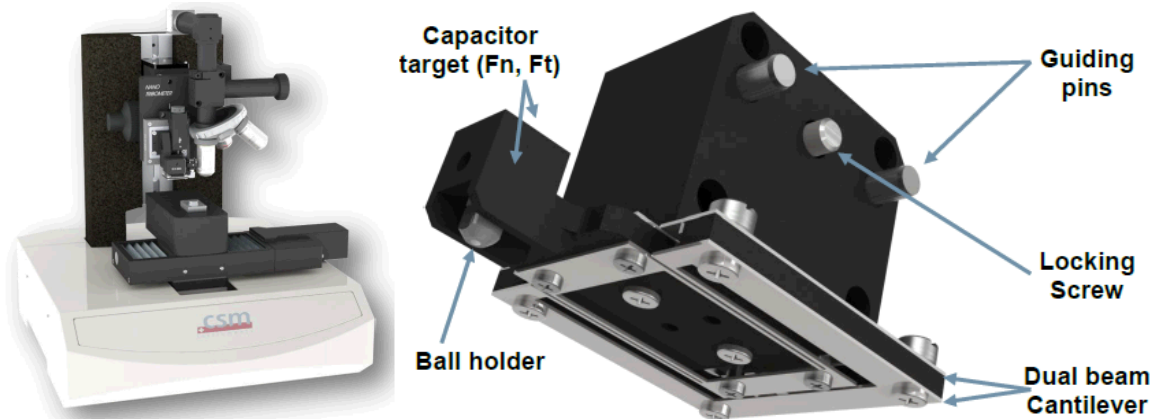
Electrical Contact Nanotribometer

CSM nanotribometer modified for 4-wire ECR measurement

- DC power supply
- nano-ohm meter

- $N = 88 \text{ mN}$
- pin radius = 1.6 mm
- track length = 1 to 2 mm
- fluid volume = 5 mL
- $i = 20 \text{ mA}$, 1.1 V open circuit
- $\text{vibe} = 50 \text{ } \mu\text{m}$ at 100 Hz

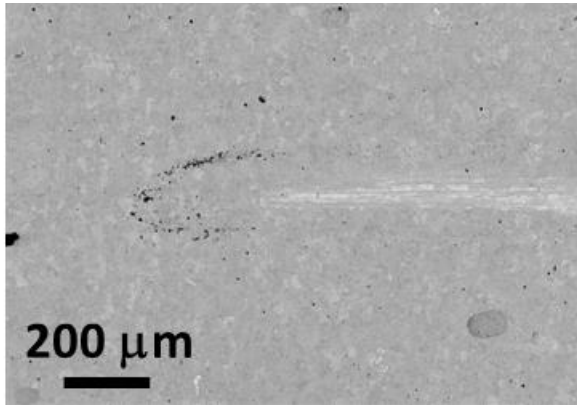
current + no vibration

- current alone produced gold transfer, but very little deposit
- suspected make-break arcs during movement, leading to thermal decomposition of silicone

Deposit is created during mechanical contact of the metals, with little or no influence of current

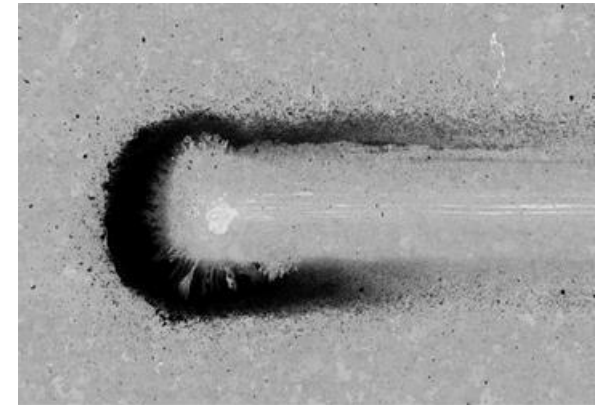
no current + vibration

- related to the creation of freshly-exposed metal surface by sliding

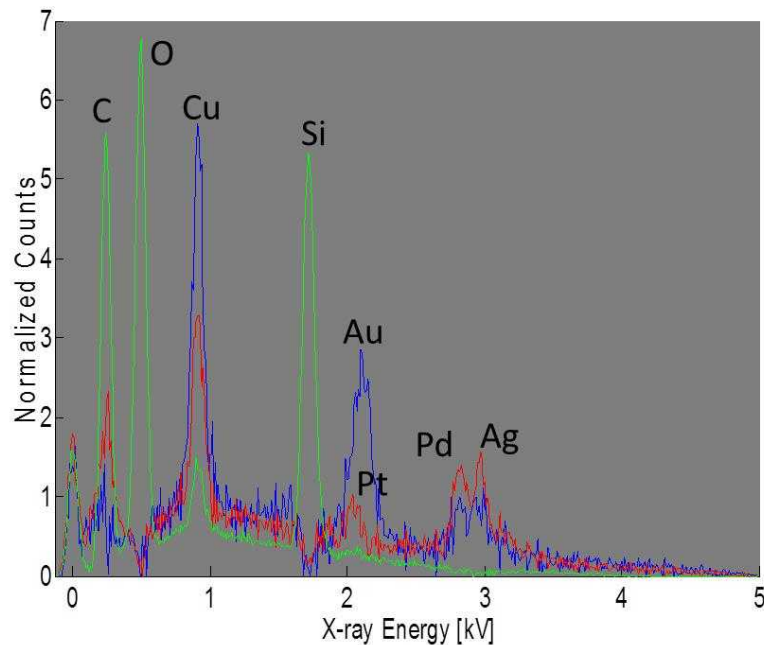
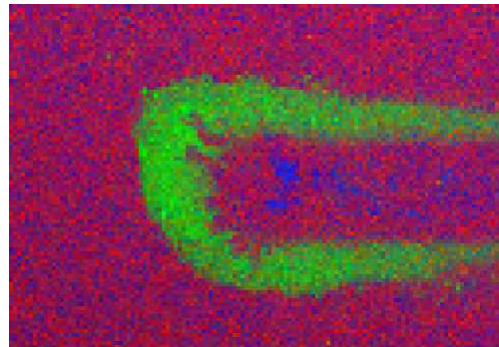
Deposit Characterization

Red = Paliney-7 coupon
Blue = Neyoro-G transfer
Green = Si-C-O deposit

Automated eXpert Spectral Image Analysis (AXSIA)

- uses full EDS spectrum from each pixel
- principal component analysis technique to identify major spectral components

- Deposit contains constituents of the silicone fluid
- Composition identical to that on accelerometer pins
- Surface analytical methods (Auger, XPS, ToF-SIMS) provided no insight into deposit formation mechanism

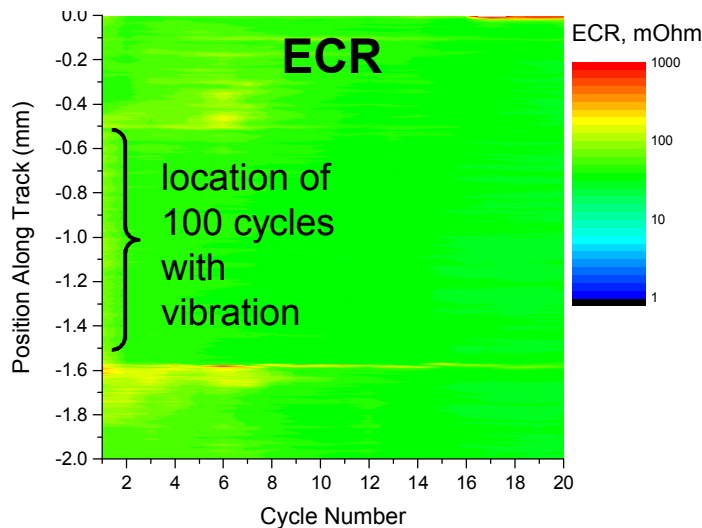
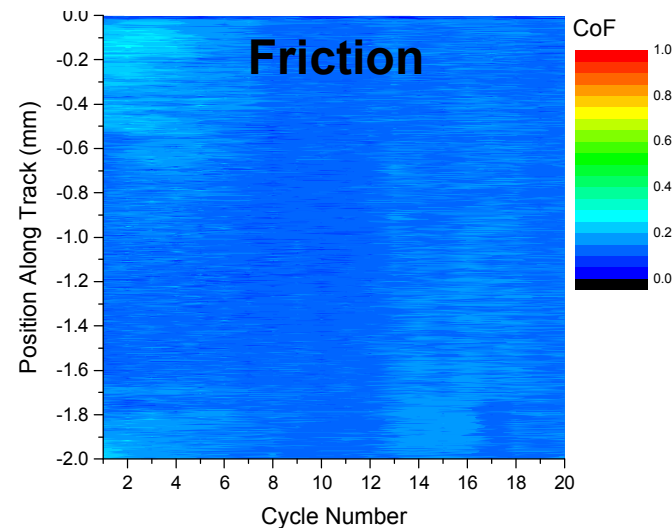
Relating Deposit to ECR Change

1. Measure CoF and ECR along 2 mm track for 3 cycles with no vibration
 - a. 88 mN (9 gf) contact force
 - b. 20 mA DC current, with 1.1 V open circuit limit
2. Perform 100 cycles sliding with vibration on central 1 mm
 - a. 50 μm displacement amplitude orthogonal to sliding direction, 100 Hz
3. Measure CoF and ECR along 2 mm track for 20 cycles with no vibration

initial wear track
with vibration

Increased ECR is observed when pin slides over deposit

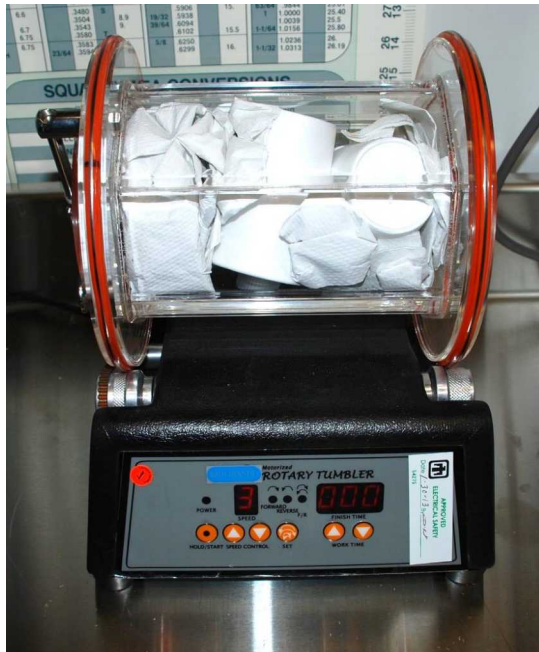
rock tumbler

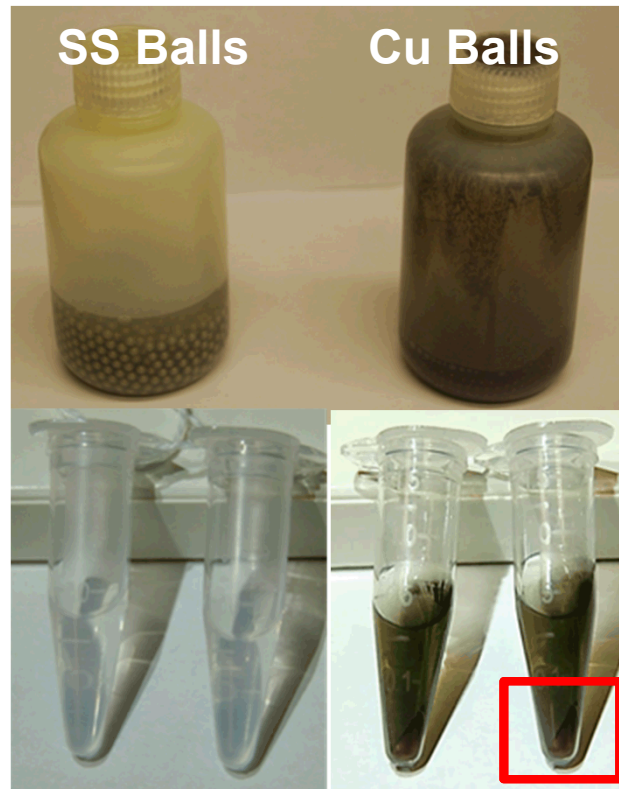
bottles filled with 3.2 mm dia. balls, covered with silicone fluid, tumbled 12 hrs.

fluid centrifuged
thin black film isolated

- degradation is not due to fluid shear, since the squeeze film shear rate would be greater with SS balls (greater mass)
- not thermal decomposition since interfacial flash temperature during contact would be higher for steel balls (greater impact energy and lower thermal conductivity)

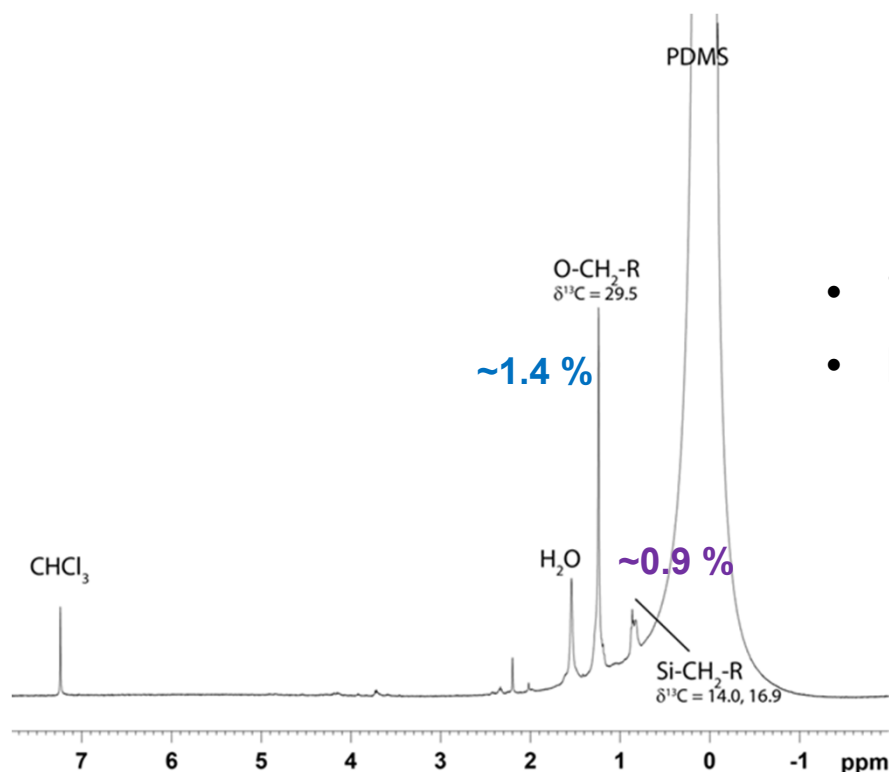
$^1\text{H}/^{13}\text{C}$ NMR Analysis of the Black Film

- ^{13}C NMR reveals these are CH_2 species
- Data bases suggest a $\text{O}-\text{CH}_2-\text{R}$ linkage

- Product is consistent with alkyl radical formation by oxidative metal catalysis
- Methyl side group oxidation, free radical hydrocarbon oxidation

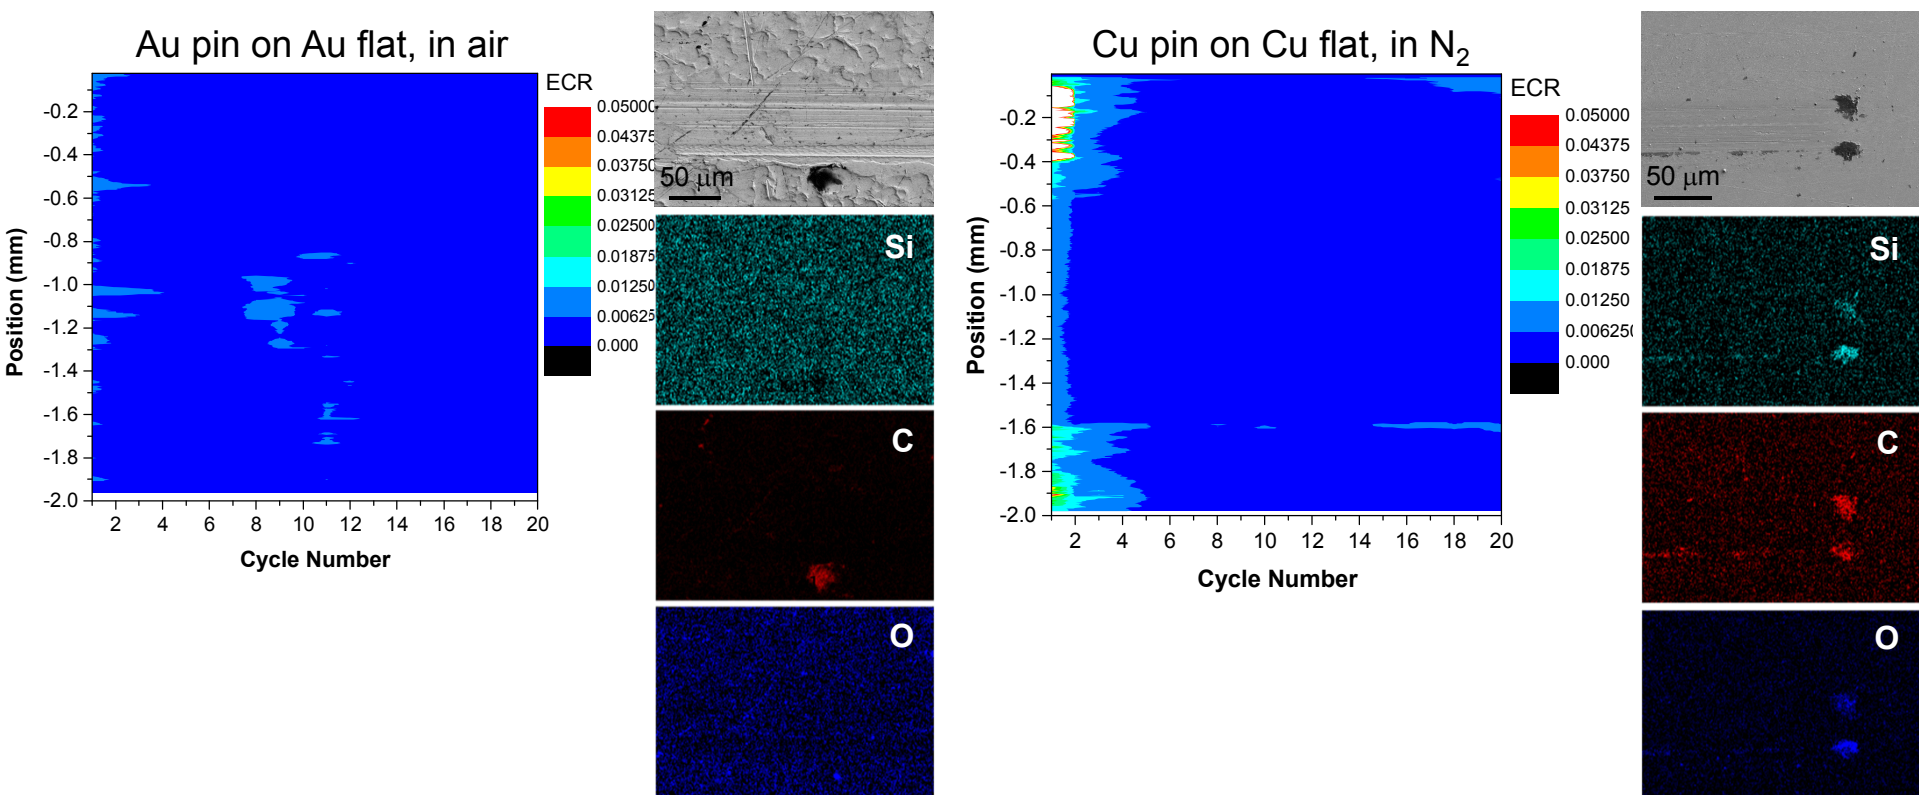
Testing the Reaction Hypothesis

- Sliding of gold surfaces in silicone produced no deposit nor changes in ECR
- Self-mated sliding of copper surfaces produced a change in ECR and deposit formation
 - qualitatively much less deposit than observed for contact of reactive metals in air
 - fluid may have contained some dissolved oxygen

- Silicone fluid can degrade at room temperature when exposed to oxygen and fresh metal oxide surfaces
 - deposit on Cu-containing alloys requires only mechanical agitation to continually displace passivating surface films and expose surface oxide
 - deposit increases electrical contact resistance by orders of magnitude
- NMR suggests that the deposit is formed through surface-catalyzed radical formation and crosslinking
 - methyl radical formation produced the highest concentration of degradation species
- Mitigation should be possible by eliminating reactants that facilitate radical formation
 - gold plating to eliminate metal oxide as catalyst
 - de-oxygenate fluid; may be impractical in a production setting
 - change fluid chemistry

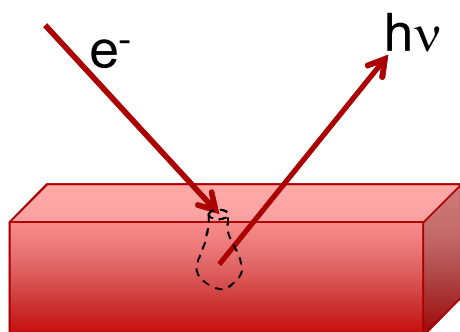
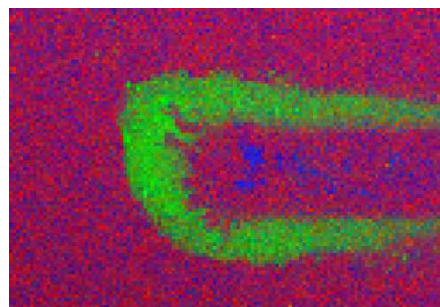
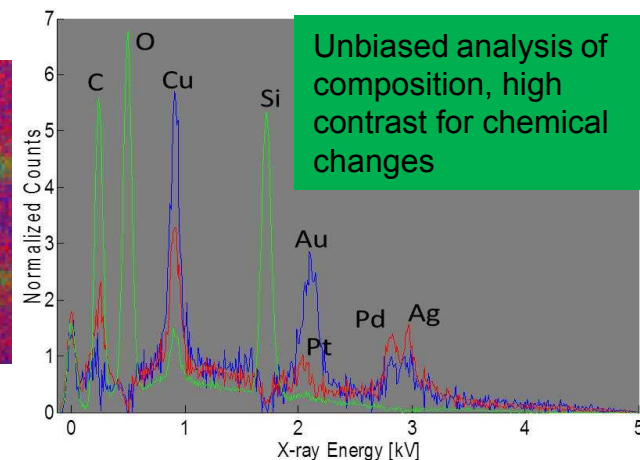
Multivariate Analysis Of EDS Data Allows Unbiased Detection of Composition Changes

Energy Dispersive x-ray Spectroscopy (EDS)
+ Automated eXpert Spectral Image Analysis (AXSIA)

Diagram illustrating the matrix equation $D = C * S^T$. D is a 3D mass map. C is a 4x1 matrix of component maps. S^T is a 4x1 matrix of component spectra.

- solve $D = C * S^T$ using constrained alternating least squares
- constrain to physically realistic solutions
- number of components C is the minimum needed to reconstruct the original data, minus noise
- no bias or assumptions; rapidly identifies subtle changes
