Application of Laser-Based Ultrasonic Inspection to Some SNL, NM Components

Jerry Knorovsky
Joining & Coating - Sandia Nat'l Laboratories
Albuquerque, NM, Dept. 1813

Marvin Klein
Intelligent Optical Systems - Torrance, CA,

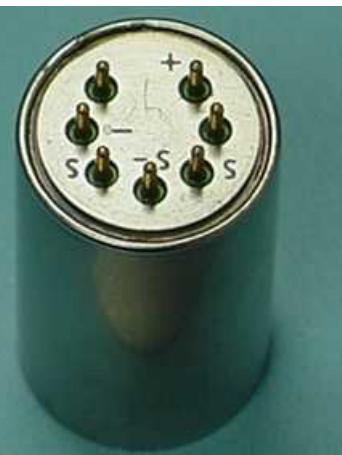
- 3 types of samples:
 - Braze: Neutron tube ceramic-to-metal seal
 - Glass-to-metal seal: connector
 - Weld: Small thermal battery

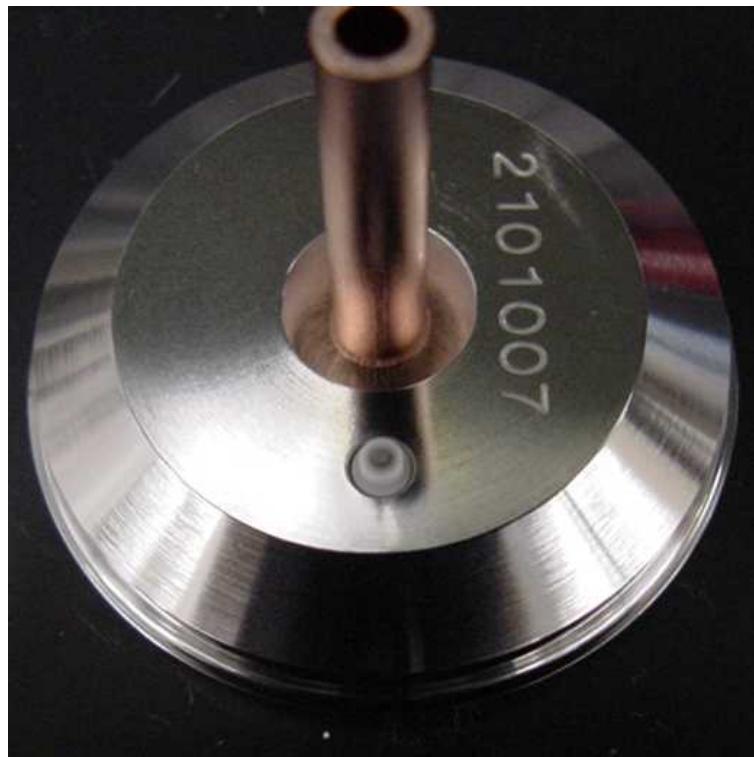
Brazement: Alumina Insulator to Kovar Header

Several assemblies have leaked through the braze.
