# Structural Testing of 9 m Carbon Fiber Wind Turbine Research Blades\*

Three 9 m carbon fiber wind turbine blades have been designed through a research program initiated by Sandia National Laboratories. The individual designs feature such innovations as carbon spar caps, material-induced twist-bend coupling, and flatback airfoils, among others. All blades were constructed with conventional dry lay-up and VARTM infusion processes. Static tests of these blades were conducted at the National Wind Technology Center. The blades were subjected to flapwise loading to simulate the extreme wind loads expected for each design in a Class 2b wind site. The blades were loaded with a three-point whiffle-tree arrangement. Upon obtaining the predetermined test load, the blades were subsequently loaded to failure. Load, deflection, strain, and acoustic emissions were monitored throughout the experiments. All blades survived the specified test loads, with two designs exceeding it significantly. In addition, carbon strains of over 0.8% in both tension and compression were recorded in one of the tests. Finally, acoustic microphones were able to detect areas where damage was occurring, and indicated

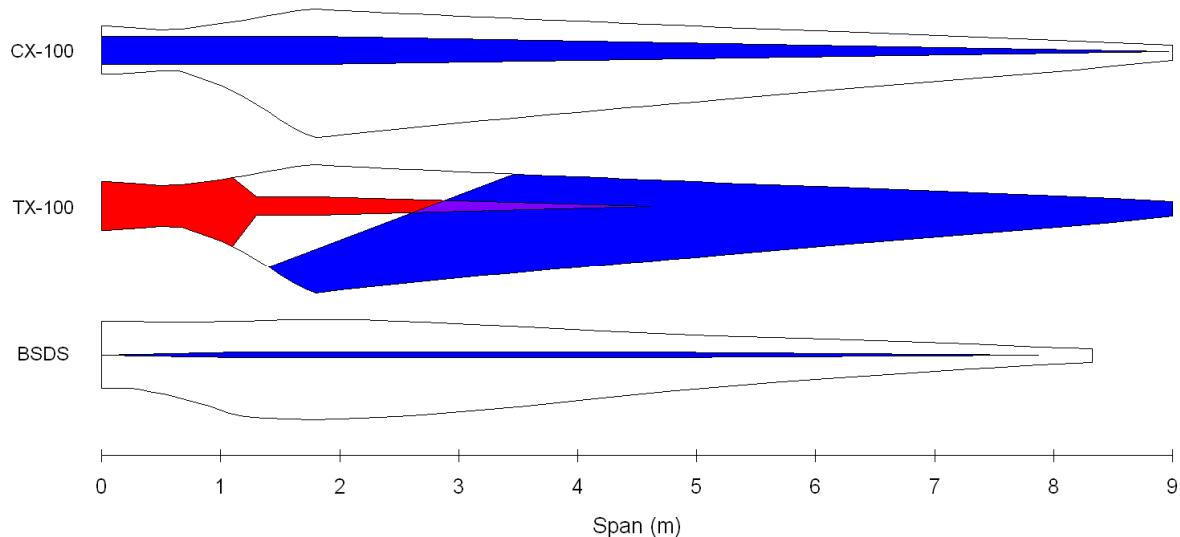
**Figure 1: 9 m blade plan forms and major material regions.**

design. The blade was designed to have passive aerodynamic load reduction by orienting unidirectional carbon 20° off of the pitch axis in the skins from approximately 3.50 m outward. Studies<sup>7,8,9,10,11,12</sup> had indicated the possibility of such a method of passive aerodynamic load alleviation through material induced twist-bend coupling, with 20° being determined as the optimum angle. Other methods of twist-bend coupling have also been suggested<sup>13,14,15,16</sup>. The TX-100 also contained a fiberglass spar cap which terminated at the mid-span of the blade. The final blade design was named the BSDS, owing its name to the research program under which it was created. The BSDS had a length of 8.325 m rather than the 9.000 m length of the CX-100 and TX-100. This blade design exhibited a highly efficient structure which included such features as a thin, large-diameter root; flatback airfoils; integrated root studs; and a full-length, constant-thickness, carbon spar cap. A drawing of the plan form of these blades is shown in Figure 1, with the carbon-containing areas shown in blue. Note the carbon spar caps of the CX-100 and the BSDS blades, and the carbon outboard skins of the TX-100. The unidirectional fiberglass spar cap of the TX-100 is shown in red in the figure and extends only to the mid-span of the blade. It was determined that the large amount of carbon contained in the skin was adequate to carry loads outboard in this design, making a full length spar cap unnecessary. The narrow, constant thickness spar cap of the BSDS blade alludes to the inherent structural stiffness of this design. In addition, the BSDS design features a gradual transition between the root and max-chord areas as compared to the CX and TX plan form. Figure 2 provides a view of the two different blade geometries as seen from the trailing edge. Note the flat back on the inboard portion of the BSDS blade, as well as the larger root and smoother chord thickness transition.

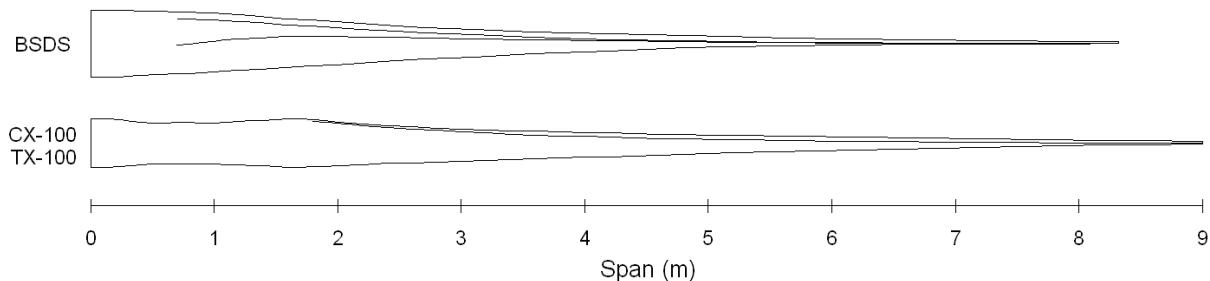
**Figure 2: 9 m blade geometries as viewed from the trailing edge.**

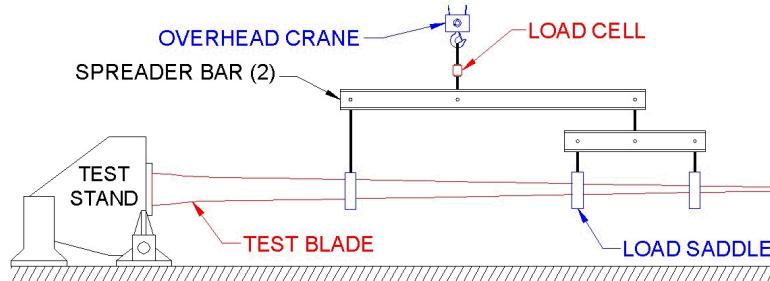
Figure 4: Three point whiffle-tree used in 9 m static blade tests.

The blades were mounted to a 1360 kN-m test stand and subjected to a flapwise bending load case to approximate the extreme loading events for the wind class that each blade was designed to<sup>17</sup>. In the case of the CX-100 blade, the extreme load case resulted in a root moment of 86.4 kN-m. For the TX-100 and BSDS blades, the extreme load case resulted in a root moment of 53.8 kN-m. All blades were loaded by use of a three-point whiffle tree and saddle arrangement connected to an overhead bridge crane which is shown schematically in Figure 4.

An array of sensors was used in the tests to monitor strain, deflection, load, and acoustic emissions. Load was monitored with a 100 kN load cell mounted between the whiffle-tree and the overhead crane (see Figure 4). Deflection was monitored by string potentiometers (pots) located near the saddle positions. For the CX-100 and BSDS blades, a string pot was located near the trailing edge of the blade near each saddle location. For the TX-100 test, additional string pots were mounted at the leading edge of the blade near the two inner most saddles to measure twist. Inclinometers were also mounted at 4.300 m and 6.250 m on the TX-100 blade to measure twist at those stations. The test blades were outfitted with a suite of 30-40 strain gages to measure strains along the blade centerline, in large panel regions near max-chord, and at other material and structural points of interest. Finally, the blades were instrumented with a grid of surface-mounted microphones to detect acoustic events that can point to regions of the blade incurring damage and thus, may indicate incipient failure regions.

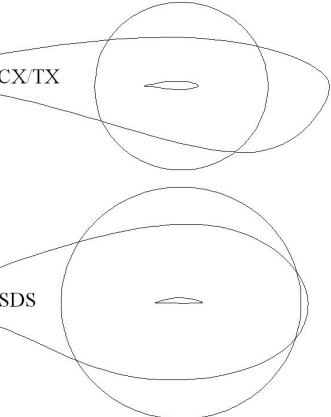
Figure 3: 9 m airfoil geometries at root, max-chord, and tip.

Figure 3 shows the airfoil geometries and relative sizes at the root, max-chord, and tip of the CX-100, TX-100, and BSDS blades. Note that in the figure the airfoils are shown without pre-twist. The BSDS blade can be seen to have a larger root diameter while also having a shorter max-chord length. The tip airfoil of the BSDS blade is representative of the outboard airfoils in the blade which are thin and aerodynamically high performing.

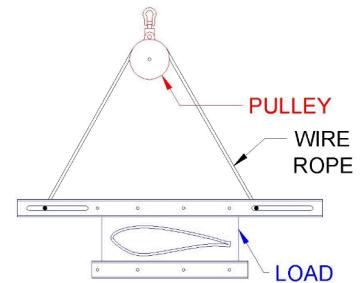
Figure 5: Rope and pulley arrangement for TX-100 blade test.

For the TX-100 blade test, a rope and pulley arrangement was attached to the saddles in an attempt to allow twisting without altering the loading point. When optimized correctly, the system can allow for loading through a stationary point on the chord line within a given rotation range. A schematic of the setup is shown in Figure 5.

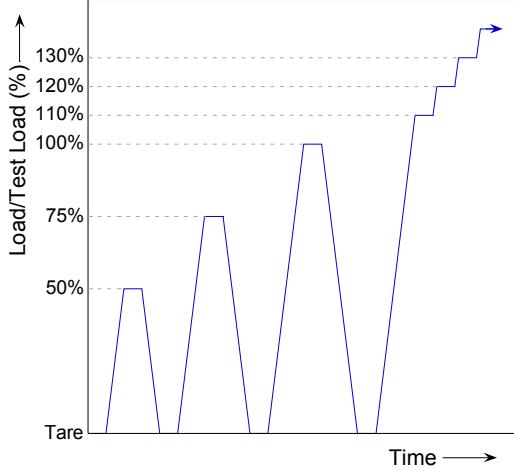
**Figure 6: Loading sequence for 9 m blade tests.**

The blades were loaded and unloaded in increasing 25% increments up to the 100% test load as shown schematically in Figure 6. At each load step, the load was held for approximately 60 s. The 100% test load was calculated by multiplying the design load distribution for each blade by 1.10 to account for test-to-test variability. The resulting distribution was then approximated with a piece-wise linear fit achieved by point loads applied at the three saddle locations. The desired and applied test moment distributions for the CX-100, TX-100 and BSDS blade tests are shown in Figure 7, Figure 8, and Figure 9

respectively. After reaching the 100% test load, loads were increased in 10% increments and held for 60 s until failure occurred (see Figure 6).

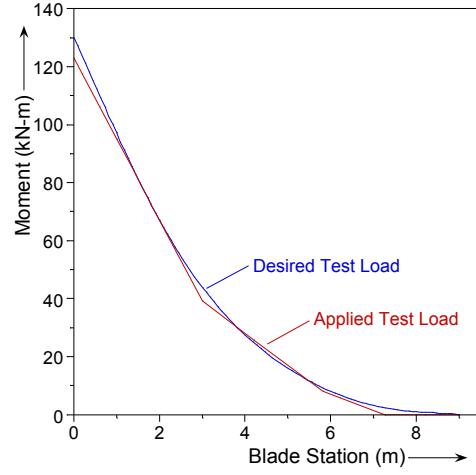
**Figure 7: CX-100 test loading distribution.**

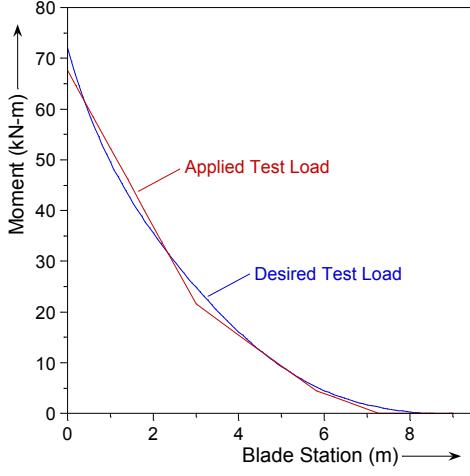
**Figure 8: TX-100 test loading distribution.**

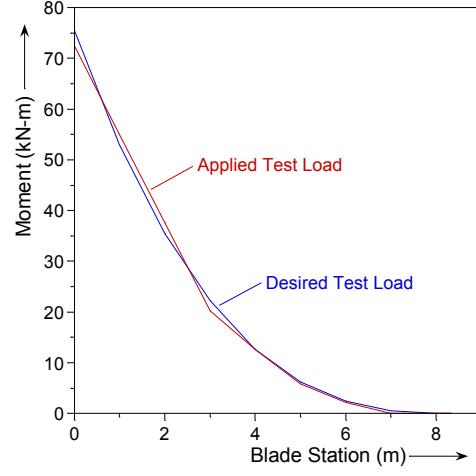
**Figure 9: BSDS test loading distribution.**

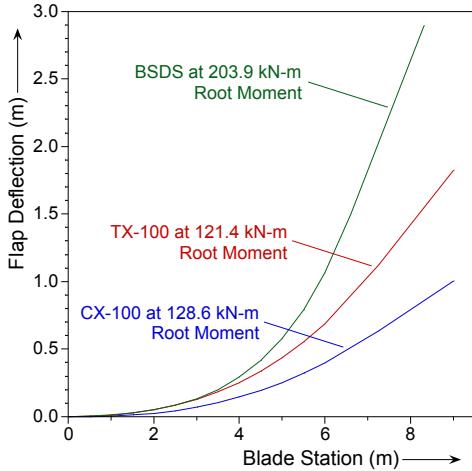
**Figure 10: Maximum deflections for 9 m blades.**

All three blade designs successfully withstood the prescribed test loads. Figure 10 shows the maximum deflections that were measured in the three blade tests along with the corresponding root moments. The deflections are the result of a polynomial fit of the string pot results. The maximum tip deflections for the CX-100, TX-100, and BSDS blades were 1.05 m, 1.80 m, and 2.79 m respectively. Figure 11 compares the deflections at a root moment of 100 kN-m. The results show that the CX-100 blade was significantly stiffer than the TX-100 and BSDS blades.

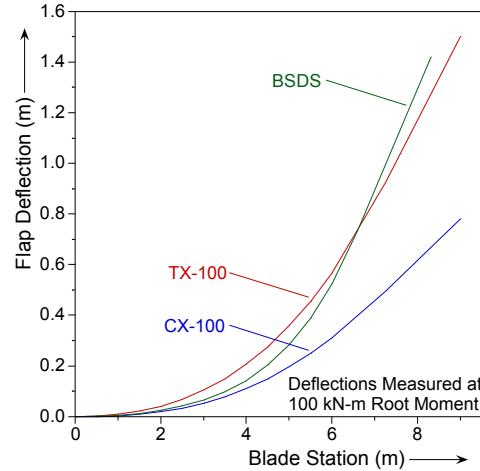
**Figure 11: 9m blade deflections at 100 kN-m root moment.**

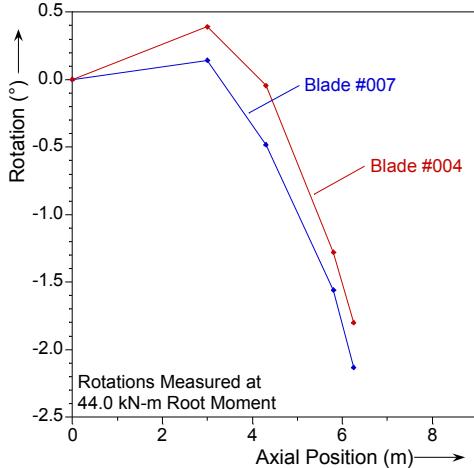
**Figure 12: TX-100 #004 and #007 twist angles at 44 kN-m root moment.**

The rotation angles about the spanwise axis at different stations of the TX-100 blade were measured during the test. The measurements were taken both from leading edge and trailing edge mounted string pots, and inclinometers mounted along the blade centerline. A positive angle corresponds to an increasing angle of attack for the airfoil at a given station. Figure 12 shows the twist angles that were measured at a 44.0 kN-m root moment in the test of blade #004 (blade with added material) and blade #007 (blade without added material) of the TX-100 blade set. Blade #004 was did not twist as much as blade #007 at the same load. This provides evidence of the effect that the extra leading material had on blade #004. Figure 13 shows the rotations measured along blade #004 at the 100% test load and at the failure load. The TX-100 blade showed a maximum twist of about  $-5^\circ$  at the 6.25 m station for a root moment of 116.9 kN-m.

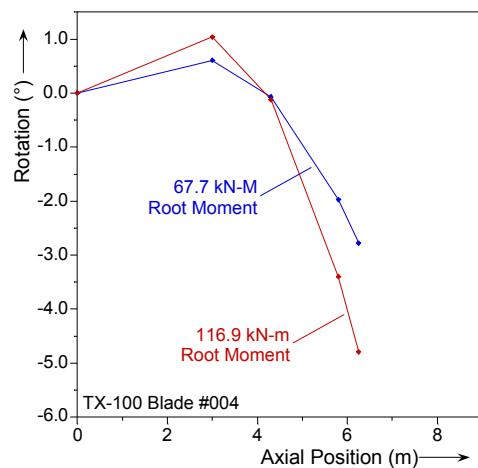
**Figure 13: TX-100 #004 twist angle at test load and near failure.**

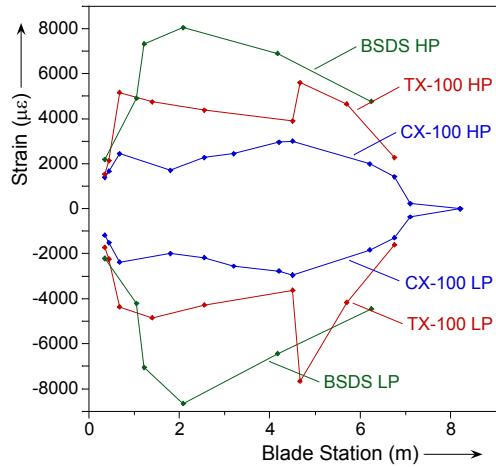
Figure 14: 9 m spar cap strains near failure.

Figure 14 shows the strains that were measured along the high-pressure and low-pressure spar caps for the three blades that were tested. Note that for the TX-100 blade, the spar cap terminates at the mid-span of the blade and thus strains outboard of that point are along the blade centerline. The carbon spar cap of the CX-100 blade experienced strains of around  $3000 \mu\epsilon$  before failure. The TX-100 blade exhibited maximum strains of approximately  $5500 \mu\epsilon$  near the termination point of the spar cap and strains elsewhere in the blade were generally lower. The high strain at the spar cap termination was likely the result of a stress concentration emanating from the tapered end of the spar cap (see Figure 1). The carbon spar cap of the BSDS blade experienced maximum strains of over  $8000 \mu\epsilon$  on both the high-pressure and low-pressure surfaces.

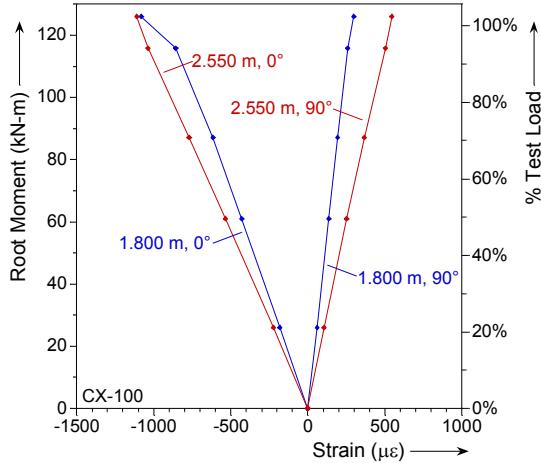
Figure 15: CX-100 aft panel strains parallel and perpendicular to blade axis.

Figure 15, Figure 16, and Figure 17 show the strains measured in the panel regions aft of the spar cap for the CX-100, TX-100, and BSDS blades respectively. These are regions that are susceptible for buckling in extreme loading situations. The CX-100 and TX-100 blades showed indications of buckling in the 1.800 m region near a root moment of about 117 kN-m. These blades were of identical geometry and had similar construction in this area. Thus, this result is not unexpected. The BSDS blade showed slight signs of buckling at the 1.575 m station at around a 150 kN-m root moment. However, it is important to note that the blade continued to withstand load well beyond this point.

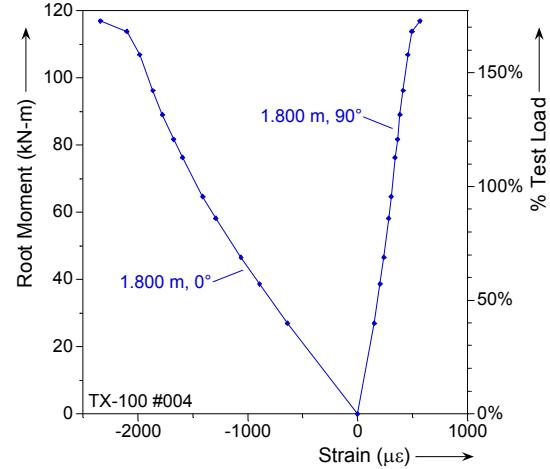
Figure 16: TX-100 aft panel strains parallel and perpendicular to blade axis.

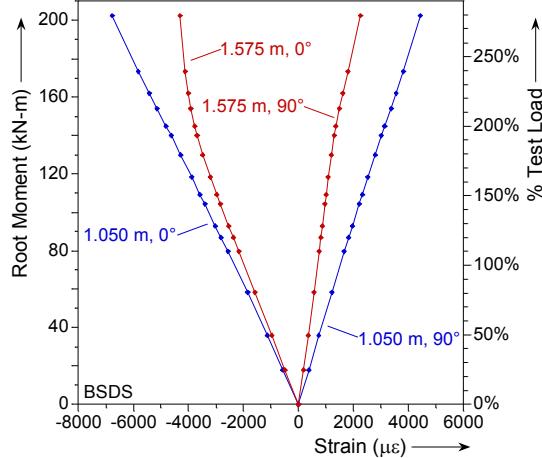
Figure 17: BSDS aft panel strains parallel and perpendicular to blade axis.

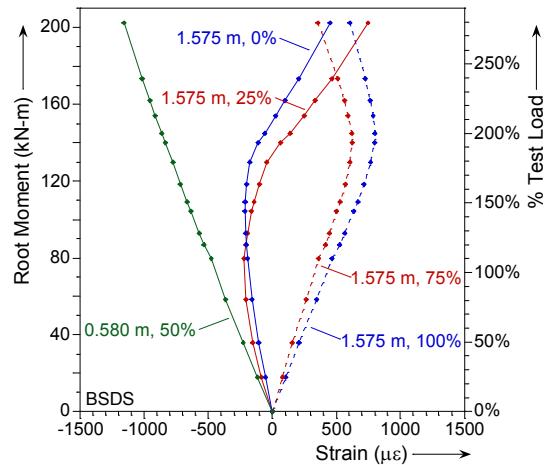
Figure 19: BSDS flat back strains.

For the BSDS test, strain gages were placed on the flat back, perpendicular to the blade axis at 0.580 m and at 1.575 m. The 0.580 m station contained one gage in the middle of the flatback (labeled 50%). At the 1.575-m station, gages were placed on the high pressure surface near the edge of the flat back (labeled 0%), on the low pressure surface near the flat back (labeled 100%), and at two intermediate positions, 25% and 75% of the distance between the high-pressure and low-pressure surfaces. The gages were intended to indicate if the flat back was collapsing or rotating relative to the high-pressure and low-pressure surfaces during the test. Figure 19 shows the strains measured at the aforementioned locations. Strain was linear with respect to load at the 0.580 m location, suggesting that the flat back was not buckling inward or outward at this location. All gages at the 1.575 m location show evidence of changes in the load path, especially beyond

a root moment of 150 kN-m. The 0% and 25% gages start to change from compression to tension while the 75% and 100% gages exhibit an inflection in strain direction. This may suggest that the flat back was beginning to collapse by the low-pressure edge in a concave direction. The strains changing in opposite directions at the opposite ends of the flat back suggest that the flat back was not experiencing concave or convex panel buckling at the 1.575 m location.

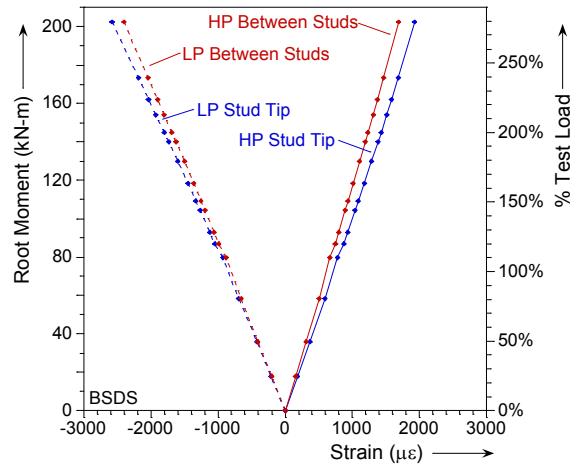
Figure 18: BSDS threaded rod strains.

Also of interest for the BSDS blade was the behavior of the root mounting studs. A novel root mounting stud design was implemented into the BSDS blade. The installation of the root mounting fasteners was integrated into the laminate infusion. Gages were placed near the tip of the most highly loaded root studs on the upper (low pressure) and lower (high pressure) surfaces. Gages were also placed at the same spanwise stations but between the root studs in the circumferential direction on the blade surface. Figure 18 shows the strain at these locations with respect to applied load. The resulting strains are relatively similar in magnitude and linear throughout the loading, indicating that the implementation of the root studs did not cause a significant stress concentration, with a relatively smooth load path between laminate and root stud. The root area was not observed to exhibit any signs of damage throughout testing.

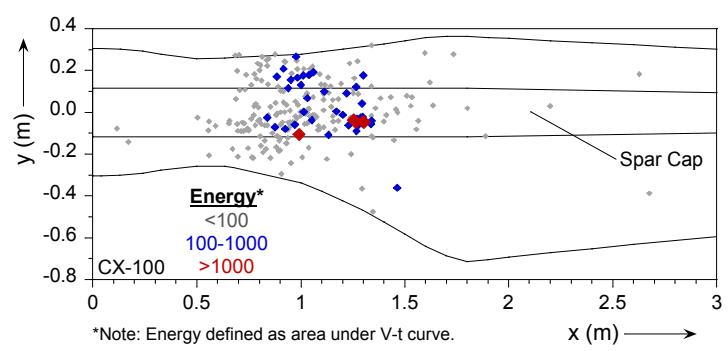
Figure 20: Acoustic event locations and energies for CX-100 blade test.

where  $a$ ,  $b$ , and  $n$  are fitting constants and  $\alpha$  is the angle between the direction vector from the sensor to the event and the blade pitch axis. The resulting located events for the CX-100, TX-100, and BSDS blade tests are shown in Figure 20, Figure 21, and Figure 22 respectively. Each event is color coded with a respective energy range. It should be noted that this energy is not the true energy, as it represents the integral of the voltage vs. time curve. The true energy is defined by the integral of the voltage squared vs. time curve. These voltage vs. time results are useful for comparative

purposes however. The events are overlaid on outlines of each blade. Since the locations of the acoustic events are two-dimensional, the outlines are of the flattened low-pressure skins of the blades. In addition to the outlines of the blades, important regions such as spar caps and material boundaries are shown.

During the CX-100 test, several high-energy events were located between 1.20 m and 1.30 m along the spar cap. The CX-100 blade was observed during failure to experience a catastrophic buckling of the low-pressure skin near the 1.2-m station. A post mortem inspection of the blade in this region showed a large crack in the bond joint between the low pressure skin and the shear web. A photograph of the crack is shown in Figure 23.

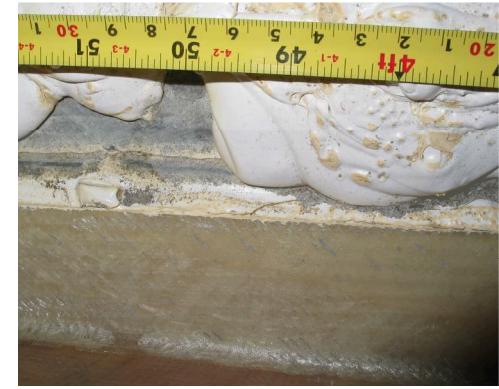
**Figure 23: Crack in shear web to LP skin bond joint at 1.20-1.30 m on the CX-100 blade.**

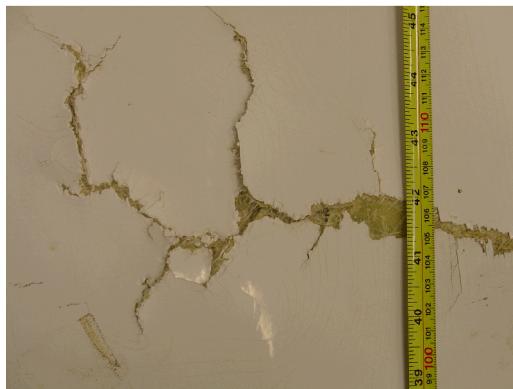
**Figure 24: Crack near blade centerline on TX-100 blade.**

The TX-100 blade test produced high-energy events just beyond the 1.00 m station. The blade eventually failed at the 1.0-m station, with a failure described as a buckling of the compressive skin, initiated towards the leading edge. A photograph of the fracture is shown in Figure 24.

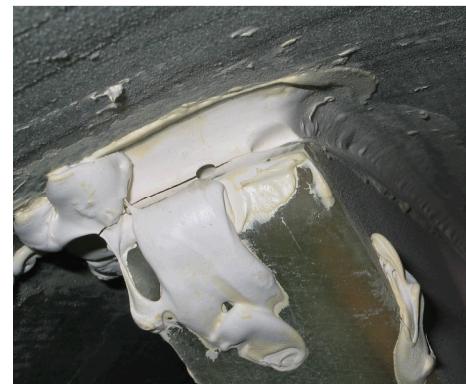
**Figure 25: Crack at shear web termination on the LP surface of the BSDS blade.**

During the BSDS test, the only high-energy events were located around 0.350 m, which is the station where the shear web terminates on the root end. A closer examination of this area after the test showed that a large crack had developed between the low-pressure skin and the shear web in the bonding joint. A photograph of the crack is shown in Figure 25.

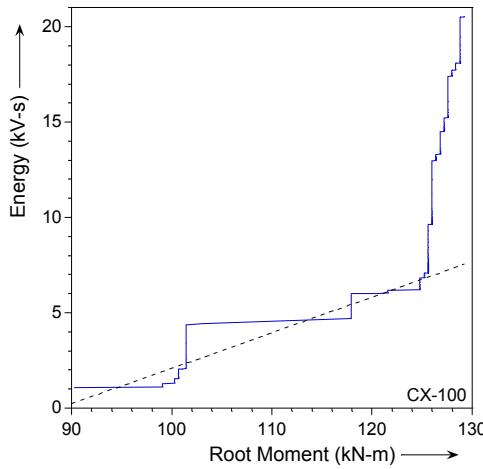
Figure 26: CX-100 acoustic energy accumulation.

In addition to indicating the location of damage occurring within a blade, acoustic emission monitoring is also a valuable tool for assessing when failure is occurring locally or globally. Figure 26, Figure 27, Figure 28, show the sum of the acoustic emission energy detected by all of the sensors in the root region of the CX-100, TX-100, and BSDS blades respectively. In each plot a trend line is drawn through the initial linear portions of the response. At some load, the response begins to become non-linear, indicating an acceleration of the acoustic emissions and the greater potential of failure. For the CX-100 and TX-100 blades, the acoustic emissions accelerate rapidly beyond root moments of 125 kN-m and 115 kN-m respectively. The response from the BSDS blade remained mostly linear until a root moment of 140 kN-m was reached. The accumulation of acoustic energy in the BSDS blade did grow non-linearly after 140 kN-m, although not as rapidly as for the other two blades.

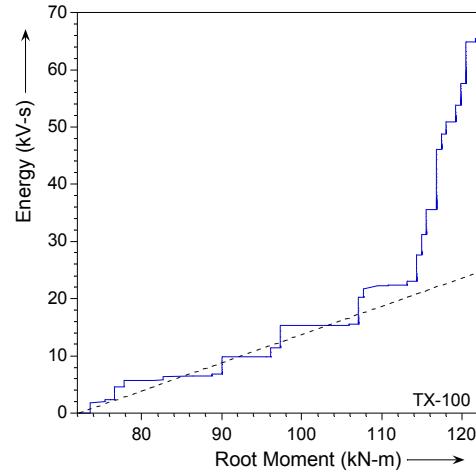
Figure 27: TX-100 acoustic energy accumulation.

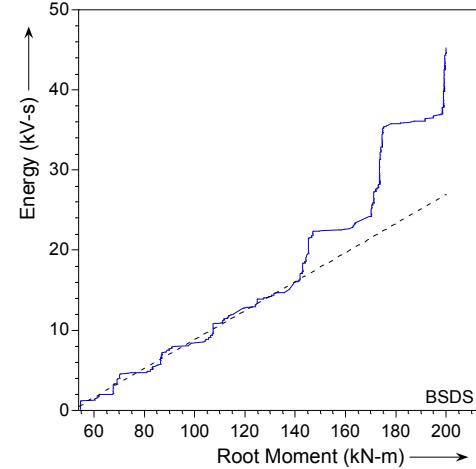
Figure 28: BSDS acoustic energy accumulation.
