# **Assessment of Environmental Qualification Practices and Condition Monitoring Techniques for Low-Voltage Electric Cables**

**LOCA Test Results**

**Brookhaven National Laboratory**

**U.S. Nuclear Regulatory Commission  
Office of Nuclear Regulatory Research  
Washington, DC 20555-0001**

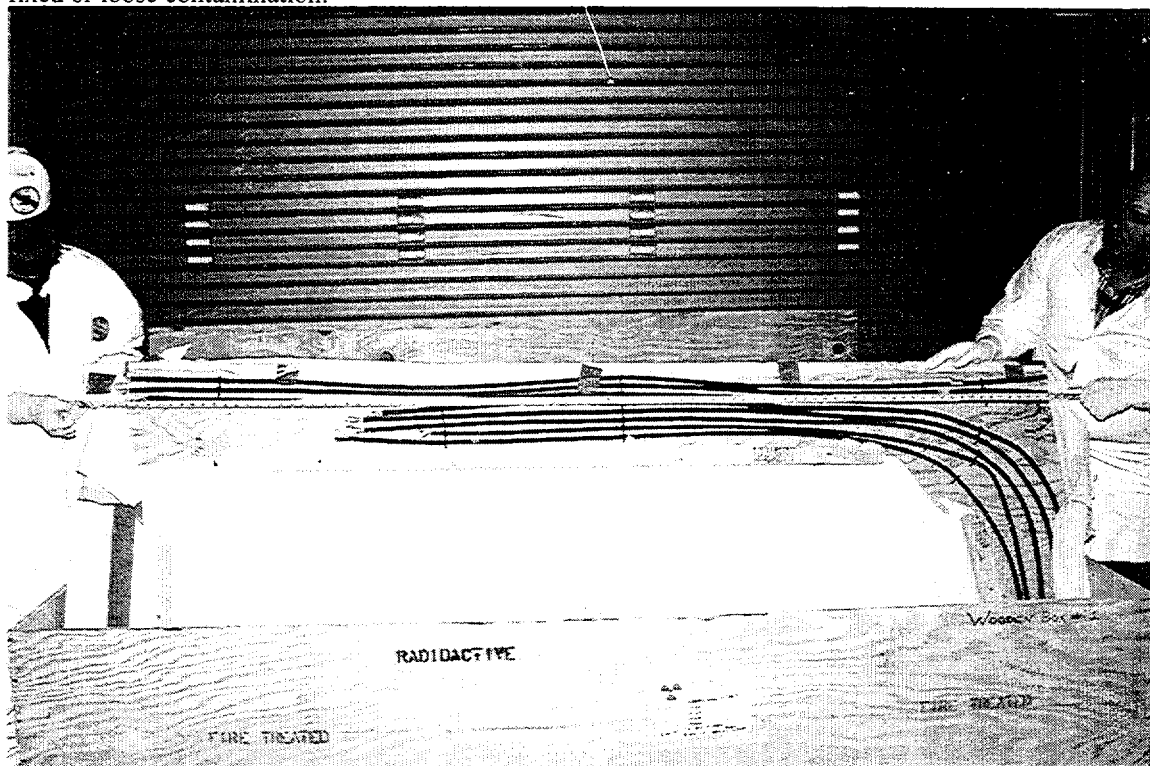
**Figure 2.1** Naturally aged cables installed on plywood boards to protect them during shipping

sheets of plywood to immobilize them and maintain their installed configuration, then placed in wooden crates to protect them during shipping (Figure 2.1). Unaged cables were coiled according to acceptable handling practices, and shipped in barrels, crates, or on pallets. Prior to removal from the plant site, each cable was radiologically surveyed to detect any fixed or loose contamination.

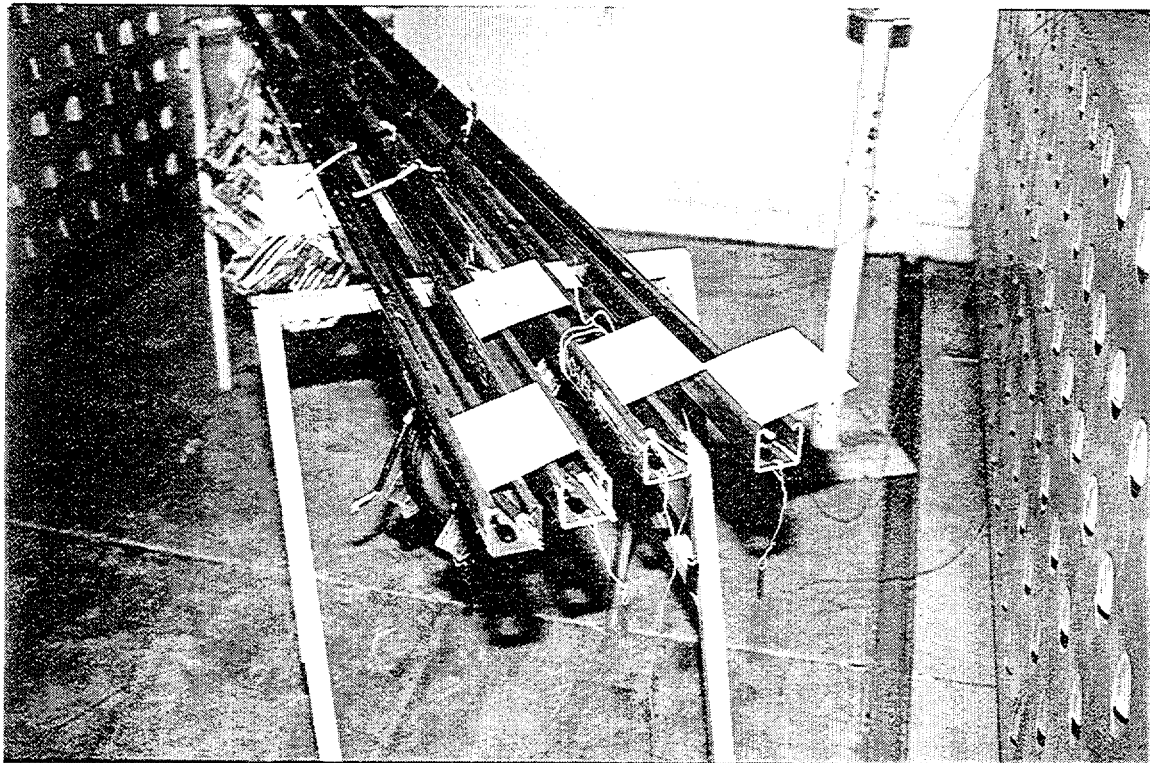
**Figure 2.2** Typical long specimens installed in Unistrut® shown in thermal aging oven

Several of the long cable specimens were placed in individual steel Unistrut® channels to simulate a typical physical configuration of cables installed in a power plant, i.e., straight horizontal cable trays or conduit. The Unistrut® channels also served to protect the cable specimens from damage during handling. Approximately one inch of insulation was removed from the conductors on both ends to allow splices to be made to facility wiring to energize the long specimens. The cables were held in place using Tefzel® tie wraps, which were applied by hand just tight enough to hold the cable snugly and prevent it from moving. Figure 2.2 is an end view of four typical Unistrut® channels with individual long cable specimens on a test fixture in the thermal aging chamber.

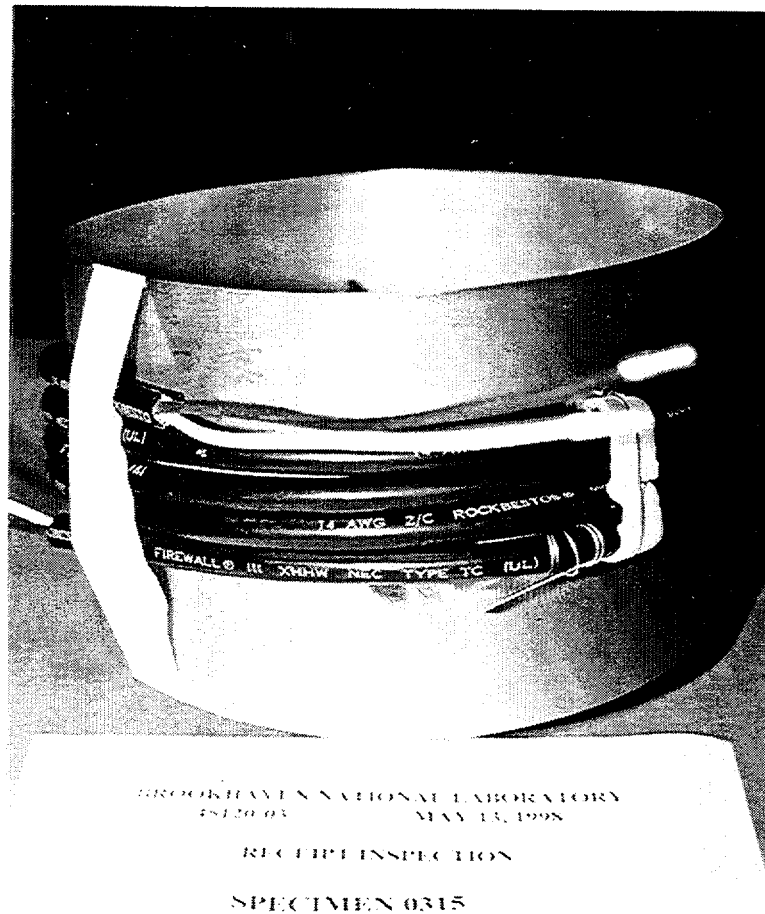
**Figure 2.3 Typical long specimen installed on a mandrel**

The remaining long specimens were installed on stainless steel mandrels to simulate actual qualification testing. The specimens were tied to the mandrel using stainless steel wire, which was also applied by hand just tight enough to hold the cable snugly and prevent it from moving. A piece of fiberglass tape was placed between the stainless steel wire and the test specimen to prevent the wire from cutting into the test specimen jacket. Figure 2.3 shows a typical long specimen mounted on a mandrel.

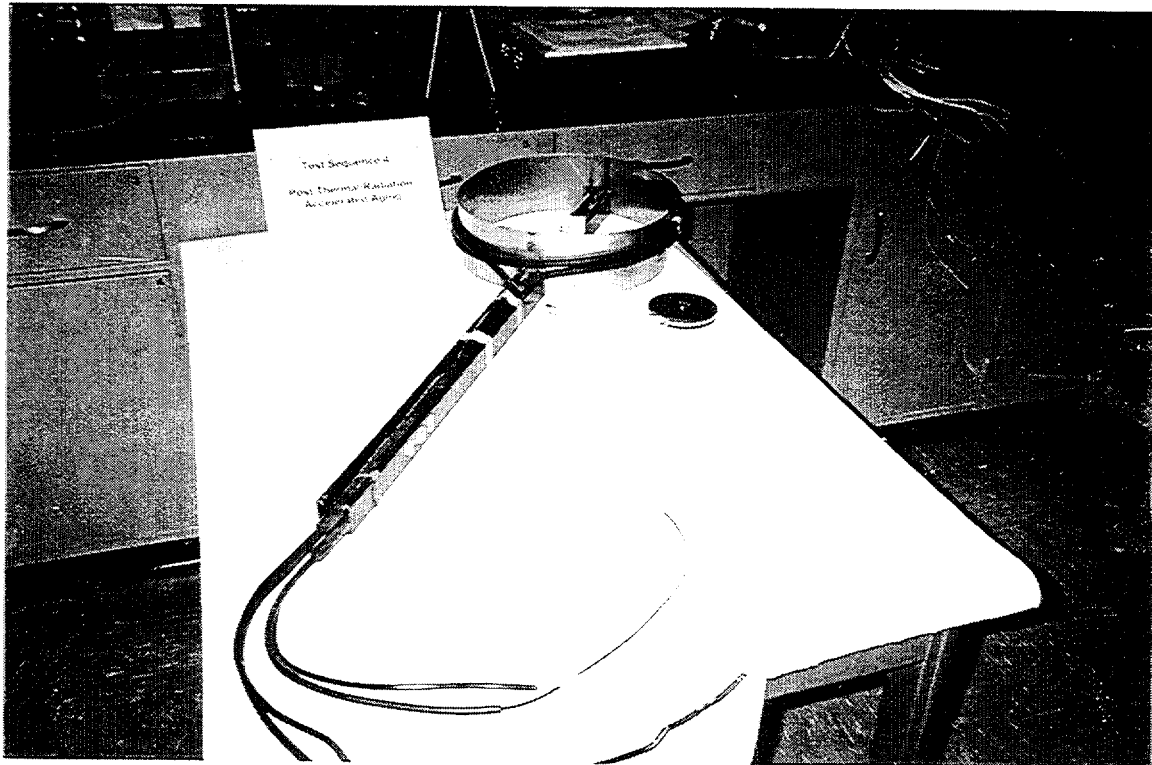
**Figure 2.4 Typical specimen mounted on a mandrel with a modified design for tests 4, 5 and 6**

mitigate the potential for handling damage to the test specimens. The pigtails were shielded from the thermal and radiation aging, to the extent possible, to keep them from becoming brittle. After aging, the facility lead wires were connected to the pigtails using a second splice. Figure 2.4 shows a typical specimen mounted on the modified mandrel with pigtails attached, as used for tests 4, 5 and 6.

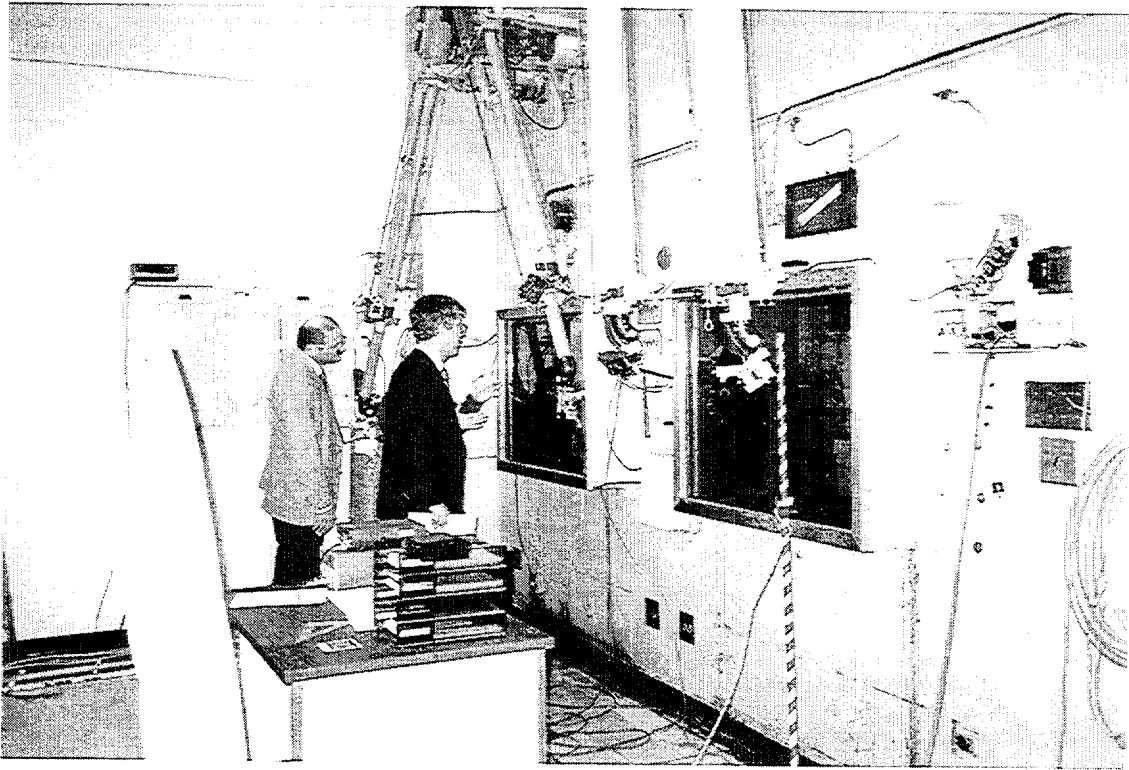
Figure 2.7 Hot cell used for irradiation of specimens at Georgia Institute of Technology

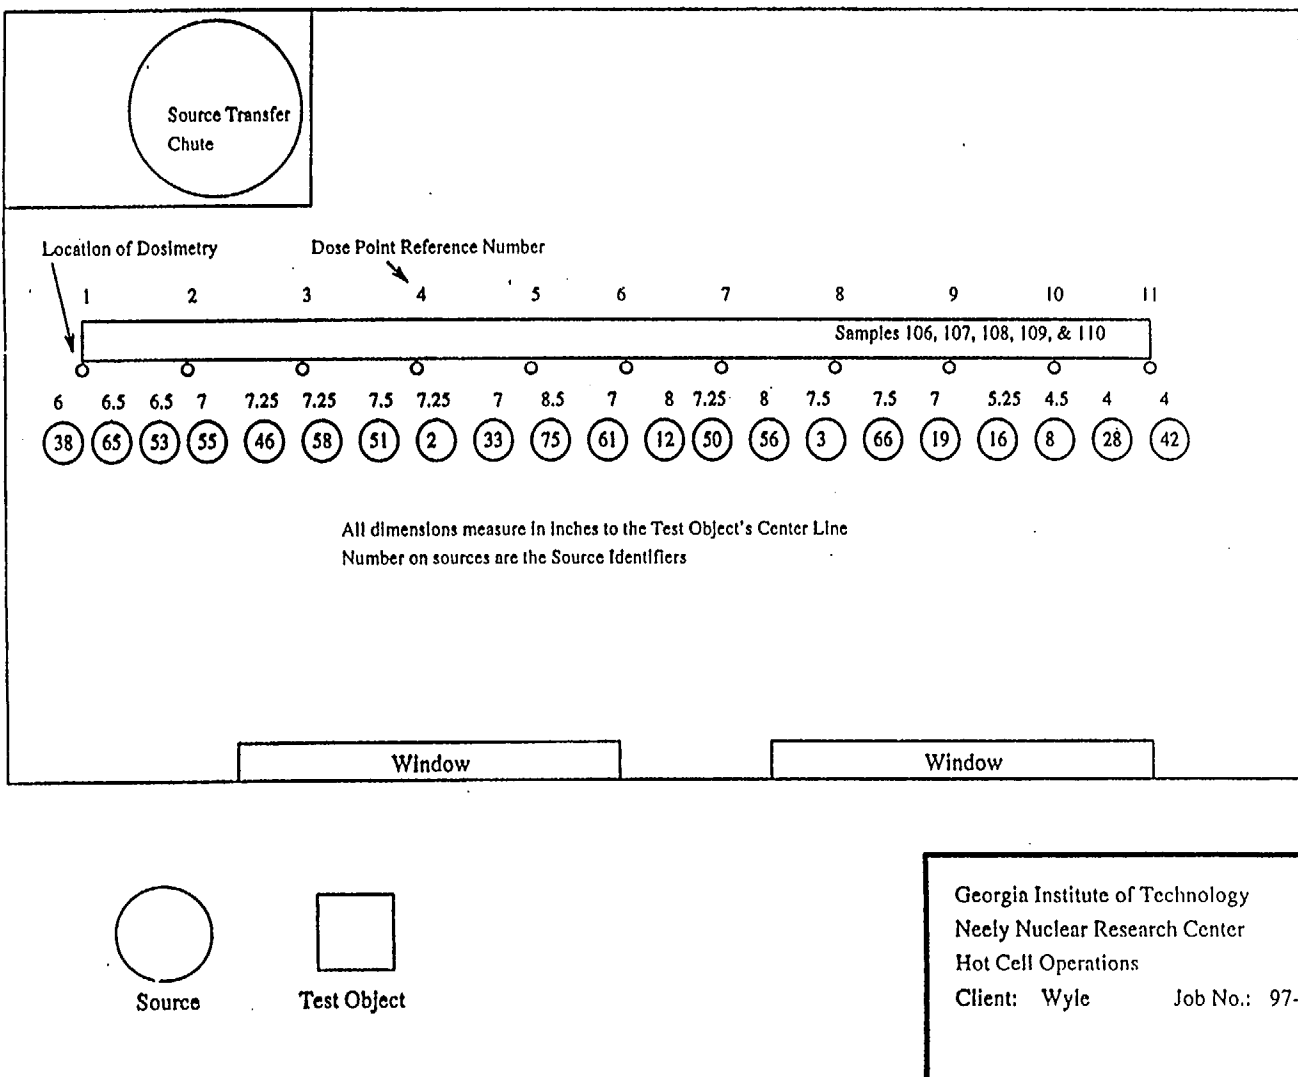
Figure 2.8 Diagram of the Hot Cell at Georgia Institute of Technology with typical arrangement of long specimens

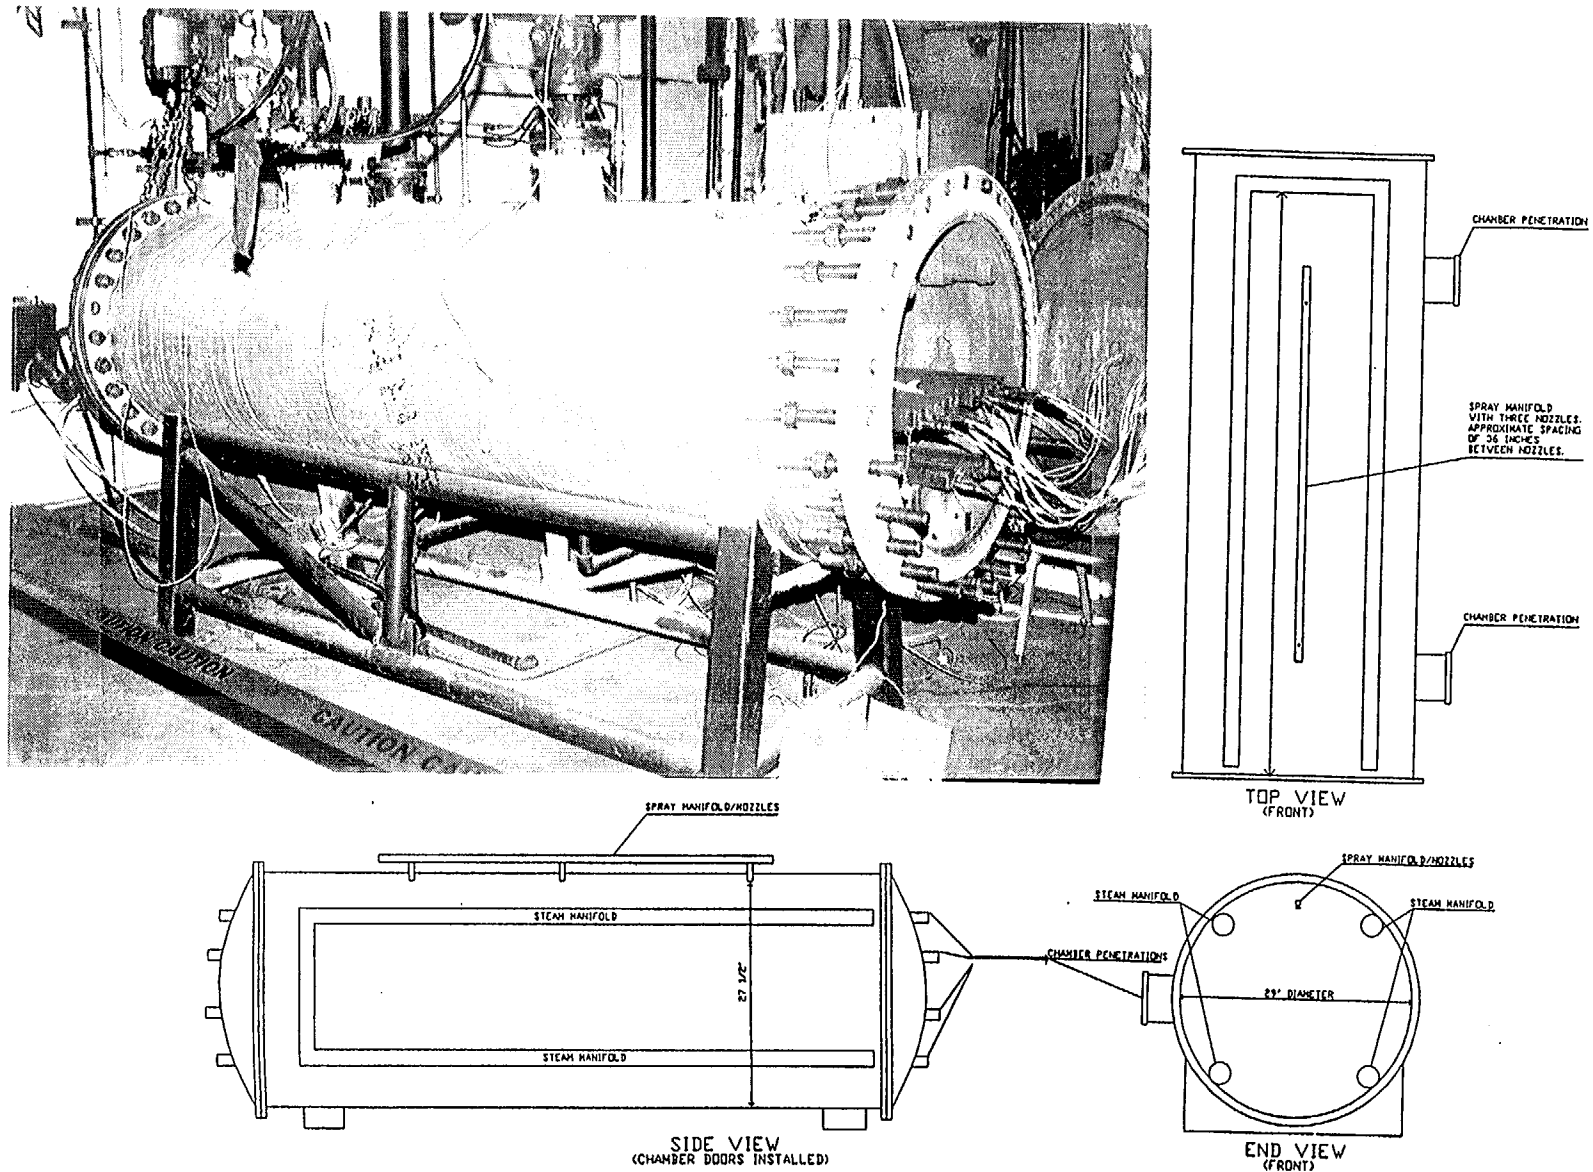
Figure 2.9 Photograph and diagram of the LOCA test chamber at Wyle Laboratories used for Tests 1, 2 and 3

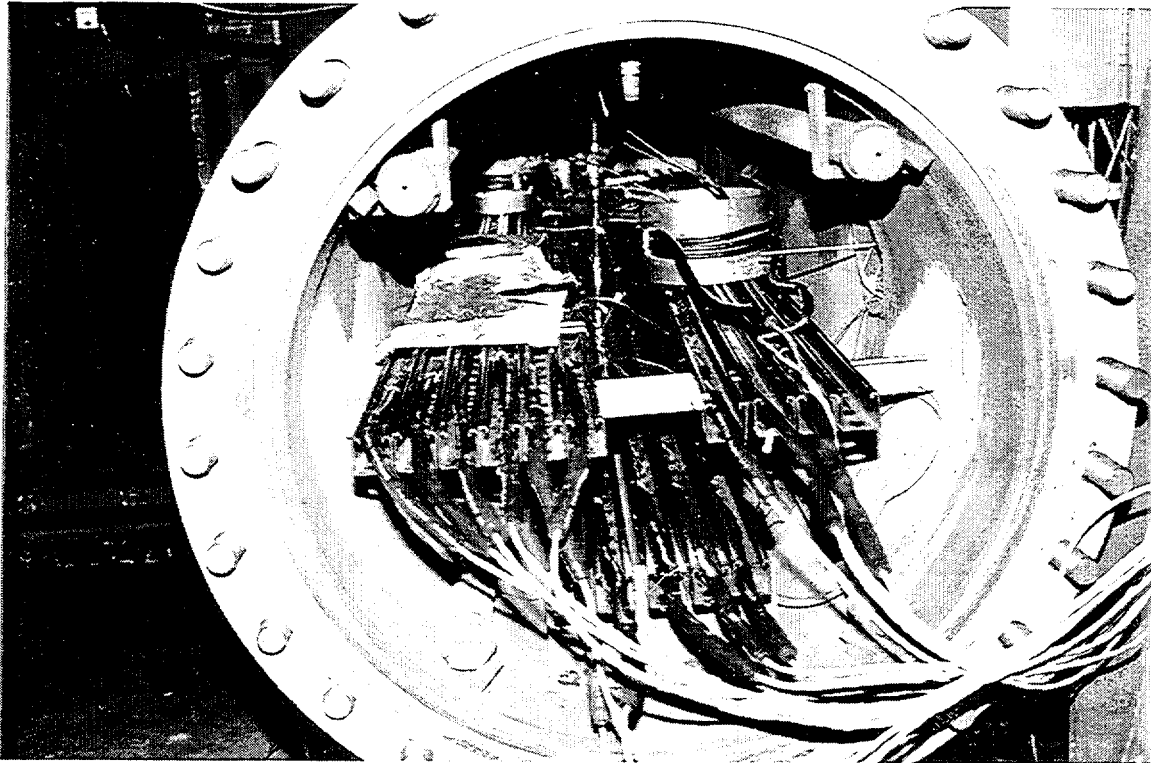
Figure 2.10 End view of the LOCA test chamber with the cable specimens loaded prior to testing

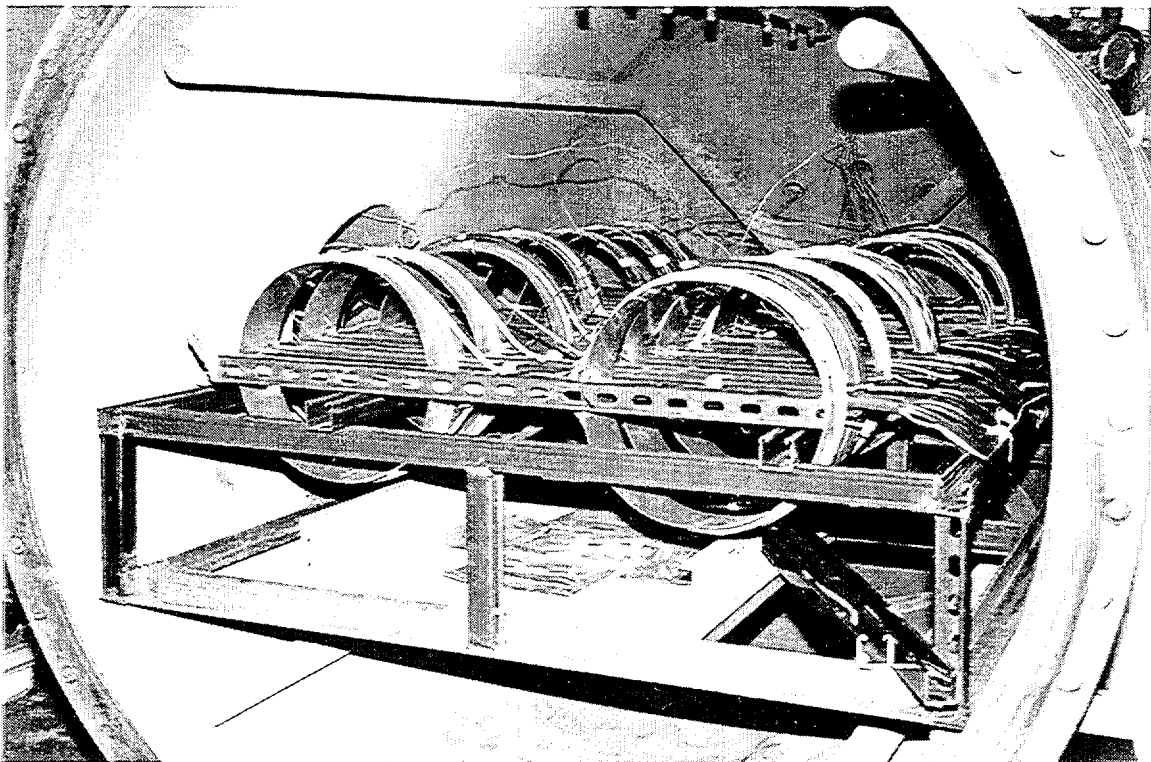
Figure 2.11 End view of large diameter LOCA chamber used for tests 4, 5 and 6

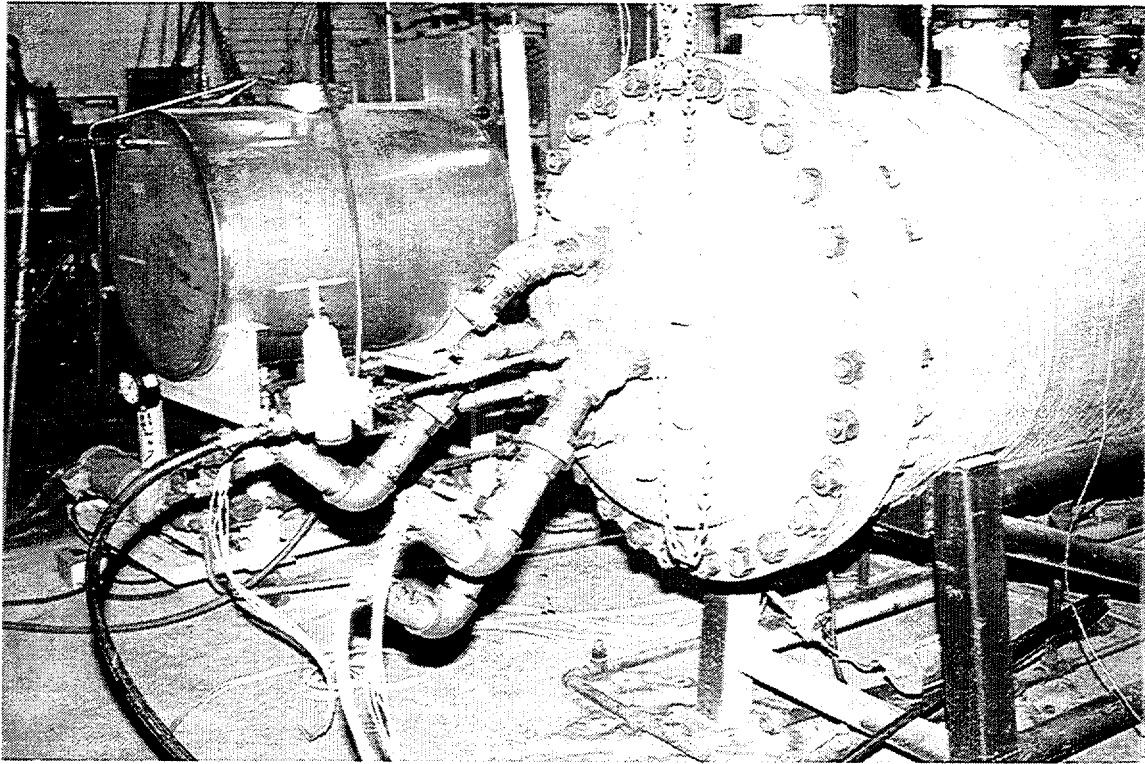
**Figure 2.12** Facility lead wires extending through the penetrations on the end of the LOCA test chamber

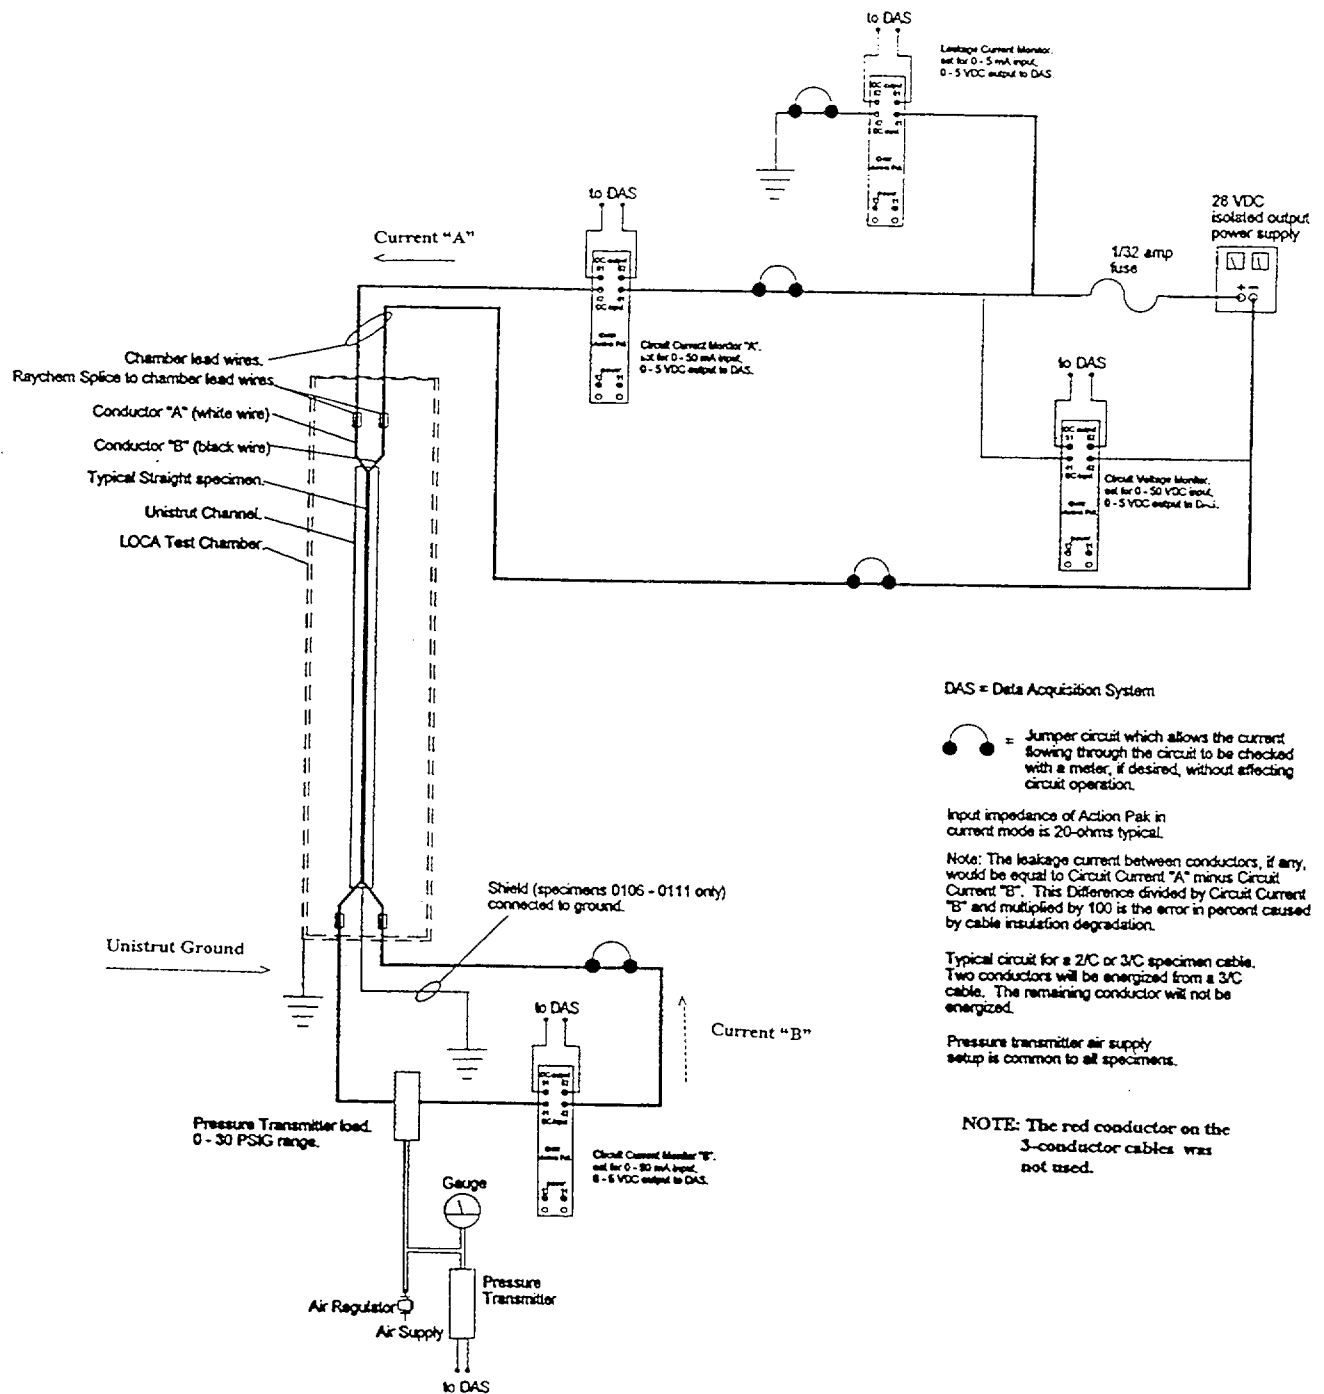
Figure 2.13 Monitoring circuit diagram for straight Unistrut® mounted specimens

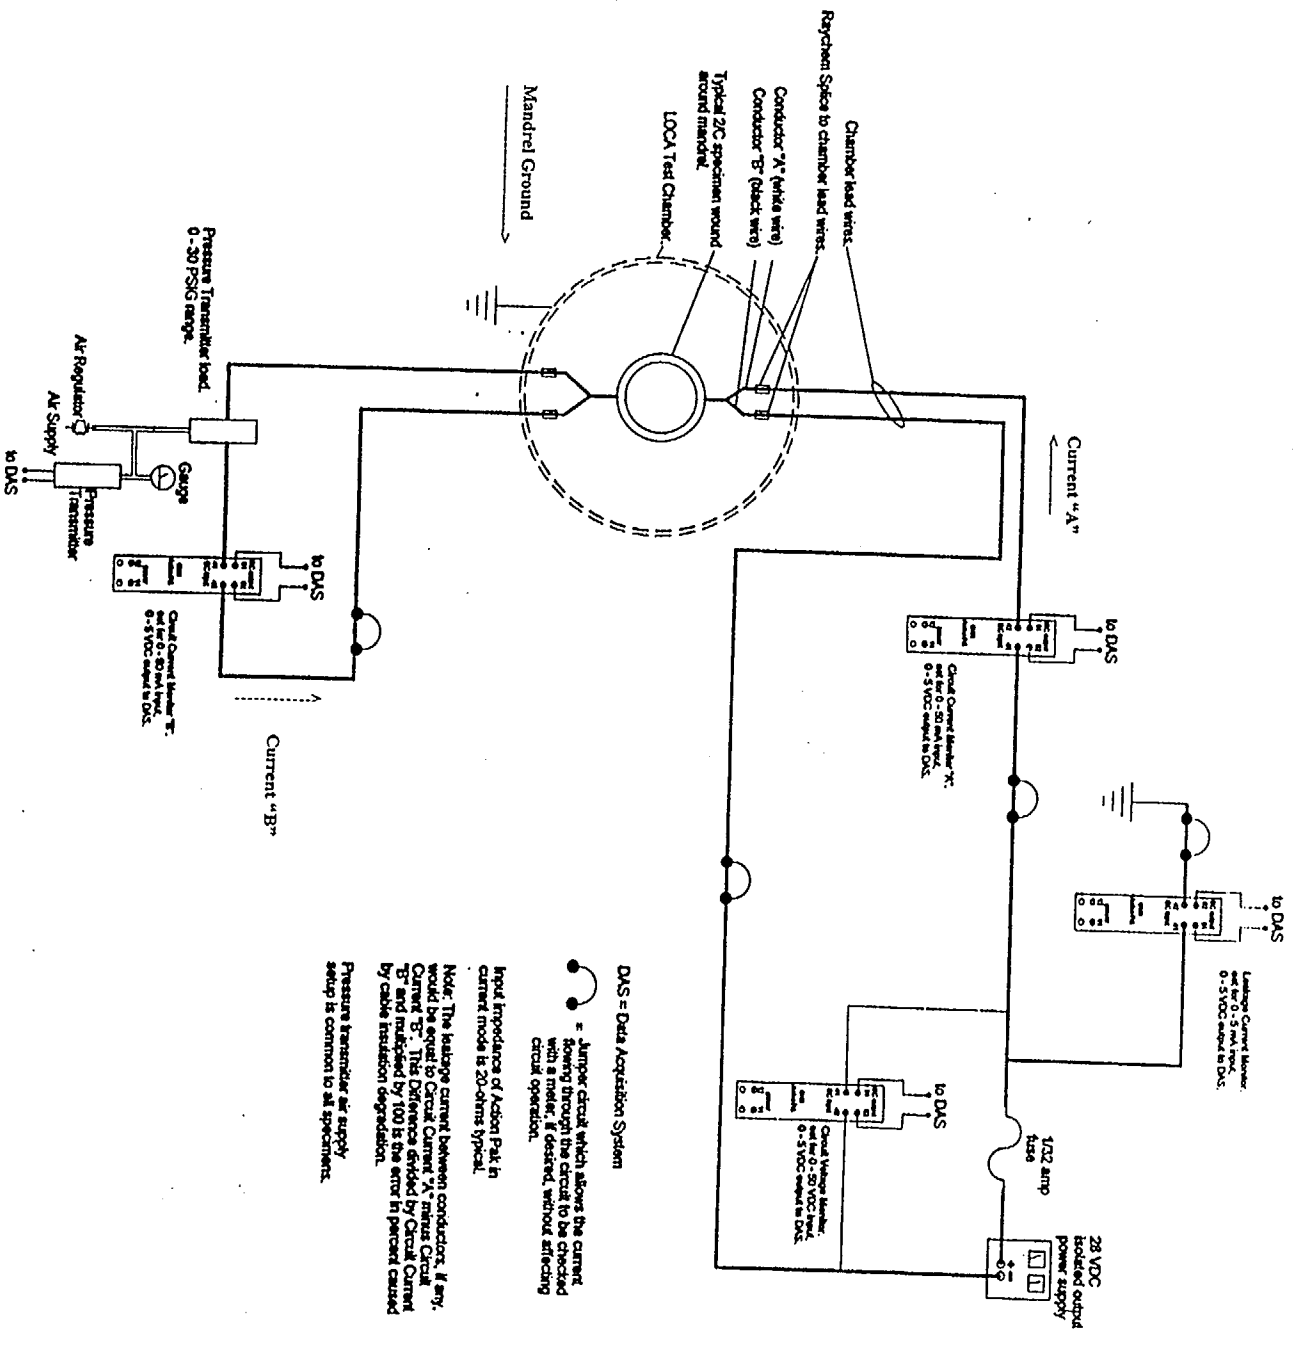
Figure 2.14 Monitoring circuit diagram for mandrel mounted specimens

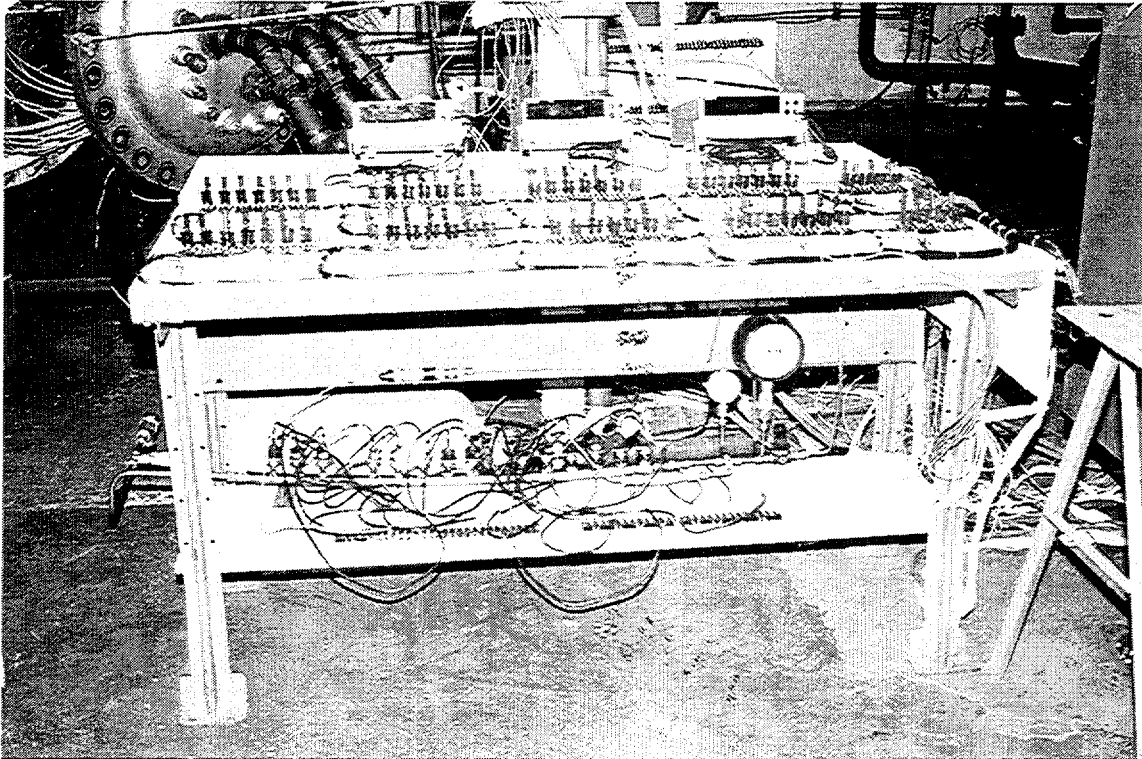
**Figure 2.15 Test bench with hard-wired monitoring circuits and simulated pressure instrumentation loops**

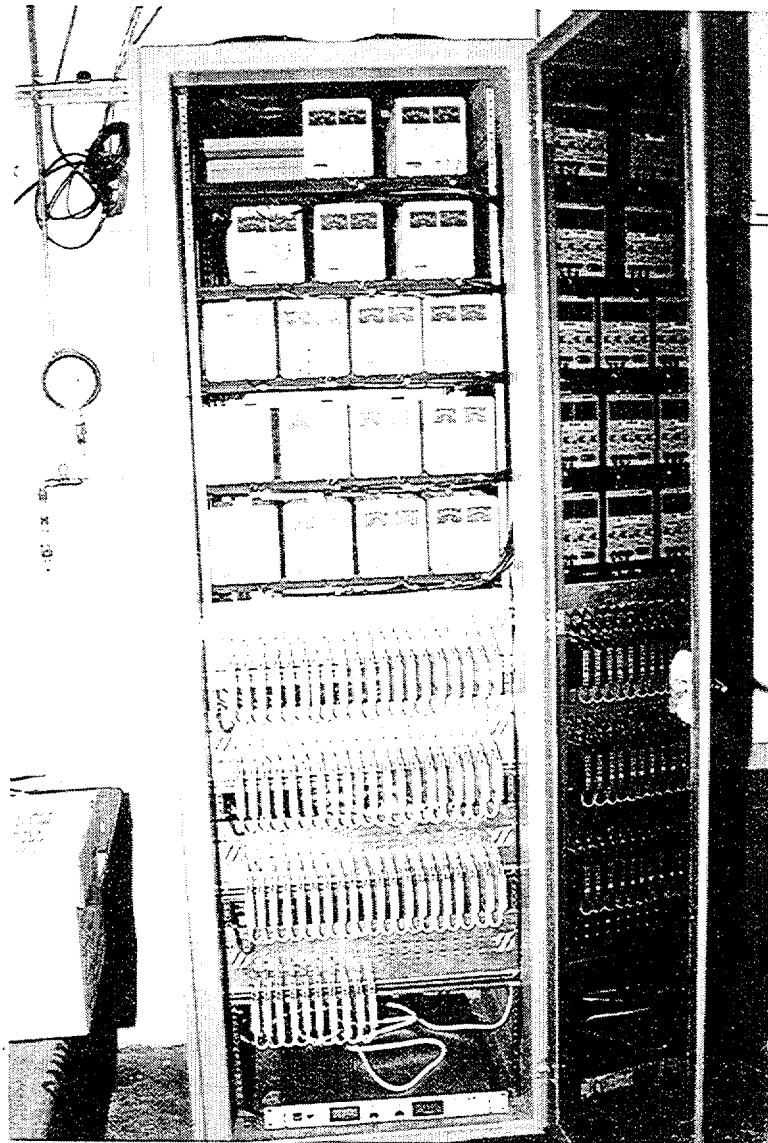
Figure 2.16 Specimen powering and monitoring equipment

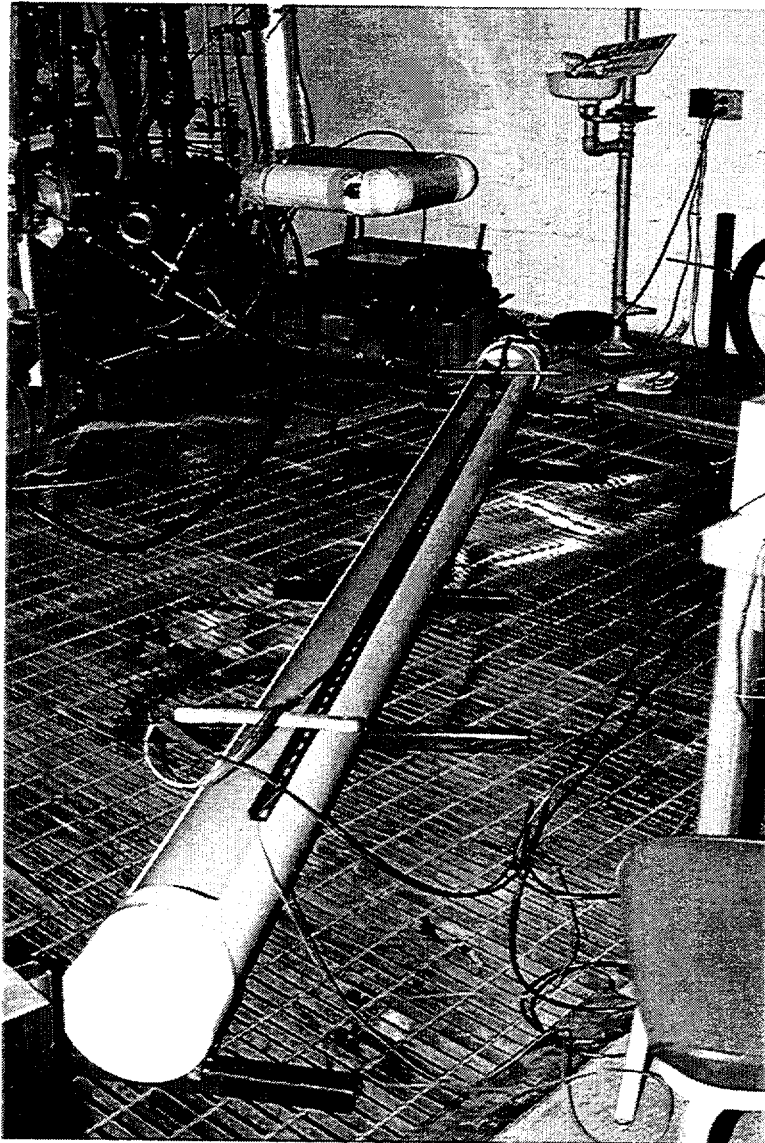
**Figure 2.17** Test setup for the submerged voltage withstand test

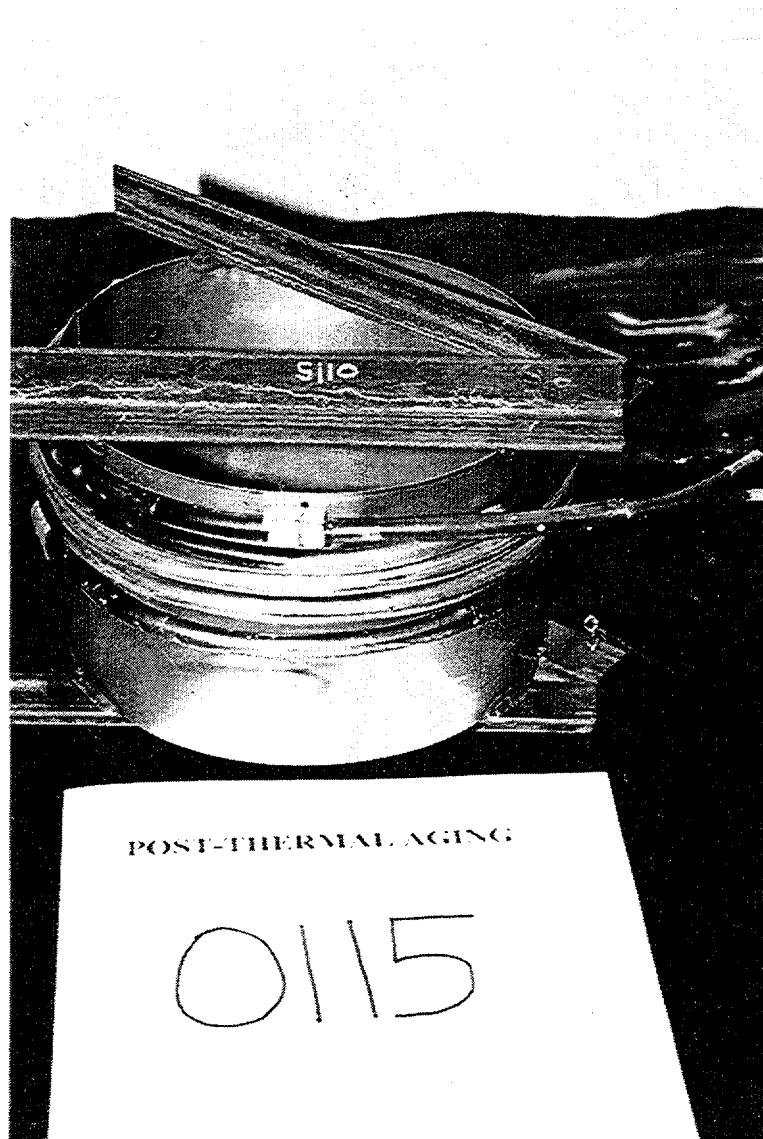
**Figure 3.1** Rockbestos specimen 0115 from Group 1.4 (pre-aged to 20 years)  
after accelerated thermal aging

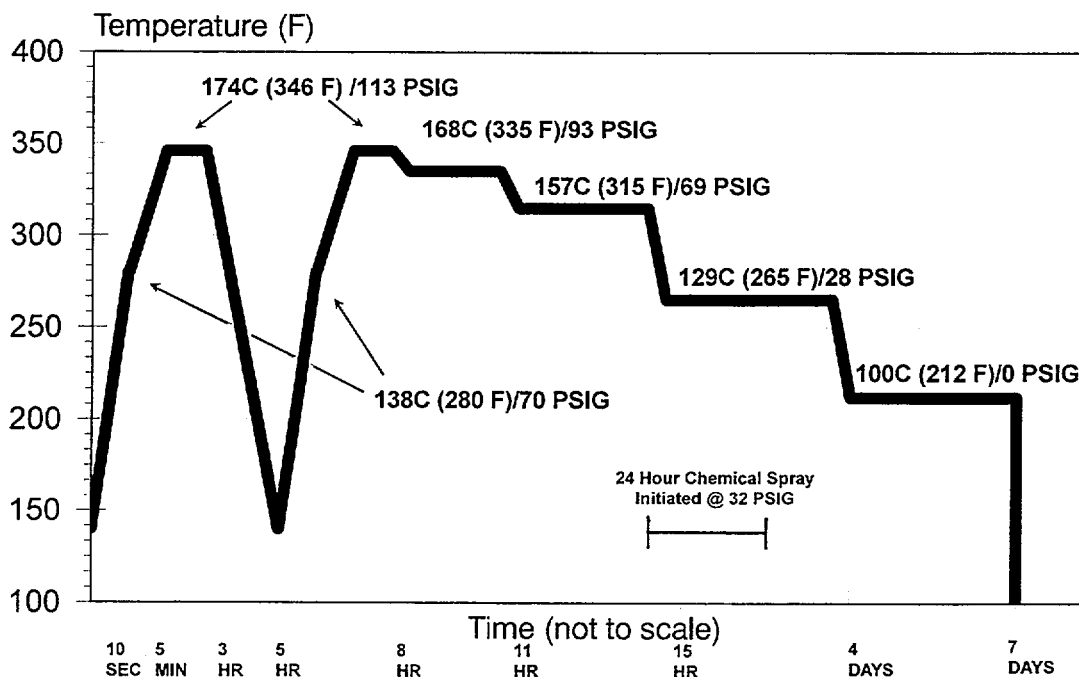
**Figure 3.3 Test chamber temperature/pressure profile used in LOCA Tests 1, 3, 4, 5 and 6**  
 (Note: LOCA Tests 4, 5 and 6 were 10 days in duration)

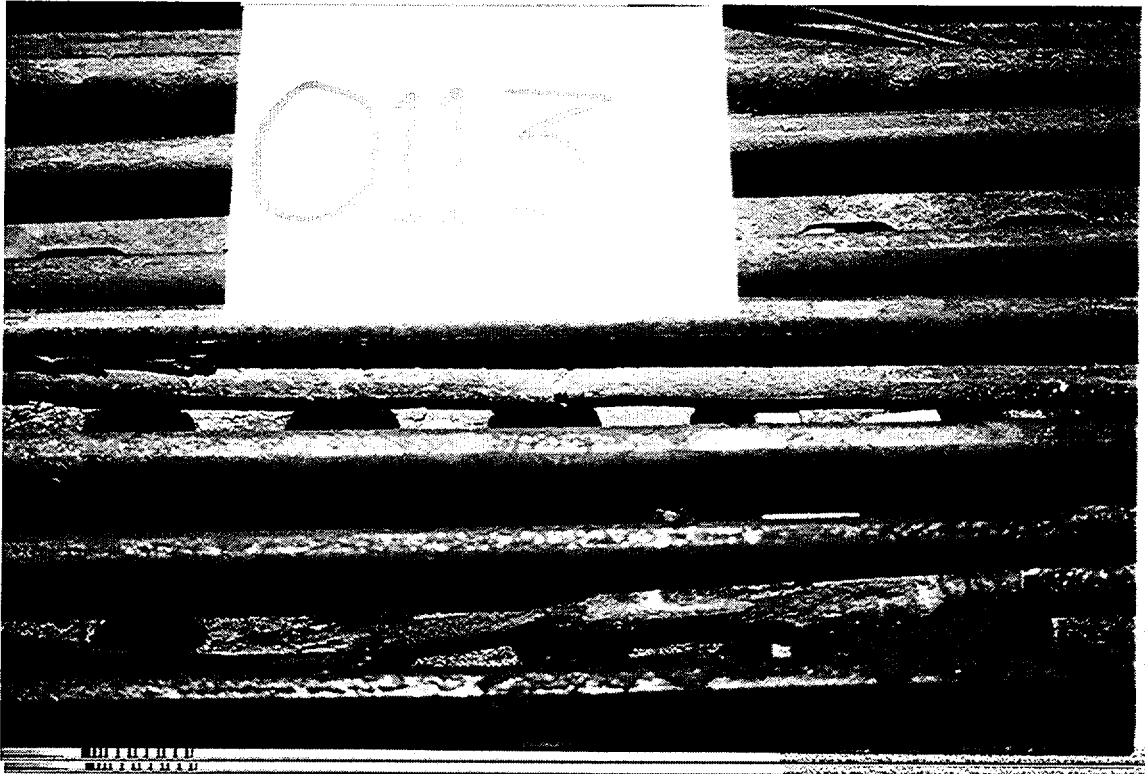
Figure 3.4 Post-LOCA condition of Rockbestos specimen 0113 from Group 1.4 (pre-aged to 20 years)

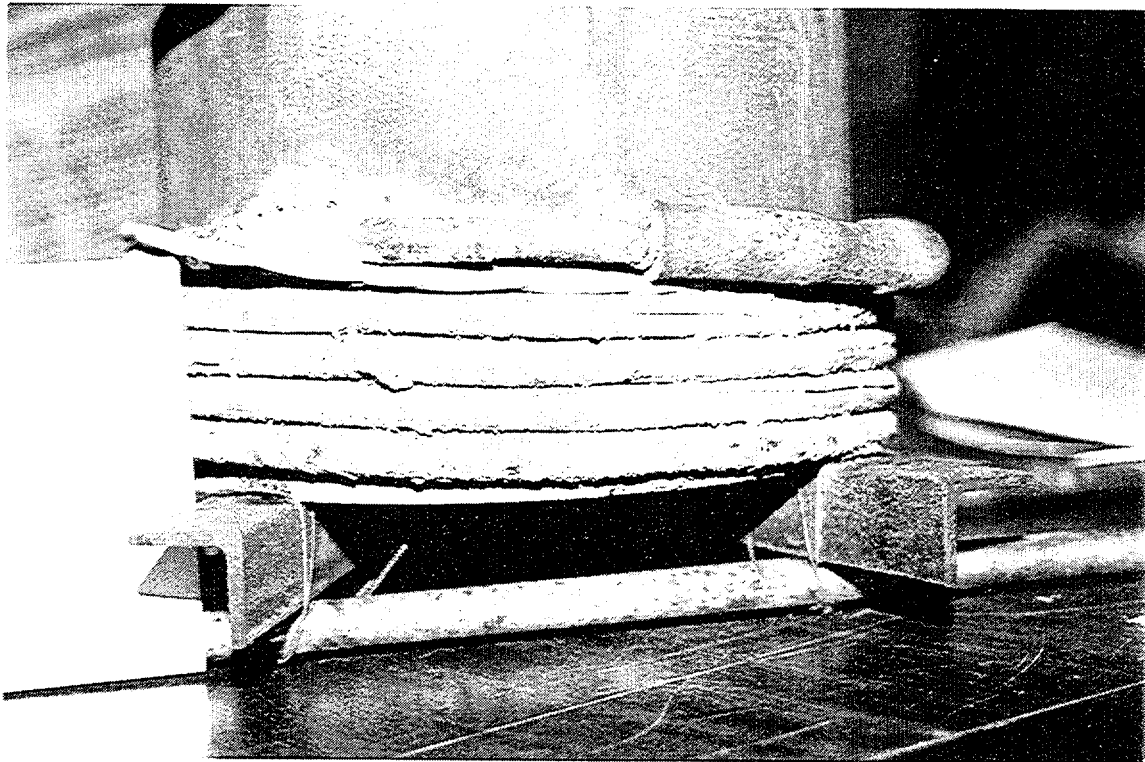
Figure 3.5 Post-LOCA condition of Rockbestos specimen 0115 from Group 1.4 (pre-aged to 20 years)

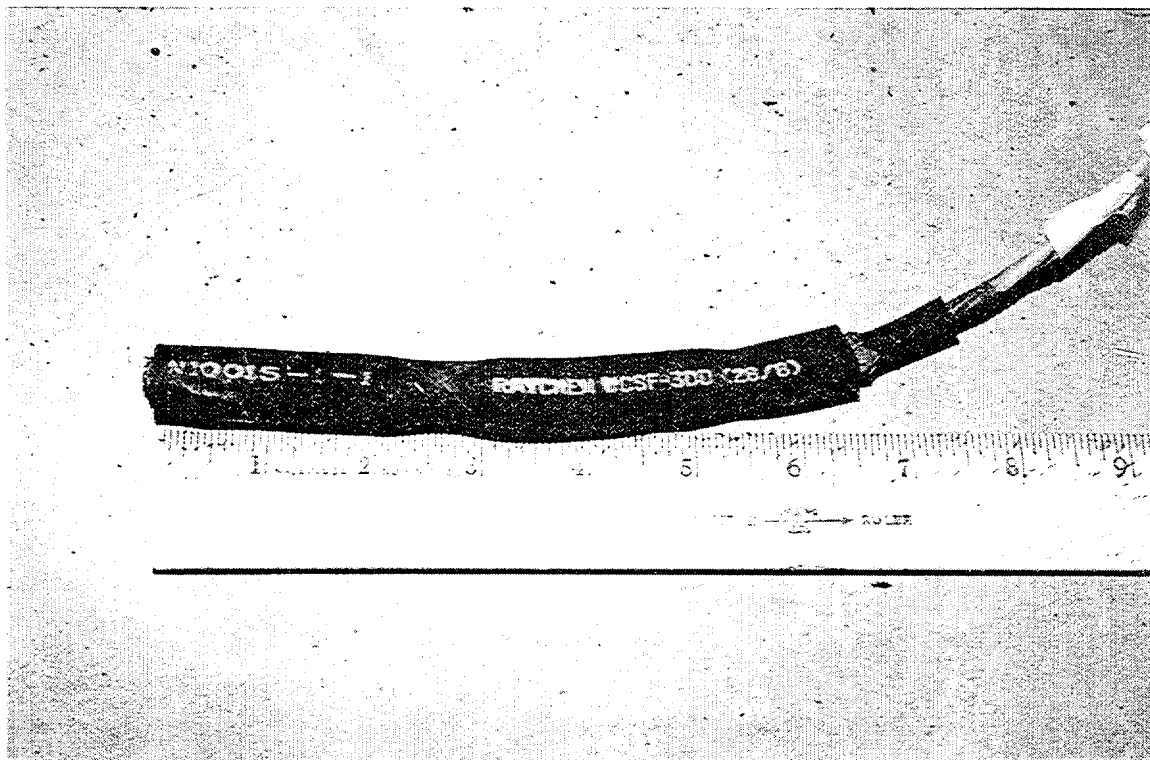
Figure 3.7 Raychem® splice as installed on specimen 0112

Figure 3.7 shows the splice prior to being dissected. One potential problem noted is that, as shown, the overall length of the outer jacket is approximately 6½ inches. According to Raychem®, a longer jacket is recommended and would have provided added protection to the splice. Figure 3.8 shows the splice after removing the outer jacket (top portion of the photograph). The splice is shown beneath the outer jacket, which includes the test specimen (0 to 4 in.), the butt splice (4 in.), an inner sleeve covering the butt splice (2¾ to 5 in.), the Wyle test lead (> 4 in.), and a shim covering the Wyle test lead (5 to 7½ in.). A shim was added to the Wyle test lead to more closely match the diameter of the test specimen, since the Wyle test lead is of smaller diameter. A second potential problem noted is that the individual sleeve used to cover the butt splice is approximately 2 inches long. Raychem® indicated that this is insufficient to prevent moisture penetration into the splice, and should be approximately 6 inches long.

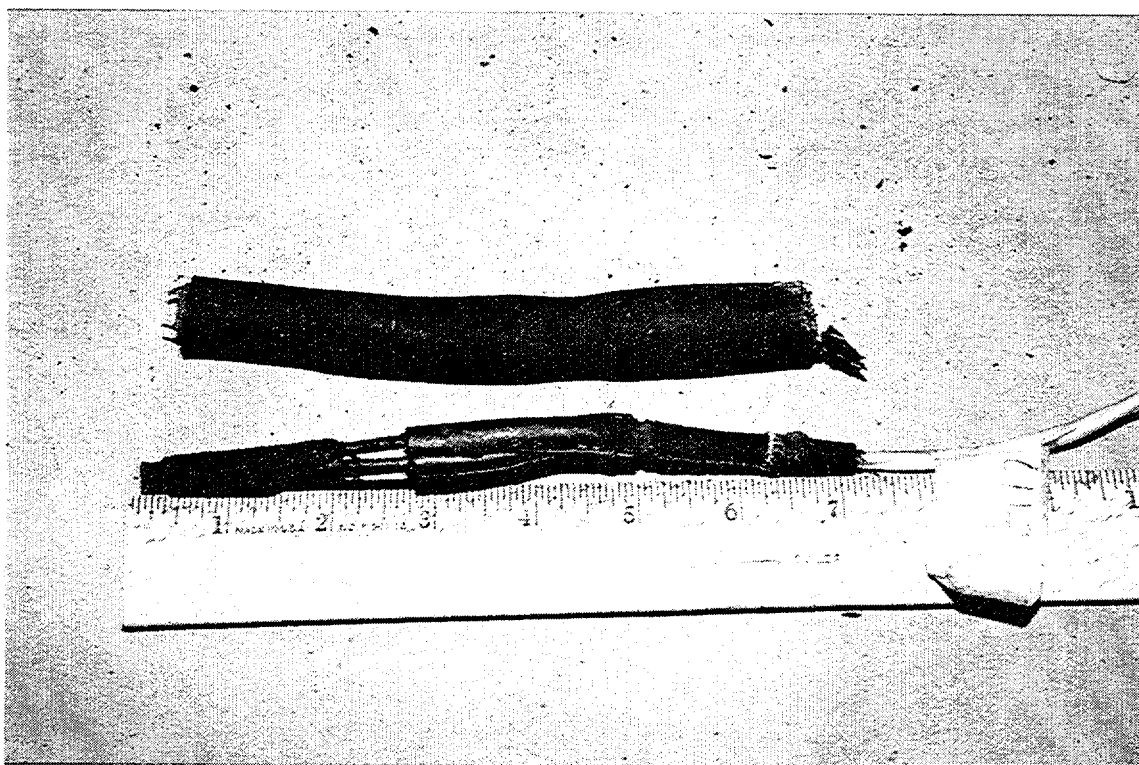
**Figure 3.8 Raychem® splice with outer jacket removed**
