# **Assessment of Environmental Qualification Practices and Condition Monitoring Techniques for Low-Voltage Electric Cables**

**LOCA Test Results**

**Brookhaven National Laboratory**

**U.S. Nuclear Regulatory Commission  
Office of Nuclear Regulatory Research  
Washington, DC 20555-0001**

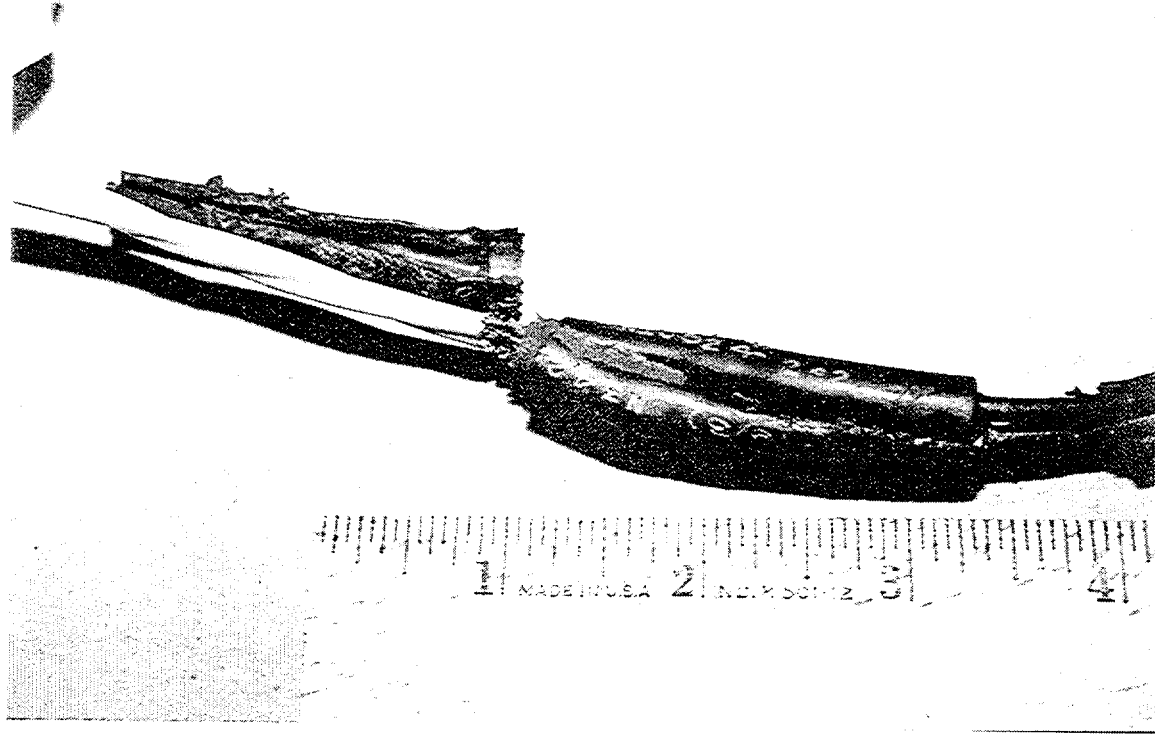
**Figure 3.9 Raychem® splice with test lead shim removed**

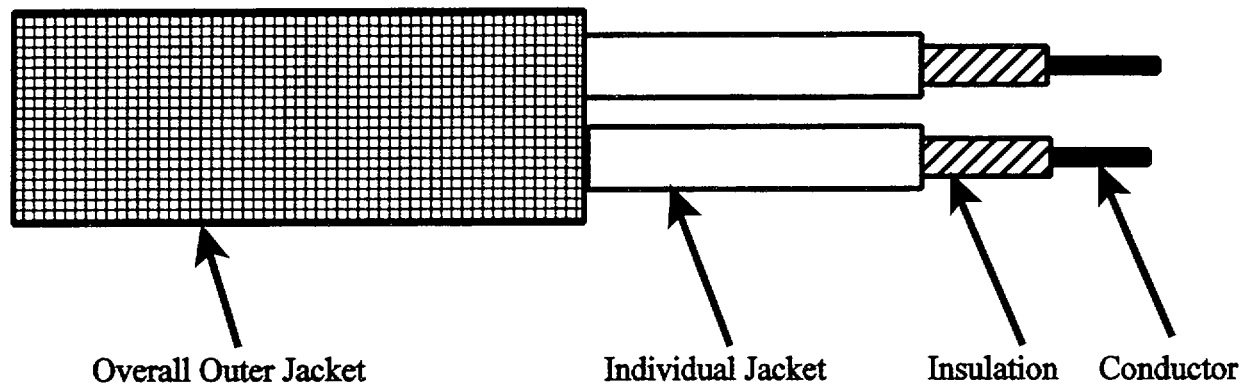
**Figure 3.10 Typical sub-components of EPR/Hypalon® cables**

cables. The conductors were covered as a group with an overall outer jacket, which was also made of Hypalon®. This overall jacket is referred to herein as the “outer” jacket. These components are shown schematically in Figure 3.10.

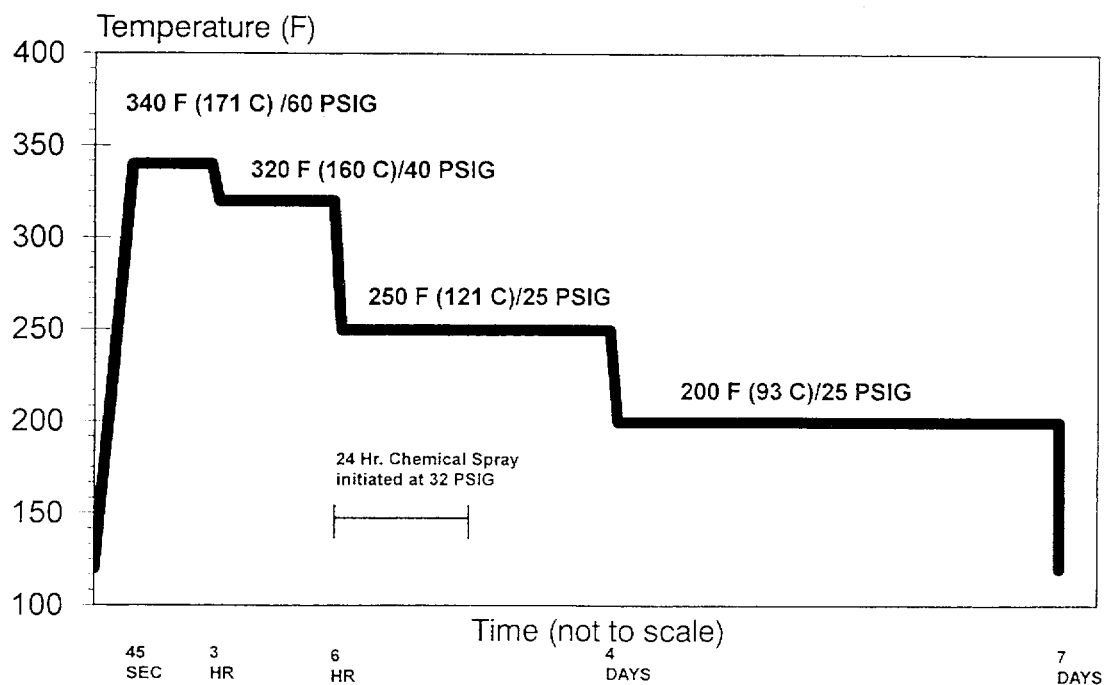
Figure 3.13 Test chamber temperature/pressure profile used in LOCA Test 2

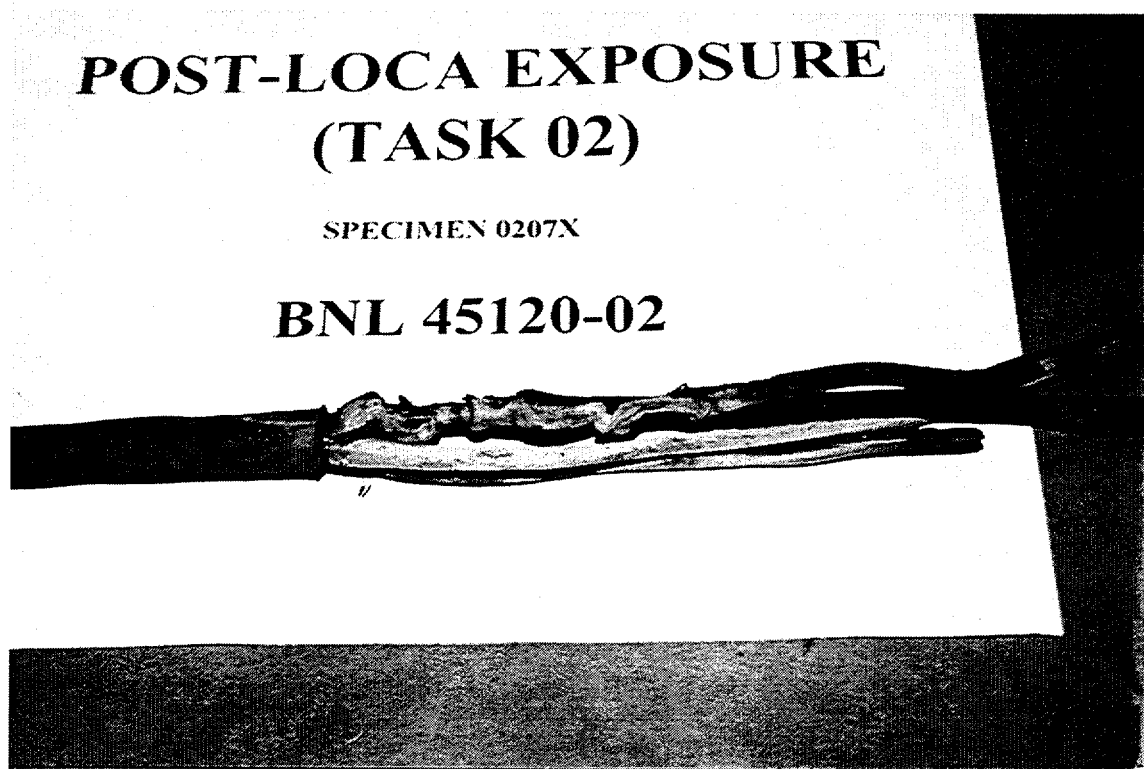
Figure 3.14 Post-LOCA condition of AIW specimen 0207X from Group 2.3 (naturally aged 24 years)

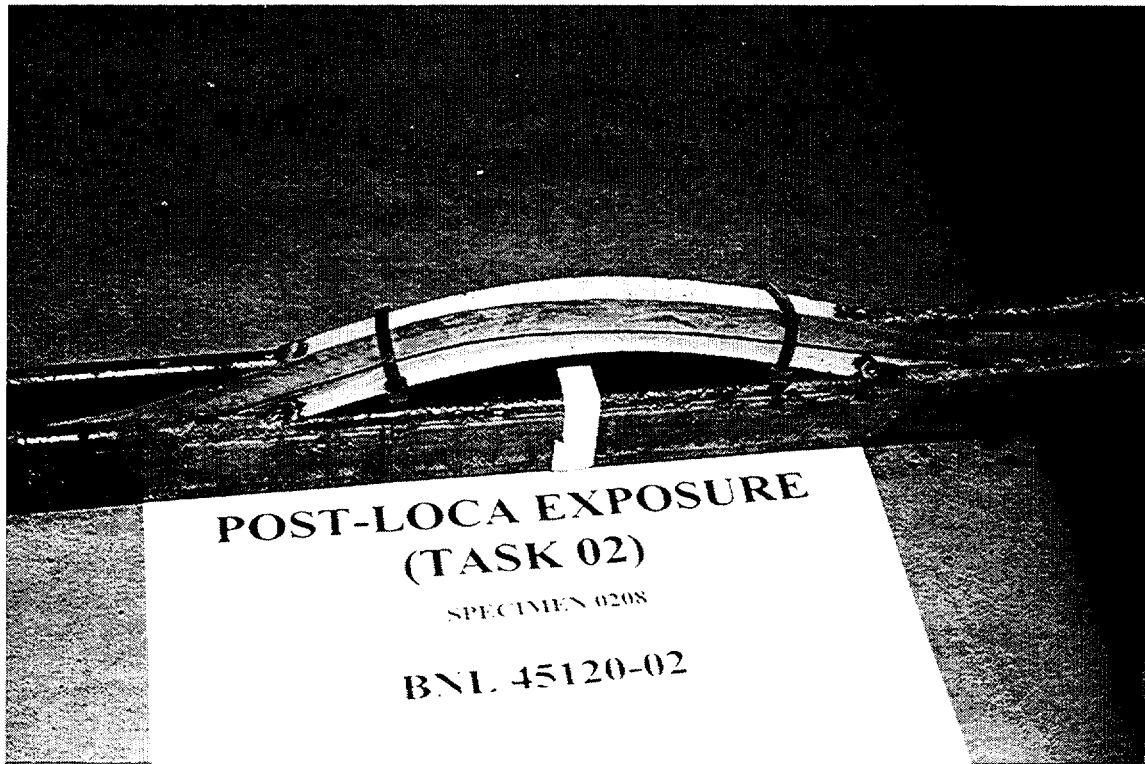
Figure 3.15 Post-LOCA condition of AIW specimen 0208 from Group 2.3 (naturally aged 24 years)

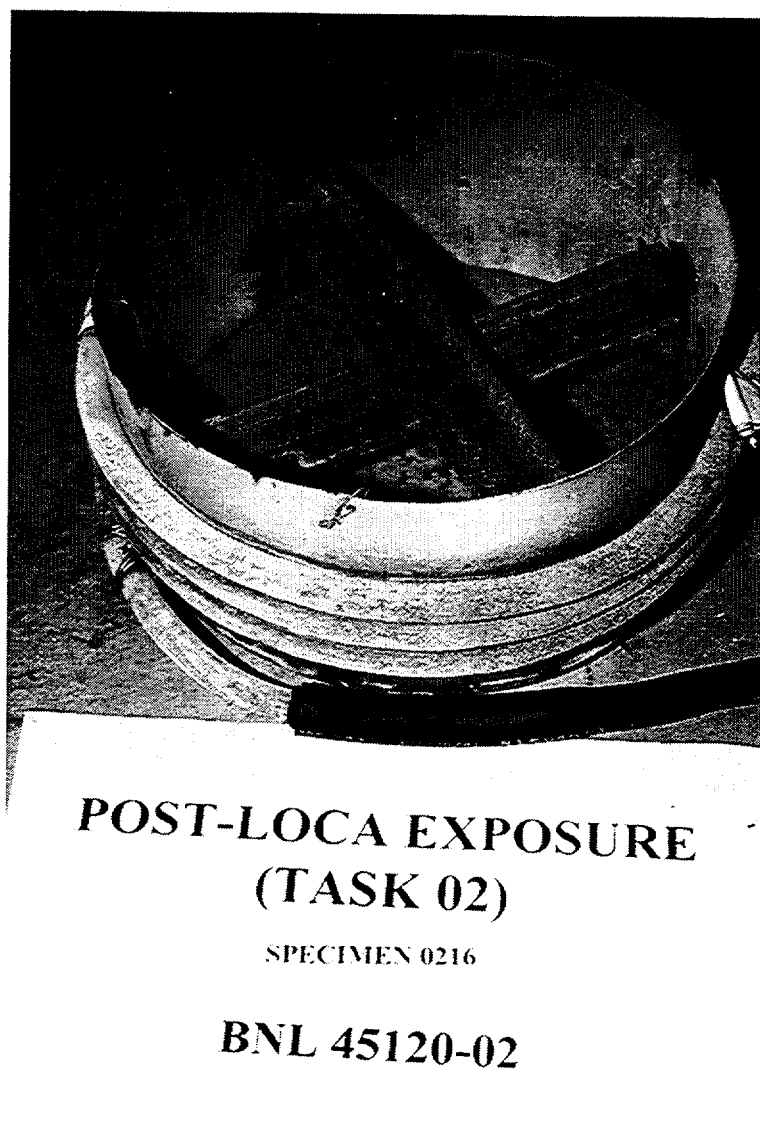
**Figure 3.16 Post-LOCA condition of AIW specimen 0216 from Group 2.4 (pre-aged to 20 years)**

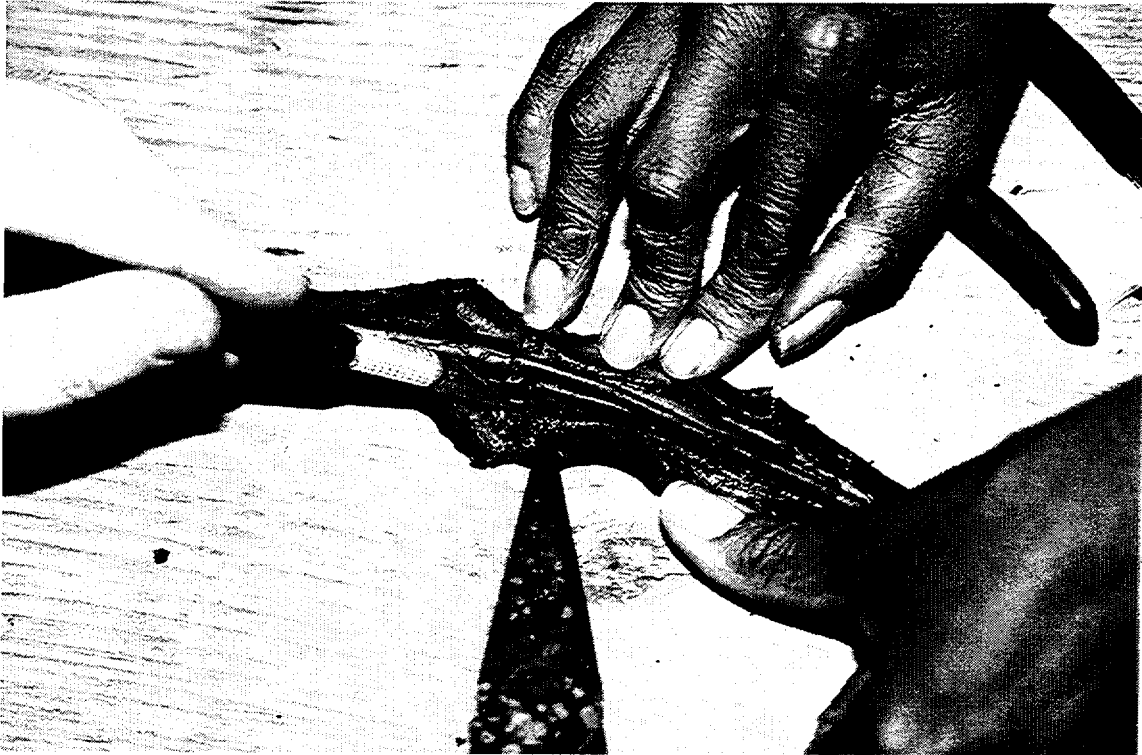
**Figure 3.17** Dissected splice from a Group 3.4 specimen after LOCA testing

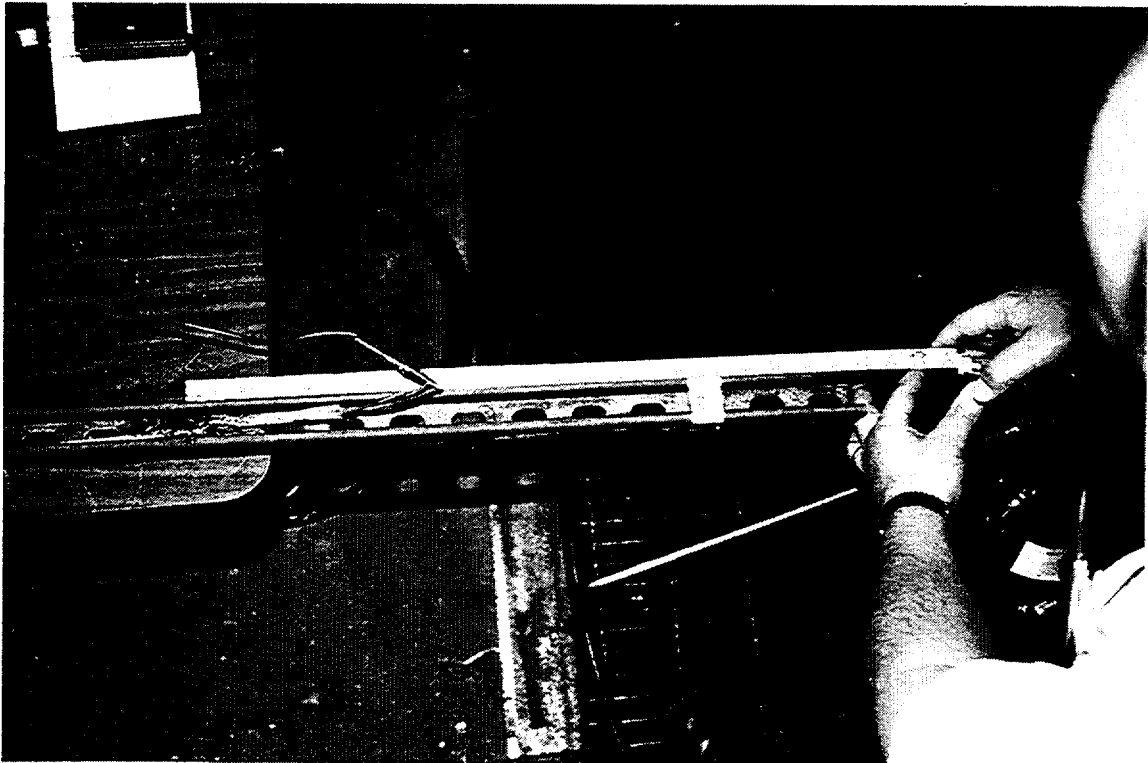
**Figure 3.18** Specimen 0313 fault location near outboard cable tie

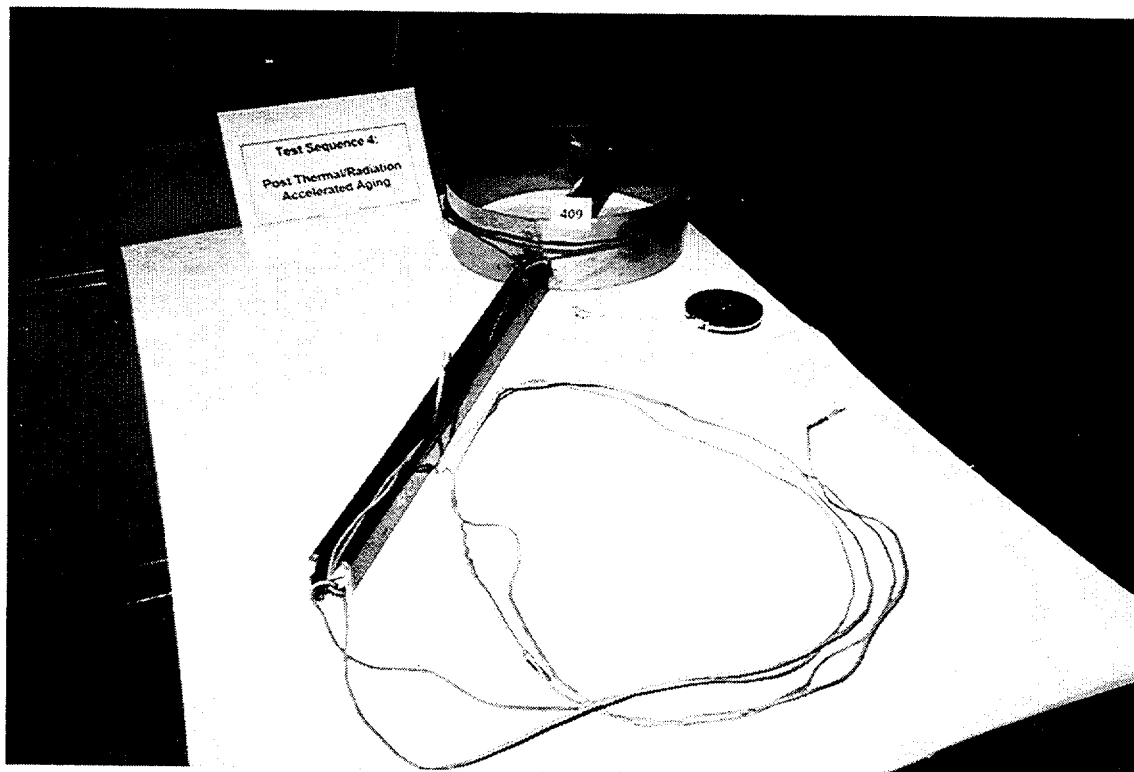
**Figure 3.19 Anaconda single conductor specimen 0409 from Group 4.3 (pre-aged to 40 years) after accelerated service aging**

Figure 3.19 shows Anaconda single conductor specimen 0409 from Group 4.3 (pre-aged to 40 years) after completion of thermal and radiation service aging. As shown, the specimen appeared in good physical condition with no cracking or discoloring noted. Similarly, Figure 3.20 shows Anaconda multiconductor specimens 0410 and 0411 after accelerated service aging, which also appeared in good physical condition. Figures 3.21 and 3.22 show Samuel Moore single conductor and multiconductor specimens 0412 and 0415 from Group 4.3 (pre-aged to 40 years), respectively, after thermal and radiation service aging. Again, these specimens appeared in good physical condition with no cracking or discoloring evident.

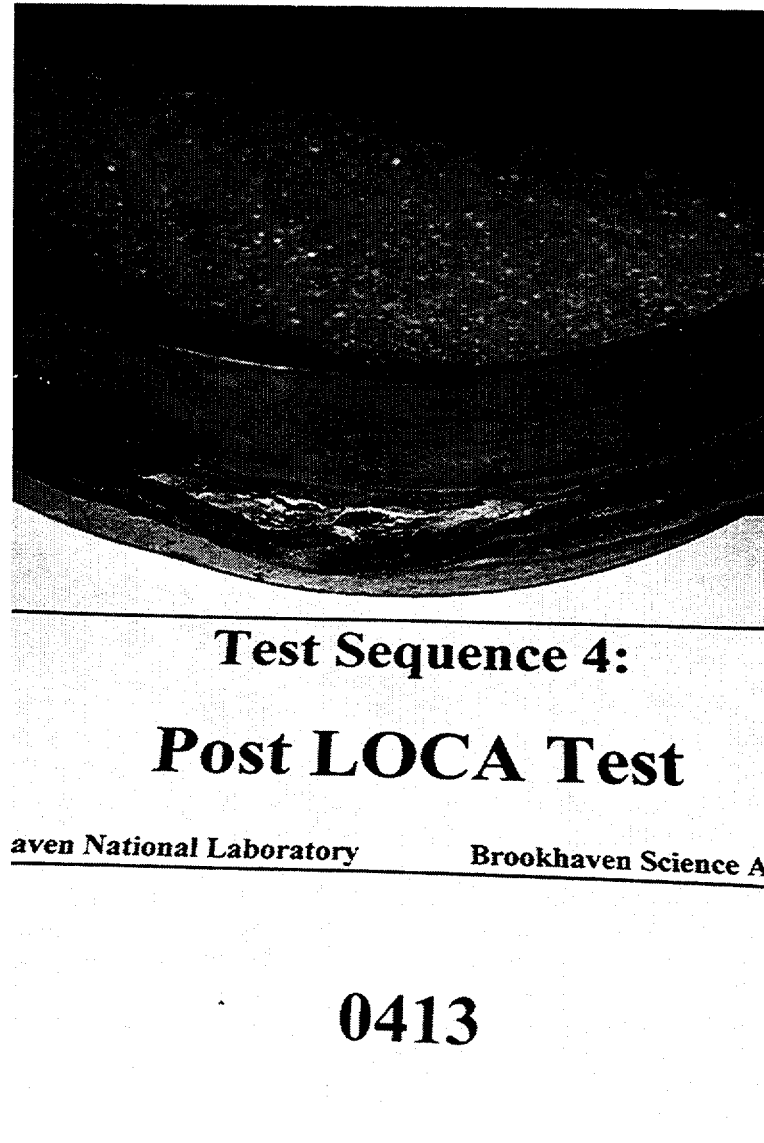
Figure 3.23 Post-LOCA condition of Samuel Moore multiconductor specimen 0413 from Group 4.3 (pre-aged to 40 years)

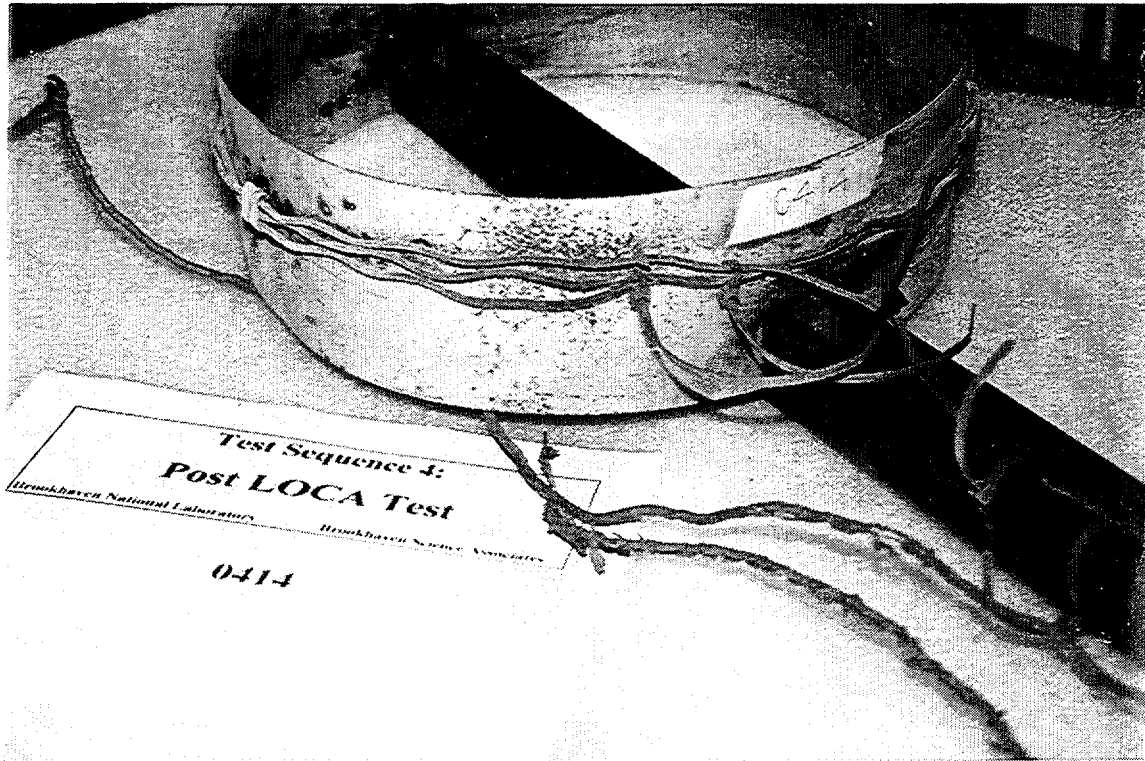
Figure 3.24 Post-LOCA condition of Samuel Moore single conductor specimen 0414 from Group 4.3

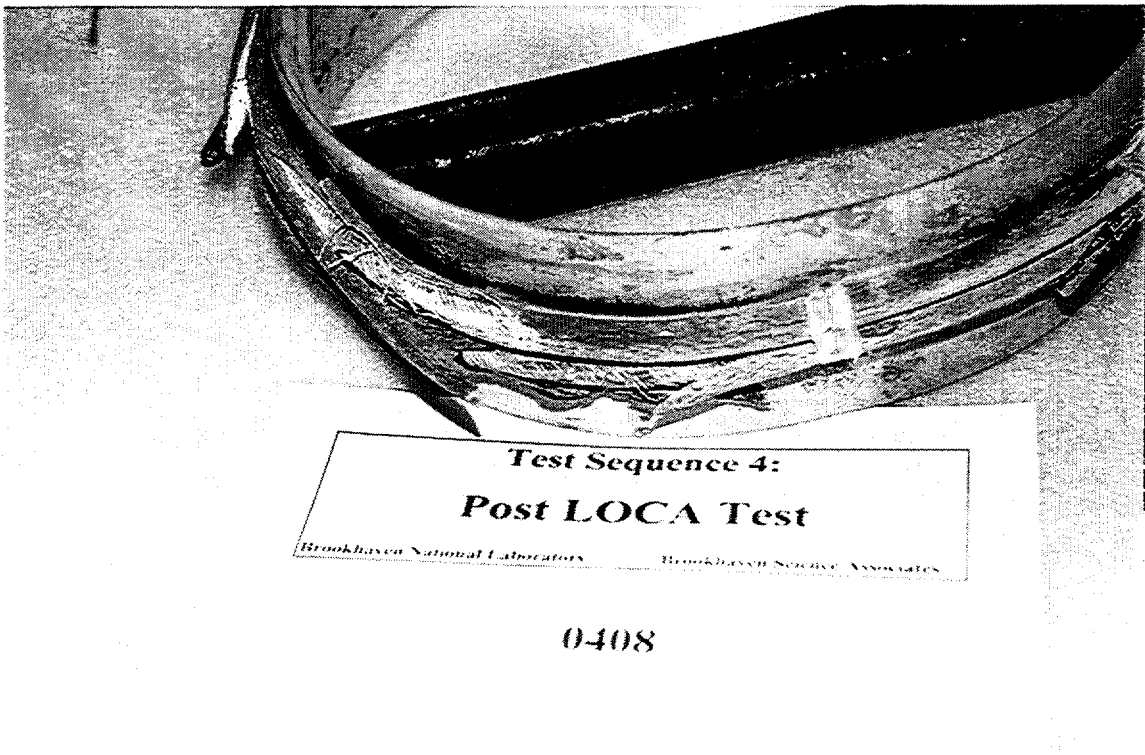
Figure 3.25 Post-LOCA condition of Anaconda multiconductor specimen 0408 from Group 4.3 (pre-aged to 40 years)

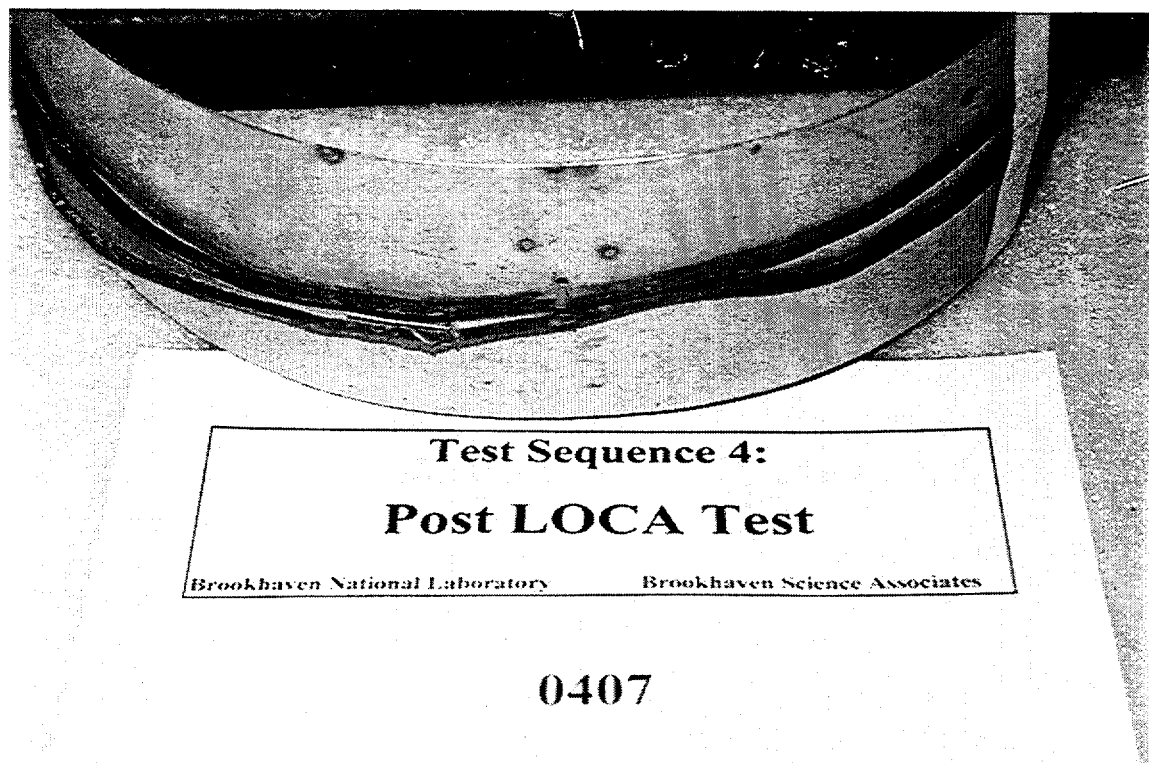
**Figure 3.26 Post-LOCA condition of Anaconda single conductor specimen 0407 from Group 4.3 (pre-aged to 40 years)**

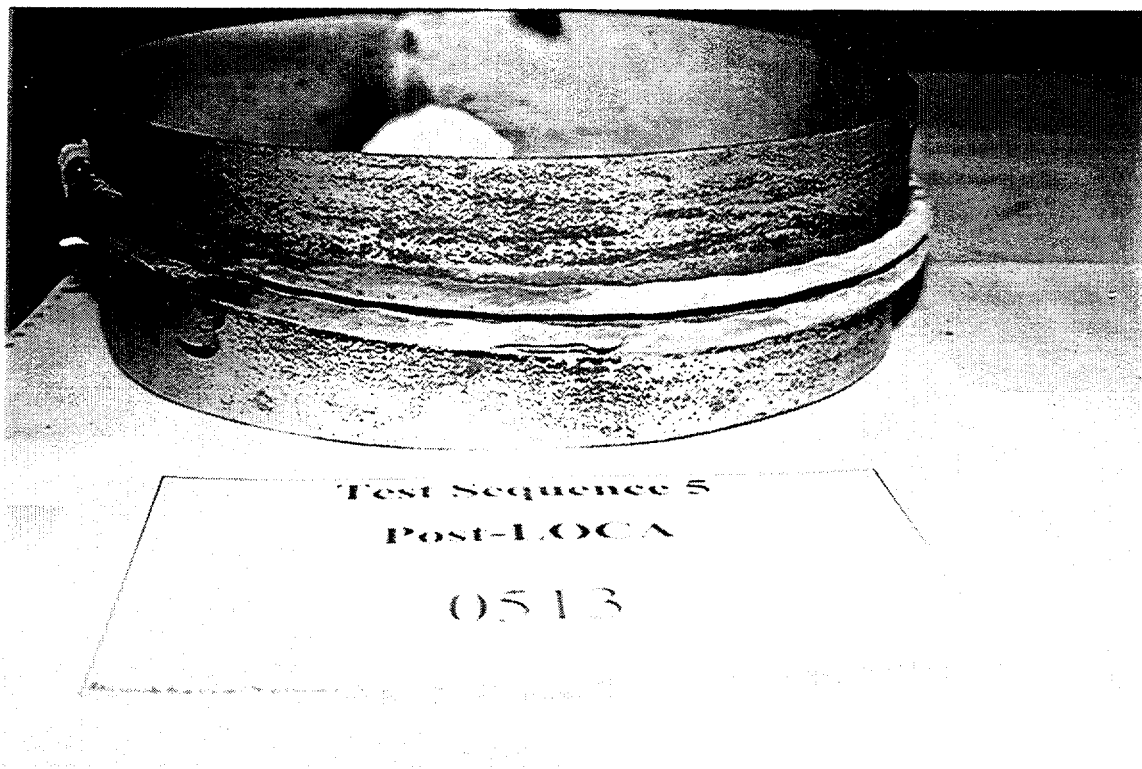
**Figure 3.28 Post-LOCA condition of Samuel Moore specimen 0513 from Group 5.3 (pre-aged to 40 years)**

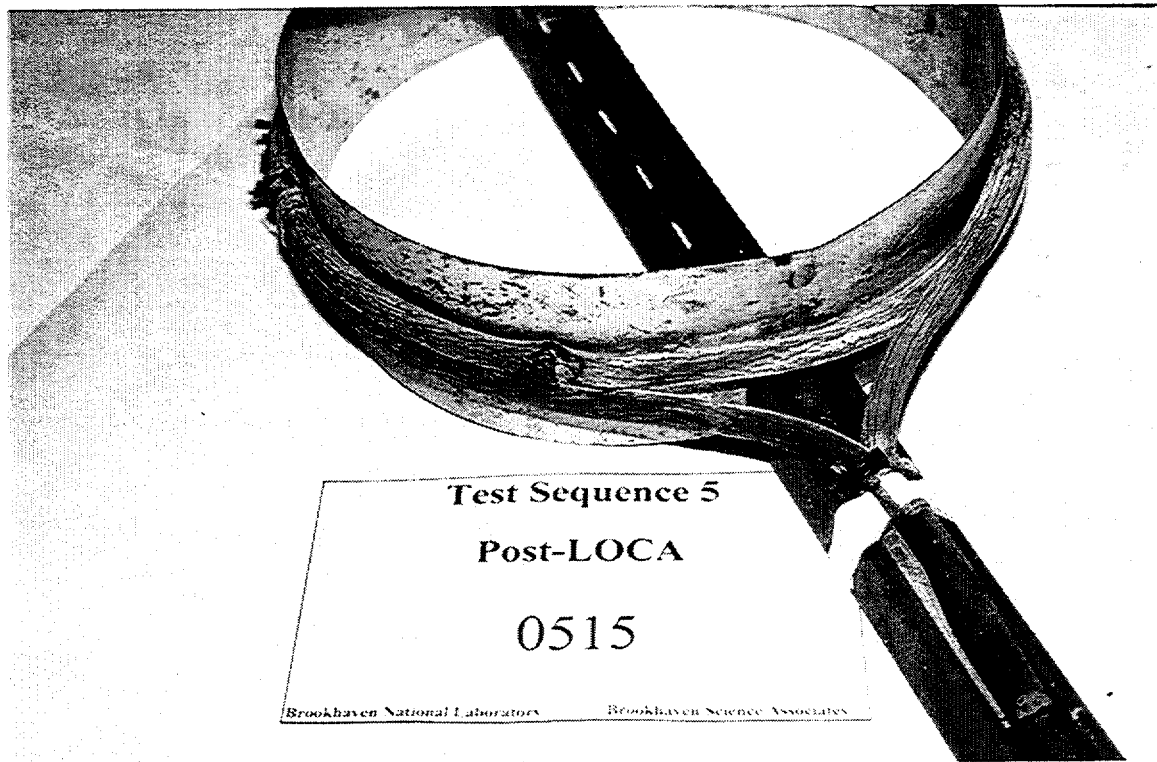
Figure 3.29 Post-LOCA condition of Anaconda specimen 0515 from Group 5.3 (pre-aged to 40 years)

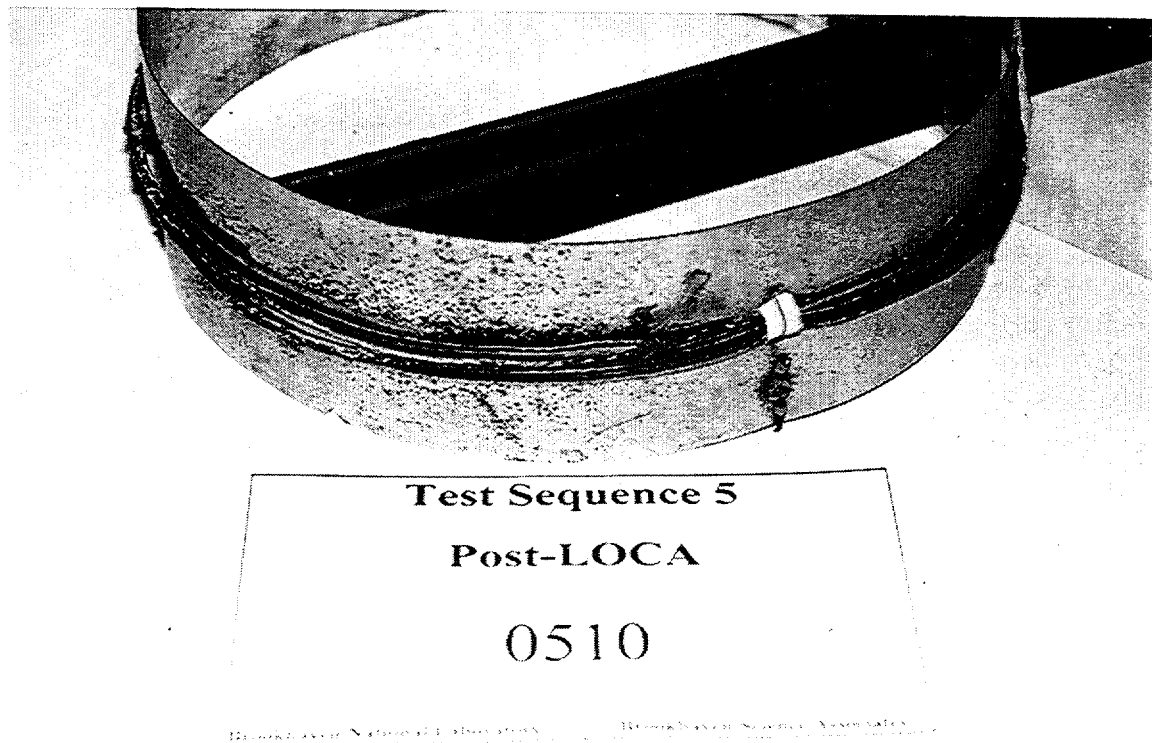
Figure 3.30 Post-LOCA condition of Okonite specimen 0510 in Group 5.3 (pre-aged to 40 years)

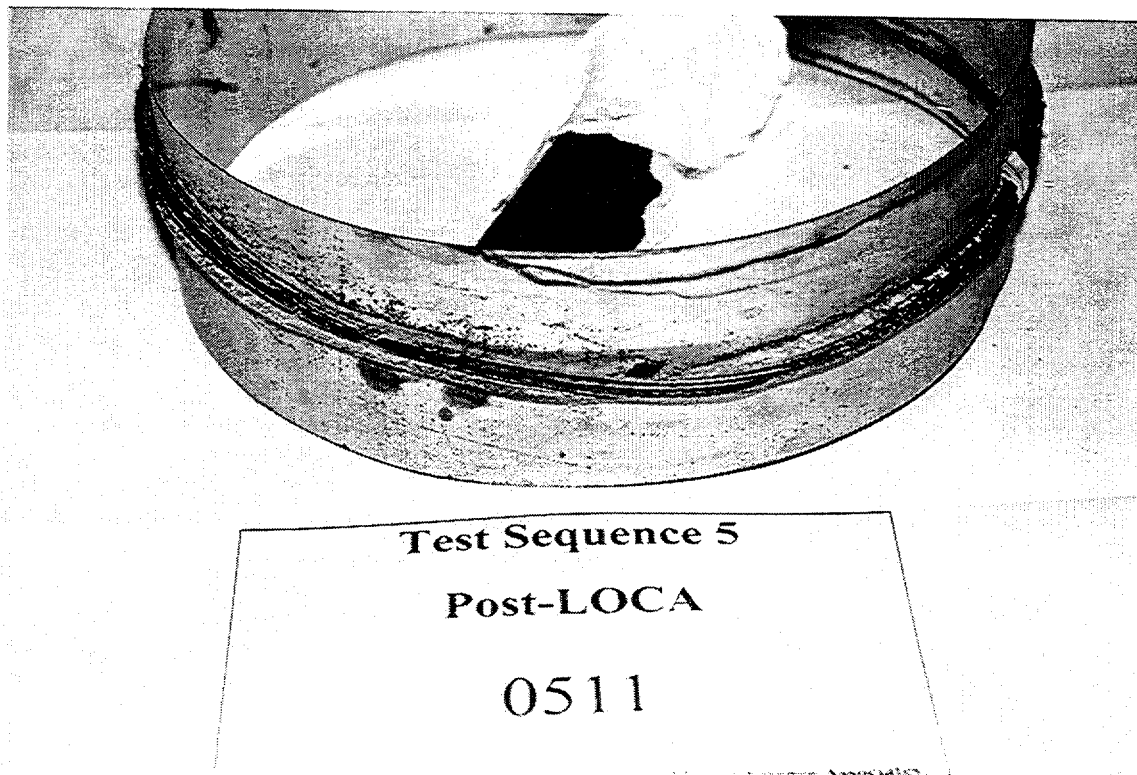
Figure 3.31 Post-LOCA condition of Okonite specimen 0511 in Group 5.3 (pre-aged to 40 years)

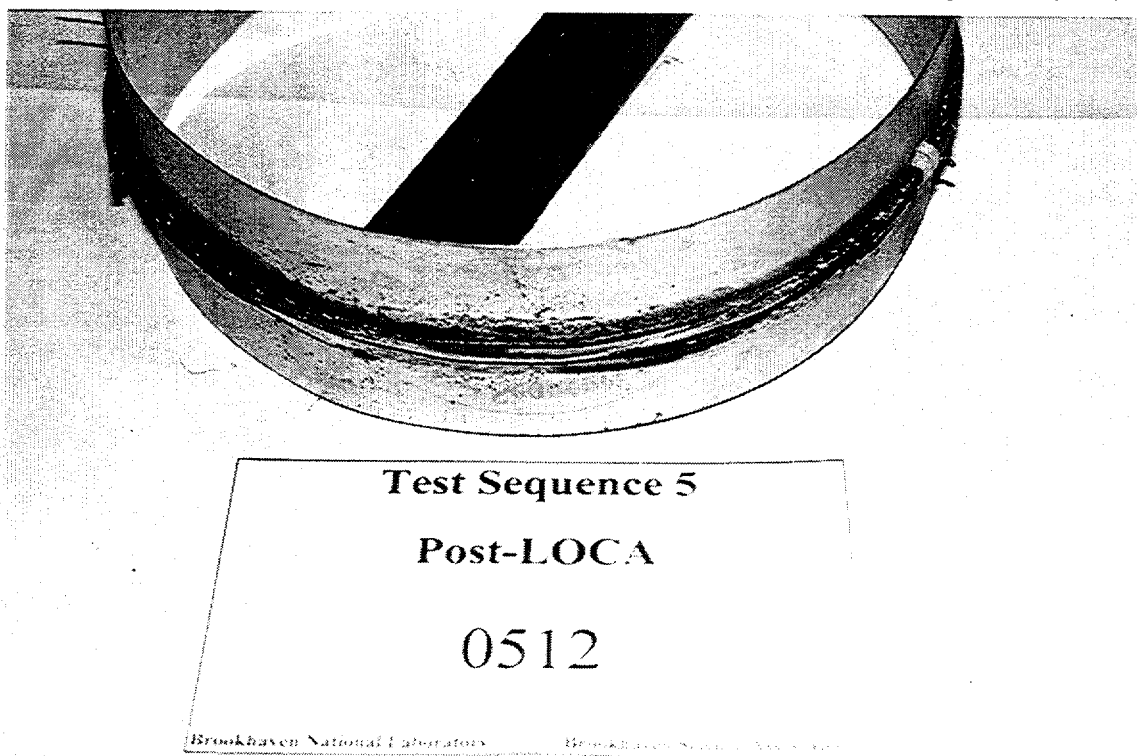
Figure 3.32 Post-LOCA condition of Okonite specimen 0512 in Group 5.3 (pre-aged to 40 years)

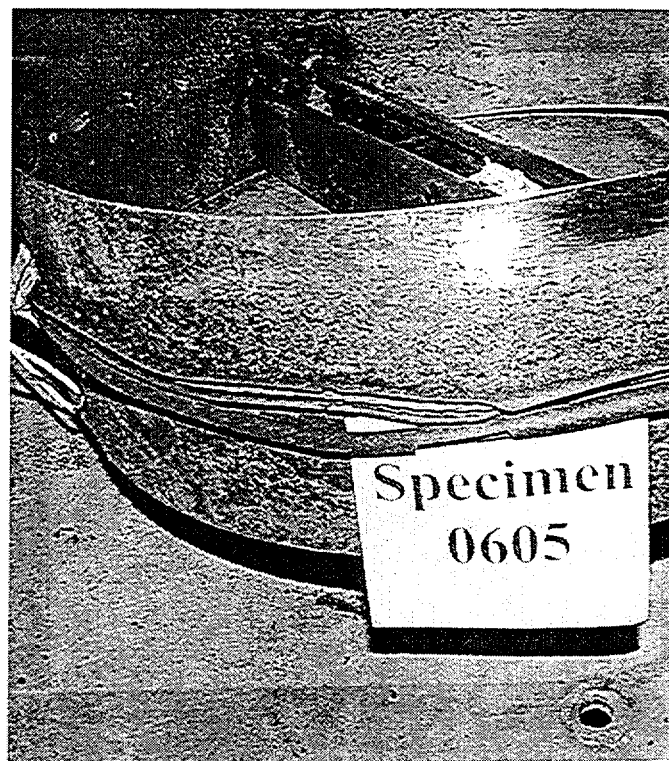
**Figure 3.37** Post-LOCA condition of Okonite specimen 0605 from Group 6.2 (pre-aged to 60 years)

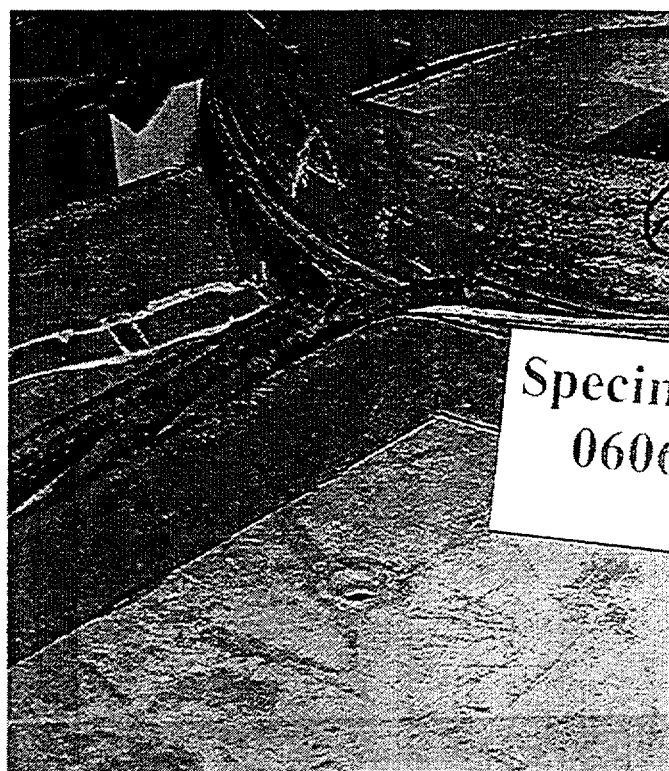
**Figure 3.38** Post-LOCA condition of Okonite specimen 0606 from Group 6.2 (pre-aged to 60 years)

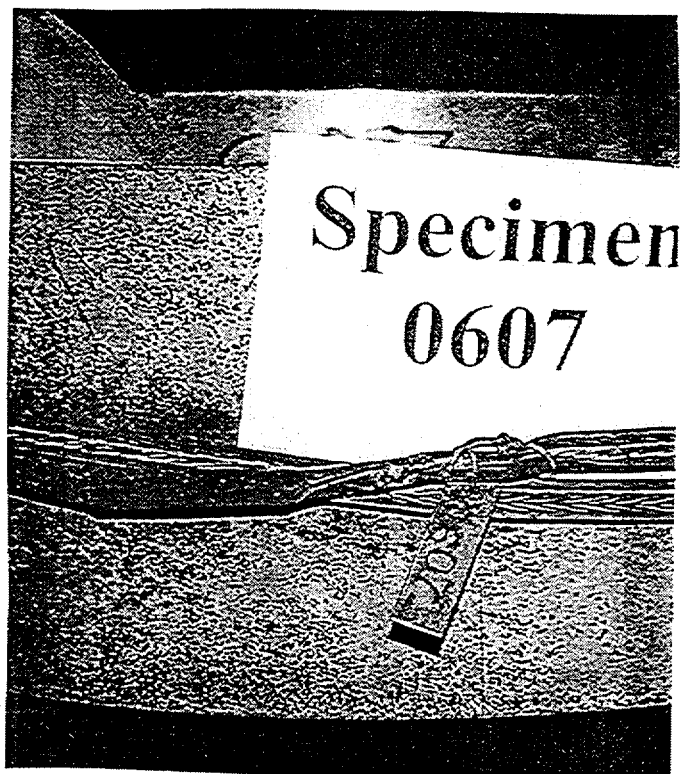
Figure 3.39 Post-LOCA condition of Okonite specimen 0607 from Group 6.2 (pre-aged to 60 years)

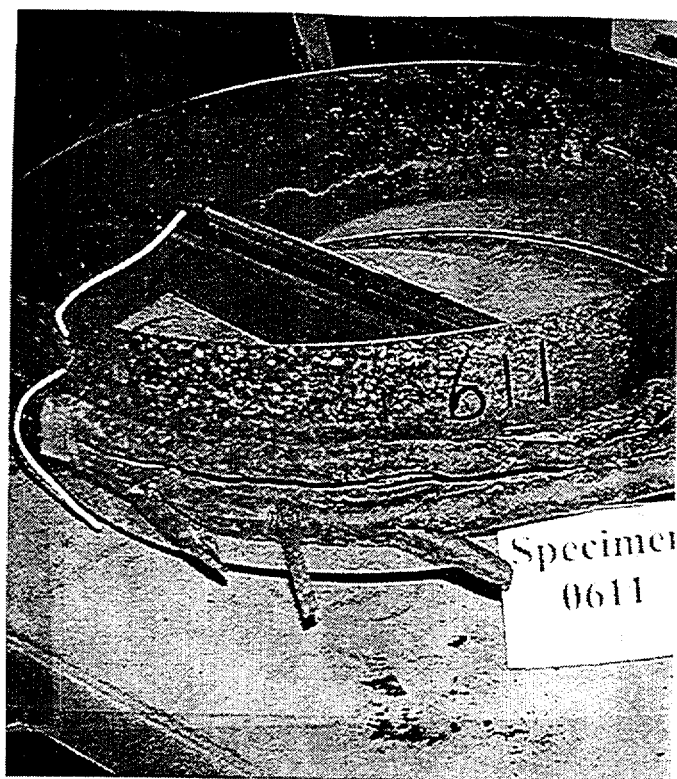
Figure 3.40 Post-LOCA condition of AIW specimen 0611 from Group 6.2 (pre-aged to 60 years)

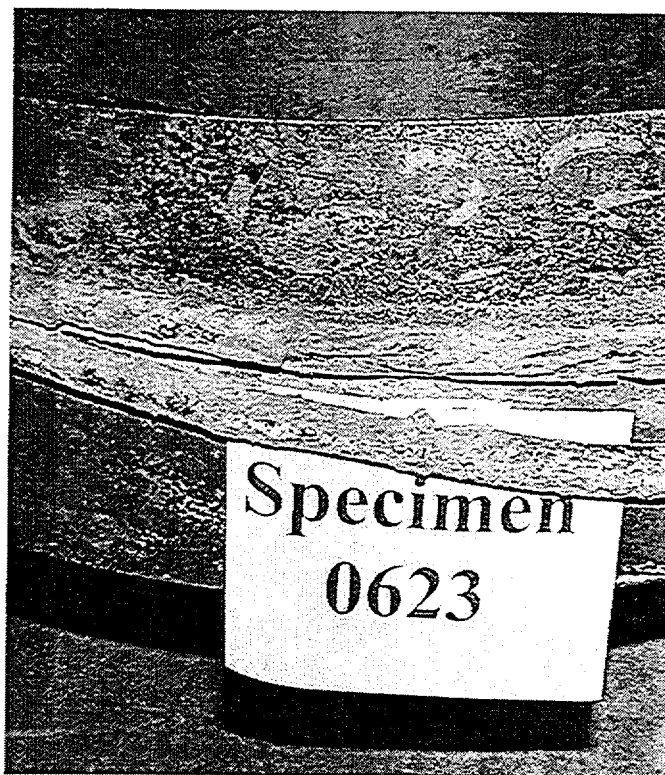
**Figure 3.41 Post-LOCA condition of Rockbestos specimen 0623 from Group 6.2 (pre-aged to 60 years)**

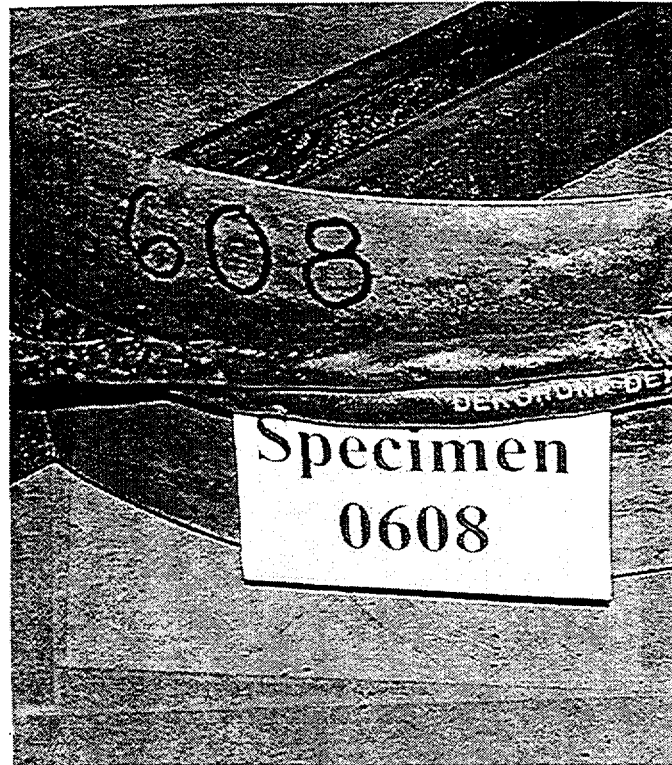
**Figure 3.42 Post-LOCA condition of Samuel Moore specimen 0608 from Group 6.2 (pre-aged to 60 years)**

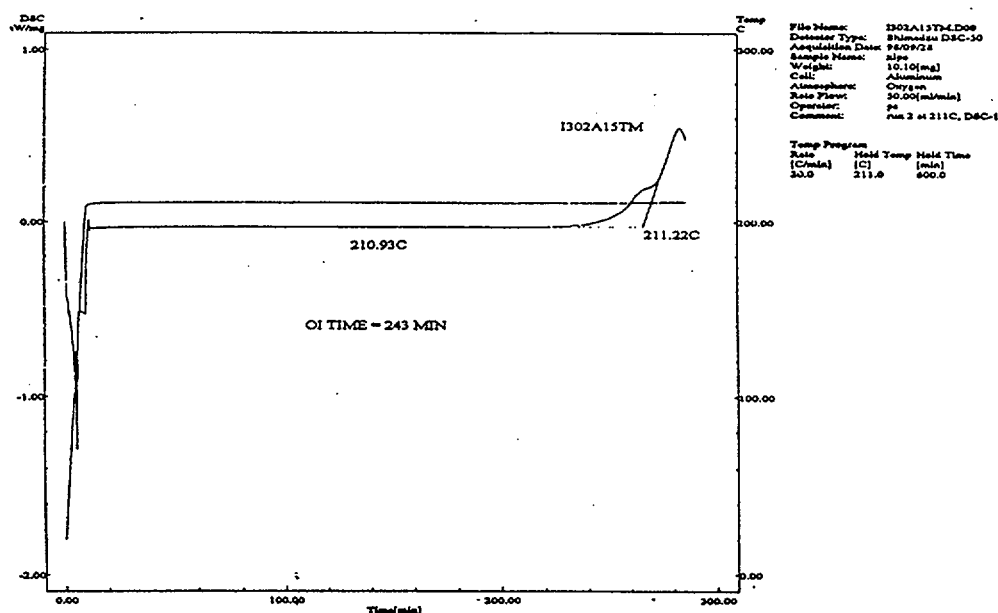
Figure 3.43 Typical DSC Thermogram for XLPE Insulation Oxidized in Oxygen at 410°F (210°C)

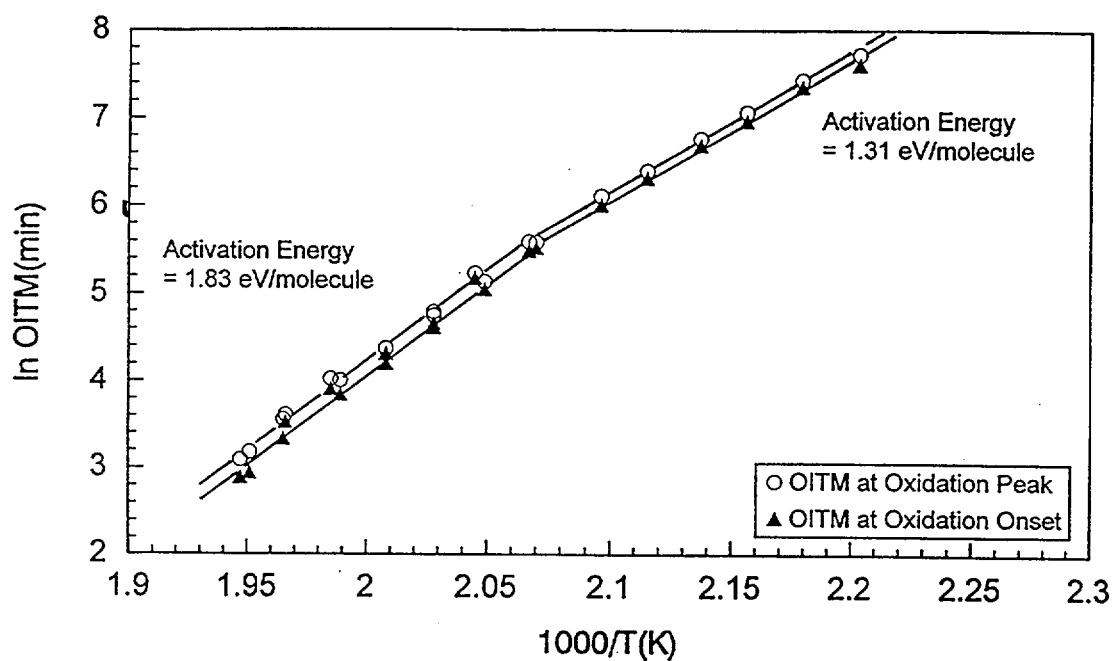
Figure 3.44 Arrhenius plot for white XLPE insulation

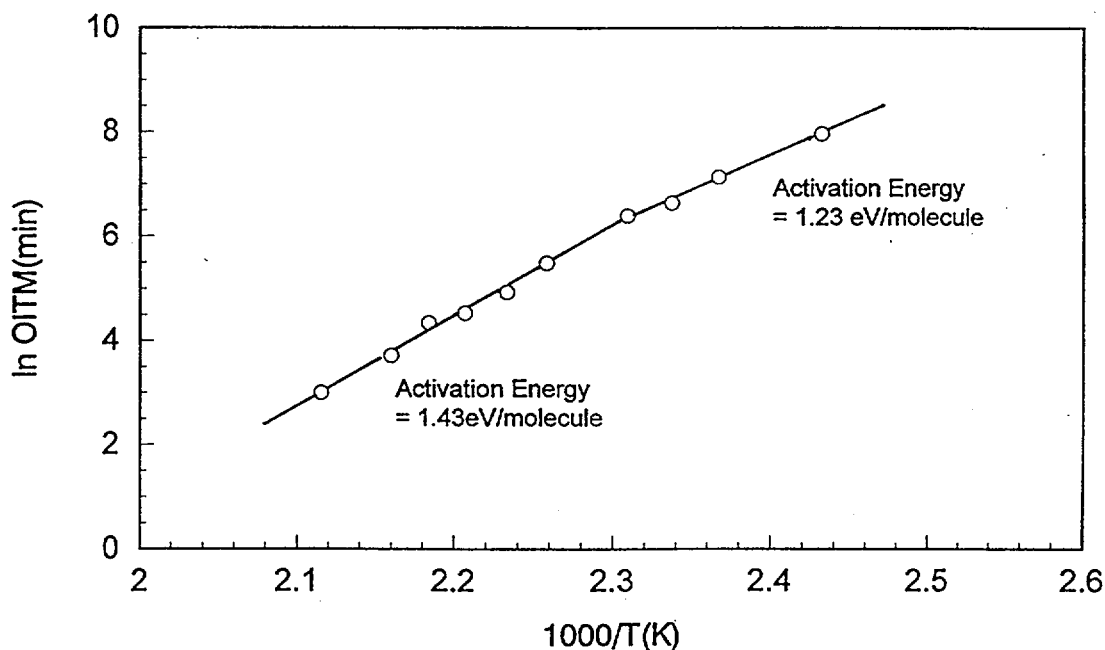
Figure 3.45 Arrhenius plot for EPR insulation

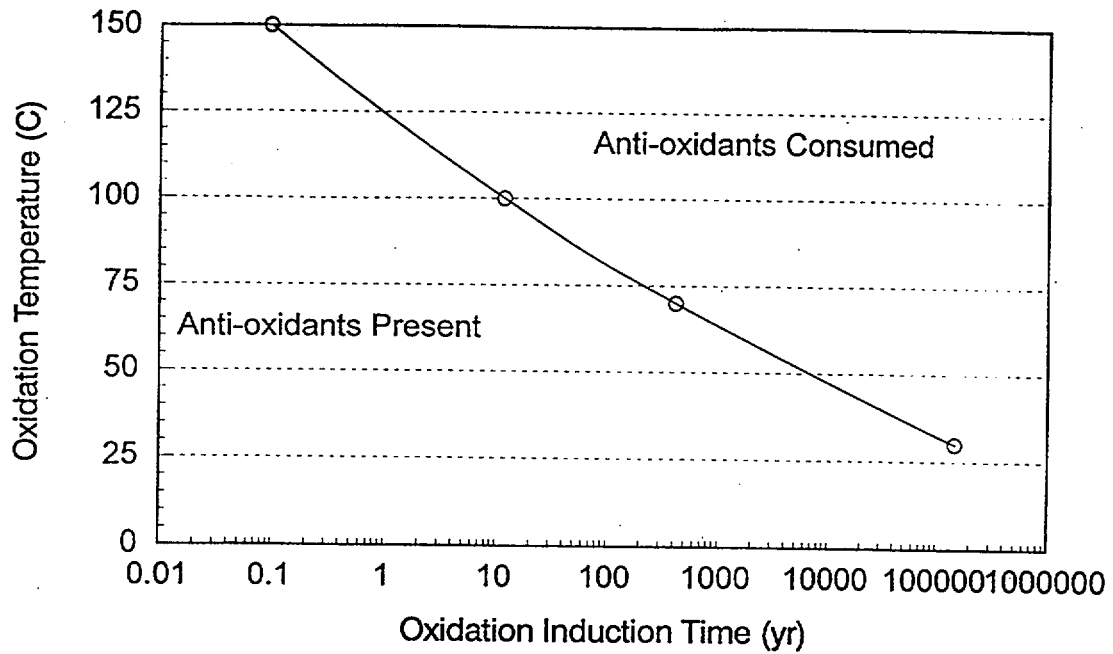
Figure 3.46 Estimated times for depletion of antioxidants in XLPE as a function of aging temperature in an air environment

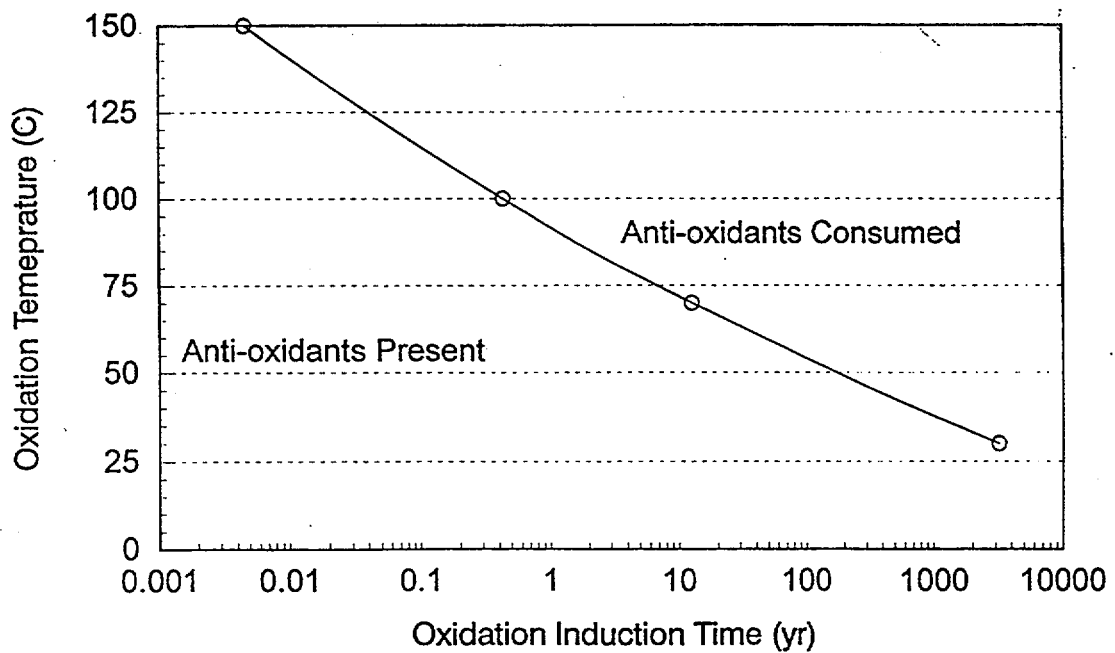
Figure 3.47 Estimated times for depletion of antioxidants in EPR as a function of aging temperature in an air environment
