# **Assessment of Environmental Qualification Practices and Condition Monitoring Techniques for Low-Voltage Electric Cables**

**LOCA Test Results**

**Brookhaven National Laboratory**

**U.S. Nuclear Regulatory Commission  
Office of Nuclear Regulatory Research  
Washington, DC 20555-0001**

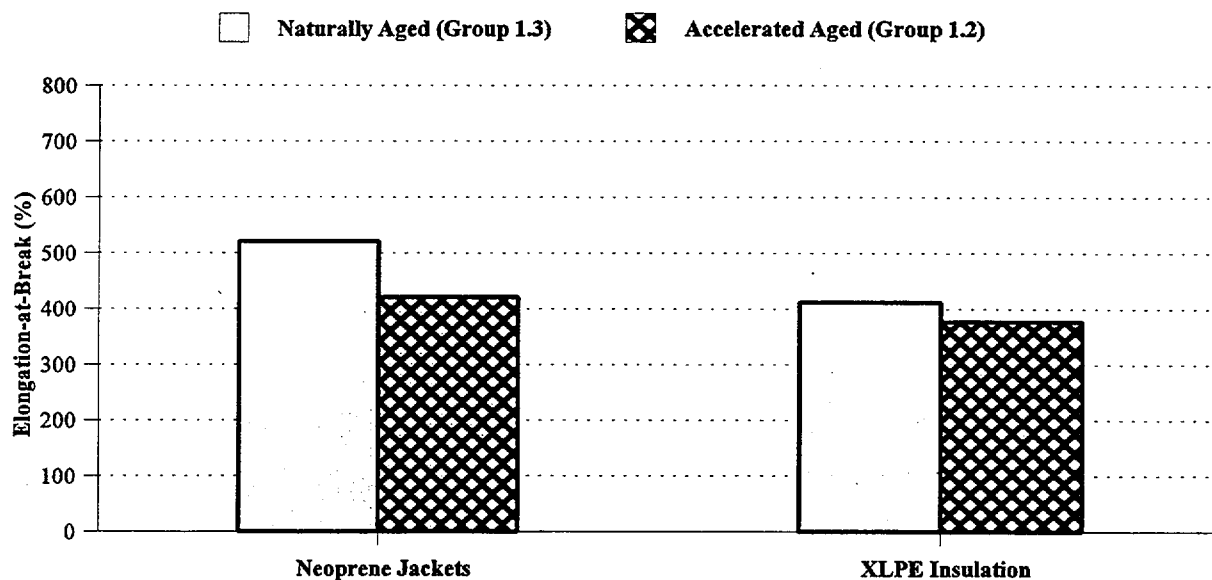
**Figure 4.1** EAB values for naturally aged and accelerated aged Neoprene®/XLPE specimens from Test Sequence 1

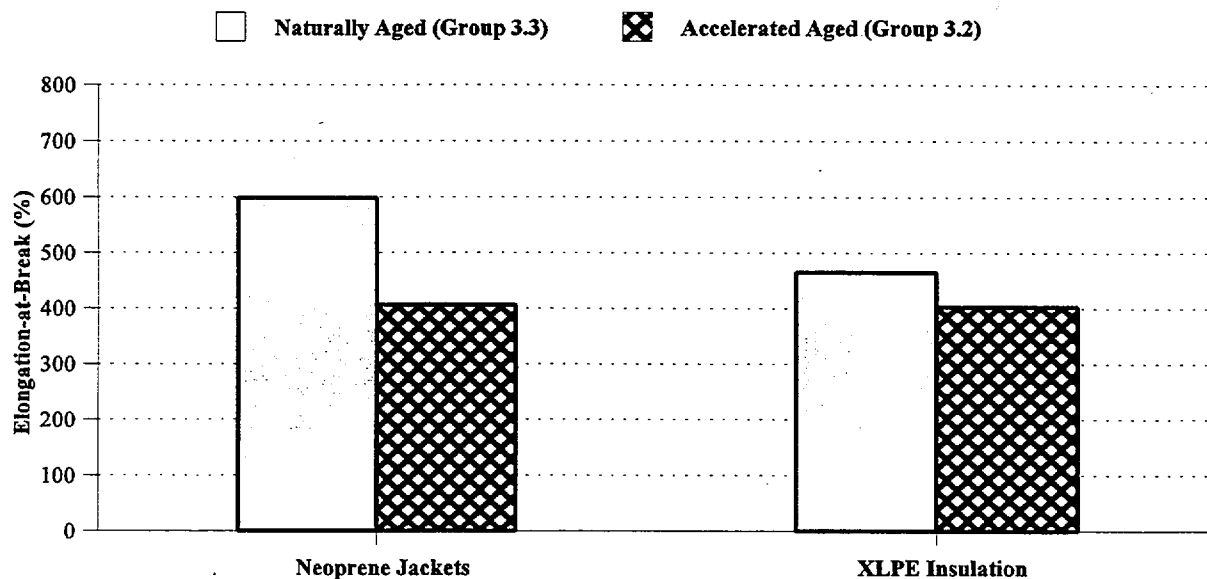
**Figure 4.2** EAB values for naturally aged and accelerated aged Neoprene®/XLPE specimens from Test Sequence 3

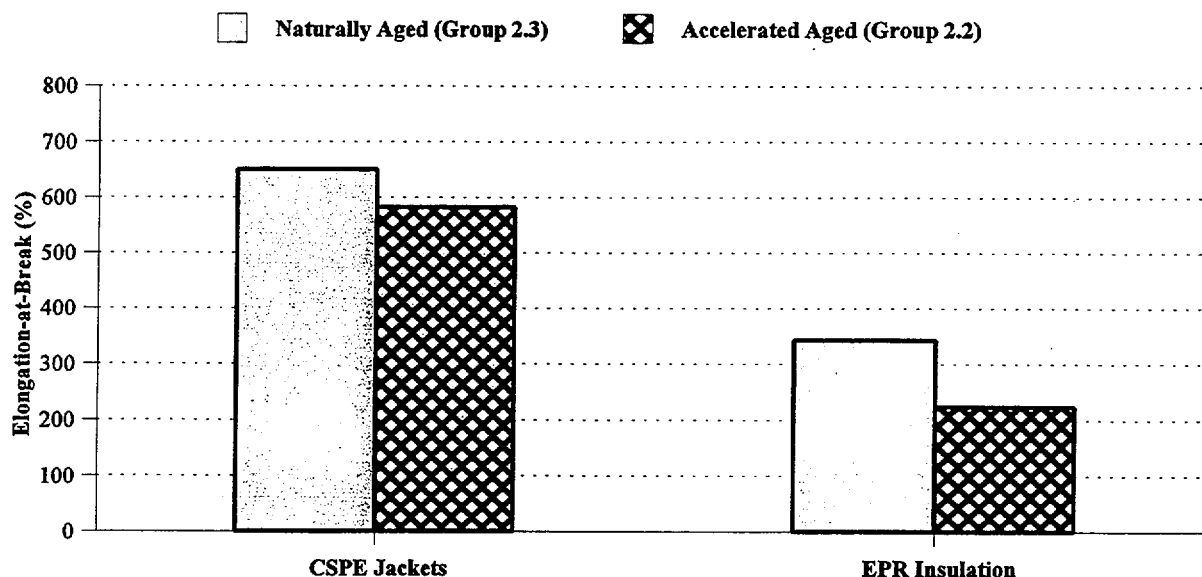
**Figure 4.3 EAB values for naturally aged and accelerated aging CSPE/EPR specimens from Test Sequence 2**
