**Supplemental Environmental Baseline Survey**  
Unlimited Release  
October 2016

# **Supplemental Environmental Baseline Survey for Proposed Land Use Permit Modification for Expansion of the Dynamic Explosive Test Site (DETS) 9940 Main Complex Parking Lot**

Prepared by  
Sandia National Laboratories  
Albuquerque, New Mexico 87185 and Livermore, California 94550

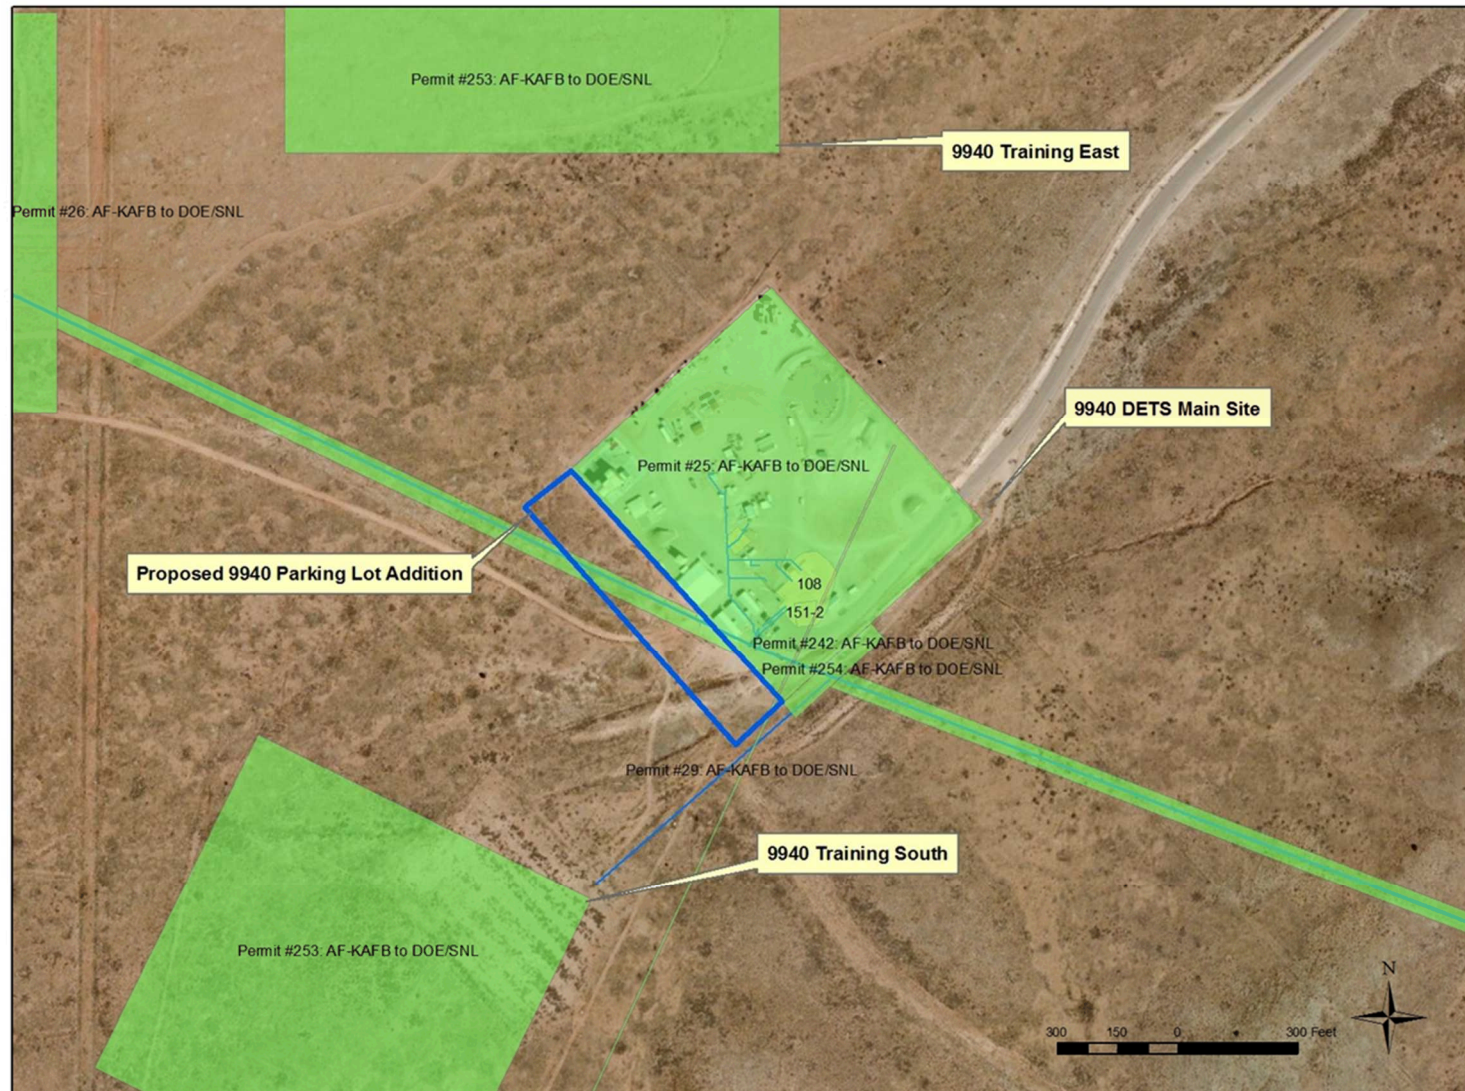
#### DETS Proposed Parking Lot Permit Expansion

The “subject property” is comprised of a parcel of land within the Kirtland Military Reservation, Bernalillo County, New Mexico, as shown on the map in Appendix B of this document. The land requirement for the parking lot addition to the 9940 Main Complex is approximately 2.7 acres.

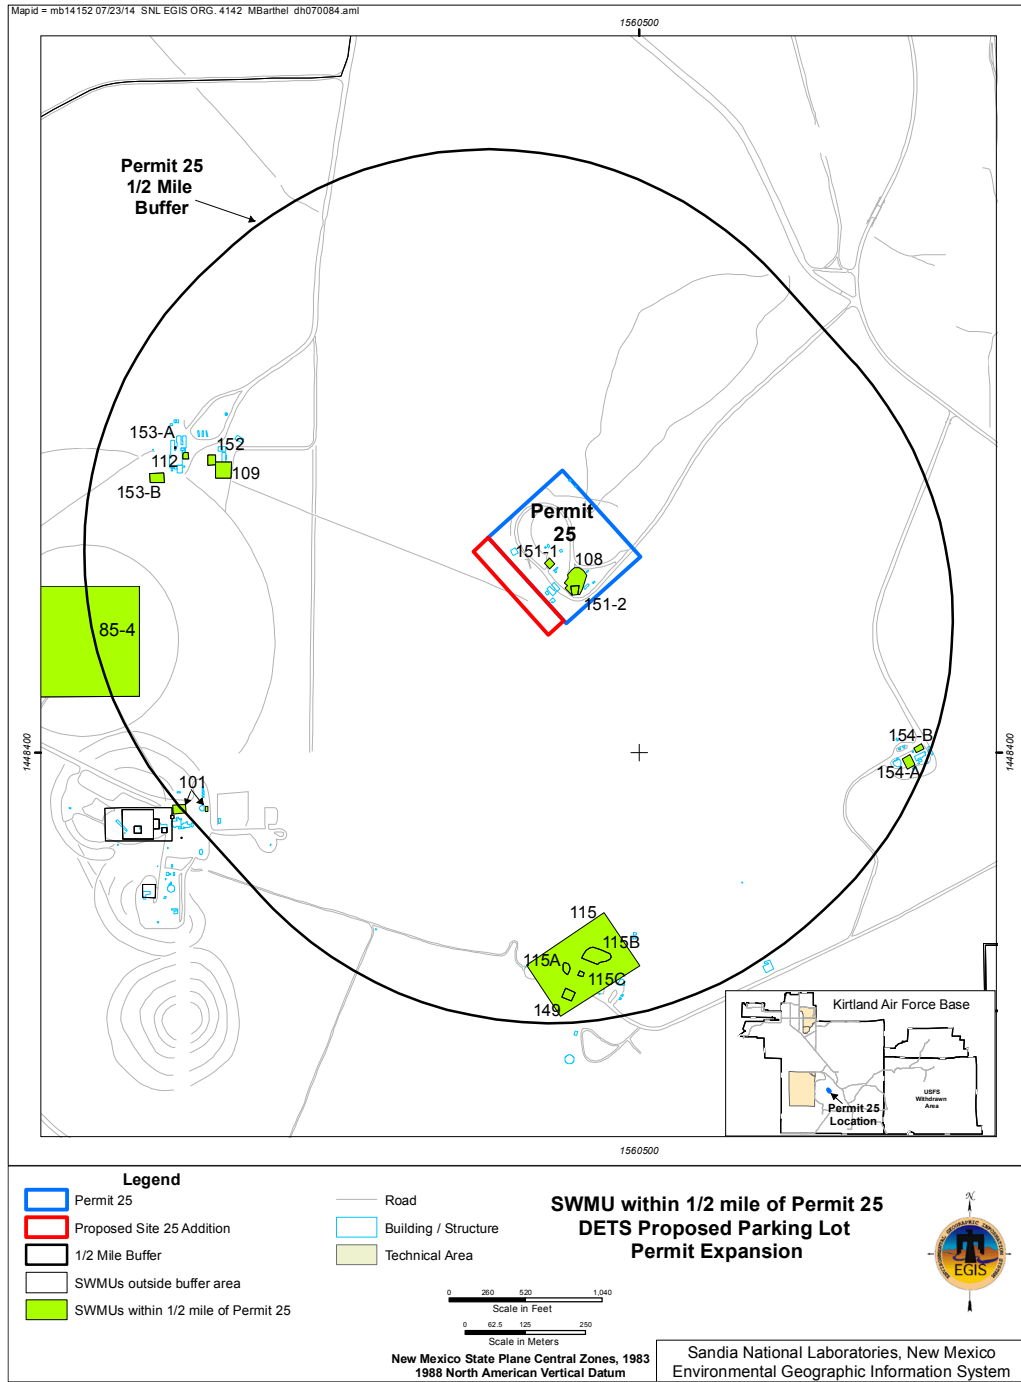
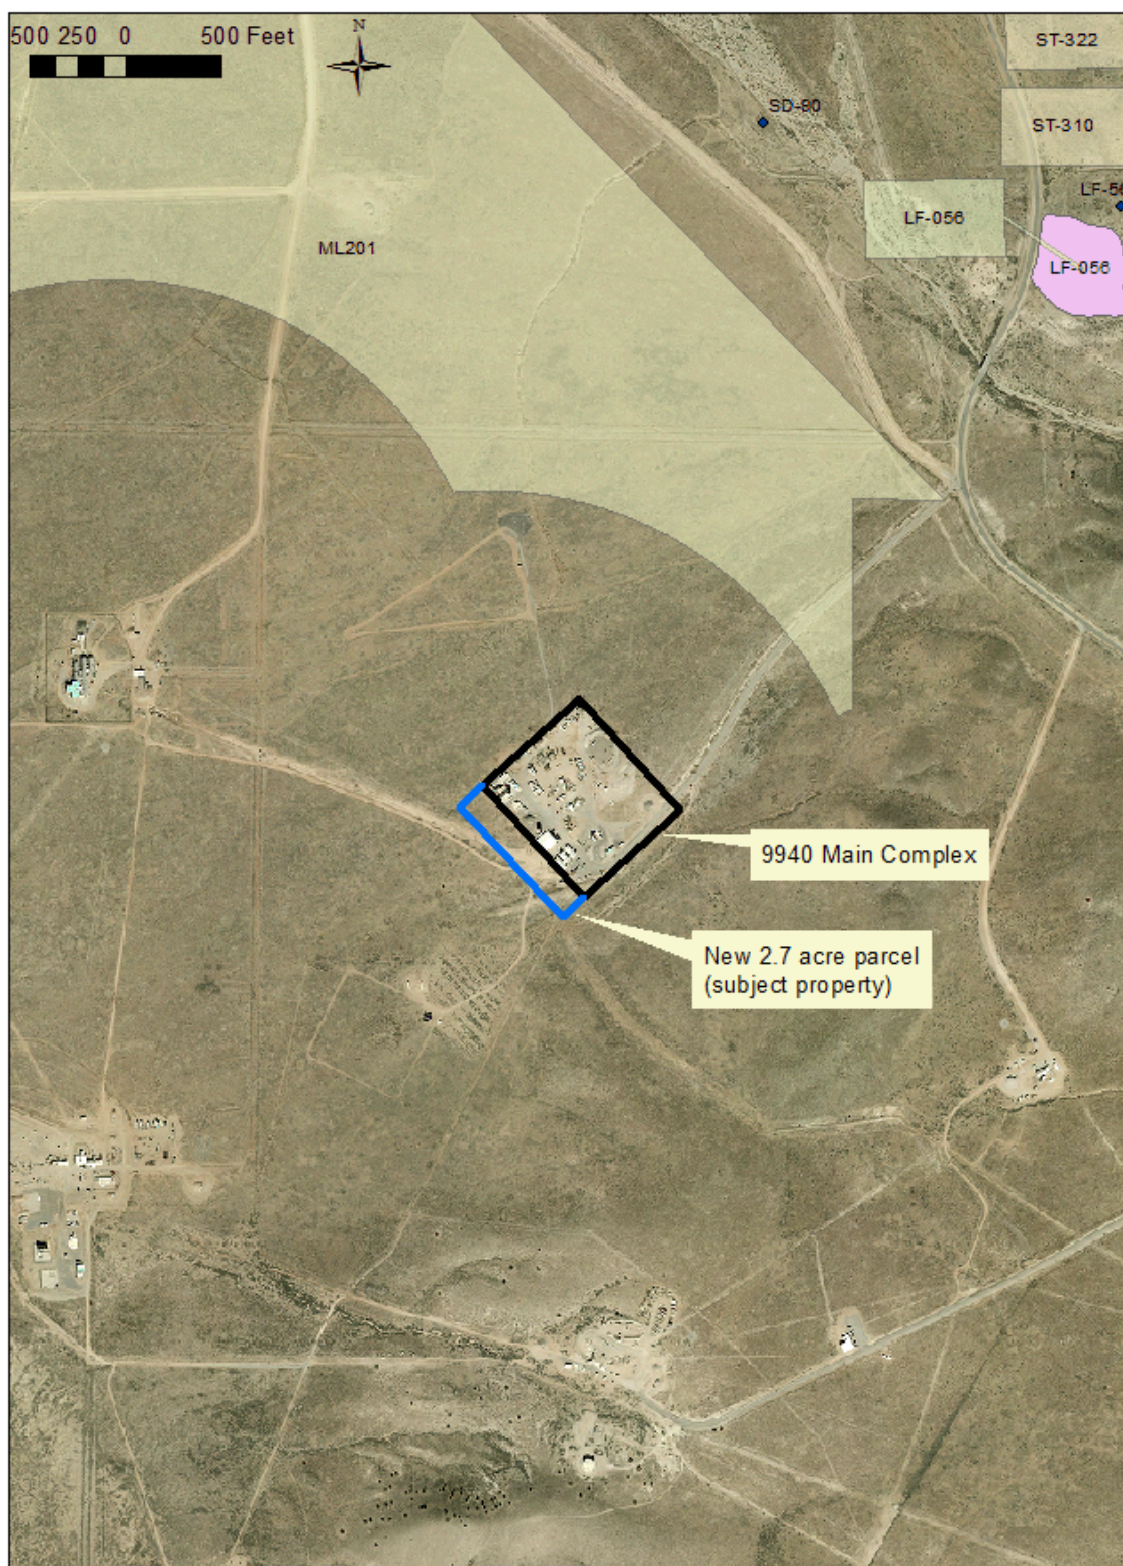
## Sandia National Laboratories, Environmental Restoration Site Characterization Maps for ER Sites within ½ Mile

Adjacent areas (within ½ mile) have been evaluated for the presence of SNL and USAF ER sites. See Section 5.4, Environmental Restoration, in this document for summary information. SNL ER sites that are within ½ mile of the subject property are listed below with brief summaries of their current regulatory status. ER Site Maps for these sites can be found above in Appendix B, including an ER sites overview map *Sandia National Laboratories, Environmental Restoration Site Characterization Maps for ER Sites within ½ Mile*.

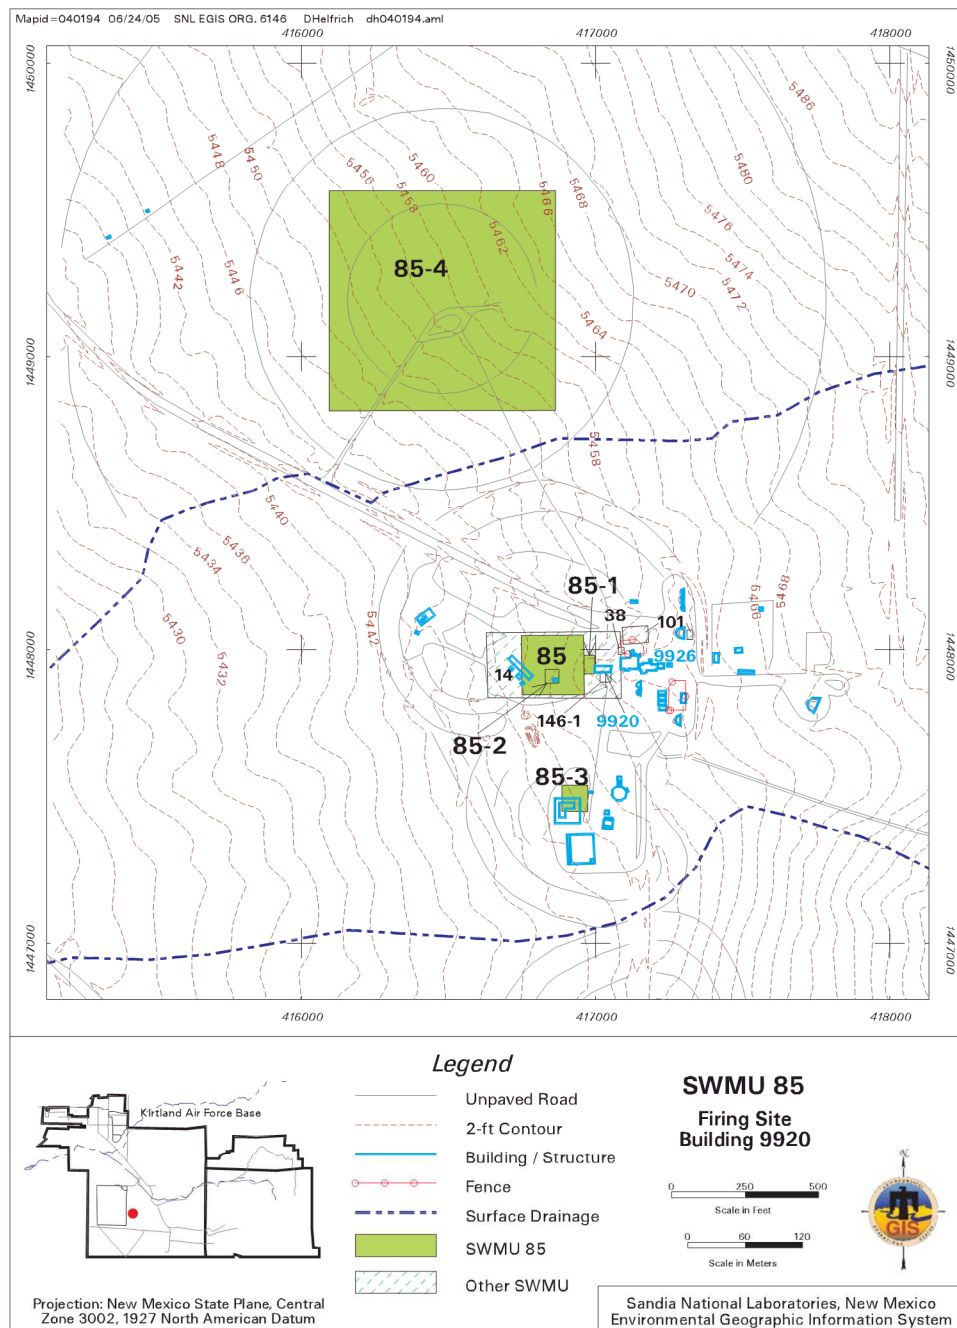
## KAFB ER, ERP, MMRP Sites Near 9940

Data Source: KAFB Environmental GIS 2014 and SNL GIS 2016

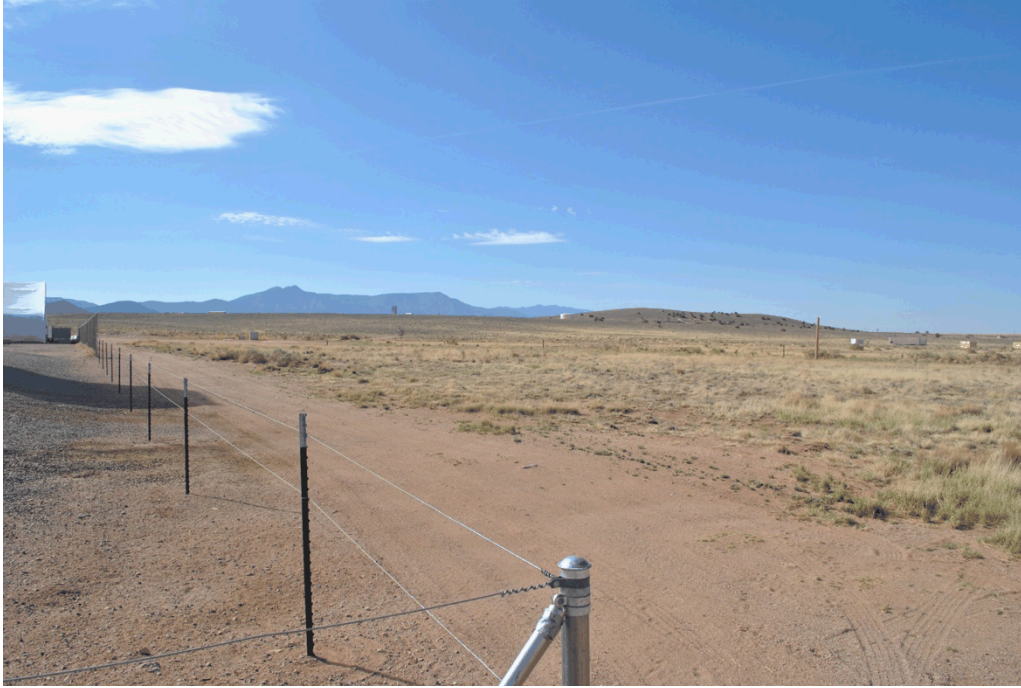
Photo C-1. View from North looking South

The author and another member of the environmental management team conducted a site visit of the subject property on October 7, 2016. None of the following environmental concerns or issues were observed: no odors; pools of liquid; drums; hazardous substance and petroleum product containers; potential asbestos-containing material (ACM); PCB-containing electrical equipment; drains and sumps; pits, ponds, and lagoons; stained soil or pavement; stressed vegetation; wastewater; or dead or diseased wildlife. No concerns relating to the health and safety of

individuals or local flora or fauna, such as stains or leaks, were observed (See Appendix C for site photographs and Appendix E for the site inspection form).
