# Establishing a Ti-Cu-Pt-Au Thin Film Conductor on Low-Temperature, Co-Fired Ceramic (LTCC) for High Temperature Electronics

P. Vianco, J. Rejent, M. Grazier, B. McKenzie, A. Allen, and A. Kilgo,

Sandia National Laboratories\*  
Albuquerque, NM 87185  
*Contact: [ptvianc@sandia.gov](mailto:ptvianc@sandia.gov)*

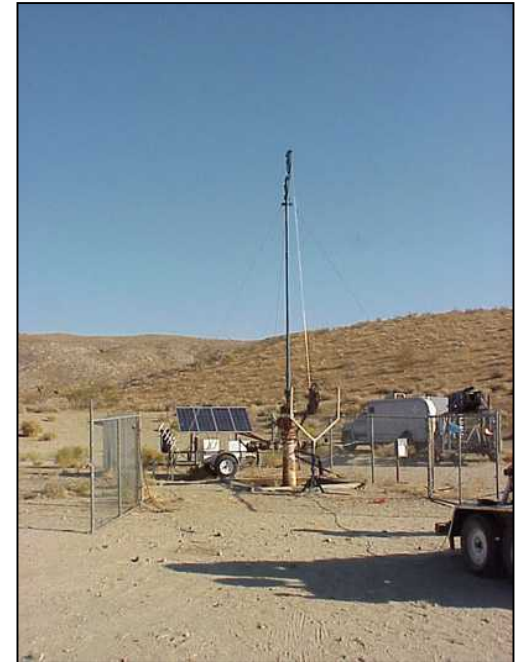
- ◆ **Placing sensor electronics directly down hole can significantly improve both the efficiency and the reliability of well production.**
- ◆ **Oil, gas, and geothermal wells present some of the harshest service conditions for electronics and electrical equipment.**
  - **Temperatures: 300°C continuous; 350°C peak**
  - **Pressures: 15,000 to 30,000 psi**
  - **Vibration: PDS ( $\text{g}^2/\text{Hz}$ ), 0.01 – 0.1 (0.6 – 3 kHz)**
  - **Corrosion:  $\text{H}_2\text{S}$  and  $\text{H}_2$  gas, brine, and superheated steam.**

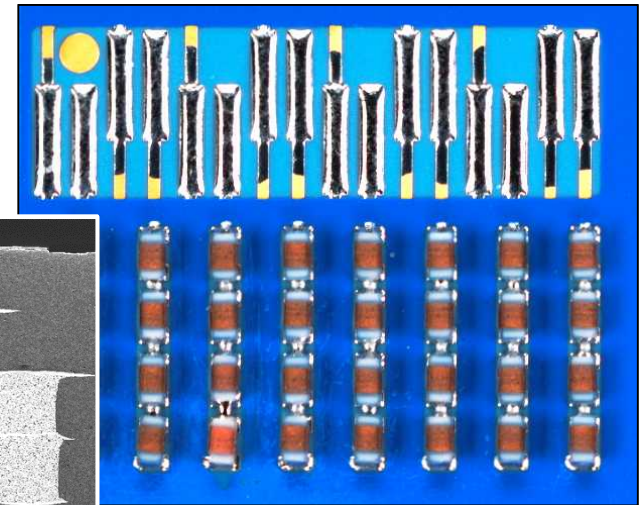
*Miniaturization  
of circuits*

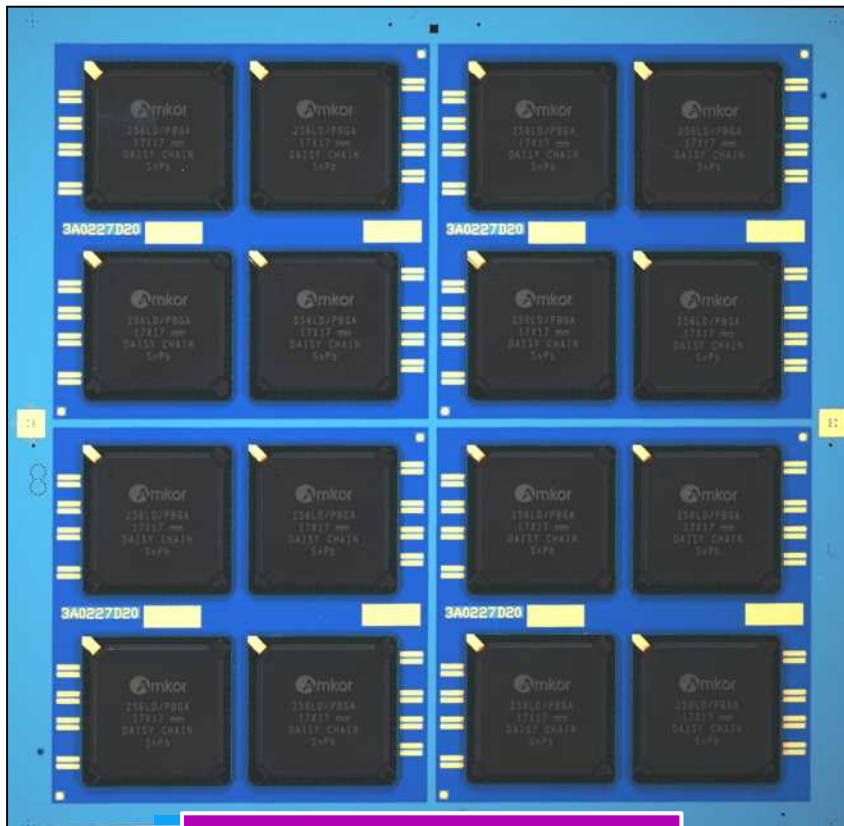
*Area-array packages*

- ◆ The **LTCC-based, HMC technology** using **thin film conductors** is illustrated by these accelerated aging test vehicles that readily incorporates 1.0 mm BGAs and 0402 passive devices.

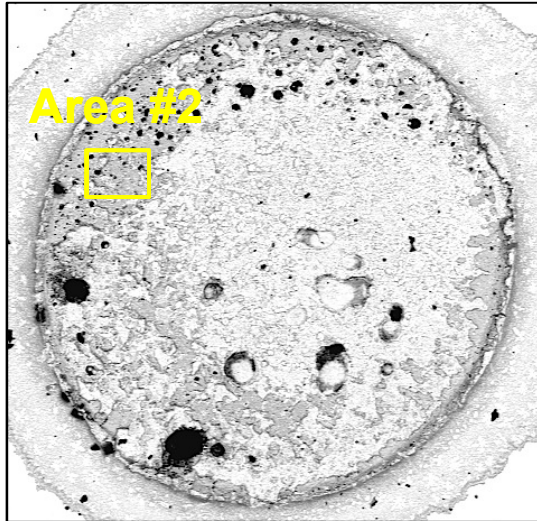
- ◆ The fracture surface changed with process parameter “severity.”

- ◆ The area #2 fracture surface increased with “severity.”
- ◆ The **area #2** fracture surfaces of 260°C, 60s and 290°C, 120s progressed through the **low-Au, (Cu-Au)-Sn IMC**.
