Report Title: **SOFC Systems with Improved Reliability and Endurance**

Type of Report: Final Technical Report

DOE Award No.: DE-FE0011691

Name & Address of Submitter: FuelCell Energy, Inc.
3 Great Pasture Road
Danbury, CT 06813

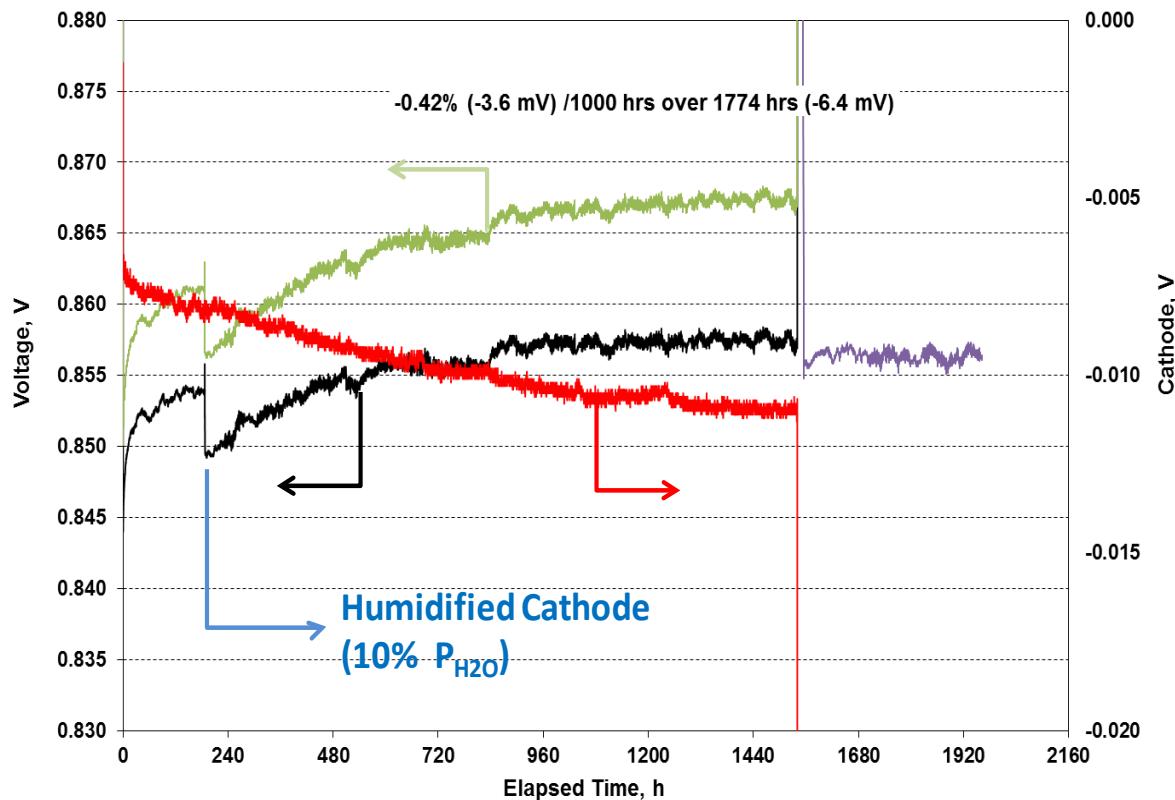
Figure 2-1. Single-Cell Test ($0.5\text{A}/\text{cm}^2$, 750°C) Featuring Design 2 Cr-getter in Cell, Co-Coated Cathode Hardware and Al-Coated Cathode Pipe (Cell GT101884)

A long-term single-cell test was conducted featuring a combination of validated Cr tolerant technologies. The technologies included in this test were Design 2 Cr-getter in cell, Co-coated cathode hardware (jig) and Al-coated cathode pipe. The test started initially using dry cathode air. After about 200 hours, 10% water vapor (moisture) was added to the cathode stream. Steady state testing of the cell was conducted at $0.5\text{A}/\text{cm}^2$ and 750°C . The test accumulated close to 2000 hours. As shown in Figure 2-1, there was no performance degradation (only cell voltage improvement) during the 1774 hour-period with humidified cathode air. This test met the SECA FY14 Q1 (Dec 27, 2013) GPRA Milestone: *Demonstrate Chromium Resistant Cell Technology with <0.5%/1000 hr. Degradation Rate in >3% Humid Air.*

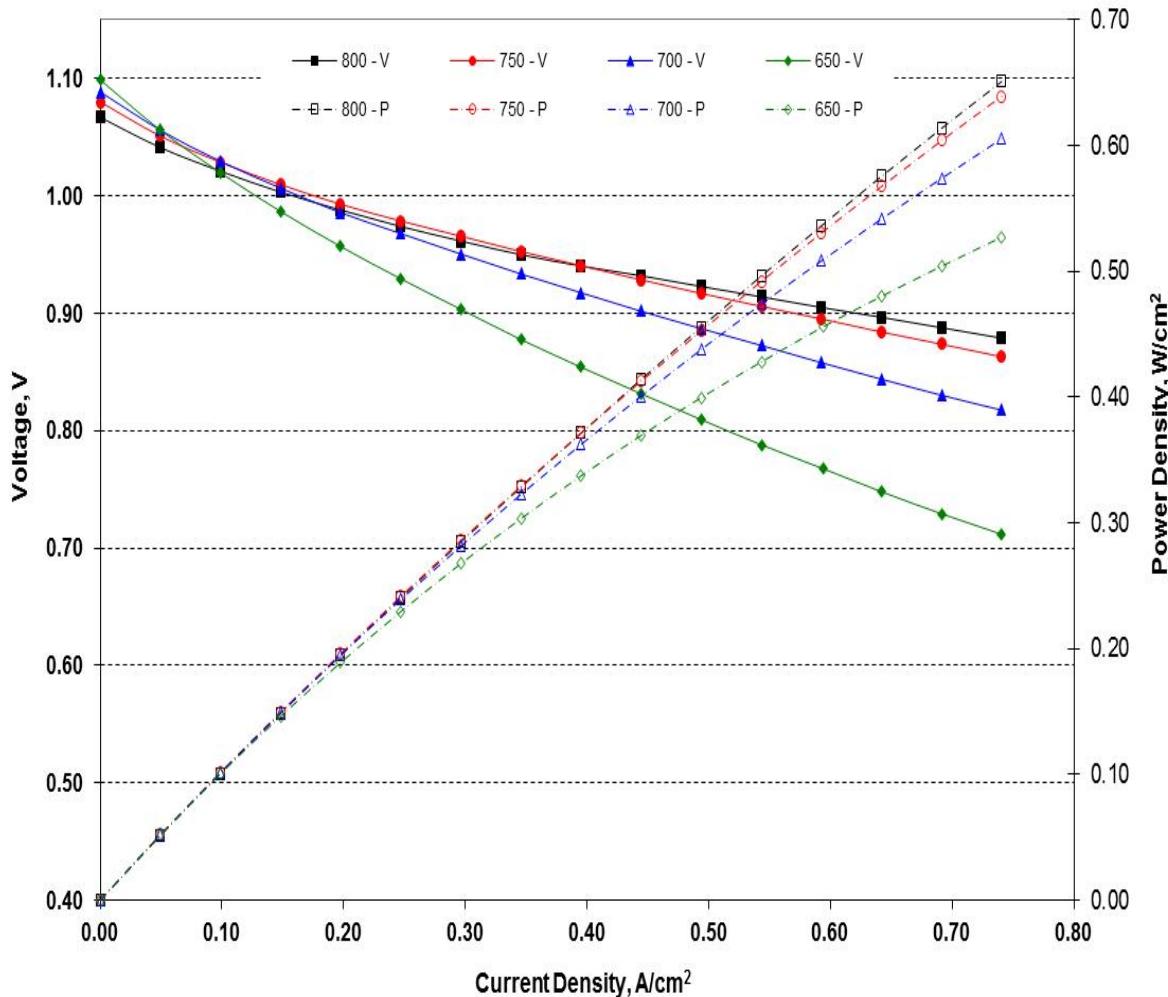
Figure 2-2. Power Curves of Cell with PBSCF Cathode (in Temperature Range of 650 – 800°C)

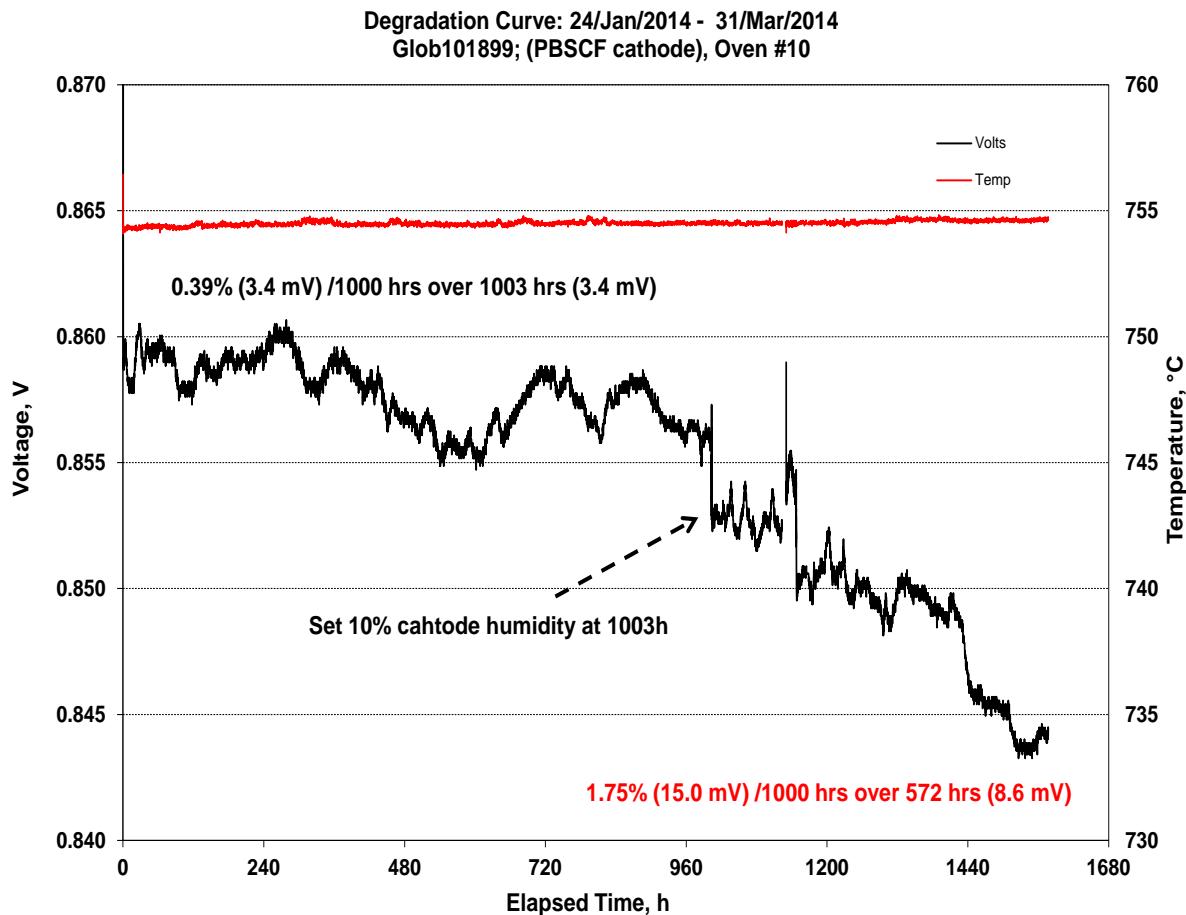
Figure 2-3. Performance Stability of Cell GLOB 101899 Containing PBSCF Cathode

The cell was then set to run for 1000 hours in dry cathode air at 0.5 A/cm², 750°C furnace temperature, 50% Uf (hydrogen + 3% water) and 25% Uo. Figure 2-3 shows the cell voltage and temperature vs. time trends during this period. The cell performance degradation rate during 1003 hours with dry cathode air was 0.39% (3.4 mV) per 1000 hours. After completing the testing in dry cathode air, the cell was tested with 10% cathode gas humidity condition for 572 hours. During the 572-h period with 10% cathode gas humidity, the degradation rate was 1.75% (15 mV) per 1000 hours. It was decided to terminate the test to facilitate post-test analysis.

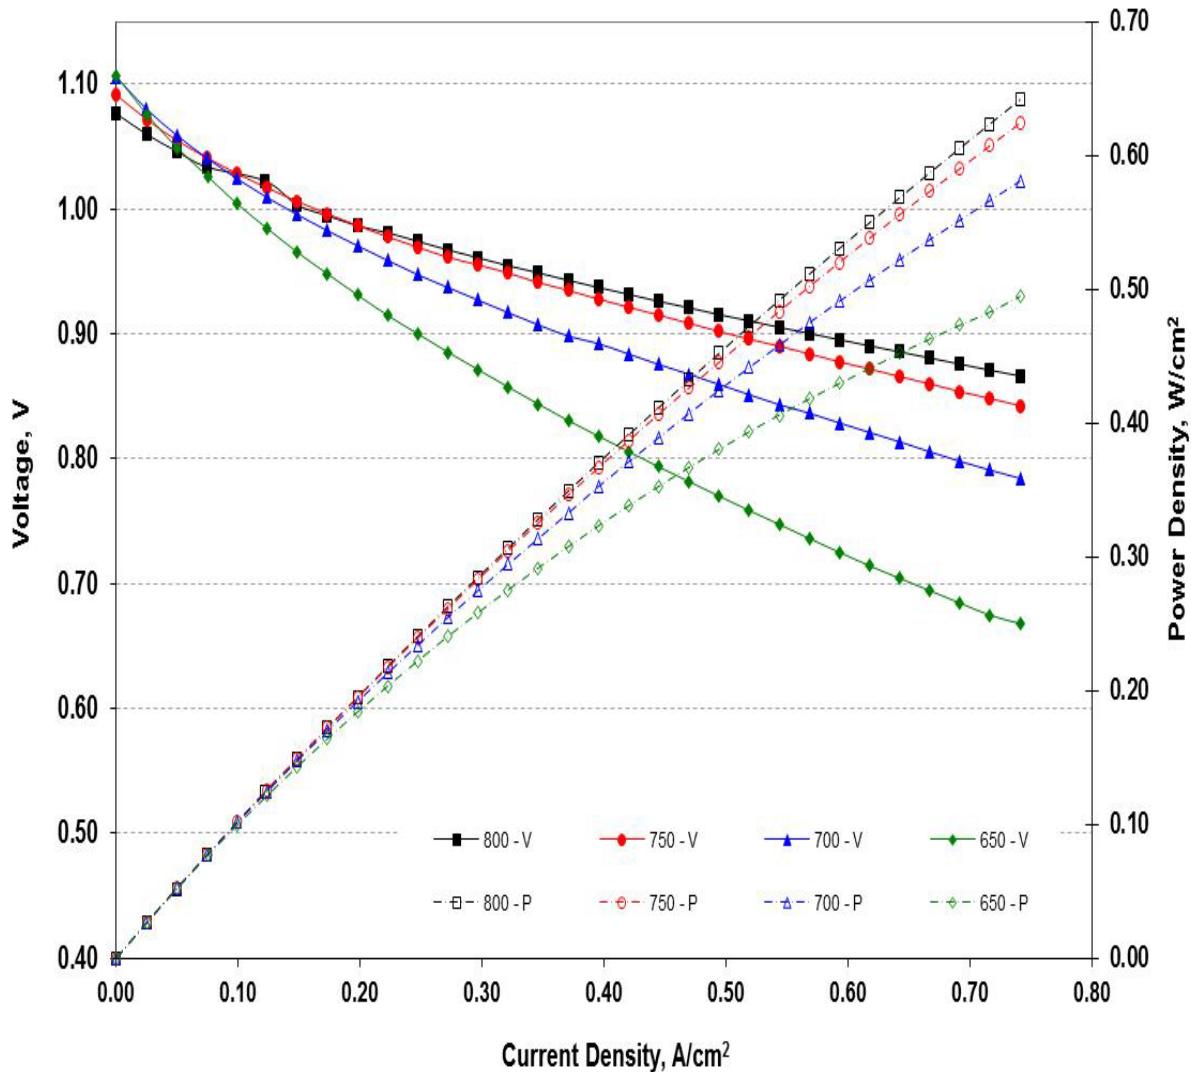
Figure 2-4. Performance Characteristics of Cell GLOB 101922 Containing LSCF Cathode (in Temperature Range of 650 – 800°C)

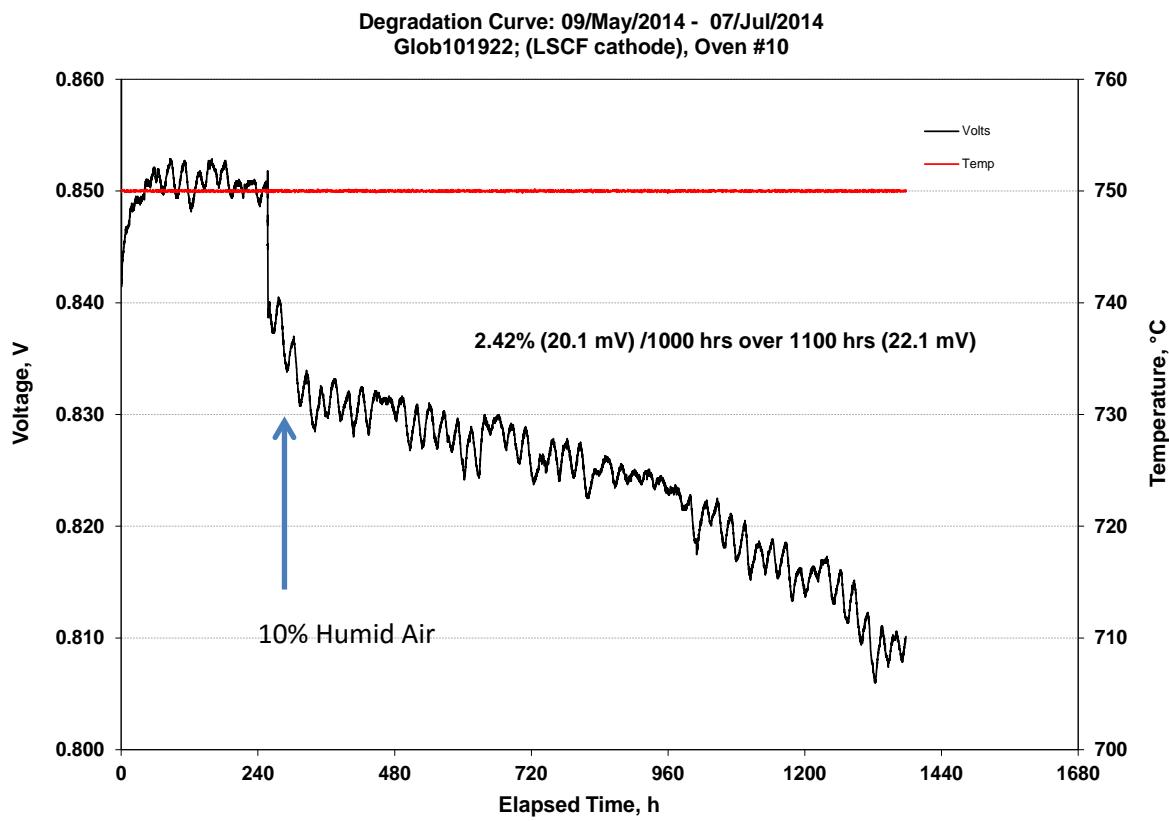
Figure 2-5. Performance Stability of Cell GLOB 101922 Containing LSCF 6428 Cathode

During testing with 10% cathode gas humidity (introduced to the air) the performance degradation rate increased with a final value of 2.4% (20 mV) per 1000 hours over 1100 hours before the test was terminated.

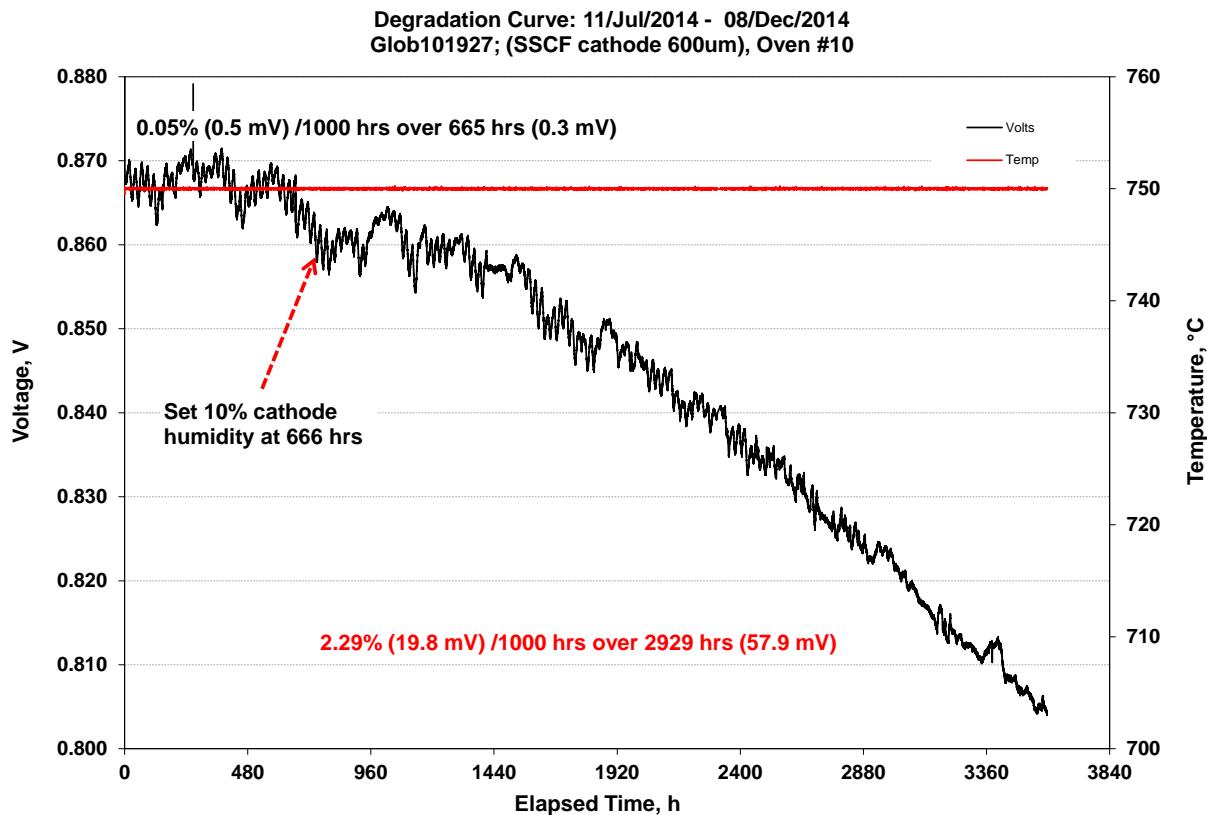
Figure 2-7. Performance Stability of Cell GLOB 101927 Containing SSCF 5528 Cathode

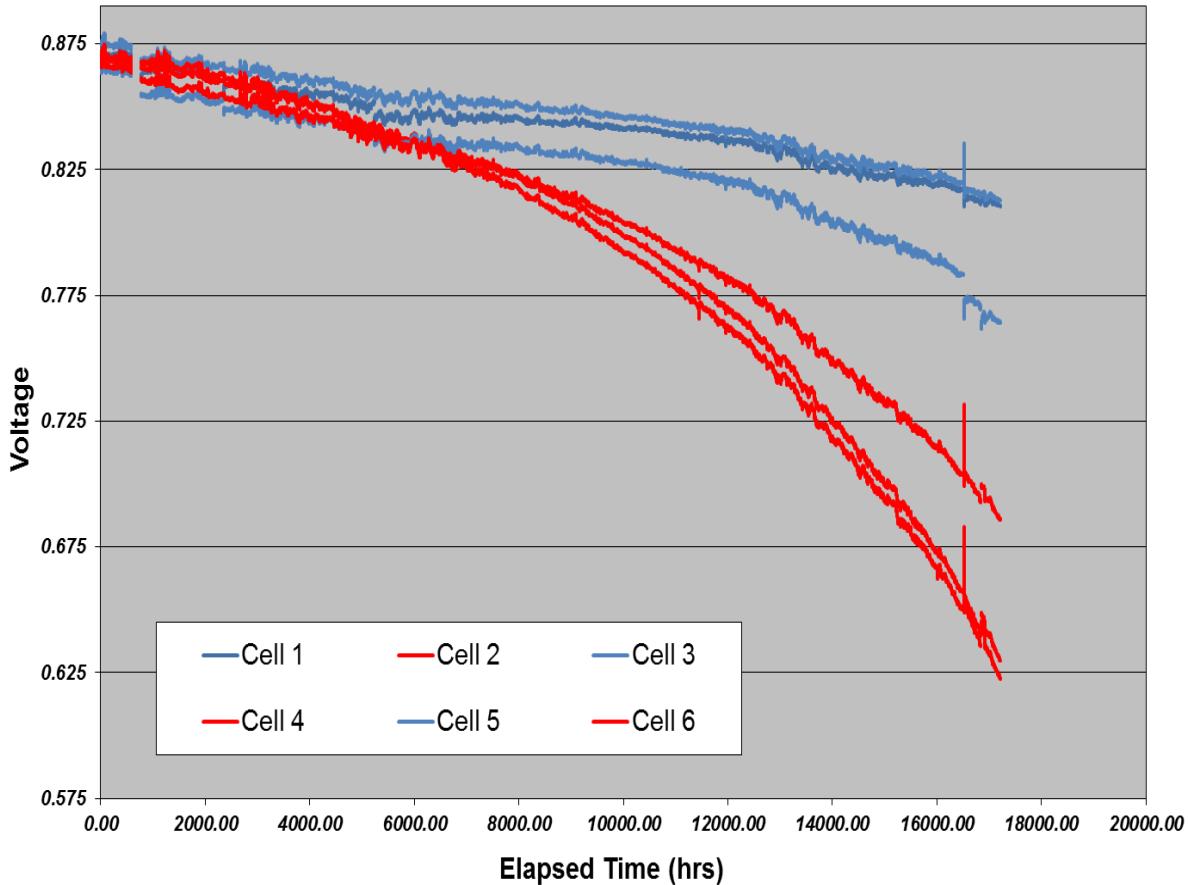
Figure 2-12. Performance Stability of Cells with Cr-getters Compared to Standard TSC-3 Cells in Six-Cell Stack GT055296-0140 (Cells 1, 3 and 5 contain Cr getter materials)

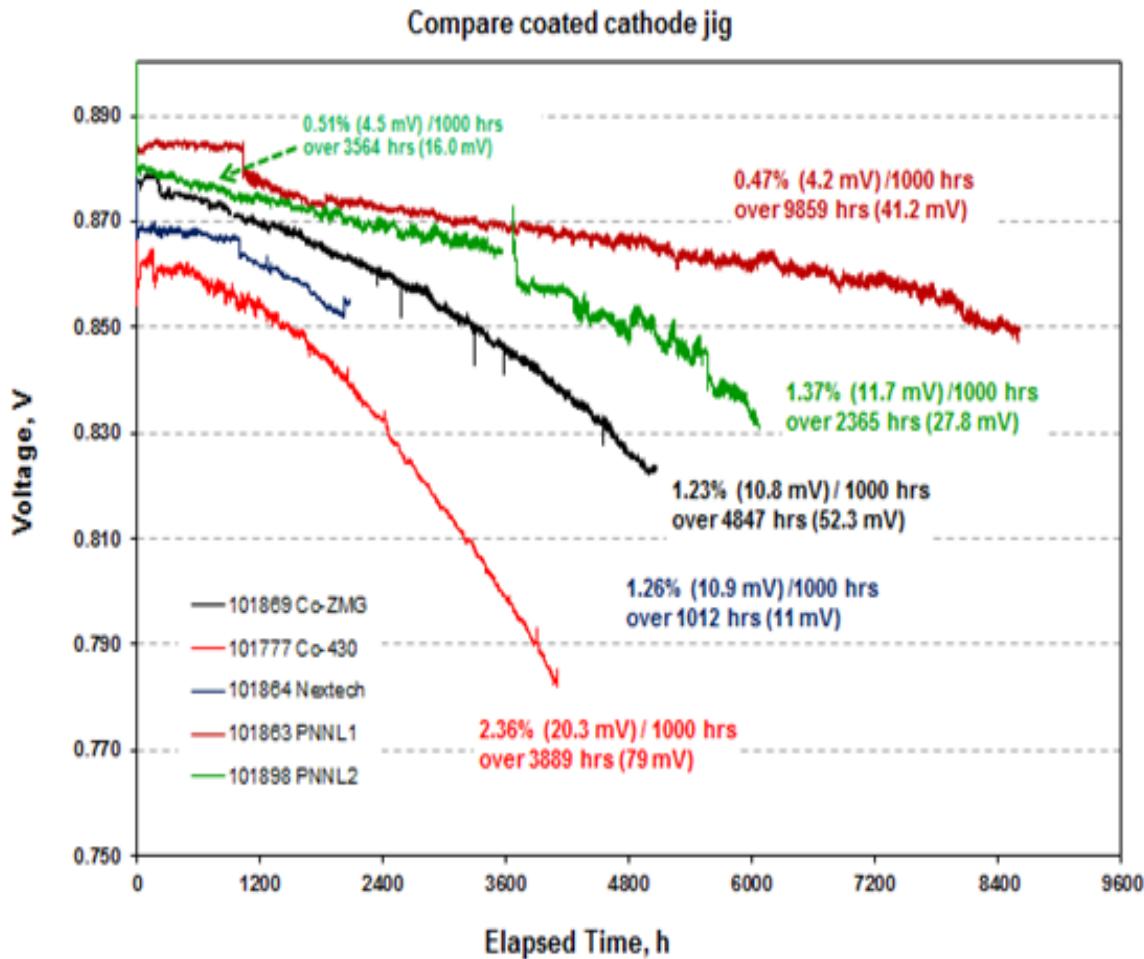
Figure 2-13. Single-Cell Tests with Coated Jigs (Hardware)

Cobalt and MCO coatings had been tested in single cells using both dry and humidified cathode air with significant improvement to cell life. Figure 2-13 summarizes the long term single-cell accelerated tests with cathode gas humidity of 10%. Single-cell test GLOB 101863 (81 cm² active area) with PNNL-coated MCO on cathode jigs (hardware) performed the best. The second single-cell test with MCO coated jigs from PNNL (GLOB 101898) was conducted. The performance degradation rate was about 0.51%/1000h during testing in dry cathode air (at 500 mA/cm², 750°C) over 3564 hours. Cathode gas humidity was then introduced. The cell degradation rate was 1.37% per 1000 hours over 2365 hours of operation with 10% water in cathode air. It was also found that the first test GLOB 101863 with PNNL-coated jig had a testing fault and humidity addition stopped during the test thereby explaining its low degradation rate.

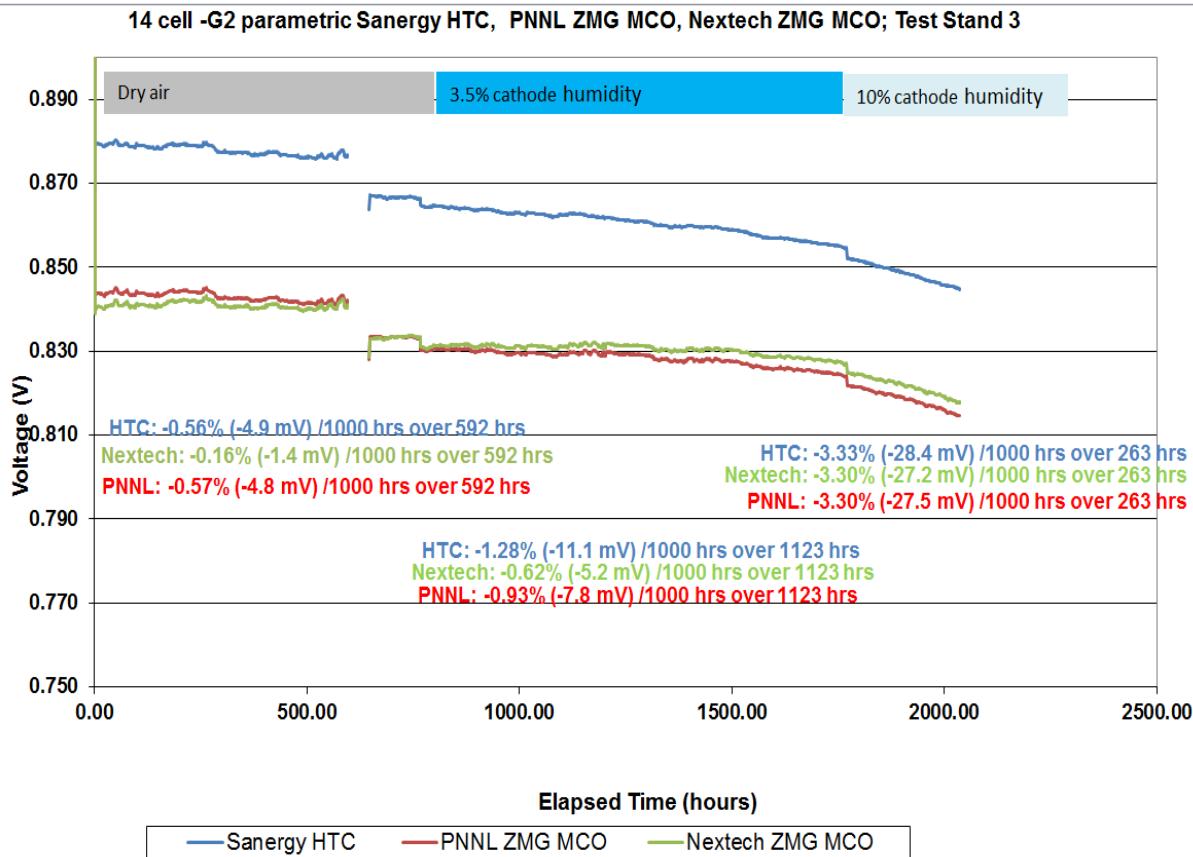
Figure 2-14. Stack Test GT0596000-0002 Evaluating MCO-coated and Cobalt-coated Interconnects

gas humidity, cells with MCO coated layers had lower performance degradation rate than the cells with Sanergy coated layers, over an 1123-h test period. The degradation rate increased significantly after increasing the cathode gas humidity level to 10%. The stack test was terminated to facilitate the post-test examination.

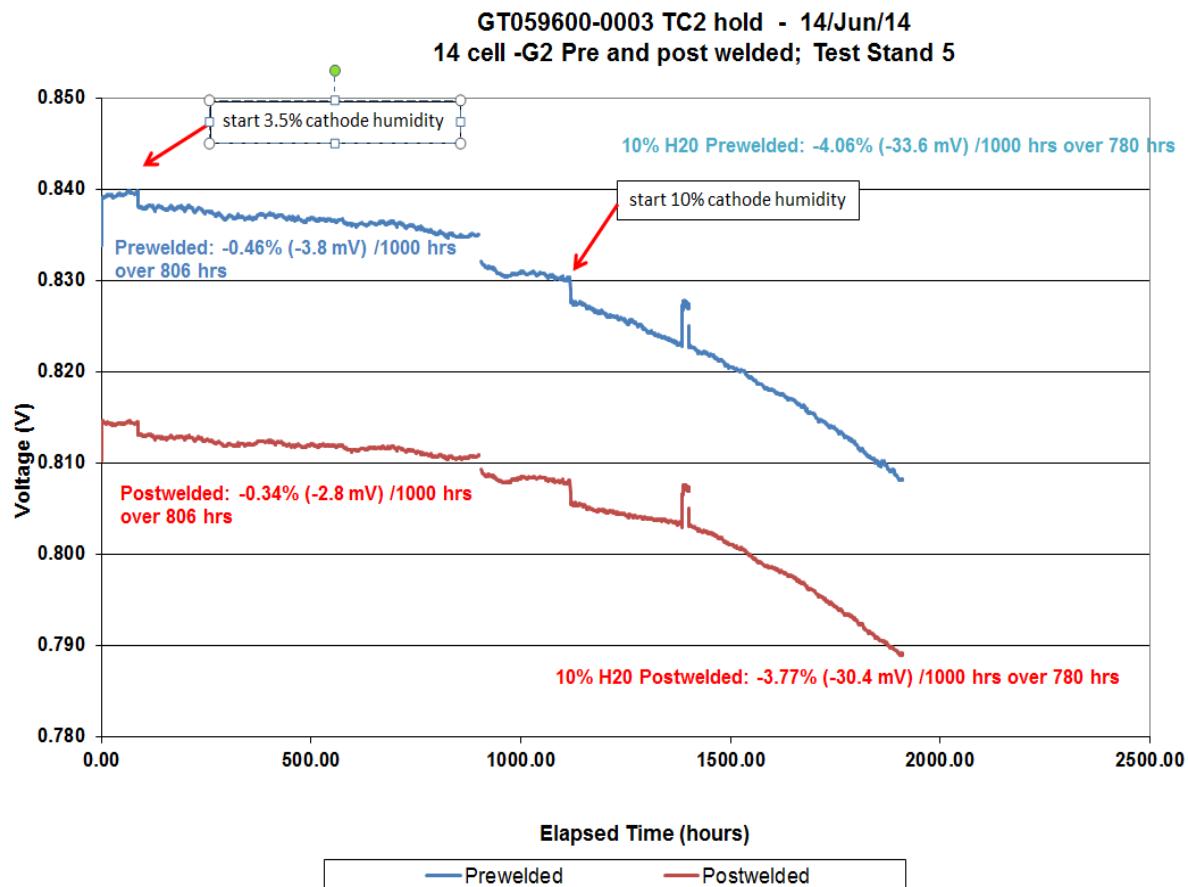
Figure 2-18. Stack Test GT0596000-0003 Evaluating MCO-coated (by Nextech) ZMG232G10 Cathode Flow Fields

After completing 1000 hours of testing in dry cathode air, the stack was moved to another test stand capable of testing with cathode gas humidity. Cathode gas humidity was introduced for further testing with 3.5% and 10% humidity as shown in Figure 2-18. The performance degradation rates increased significantly after increasing cathode gas humidity to 10%. The test was terminated after more than 1600 hours of testing with cathode gas humidity.

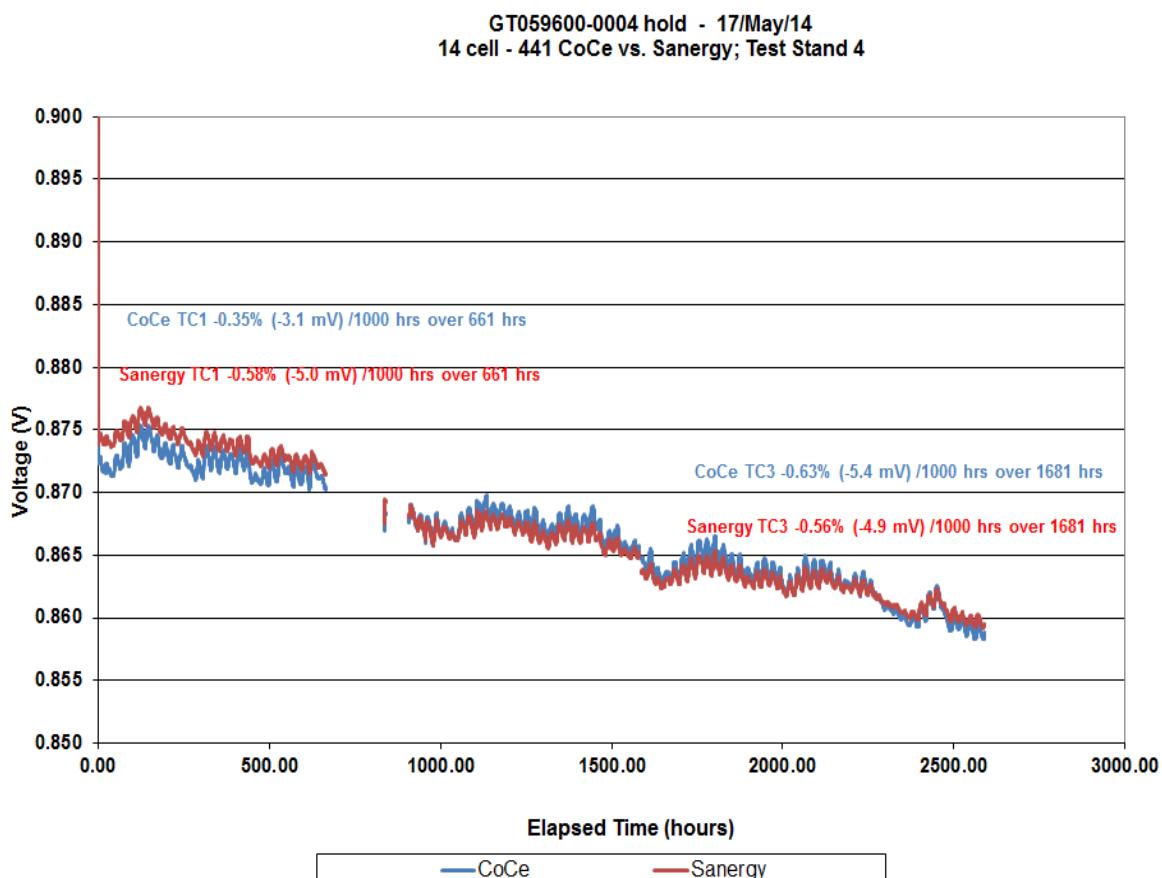
Figure 2-20. Stack Test GT0596000-0004 Evaluating CoCe-coated 441 Alloy and Co-coated Sanergy Flow Fields (with Dry Cathode Air)

A new 14-cell stack was built with Co-coated Sanergy and Co-Ce coated 441 alloy flow fields. This stack was to test the low-cost option of coated 441 alloy. As shown in Figure 2-20, cells with Co-Ce coated 441 layers initially (over a 661-h period) had lower degradation rate while the performance was similar to cells with Co-coated Sanergy layers. The performance degradation rate for both cell groups was then comparable over a 1681-h period. The stack was tested in dry cathode air conditions for more than 2000 hours before introducing humidity.

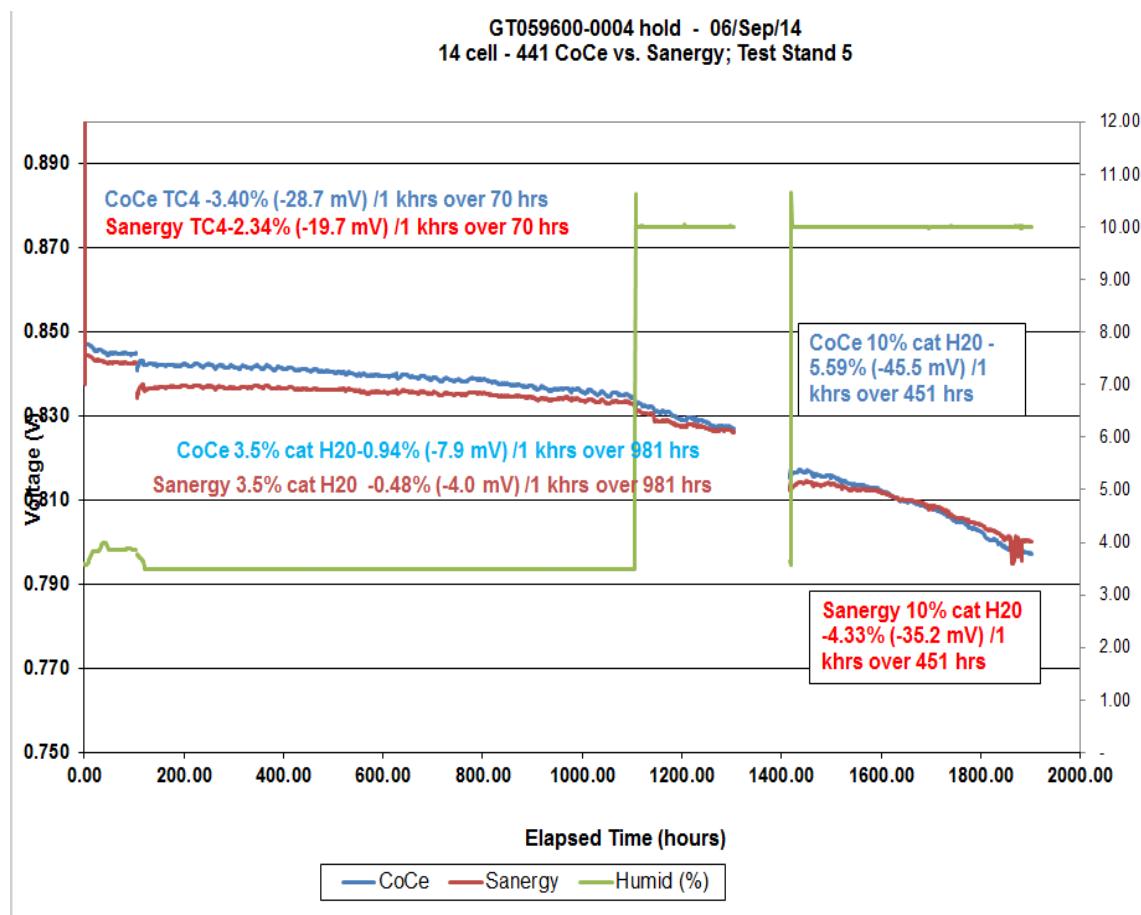
Figure 2-21. Stack Test GT059600-0004 Evaluating CoCe-coated 441 Alloy and Co-coated Sanergy Flow Fields (with Cathode Gas Humidity)

Figure 2-21 shows the results from testing with cathode gas humidity. With 3.5% humidity for 980 hours, the cell group containing Co-Ce coated 441 layers showed higher performance degradation rate compared to Co-coated Sanergy cell group. The humidity was then increased to 10% for a 640-hour period. Degradation rates increased for both steels.

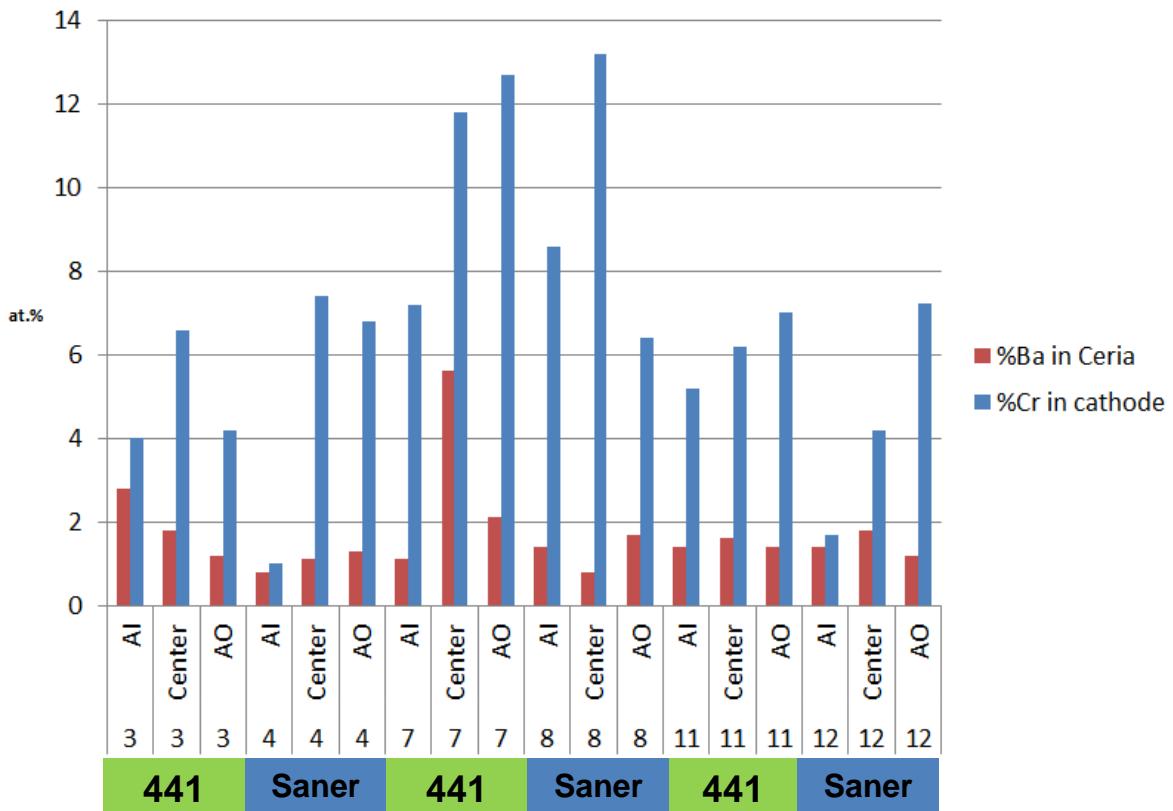
Figure 2-23. Elements Analysis in Cell Layers; Ba in Ceria and Cr in Cathode

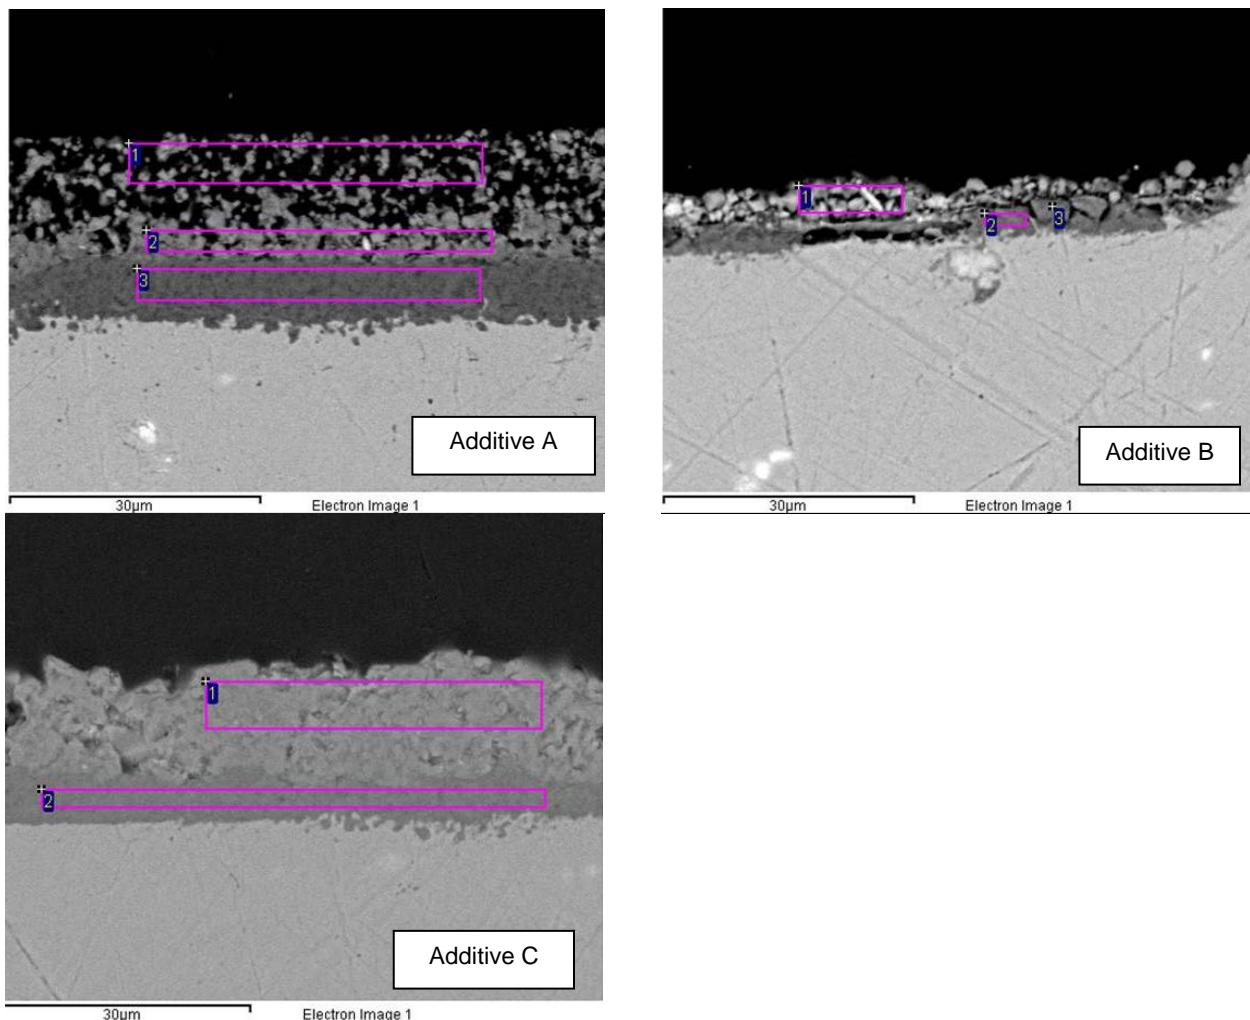
Figure 2-27. Post-test Micrographs of Cross Sections of Coated Coupons Prepared with Additives A, B, and C

In-house MCO Coating Development: A number of ZMG232G10 alloy coupons were dip coated. After coating, the heat treatment process was carried out including without reduction at 800°C for five hours then in air at 800°C for 500 to 1000 hours. Three different additives were used to modify the coating morphology and reduce the heat treatment temperatures. These additives had different influences on the oxide thickness and the coating morphology. Figure 2-27 shows the micrographs of cross-sections of coated coupons. Additive A affected the steel oxidation as seen by the thick oxide layer. Additive B led to a thinner oxide layer. Additive C was a good sintering aid as observed by the very dense coating. Combinations of two additives were also tried with different results. Also trials were performed to adjust the Mn to Co ratio in the coating to obtain a final composition close to $Mn_{1.5}Co_{1.5}O_4$. This composition offered the highest conductivity.

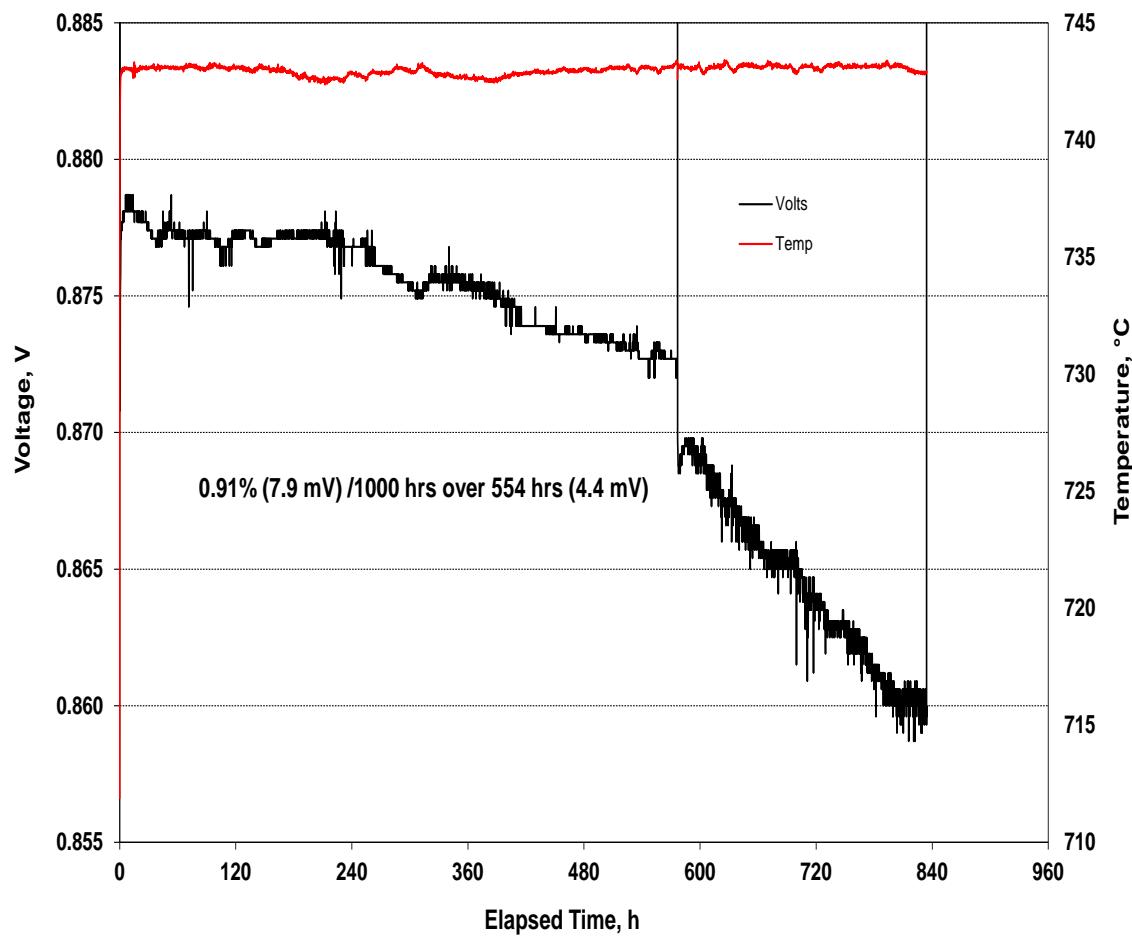
Figure 2-29. Single-Cell Test 101906 Evaluating Two-layer (Co and MCO) Coating with Additive B (Applied to Cathode Jig)

Subsequently, a two-layer coating (Co_3O_4 first and then MCO) was applied to a ZMG232G10 alloy jig. Additive B was added in both layers to facilitate sintering at 800°C. However, as shown in Figure 2-29, the cell exhibited high degradation rate while the initial performance was very good.

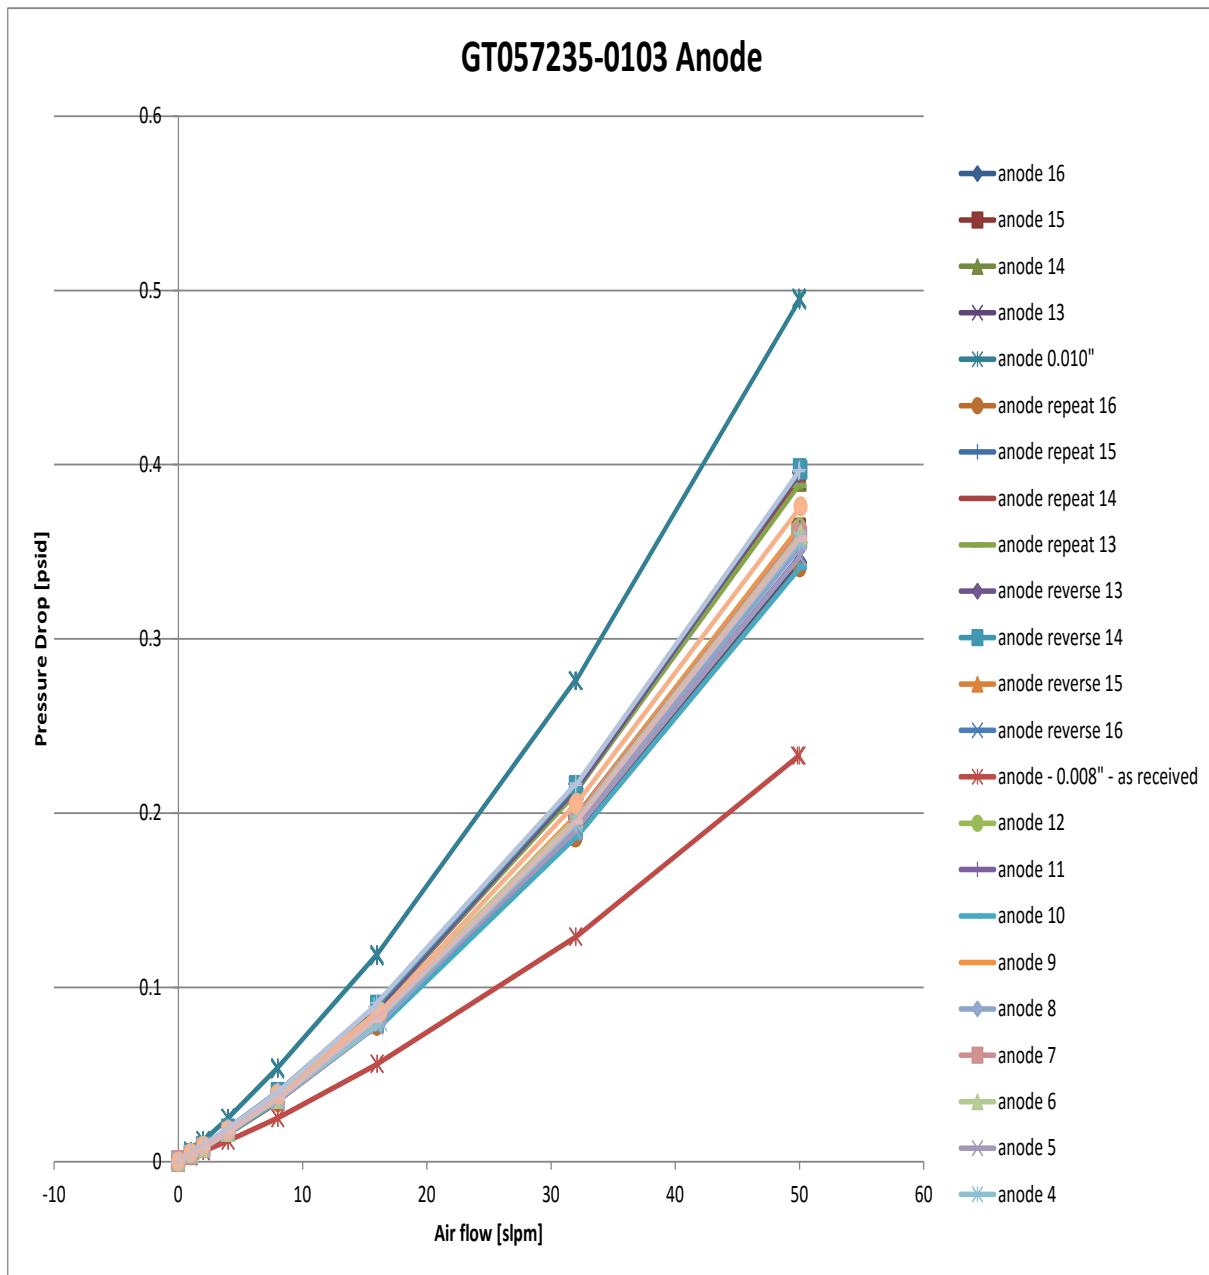
Figure 2-48. Pressure Drop Characterization of Anode Flow Fields to be Used in Stack GT057235-0103

deviations can be as high as about 10% above and below average. Noting that the flow pressure drop relationship is nearly linear, this means that for a given pressure drop condition in stack, the flows through individual layers might deviate by an amount approaching $\pm 10\%$.

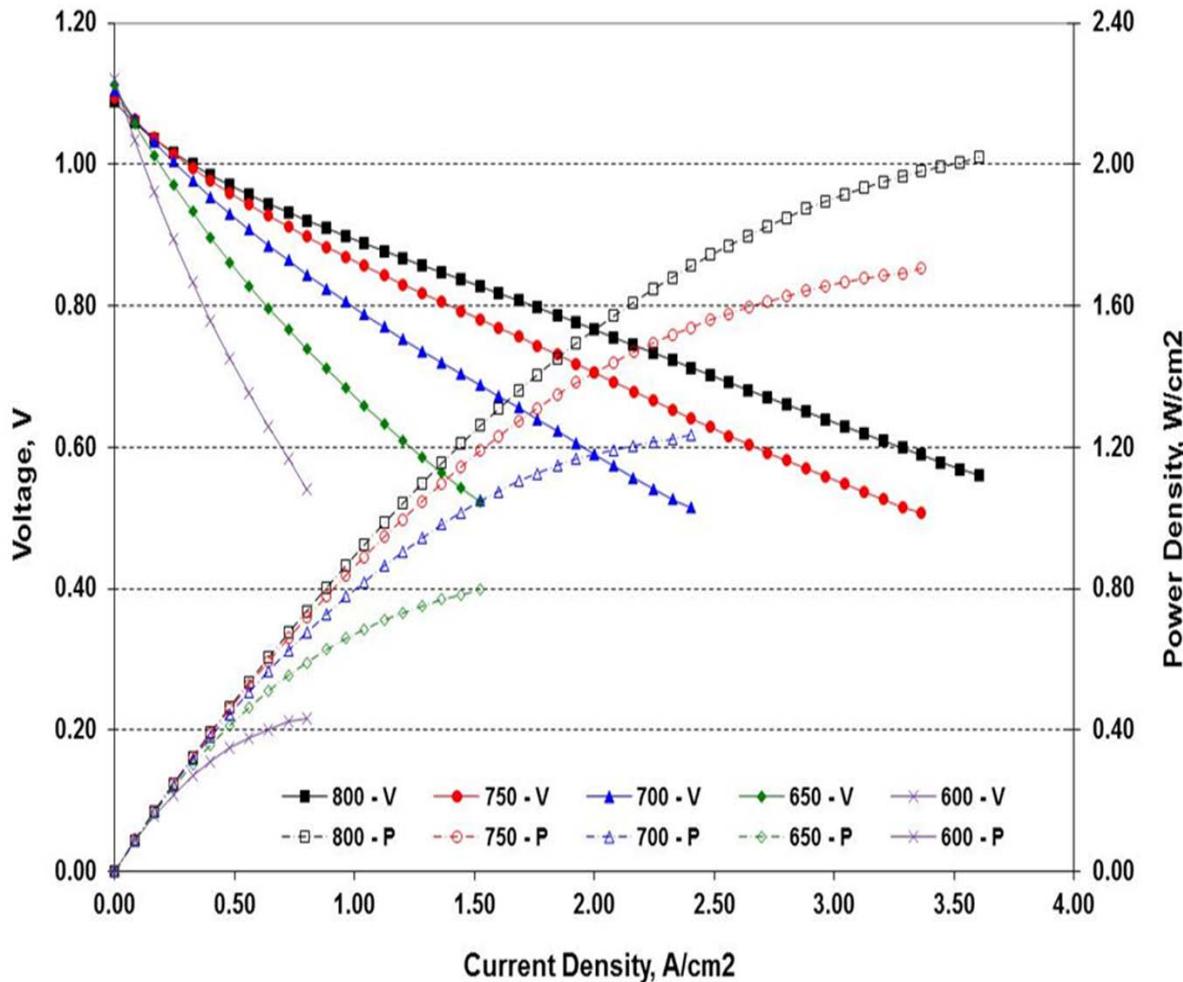
Figure 2-58. Performance Characteristics of a 0.3 mm TSC-3 cell (in Temperature Range of 600 – 800°C)

The excellent performance of 0.3 mm cells led to further exploring the maximum power density for the cell design. Due to the test equipment limitation, a smaller square cell (25 cm² active area) was used in this test. As shown in Figure 2-58, the cell demonstrated maximum power density of over 2 W/cm² at 800°C. Even at lower temperature of 650°C, the maximum power density of 0.8 W/cm² was reached.

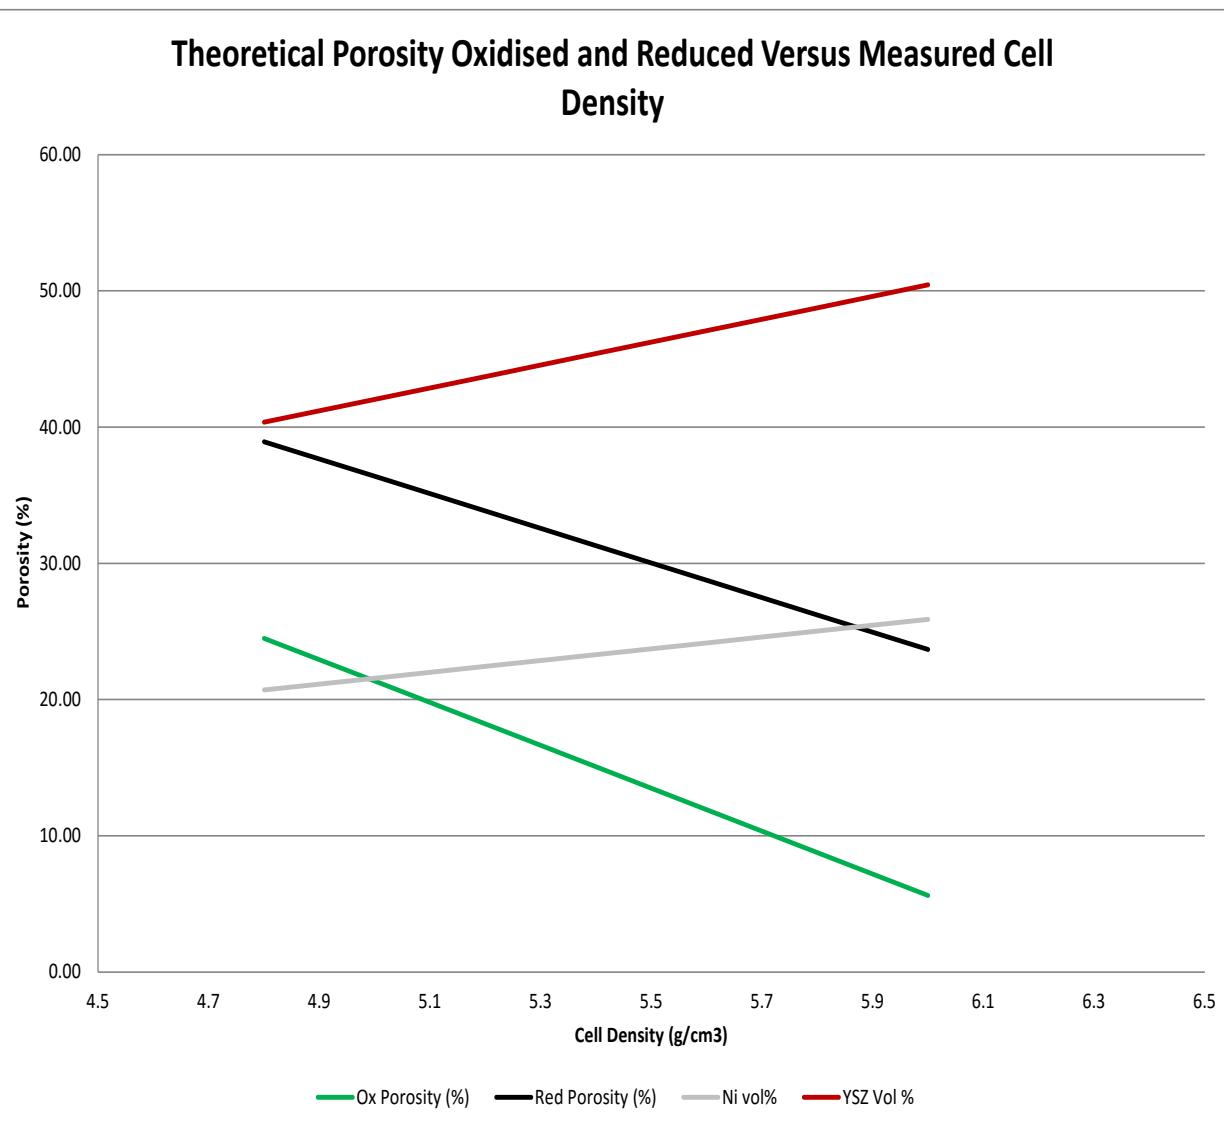
Figure 2-59. Theoretical Ni and YSZ Volume Percent, and porosity (oxidized and reduced) vs. Measured Cell Density for 50% w/w NiO Anode Substrate

Cells with different NiO/YSZ ratios and different densities were also tested. Anode substrates with 50, 60, and 65% w/w NiO (standard is 57% w/w) were prepared and fired at different temperatures to obtain different cell densities. Cells with two different densities for each NiO content were prepared and tested with the exception of 65% w/w NiO at the higher density (as some cells had to be fired at too high a sintering temperature to give acceptable leak rates due to low shrinkage of the substrate). Figure 2-59, Figure 2-60, and Figure 2-61 show the Ni and YSZ volume percent and porosity for both oxidized and reduced forms vs. the measured cell density for 50, 60, and 65% w/w NiO anode substrates, respectively. Single-cell tests were conducted. The higher NiO content cells show some promise in terms of performance, however, the shrinkage is too low at standard cell firing temperatures so some formulation changes are required. Next, tests to increase cell shrinkage at lower firing temperatures allowing production of dense electrolytes will be conducted by blending different particle sizes of nickel oxide.
