Report Title: **SOFC Systems with Improved Reliability and Endurance**

Type of Report: Final Technical Report

DOE Award No.: DE-FE0011691

Name & Address of Submitter: FuelCell Energy, Inc.
3 Great Pasture Road
Danbury, CT 06813

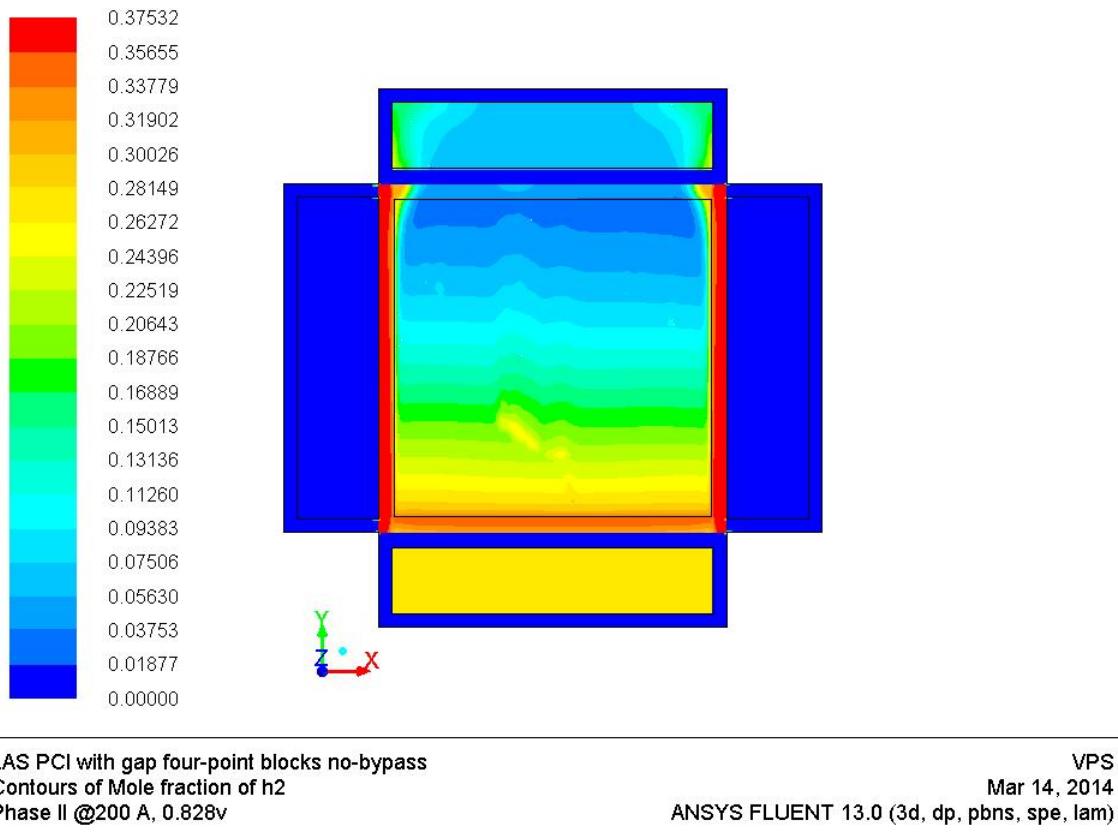
Figure 2-67. H_2 Profile on the Anode Layer

The profiles of CO and H_2 concentration resulting after reforming reaction along the gap were also generated (assuming no fuel is leaking into cathode domain in the model). The H_2 concentration profile for the cell anode area is shown in Figure 2-67. The figure shows that the fuel penetrates into the anode layer (at the left corner).

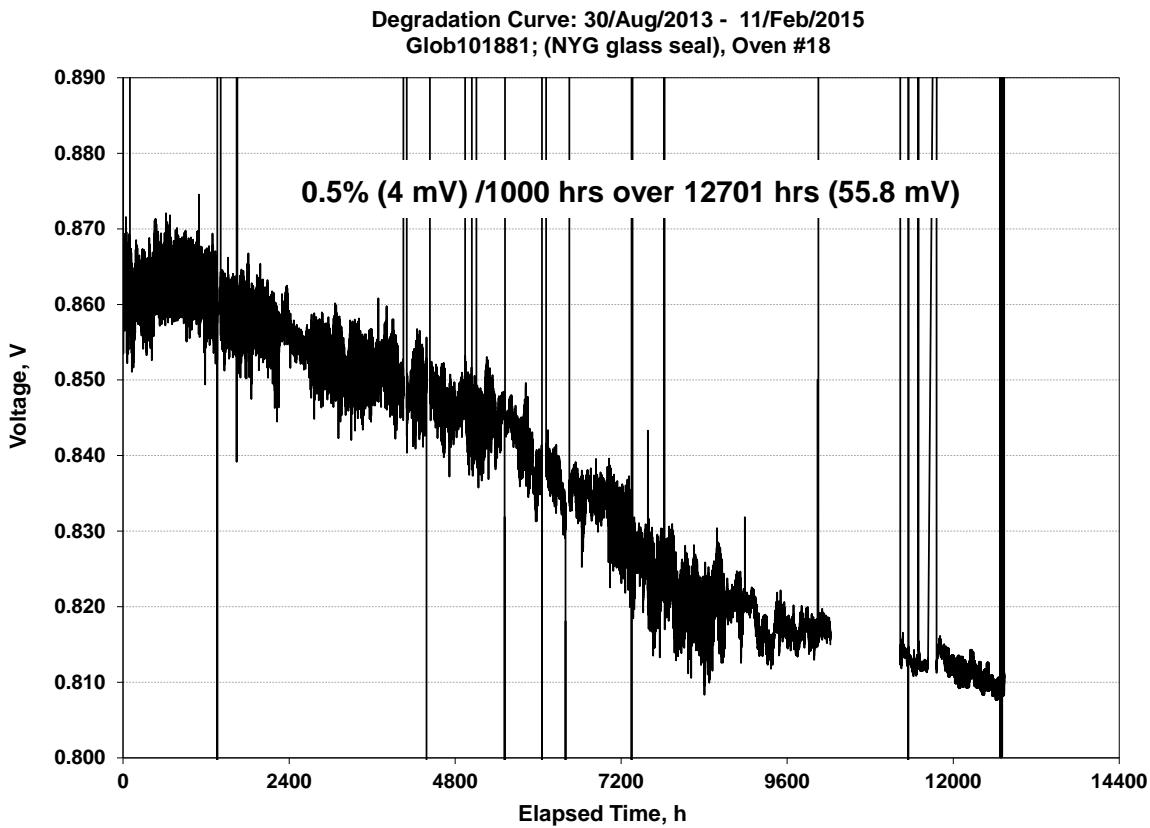
Figure 2-77. Performance Stability of Cell GLOB 101881 Containing NYG-353 Glass-ceramic Seals

A new glass-ceramic from NYG, called NYG-353, was evaluated to see if it is feasible for use in stacks. Initially, this material was tested in a single-cell with the cathode jig machined so that a glass-ceramic seal could be used on both the cathode and anode side. The material has reasonably high boron content [4], so it was important to evaluate the effect on degradation rate. Cell test GLOB101881 with NYG-353 seals on both cathode and anode sides was conducted. Figure 2-77 shows the cell voltage vs time trend at 750°C, 0.5 A/cm², 50% Uf (hydrogen + 3% water), and 25% Uo (air). The degradation rate was 0.5% per 1000 hours over 12,701 hours operation including ten thermal cycles. Clearly the material did not cause an increase in degradation rate. The material can be used to seal the edge of the cell anode substrate (as a more stable alternative to the commercially available coating used in Thermicullite 866LS (discussed later in this section). By applying this material to standard Thermicullite 866, it may be possible to tailor compressibility and have a stable hybrid seal for the stack.

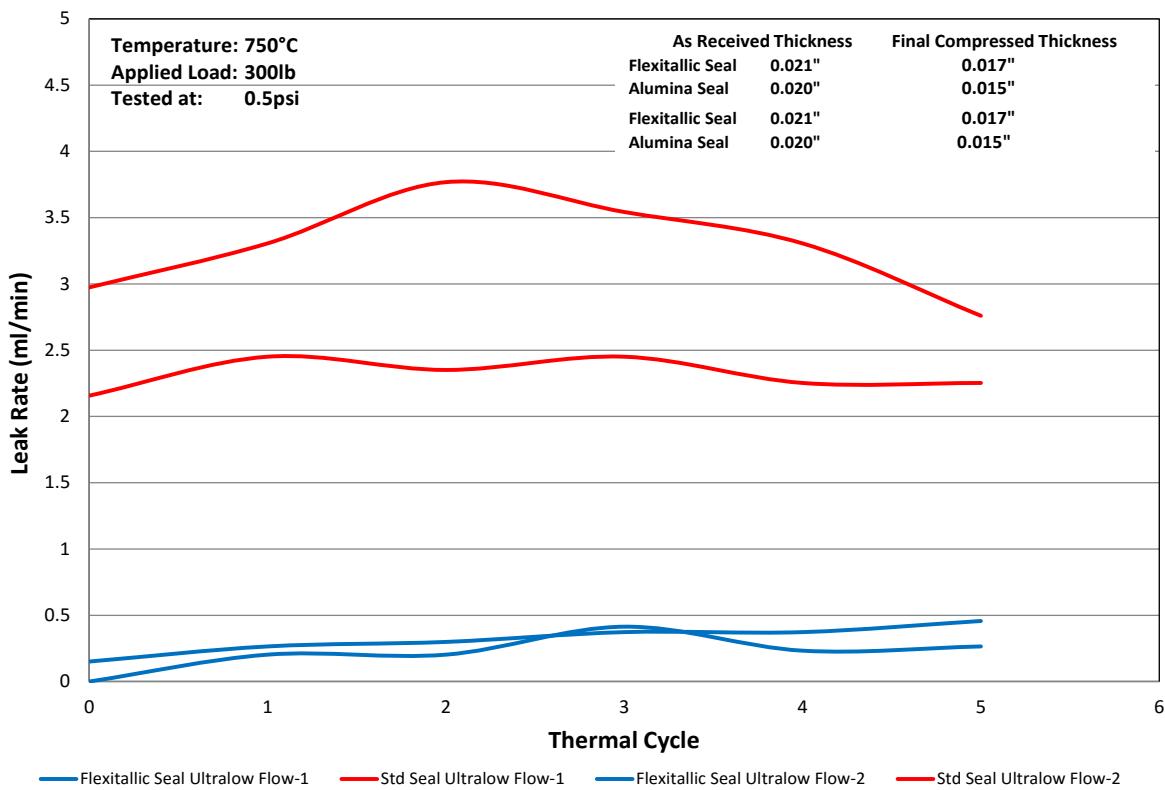
Figure 2-80. Leak Rate at 750°C and 0.5 psi Air of Thermicullite 866 LS (blue) and Standard Seals (red)

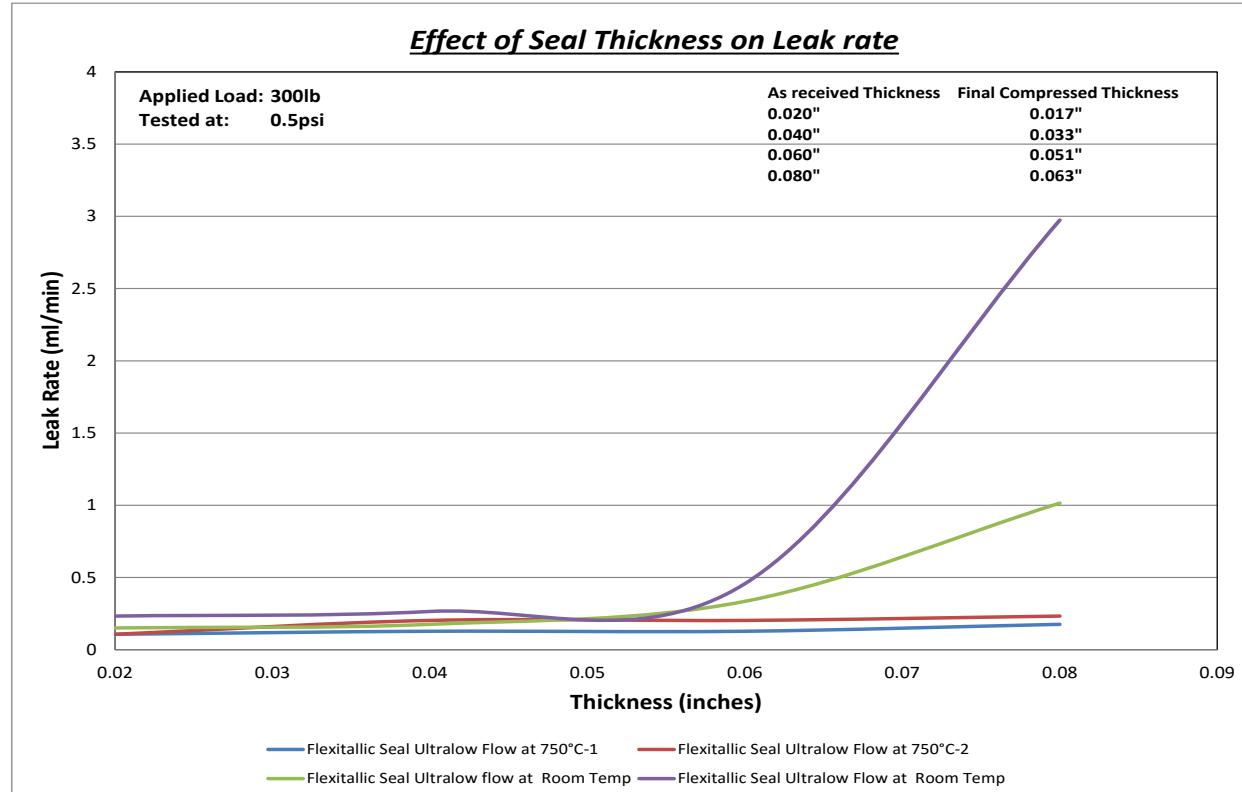
Figure 2-82. Effect of Seal Thickness on Leak Rate for Flexitallic Thermicullite 866 LS Seals

For the purposes of stack testing it was necessary to investigate compressibility with thicker seals. Since the sheets were only available in one thickness, it was decided to stack them to increase thickness. Figure 2-82 shows leak rate vs. initial seal thickness at 750°C and room temperature for one seal layer (~0.020" height), two seal layers (~0.040"), three seal layers (~0.060"), and four seal layers (~0.080"). Upon initial testing at 750°C, the leak rate hardly changed with seal thickness which is very promising. However, when cooled to room temperature and leak tested again, the four-layer seal had a significantly higher leak rate suggesting the thicker seals failed on thermal cycling.

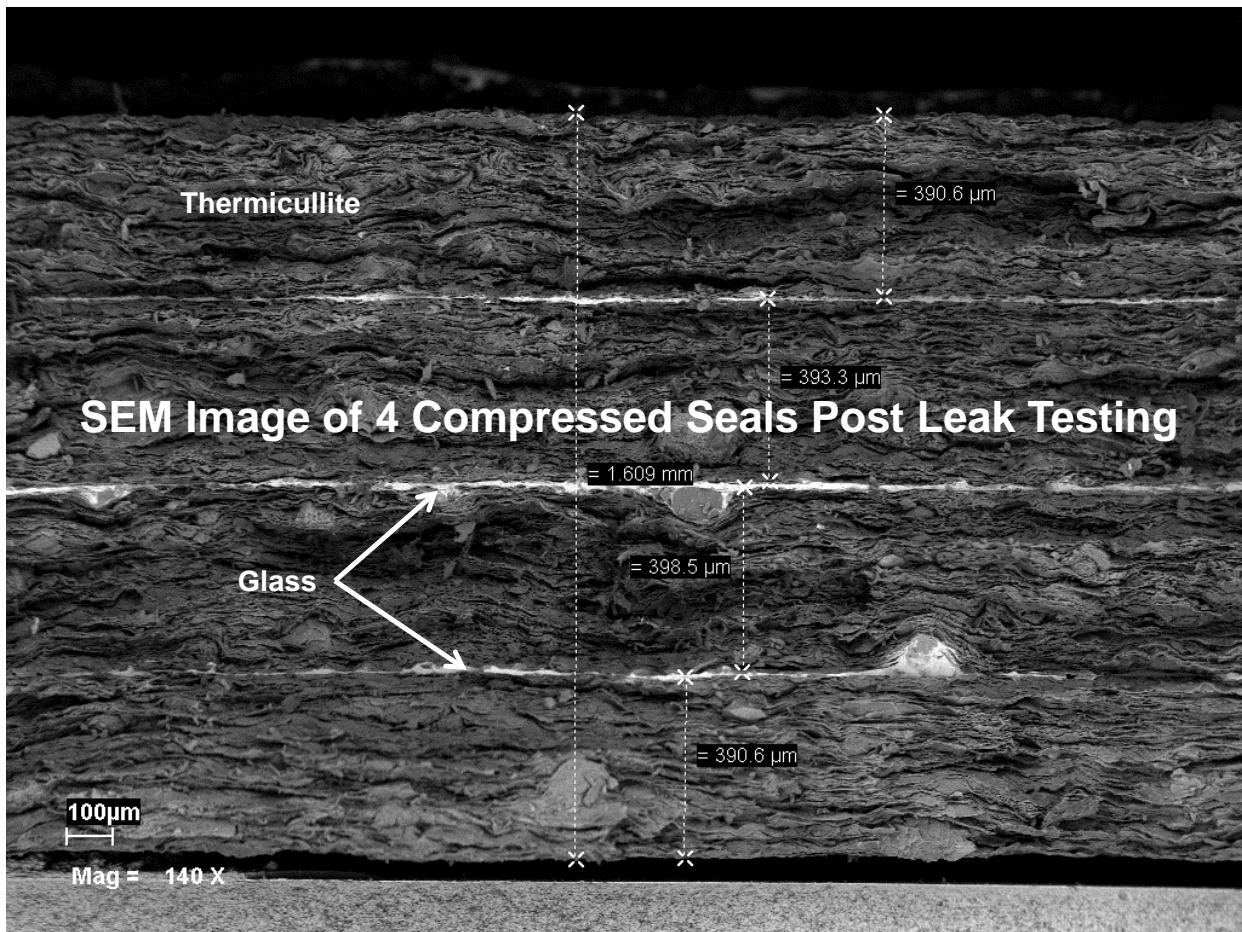
Figure 2-83. SEM Cross-Section of Thermicullite Seal Broken Away from the Jigs

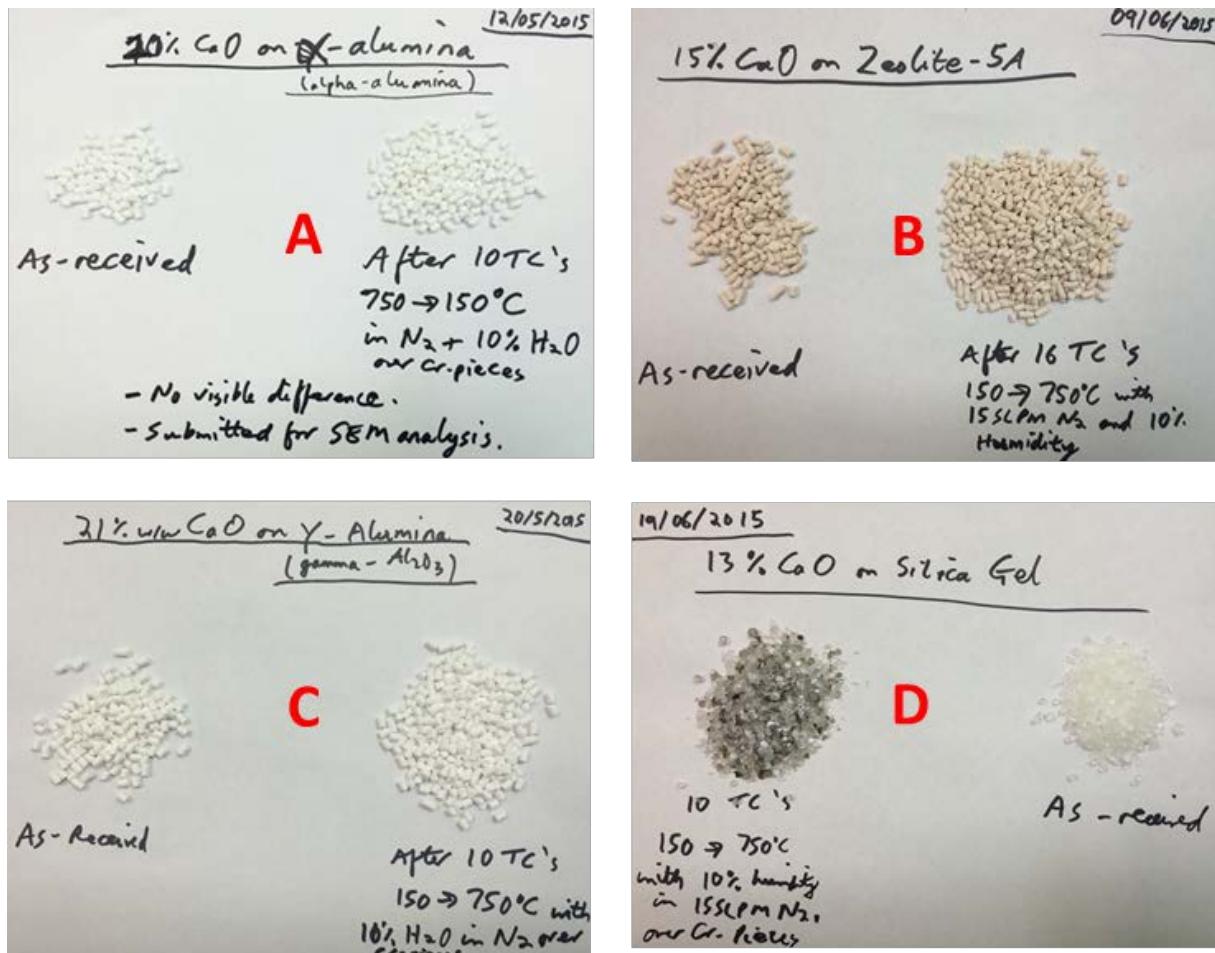
Figure 2-99. Samples Before and After Thermal Cycling with Humidified Nitrogen

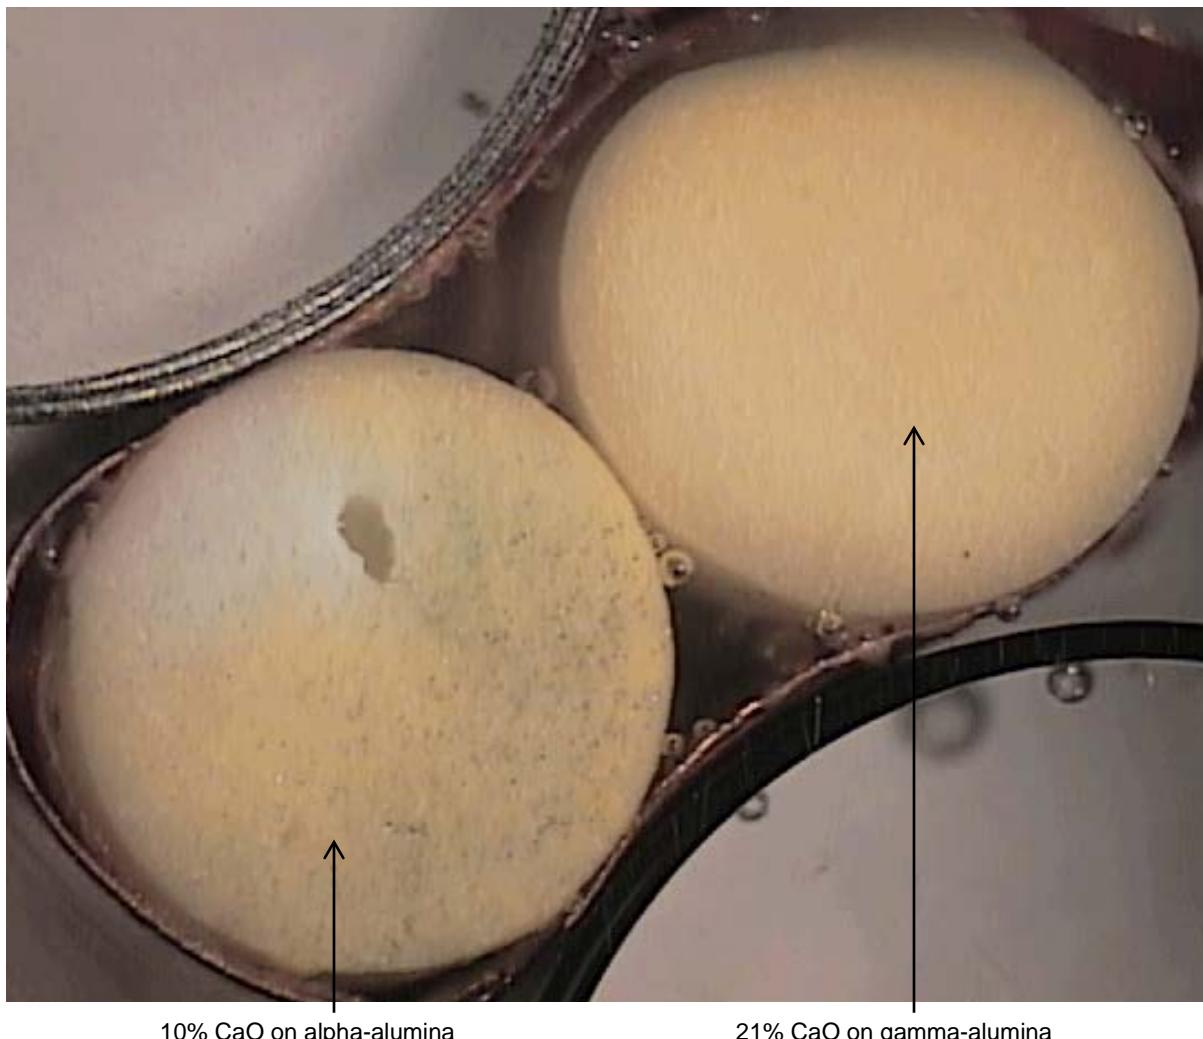
Figure 2-101. Micrograph of Alumina-supported CaO Samples After 5000-Hour Test: Showing Discoloration Due to Cr-Species Interaction

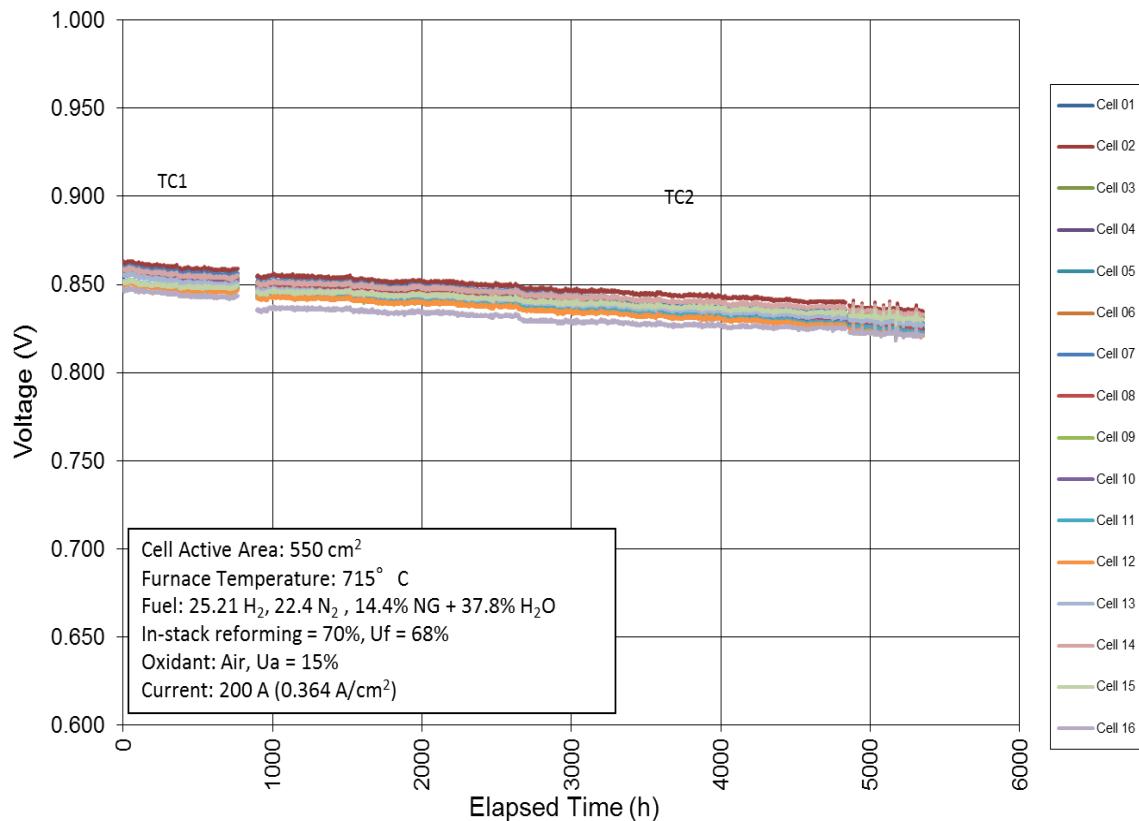
Figure 2-108. Individual Cell Voltages of 16-Cell Stack GT057235-0097

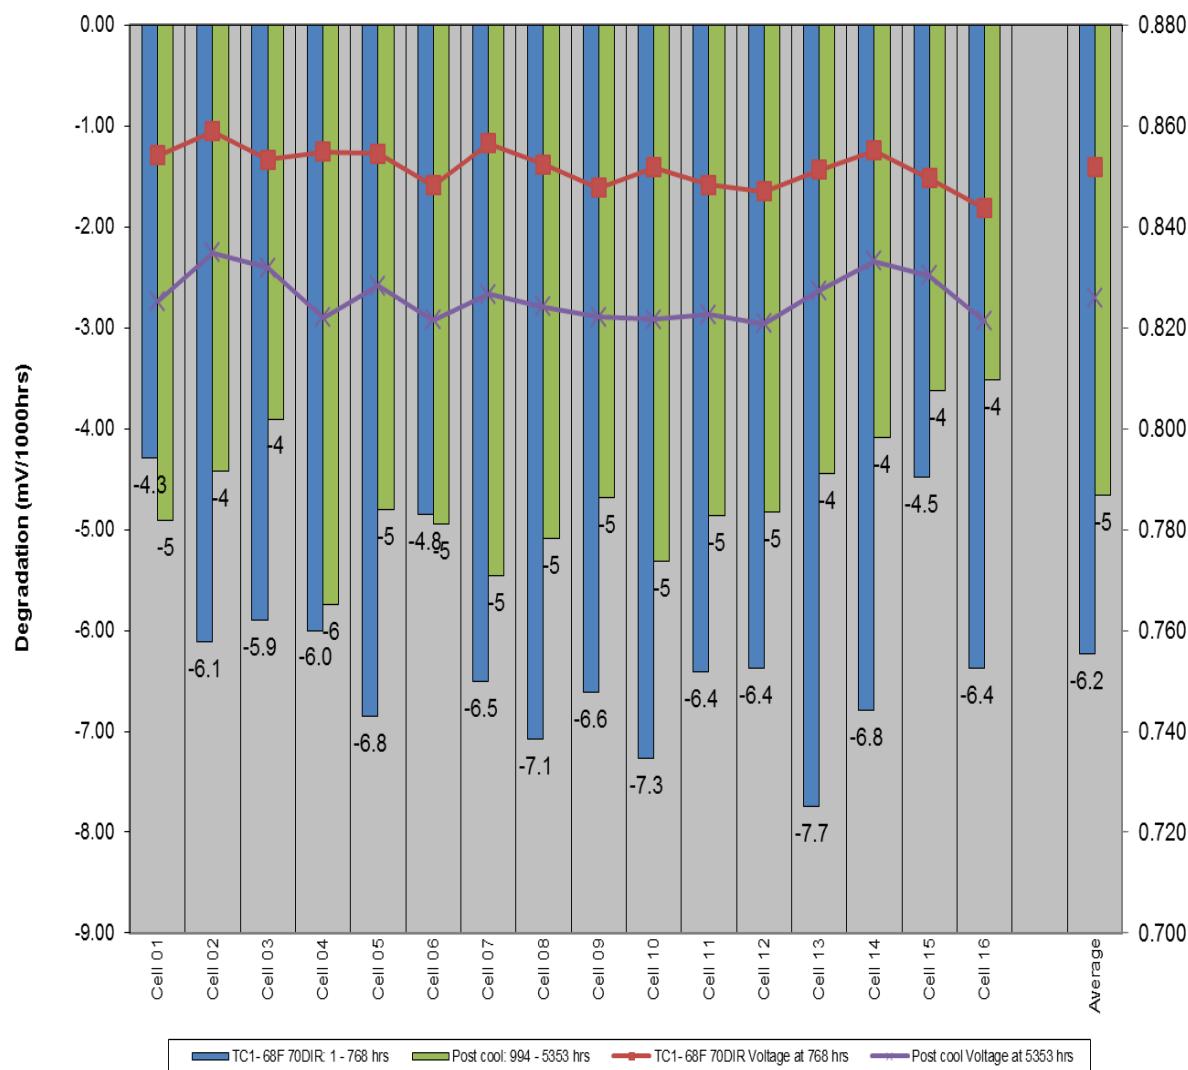
Figure 2-109. Distribution of Performance Degradation Rates for Stack GT057235-0097 at Phase II System Operating Conditions

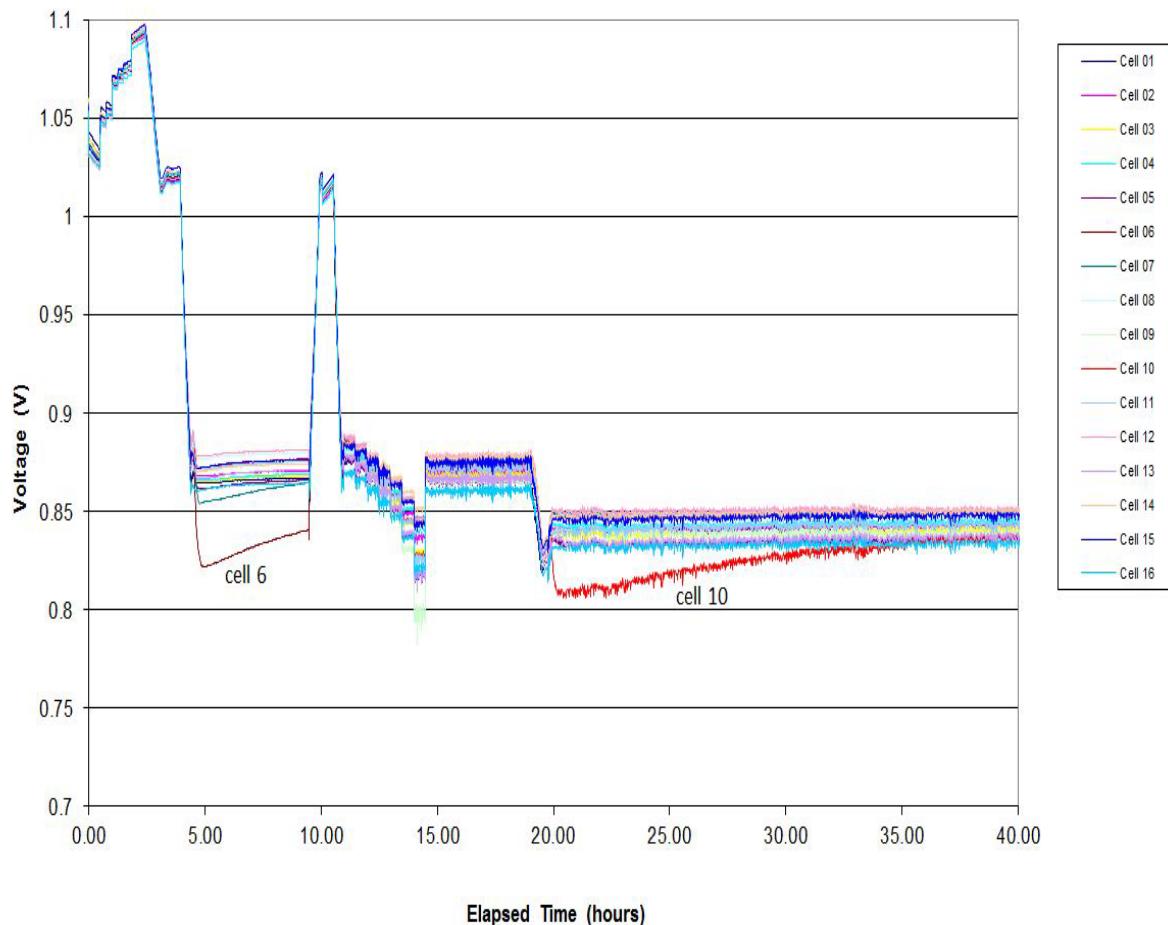
Figure 2-110. Stack GT057235-0099 – Random Drooping of Cells after One Thermal Cycle

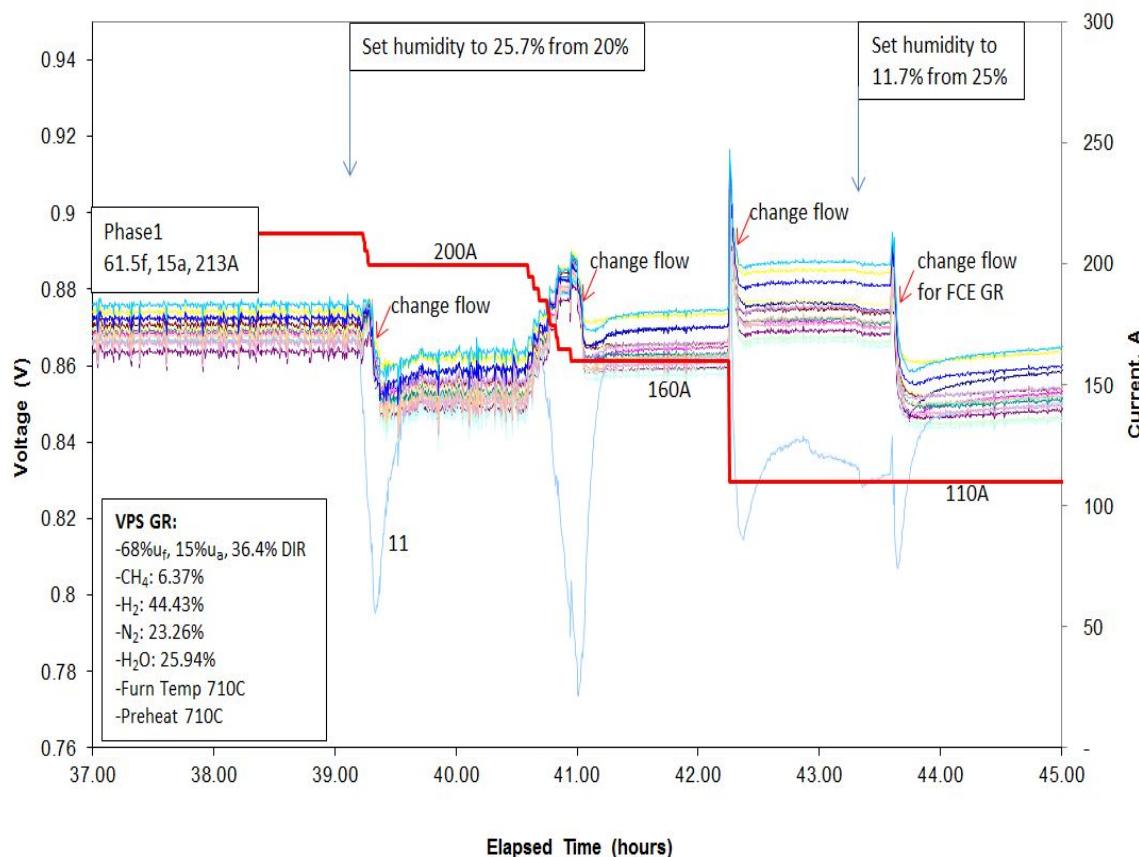
Figure 2-113. Stack GT057235-0101 – Testing at VPS GR Conditions (after Two Thermal Cycles)

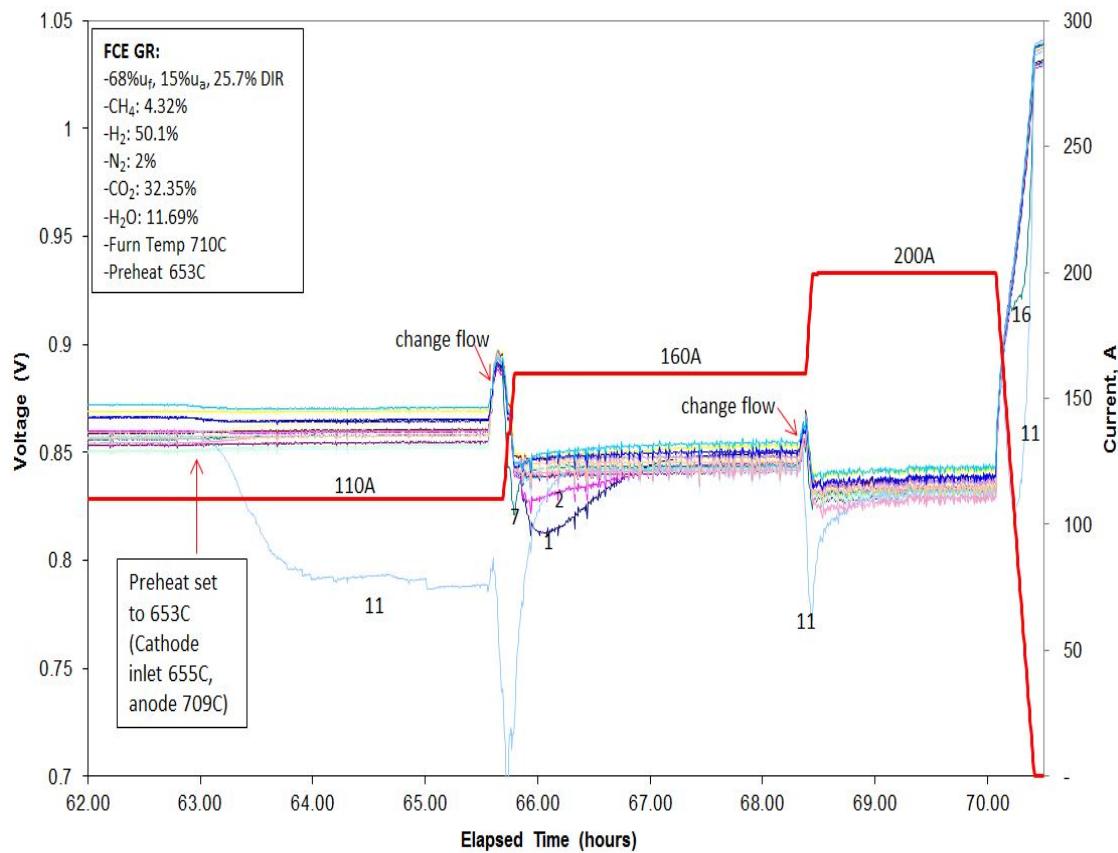
Figure 2-114. Stack GT057235-0101 – Testing at FCE GR Conditions (after Two Thermal Cycles)

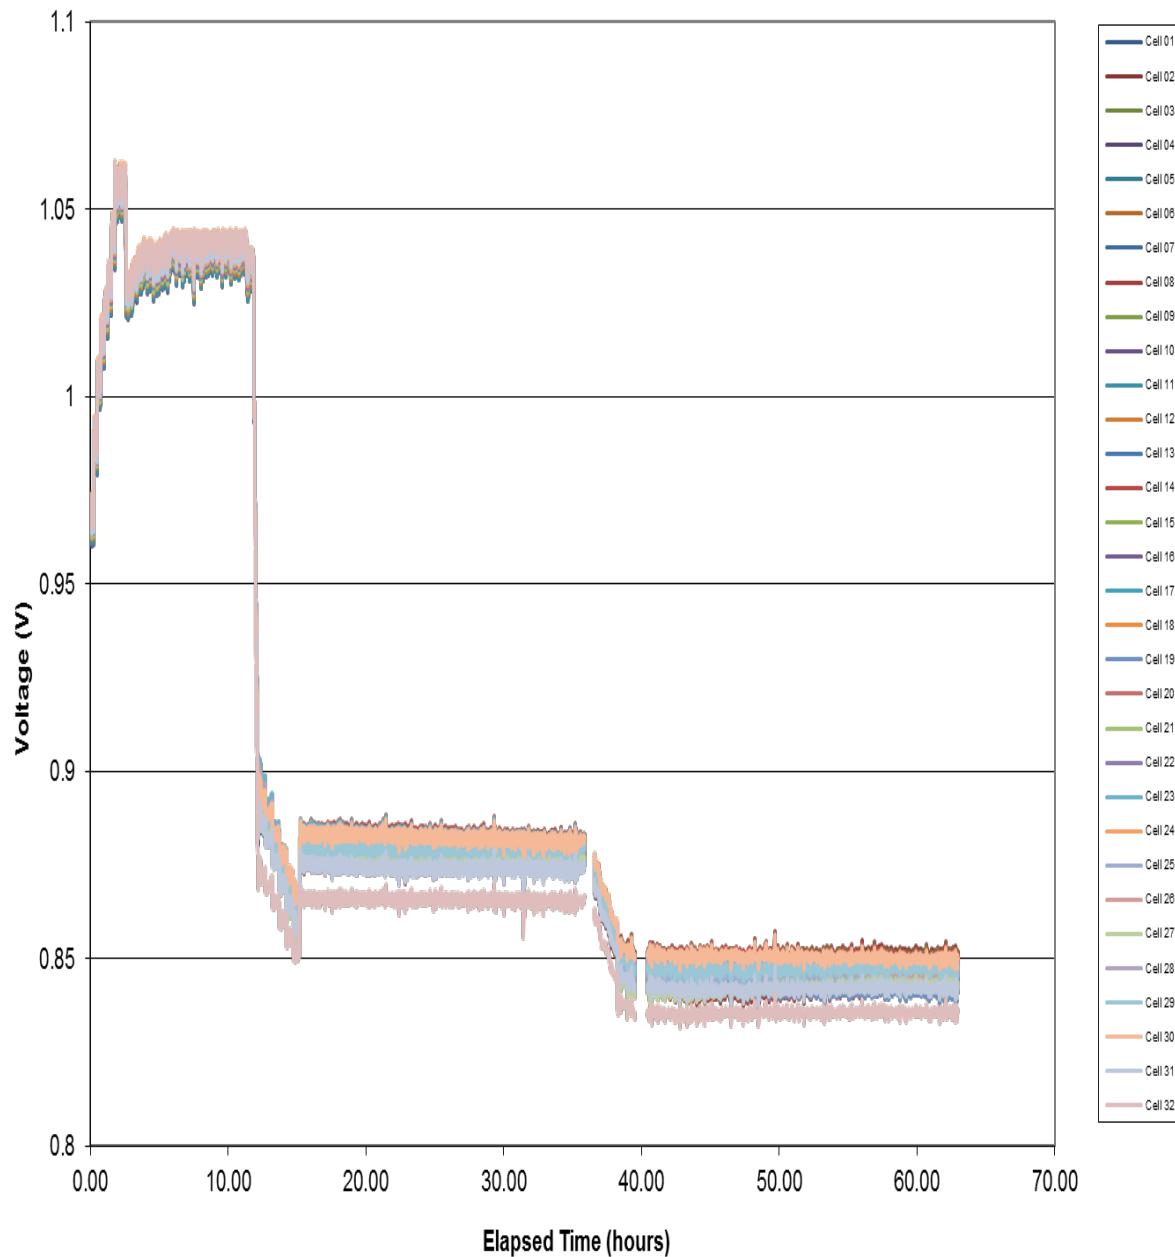
Figure 2-116. Stack GT057832-0005 Fuel Utilization Test After First Thermal Cycle

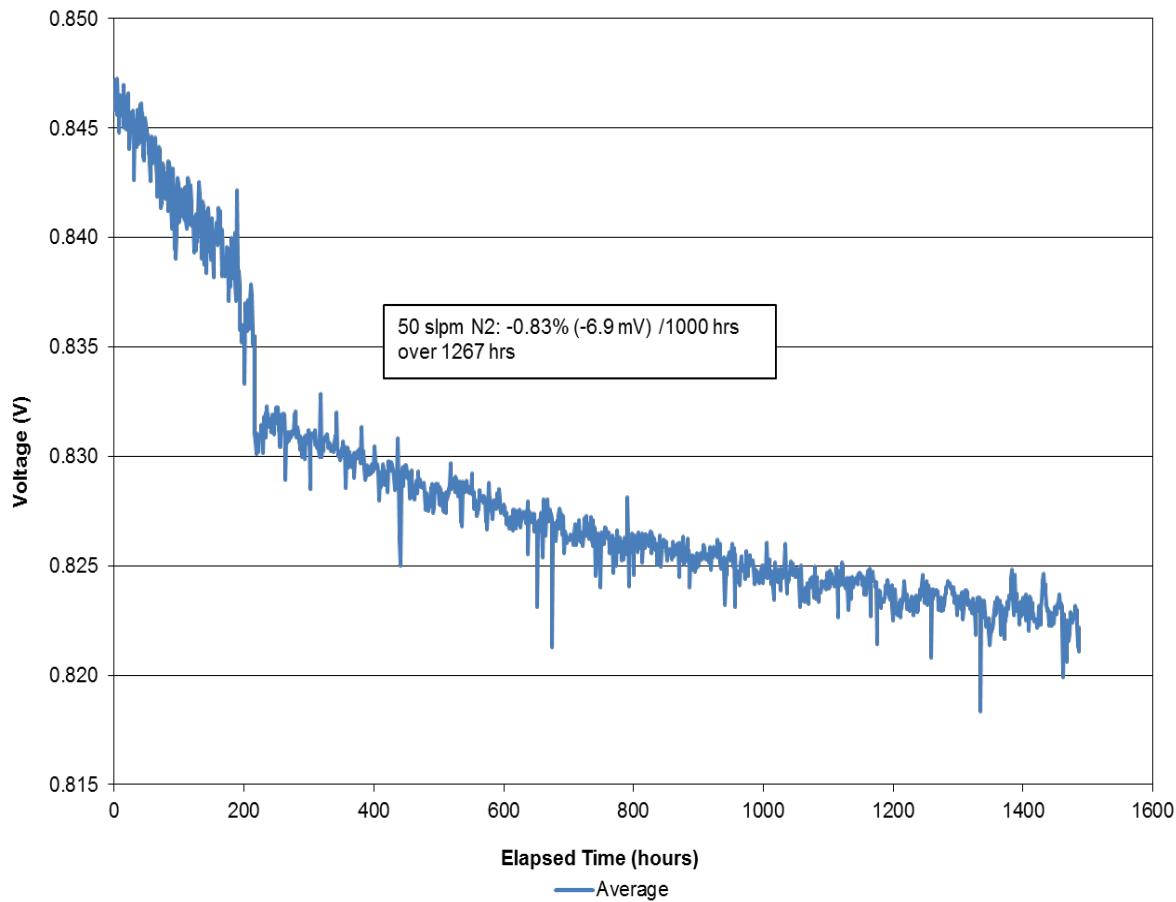
Figure 2-117. Stack GT057832-0005 Performance at Phase II System Operating Conditions (with increased N₂ flow)

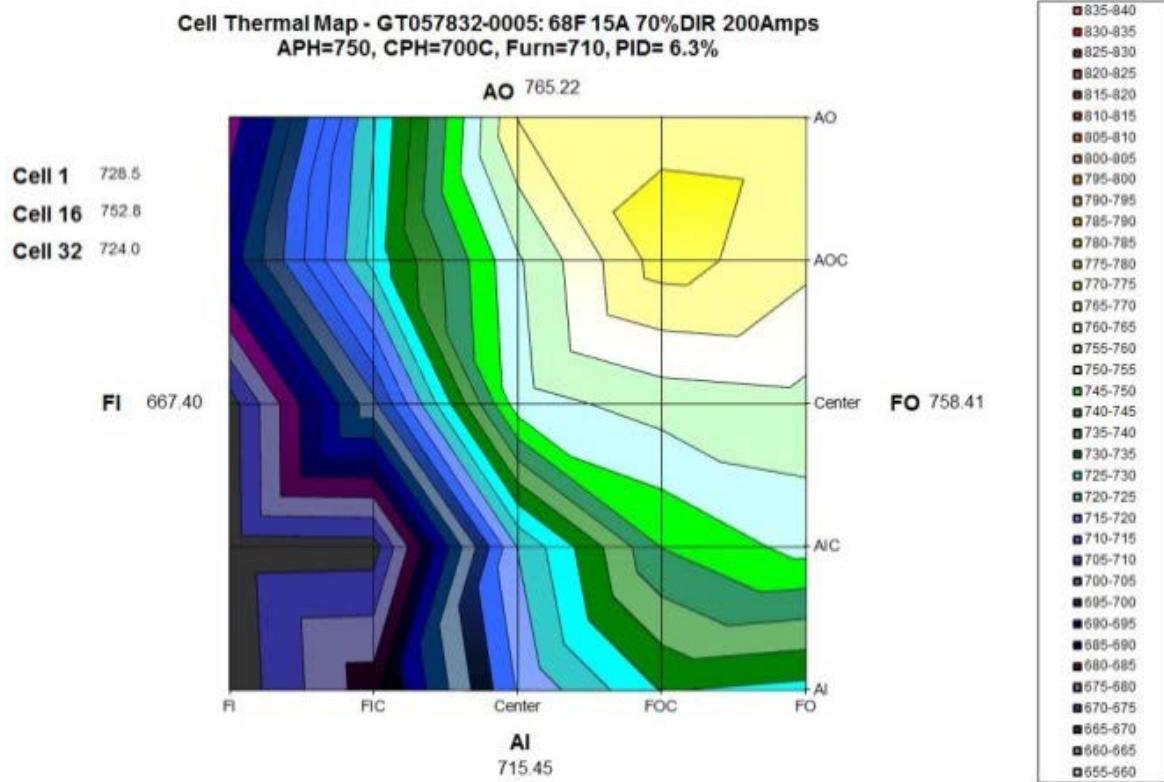
Figure 2-118. Stack GT057832-0005 – Thermal Maps Before (top) and After (bottom) N₂ Flow Increase at Anode

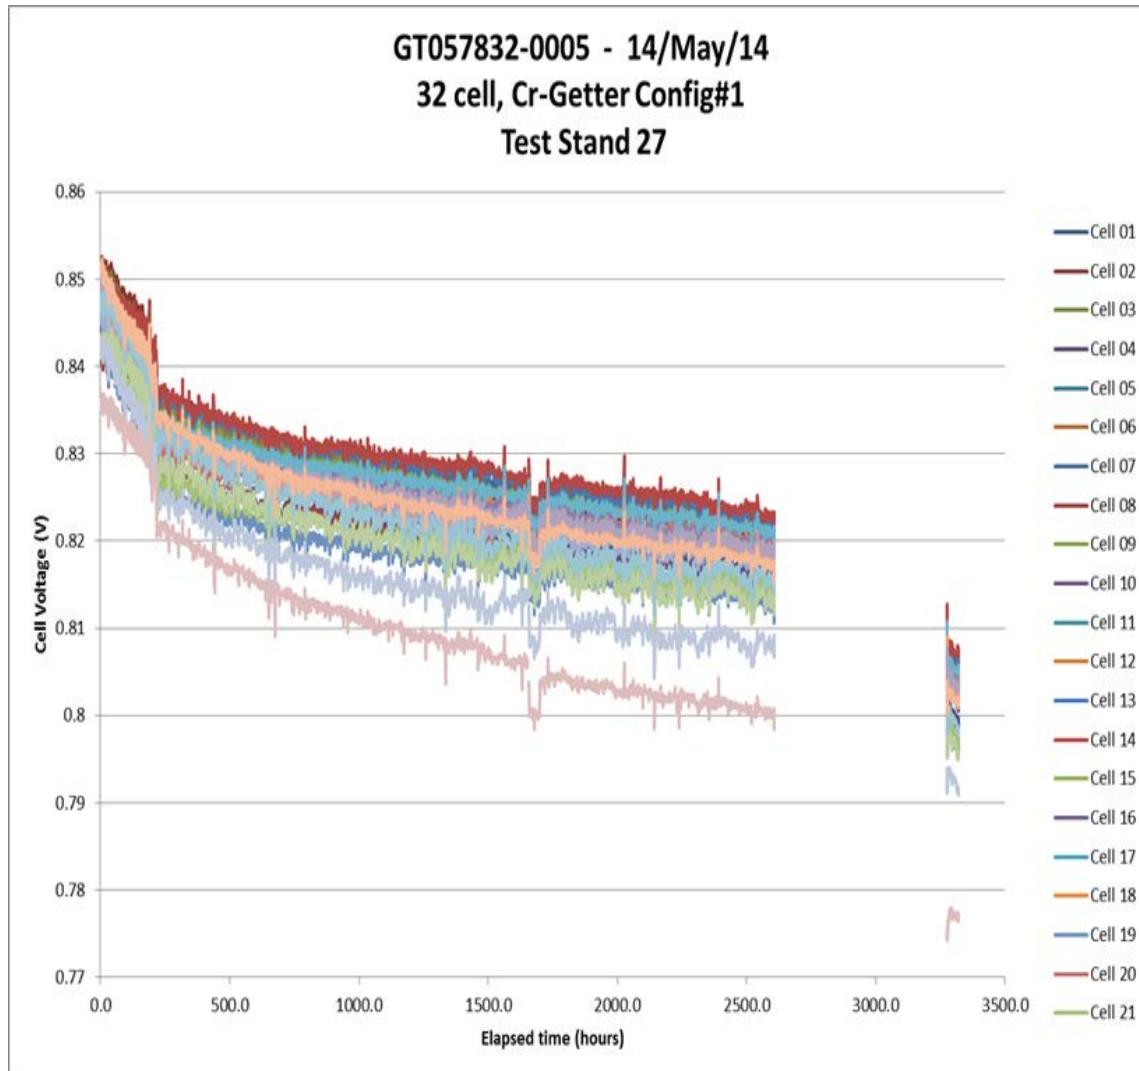
Figure 2-119. Individual Cell Performance Trends of Stack GT057832-0005 at Phase 2 System Operating Conditions (with increased N₂ flow)

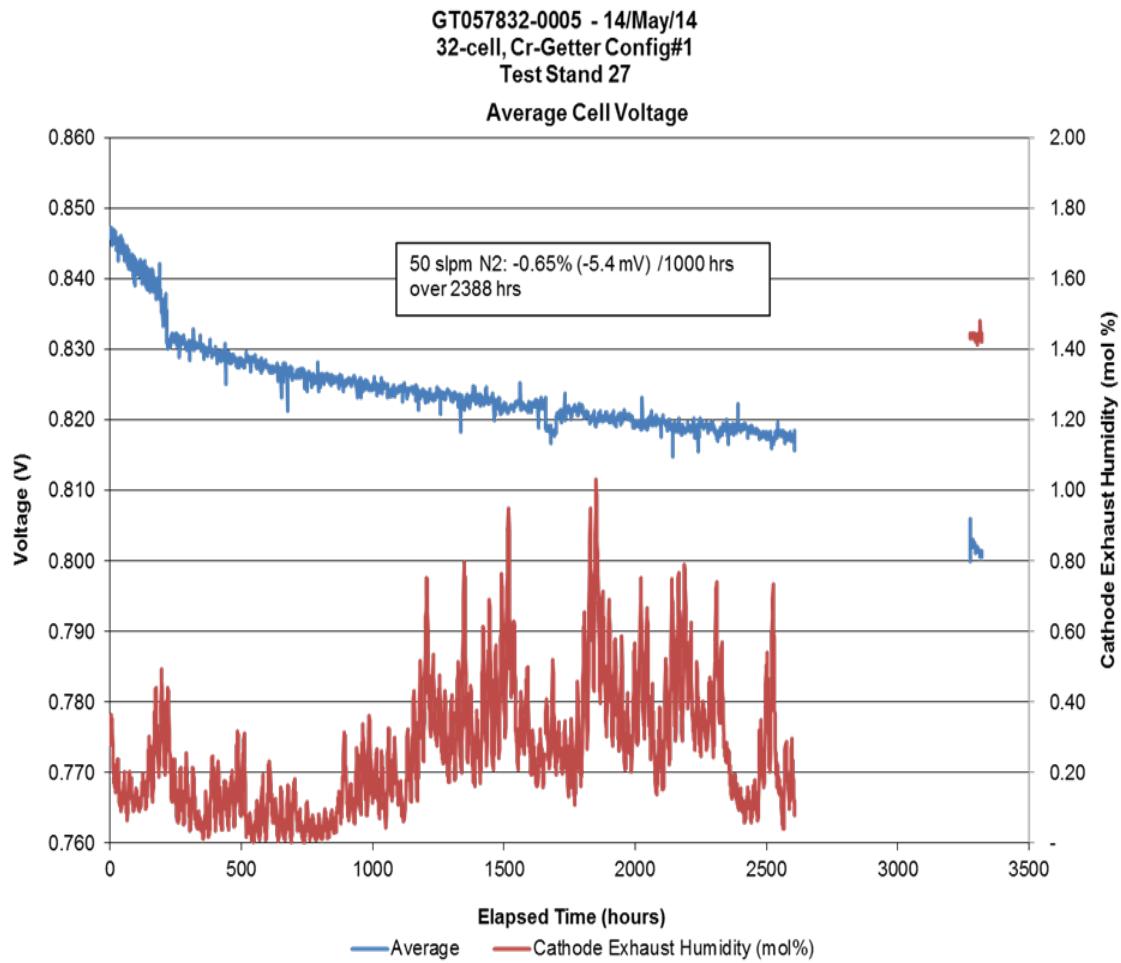
Figure 2-120. Stack GT057832-0005 Performance Stability at Phase 2 System Operating Conditions (with increased N₂ flow)

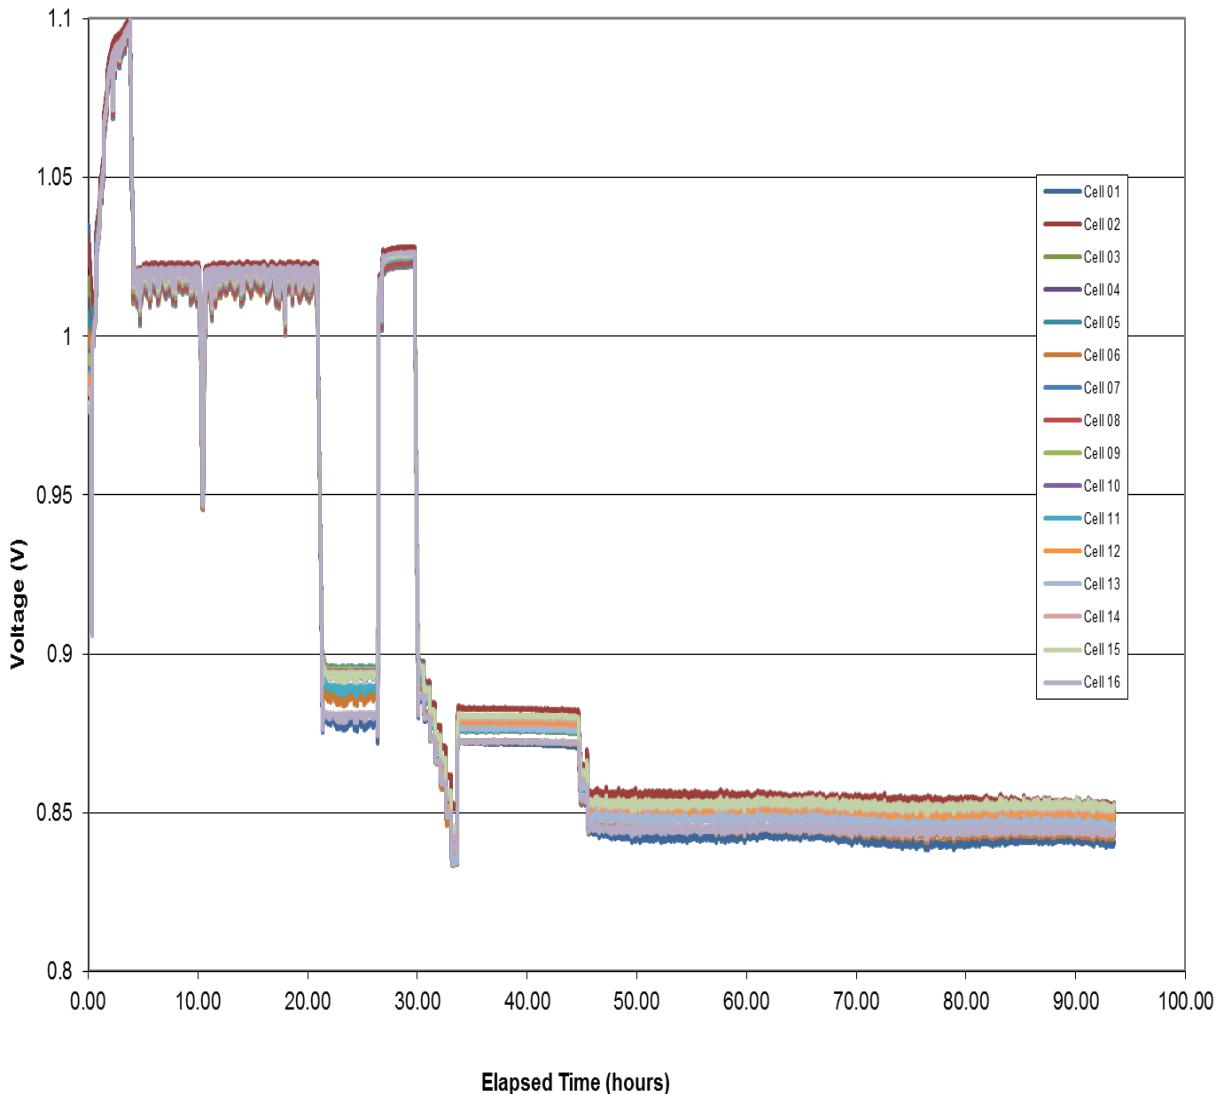
Figure 2-121. Stack GT057235-0108 Fuel Utilization Testing After First Thermal Cycle

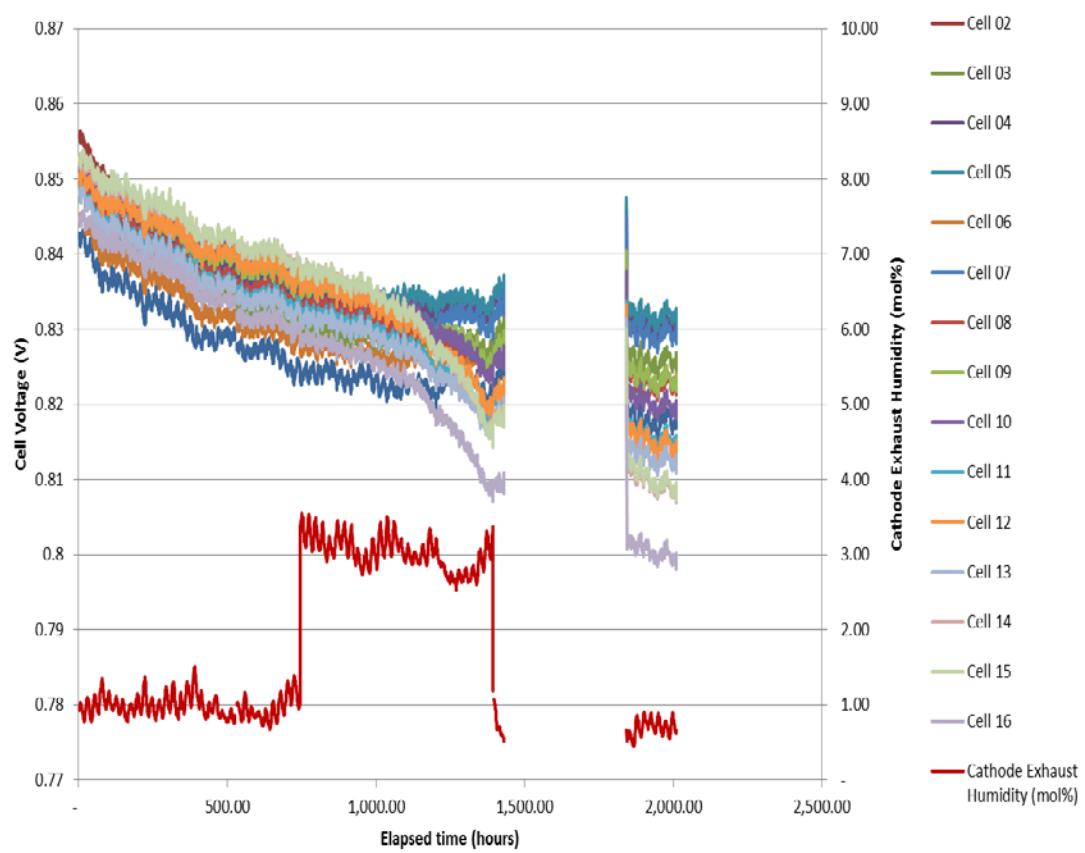
Figure 2-122. Individual Cell Performance Trends for Stack GT057235-0108 at Phase 2 System Operating Conditions

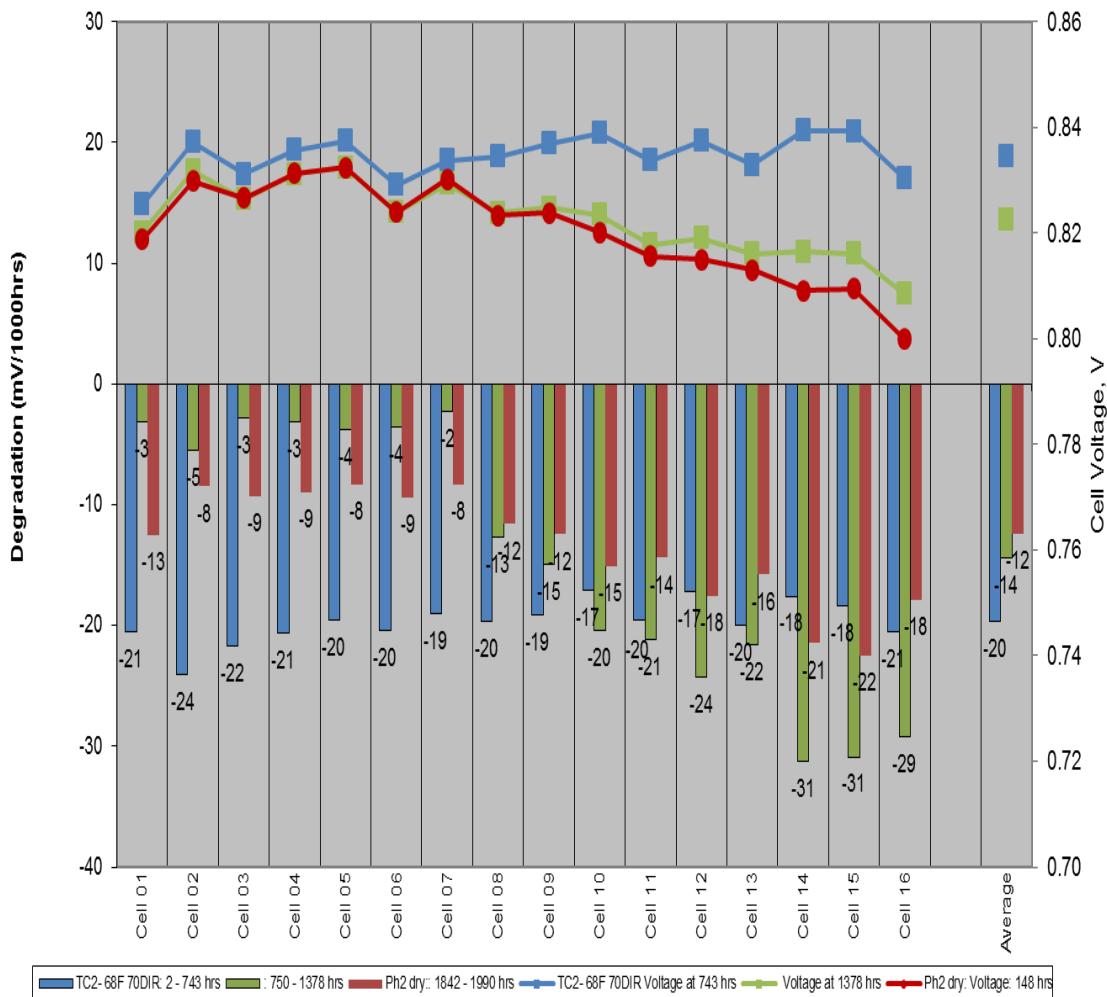
Figure 2-123. Individual Cell Performance and Degradation Rates in Stack GT057235-0108 at Phase 2 System Conditions
