Report Title: **SOFC Systems with Improved Reliability and Endurance**

Type of Report: Final Technical Report

DOE Award No.: DE-FE0011691

Name & Address of Submitter: FuelCell Energy, Inc.
3 Great Pasture Road
Danbury, CT 06813

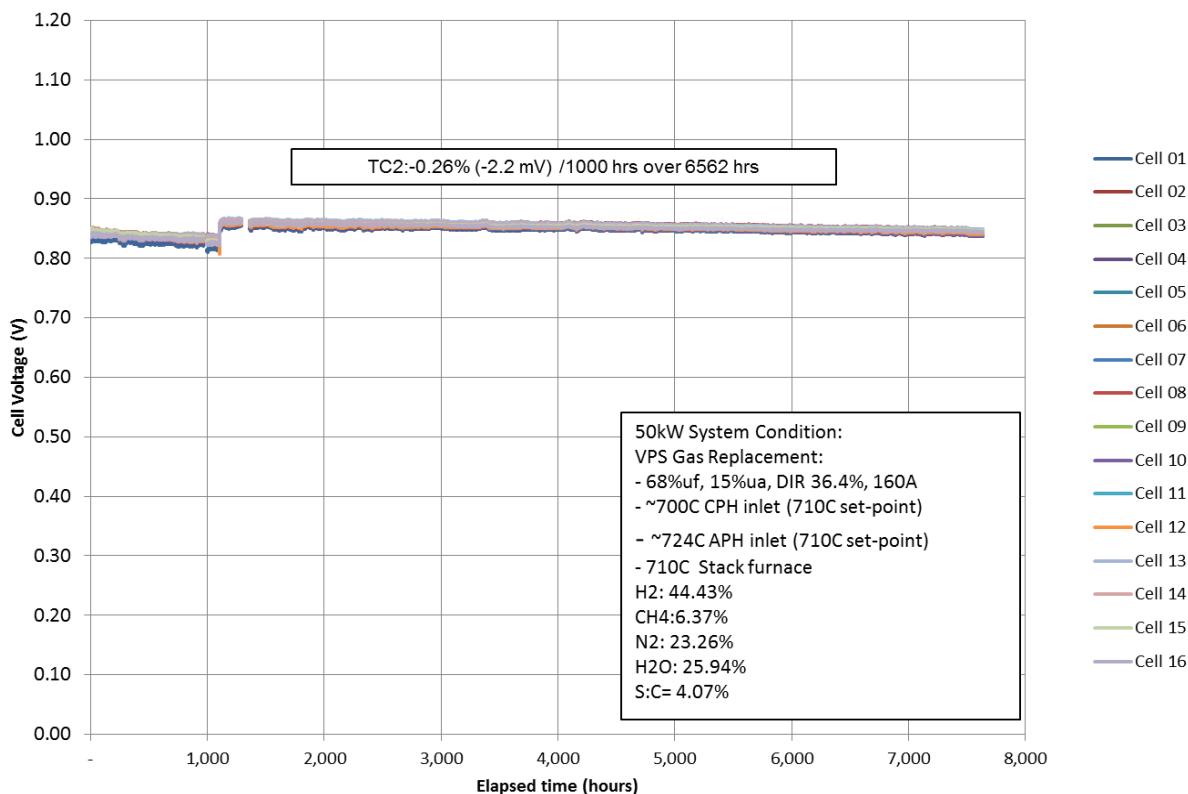
Figure 2-124. Stack GT057235-0109 Performance at VPS GR Conditions

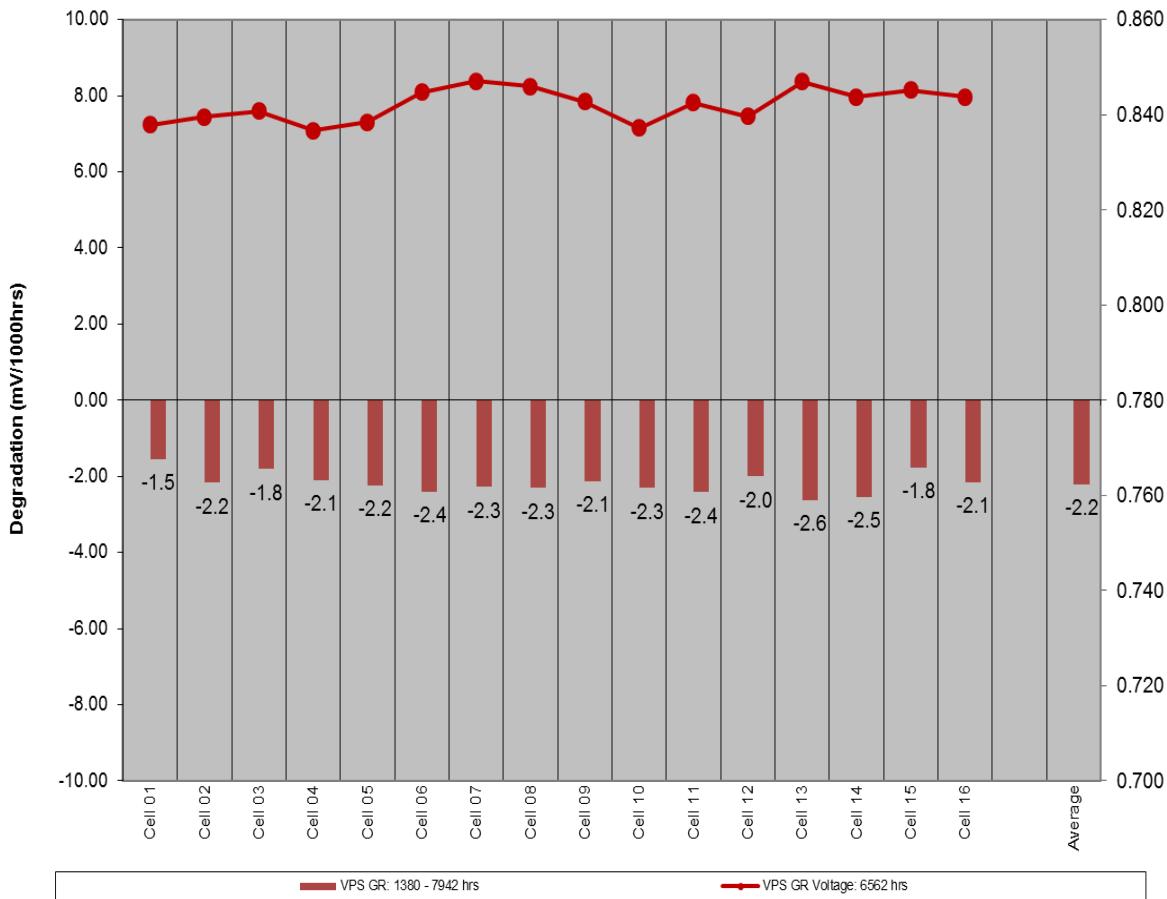
Figure 2-125. Individual Cell Performance Degradation Rate Distribution for Stack GT057235-0109 at VPS GR Conditions

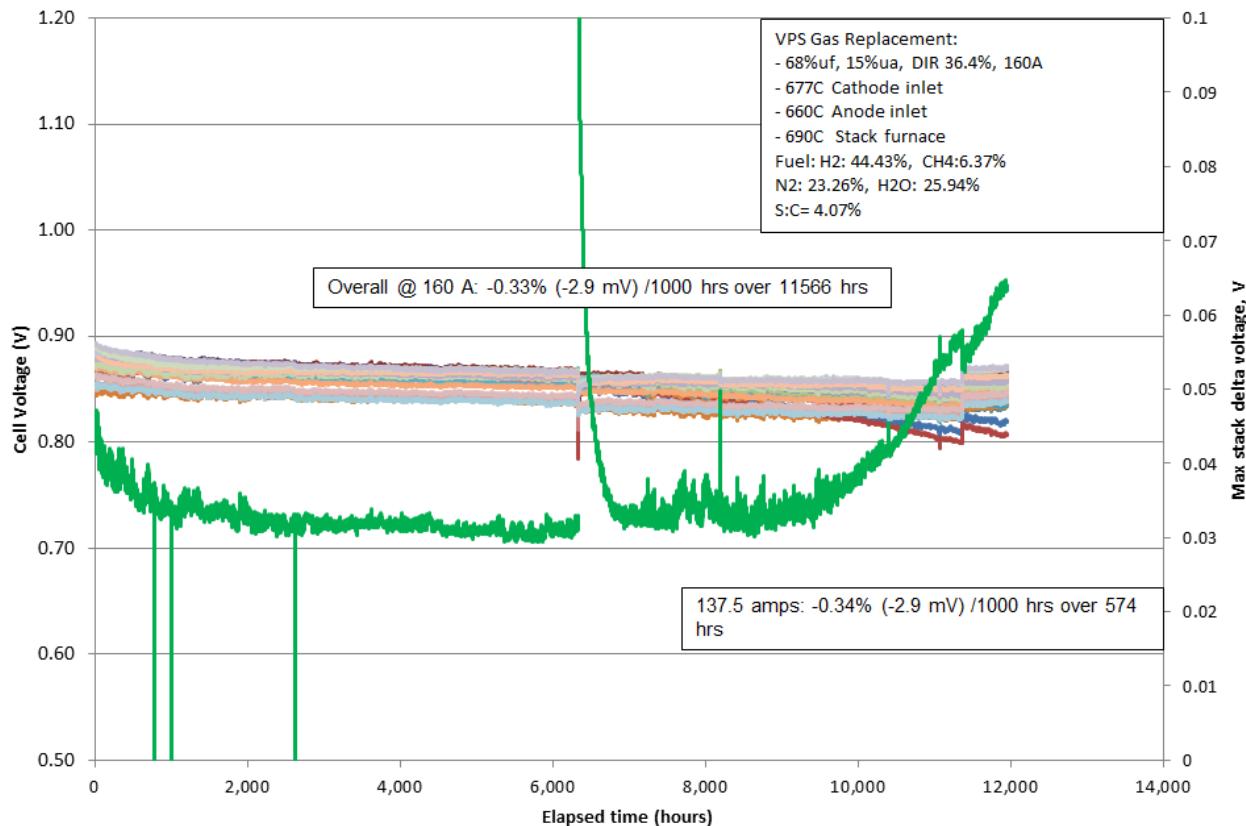
Figure 2-126. Performance Stability of Stack GT058139-0002 at VPS Gas Replacement Conditions

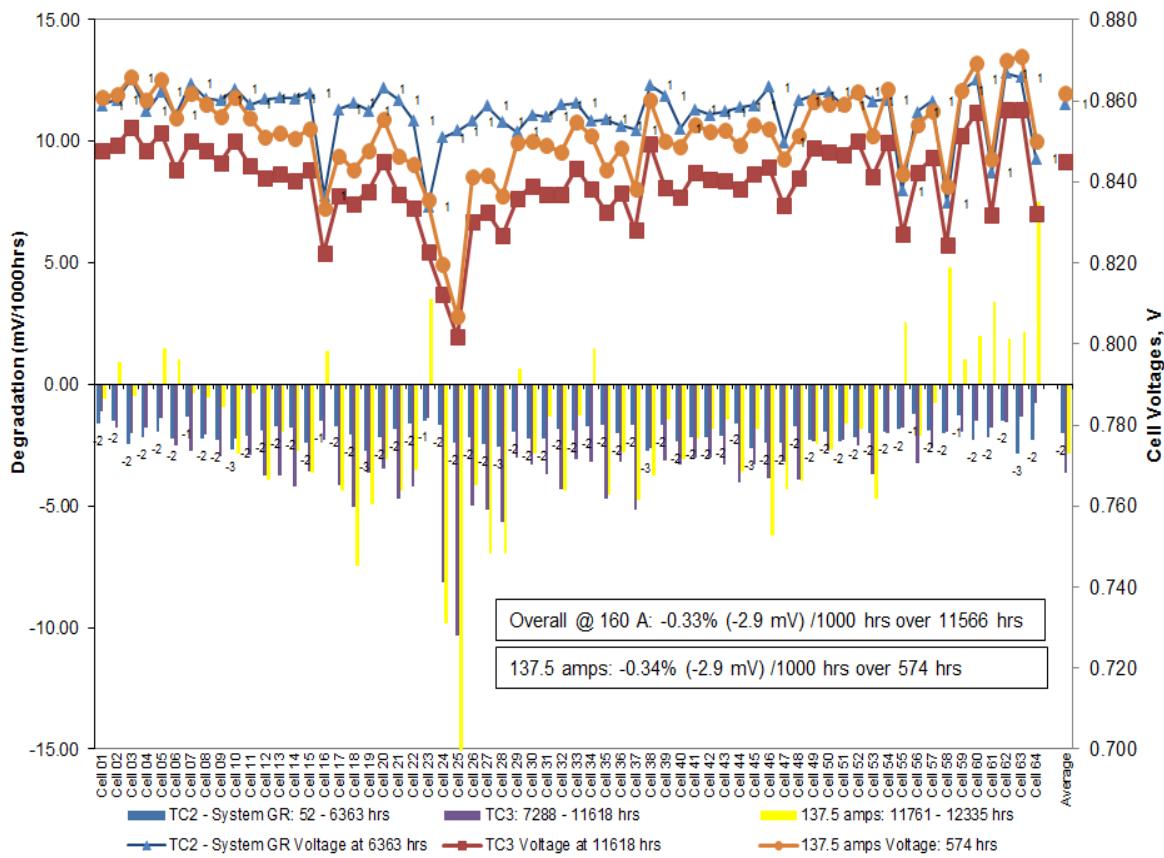
Figure 2-127. Distribution of Individual Cell Performance Degradation Rates for Stack GT058139-0002 at VPS Gas Replacement Conditions

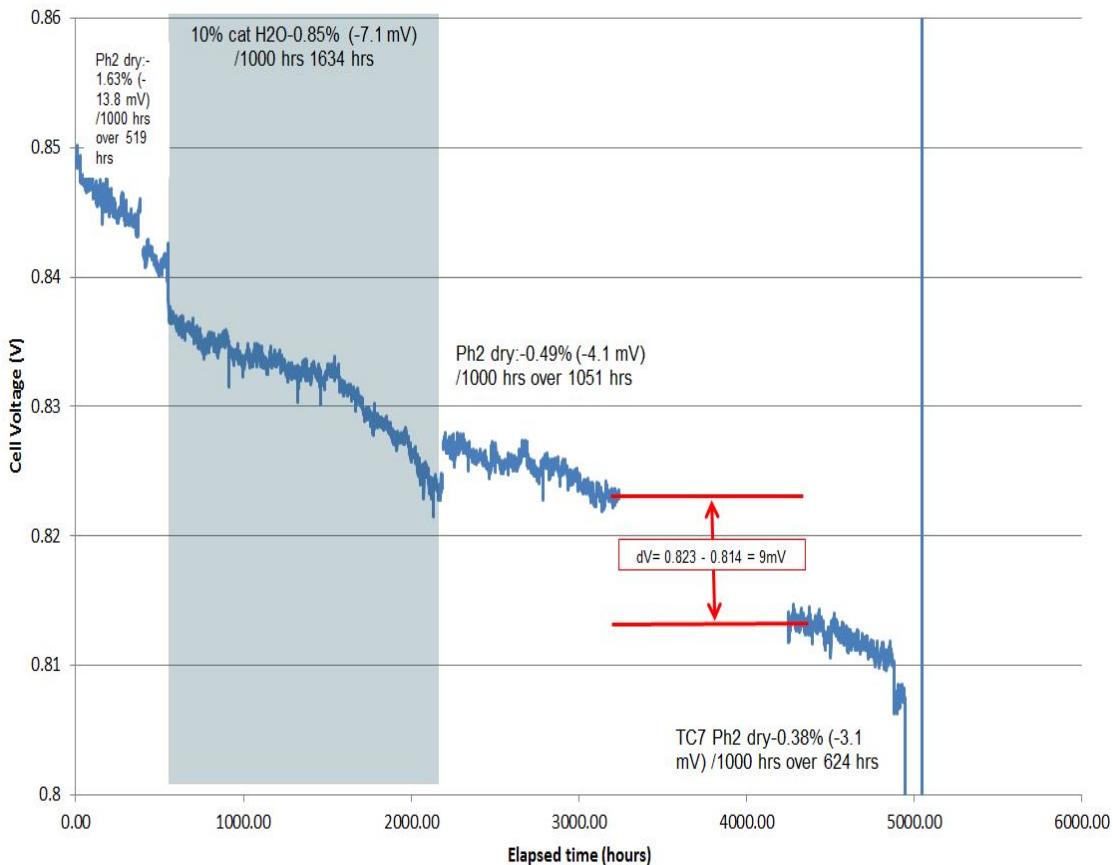
Figure 2-128. Performance Stability of Stack GT057235-0111 at Phase 2 System Conditions (with dry cathode air and with 10% cathode gas humidity)

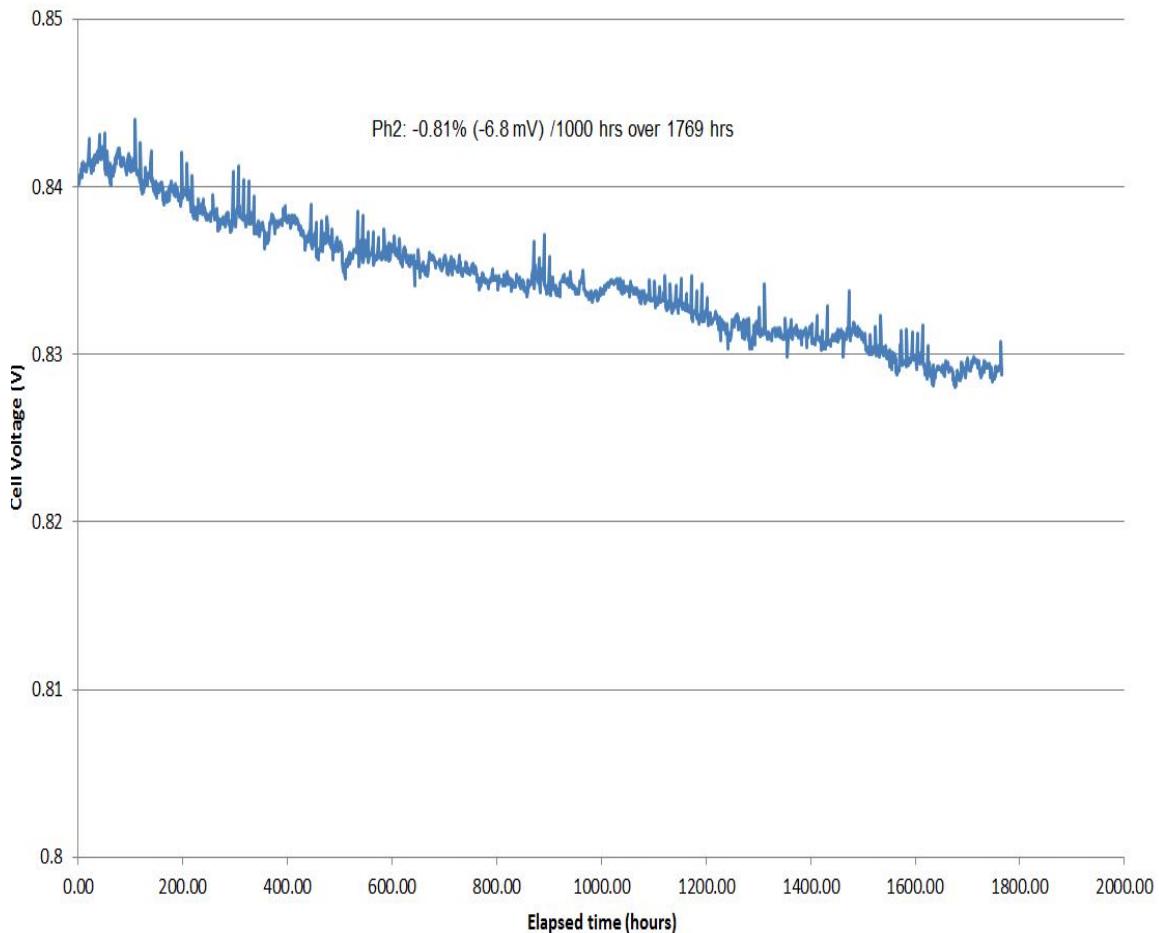
Figure 2-129. Performance Stability of Stack GT057235-0112 at Phase 2 System Conditions

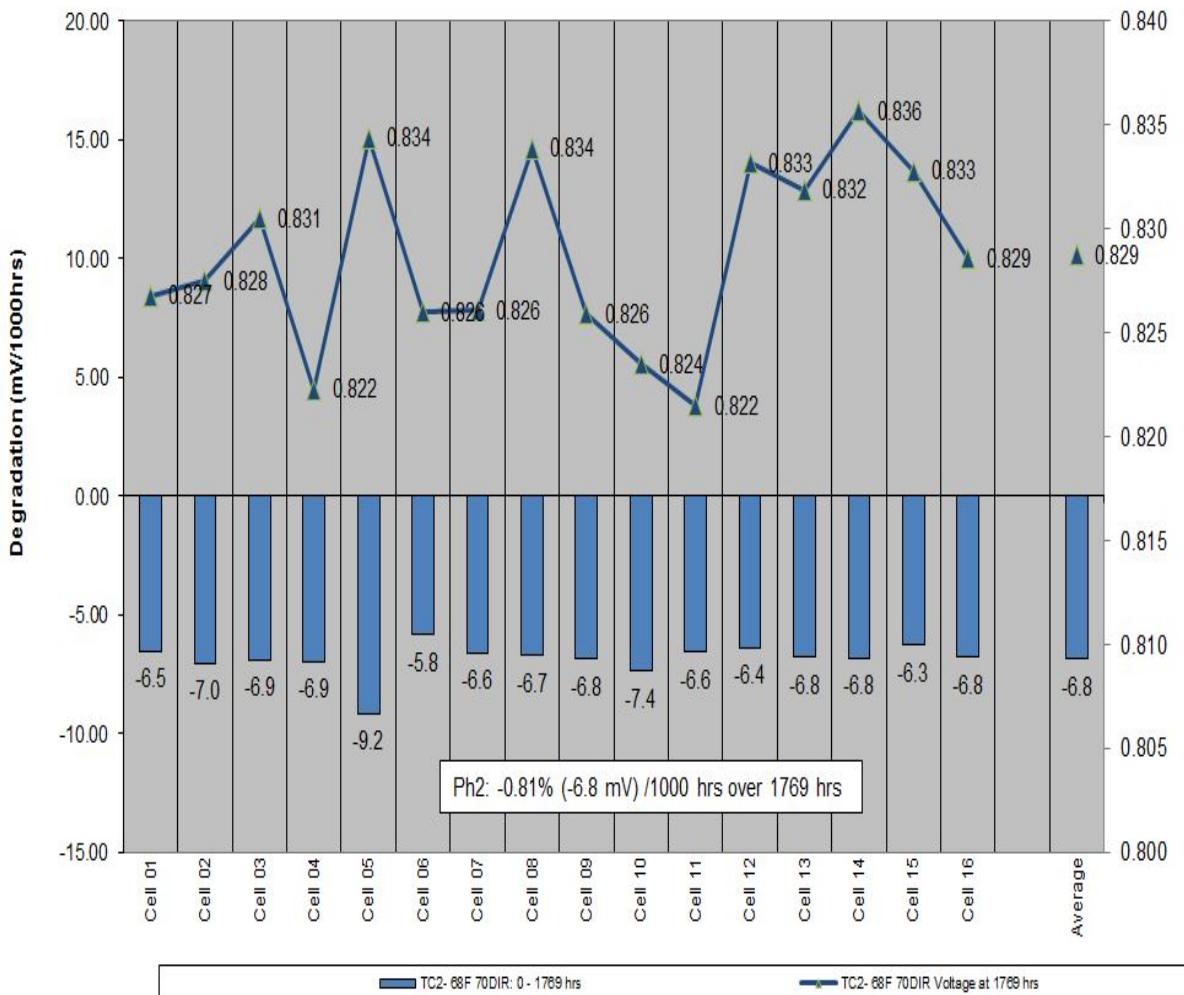
Figure 2-130. Degradation Rate Distribution in Stack GT057235-0112

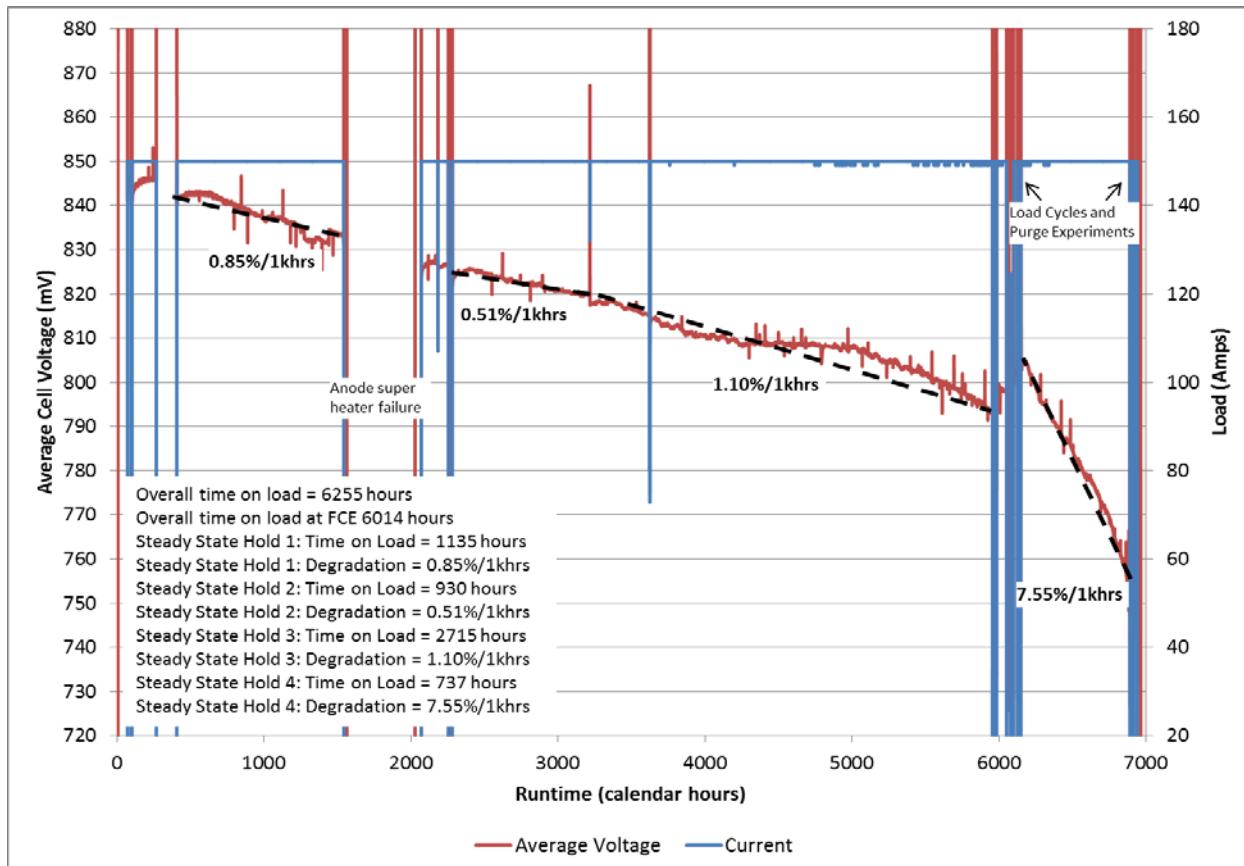
Figure 2-134. Average Cell Voltage and Stack Current During 16-Cell Stack Test GT057235-0100

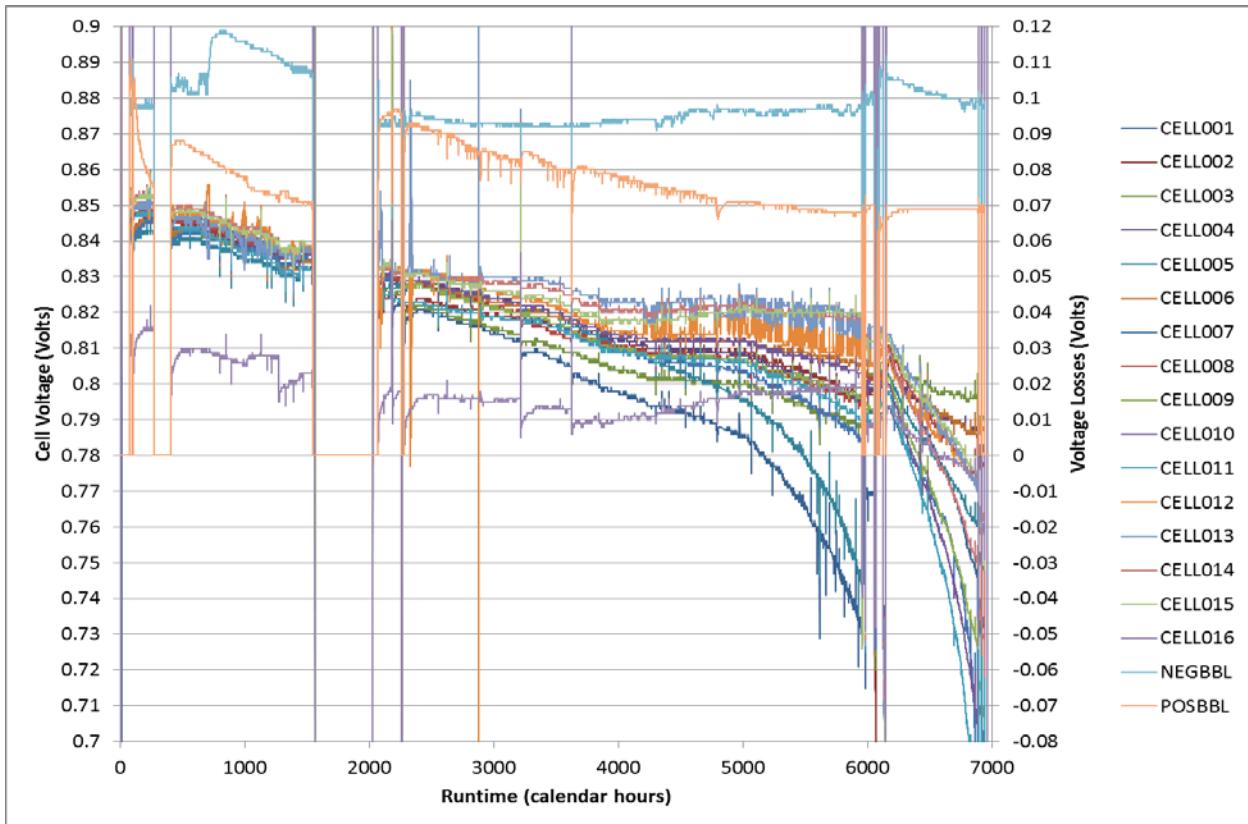
Figure 2-135. Individual Cell Voltages and End-Losses During 16-Cell Stack Test

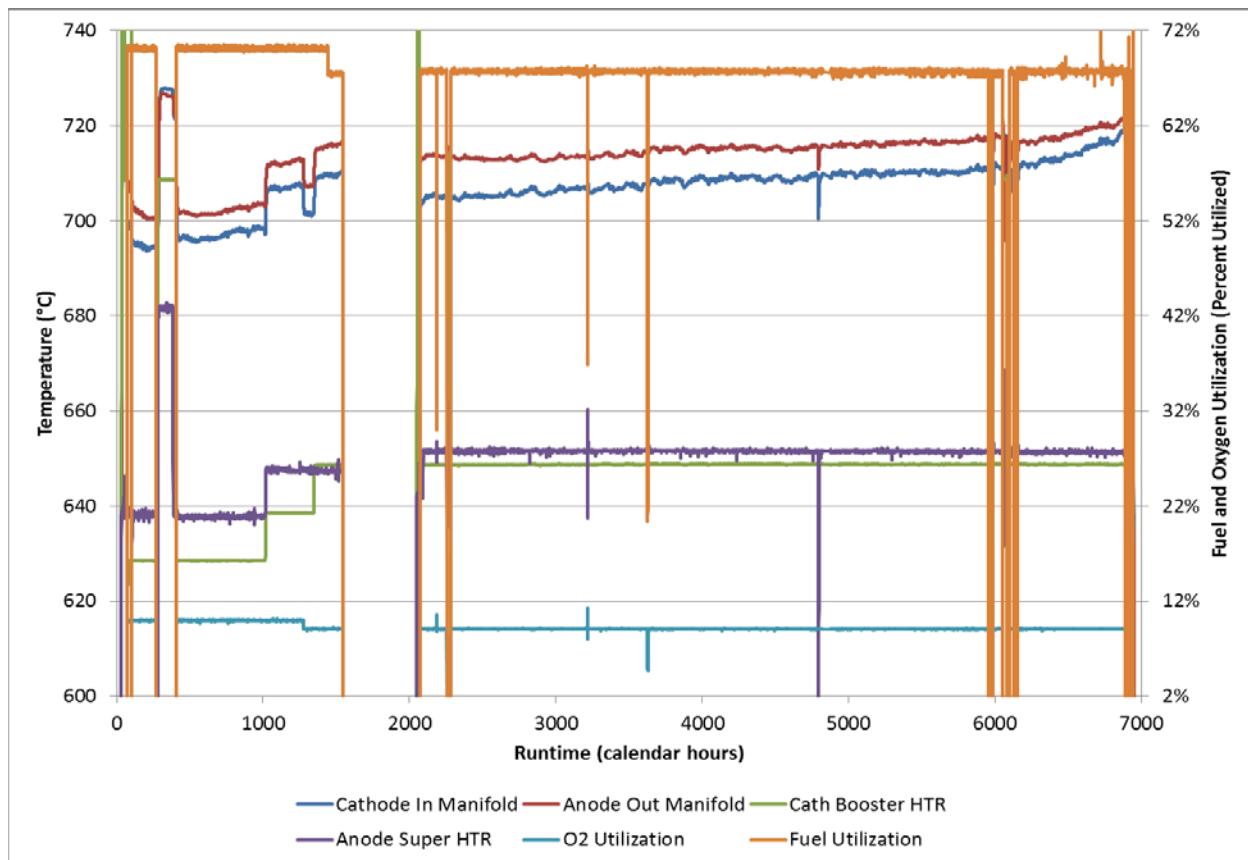
Figure 2-136. Manifold and Heater Temperatures and Reactant Utilizations During 16-Cell Stack Test

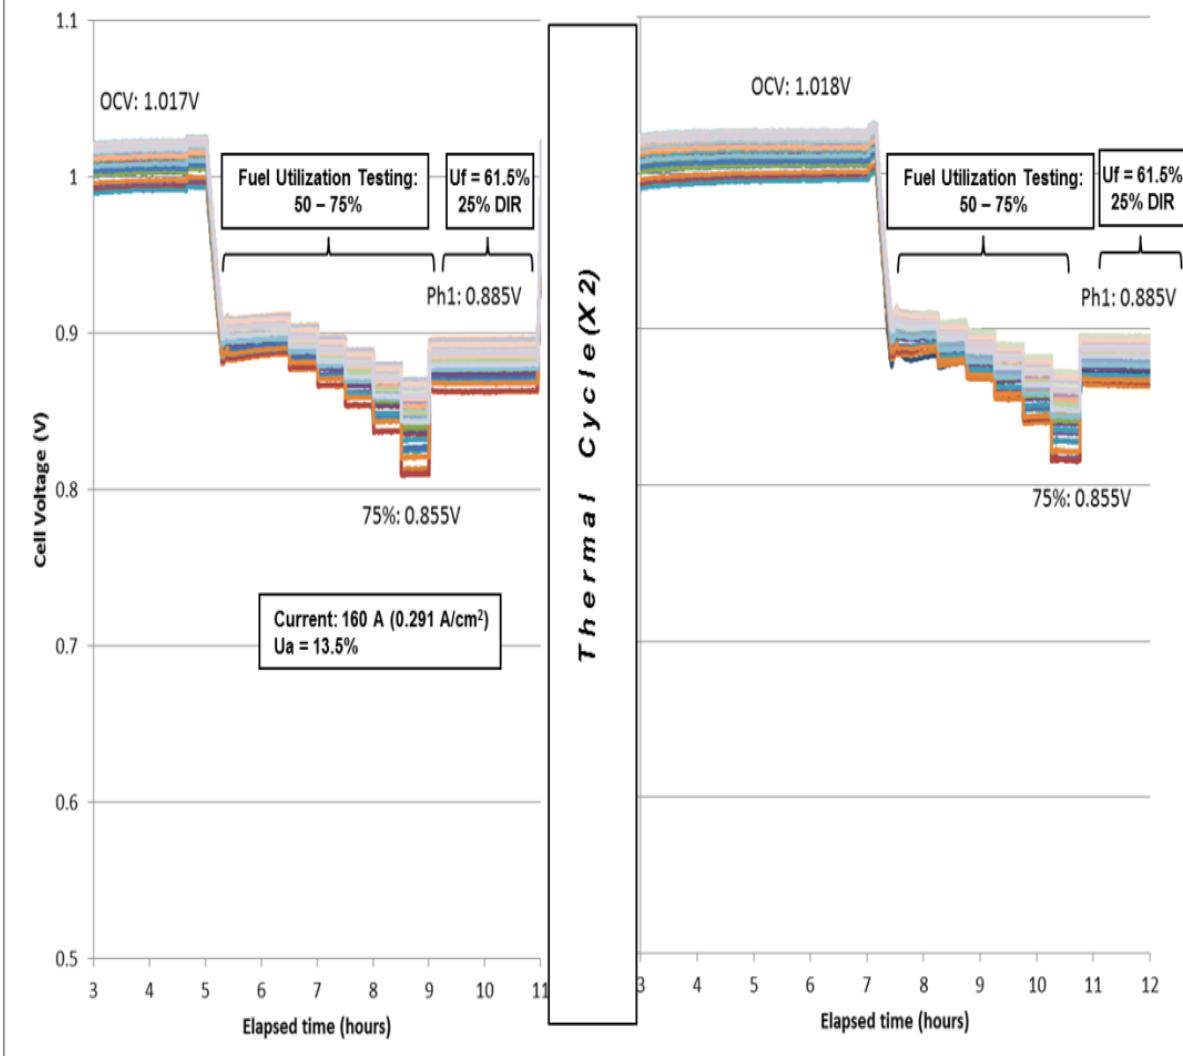
Figure 2-141. 120-Cell Stack GT059636-0001 TC0 and TC2 Performance Test Results

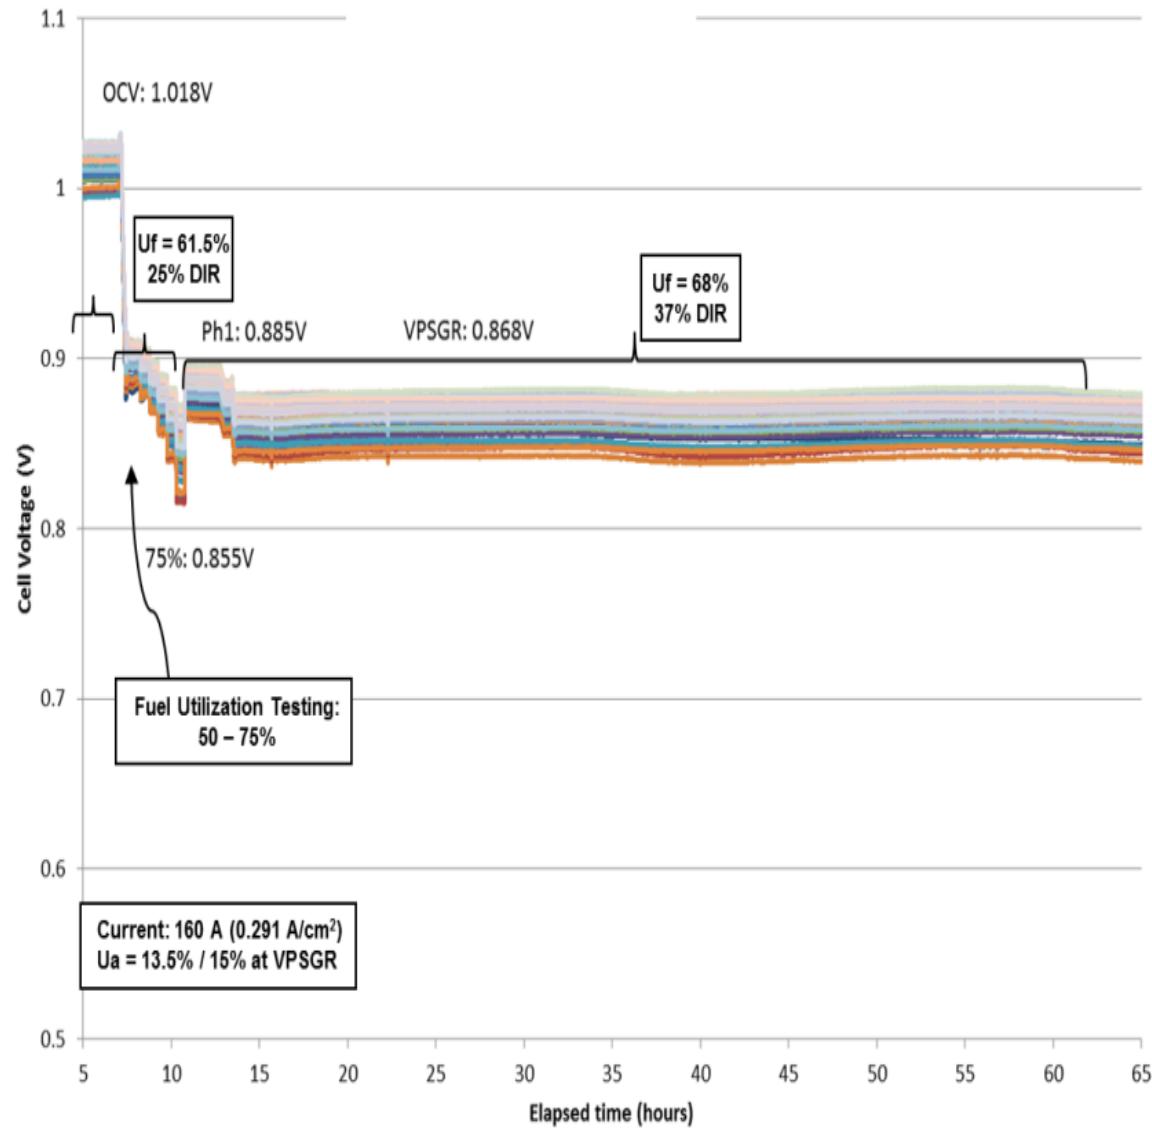
Figure 2-142. Stack GT059636-0001 Performance at VPS GR Conditions

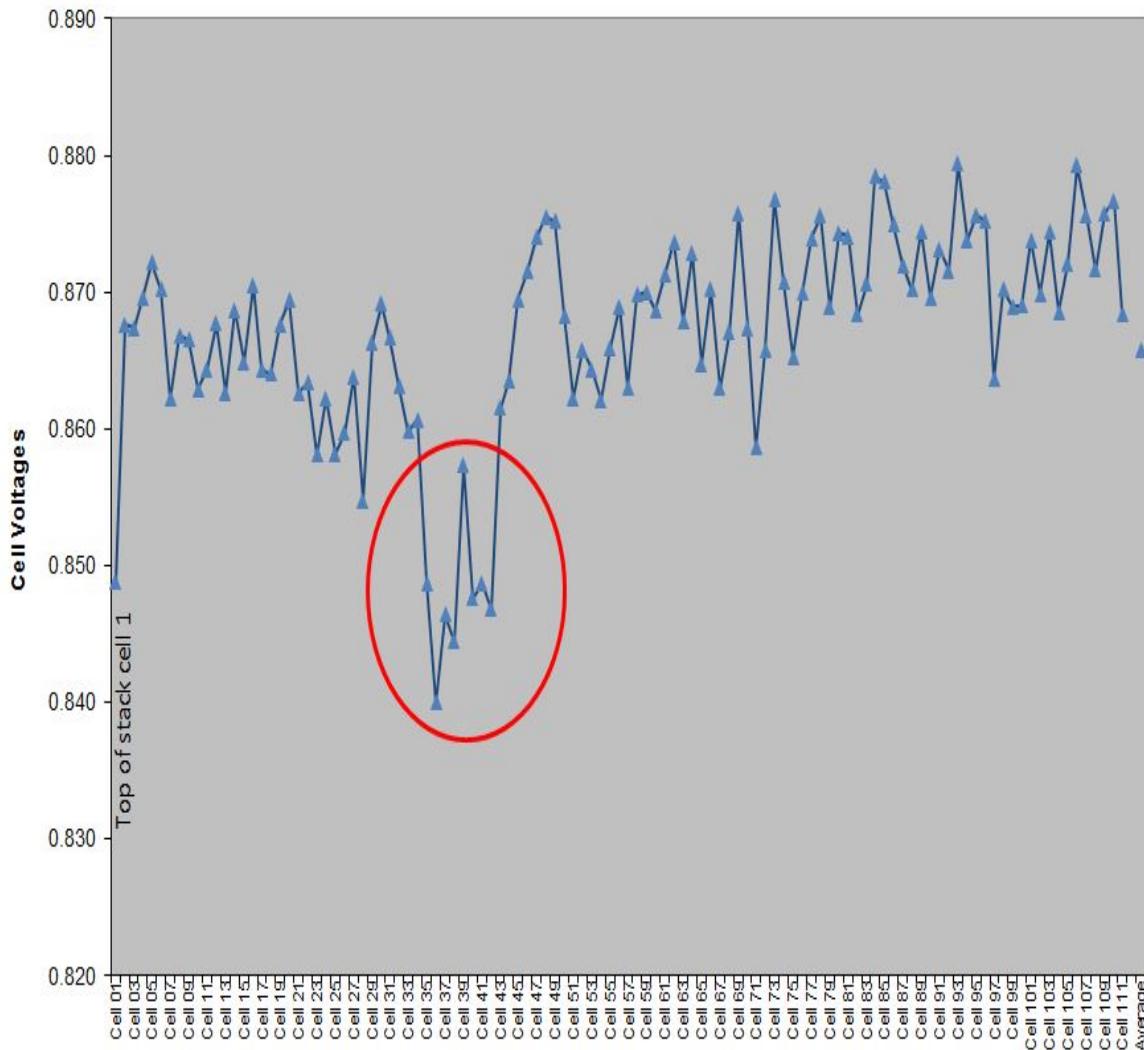
Figure 2-143. Stack GT059636-0001 Cell Voltage Distribution at VPS GR Conditions

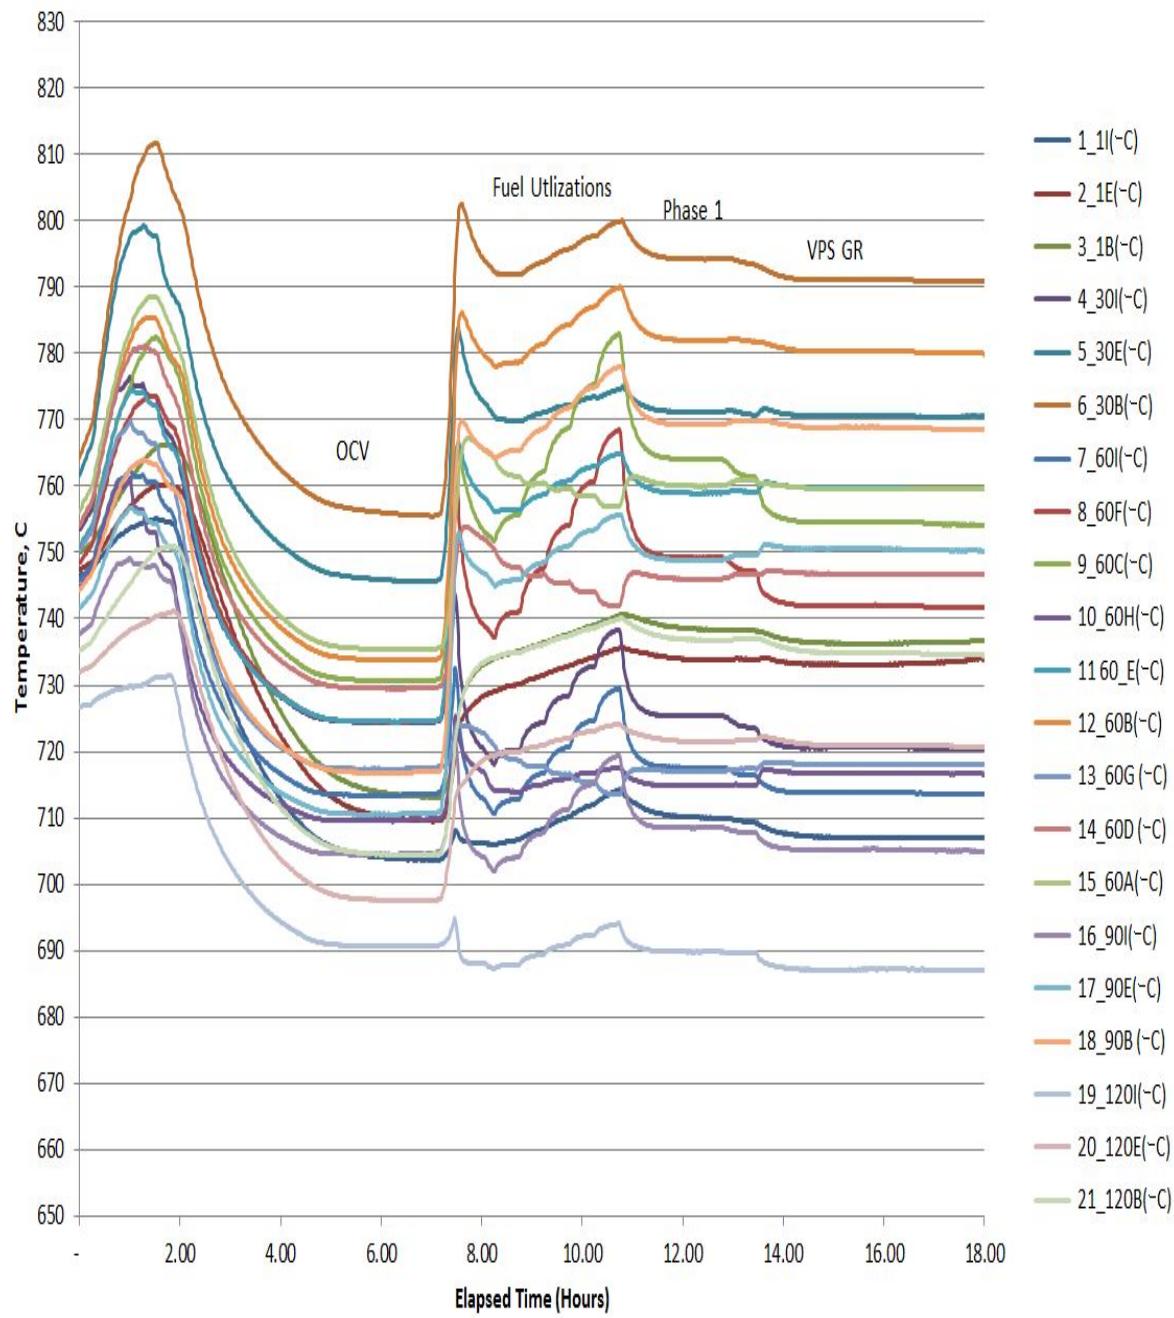
Figure 2-144. Stack GT059636-0001 In-Stack Temperatures During TC2 Testing

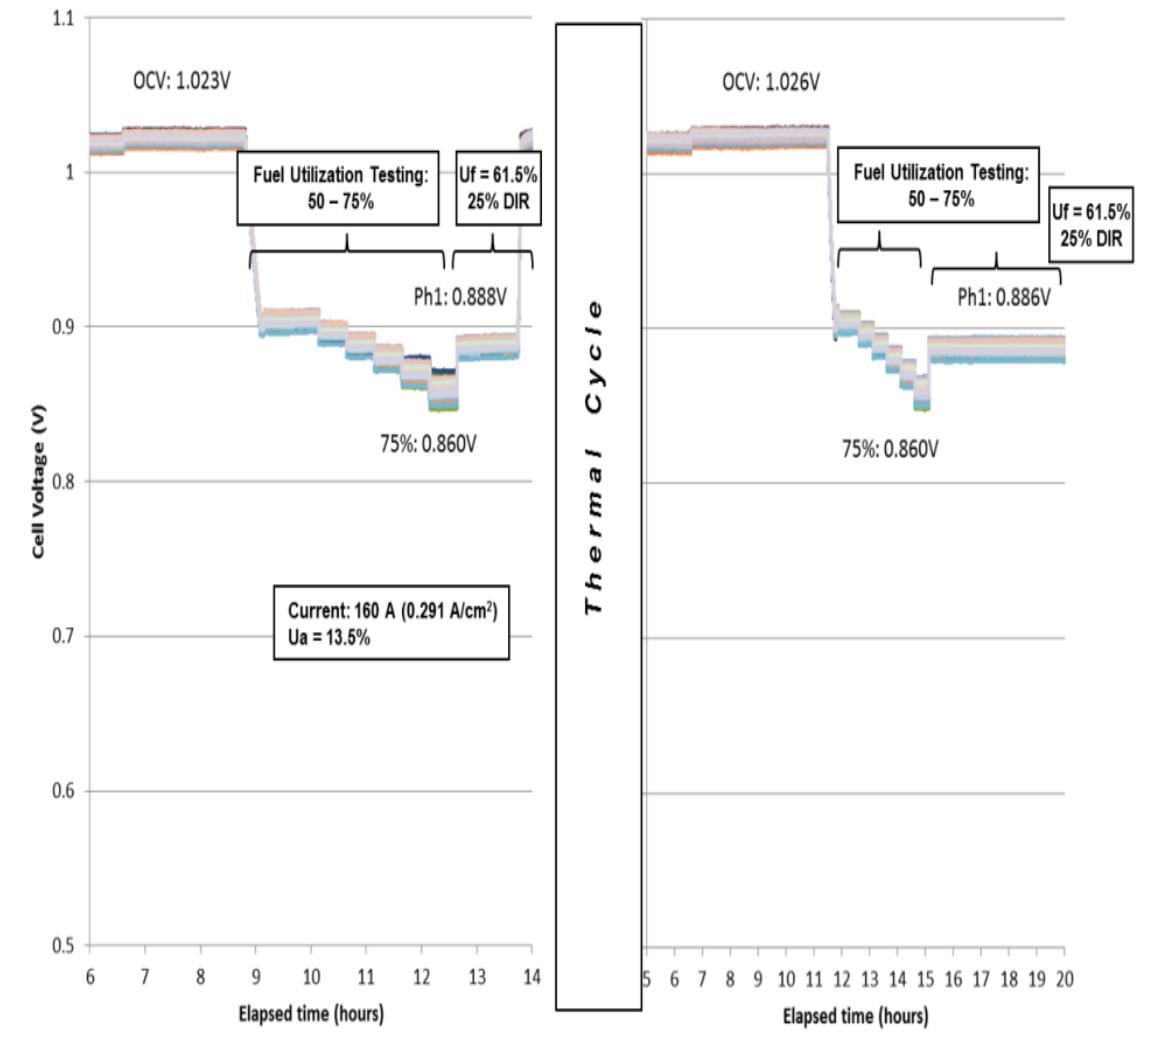
Figure 2-145. Stack GT059636-0002 TC0 & TC1 Performance Test Results

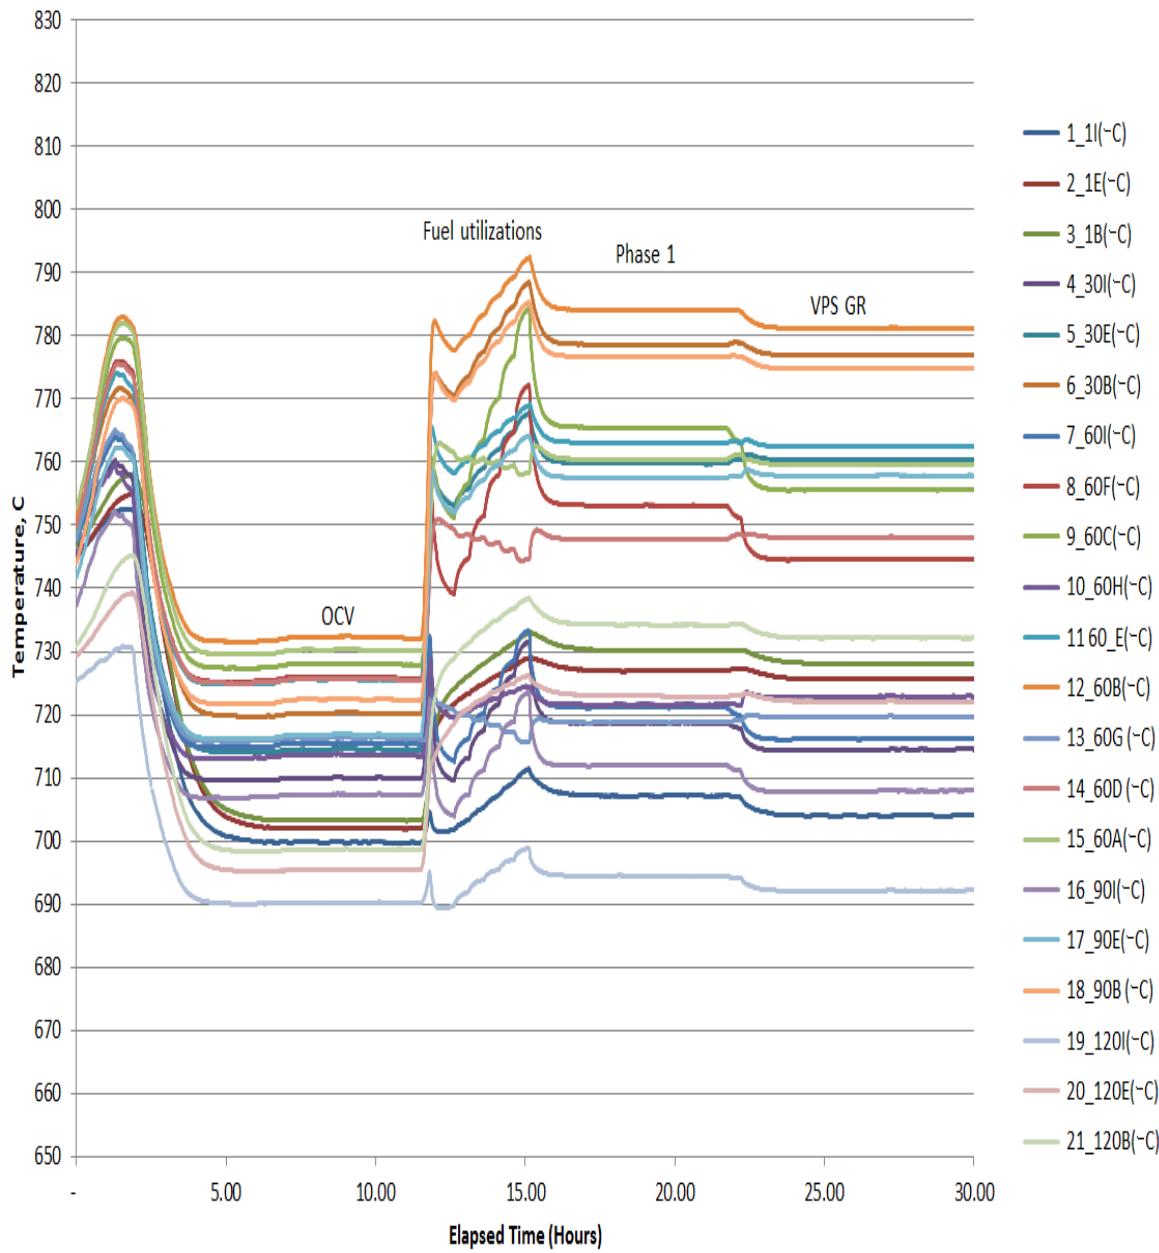
Figure 2-146. Stack GT059636-0002 In-Stack Temperatures During TC1 Testing

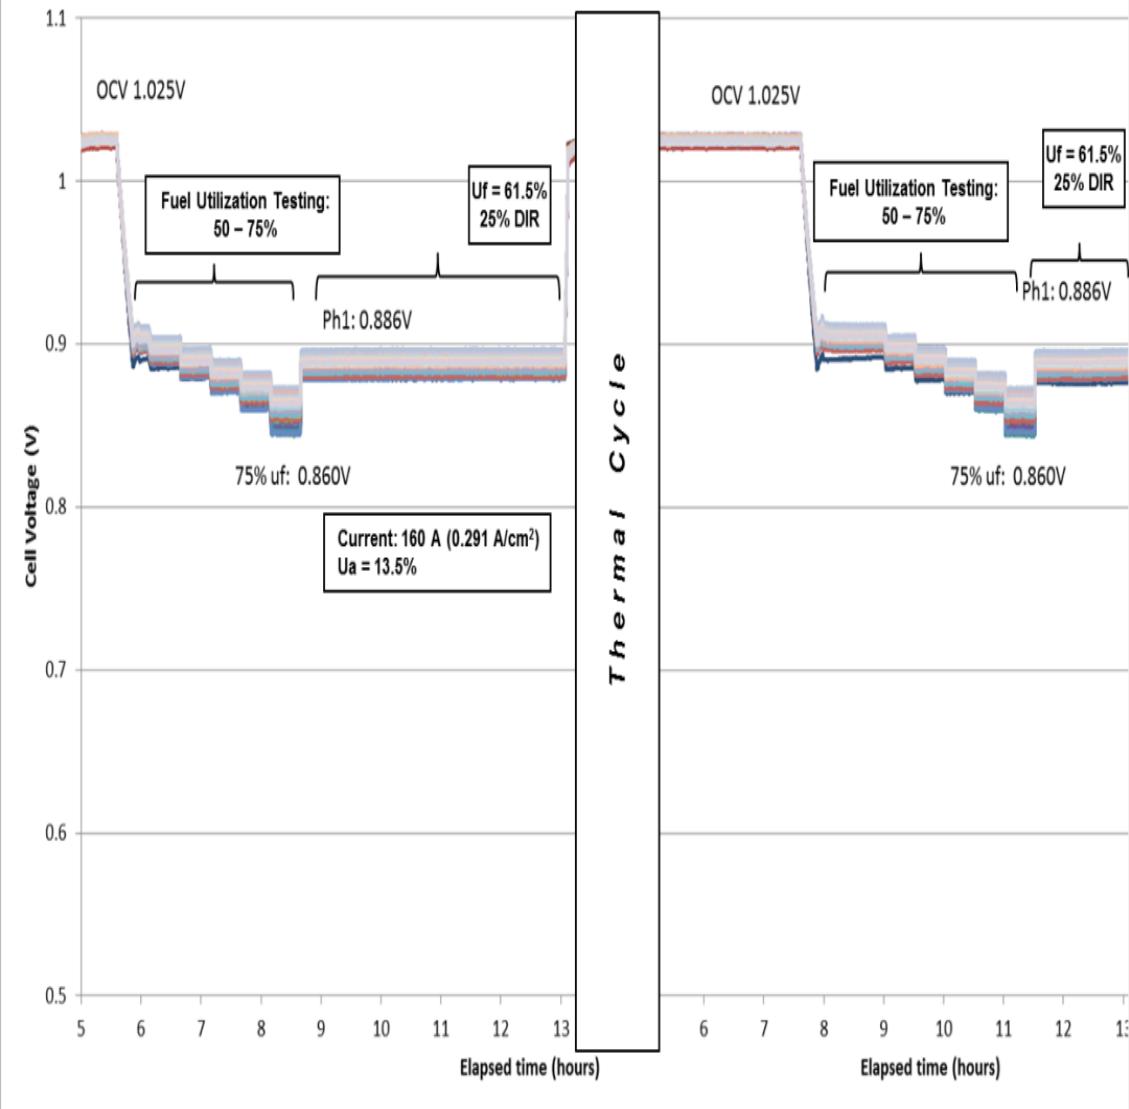
Figure 2-147. Stack GT059636-0003 TC0 & TC1 Performance Test Results

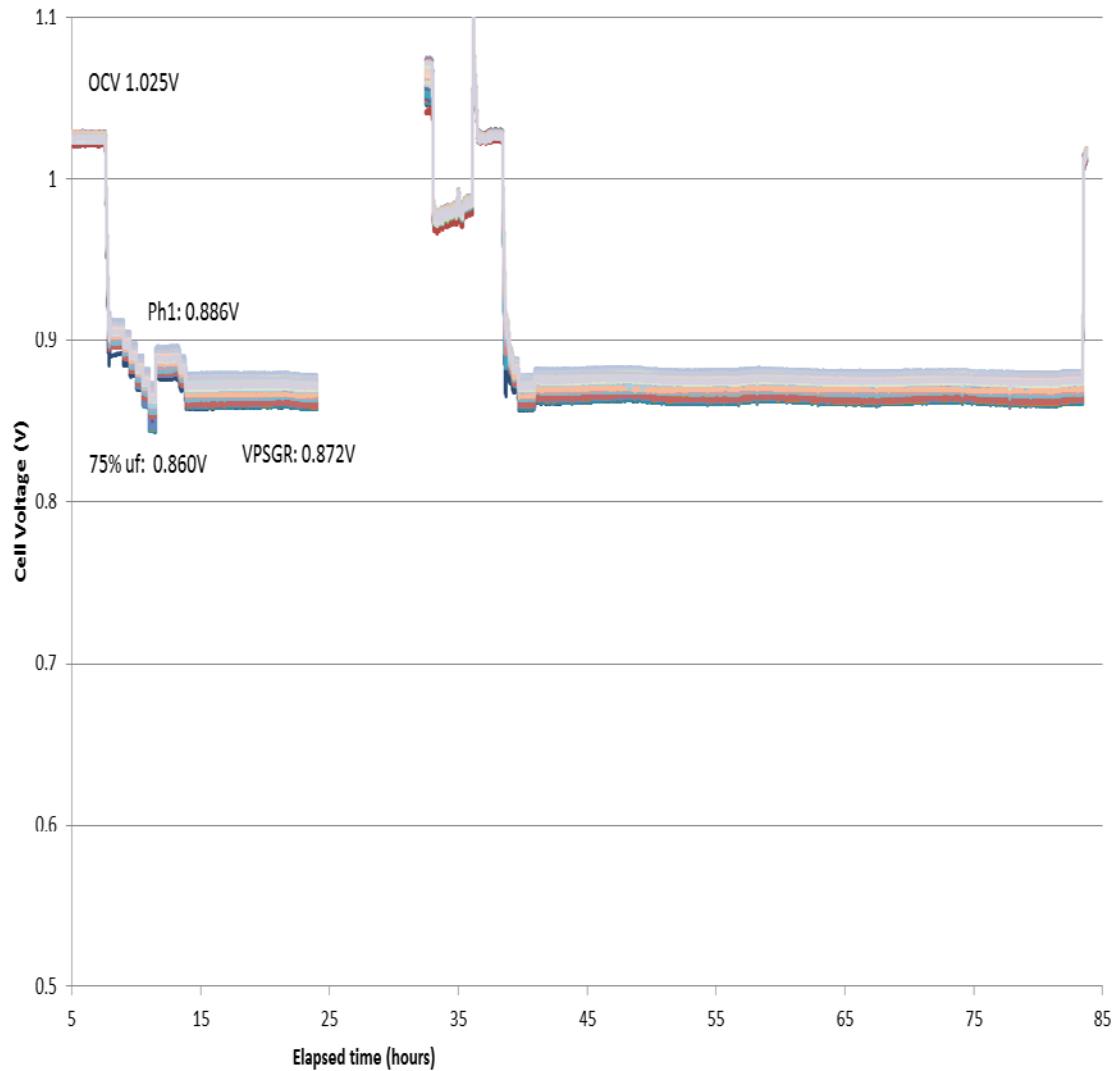
Figure 2-148. Stack GT059636-0003 Full TC1 Performance Test Results

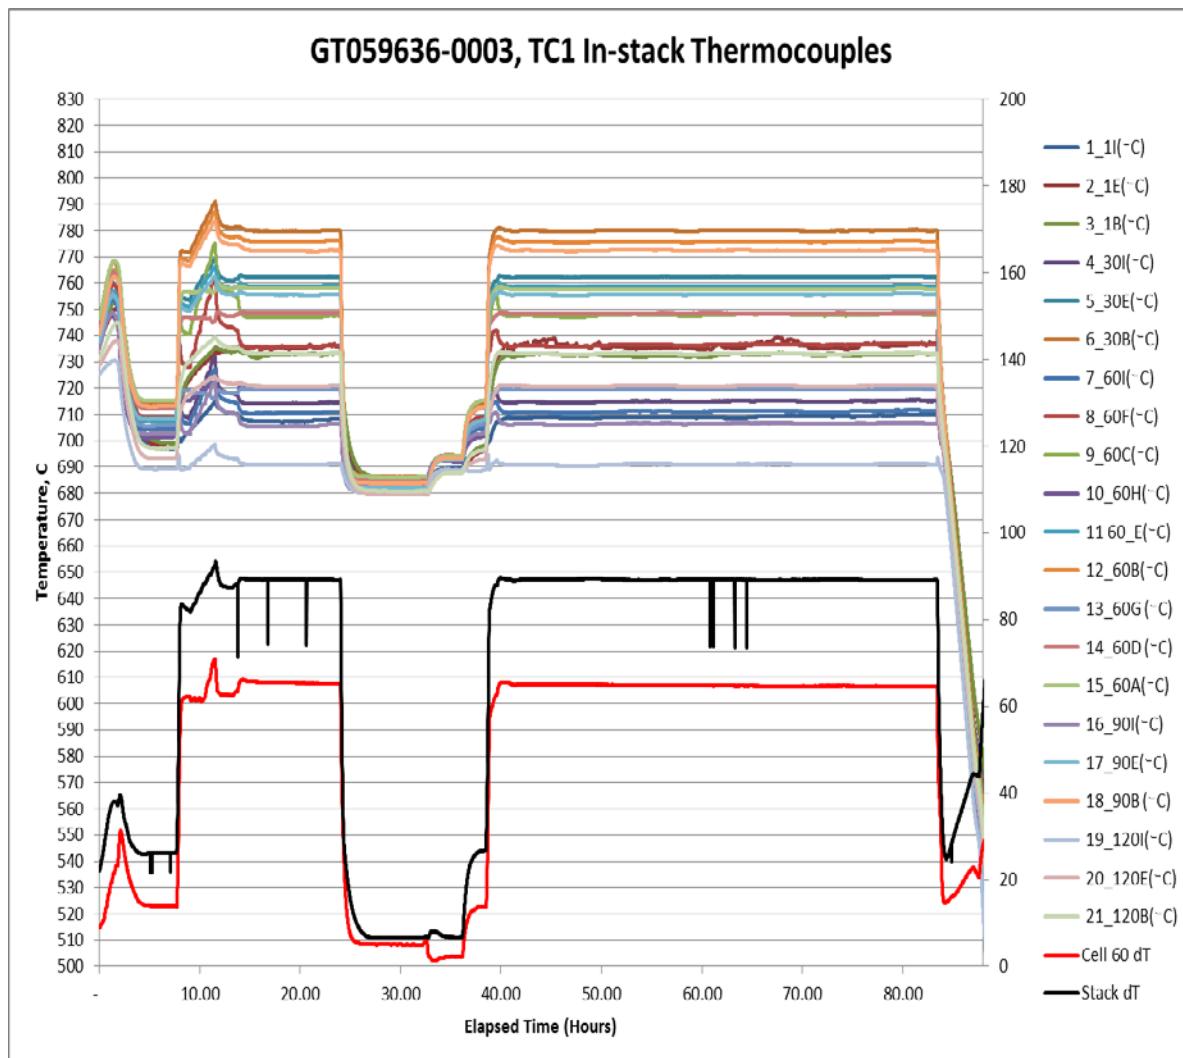
Figure 2-149. Stack GT059636-0003 TC1 In-Stack Temperatures
