Report Title: **SOFC Systems with Improved Reliability and Endurance**

Type of Report: Final Technical Report

DOE Award No.: DE-FE0011691

Name & Address of Submitter: FuelCell Energy, Inc.
3 Great Pasture Road
Danbury, CT 06813

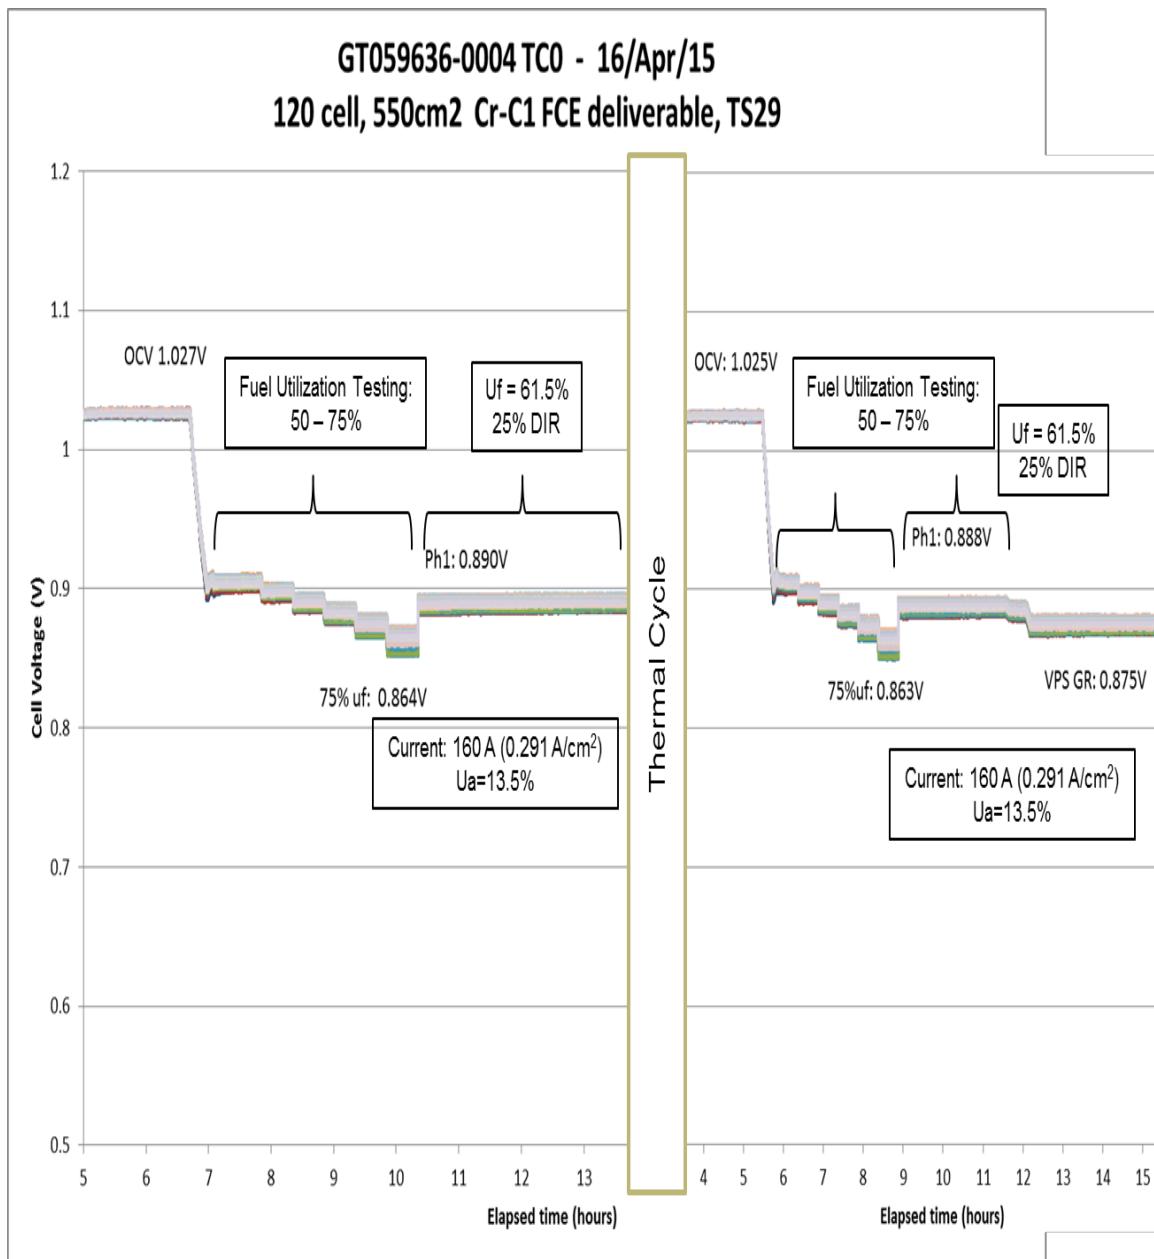
Figure 2-150. Stack GT059636-0004 TC0 & TC1 Performance Test Results

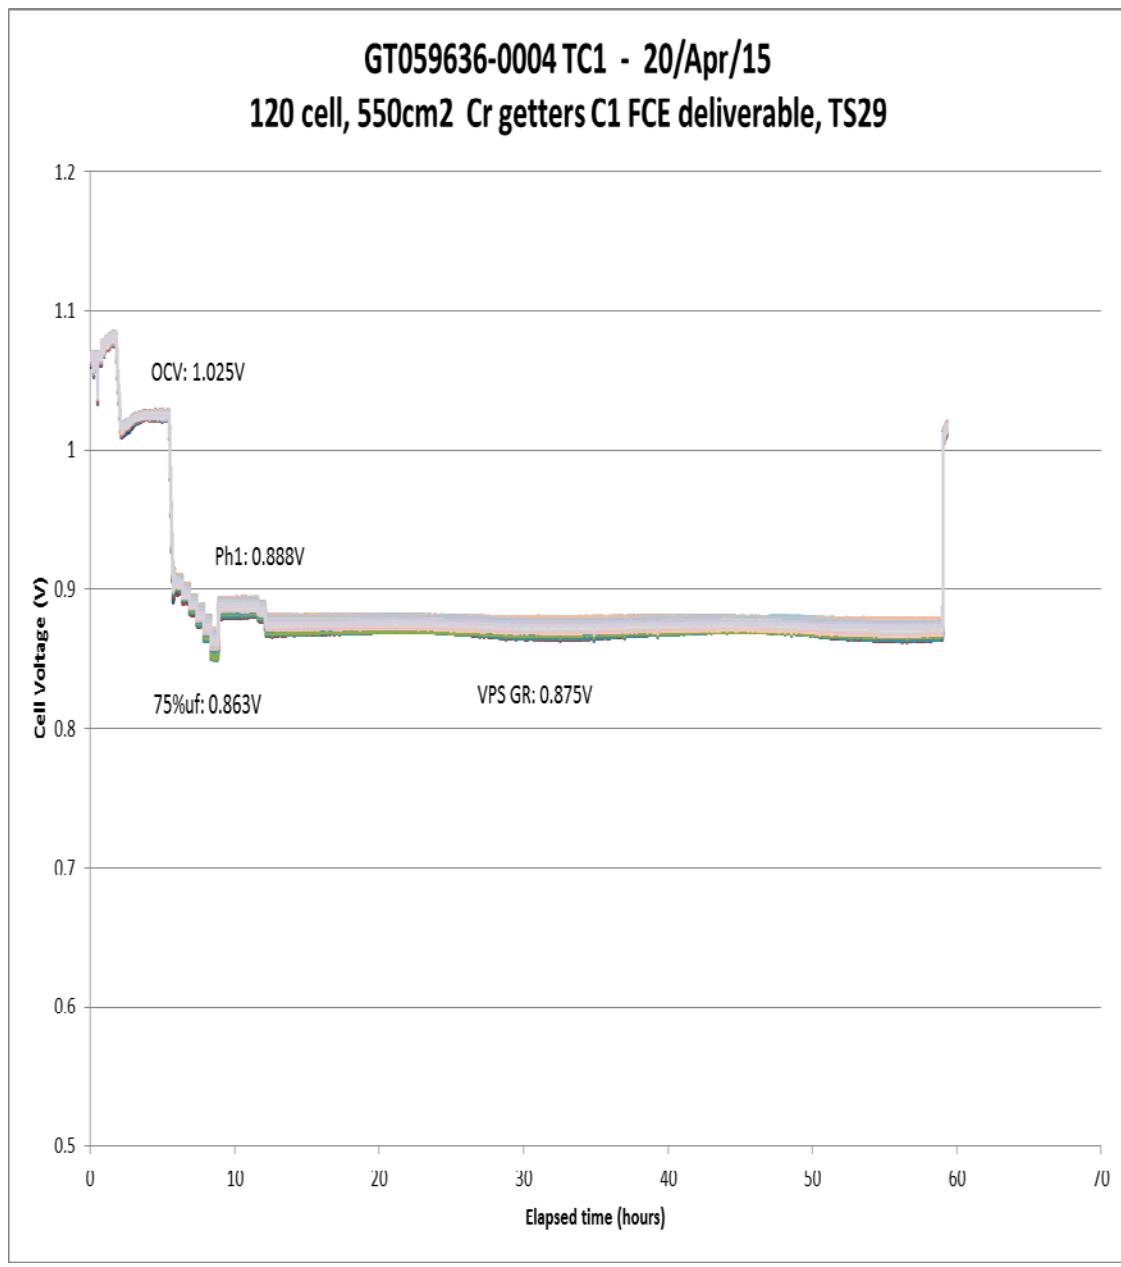
Figure 2-151. Stack GT059636-0004 Full TC1 Performance Test Results

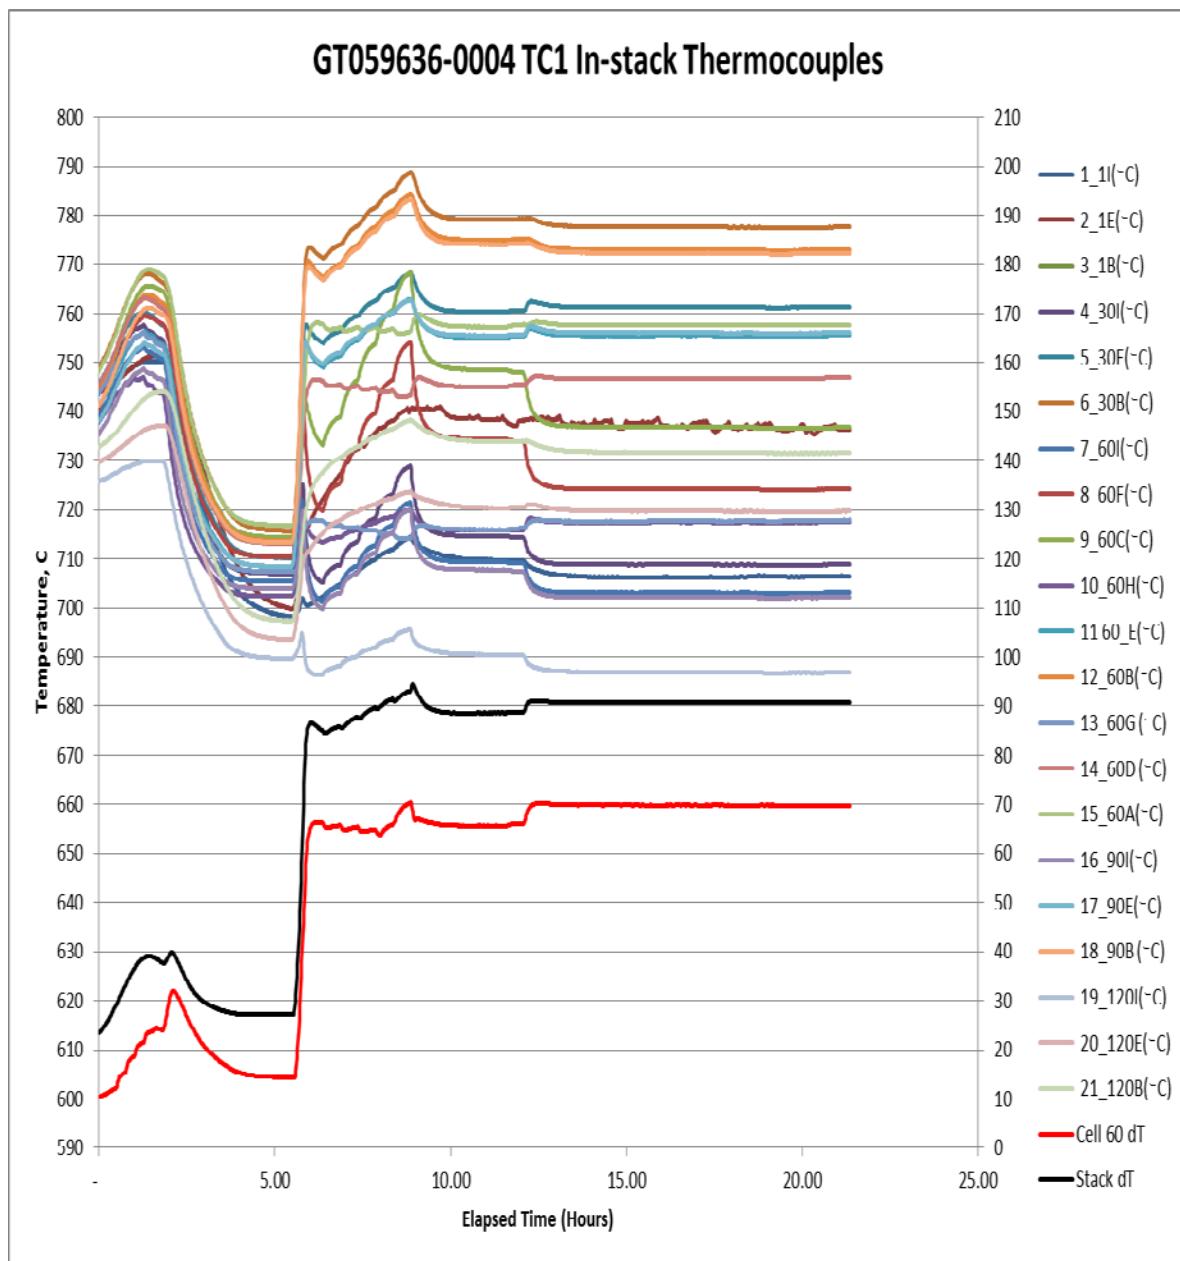
Figure 2-152. Stack GT059636-0004 TC1 In-Stack Temperatures

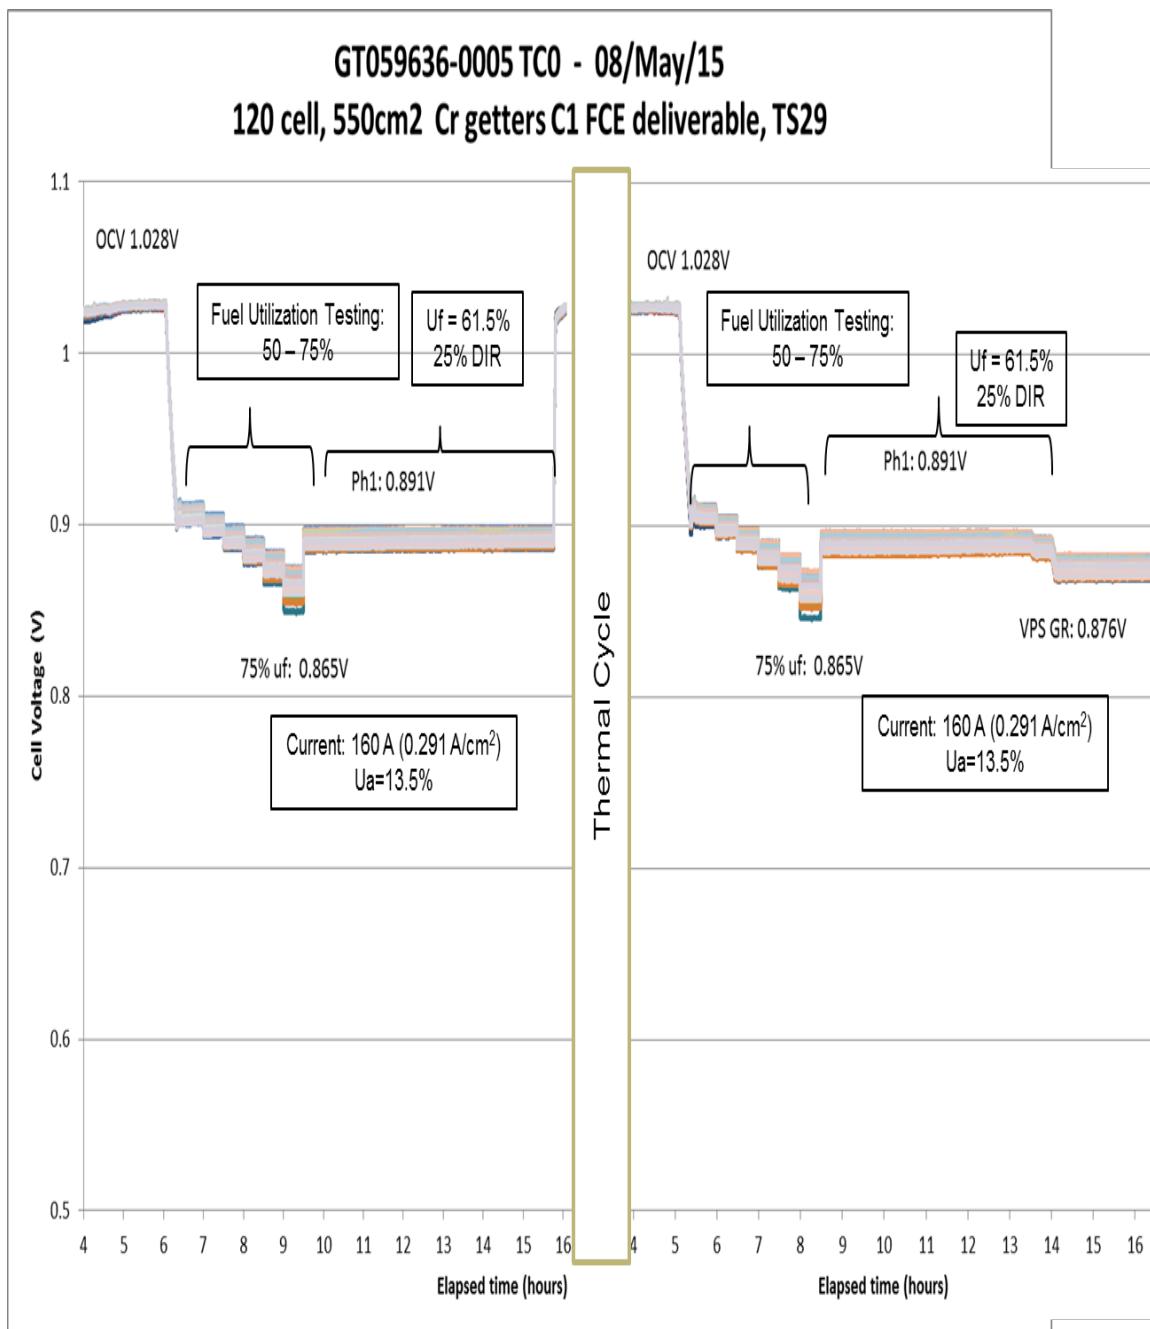
Figure 2-153. Stack GT059636-0005 TC0 & TC1 Performance Test Results

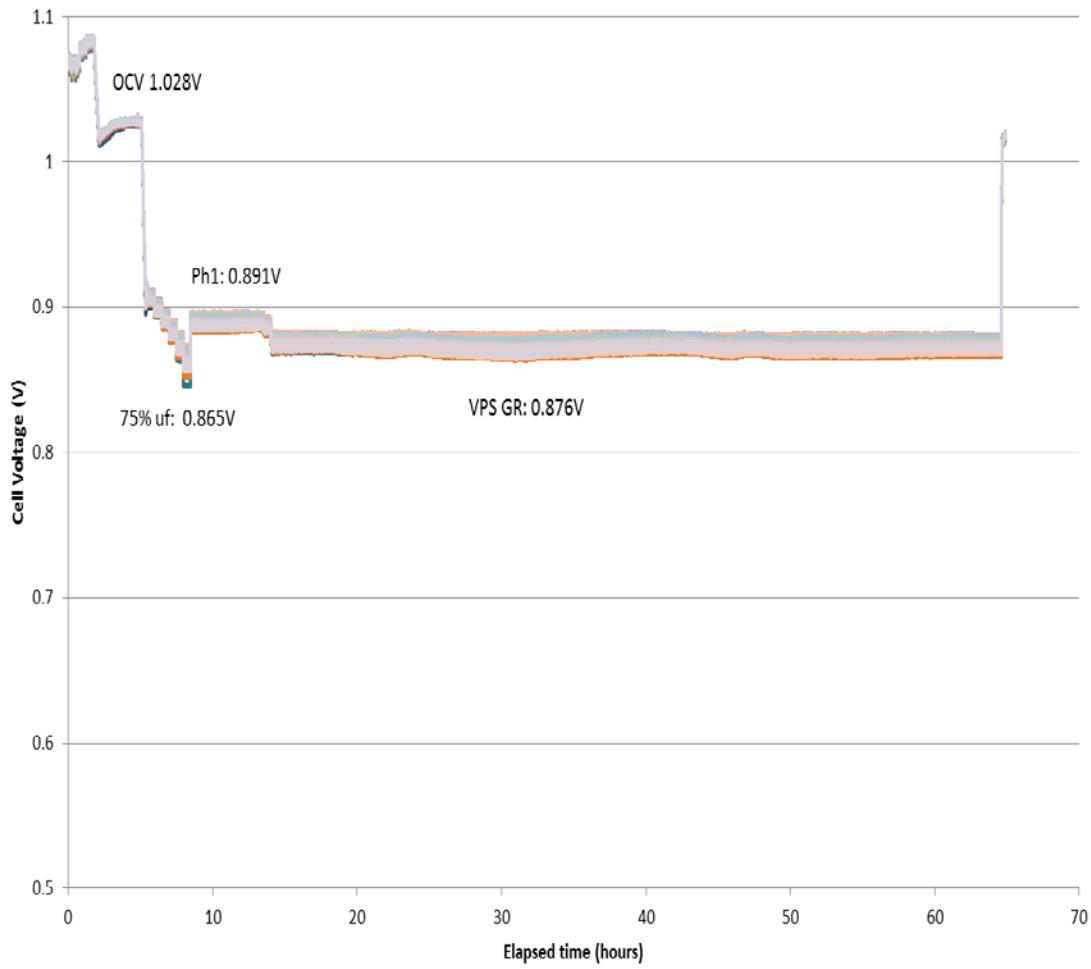
Figure 2-154. Stack GT059636-0005 Full TC1 Performance Test Results

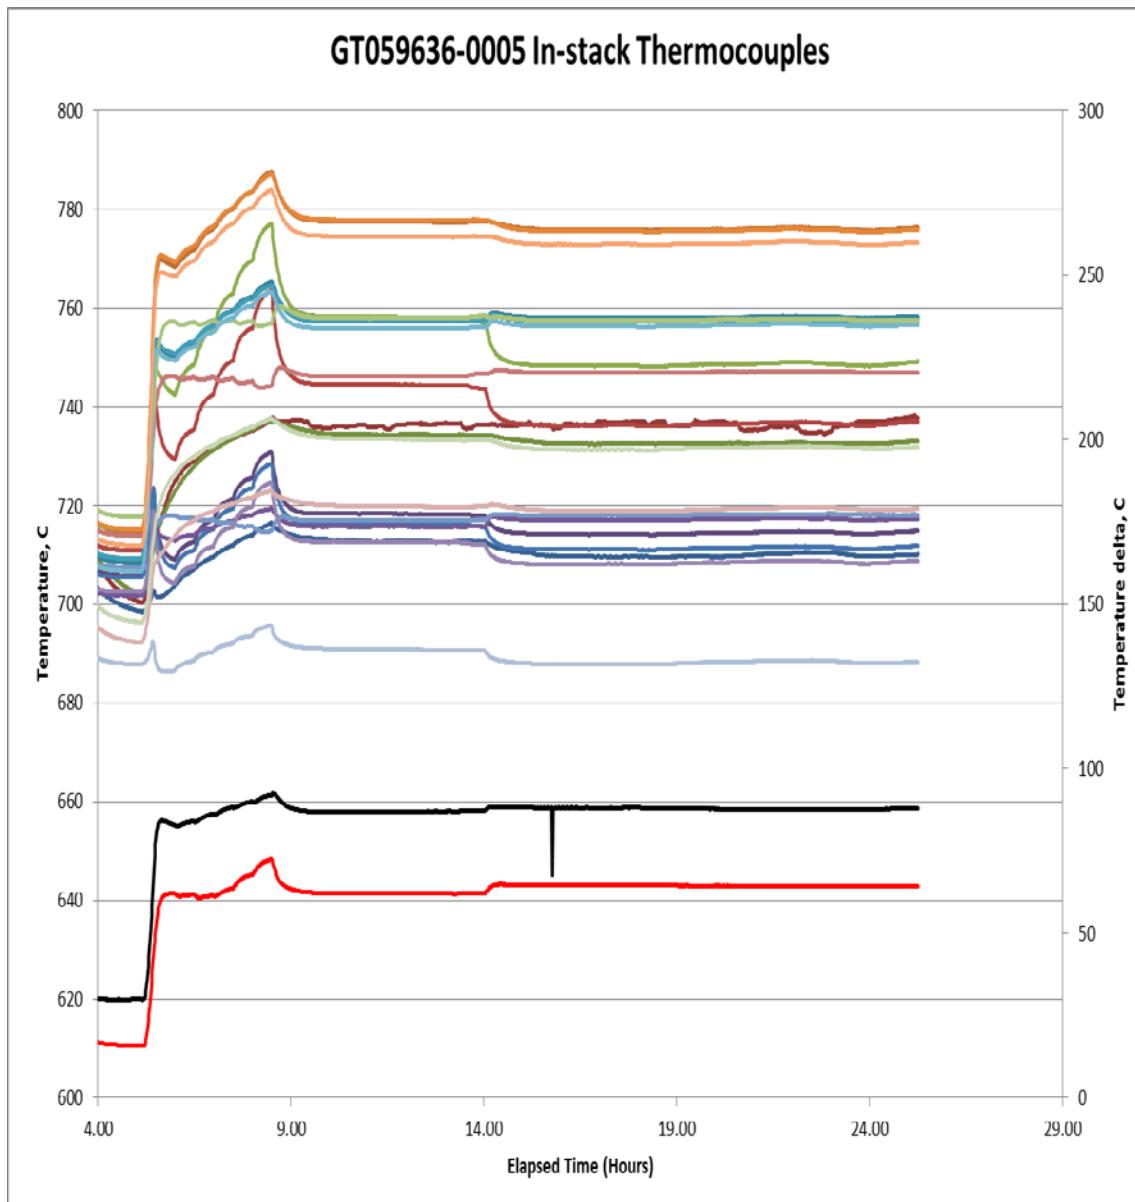
Figure 2-155. Stack GT059636-0005 TC1 In-Stack Temperatures

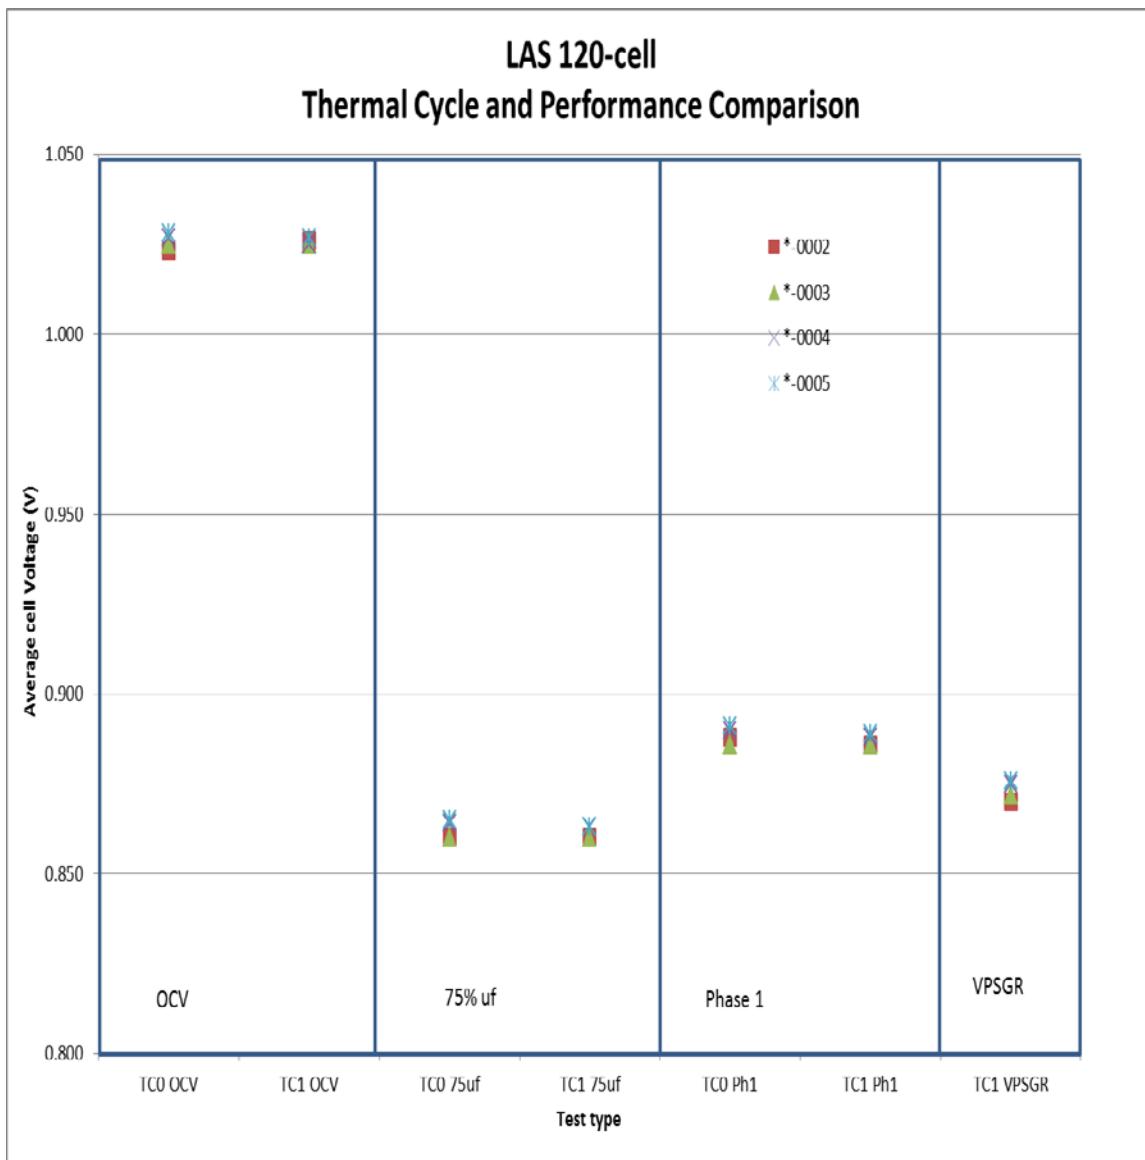
Figure 2-156. Performance During Factory Acceptance Tests of 120-Cell Stacks #2 - #5

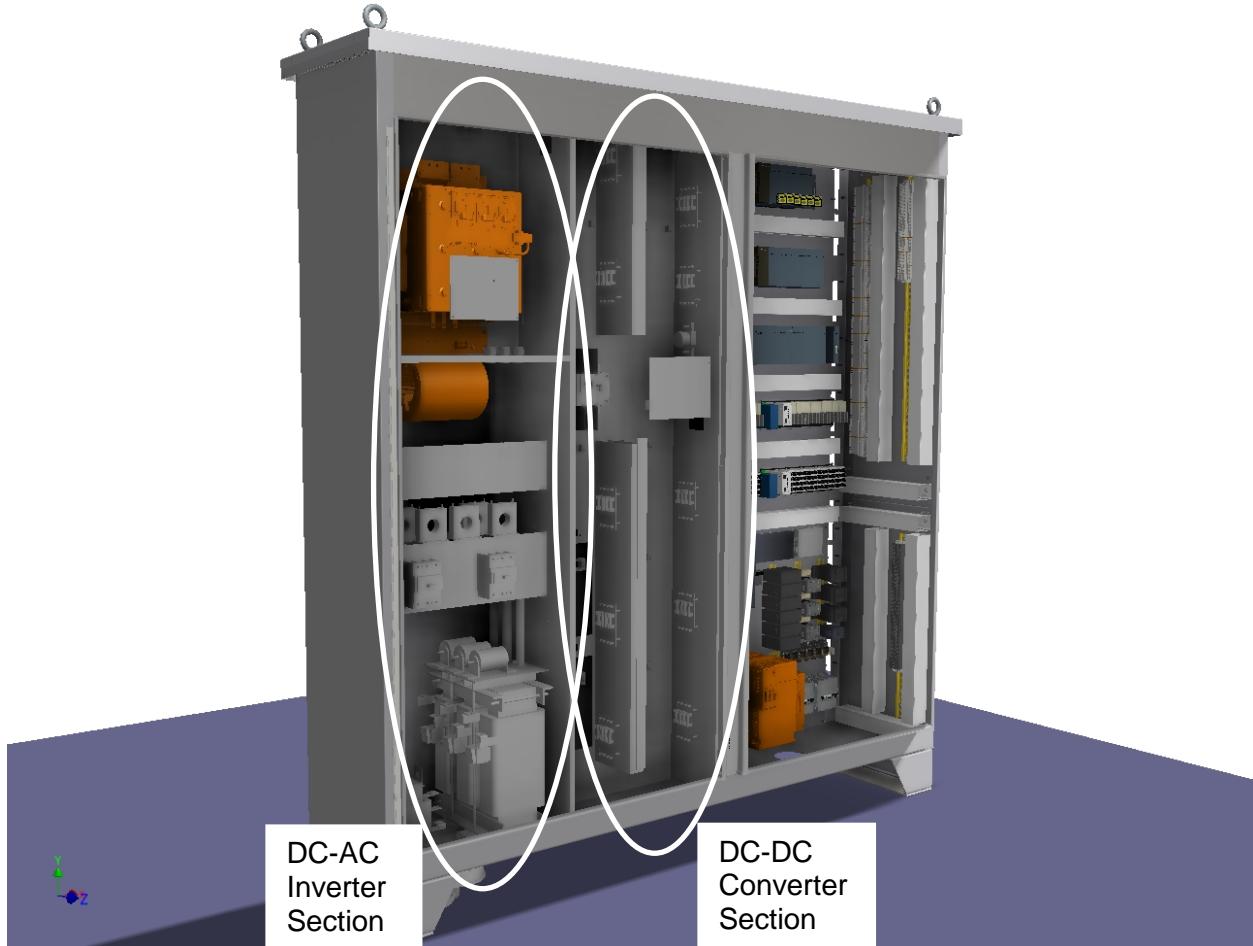
Figure 5-17. EBOP Enclosure Showing DC-AC Inverter Section and DC-DC Converter Section.

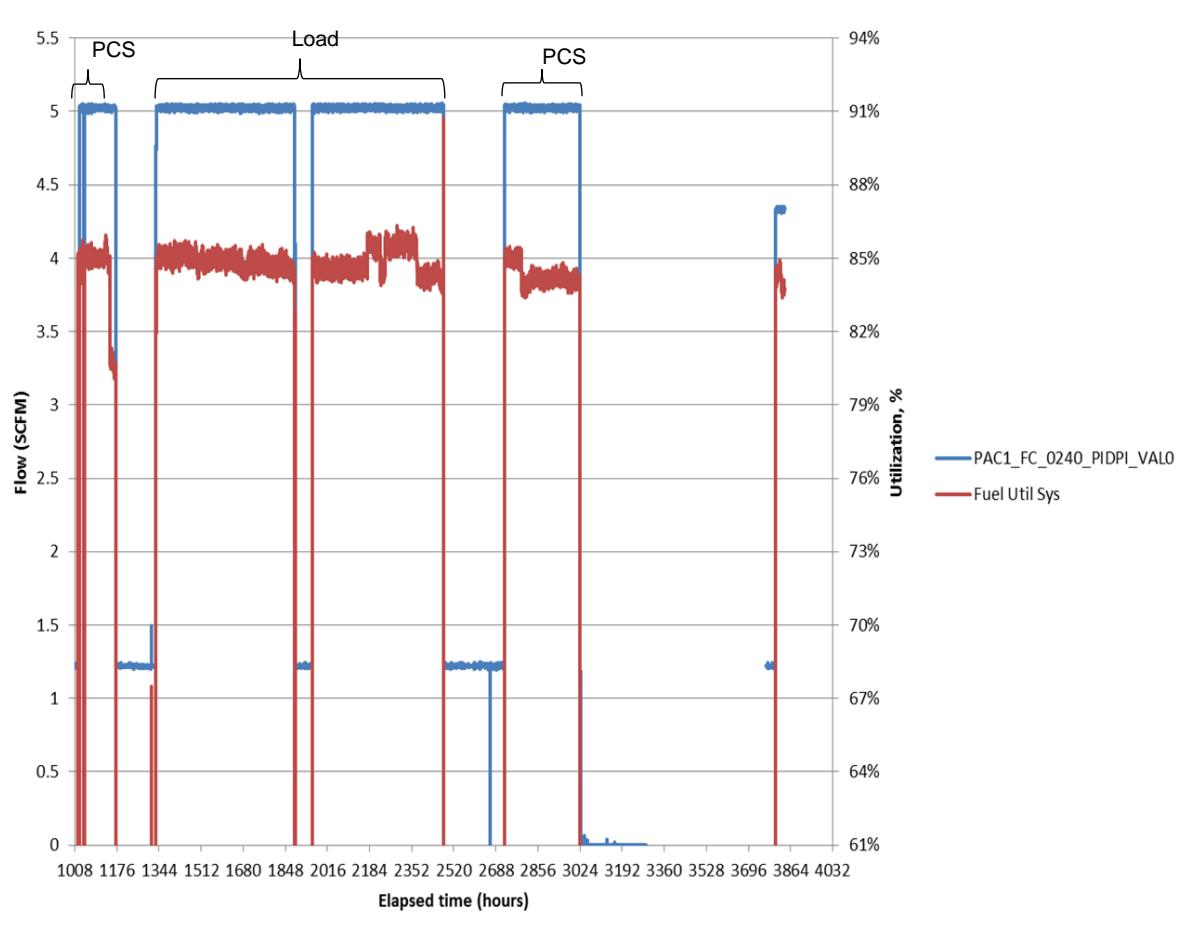
Figure 5-28 Fuel Flow Rate and Utilization During 50 kW PCM System Factory Testing

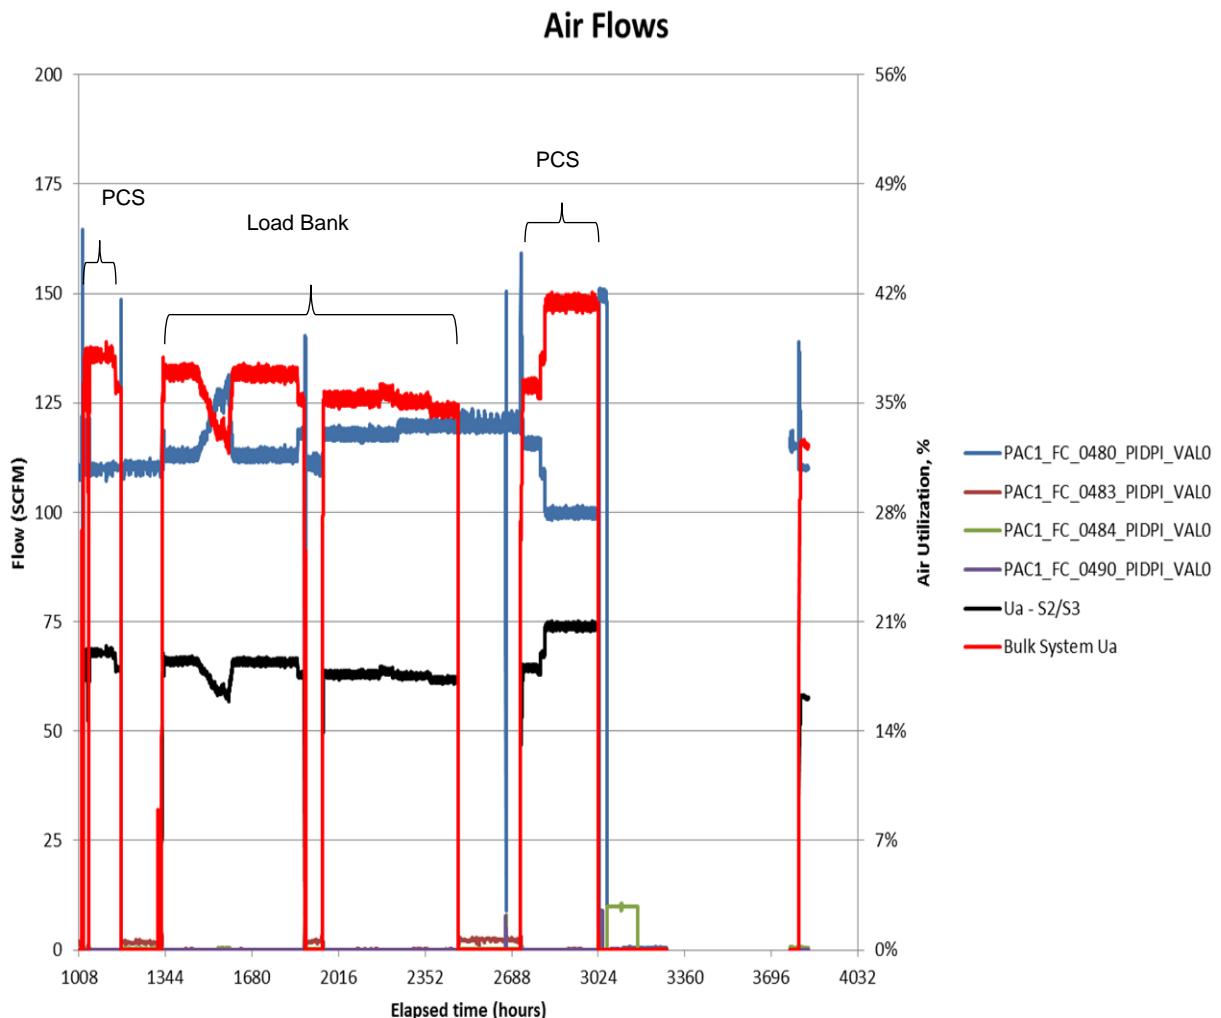
Figure 5-29. Air Flow Rate and Utilization During 50 kW PCM System Factory Testing

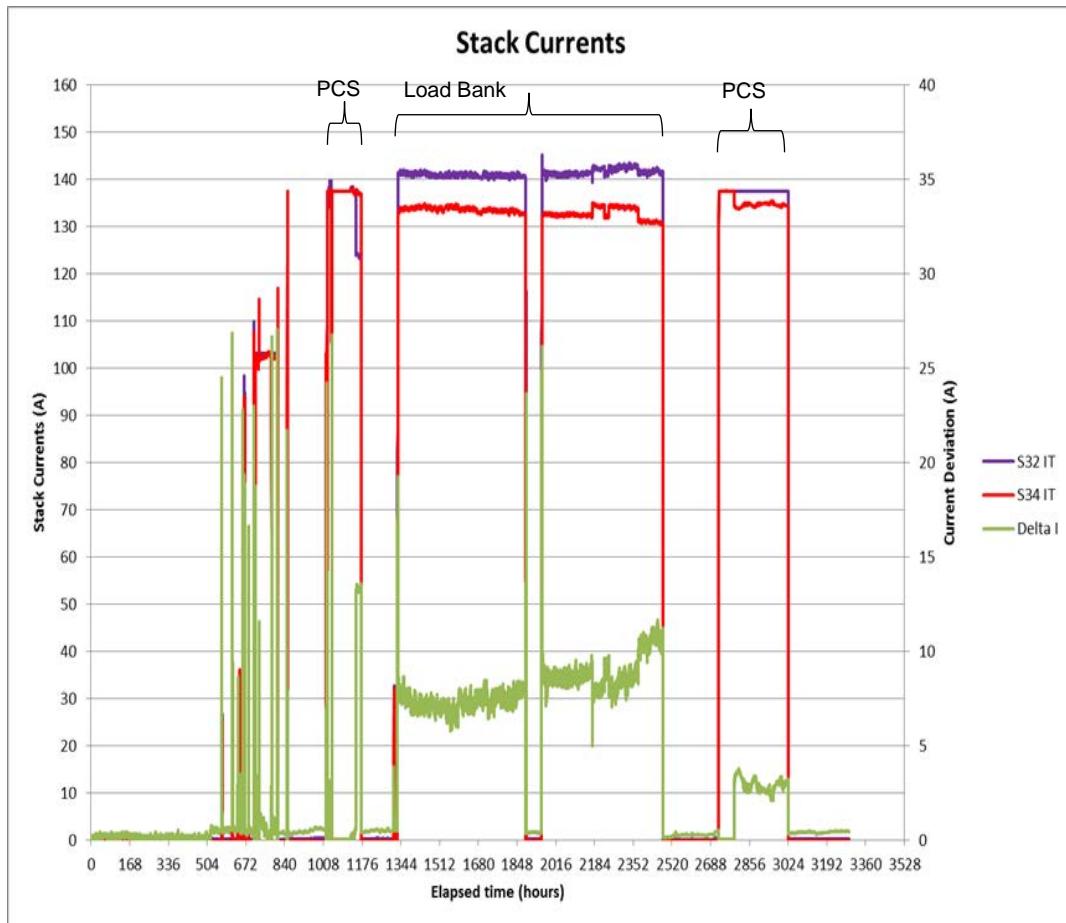
Figure 5-30. Stack Currents During 50 kW PCM System Factory Testing (PC indicates testing using power conversion system)

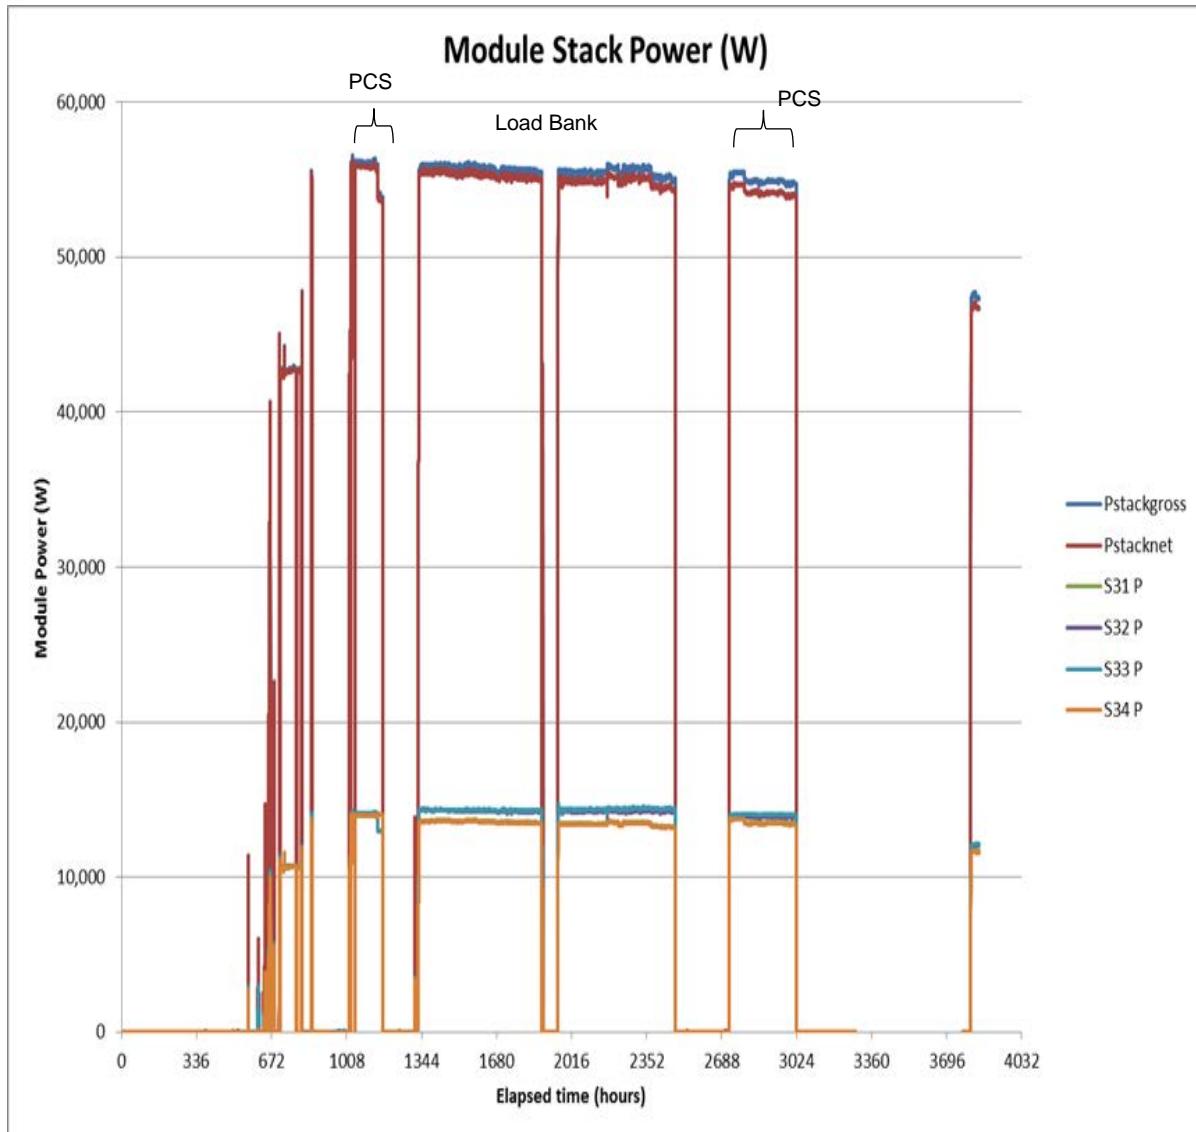
Figure 5-32. SOFC Module Power Output During 50 kW PCM System Factory Testing

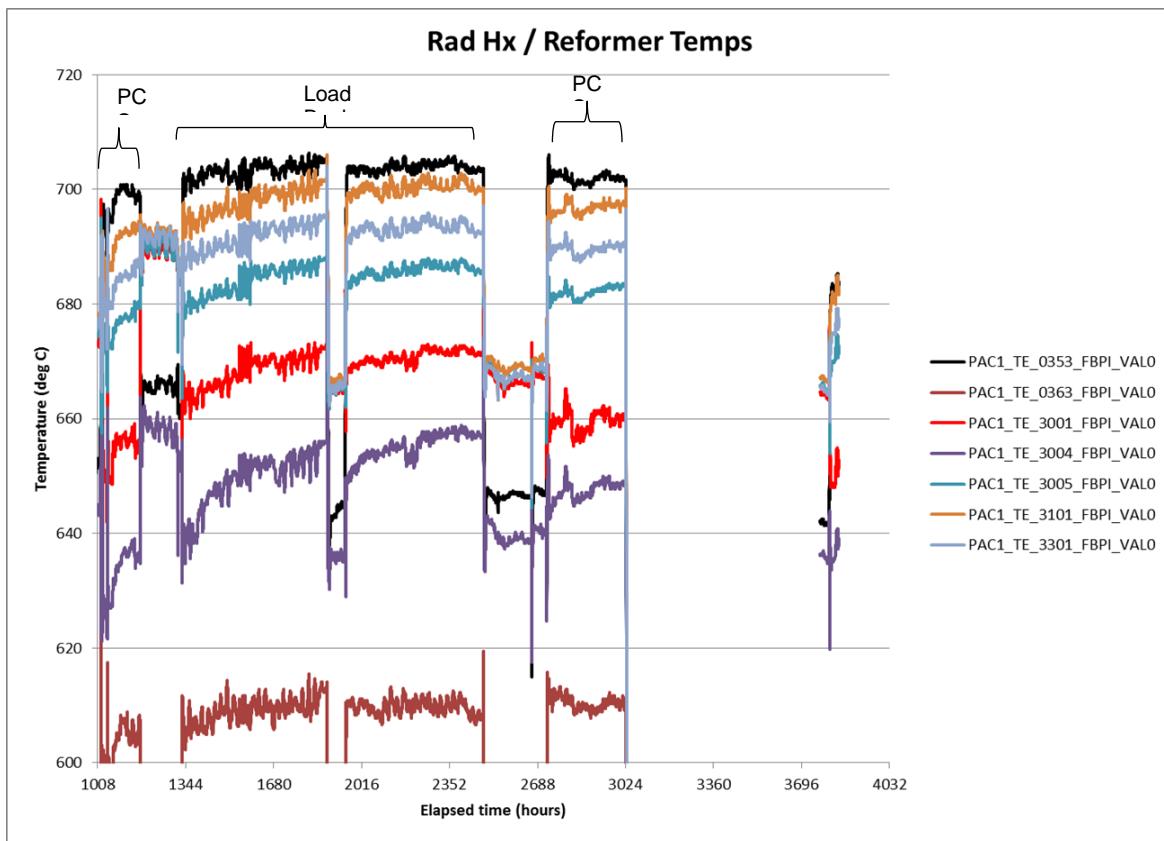
Figure 5-33. Radiative Reformer Temperatures
