Load Verification of the ABL Friction Tester

Energetics Characterization, Org. 2555

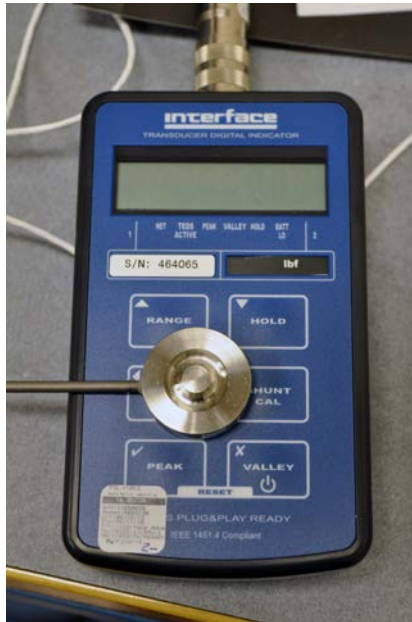
- High accuracy compression load button (model LBMU - Interface, Inc.)
- Model 9320 indicator (Interface, Inc.) was used to take measurements in lbf

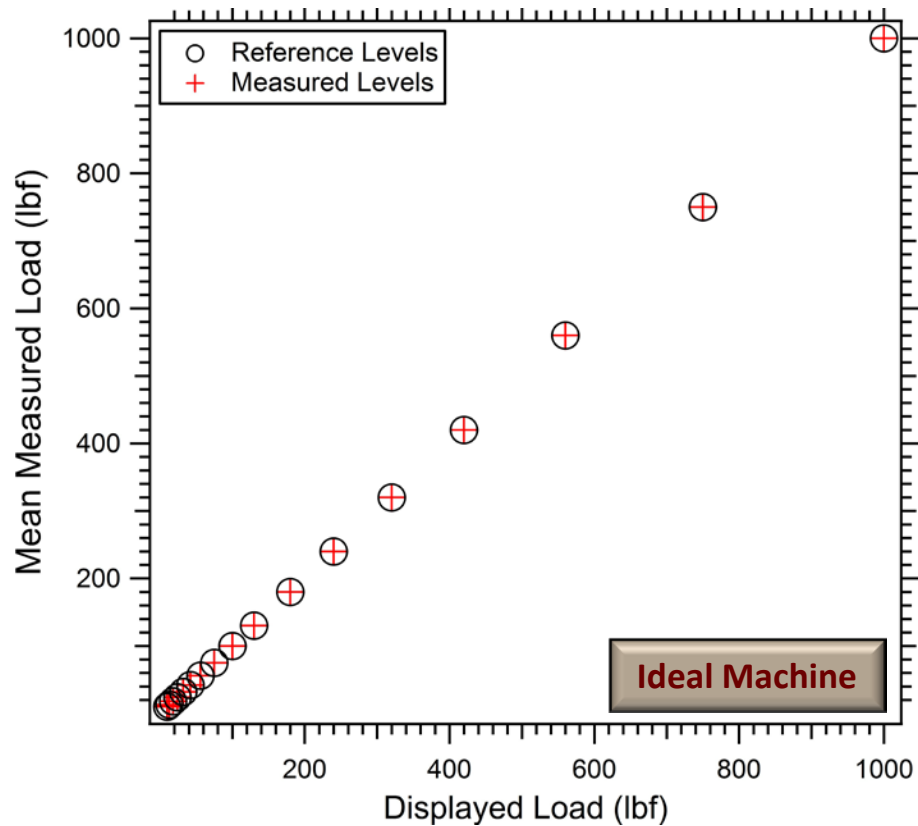
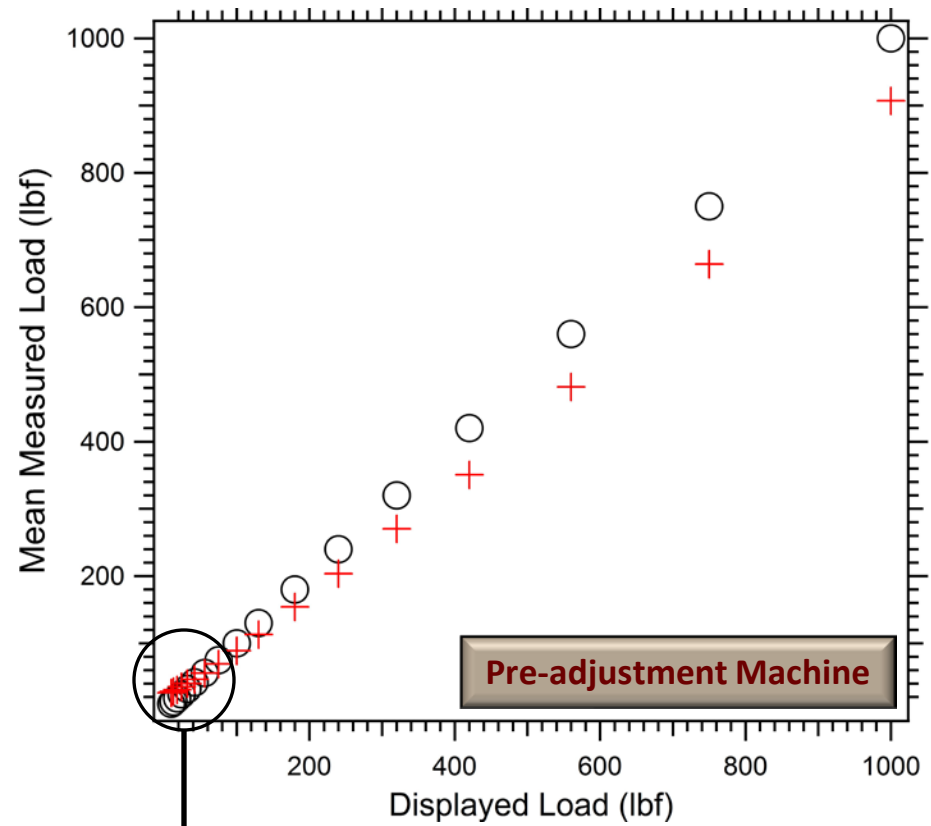
Ideal Machine
vs.
Pre-adjustment Machine

- Trials were split among 3 different operators to maximize the included variability.
