Evaluation of Erosion of the Dummy “EE” Plate 19 in YA Type ATR Fuel Element During Reactor PALM Cycles

**Idaho National Laboratory
Advanced Test Reactor
Idaho Falls, Idaho 83415**

INL/EXT-16-38324
Revision 0

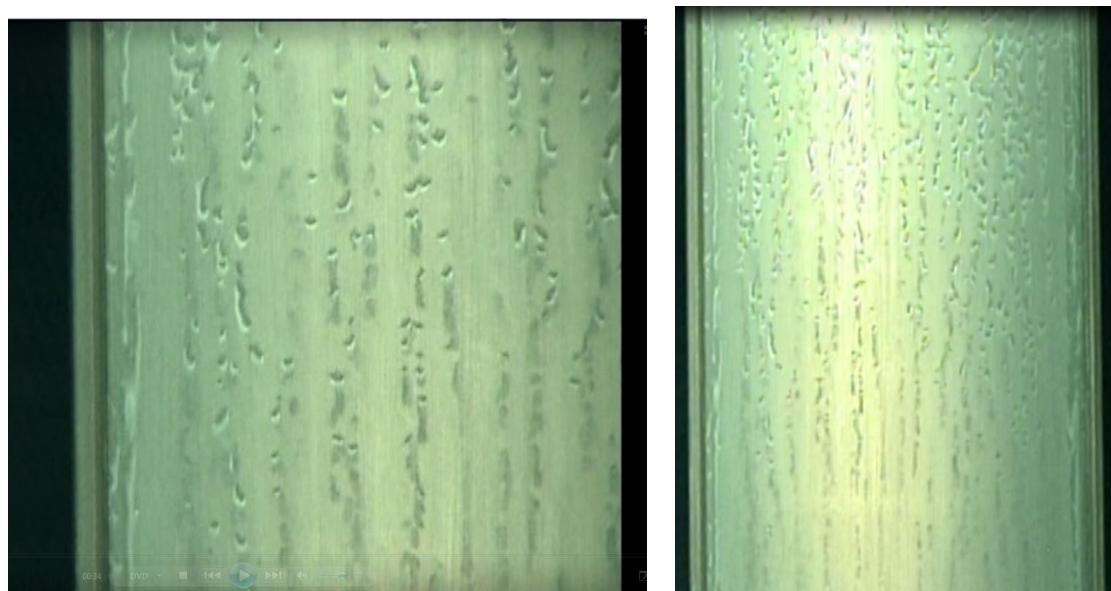
After 14 days of power operation, the reactor was shut down as scheduled to begin a planned refueling and maintenance outage. All 40 of the fuel elements loaded in the core were removed and visually inspected. Eight previously new YA-M type ATR fuel elements [1, 6, 7] were observed to have significant pitting degradation on plate 19. Plate 19 on a YA-M fuel element is an aluminum “dummy” plate, without any fuel material, fabricated to replace the fuel plate 19 in a standard XA/7F type fuel element. The fuel fabricator BWX Technologies, Inc. (BWXT) Nuclear Operations Group (NOG) in Lynchburg, VA identifies this aluminum “dummy” plate as an “EE” plate during fuel fabrication. The ATR Canal Operators described the dummy plates on these YA-M fuel elements as being “scaly” or “pitted” in appearance. Upon closer examination, thousands of flow erosion/corrosion pits were readily visible over approximately 40 inches of the 49.5-inch-long exterior surface of the EE plate on each of the previously new YA-M type fuel elements. The top 4 inches and bottom 4 inches of plate 19 were smooth. Similar pitting degradation was not observed on the exposed surface of plate 1 or the side plates of these YA-M type fuel elements, nor was any pitting degradation observed on any of the standard XA/7F fuel elements that had been loaded in the core, including those that were loaded immediately adjacent to the YA-M fuel elements [1-5]. The interior surface of plate 19 and none of the other fuel plates (plate 2 - 18) can be visually inspected [6-10]

Figure 1. Corroded dummy plate – photographs taken after the fuel elements were removed from the reactor.

In the case of pitting erosion the following corrective measures were proposed based upon the results of JMatPro v.8.2 modeling (TTT- and CCT-diagrams): change the fabrication process by adding blister anneal before program anneal, immediately after cold rolling of AA6061 plate. This step will allow achieving complete recrystallization, eliminating of strengthening due to metastable precipitates, and reduce the possibility of forming sharp microstructural features upon the surface.

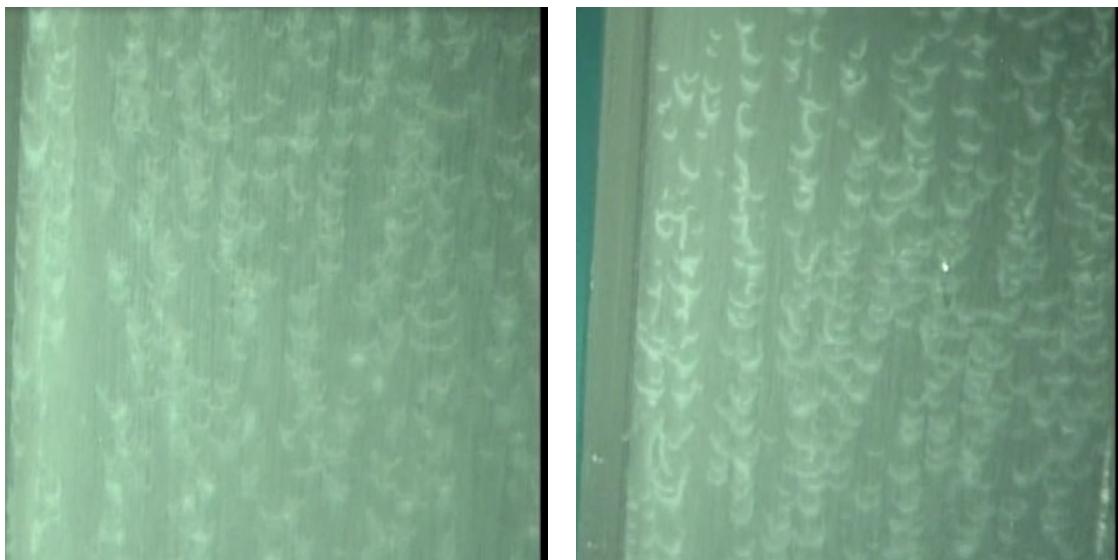
Yet another, very different type of erosion was also observed, see Figure 2:

Figure 2. “Scalloping,” or horseshoeing erosion - 6061 “dummy” plate

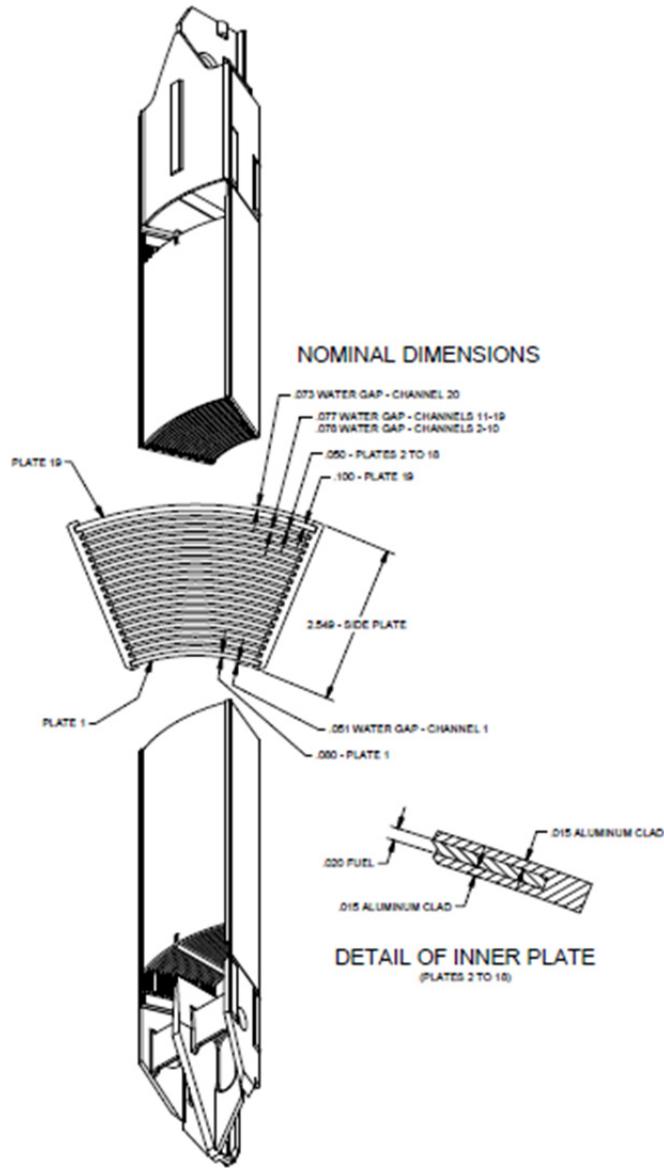
Each ATR fuel element consists of 19 parallel curved fuel plates attached to two side plates to form a 45-degree sector of a right circular cylinder. Plate 1 is the smallest of the 19 plates, and plate 19 is the largest of the plates. Each fuel element has 20 coolant channels with Channel 1 on the inner radius of Plate 1, Channels 2 through 19 between adjacent fuel plates, and Channel 20 on the outer radius of Plate 19. A schematic of the AA6061-clad nuclear fuel element is presented in Figure 3:

Figure 3. A schematic of an ATR nuclear fuel element [6-10]

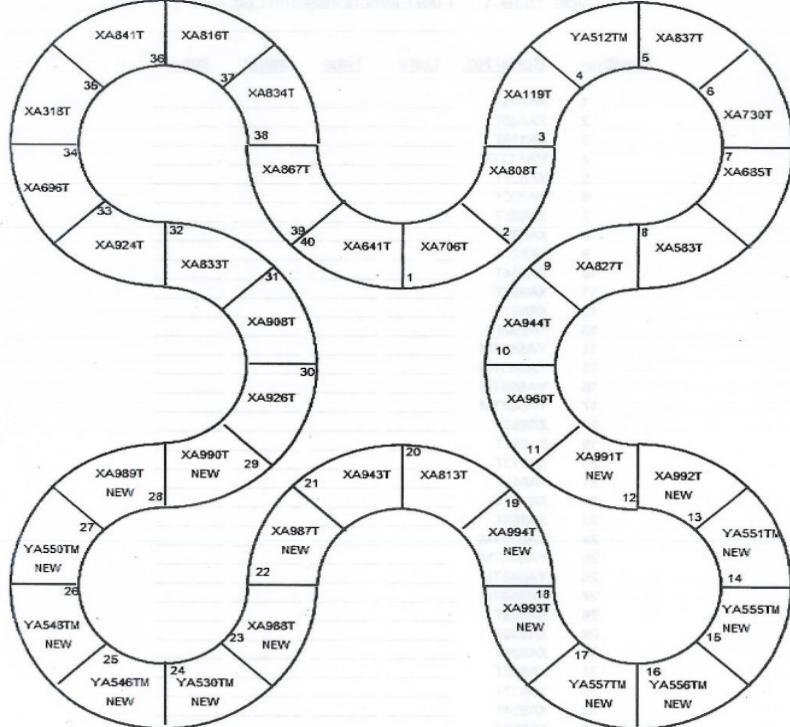
All ATR fuel elements are fabricated with thicker cladding on Plates 1 and 19. The two outermost fuel plates (1 and 19) of each element are designed with extra thick clad to withstand the greater differential pressure resulting from variability of the coolant channels formed by the outer fuel plates and the adjacent beryllium reflector block, flux trap baffle, and neck shim housing (IDO-17021-1). Damage to the structural components (such as the upper and lower adapters), side plates, and exposed surfaces of Plates 1 or 19 is anticipated during fuel element insertion and removal in the core, transfer cans, and storage locations. Plates 1 and 19 are designed to protect the fuel meat from minor damage. The general schematic of the ATR core fuel positions is presented in Figure 4 below.

Figure 4. General configuration of the fuel elements in INL Advanced Test Reactor [9] (This core loading corresponds to fuel cycle 153B-1 studied in this report.)

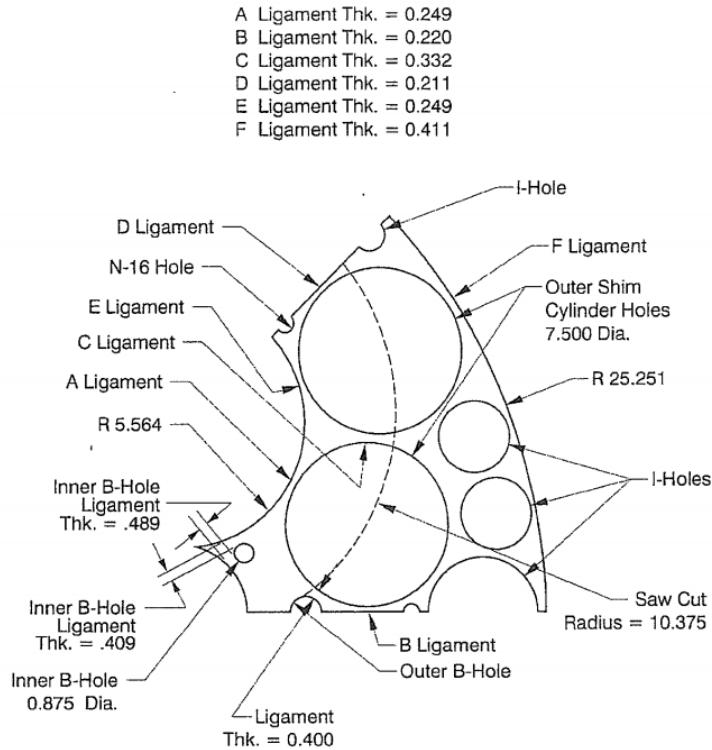
Figure 5. ATR beryllium reflector block ligaments [10]

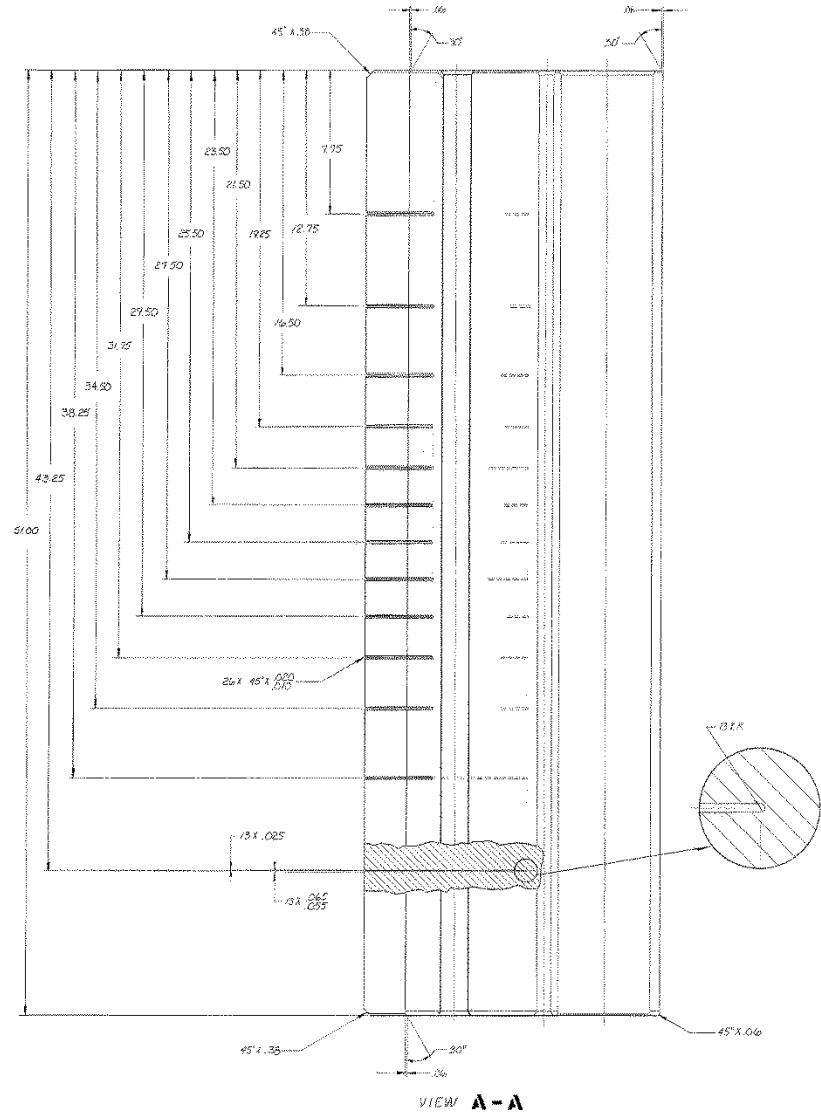
Operating experience with the first two ATR beryllium reflector blocks led to incorporation of horizontal saw cuts in the beryllium blocks of the third and all subsequent beryllium reflector blocks to delay buildup of internal stresses. Axial locations of these saw cuts are shown in Figure 6. Figure 5 shows the radial location of the saw cuts in relation to the A and E ligaments. The saw cuts limit initial cracking in the A and E ligaments to the saw cut segment in which the crack starts.

Figure 6. INL drawing DWG 419609 illustrating the geometry and arresting horizontal saw cuts of the beryllium reflector block(s) installed at ATR.

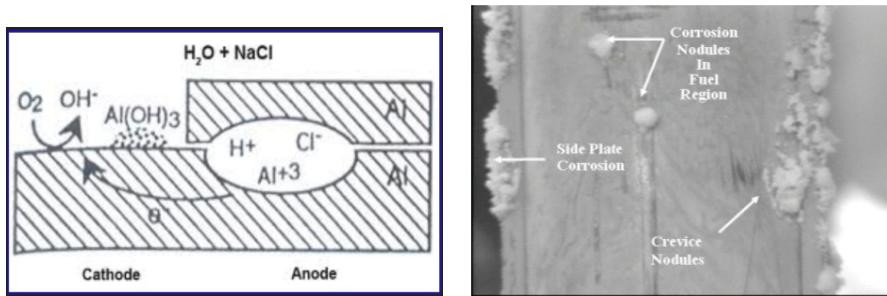
Figure 7. Schematic of crevice corrosion,¹ crevice corrosion at side plates in wet storage.²

This is typical of the pitting erosion process, possibly accompanied by some crevice and/or erosion corrosion. The general schematic of the crevice corrosion is presented in Figure 7, see above.

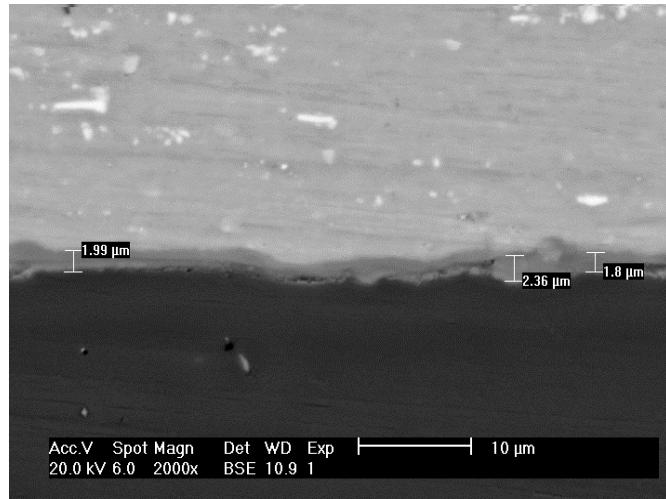
Figure 8. Protective layer of boehmite on the surface of aluminum alloy 6061 [15]

A protective layer of boehmite is of the order of 0.06 to 0.3 mils (1.5μm to 7.6μm) thick [16]; a typical view of 0.08 mil (2μm) the protective boehmite film is presented in Figure 8, see above.

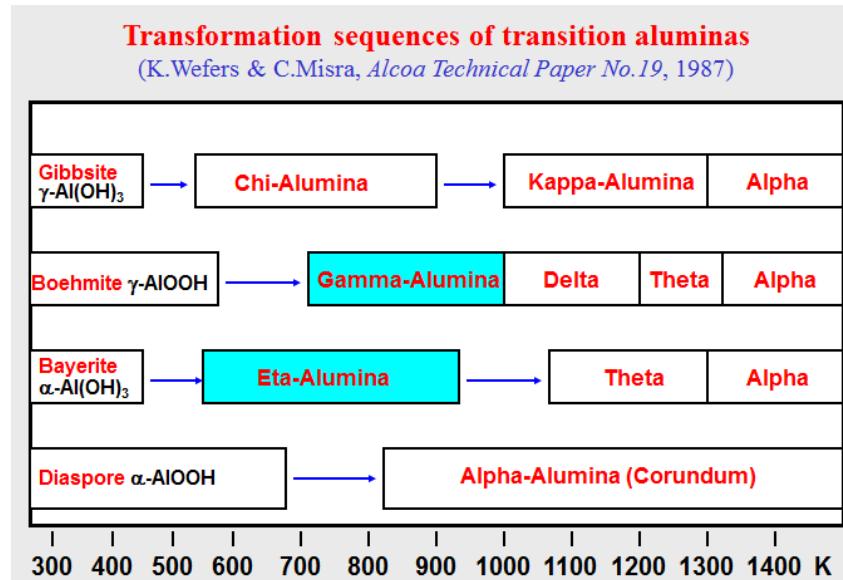
Figure 9. Crystallographic transformation sequences for different alumina polytypic structures.⁹

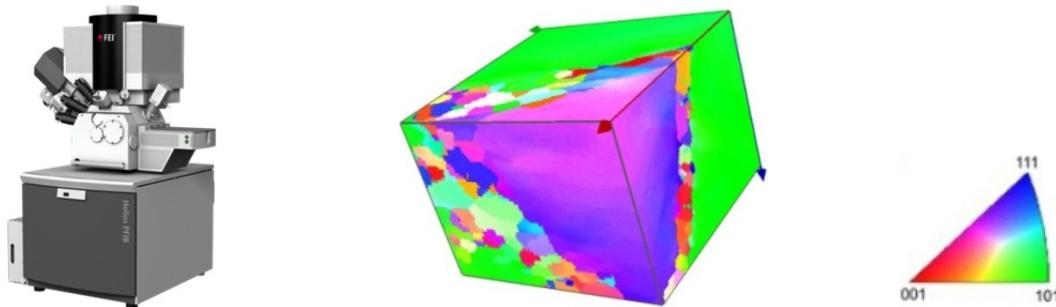
An example of incomplete recrystallization that may cause residual stresses in alloy micro-structure is presented below.⁴ The picture was obtained on a modern Helios PFIB 3D-microscope.⁵

Figure 10. Left: a modern Helios PFIB microscope;⁴ Right: 3D-representation of partial recrystallization in Al alloy.⁵

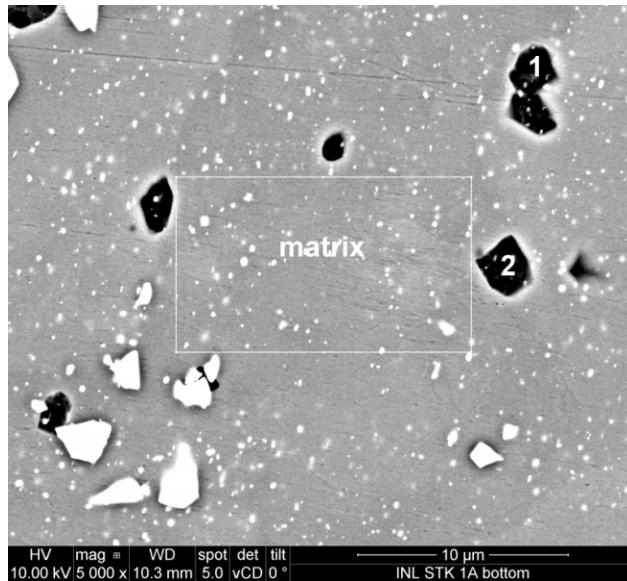
Figure 11. Typical microstructure of AA6061 “dummy” plate: saturated Al-based solid solution, particles of Mg_2Si (dark, 1 and 2), and white particles of Fe-bearing phases such as Al_3Fe , Al_5FeSi , etc. (our data).

According to Figure 11, particles of Mg_2Si , Al_3Fe , Al_5FeSi etc. were found in samples of the dummy sheet. In general, a number of different phases may form in the Al-Mg-Si-Fe system (“mimicking” alloy 6061 to a certain extent), including saturated solid solution (Al), Mg_2Si in different forms, Al_3Fe , Al_5FeSi , Al_8Mg_5 , etc. Clearly, this alloy, similar to any industrial alloys, is characterized

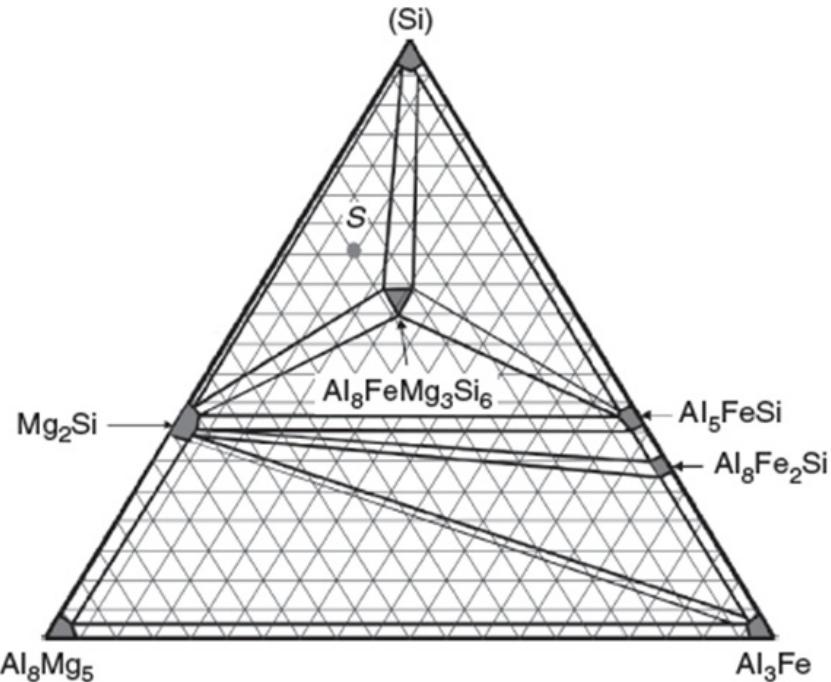
Figure 12. Isothermal cross-section in the Al_8Mg_5 – Al_3Fe – (Si) pseudo-ternary phase diagram illustrating the character of phase equilibria in this complex system and phases that can potentially be present in AA6061.¹¹

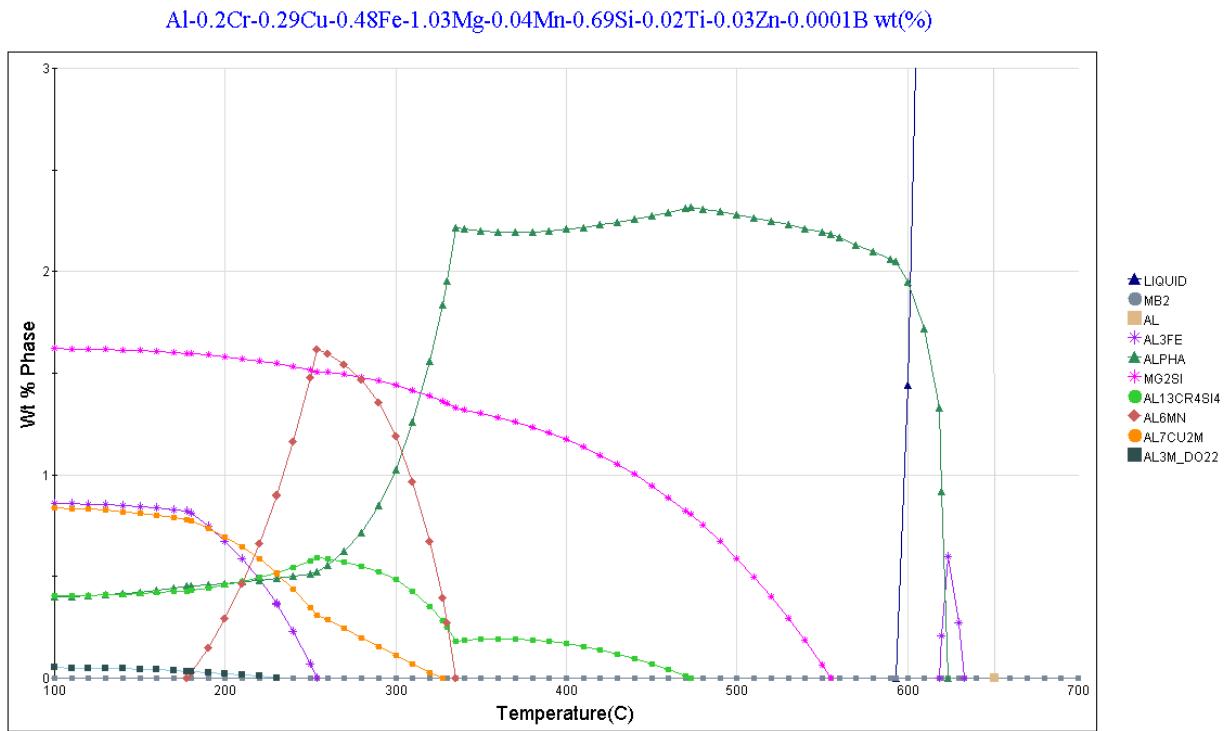
Figures 13 and 14 represent phase compositions, stable and metastable respectively, for alloy AA6061 as a function of temperature. These Figures are important for evaluating a possibility of metastable precipitates remaining in the (Al)-matrix and, consequently, for creating and retaining a certain level of the residual stress that may contribute to the phenomenon of pitting erosion.

Figure 13. Temperature dependence for equilibrium alloy 6061 phase composition.

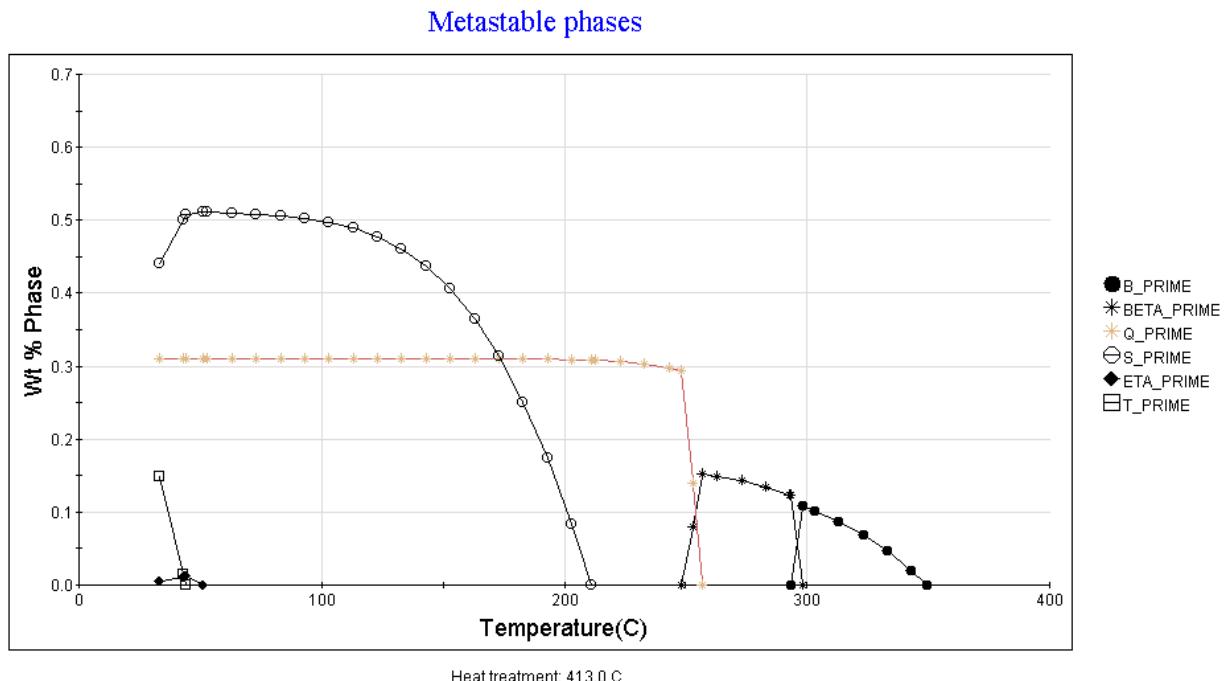
Figure 14. Metastable phases and their weight content as a function of temperature for the preceding heat treatment at 413°C.

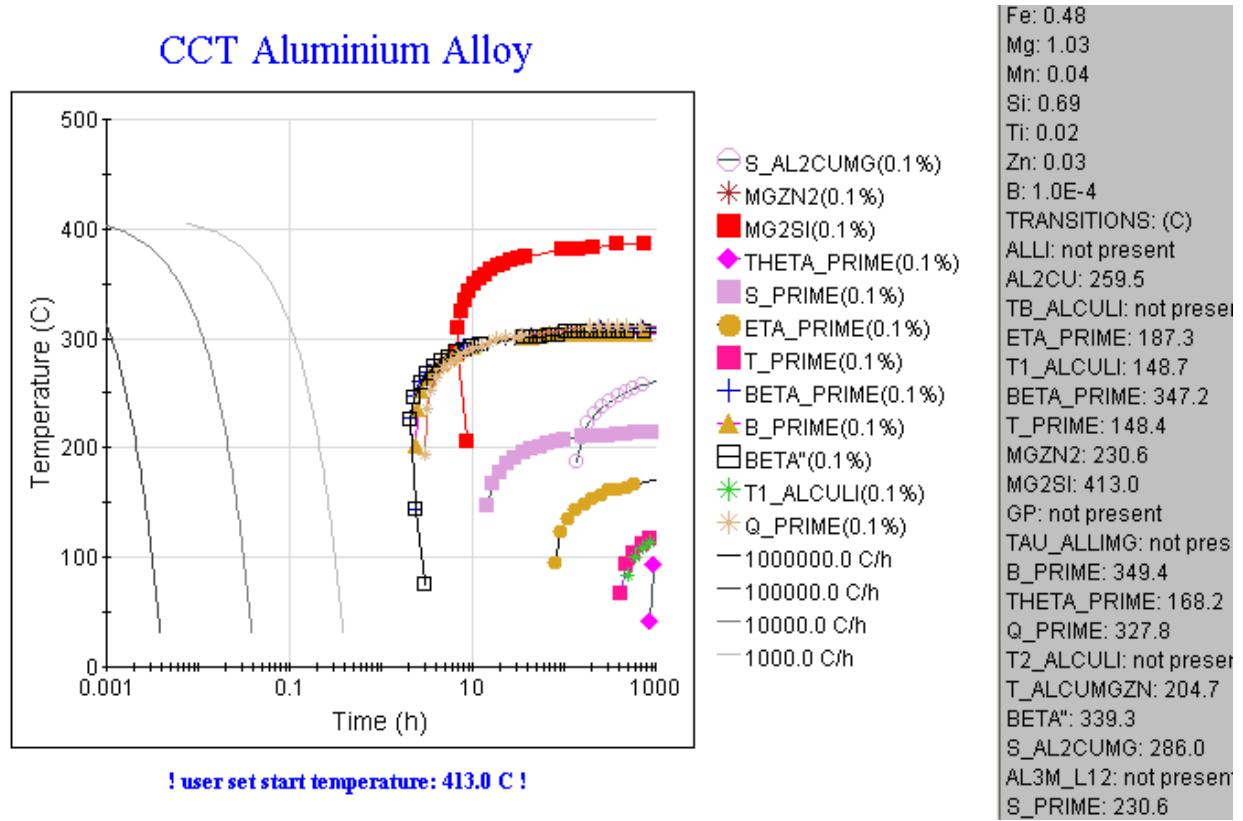
Our next goal was to model the kinetics of precipitation of both equilibrium and metastable phases in AA6061 subjected just to thermo-mechanical treatment of reduction by 33% (cold rolling) and subsequent anneal at 413°C for 2 hours. The results are demonstrated in Figure 15.

Figure 15. Continuous cooling diagrams from 413°C down to room temperature for different cooling rates, including cooling in the ambient air (1000 C/hour; light grey line).

One can see that the light grey line corresponding to cooling in the air (~1000C/h) is uncomfortably close to the CCT lines for precipitation of different metastable phases such as β' or β'' . Consequently, additional high temperature anneal seems attractive both from the complete recrystallization and the elimination of metastable phase point of view.

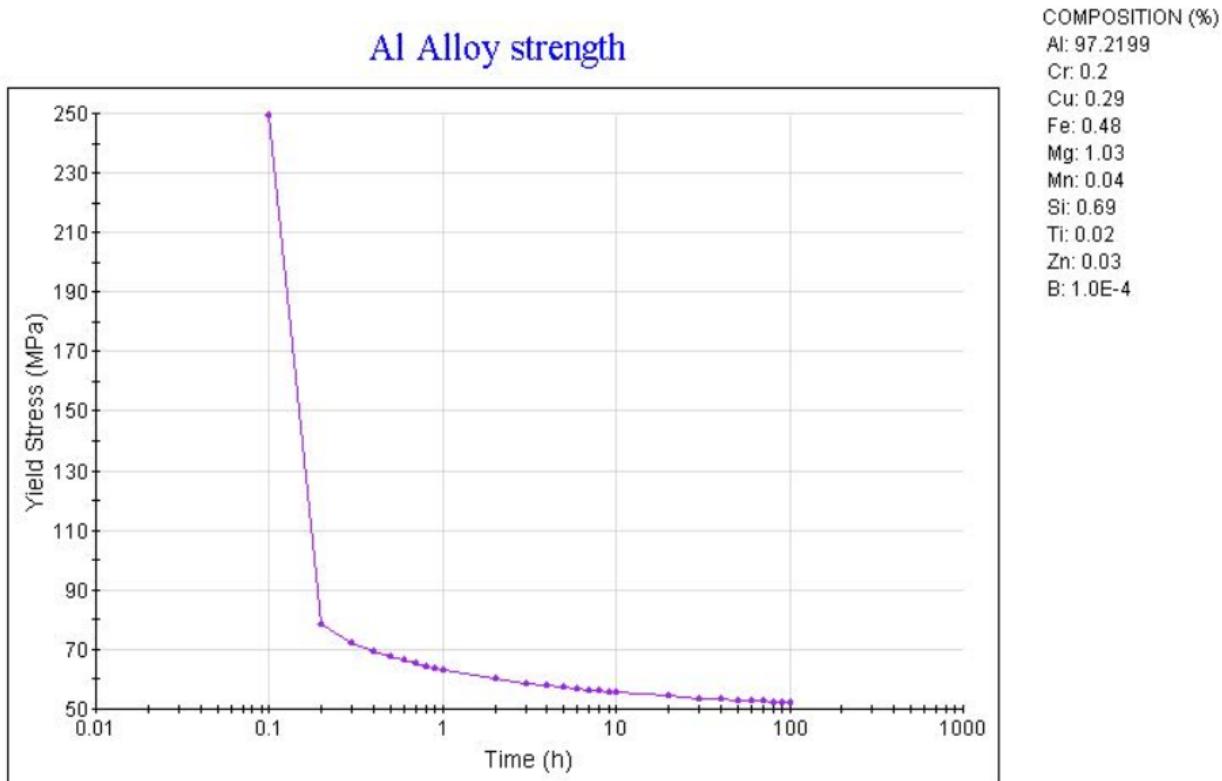
Figure 16. Modeling of residual AA6061 alloy strength: after 2 hours of heat treatment at 413°C sheet still has about 62MPa residual strength. This is higher than 55MPa for AA6061-O. Strength can further increase as a result of natural aging during cooling in the air.

One possible solution to eliminate the flow-assisted erosion problem would be to cold roll, then add blister anneal (2 hours at 900°F), then follow up with program anneal (2 hours at 775°F). Probably it could even be possible to drop temperature of the 2nd anneal down to 700°F. This was suggested to the fuel fabricator, BWXT. The annealing procedures were revised to add the higher temperature blister anneal to the EE plate fabrication procedure.

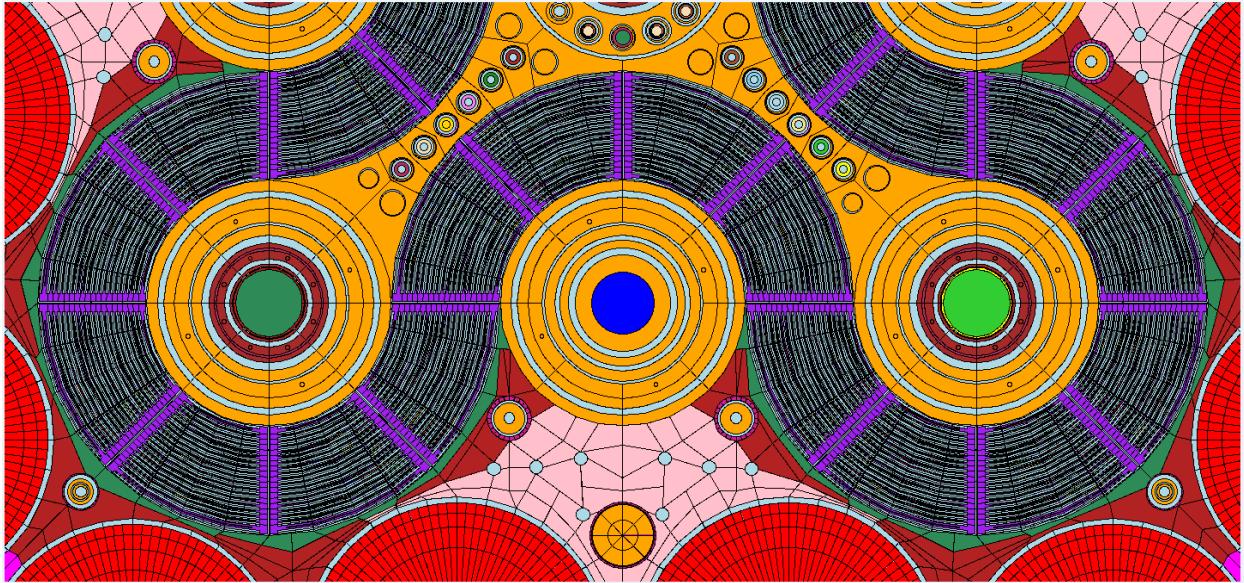
In order to obtain the necessary data on the neutron flux distribution along the YA element plate, MCNP and HELIOS modeling was conducted. In turn, this data provides information about the heat flux distribution in the axial direction for the core lobes SW and SE, see Figure 17

Figure 17. General schematic illustrating positions of the ATR South lobes (cycle 153B).

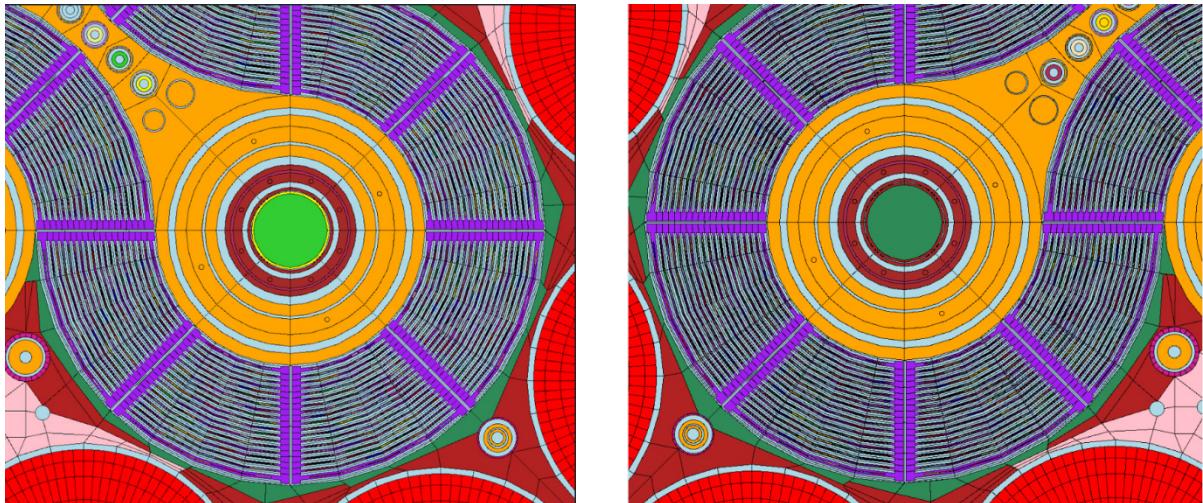
Figure 18. (left) South-East (SE) lobe in ATR cycle 153B; and (right) South West lobe (SE) of ATR in reactor cycle 153B.

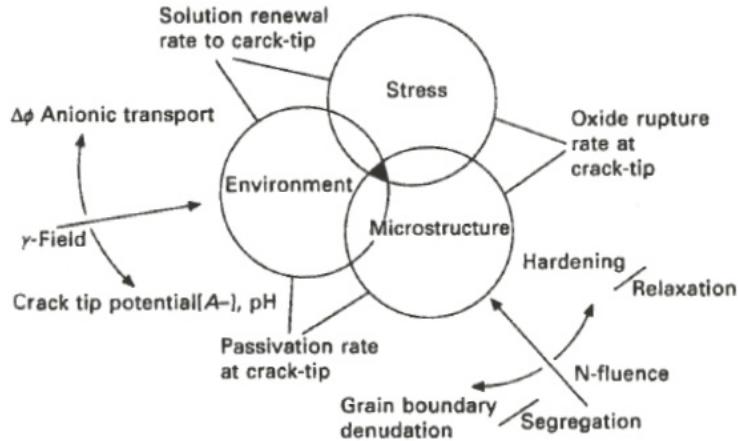
As mentioned in Section 1, localized flow assisted axial erosion with possible de-alloying and the formation of pits was observed predominantly in the central part(s) axially of the aluminum dummy plate of YA elements in the SW and SE lobes during the 153B PALM cycle. The initial assumption was that the predominant location of erosion sites in the central parts of the affected plates was the result of residual stresses in the YA fuel plates and the increased levels of axial neutron flux distribution. It is this combination of factors that may have resulted in the observed erosion phenomena. It can be conveniently illustrated by Figure 19.¹⁰

Figure 19. Schematic of primary engineering parameters that affect SCC (Stress Corrosion Cracking) – stress, microstructure, and environment. Radiation affects SCC via segregation, hardening, relaxation, and water radiolysis.¹⁰

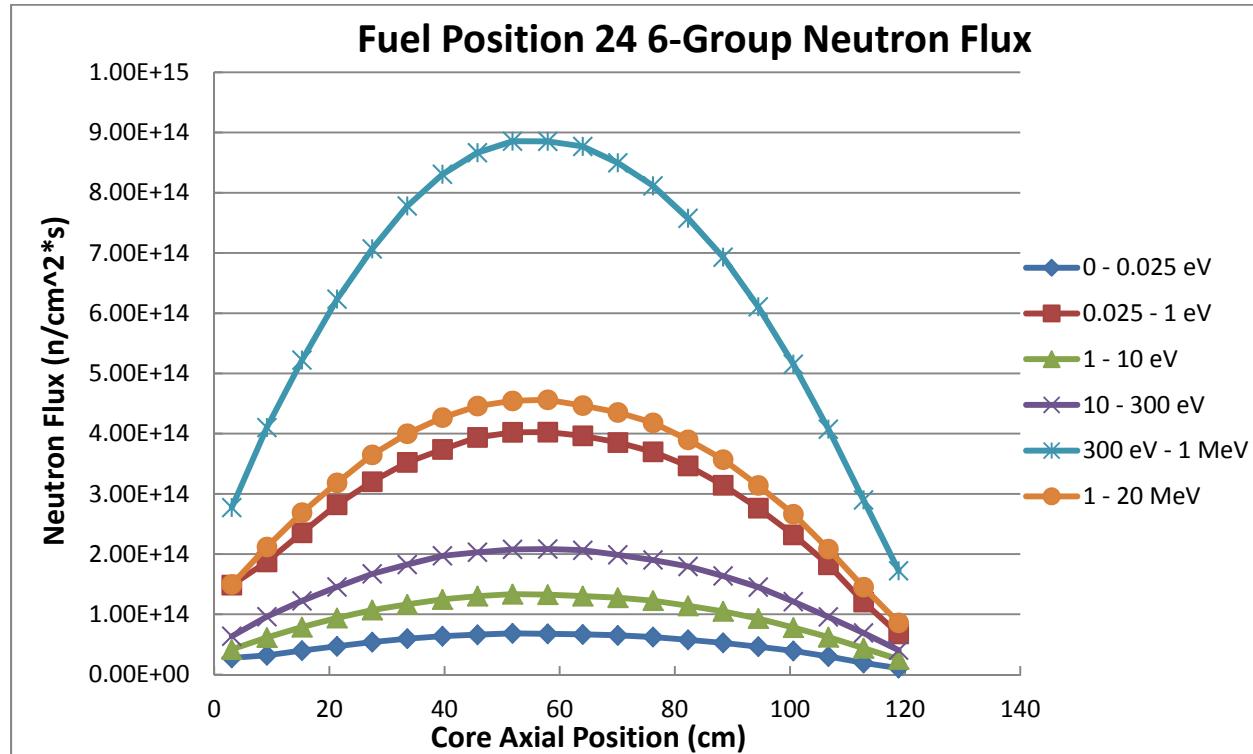
Figure 20. Neutron flux distribution in the approximation of 6 energy groups for the fuel element in position 24, SE ATR lobe.

The maximal values of the neutron flux were realized in the central part(s) of the corresponding elements, which may contribute to the observed corrosion/erosion described in Section 1 of this Report.

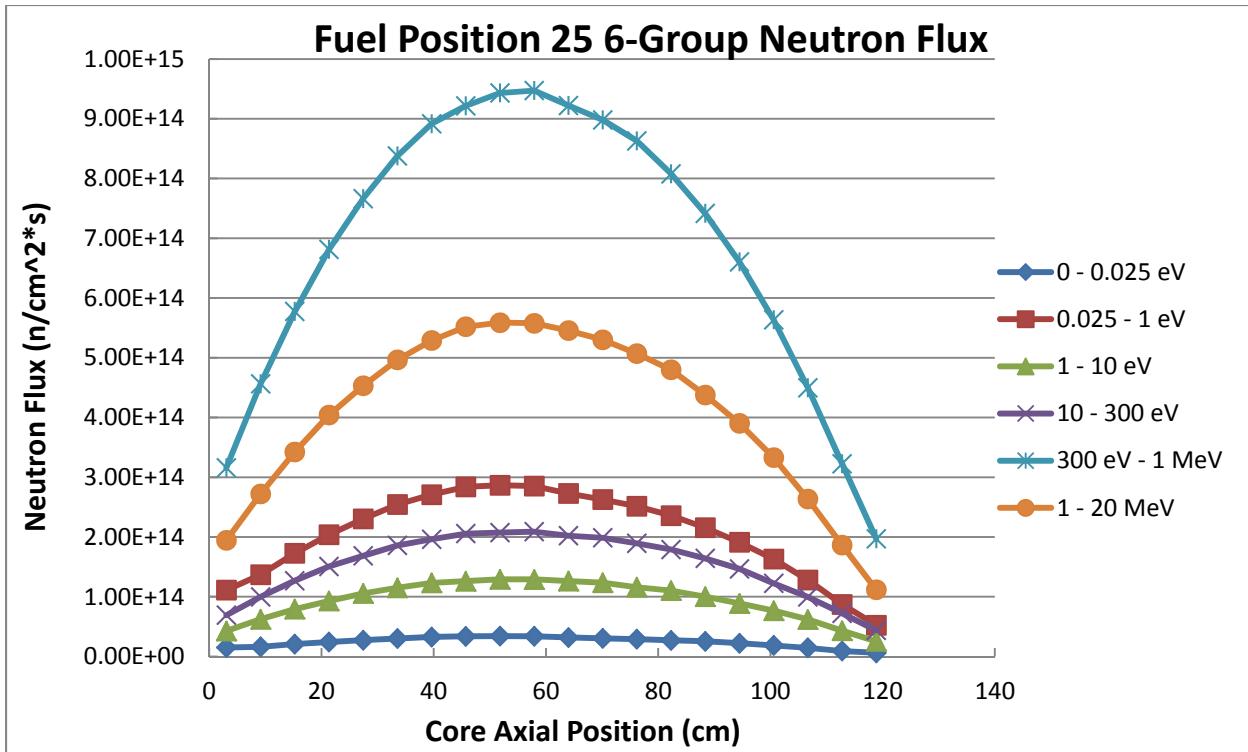
Figure 21. Neutron flux distribution in the approximation of 6 energy groups for the fuel element in position 25, SE ATR lobe.

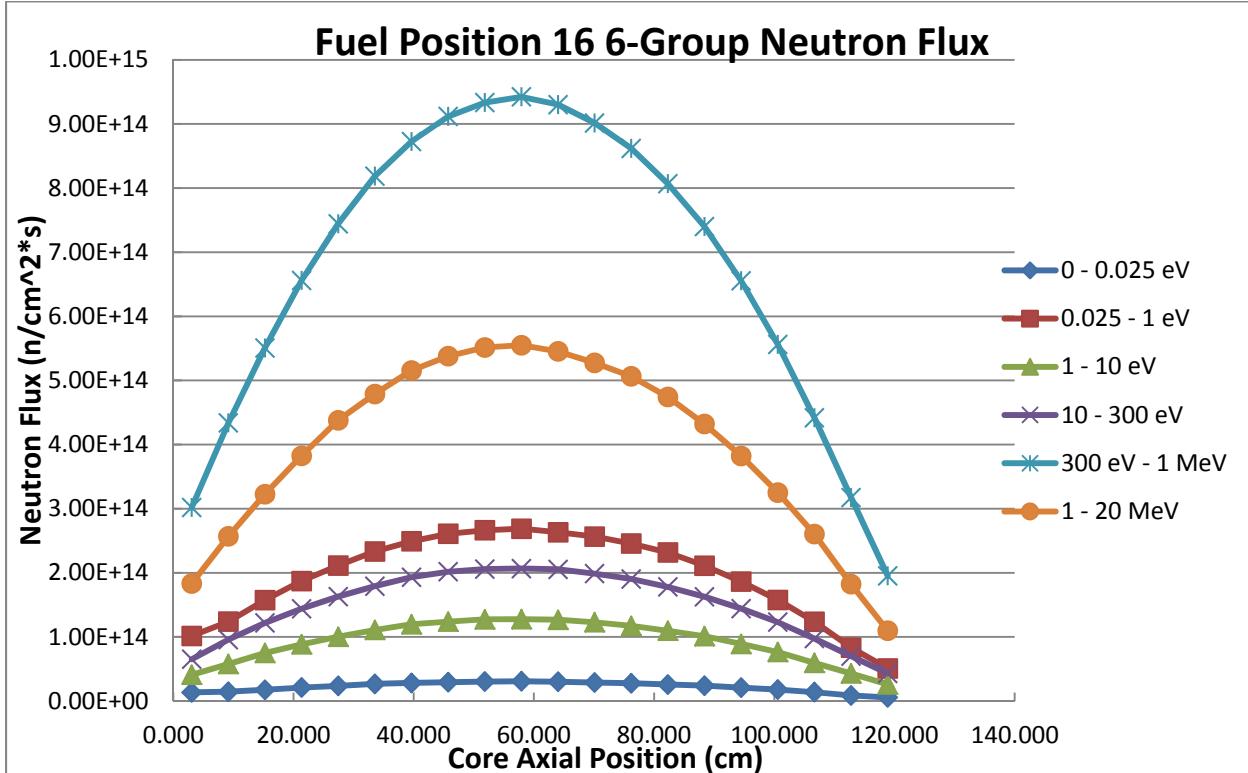
Figure 22. Neutron flux distribution in the approximation of 6 energy groups for the fuel element in position 16, SW ATR lobe.

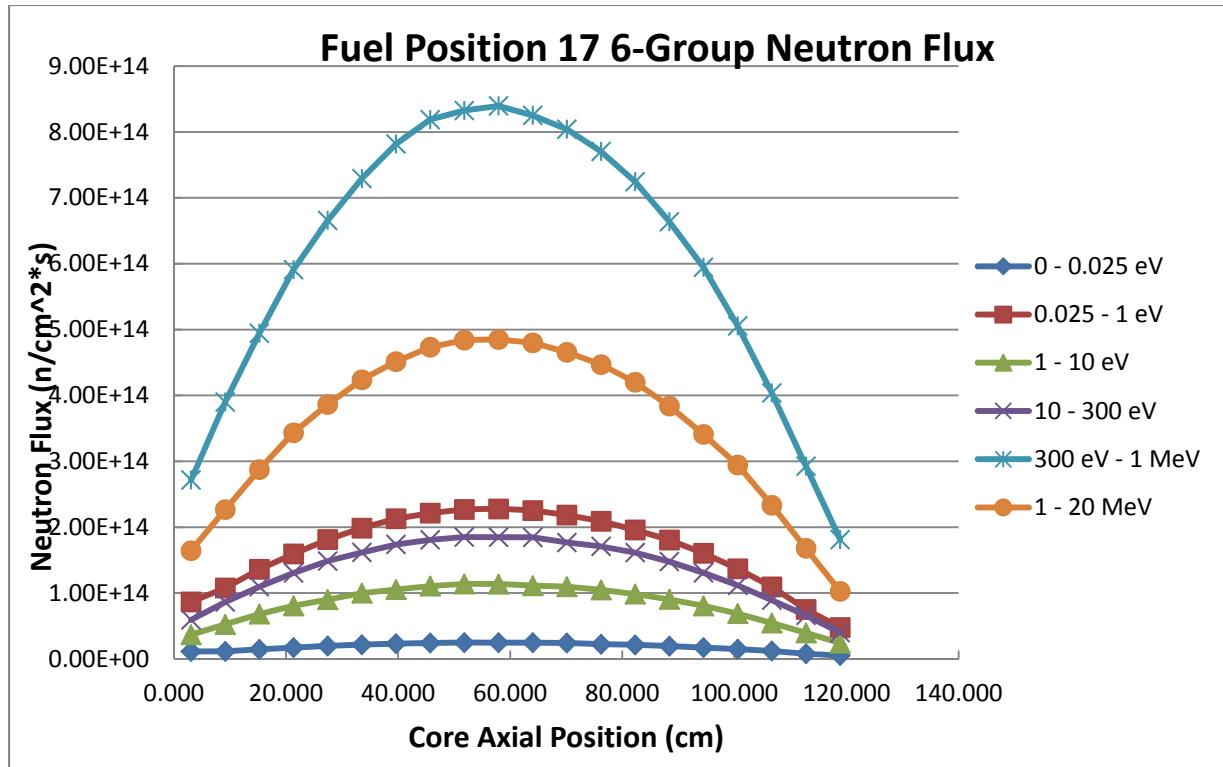
Figure 23. Neutron flux distribution in the approximation of 6 energy groups for the fuel element in position 17, SW ATR lobe.

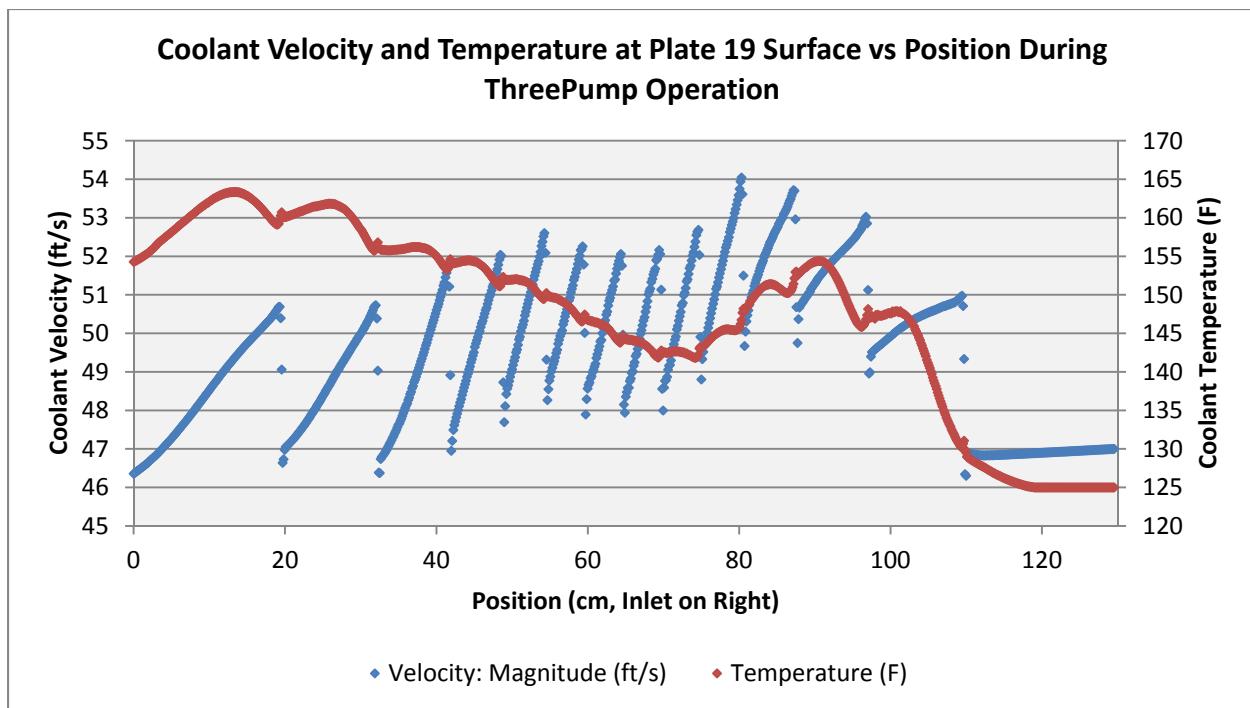
Figure 24. Cycle 153B; Coolant velocity and temperature vs position for three primary coolant pumps in Coolant Channel 20.

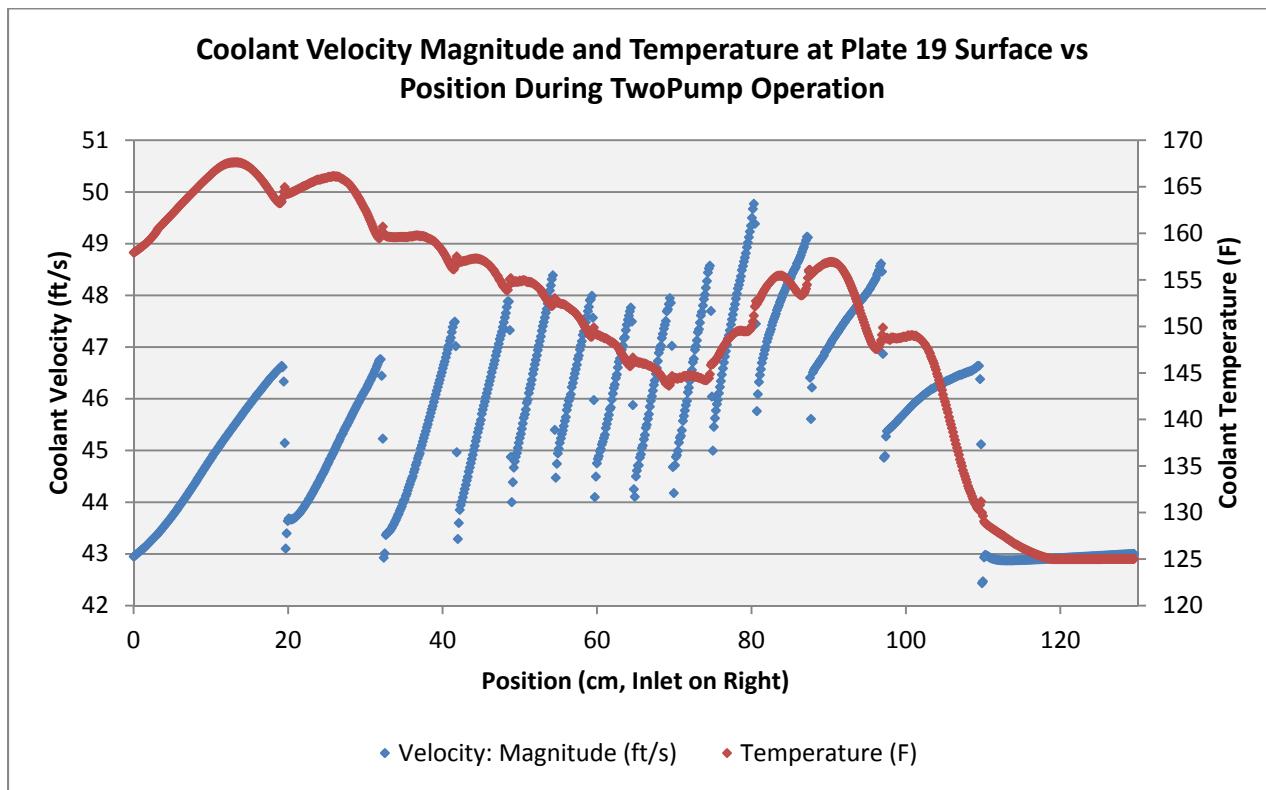
A second case was run using the same parameters but reducing the inlet velocity to two-pump operation (43 ft/s) to investigate the velocity and temperature profiles. Figure 25 shows the results of the two-pump operation with nearly identical results. The main difference between two and three pump operation is the coolant velocity magnitude, as expected. The slight reduction in flow resulted in slightly higher temperatures with all other input parameters held constant.

Figure 25. Cycle 153B; Coolant velocity and temperature vs position for two primary coolant pumps in Coolant Channel 20.

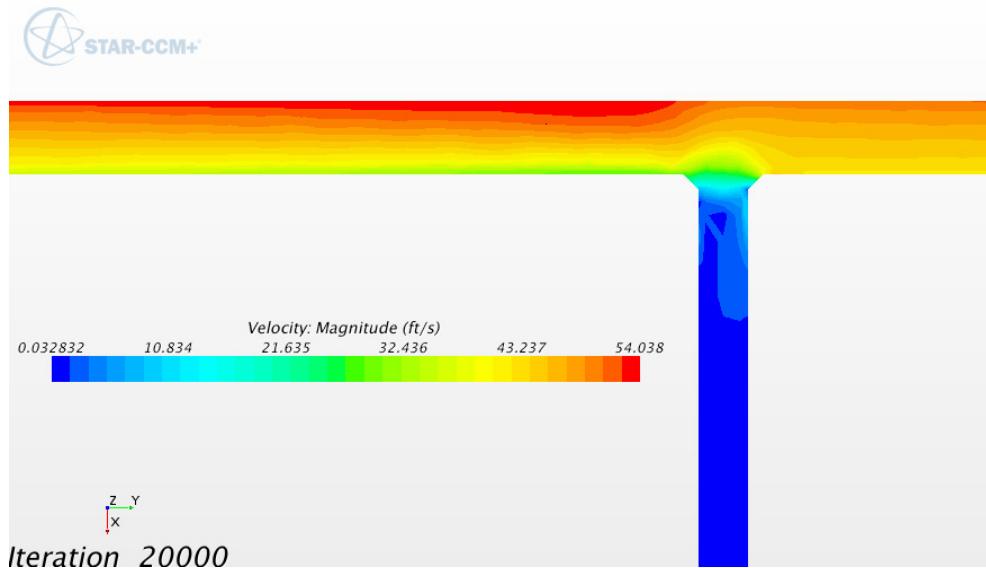
Figure 26. Flow structure: velocity distribution field around the cut in beryllium reflector block.

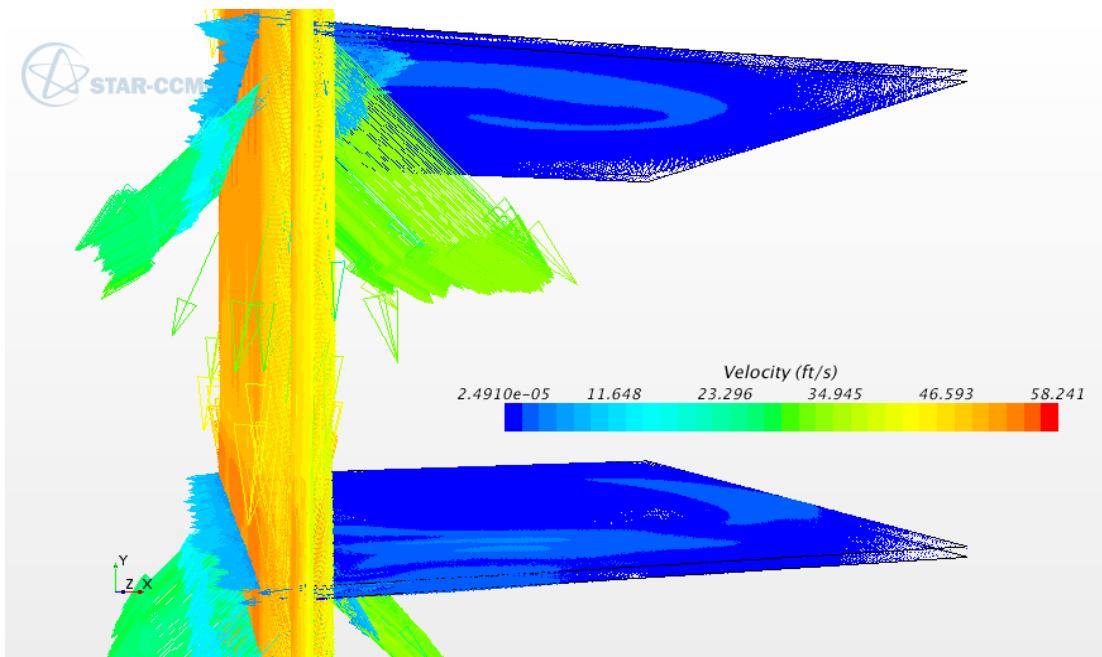
Figure 27. Flow Structure in 3D: the same as the previous figure, but with a vector field distribution for flow velocities in the direct vicinity of the cut. Perturbations from the stress-relief cuts cause the coolant to flow into the plate face at up to 35 ft/s.
