Evaluation of Erosion of the Dummy “EE” Plate 19 in YA Type ATR Fuel Element During Reactor PALM Cycles

**Idaho National Laboratory
Advanced Test Reactor
Idaho Falls, Idaho 83415**

INL/EXT-16-38324
Revision 0

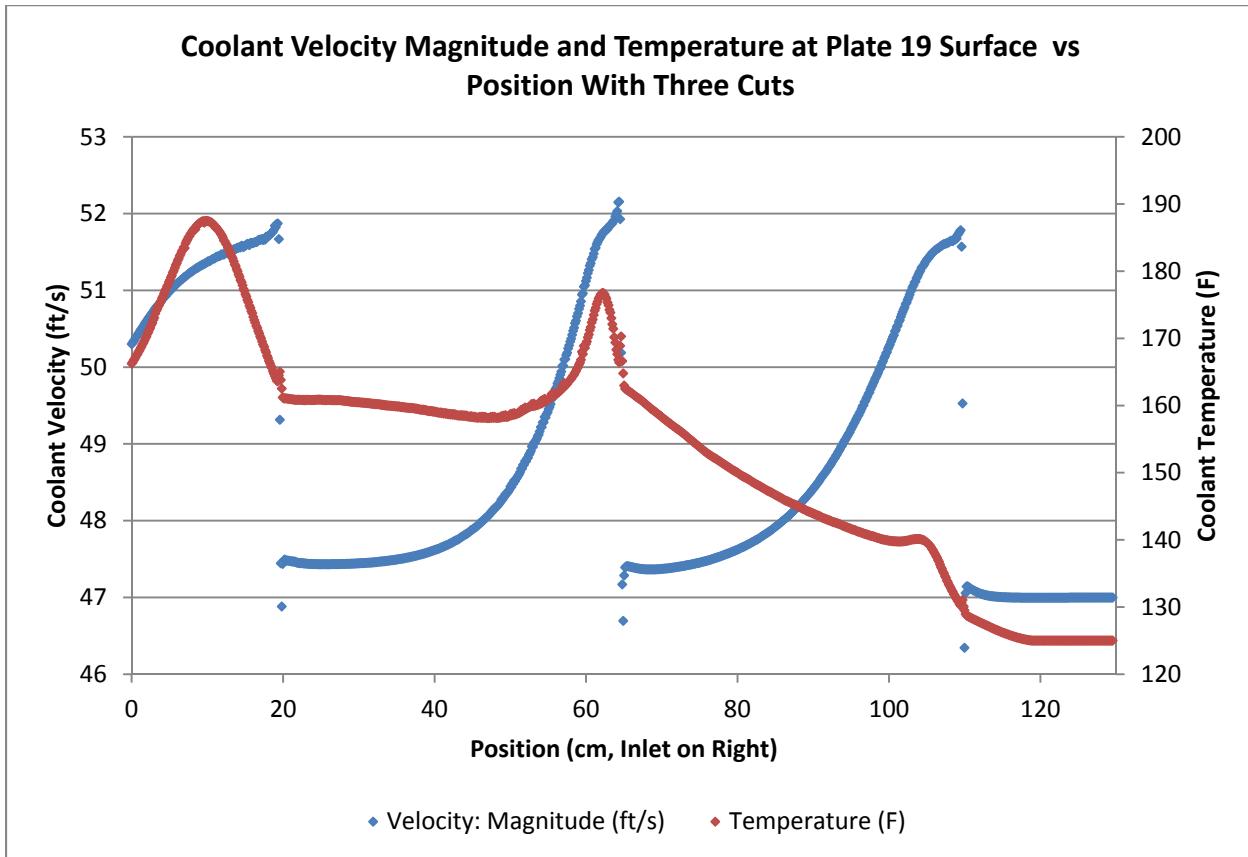
To further explore and verify the temperature profile of these standard cases, the coolant channel geometry was modified. Instead of 13 cuts, only three were used (no. 1, no. 7, and no. 13). The results in Figure 28 demonstrate that the distribution profile (shape) depends almost exclusively upon the absence or presence of horizontal cuts and their total number.

Figure 28. Cycle 153B; coolant velocity and temperature vs position – system with three cuts.

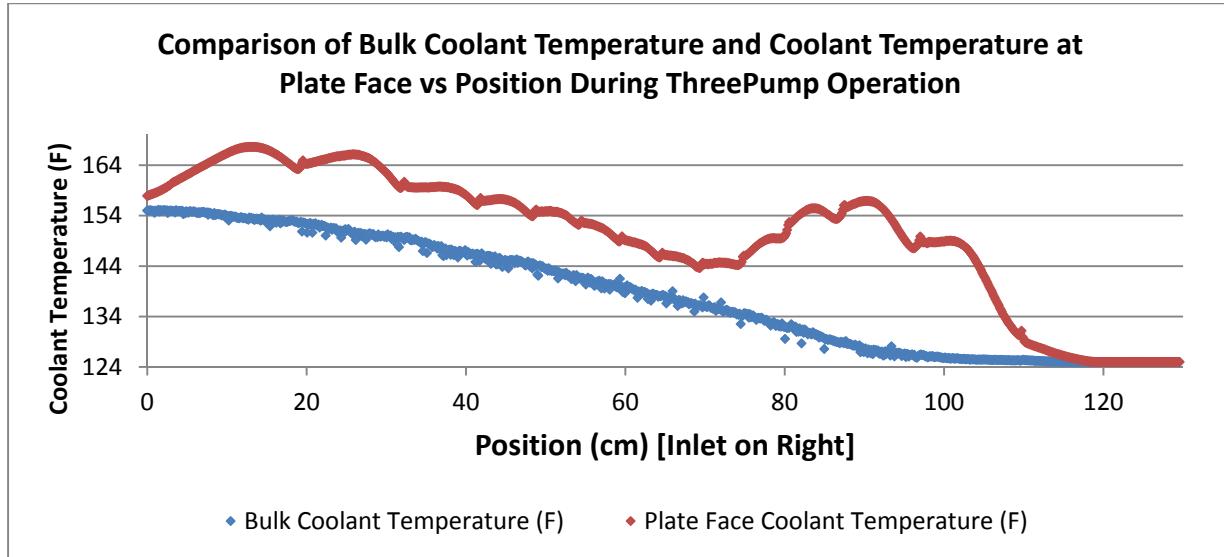
While the phenomena detailed above may cause the coolant temperature profile at the plate surface to appear strange, the temperature profile of the bulk coolant still exhibits the expected “S” curve, as shown in Figure 29.

Figure 29. Cycle 153B; coolant temperature at the plate face compared to bulk coolant temperature.

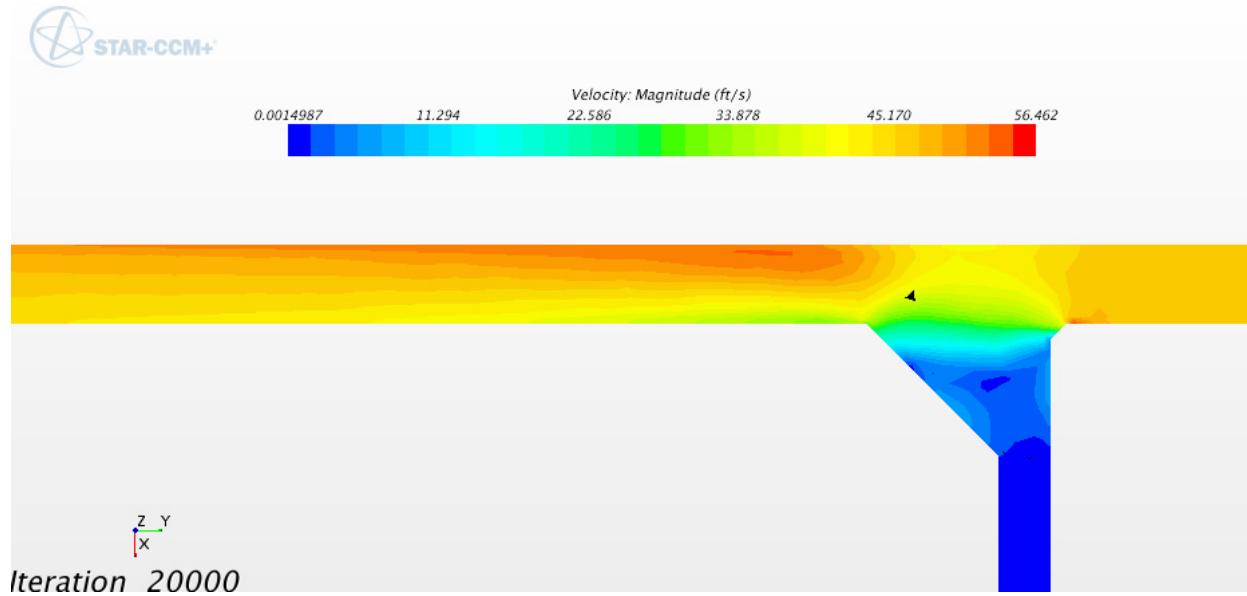
As these simulations identified erosion as a possible primary contributor to the YA-Plate 19 pitting degradation issue, the channel geometry was further modified to attempt to find a solution to the post-cut flow perturbations. A proposed solution was to exaggerate the chamfer on the bottom of the cut to observe how this change affected the solution, even though this change would likely not be beneficial as the reflector block ligaments are only 1/8 in. thick. Figure 30 shows the model geometry at a single cut site and the velocity magnitude as a result of the modification. The new bottom, “deep” chamfer is 1/8 in. deep, compared to 1/64 in. in the standard case.

Figure 30. Flow structure: velocity distribution field around the cut in beryllium reflector block with a modified (1/8 in.) bottom chamfer.

The chamfer modification had a modest impact on the coolant velocity vectors. There are still velocity vectors toward the plate, but these are reduced in number and much more spread out axially.

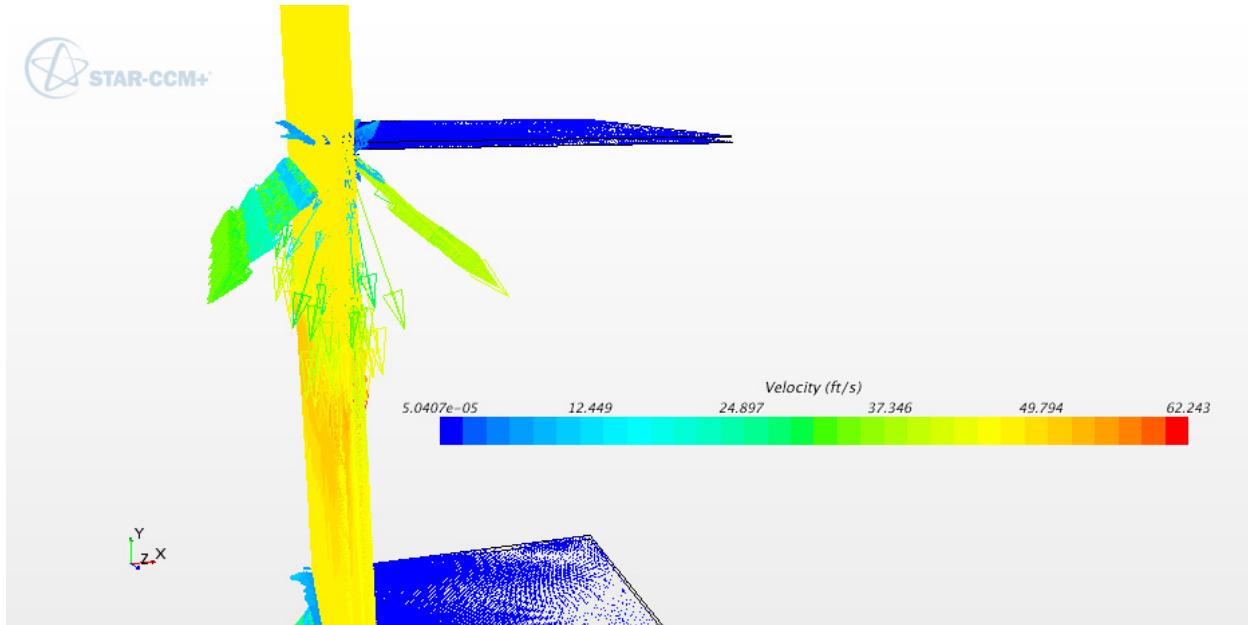
Figure 31. Flow structure in 3D: the same as the previous figure, but with a vector field distribution for flow velocities in the direct vicinity of the cut.

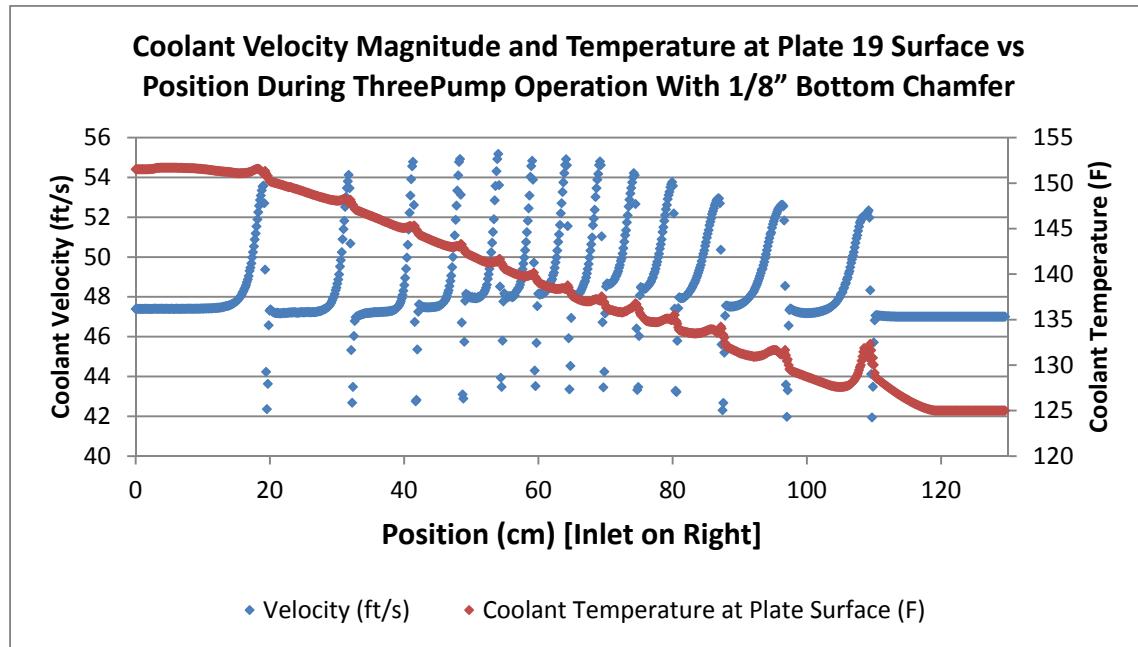
Figure 32 shows the velocity and temperature profiles versus axial position with the modified chamfer. While the magnitude at the discontinuity is not markedly different than the standard case, it is important to note that the temperature is significantly more linear and is lacking the dual-maxima of previous cases.

Figure 32. Velocity magnitude/temperature at the Plate 19 surface. While the discontinuities still exist with the modified chamfer, it is important to note that the magnitude does not say anything about the direction of the flow.
