FINAL TECHNICAL REPORT

U.S. Department of Energy
National Energy Technology Laboratory

DE-FE0009562

Wellbore Seal Repair Using Nanocomposite Materials

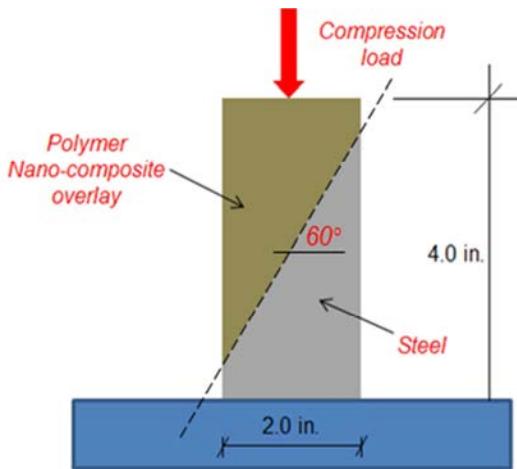
Fig.2.3: Schematic of slant shear test set-up (1 in = 25.4 mm).

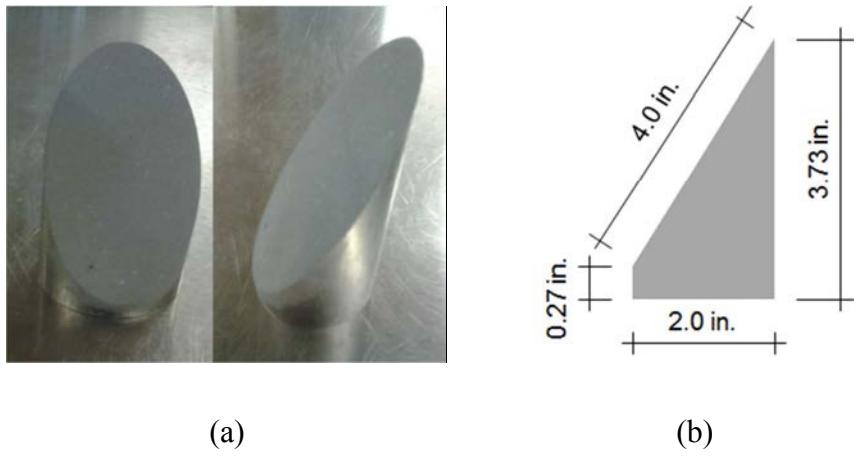
Fig.2.4: Dimension of slant shear test (a) steel part (b) sandblasted steel halves (1 in = 25.4 mm).

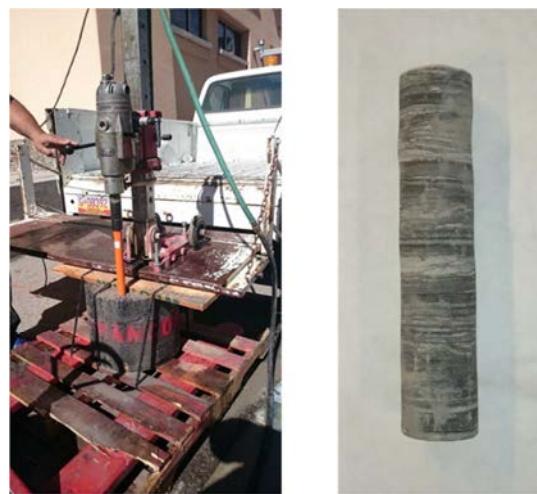
Fig.2.11: Core drilling (left), and obtained shale core (right).

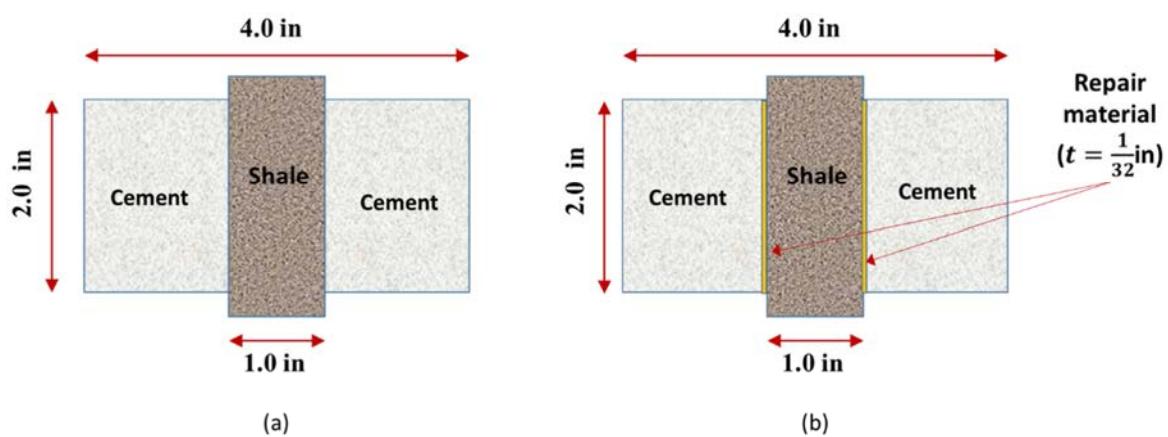
Fig.2.12: Schematic of push-out specimens (a) First set: without repair material and (b) Second set: with repair material (1 in = 25.4 mm).

Push-out tests were used to investigate the bond strength of the shale with different repair materials. Two sets of specimens were prepared for push-out tests. The first set was used to measure the bond strength between the shale and the cement. Cylindrical specimens with diameter of 100 mm (4 in) and height of 50 mm (2 in) were prepared. A shale core of 25 mm (1 in) diameter and length greater than 62.5 mm (2.5 in) was fixed in the center of a plastic mold, and cement paste was then cast around the shale. The second set was prepared to investigate the bond between the repair material and the shale. Cement cylinders 100 x 50 mm (4 x 2 in) were cast with a 27 mm ($1 \frac{1}{16}$ in) hole in the center. After the cement cylinder was cured, the shale core was placed in the center of the hole. Finally, the repair material was injected in the $800 \mu\text{m} = 0.8 \text{ mm}$ gap between the shale and the cement. **Fig.2.12** shows a schematic of the push-out test specimens. **Fig.2.13** and **Fig.2.14** show the preparation of the push-out test specimen and push-out test specimen repaired with Novolac epoxy respectively.

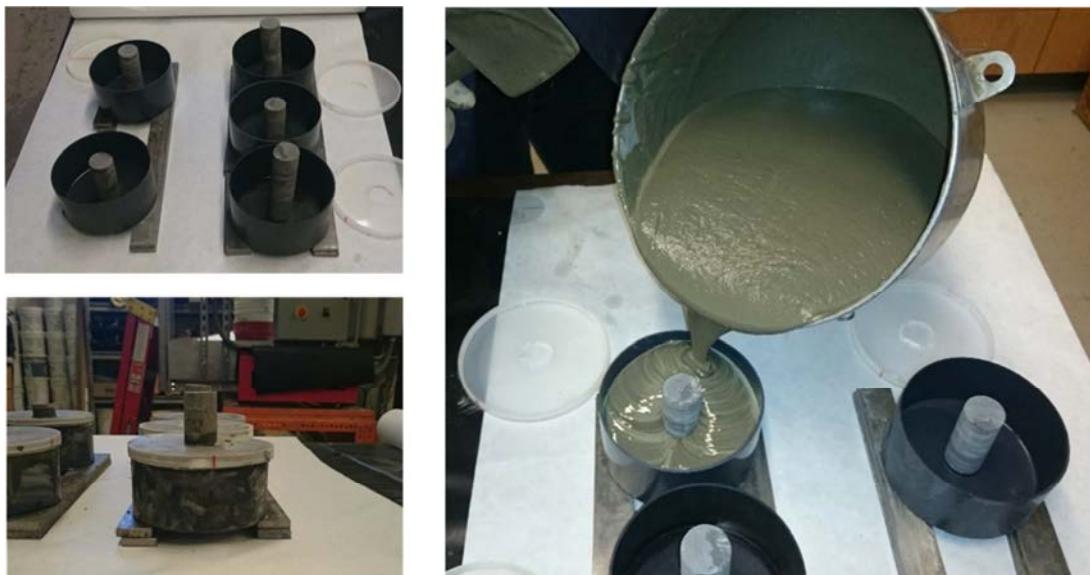
Fig.2.13: Preparation of reference push-out specimen (without repair material).

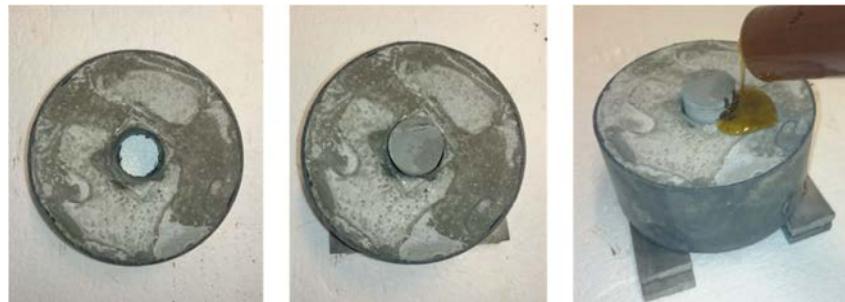
Fig.2.14: Preparation of repaired push-out test specimen with Novolac epoxy.

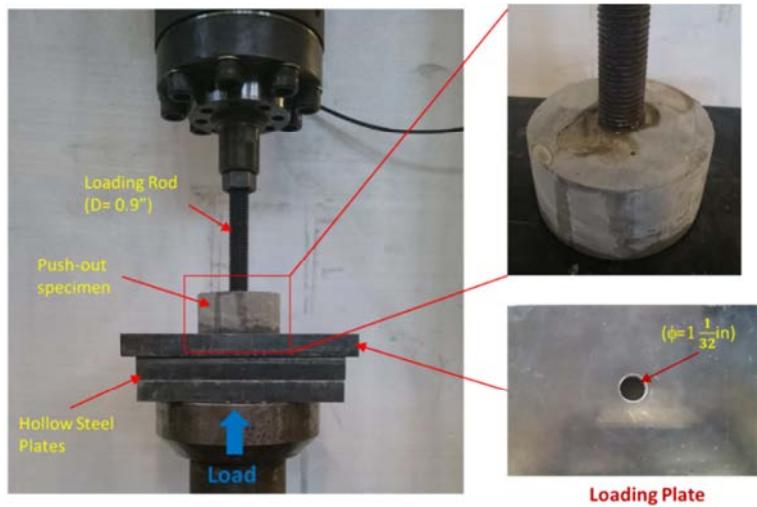
Fig.2.16: Push-out test setup.

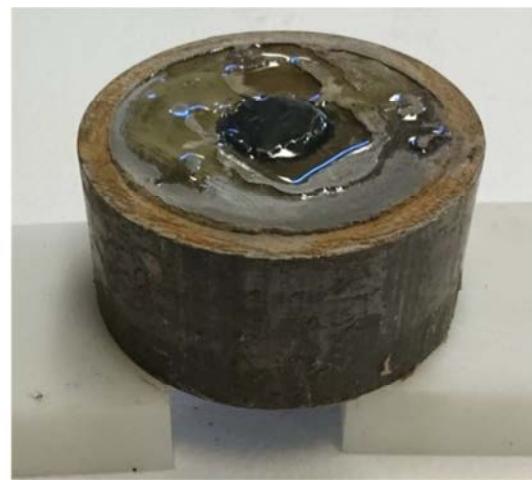
Fig.2.18: Push-out specimens with full embedment length.

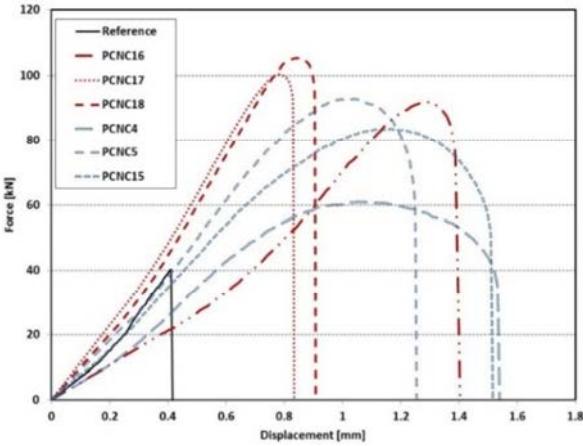
Fig. 2.22: Example median slant shear load-displacement curves of reference cement mortar (black solid curve) vs. Novolac epoxy nanocomposites incorporating PCNC16 (1.0% wt. MWCNTs), PCNC17 (1.5% wt. MWCNTs) and PCNC18 (4% wt. nanoclay) (red curves) and polysulfide siloxane epoxy nanocomposites PCNC4 (Neat), PCNC5 (0.5% wt. functionalized MWCNTs) and PCNC15 (0.5% wt. non-functionalized MWCNTs) (blue curves).

Furthermore, **Fig. 2.22** shows Novolac epoxy nanocomposites incorporating 1.0% wt. Functionalized MWCNTs, 1.5% wt. Functionalized MWCNTs and 4% wt. nanoclay. It is obvious the bond strength of Novolac epoxy with steel substrate is much higher than the reference material. Epoxy with 1.5% Functionalized MWCNTs had a bond strength that is 15% higher than neat epoxy. Epoxy with nanoclay had a bond strength that is 16% higher than neat epoxy. Epoxy with 1.0% Functionalized MWCNTs had a bond strength that is 3% lower than neat epoxy. Statistical analysis of the bond strength test results using student t-test showed all the bond strength increases are statistically significant with 95% level of confidence. On the other hand, statistical analysis showed that the difference in the bond strength between the neat epoxy and the epoxy with 1.0% wt. Functionalized MWCNTs was statistically not significant.

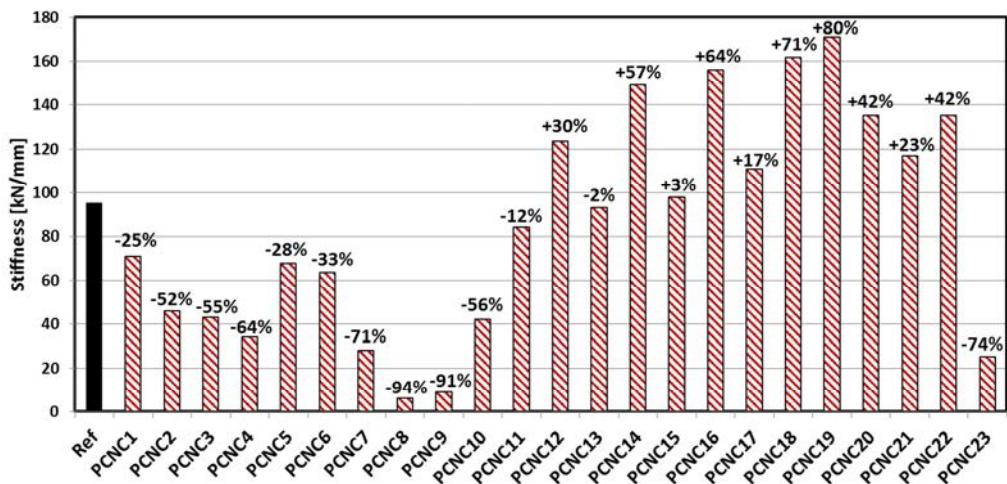
Fig.2.24: Stiffness of reference cement and 23 nanocomposites.

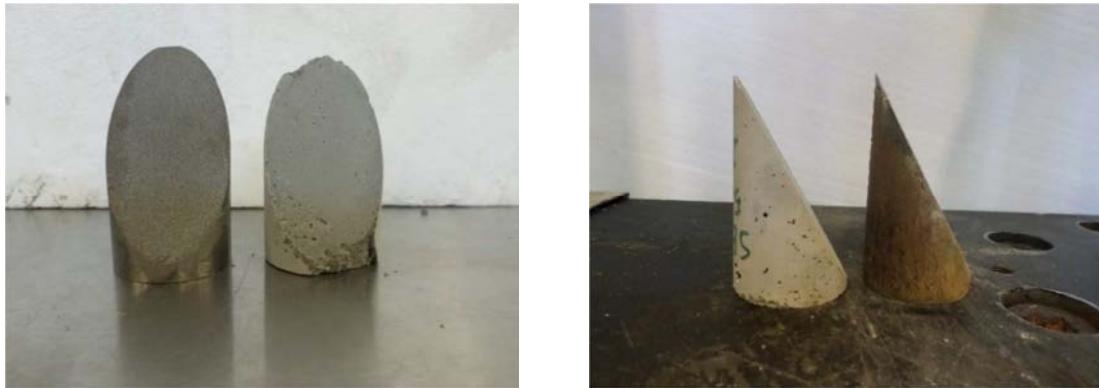
Fig. 2.25: Example failure cones of the slant shear test.

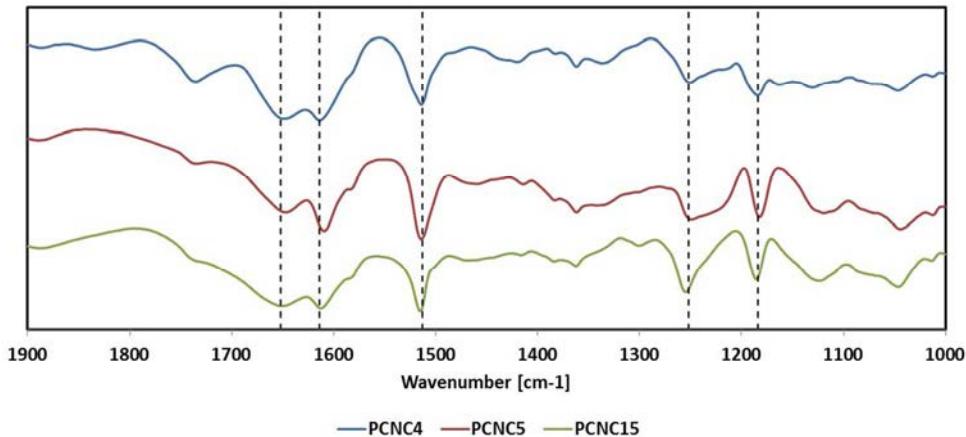
Fig. 2.26: FTIR results for PCNC4 (neat), PCNC5 (epoxy with functionalized MWCNTs) and PCNC15 (epoxy with non-functionalized MWCNTs).

A comparison of neat epoxy and epoxy incorporating functionalized and non-functionalized MWCNTs was conducted using FTIR and XPS. The results for PCNC4, PCNC5 and PCNC15 are shown in **Fig.2.26** and **Fig.2.27** for the FTIR and XPS methods, respectively. **Fig. 26** shows typical peaks of epoxy formed in all three materials for peaks up to 1600 cm^{-1} . No special peaks can be identified in one of the three epoxies and not identified in the other two epoxies. This might be attributed to performing analysis on the top of steel surface which might already include OH and Nitrogen. Further analysis is being conducted on the individual epoxy without steel.

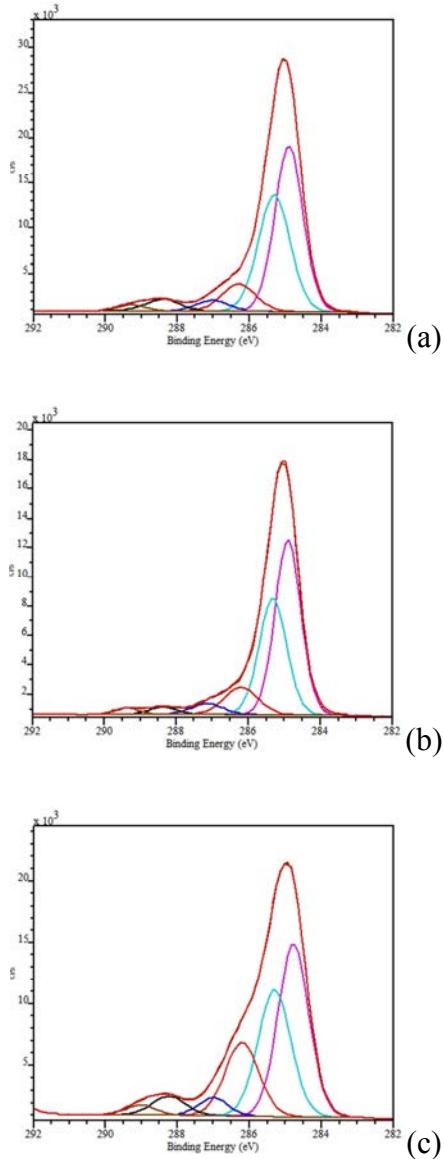
Fig. 2.28: XPS deconvoluted binding energy spectra showing binding energy for carbon bond in three materials (a) PCNC4 (neat), (b) PCNC5 (epoxy w/functionalized MWCNTs) and (c) PCNC15 (epoxy with non-functionalized MWCNTs).

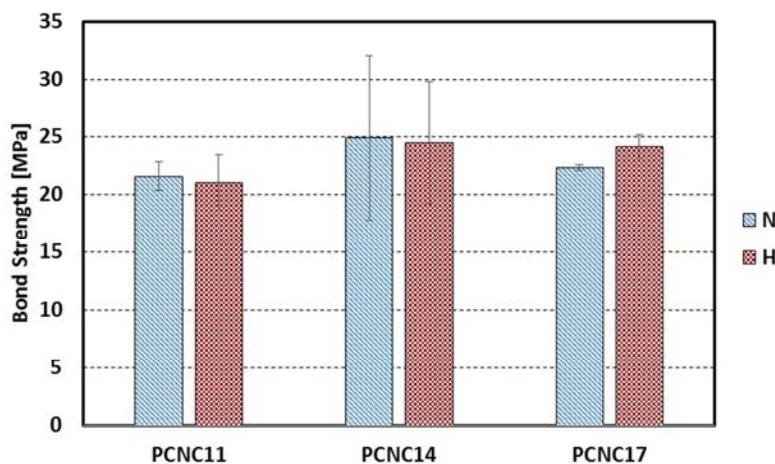
Fig. 2.29: Bond strength of Novolac PCNCs under normal curing (N) and high temperature and pressure curing (H) with PCNC11 (Neat Novolac), PCNC14 (Novolac with 2% Nanoalumina) and PCNC 17 (Novolac with 1.5% MWCNTs)

high temperature of 80 °C and pressure of 10.3 MPa (H) were found to be 21.6 MPa (3133 psi) and 21.0 MPa (3046 psi) respectively. The bond strength of PCNC14 incorporating 2.0% nanoalumina was found to be 24.9 MPa (3611 psi) and 24.5 MPa (3553 psi) under normal curing and high temperature and pressure curing respectively. For PCNC 17 incorporating 1.5 wt.% MWCNTs, the bond strength under normal curing conditions and elevated temperature and pressure curing was found to be 22.3 MPa (psi) and 24.2 MPa (psi) respectively. Statistical analysis using student t-test with 95% level of confidence showed that the effect of the curing condition on the bond strength in the case of neat epoxy (PCNC11) and 2.0 wt% nanoalumina nanocomposite (PCNC14) was statistically insignificant. On the other hand, elevated temperature and pressure curing showed 7.6% increase in the bond strength for PCNC17 incorporating 1.5 wt.% MWCNTs. This increase was found to be statistically significant with 95% level of confidence.

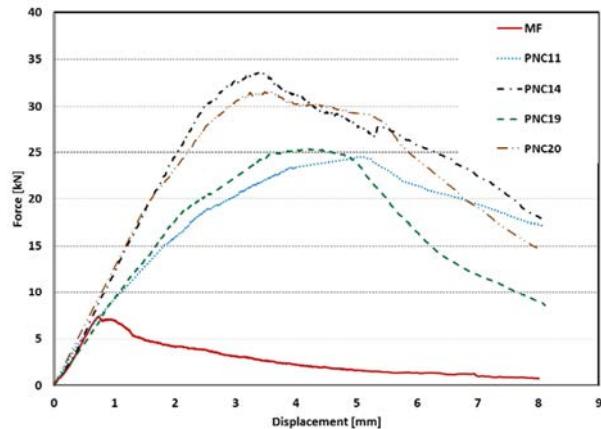
Fig. 2.32: Example push-out load-displacement curves of MF, PNC11, PNC14, PNC19, and PNC20.

Example load-displacement curves of Microfine cement (MF), PNC11, PNC19, PNC20, and PNC14 are shown in **Fig.2.32**. It is obvious that Novolac epoxy have a bond strength with shale much higher than the MF. Novolac epoxy shows improvement in the bond strength with shale of 174%. **Fig.2.33** shows the bond strength of different repair materials compared to reference material. Moreover, incorporating ANPs in Novolac epoxy improved its bond strength by 28.8%. **Fig.2.34** shows the bond strength of different Novolac polymer nanocomposites compared to Neat Novolac epoxy. Furthermore, Novolac bond is shown to result in a much more ductile interface that is capable of absorbing much higher energy compared with microfine cement interface. The ductility measured as the displacement at peak load and the toughness measured as the area under the load displacement curve are shown in **Fig.2.35** and **Fig.2.36**, respectively.

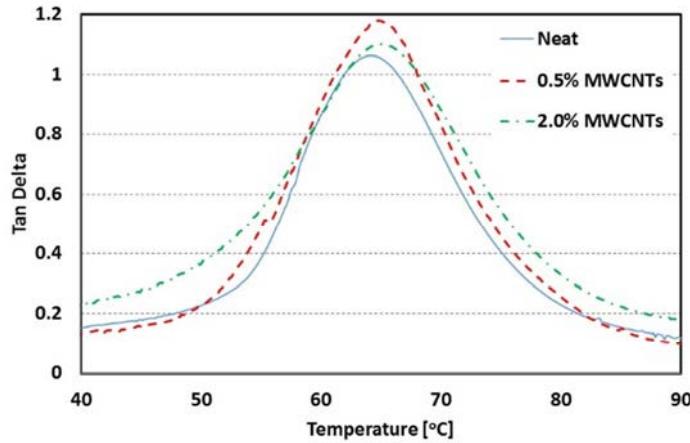
Fig.2.37: Temperature-tan delta curves for Neat Novolac epoxy, Novolac epoxy incorporating 0.5% MWCNTs, and Novolac epoxy incorporating 2.0% MWCNTs.

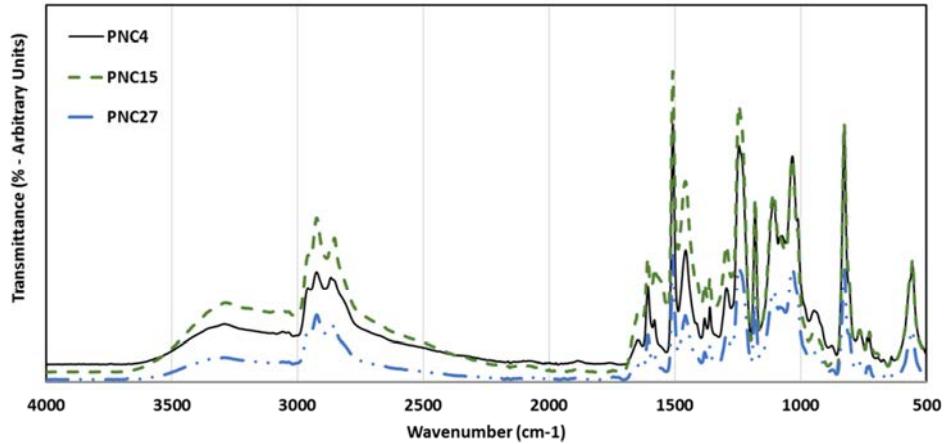
Fig.2.40: FTIR spectrographs for PNC4, PNC15, and PNC27.

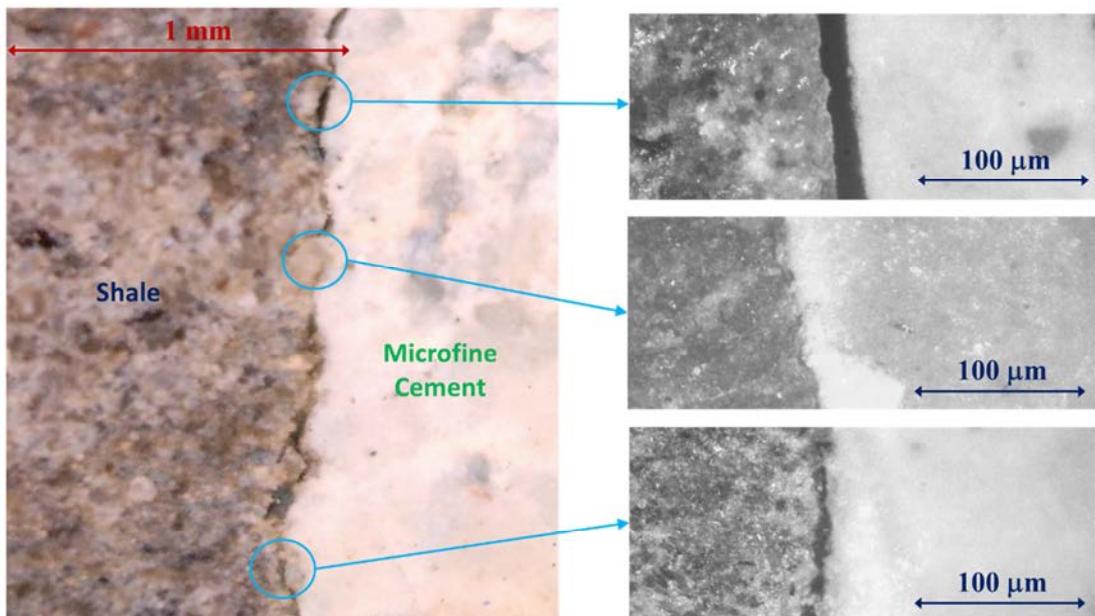
Fig. 2.43. Microscopic images of shale-microfine cement interface with two different levels of magnification showing areas with gap between microfine cement and shale.

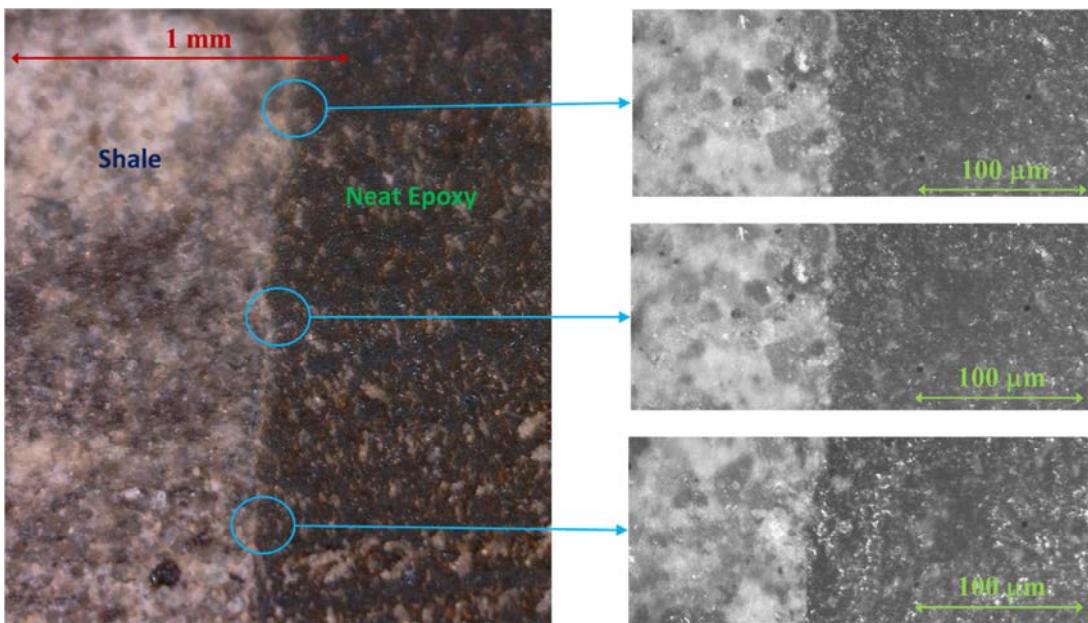
Fig. 2.44. Microscopic images of shale-neat epoxy interface with two different levels of magnification showing the ability of the neat Novolac epoxy repair material to completely fill the gap at the shale-cement interface.

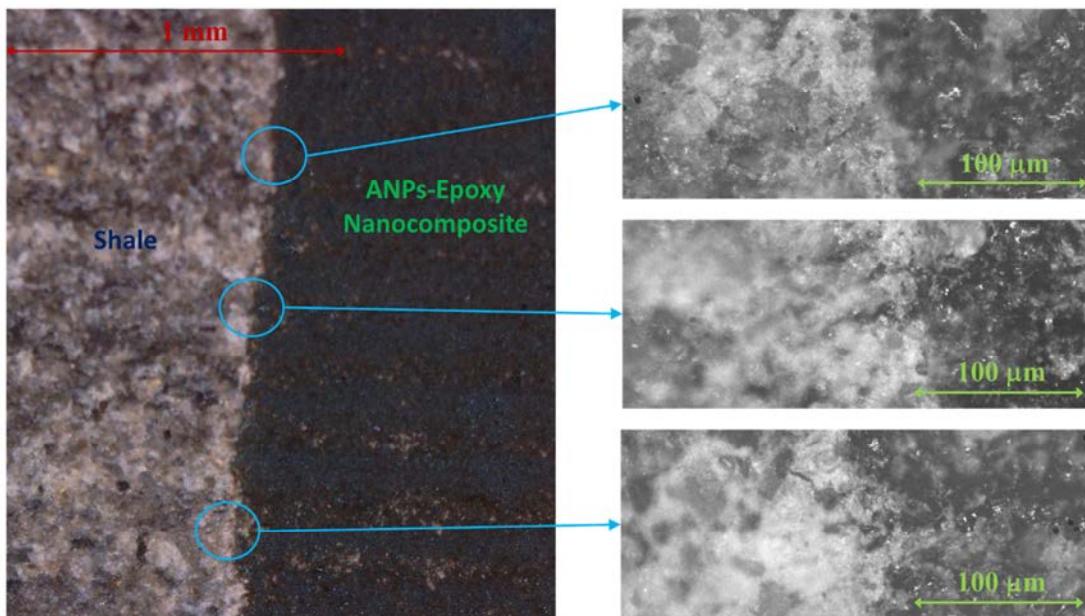
Fig. 2.45. Microscopic images of shale-1.0% ANPs-Novolac epoxy polymer nanocomposite interface with two different levels of magnification showing the ability of the Novolac epoxy incorporating ANPs repair material to completely fill the gap at the shale-cement interface.

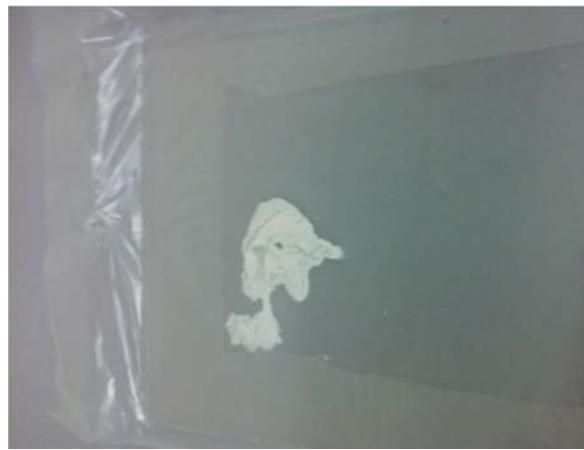
Fig.2.46: Microfine cement injected in 25 microns crack.

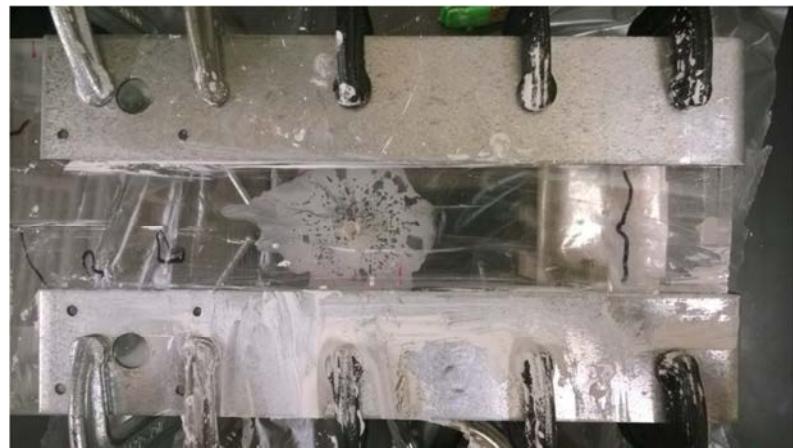
Fig.2.47: Microfine cement injected in 50 microns crack.

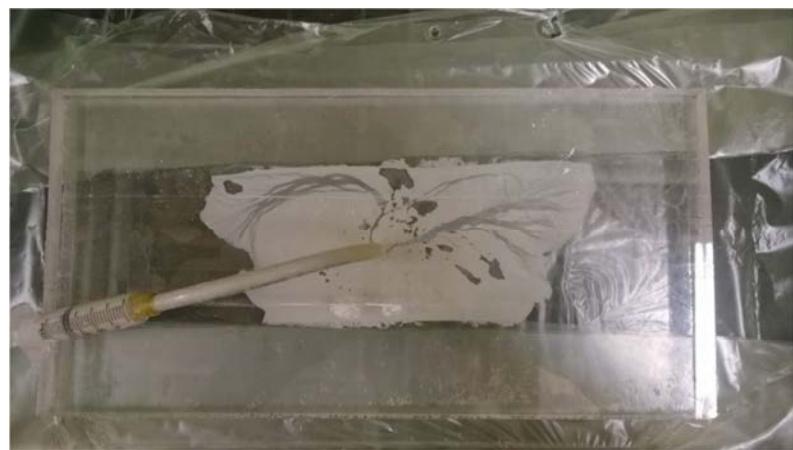
Fig.2.48: Microfine cement injected in 75 microns crack.

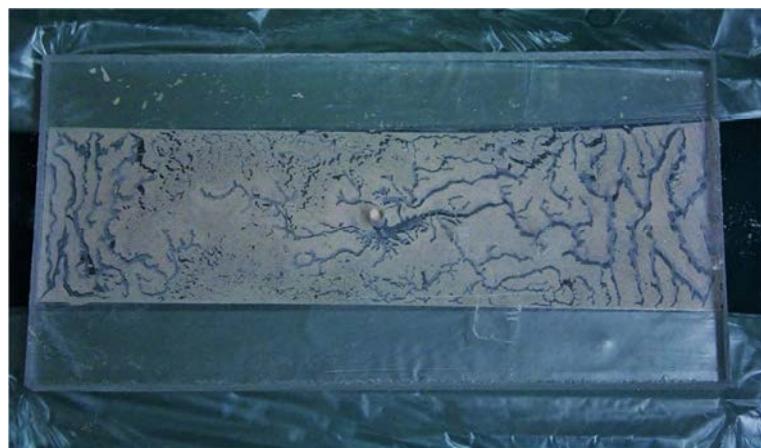
Fig.2.49: Microfine cement injected in 100 microns crack.

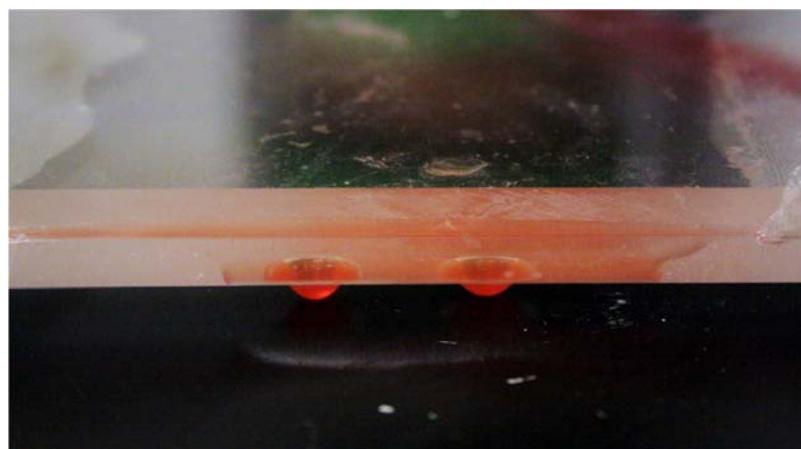
Fig.2.50: Neat Novolac epoxy injected in 13 microns crack.

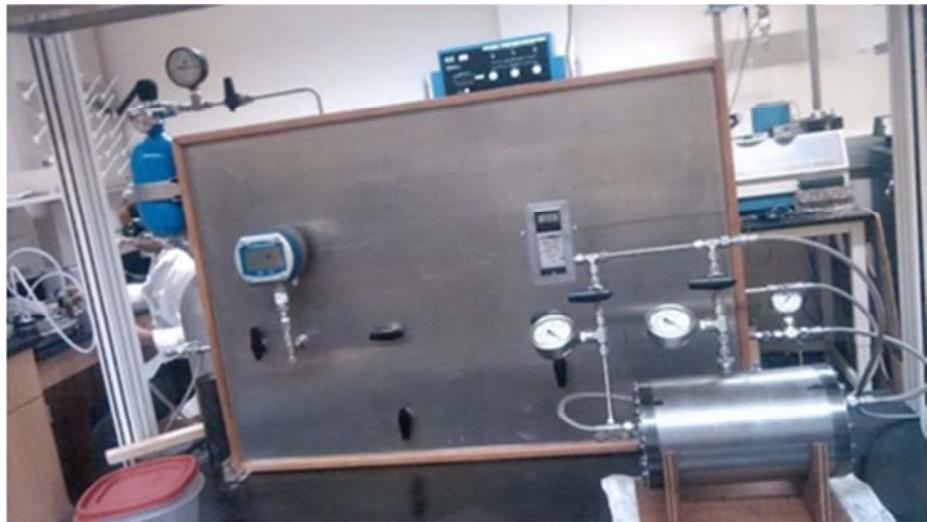
Fig.3.4: Permeameter for gas permeability measurements through cement-casing systems.

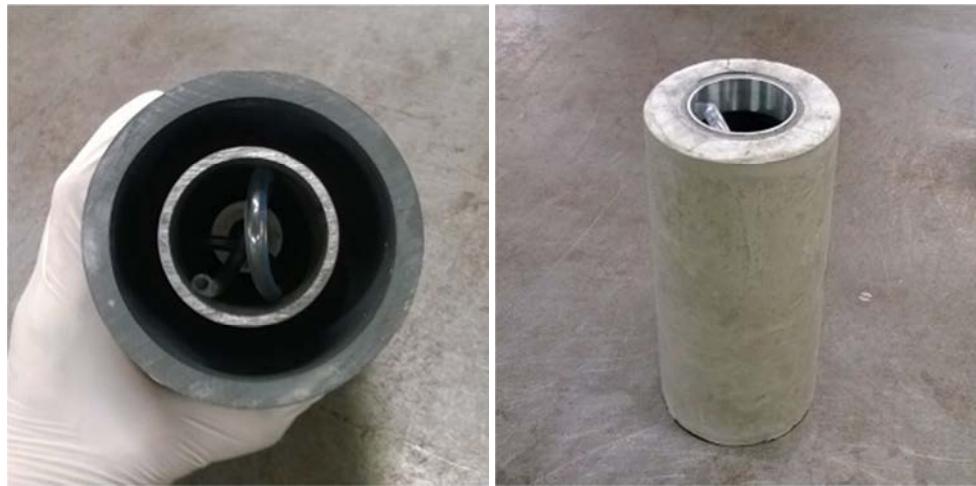
Fig. 3.6: a) Steel centered in mold ready for cement to be poured in annulus. The tube connected to the hole in the steel is visible inside the steel casing. B) Cured sample.

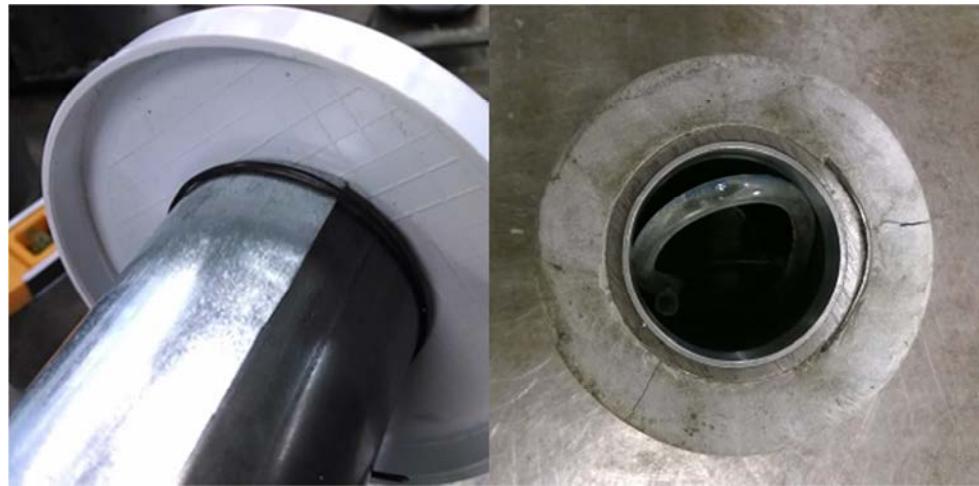
Fig. 3.7: a)Steel sheet attached to the cylinder prior to casting cement annulus to create a ‘slot flaw’ in the specimen, and b) Cured sample with slot flaw visible at contact between cement and steel casing.

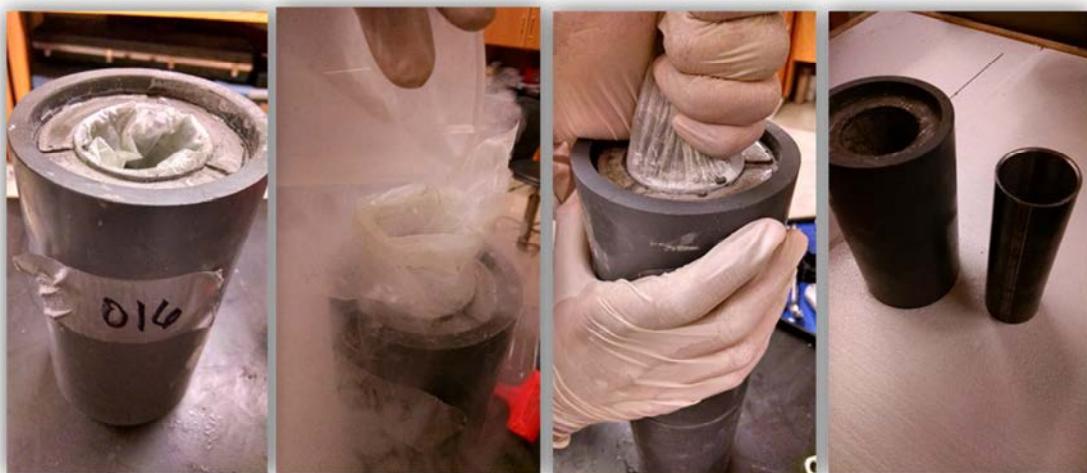
Fig. 3.8 – A sample with a microannulus created by the release film method. From left to right: sample at end of curing showing release film (plastic) on top of sample; cooling casing with liquid nitrogen; removing release film and casing; casing removed from cement sheath.

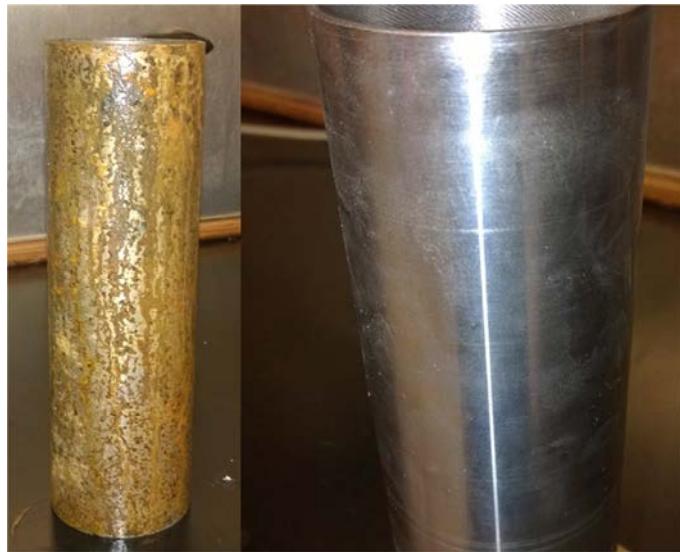
Fig. 3.10 – Casing with (left) and without (right) corrosion.

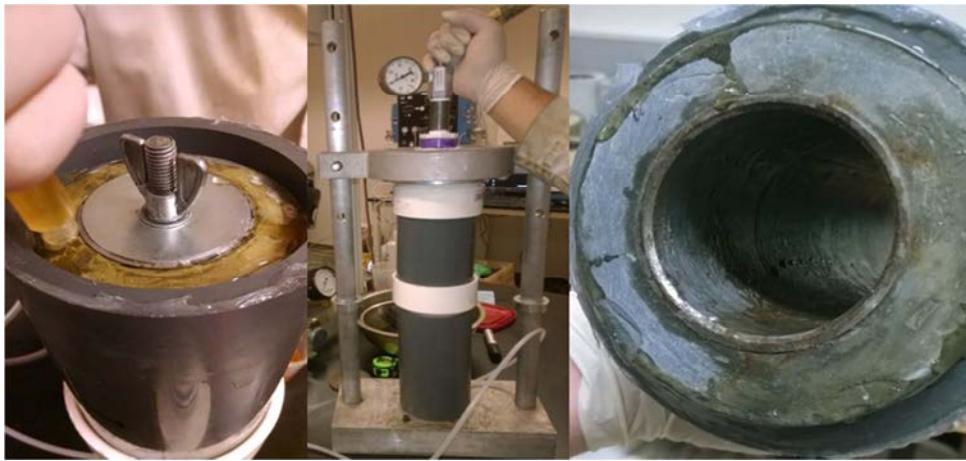
Fig. 3.11 – Figure showing the “epoxy capsule” method for injecting repair material into sample with flaws.

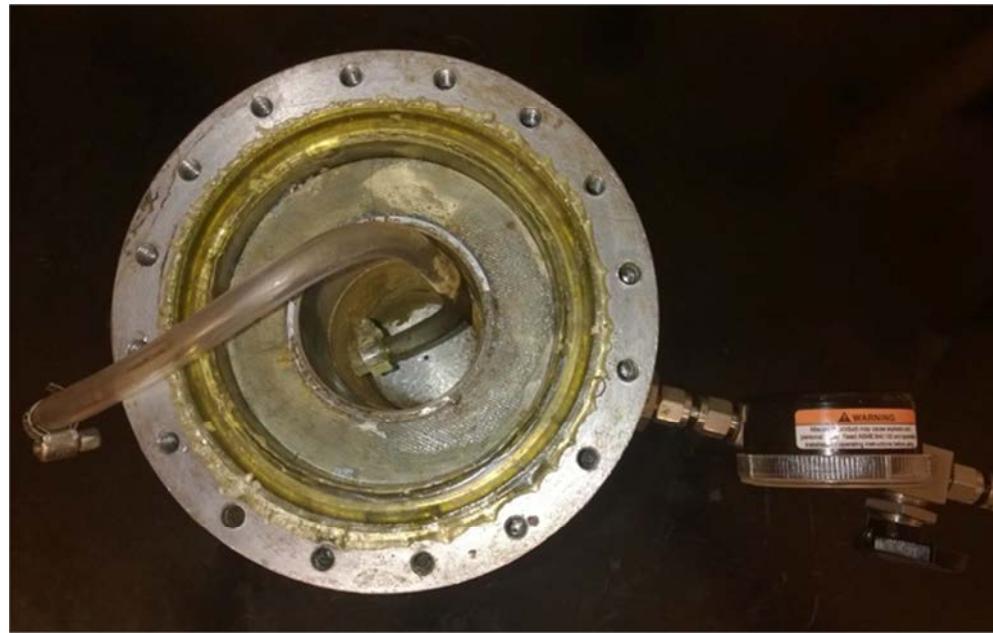
Fig. 3.12 – Sample 24 in pressure vessel with tube with epoxy. End cap was replaced and casing was pressurized in an attempt to inject epoxy into microannulus.

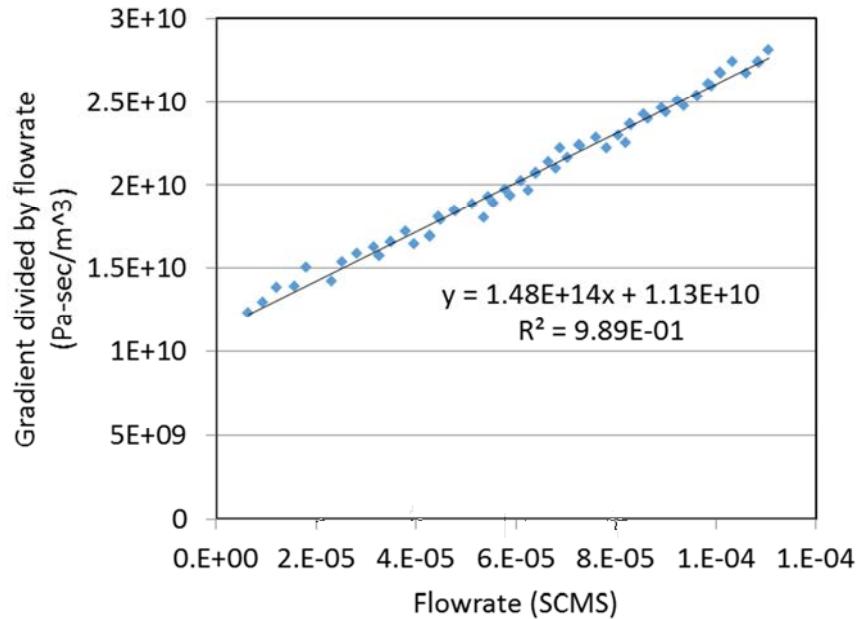
Fig. 3.13 – Analysis of non-linear flow for test on Sample 29 under 20.7 MPa confining pressure.

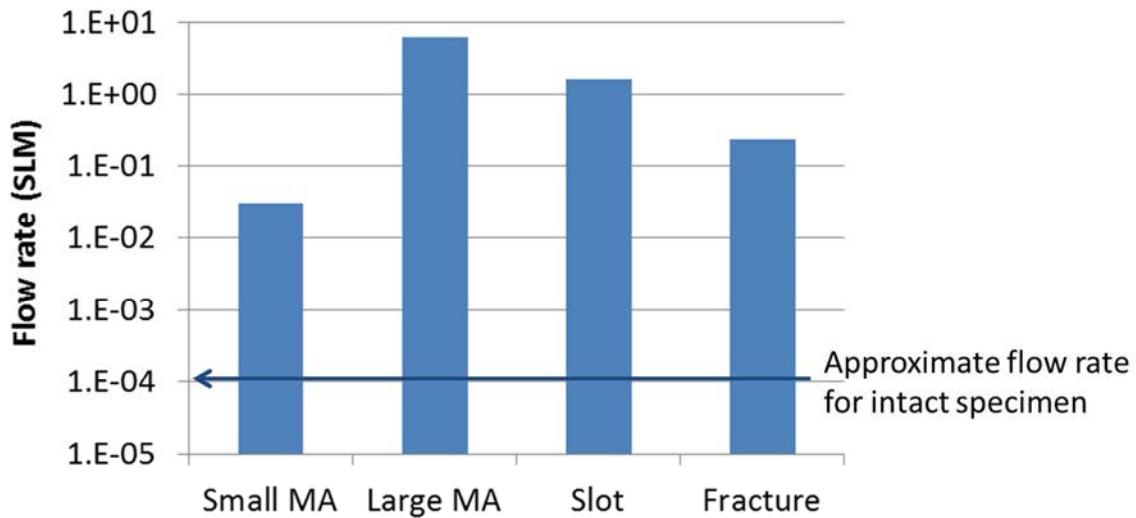
Fig. 3.14 – Flow rate through samples with representative seal system flaws. MA denotes microannulus. Microannulus is sample 11, large microannulus is sample 15, slot is sample 8, and cement fracture is sample 6.

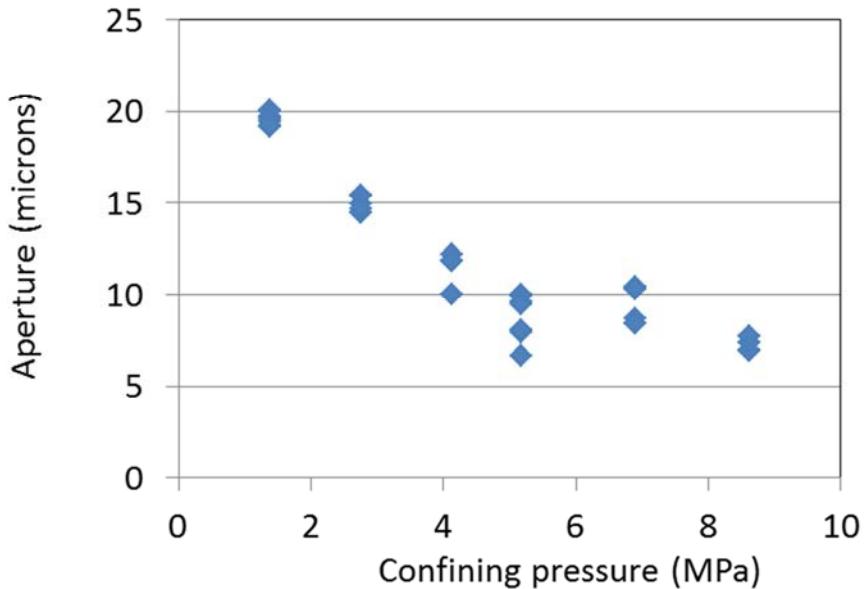
Fig. 3.15 – Hydraulic aperture of sample 6 as a function of confining pressure.

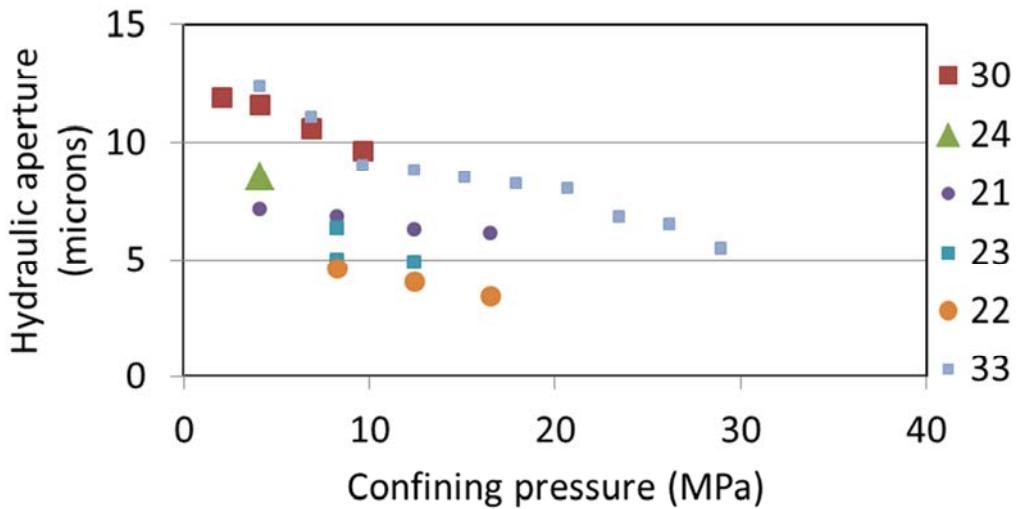
Fig. 3.16 – Hydraulic aperture interpreted from flow measurements as a function of confining pressure for samples with small microannuli.

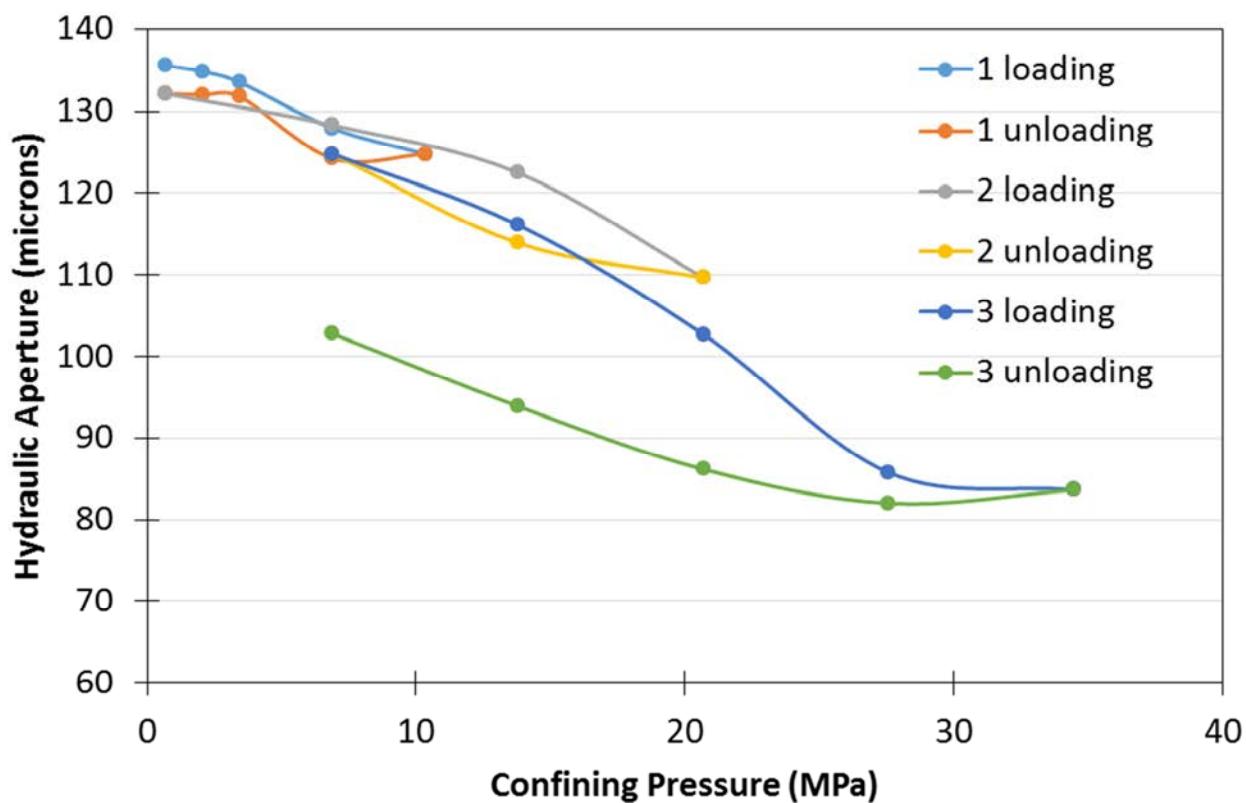
Fig. 3.18 – Hydraulic aperture interpreted from flow measurements as a function of confining pressure for Sample 48.

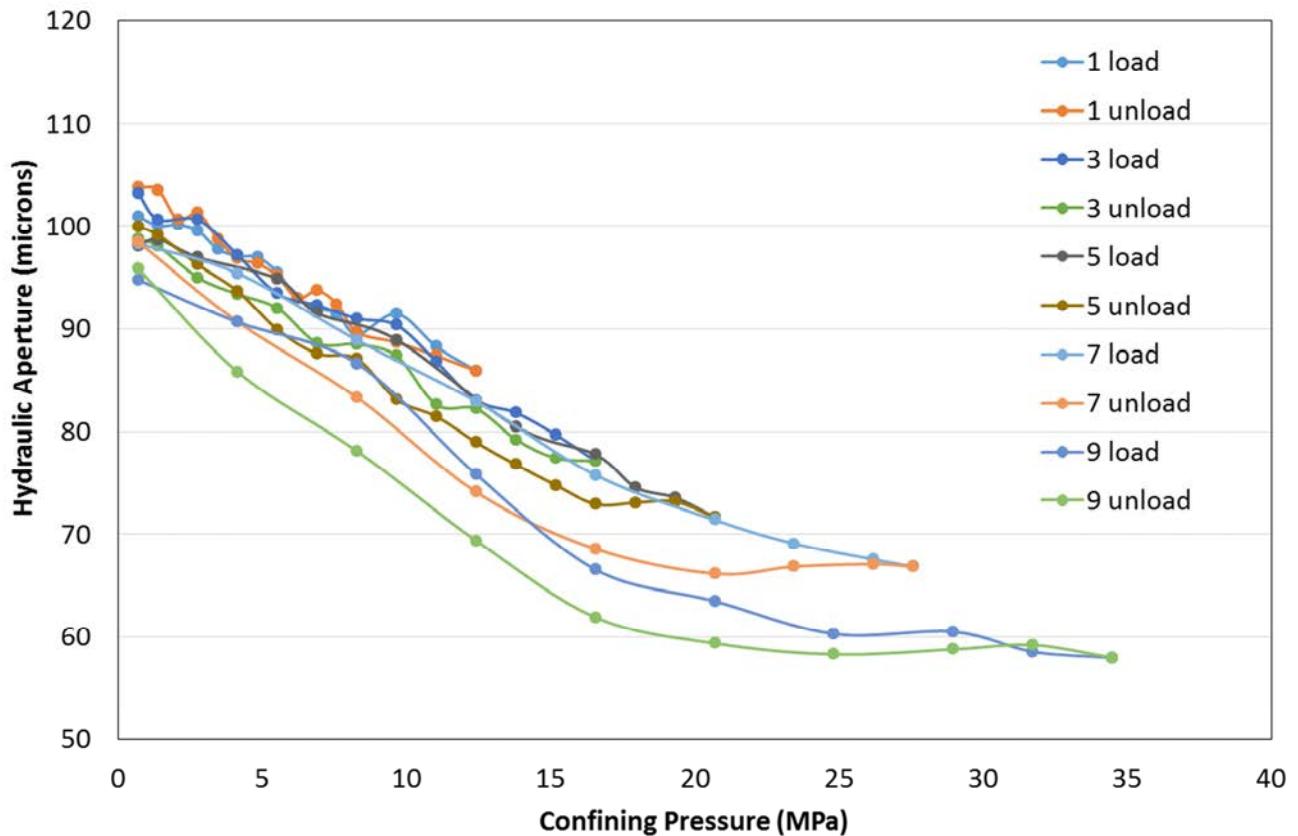
Fig. 3.20 – Hydraulic aperture interpreted from flow measurements as a function of confining pressure for Sample 51.

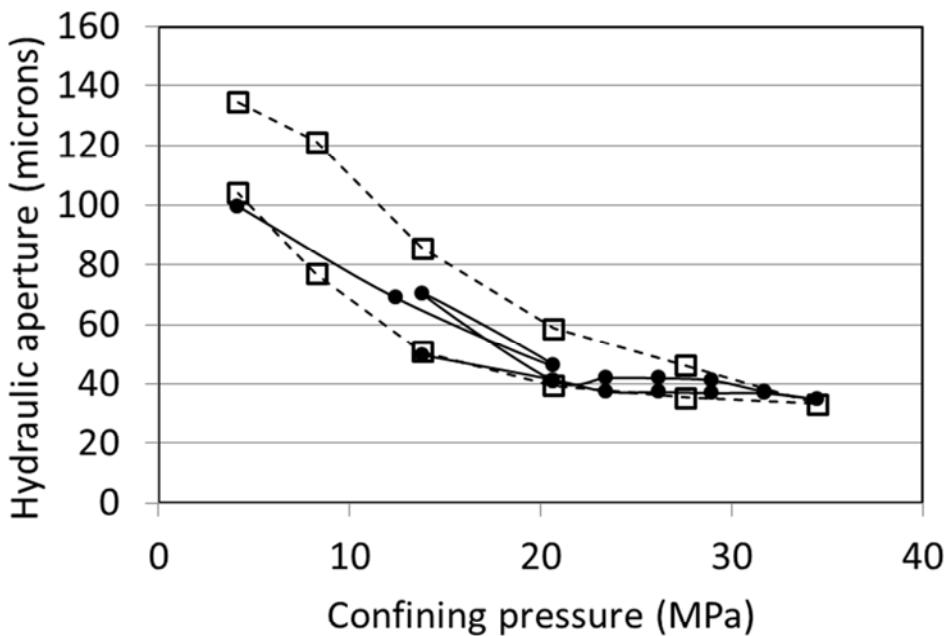
Fig. 3.21 – Hydraulic aperture interpreted from flow measurements as a function of confining pressure for Sample 29.

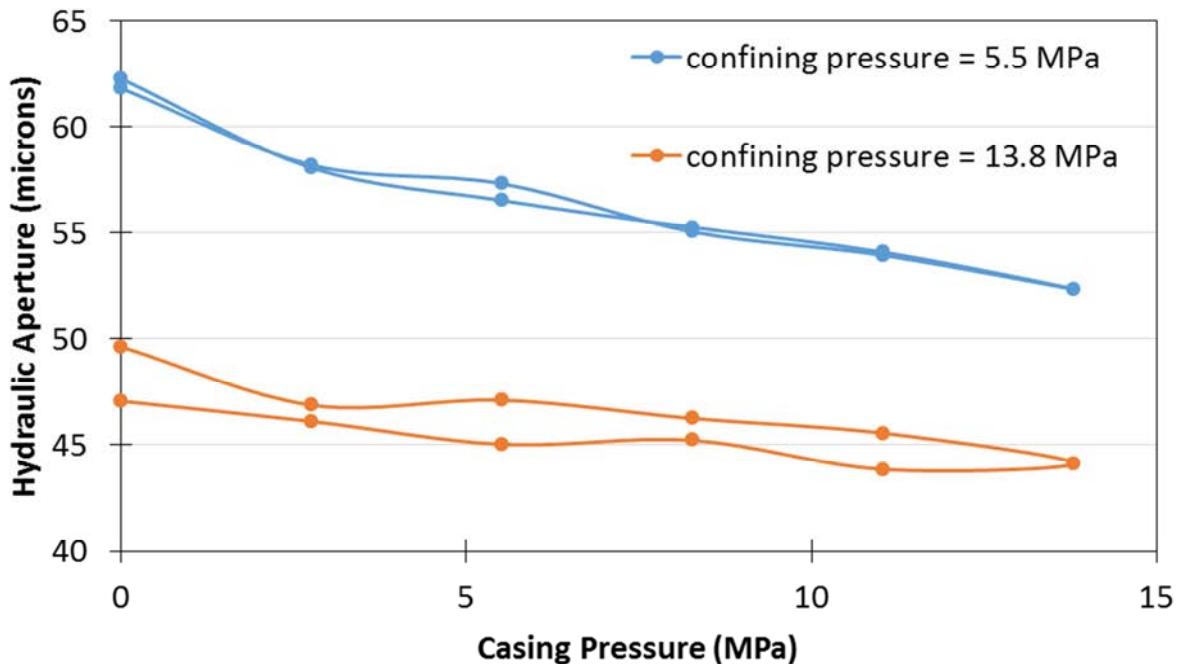
Fig.3.23 – Hydraulic aperture vs. casing pressure for large microannulus at different confining pressures (sample 60).

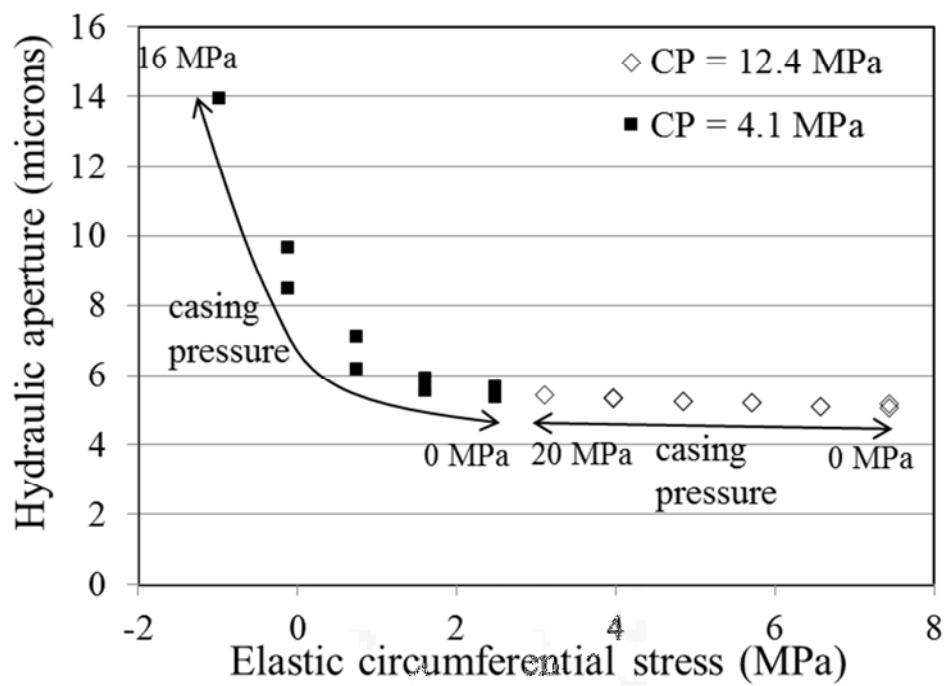
Fig. 3.24– Hydraulic aperture as a function of calculated elastic circumferential stress. Confining pressure (CP) was held constant and casing pressure varied during these tests.
