FINAL TECHNICAL REPORT

U.S. Department of Energy
National Energy Technology Laboratory

DE-FE0009562

Wellbore Seal Repair Using Nanocomposite Materials

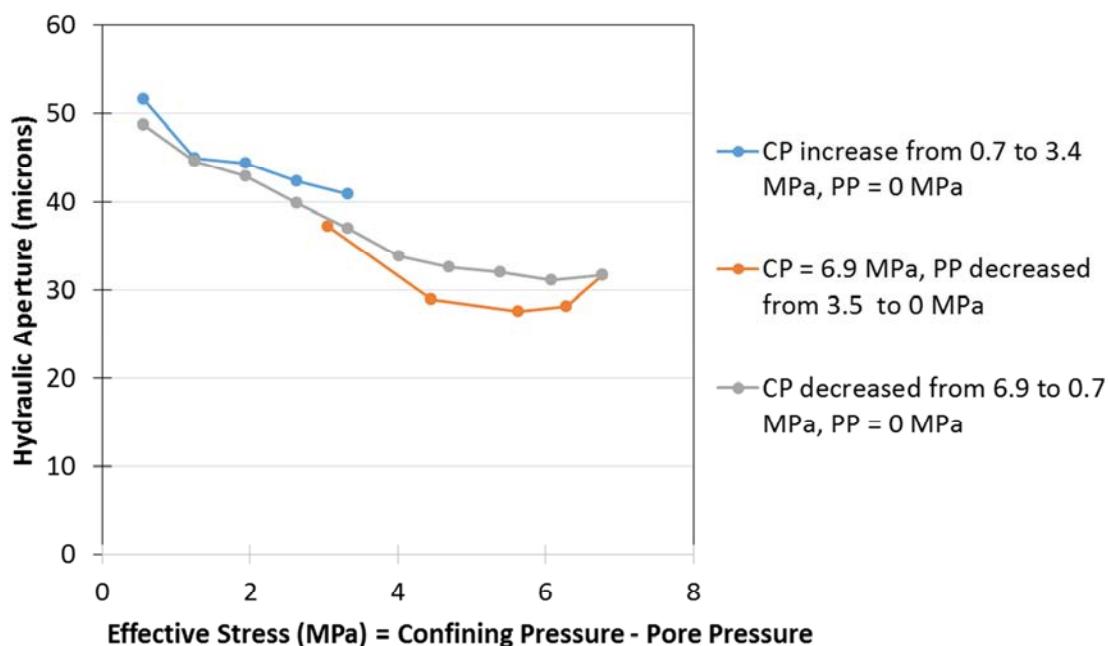
Fig.3.25 – Hydraulic aperture vs. effective stress for test on sample with large microannulus (sample 58).

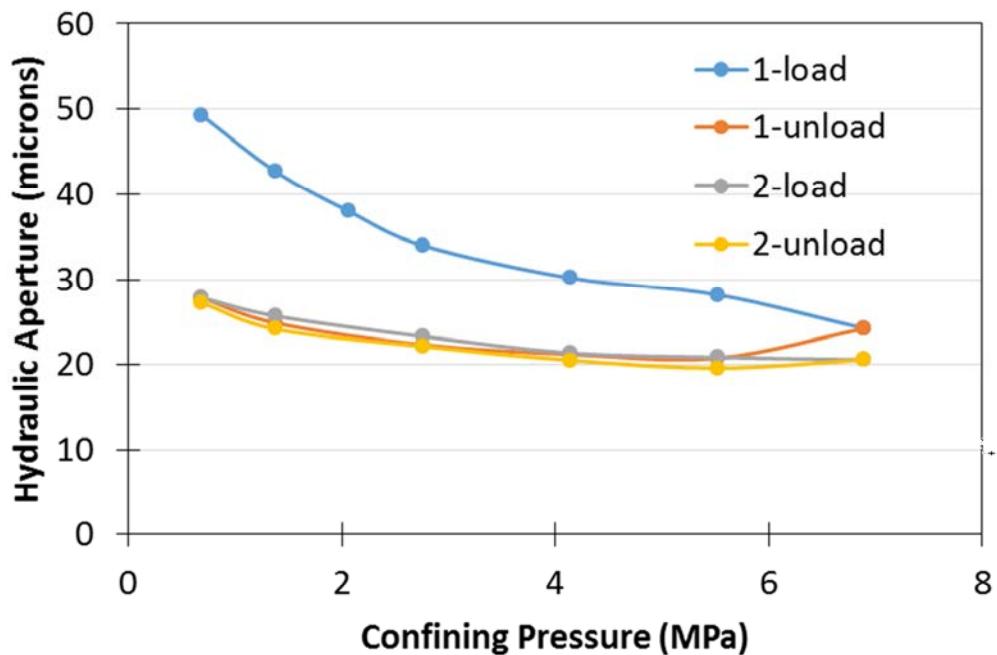
Fig.3.26 – Hydraulic aperture vs. confining pressure for test on sample with corroded casing (sample 55).

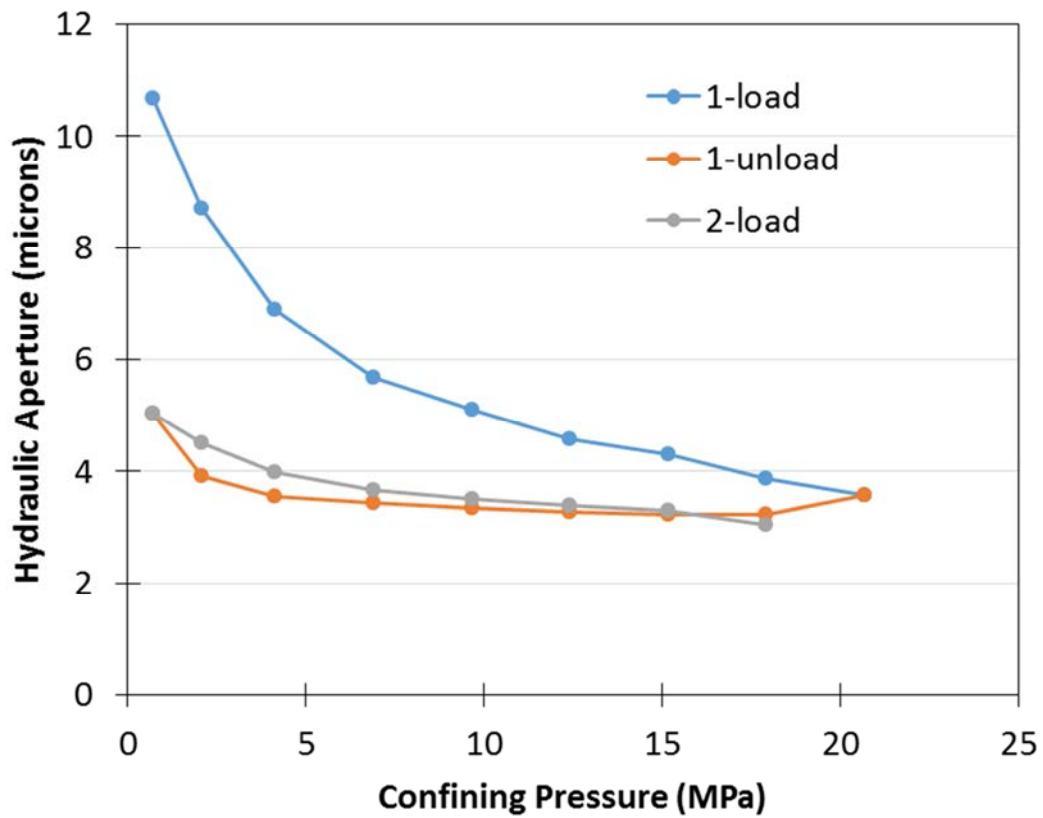
Fig.3.27 – Hydraulic aperture vs. confining pressure for test on sample with corroded casing (sample 57).

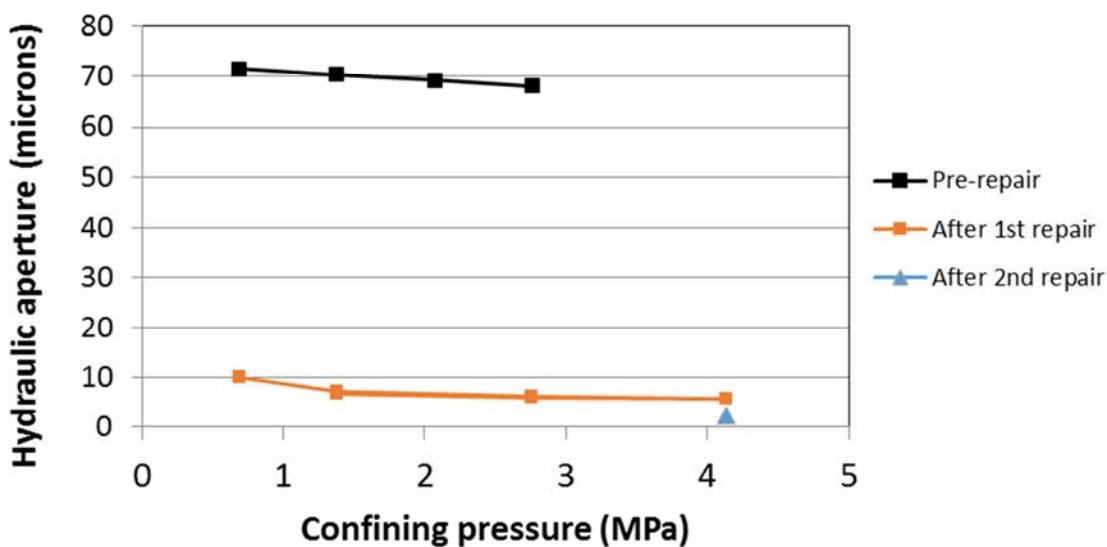
Fig. 3.28 – Hydraulic aperture as a function of confining pressure for sample 7 (radial fracture) before and after repair.

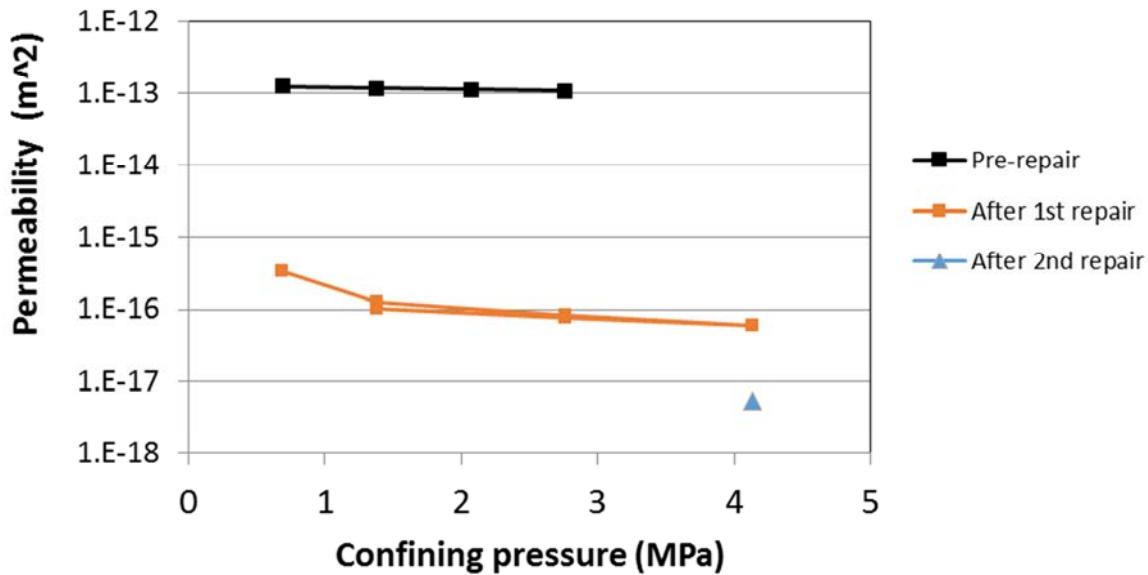
Fig. 3.29 – Permeability vs. confining pressure for sample 7 (radial fracture) before and after repair.

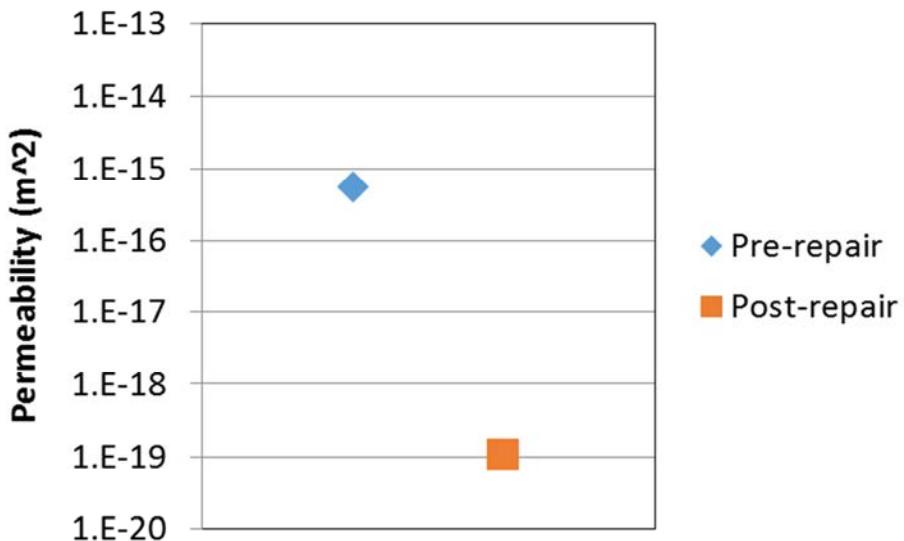
Fig. 3.30 – Permeability reduction due to repair for sample 23.

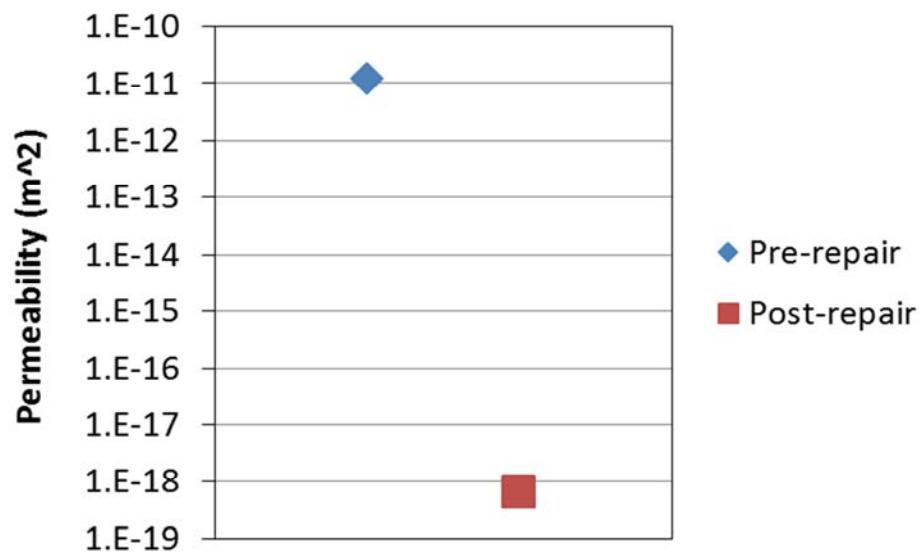
Fig. 3.31– Permeabilities of sample 15 before and after repair.

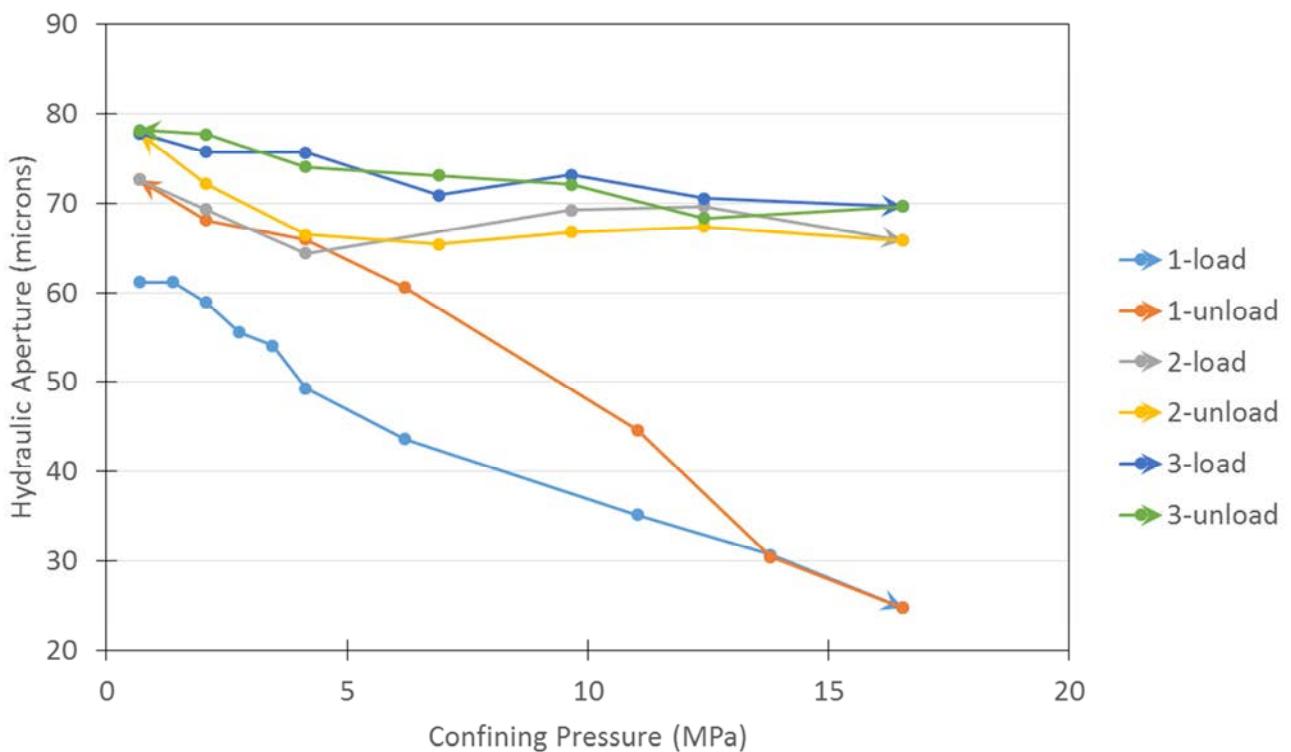
Fig. 3.32– Post-repair hydraulic aperture on sample 48 which was repaired with microfine cement.

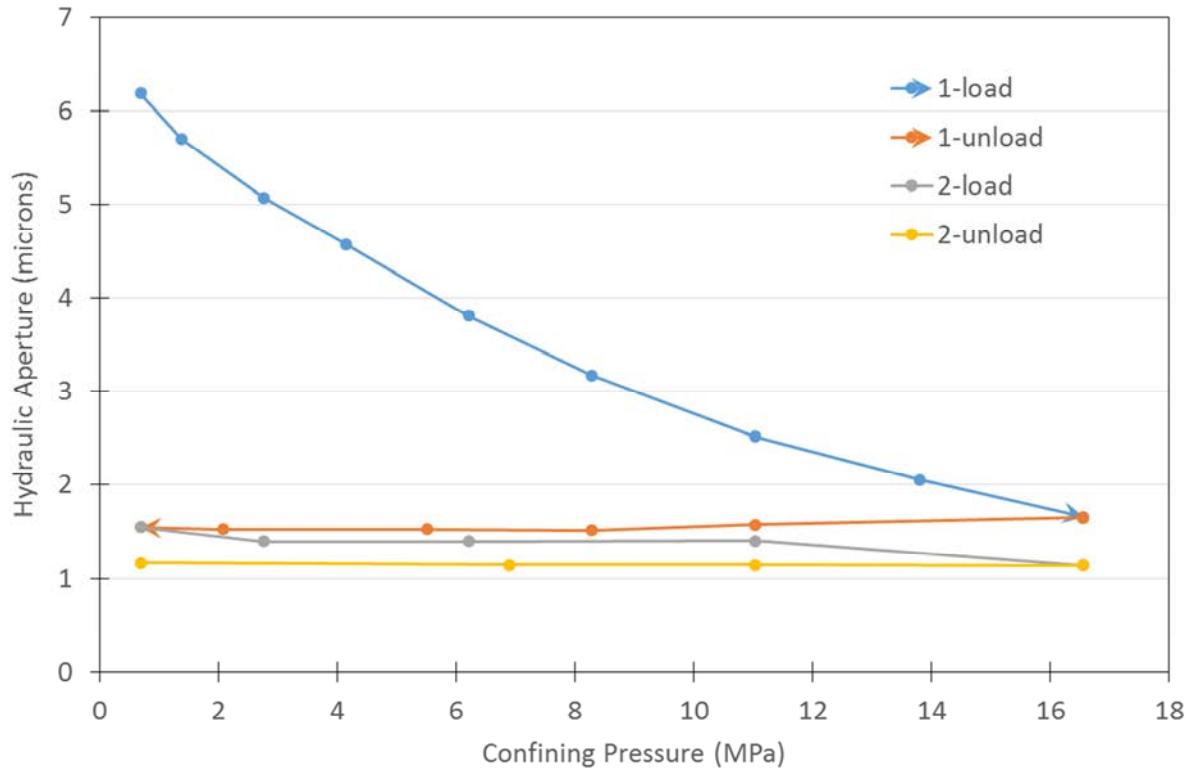
Fig. 3.33 – Post-repair hydraulic aperture on sample 49 which was repaired with nanocomposite base epoxy.

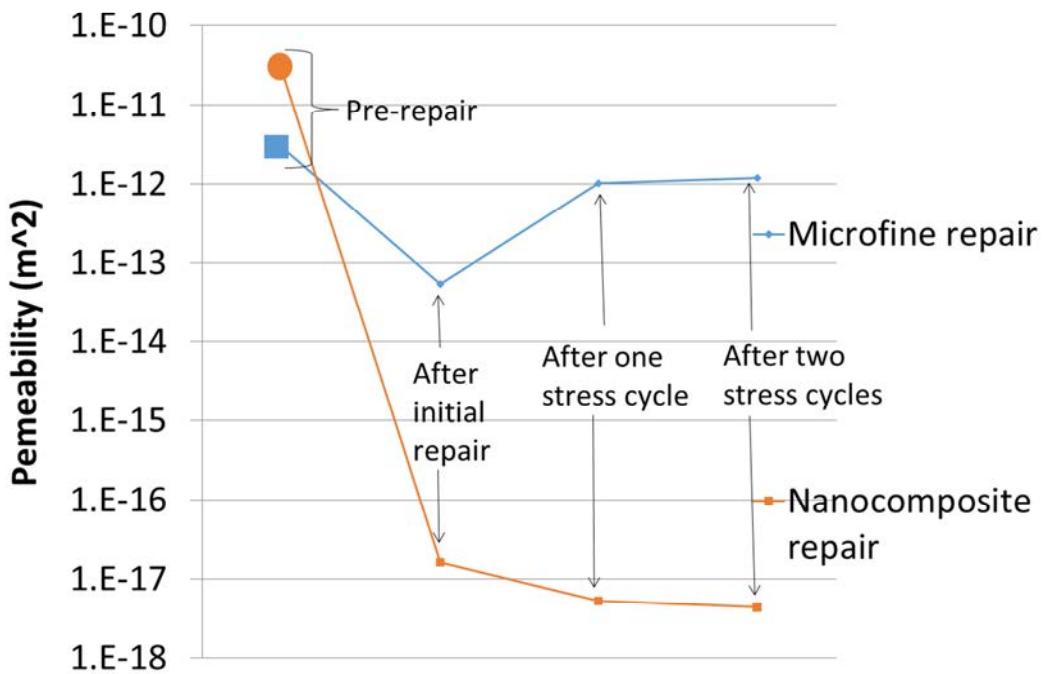
Fig.3.34 – Summary of tests on comparable samples repair with microfine (blue) and nanocomposite base epoxy (orange).

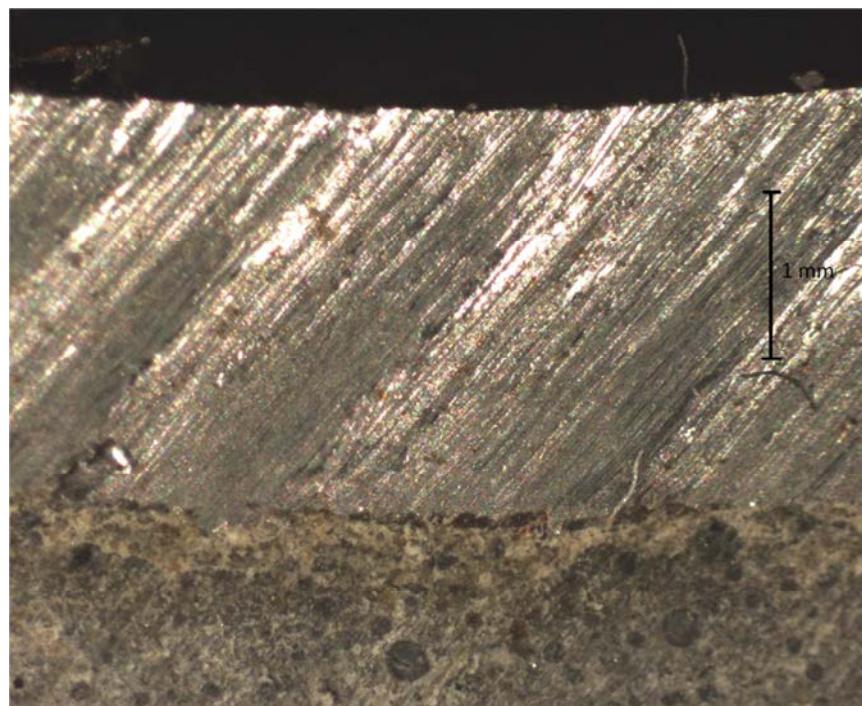
Fig. 3.35 - Microphotograph of casing – cement contact in middle of sample repaired with epoxy.

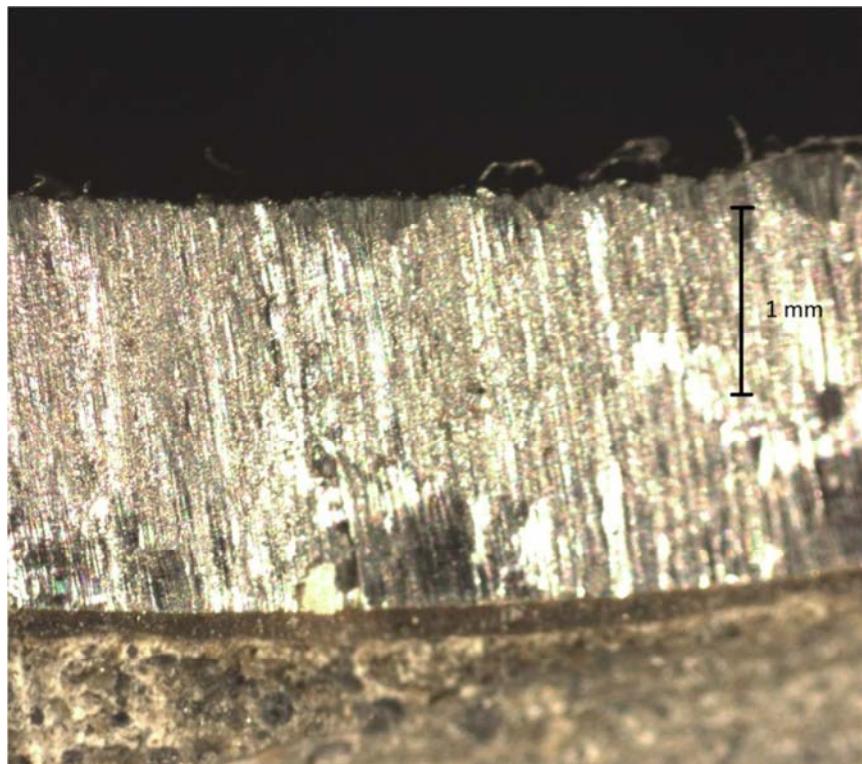
Fig. 3.36 - Microphotograph of casing – cement contact near bottom of sample repaired with epoxy.

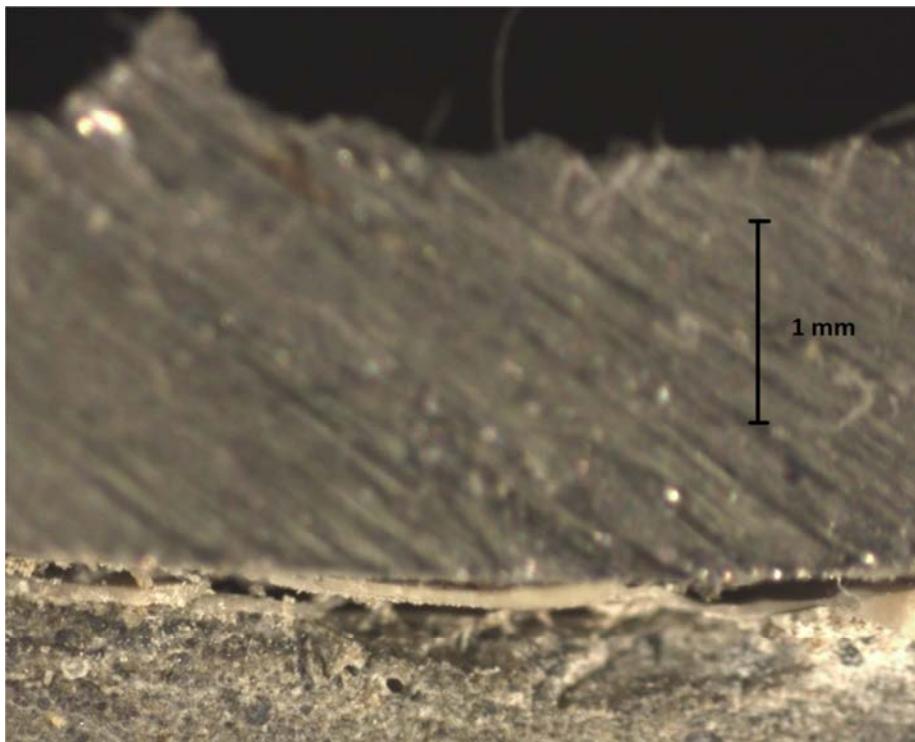
Fig. 3.37 - Microphotograph of casing – cement contact of sample repaired with microfine cement.

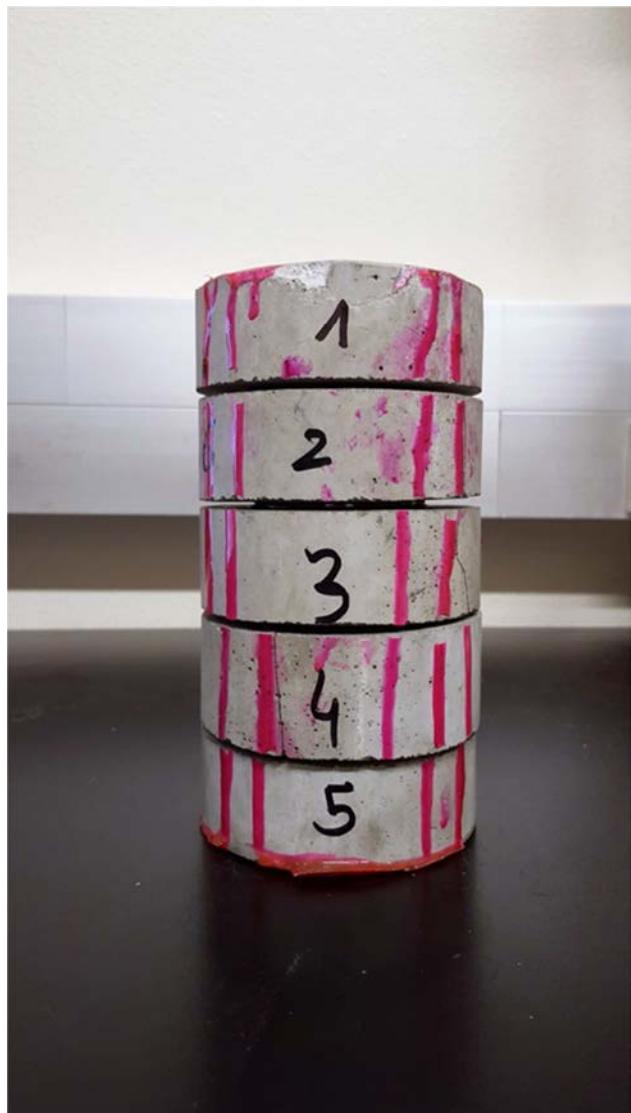
Fig.3.38: Sample 66 after repair with dyed epoxy and sectioning.

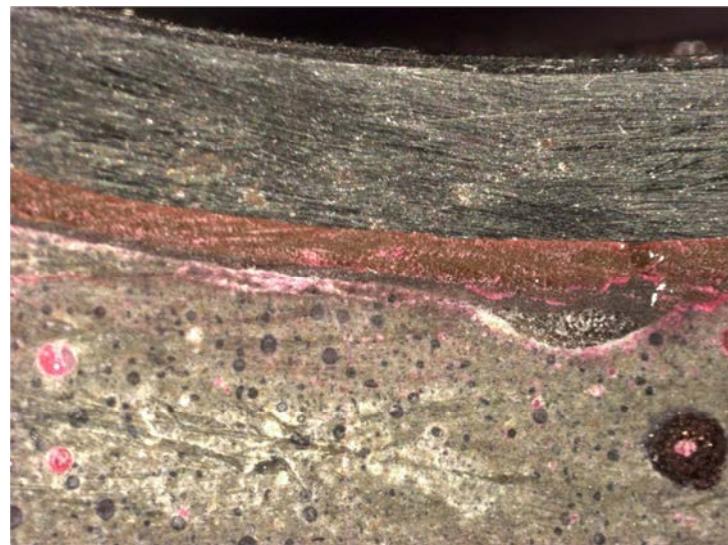
Fig.3.39: Sample 66 repaired with Epoxy and Rhodamine B

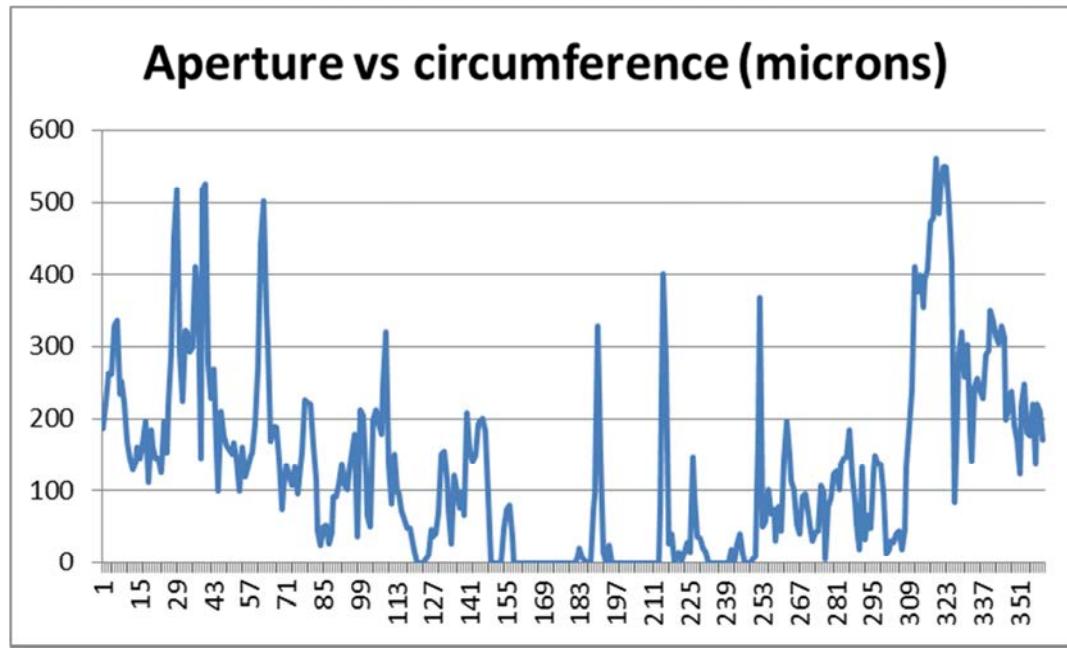
Fig. 3.40 – Aperture vs. circumference distance expressed as arc angle on the bottom of section 2 from Sample 66.

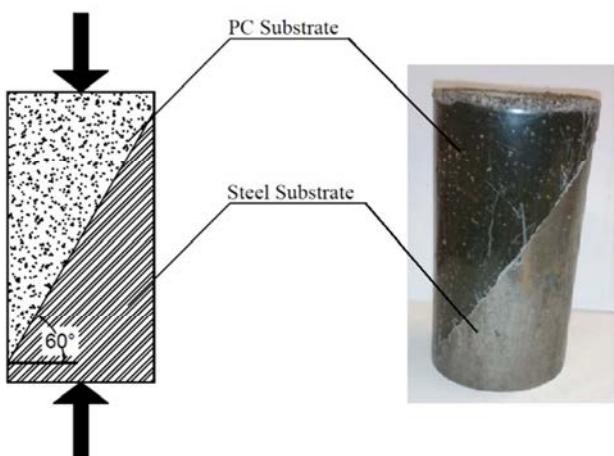
Fig 4-1: Slant shear test (left) schematics showing slant shear angle (right) actual specimen showing steel substrate and PC.

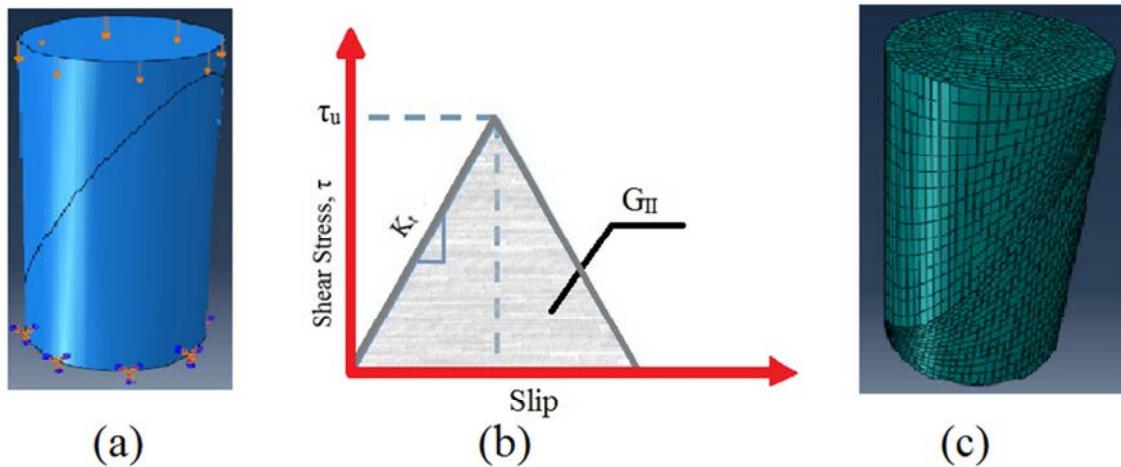
Fig4-2: FE model using ABAQUS simulation environment: (a) Boundary conditions (b) Bilinear shear stress-slip relation where K_t is shear contact stiffness, G_{II} is mode II fracture energy and τ_u is maximum shear stress (c) Meshed model using 74,524 elements.

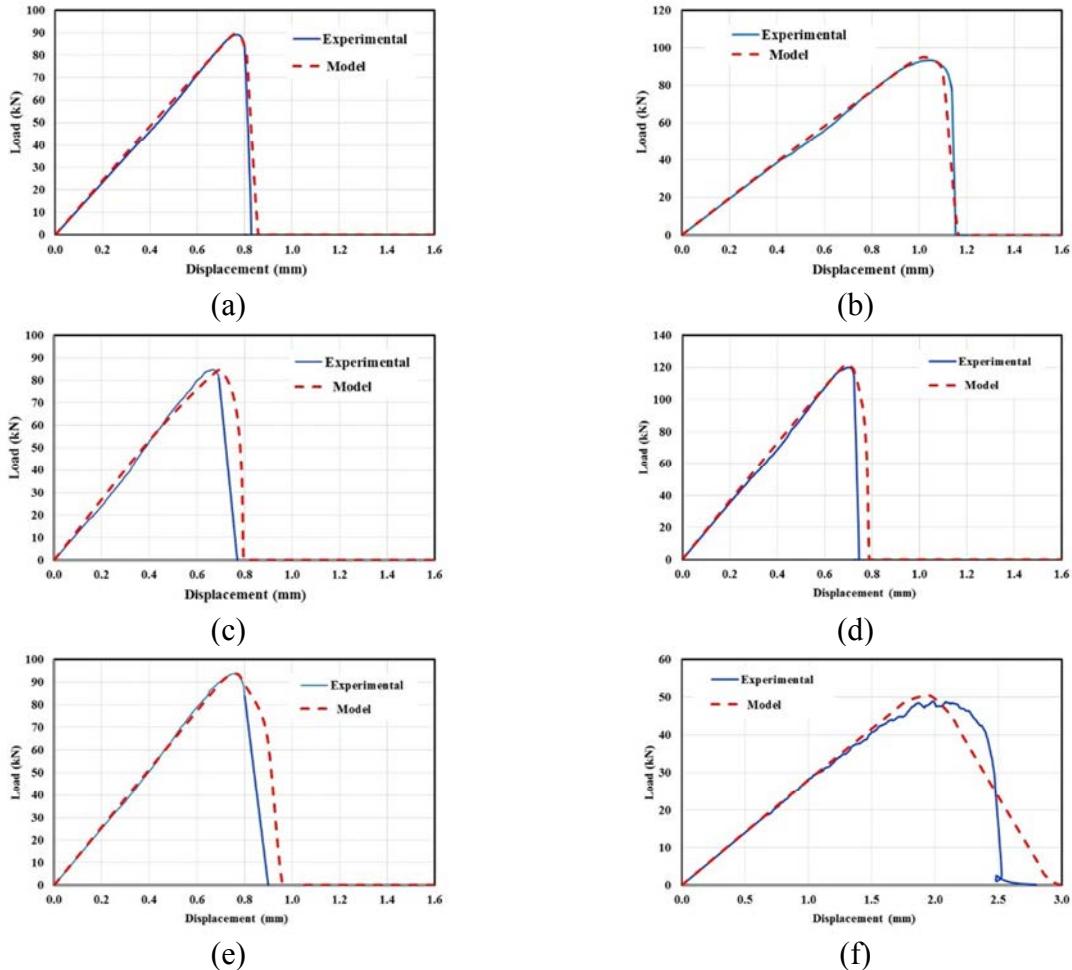
Fig4-3: Load-displacement curves of PC with different nanomaterials as measured experimentally during slant shear test and extracted using the finite element method for (a) PC-Neat, (b) PCNC-0.5, (c) PCNA-0.5, (d) PCNA-2.0, (e) PCNS-0.5, and (f) PCNS-2.0.

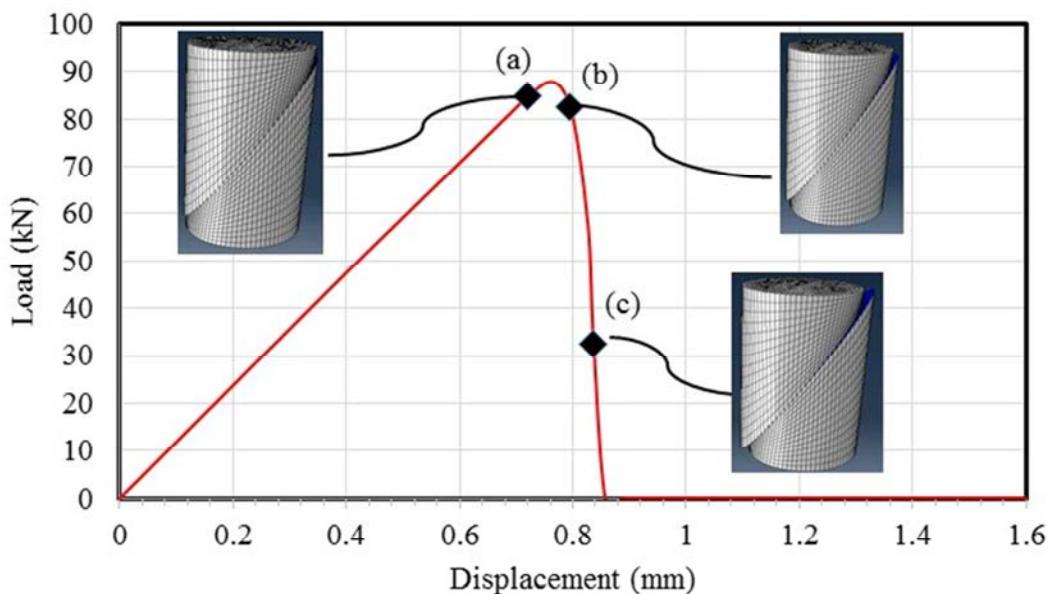
Fig 4-4: Load-displacement extract from finite element analysis of neat PC showing magnified slippage at 0.720mm, 0.802mm, and 0.837mm.

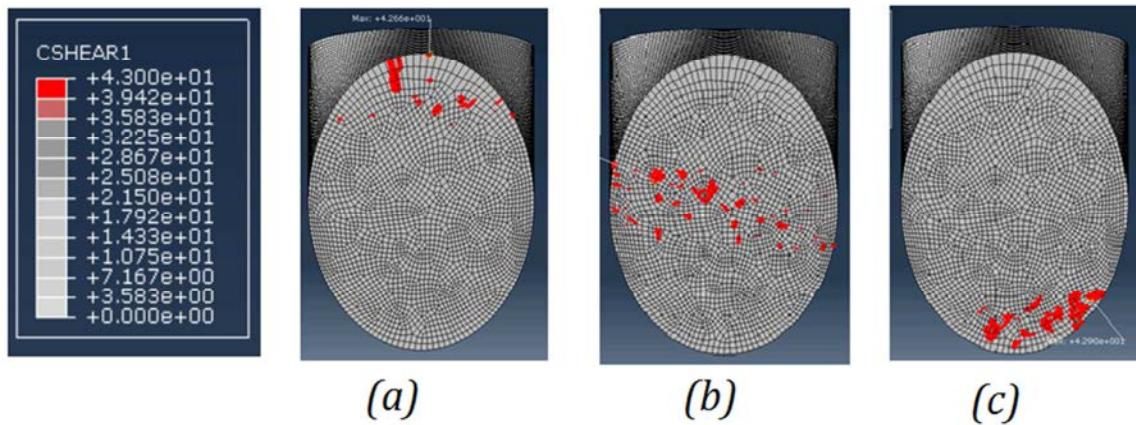
Fig4-5: Shear contours showing locations of maximum local shear stress during slippage at vertical slip of (a) 0.720 mm (b) 0.802 mm and (c) 0.837 mm

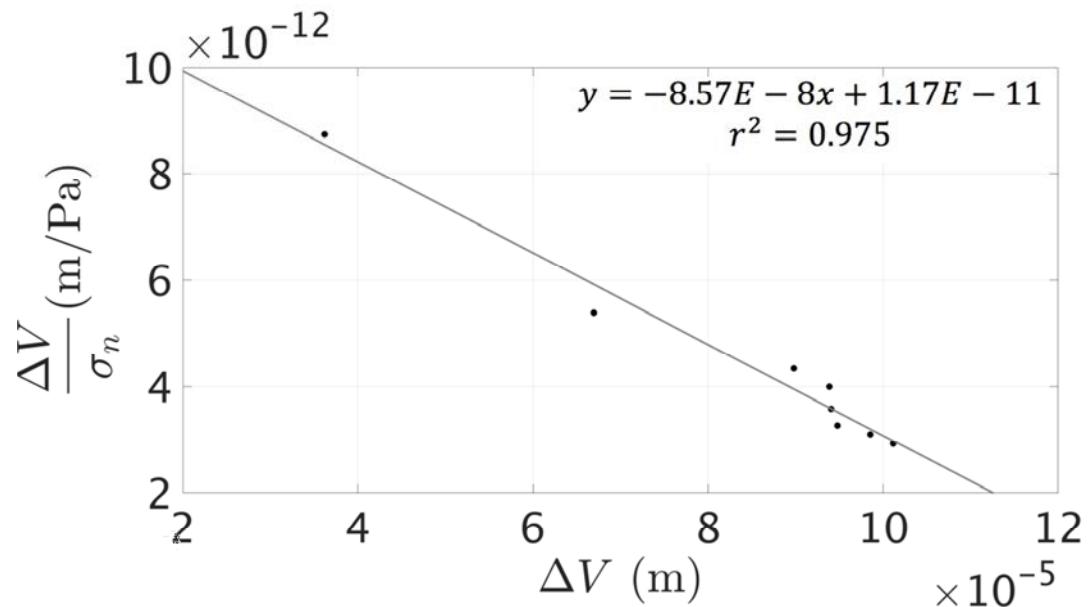
Fig 4-11: Fitting of laboratory data from large microannulus to hyperbolic model.

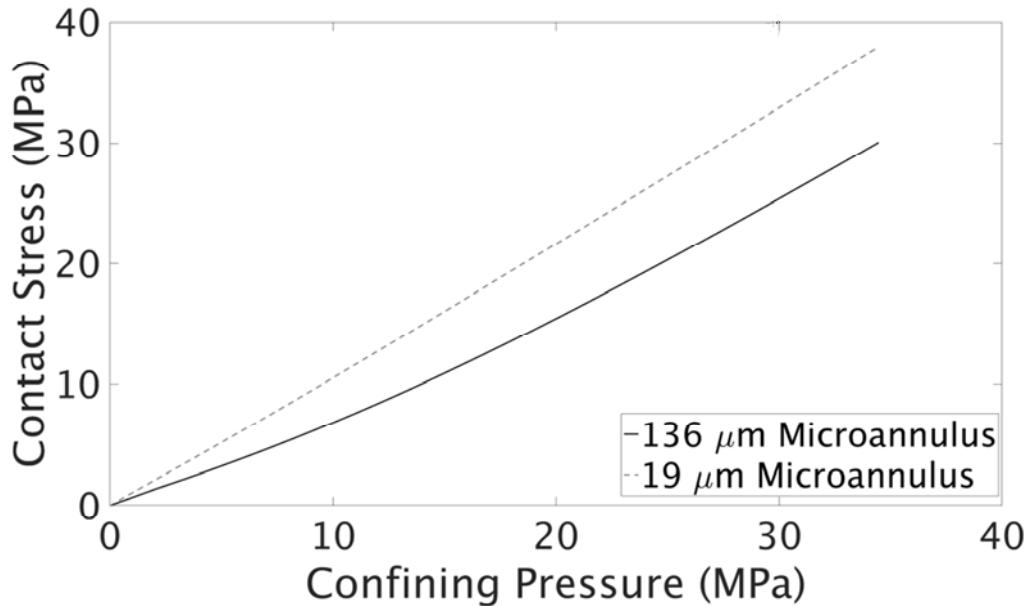
Fig 4-16: $136 \mu\text{m}$ and $19 \mu\text{m}$ microannulus joint contact stress and confinement pressure relationship.

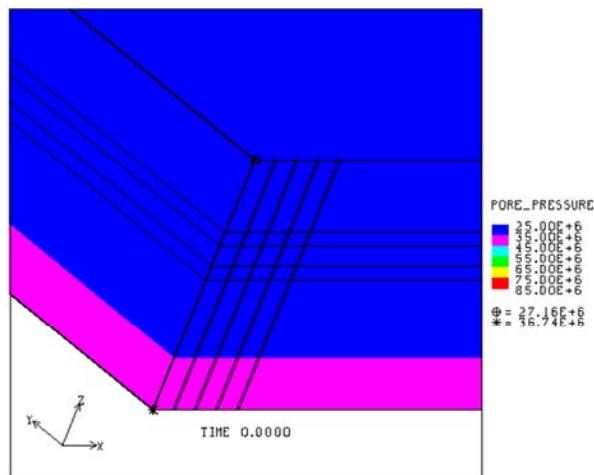
Fig 4-21. Field scale modeling results, hydrostatic pore pressure at time zero.

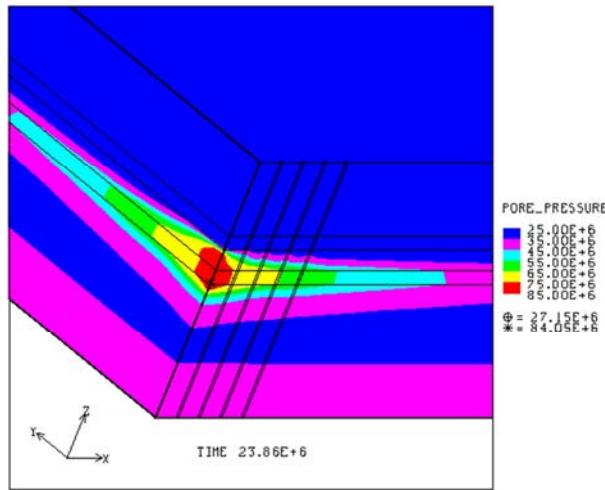
Fig 4-22. Field scale modeling results, pore pressure at 270 days of injection.

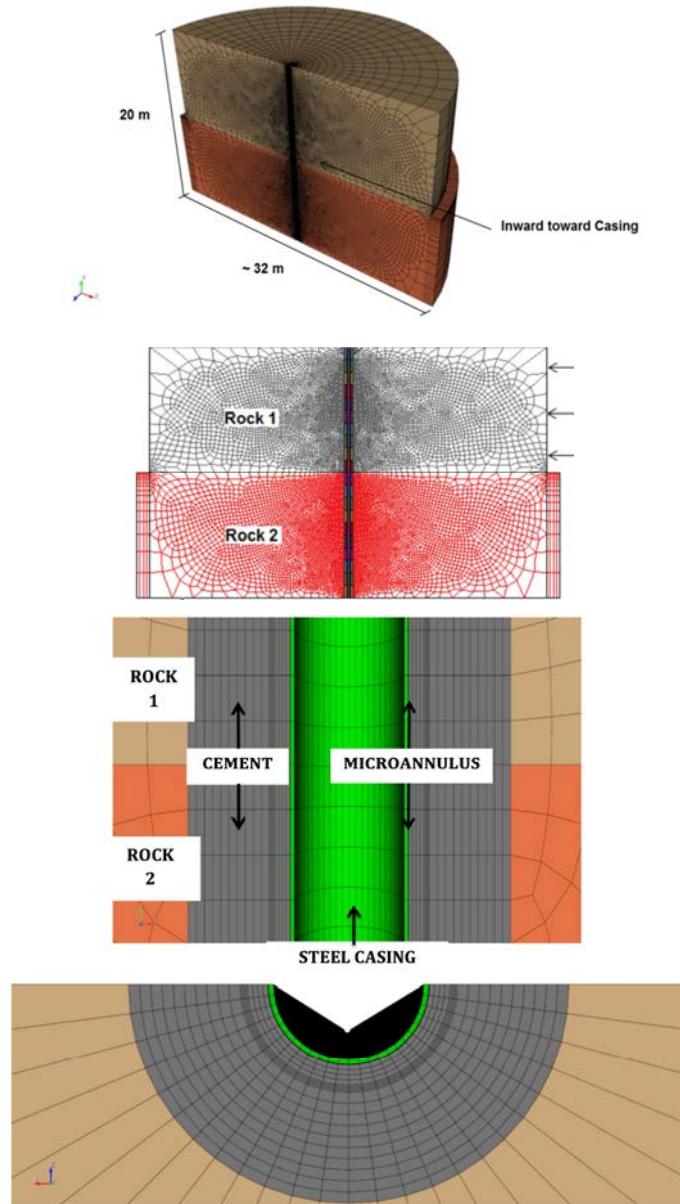
Fig 4-24. Simplified mesh (top) was used to develop and test simulation code. The mesh includes well casing, cement sheath, open annular region, and rock formation. The open annular region or “microannulus” can represent a flaw (annular gap), intact cement, or epoxy.

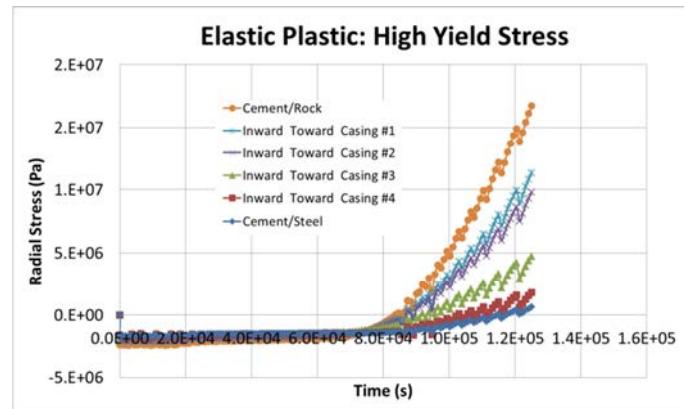
Fig 4-27. Modeling results under elastic-plastic conditions with a cement microannulus for a cement with a high yield stress.

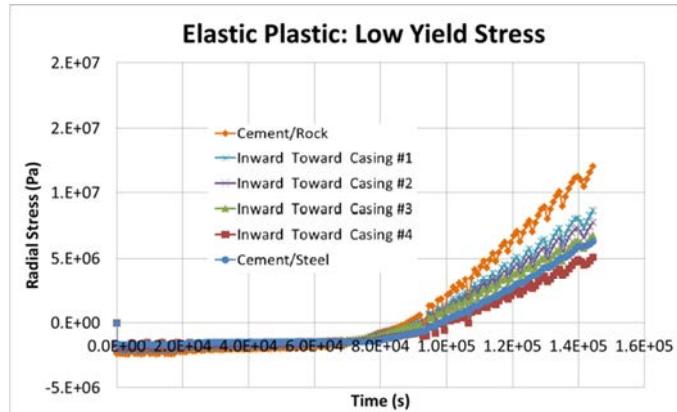
Fig 4-28. Modeling results under elastic-plastic conditions with a cement microannulus for a cement with a low yield stress, indicating the importance of the yield stress model employed.

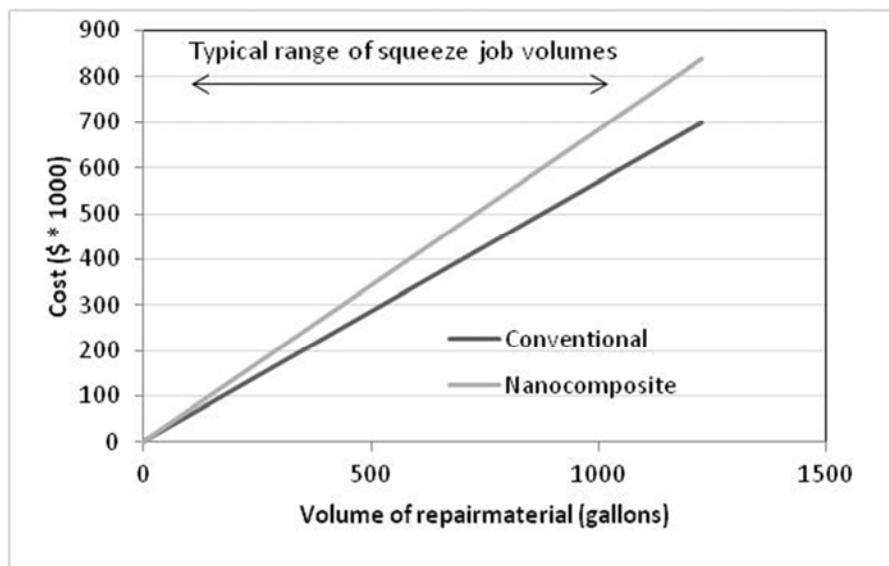
Figure A. 1 – Cost of conventional and nanocomposite wellbore seal repair material as a function of the volume of repair material required for a squeeze job.
