Battery Safety and Abuse Testing at Sandia National Laboratories

Joshua Lamb

January 19, 2016

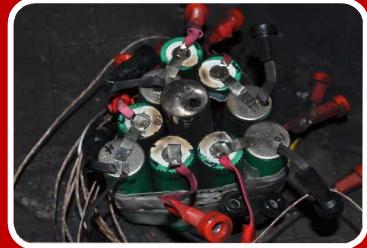
Testing

- Electrical, thermal, mechanical abuse testing
- Failure propagation testing on batteries/systems
- Large scale thermal and fire testing (TTC)
- Development for DOE Vehicle Technologies and USABC

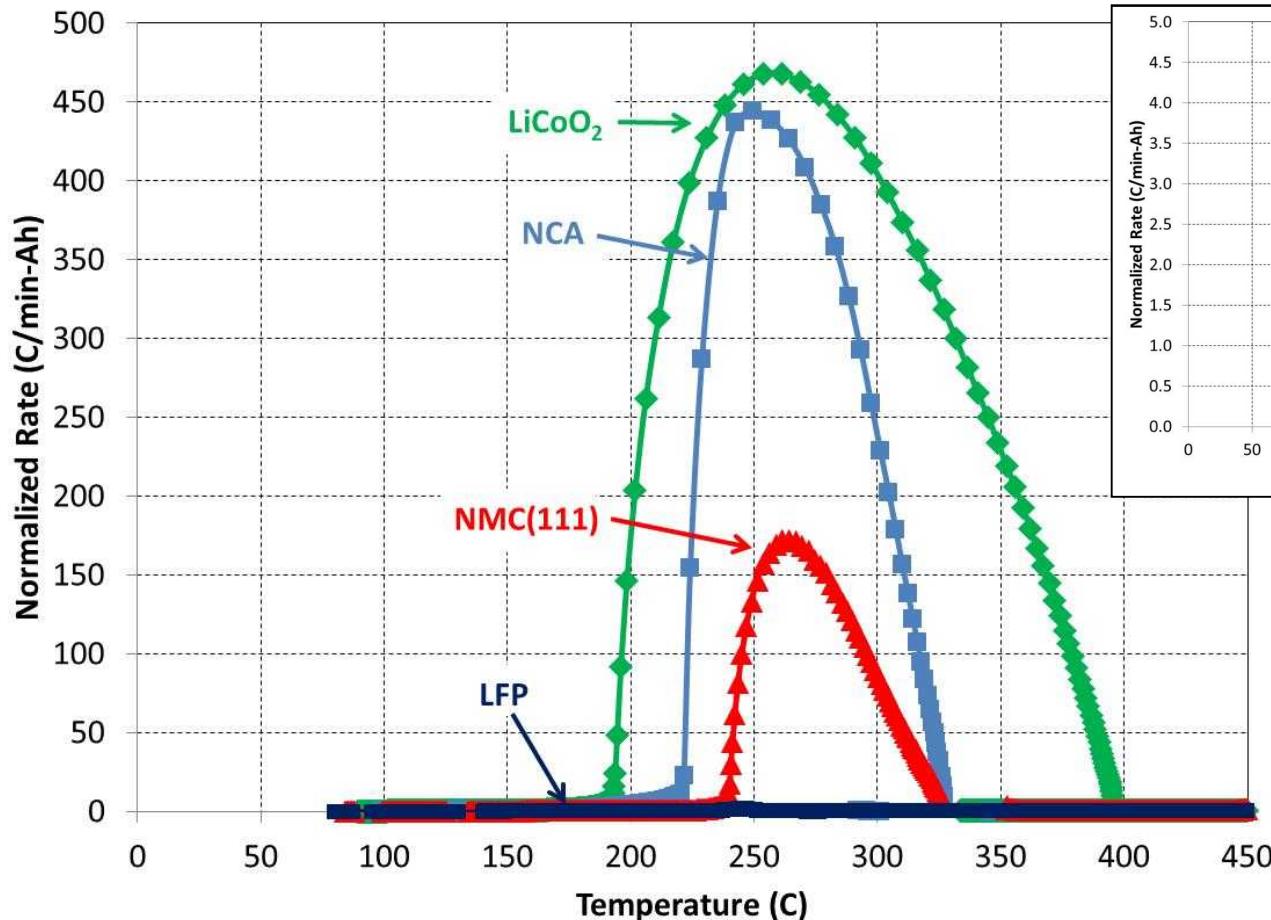
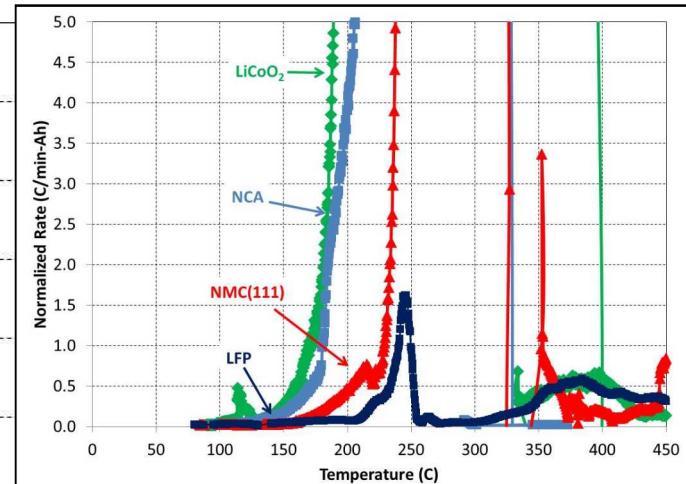
Calorimetry of Lithium-ion Cells

Understanding the Thermal Runaway Response of Materials in Cells

High Rate Runaway	
Cathode	$\Delta H_{\text{runaway}}$ (kJ/Ah)
LiCoO ₂	15.9
NCA	9.8
NMC111	8.3
LFP	2.4

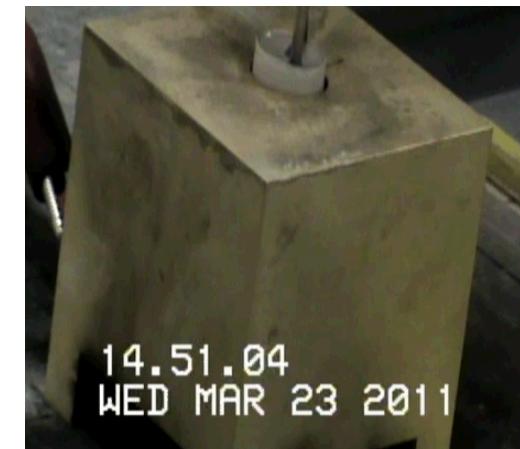
Mechanical ISC techniques

Blunt rod- first used by UL and NASA

Nail penetration

Crush

Motorola/ORNL – spherical pinch

SAE J2464 (ISC test omitted)

Internal short triggers

TIAX – internal defect w/cycling

SNL – low melting point metal

Saft – internal heater

DOE testing programs have a vested interest in evaluation of various ISC testing methods. Historically, the SNL viewpoint is that mechanical techniques are not representative of ISC, but may be useful as a runaway trigger

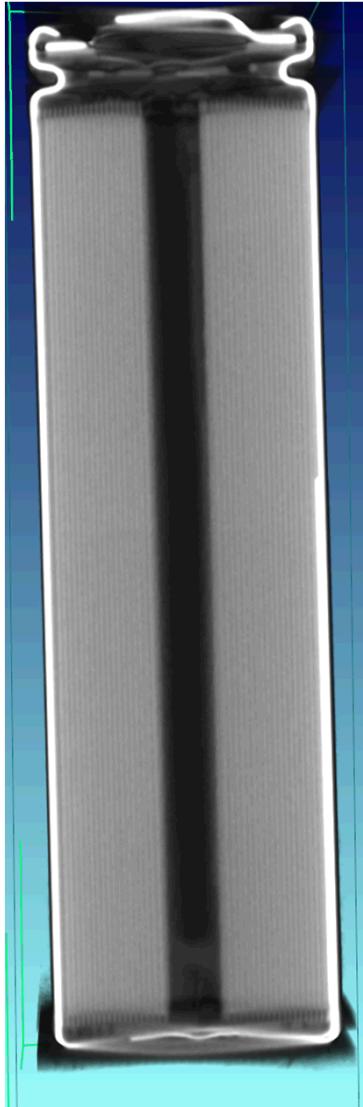
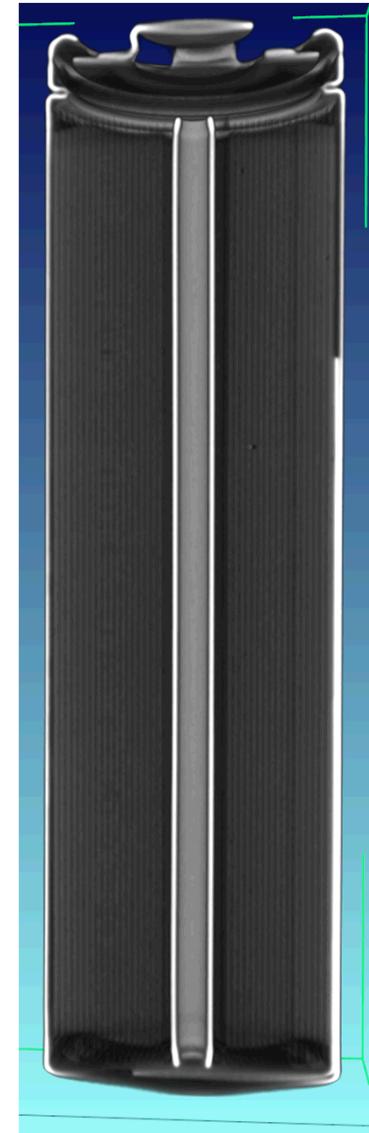
Testing methods

Differences in basic cell construction may lead to differing responses to abuse conditions

- Presence/absence of center rod
- Dead space in can
- Differing size/position of negative tab

Test conditions		
Speed	2 mm/min	
Construction	316 SS	
Nail Tip	5 mm	
Temperature	RT	60C
	100 mV	20 mm
End Conditions	drop	penetration

Cell type A

Cell type B

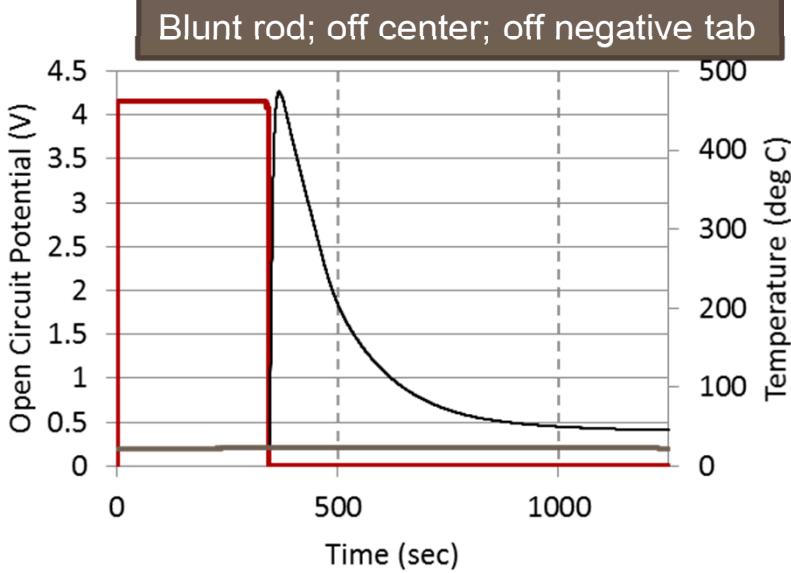
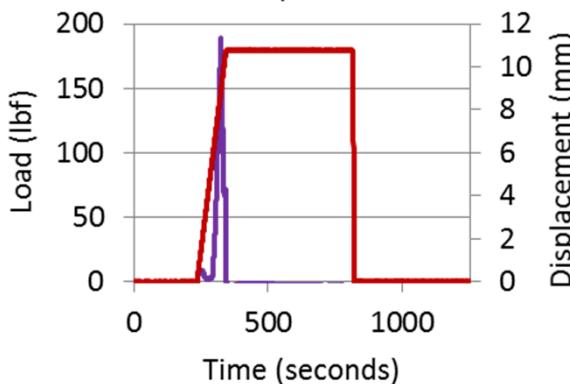
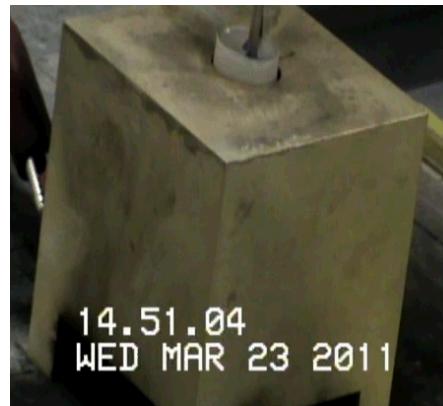
Results: Axial Loading

— Open Circuit Potential — Cell Temp

— Ambient Temp

— Load — Displacement

- Resulted in hard short with high temperature and sharp drop in voltage
- Not shown: crush directly on center difficult to fully short as rod passed through empty center

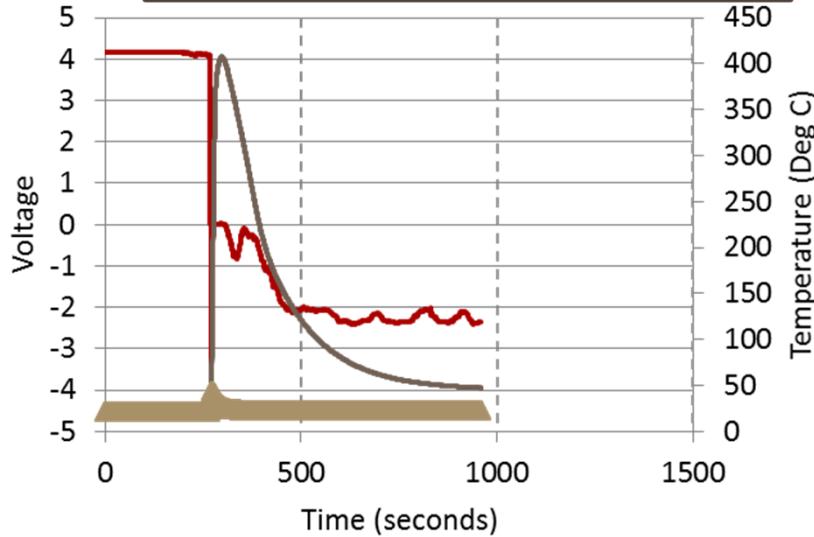
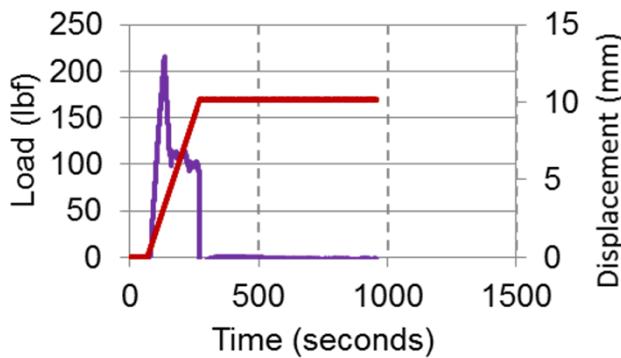
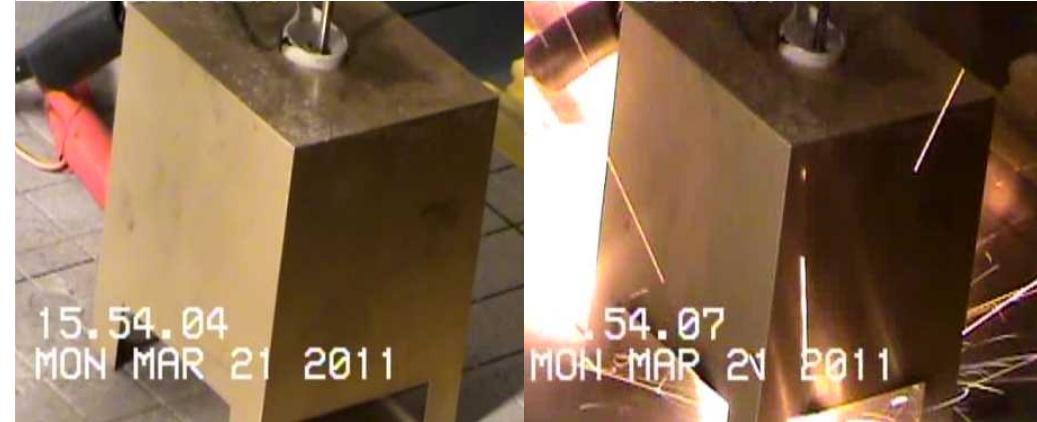
Results: Axial Loading

Blunt rod; off center; on negative tab

— Open Circuit Potential — Cell Temp

▲ Ambient Temp

— Load — Displacement

- Noisier voltage curve after short
- Hard short occurs shortly after penetration

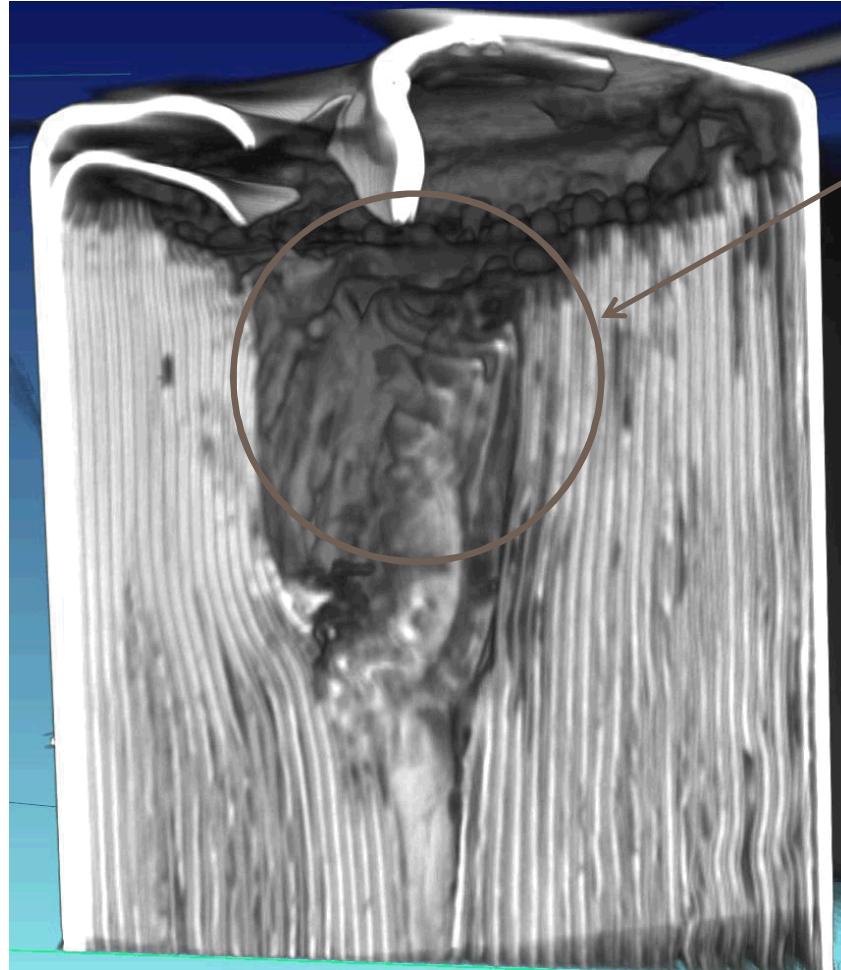
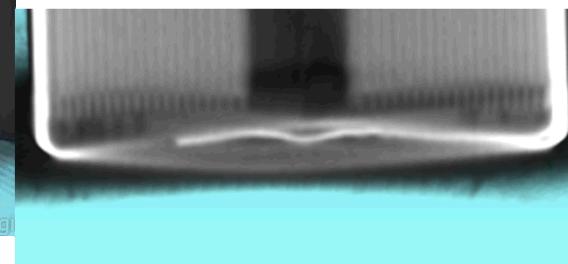
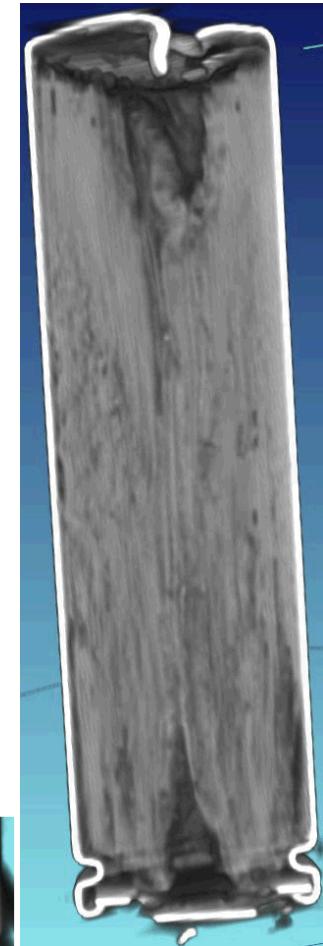
Internal damage – Axial load

Blunt rod; off center; off negative tab

Short location

- Propagation of short through cell towards vent. Damage becomes more extensive near vent from flow of escaping gas
- Large gap between can and electrodes prevent contact without cell puncture
- Limited use for internal short circuit due to large degree of cell damage before short, but reliable runaway initiation

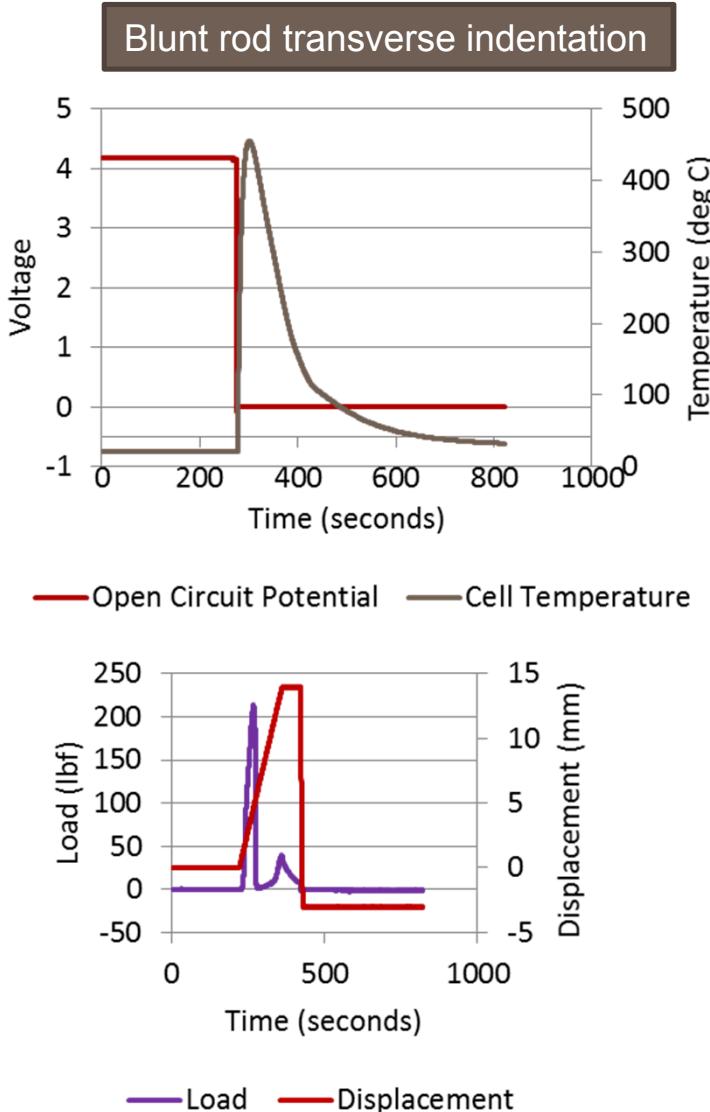
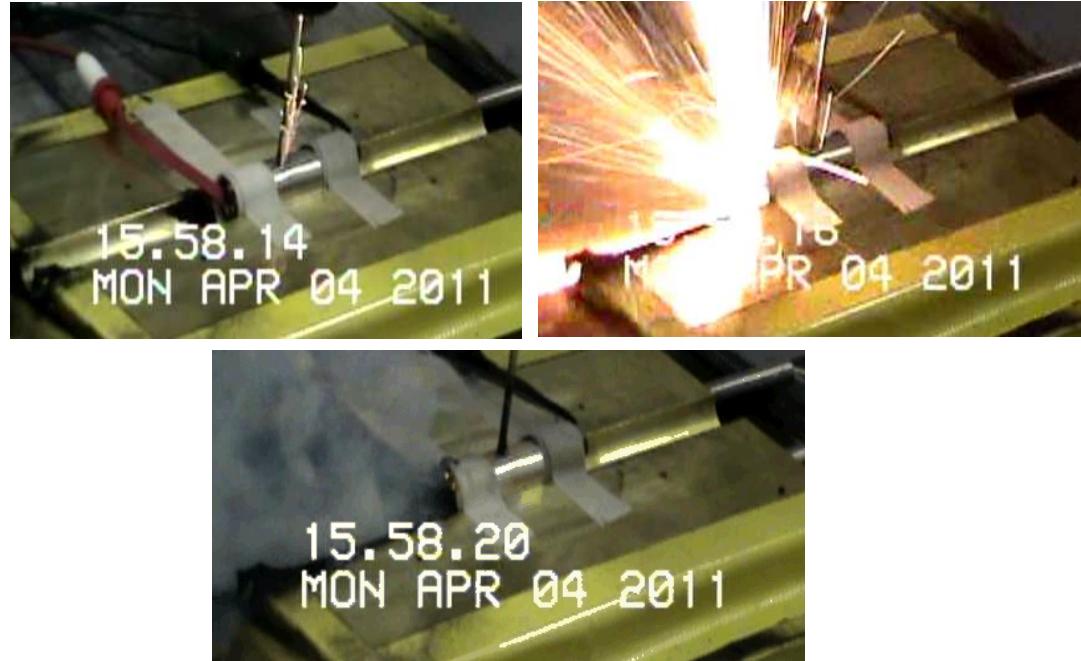
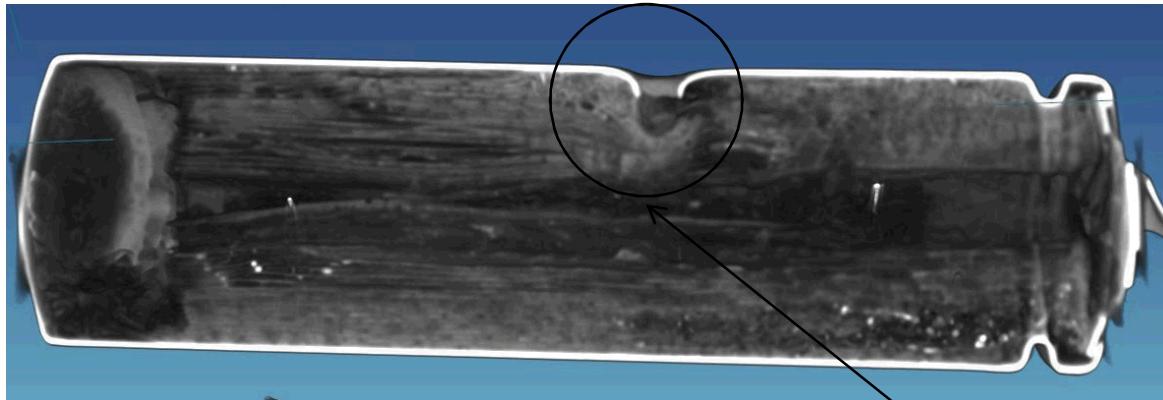
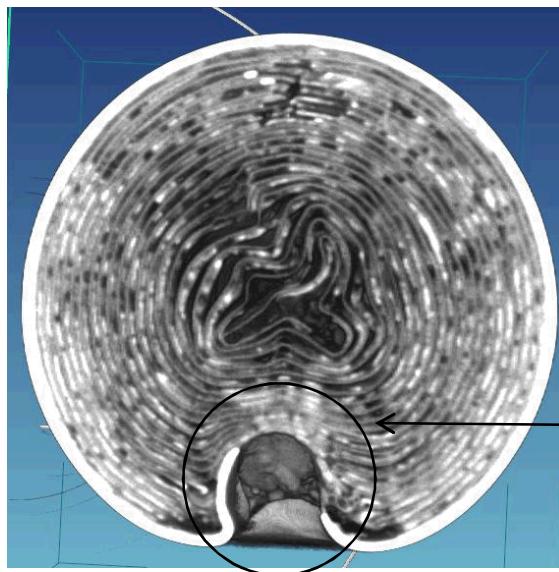
Results: Transverse load

- Cell type A: no internal core
- Catastrophic cell failure; all escaping gas comes through puncture or vent

Catastrophic short failure

Propagation of failure through cell

Short location – electrode collapses into core and escaping gas through vent forces jelly roll up towards vent

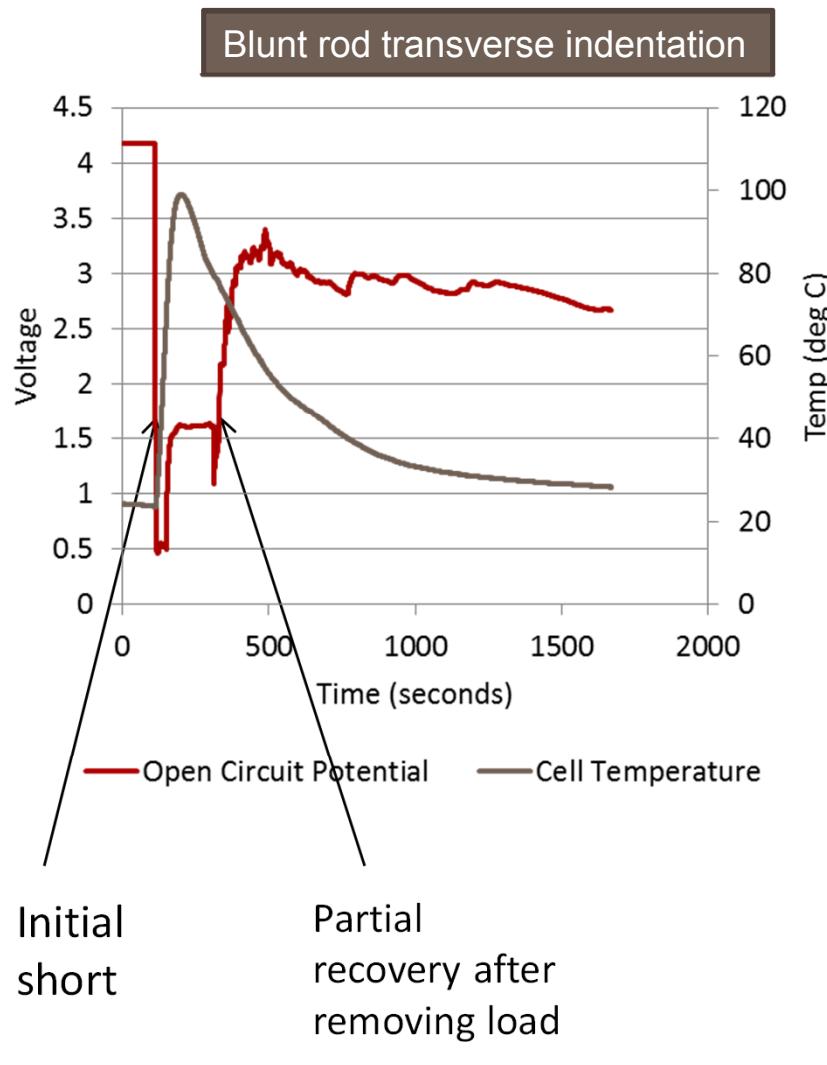
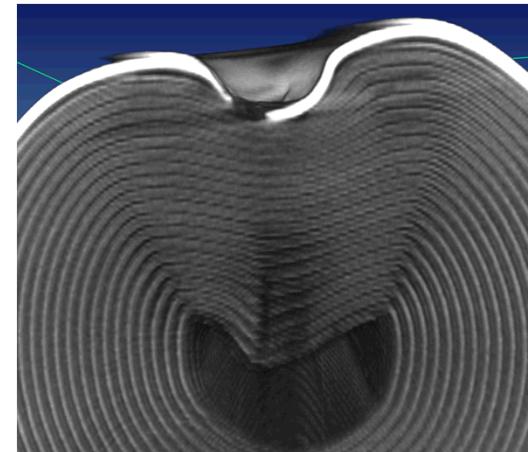
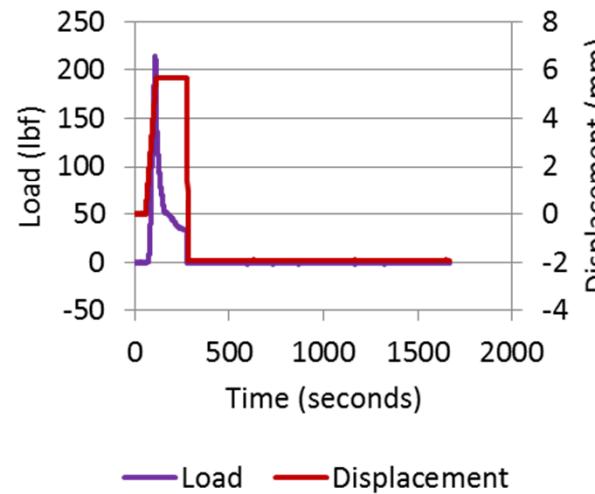
Failure: Soft short with partial recovery

Cell shorting between layers. Electrode is able to deform and collapse into open space in core of cell.

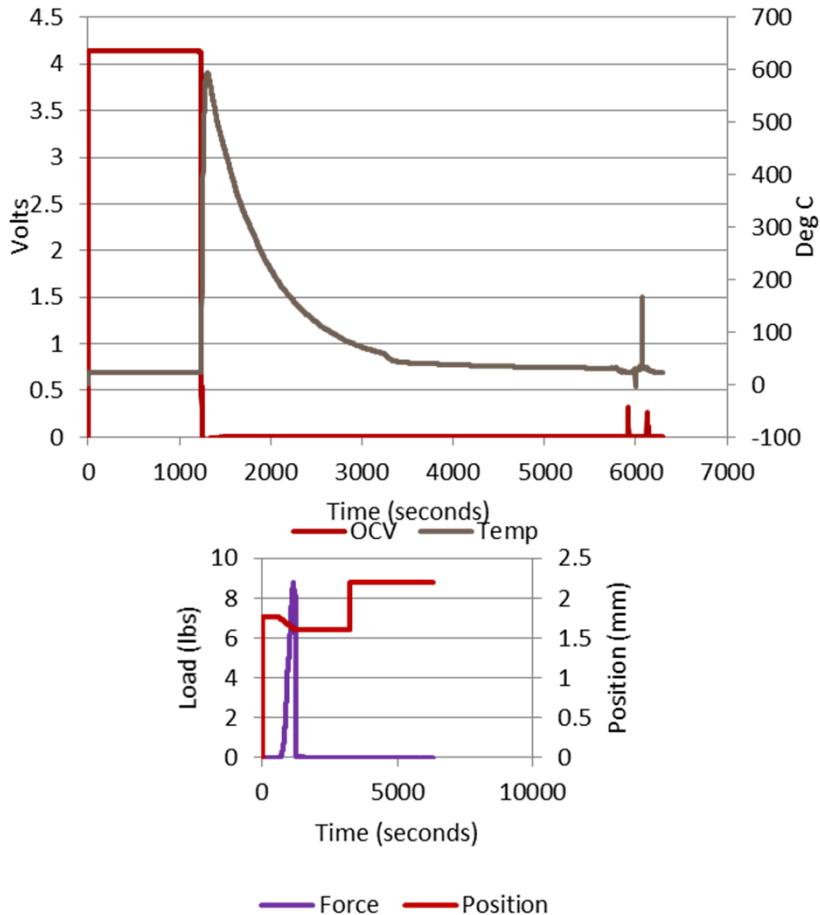
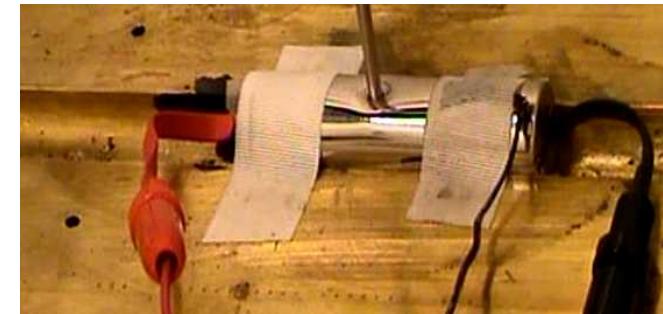
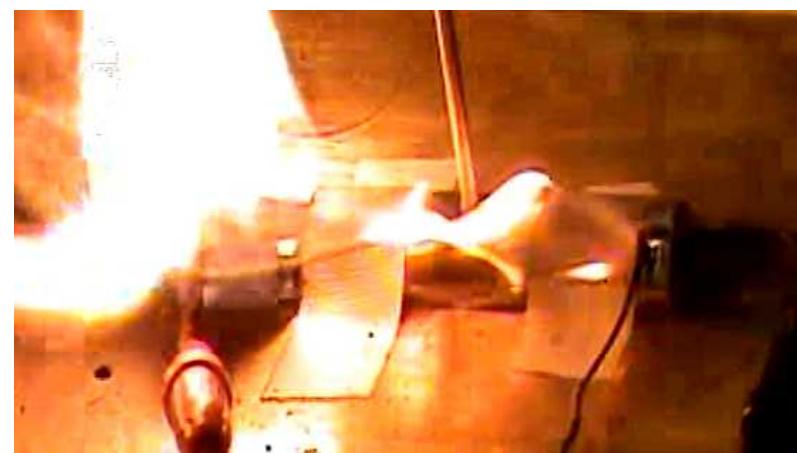
Effect of Cell construction: Cell type B

Blunt rod transverse indentation

- Catastrophic failure readily seen
- Very high temperatures and self ignition

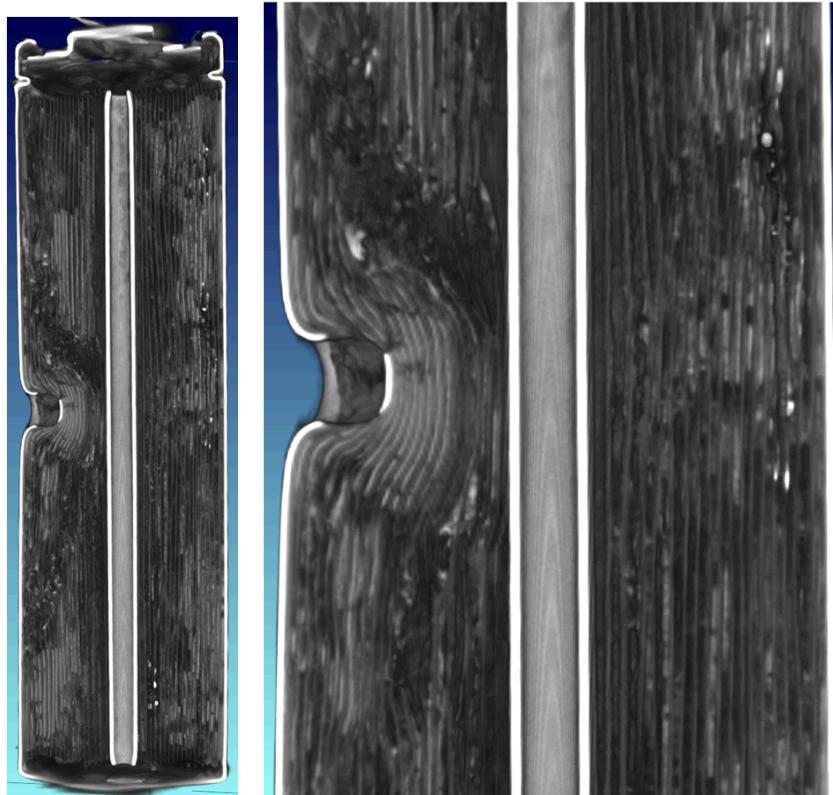
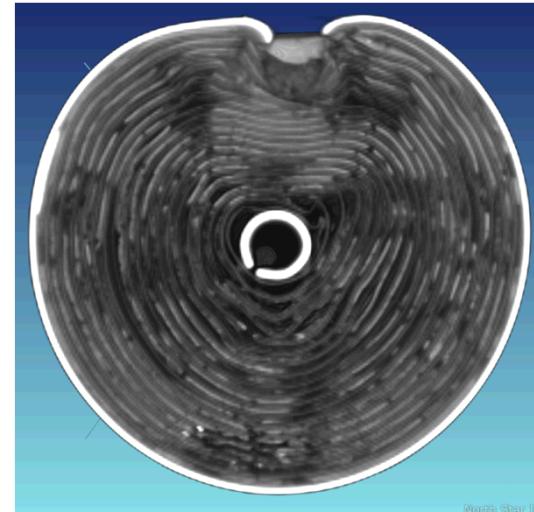
Cell type B continued

- Center core restricts contents during catastrophic failure
- Creates an effective “backing plate” allowing the electrode to be sandwiched between blunt rod and core

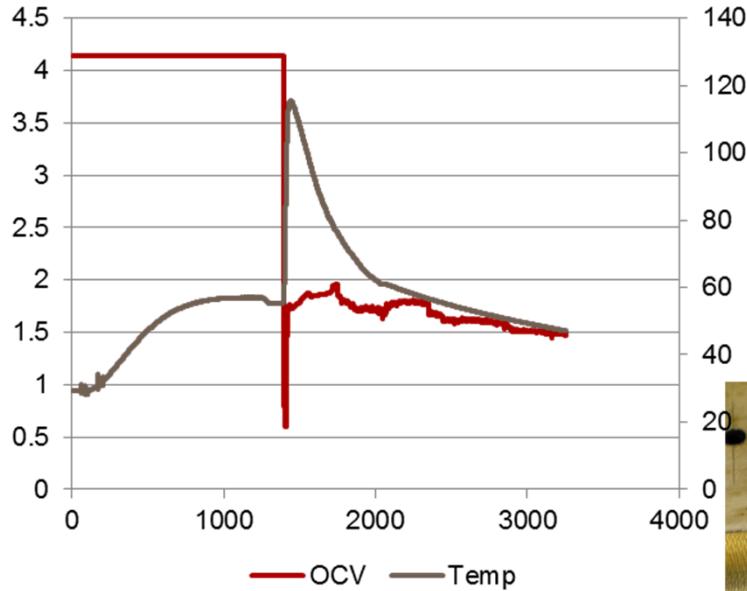
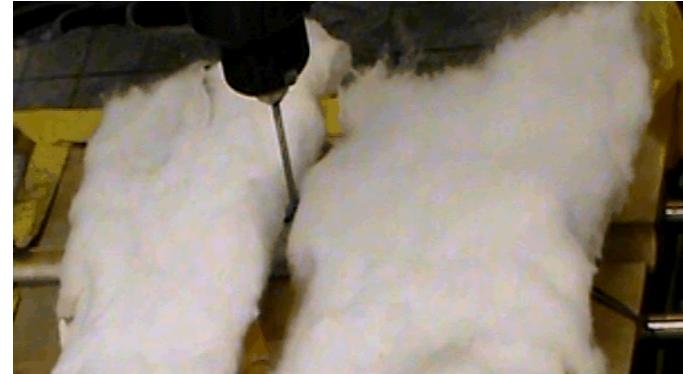
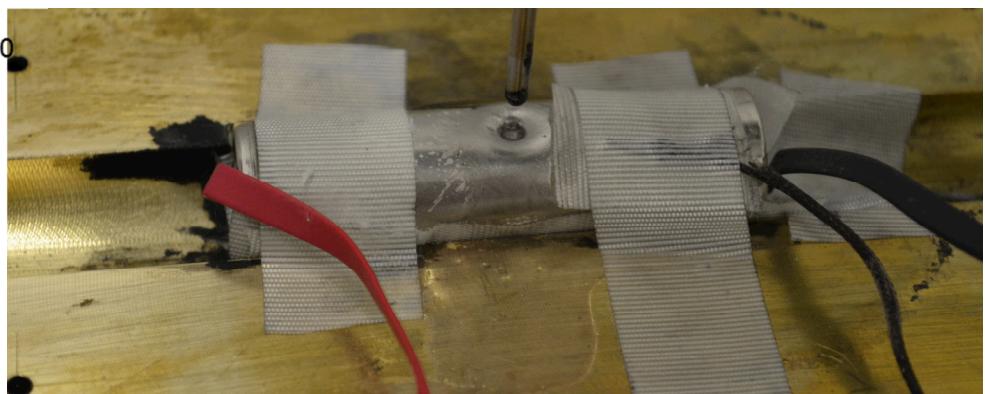
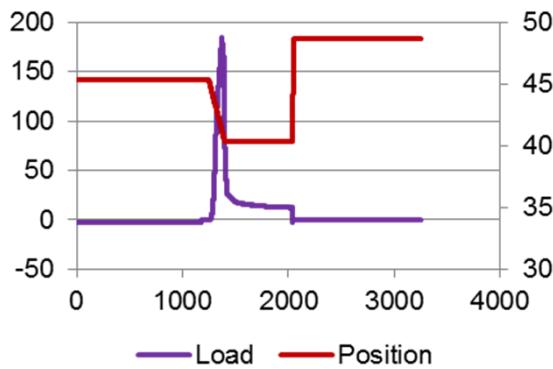
Elevated temperature - Cell type A

Blunt rod transverse indentation, 50 °C

- Full short observed, but no catastrophic failure
- Repeatedly observe 100 mV drop before catastrophic failure occurs

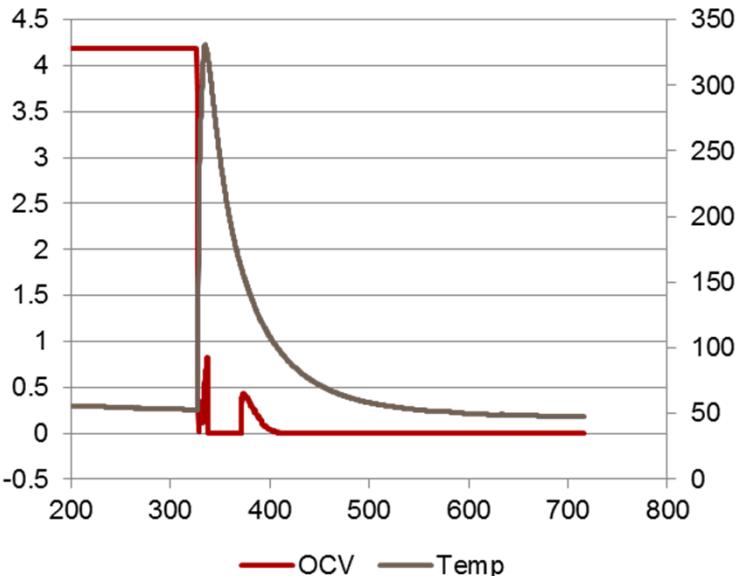
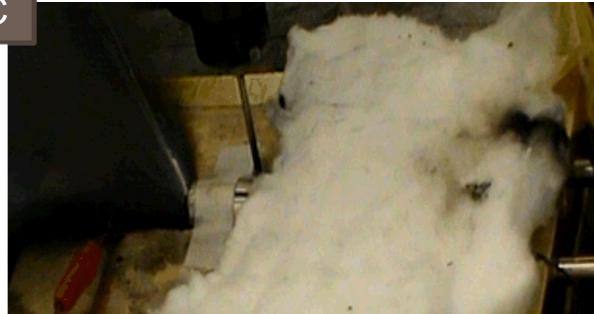
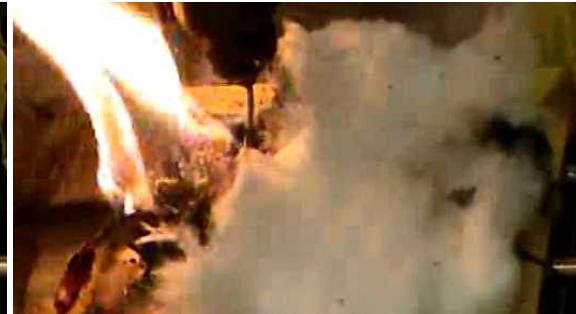
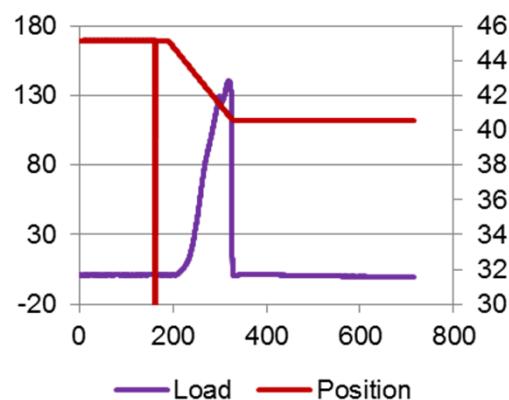
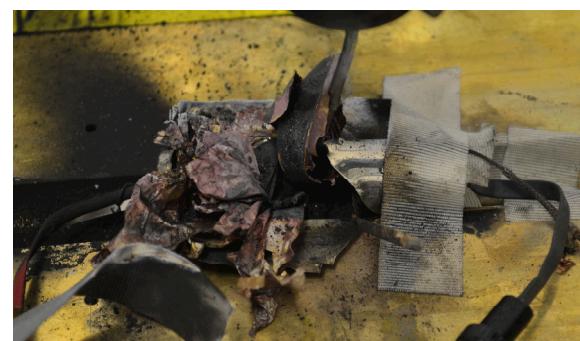
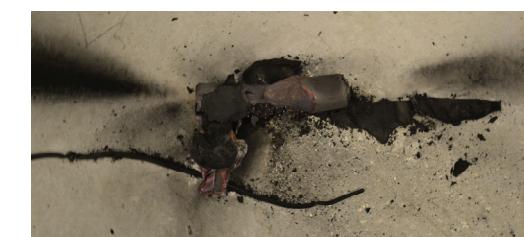
Elevated temperature – Cell type B

Blunt rod transverse indentation, 50 °C

- Very catastrophic failure
- Rupture of can
- Ejection of cell contents

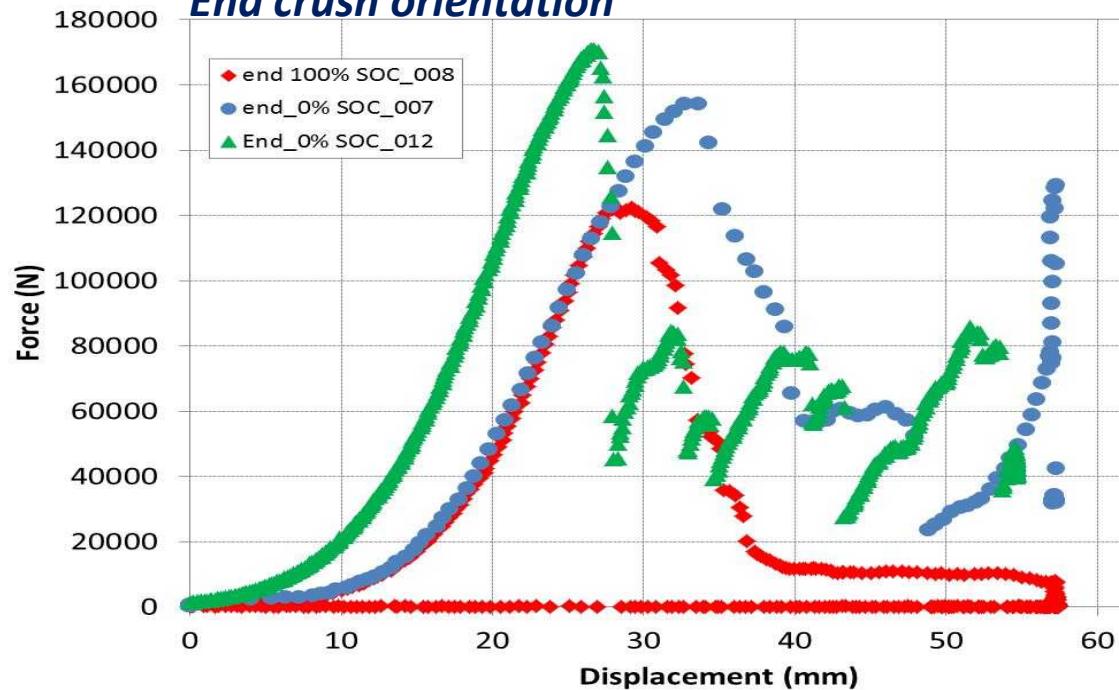
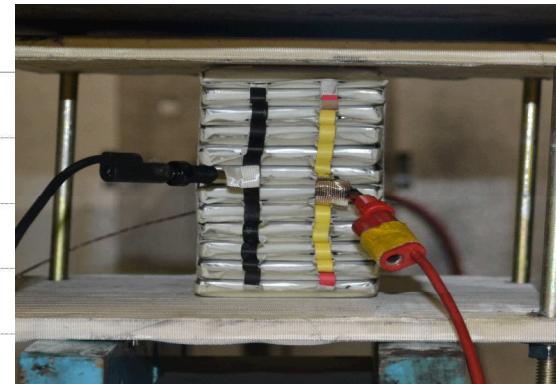
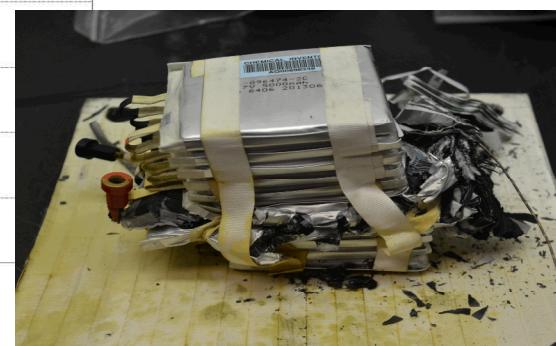
Battery Crash Worthiness

Mechanical testing support of battery mechanical model development

End crush orientation

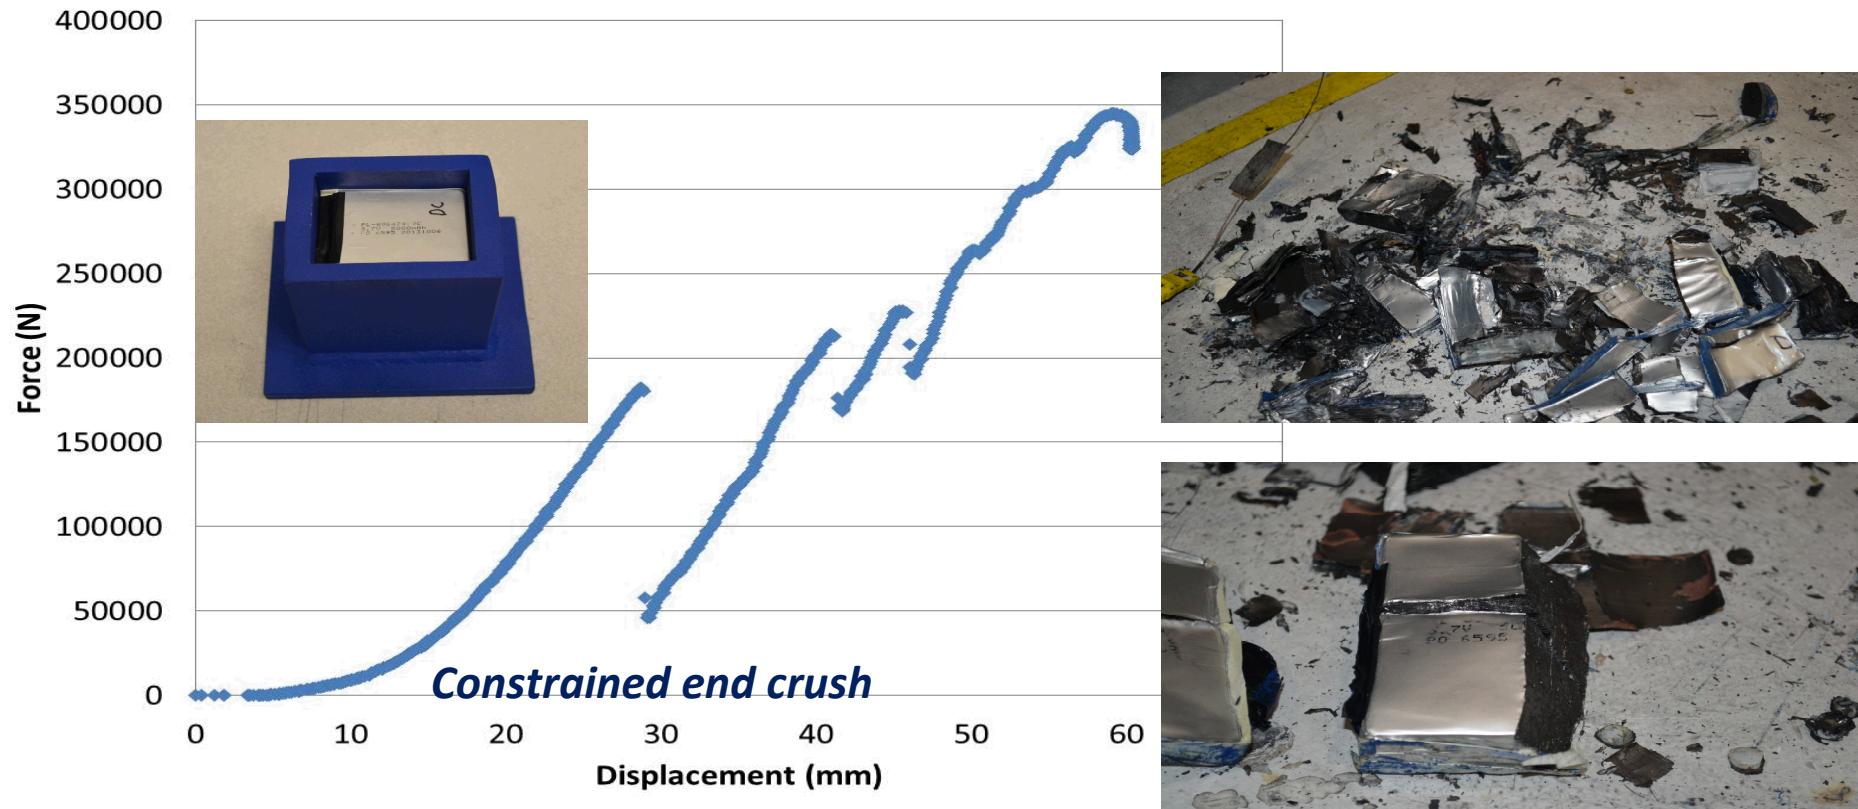
Crash Safety

Fully constrained 12 cell pack (0% SOC) crushed along the longest dimension.

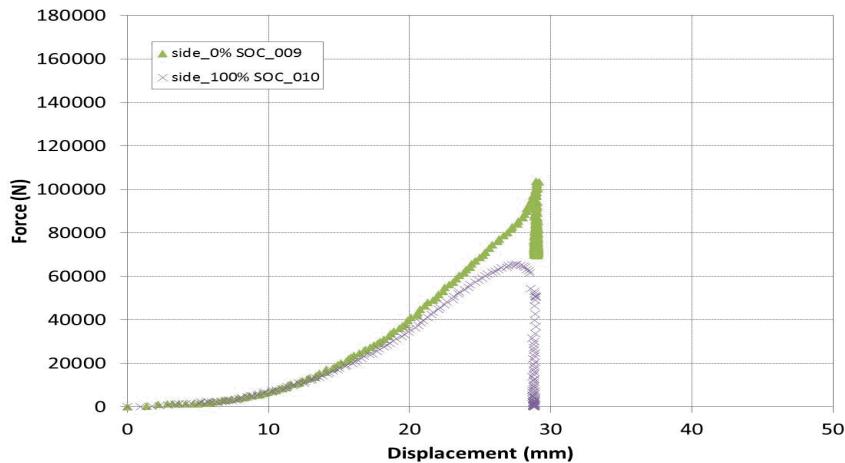
Mechanical behavior under compression

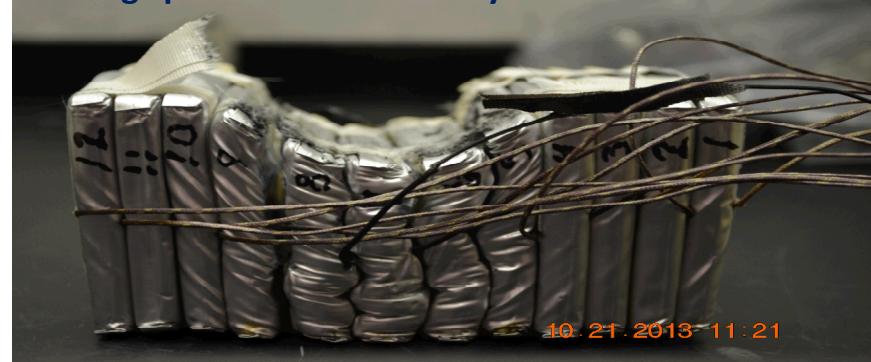
Analog “pole test” of a battery

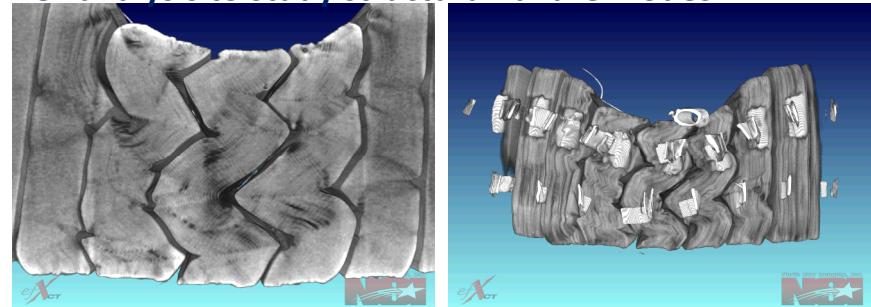
CT analysis to study structural failure modes

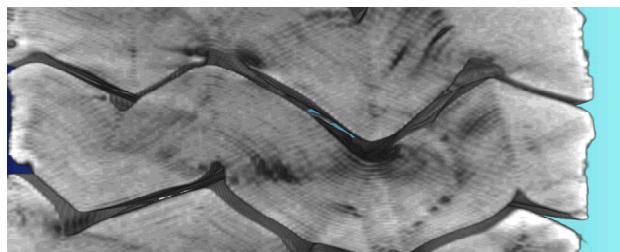
Battery Crush Experiment (SNL, USCAR)

- Use battery crush data to validate the integrated model
- Develop a predictive capability for battery thermal runaway response to mechanical insult

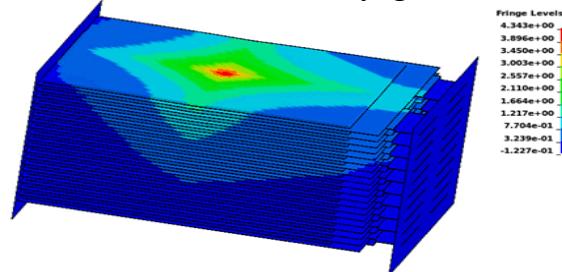
Thermal Cell-to-Cell Propagation Model

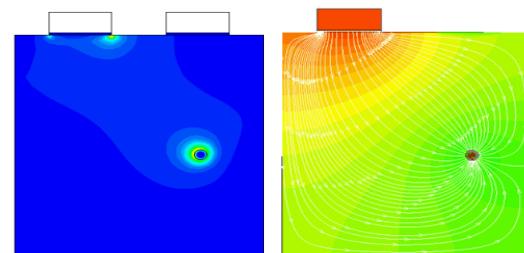
Thermoelectrochemical Model
