Defect Characterization for Material Assurance in AM Metals

Bradley Jared, Brad Boyce, Jon Madison, Jeff Rodelas, Brad Salzbrenner

Material Assurance for Additive Metals

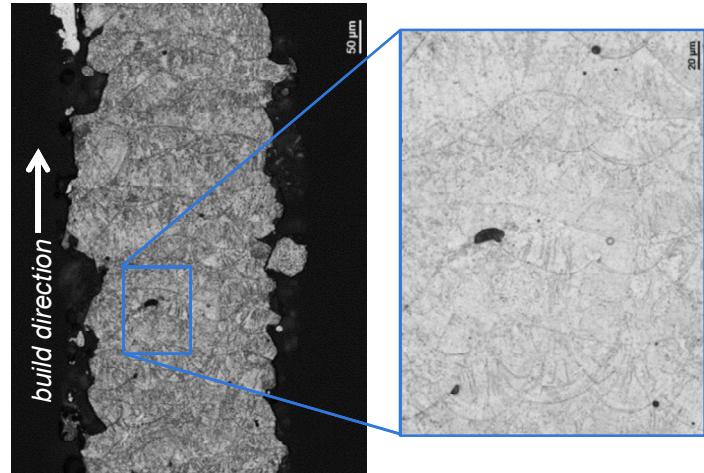
defects in 17-4 PH w/ 0.015" nominal wall thickness

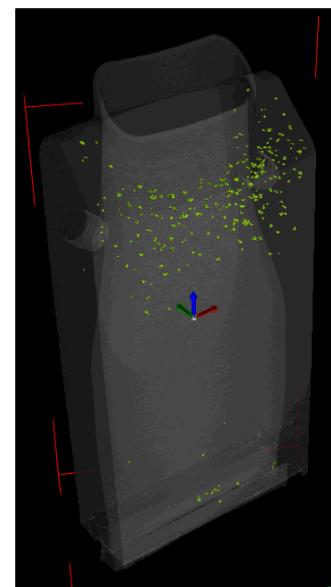
CT scan of NSC Al10SiMg

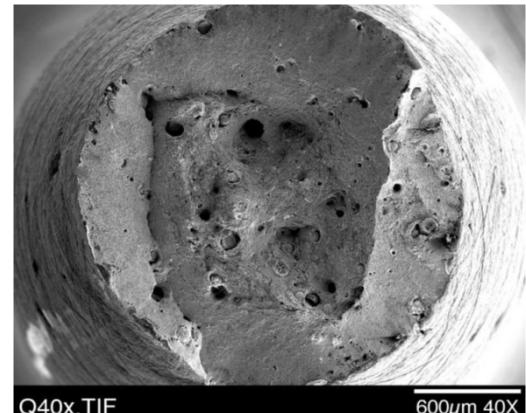
ductile fracture initiated by LENS® defects in PH13-8Mo*

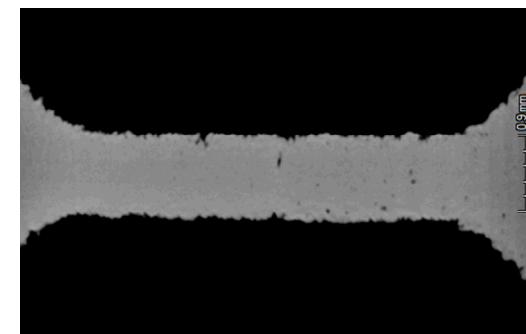
CT of 17-4PH dogbone sample

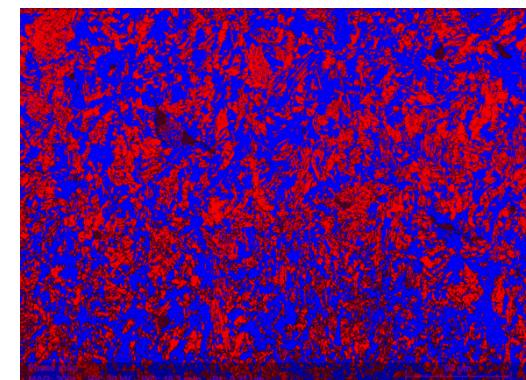
47% ausetnate + martensite in 17-4PH

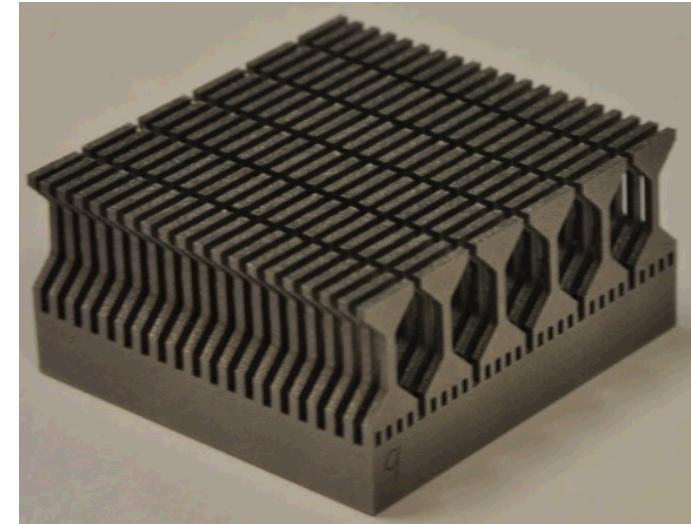
high throughput test sample w/120 dogbones, 1x1mm gage x-section

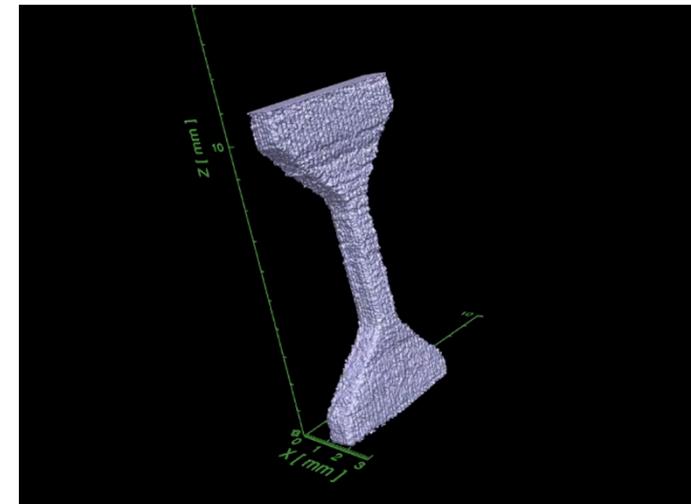
CT model of 1x1 mm test sample

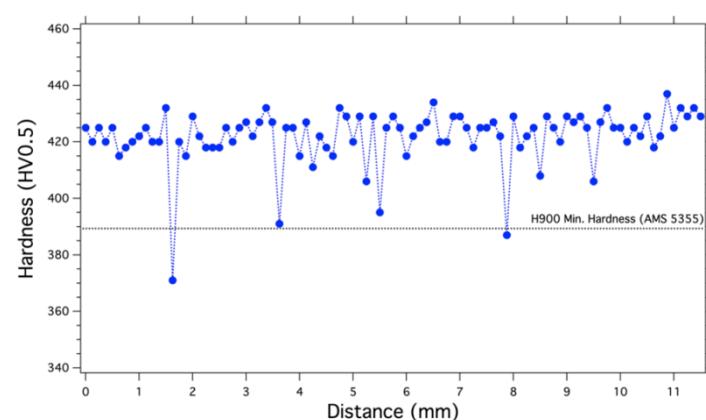
vendor 1, H900 microhardness along dogbone length

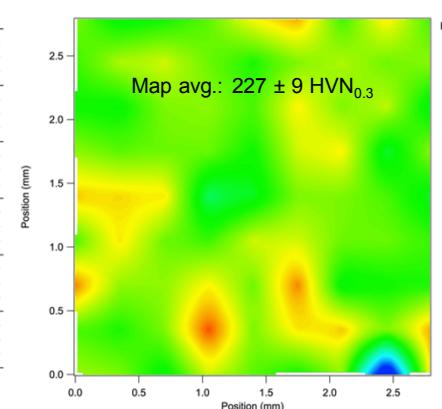
vendor 2, as-printed microhardness on gauge cross section

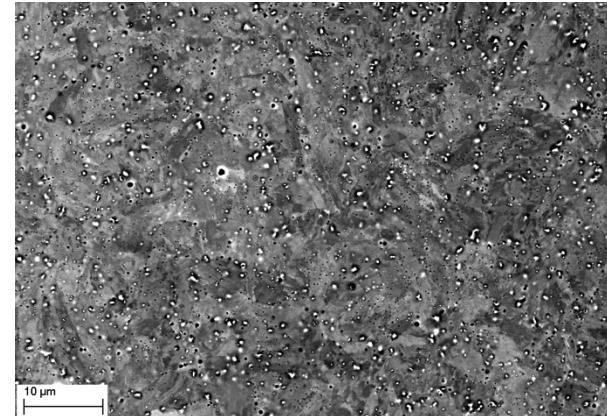
fine martensitic microstructure of Vendor 1,
H900, Nb precipitates visible as light particles

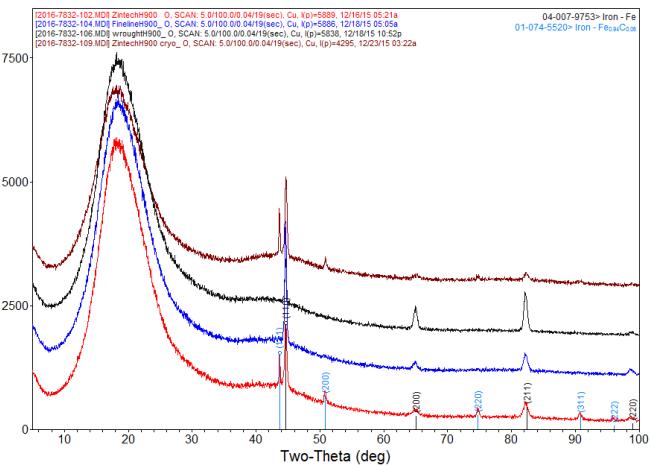
bulk XRD analysis for vendor 2

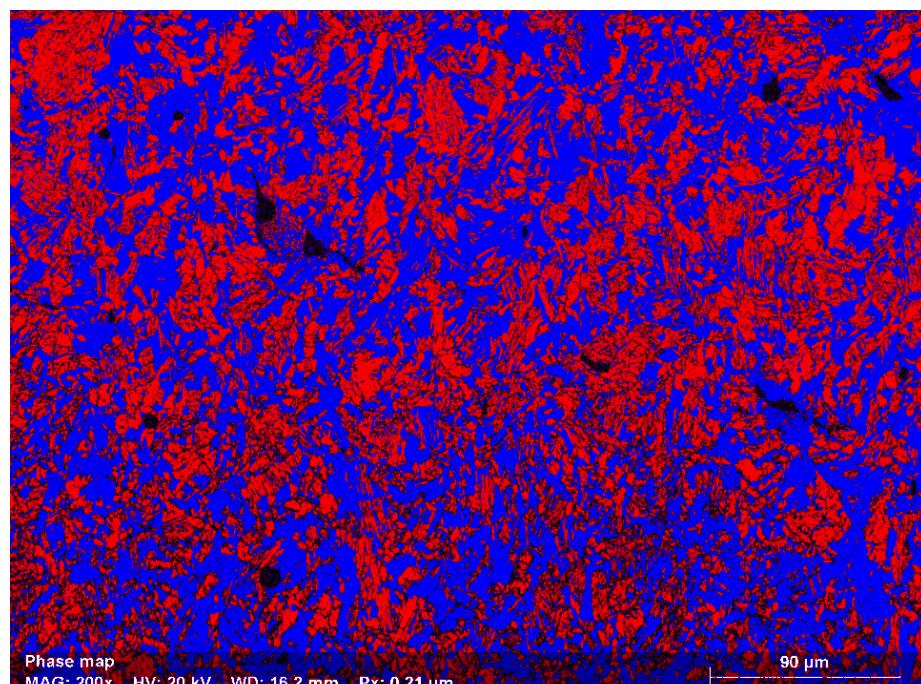
as-printed, 47% austenite

- Conventional 17-4 PH H900 should contain effectively no retained austenite
- Large fraction of retained austenite exists after solution heat treatment + H900 age
 - cryo treatment to -196°C for 5 min does not transform Austenite
 - suspect that alloy micro-segregation may have occurred

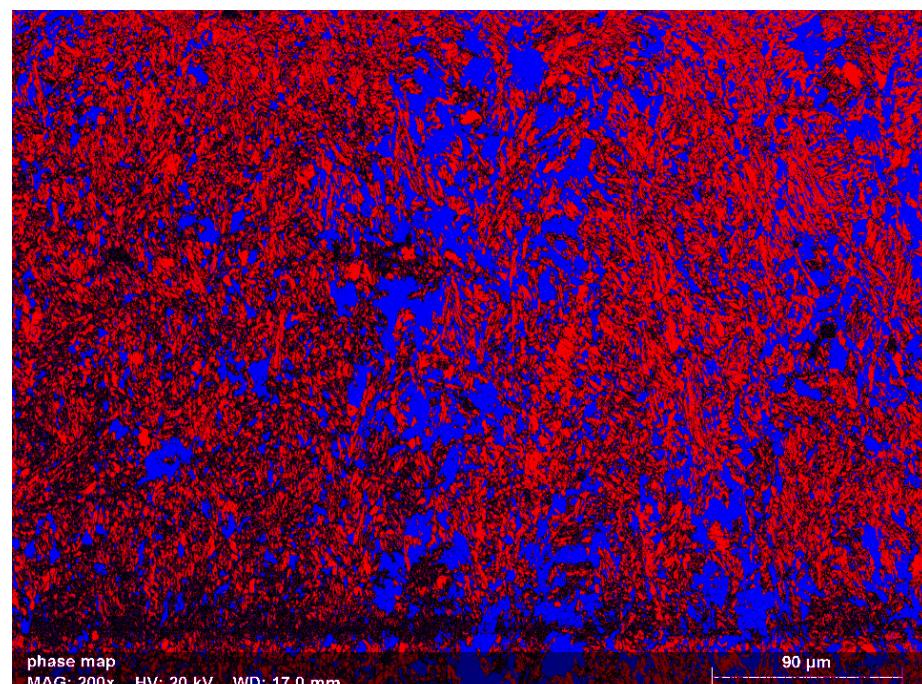
SHT + H900 age, 43% austenite

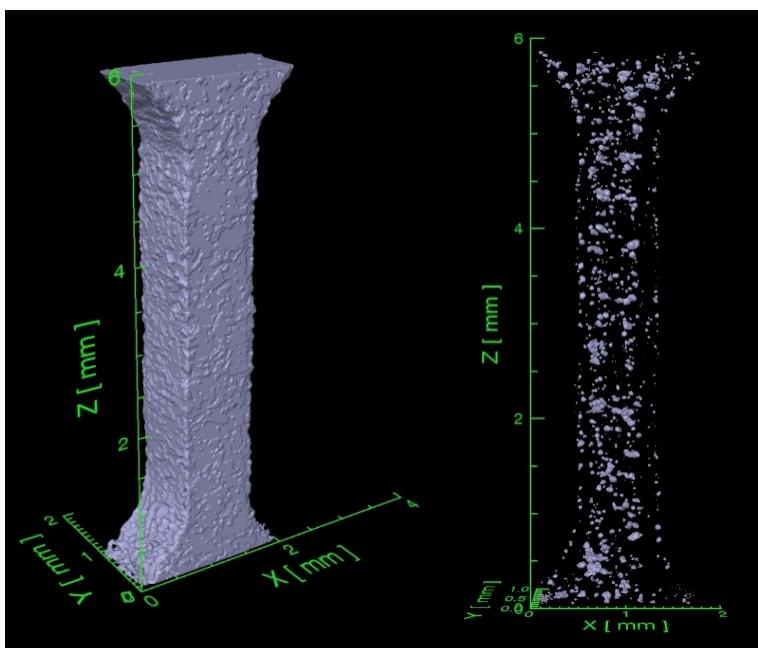
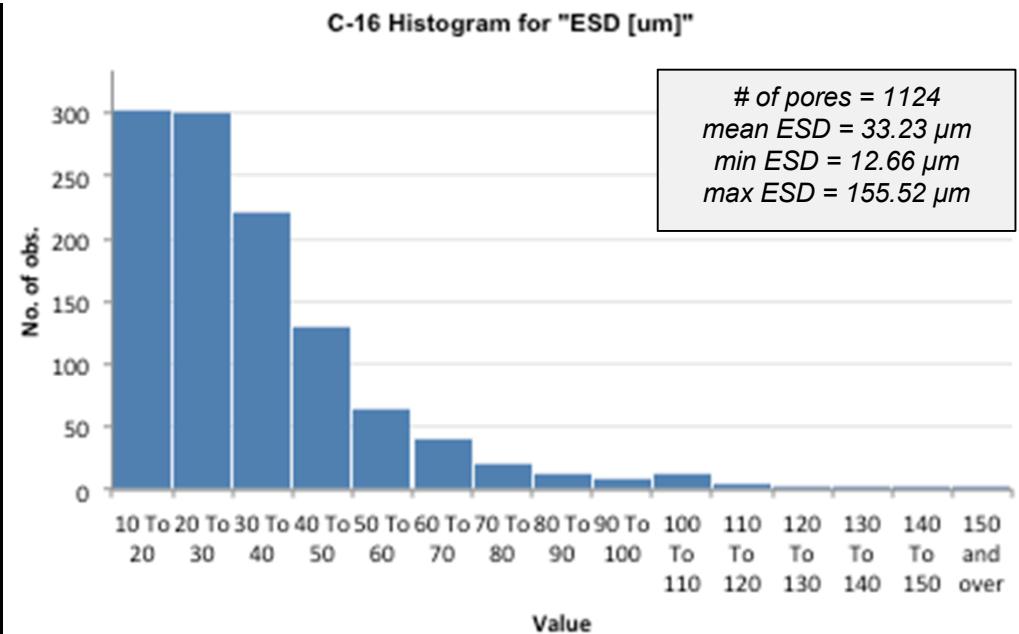
dogbone C,16 CT surface image (left), porosity map (center) & porosity distribution (right)

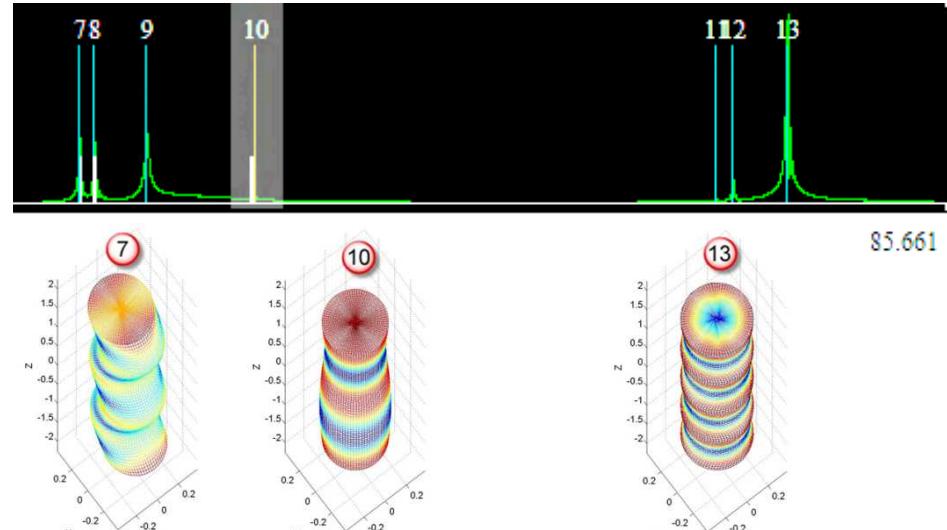
example resonance spectrum & corresponding mode shapes

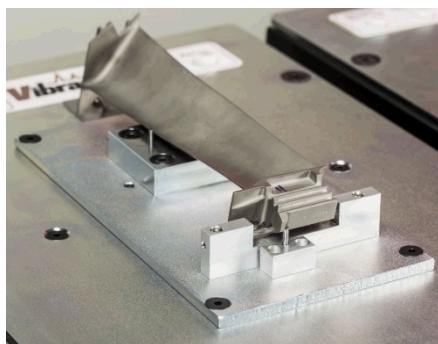
turbine blade in a 3-point fixture

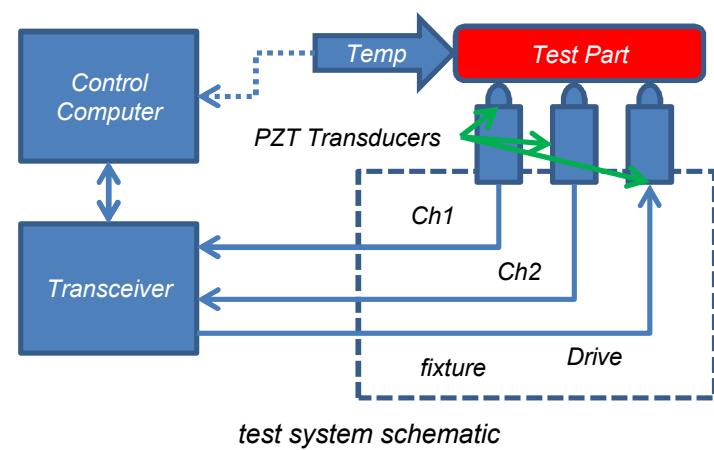
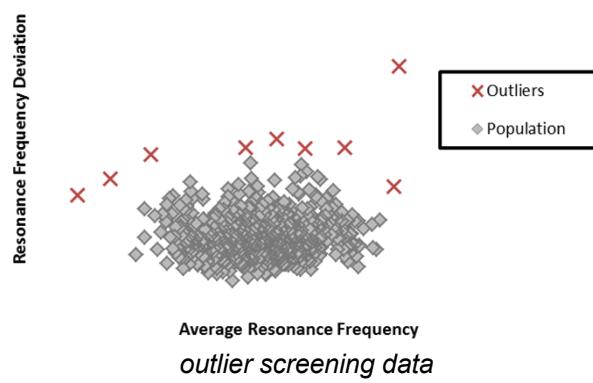
Average Resonance Frequency
outlier screening data

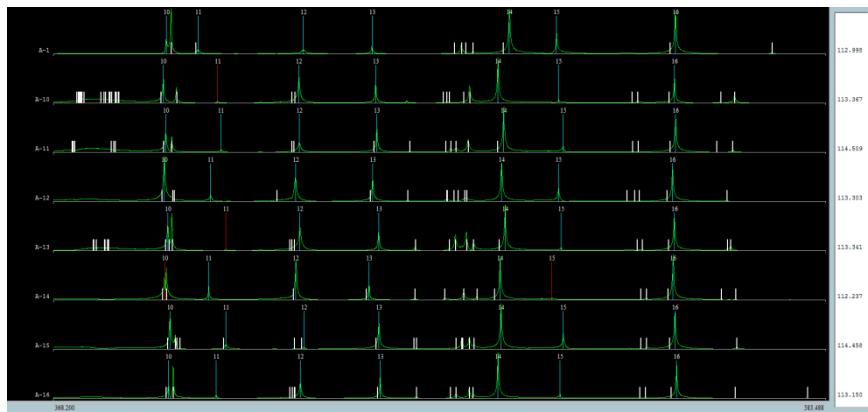
sample of resonance response spectra

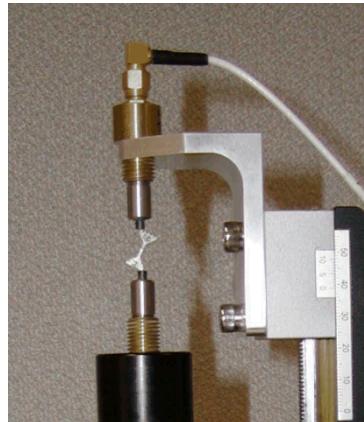
dogbone in the 2-point test fixture

- 2-point transducer configuration w/preload
- Spectrum settings
 - broadband = 74.2 kHz to 1.6 MHz
 - 28 sub-bands record 19 resonances
- Z-score analysis
 - compares peak resonant frequencies with population average & std. dev.

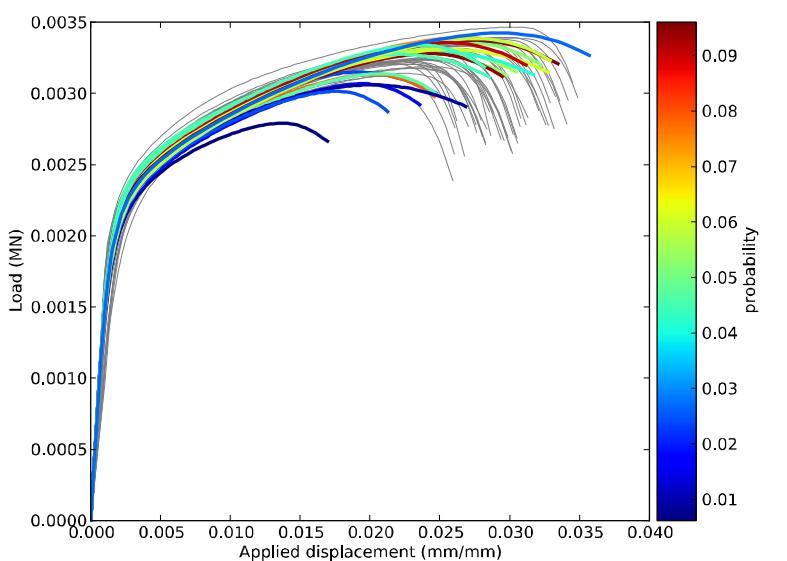
predicted (color) vs. measured (grey) response for welds (PPM)
