# Well Integrity Assessment of CFU31-F2 and CFU-31F3

## **Statistical Analysis of CO<sub>2</sub> Exposed Wells to Predict Long Term Leakage through the Development of an Integrated Neural-Genetic Algorithm**

May 23, 2017

Prepared by: Andrew Duguid Ph.D., P.E.  
Battelle

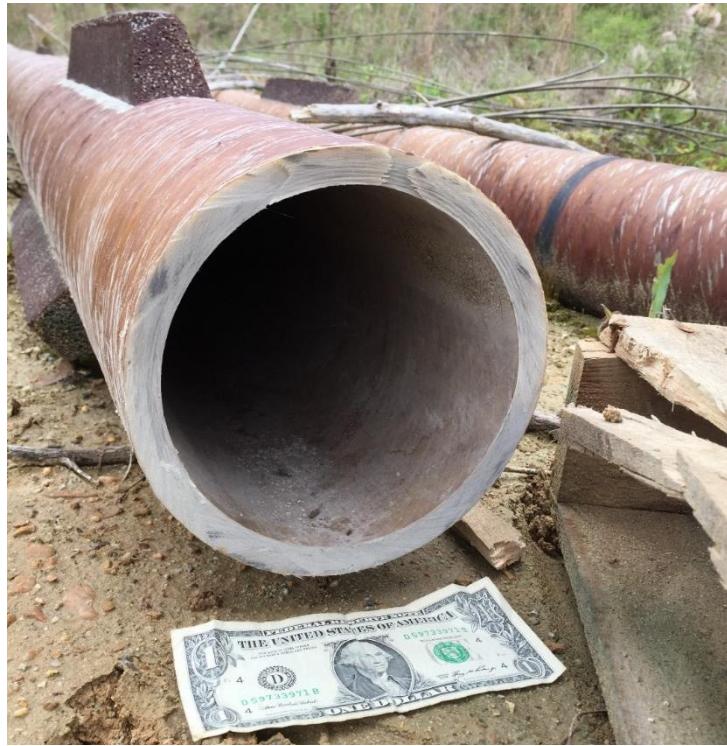
**Figure 4 Bluebox 2500 casing used to construct both monitoring wells.**

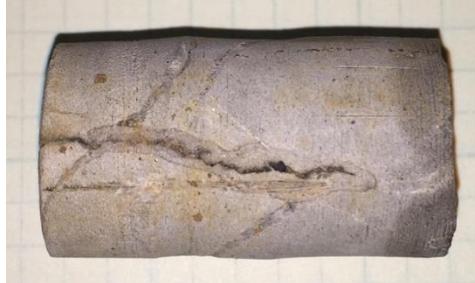
The upper core in CFU31F-2 was collected at 7900 ft. The core was solid cement with a crack running through it from the casing side of the annulus toward the formation side. The crack is approximately 1/2-mm-wide and 35-mm-long. There is an approximately ½- to 1-mm-wide discolored zone surrounding the crack and crystals precipitated in the cement in the crack (Figure 8).

**Figure 8** Sidewall core collected at 7900 ft showing crack starting at the casing end (left) and extending toward the formation end (right). Note, the sidewall core is approximately 23 mm in diameter and each square in the background is 5.08 mm on a side. It is discolored on the formation side due to exposure to hydrocarbon in the sidewall coring tool.

Each of the cored depths showed changes in acoustic impedance and CBL amplitude. Each of the cores collected in each well showed evidence of carbonation. The XRD data for each core show calcium carbonate phases. The core at 7900 ft contained a crack surrounded by a visible reaction front. The LA-ICP-MS analysis shows an increase in Ca/Si moving away from the crack and a spike in Ca/Si on the left visible edge of the front (Figure 17 and Figure 19) which may indicate a calcium carbonate front. XRD analysis on the crack zone indicated a higher calcium carbonate percentage than in the non-crack zone indicating that the crack is acting as a pathway for CO<sub>2</sub>.

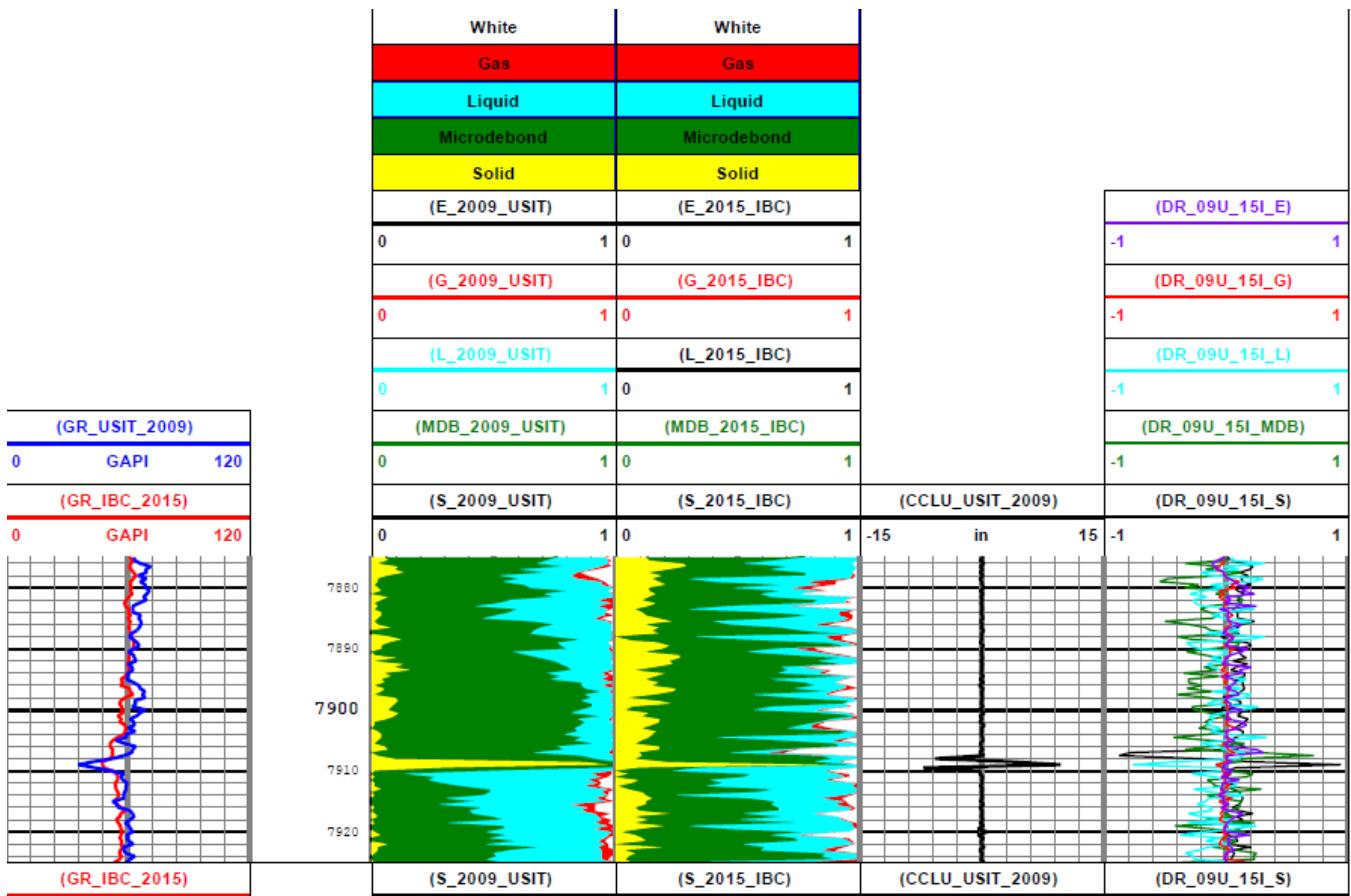
**Figure 11 Comparison of ultrasonic data collected at 7900 ft in CFU31F-2. Note the 2009 data are denoted with USIT and the 2015 data are denoted with IBC.**

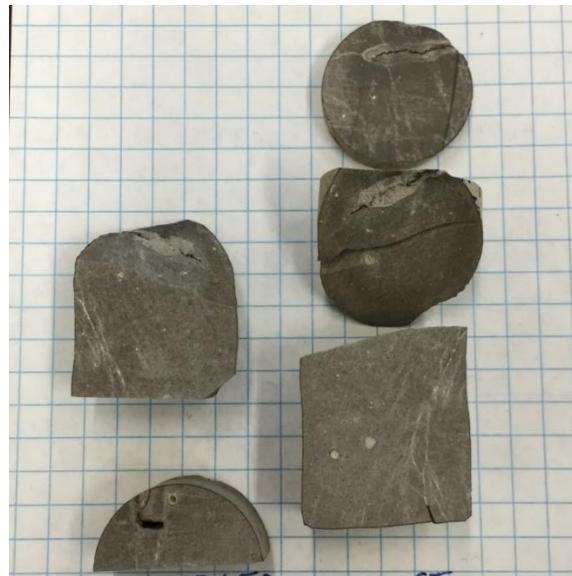
The sample was sectioned for further analysis using the micro-CT scan to aid sectioning the crack and surrounding reaction zone (Figure 13). Visual analysis of the sectioned core showed that there is a 1 to 2 mm visible reaction zone surrounding the crack. Visual analysis also shows that the crack is filled along some portions of the core and open in others.

**Figure 13 CFU31-F2 7900 ft sample cut for further analyses.**

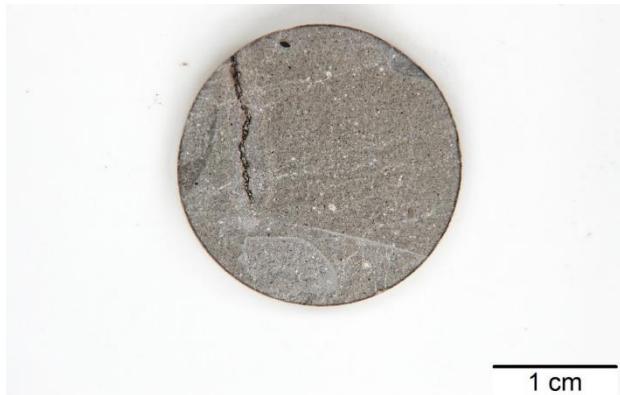
A portion of the sample (Figure 14) was polished and used for ESEM imaging and EDS analysis.

**Figure 14 Section of sidewall core collected in CFU31-F2 and 7900 ft used to conduct ESEM and EDS measurement**

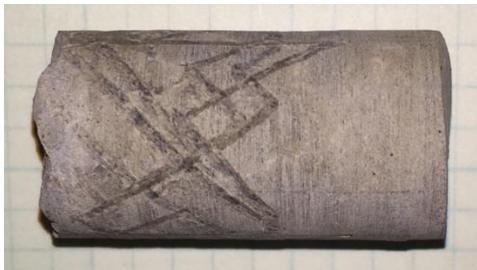
The core collected at 9530 ft consisted of solid cement (Figure 24). A comparison of the CBL data collected at this depth was conducted. The 2009 data show a bond amplitude generally between 5 and 16 mV with higher values at the casing joint between 9514 and 9518 ft in the 2009, DSLT, log. The 2015 SCMT CBL data show a deterioration of the bond with signals between 16 and 48 mV (Figure 26). The cement ultrasonic image logs also show a deterioration of cement quality. The raw acoustic impedance tracks exhibit a lower acoustic impedance (lighter color) in the 2015 track versus the 2009 track (Figure 28). Averages of the acoustic impedance data for solid, liquid, gas, and un-attributable phases (E in Figure 27) show that the solid material behind the casing decreased, the microdebonded material increased, the liquid decreased and the un-attributable signals remained nearly unchanged. This can be seen in the right-most track in Figure 27 where tracks that move to the right of zero show an increase from 2009 to 2015 and tracks that move to the left show a decrease. At this depth, the ratio of overall solid material (the sum of microdebonded and solid cement) to all material behind the casing decreased from 0.86 to 0.61 between 2009 and 2015.

**Figure 24 Sidewall core collected at 9530 ft. The casing end of the core is on the left and the formation end is on the right. Note, the sidewall core is approximately 23 mm in diameter. The jagged marks on the left half of the core are caused by reciprocation of the core bit during coring.**

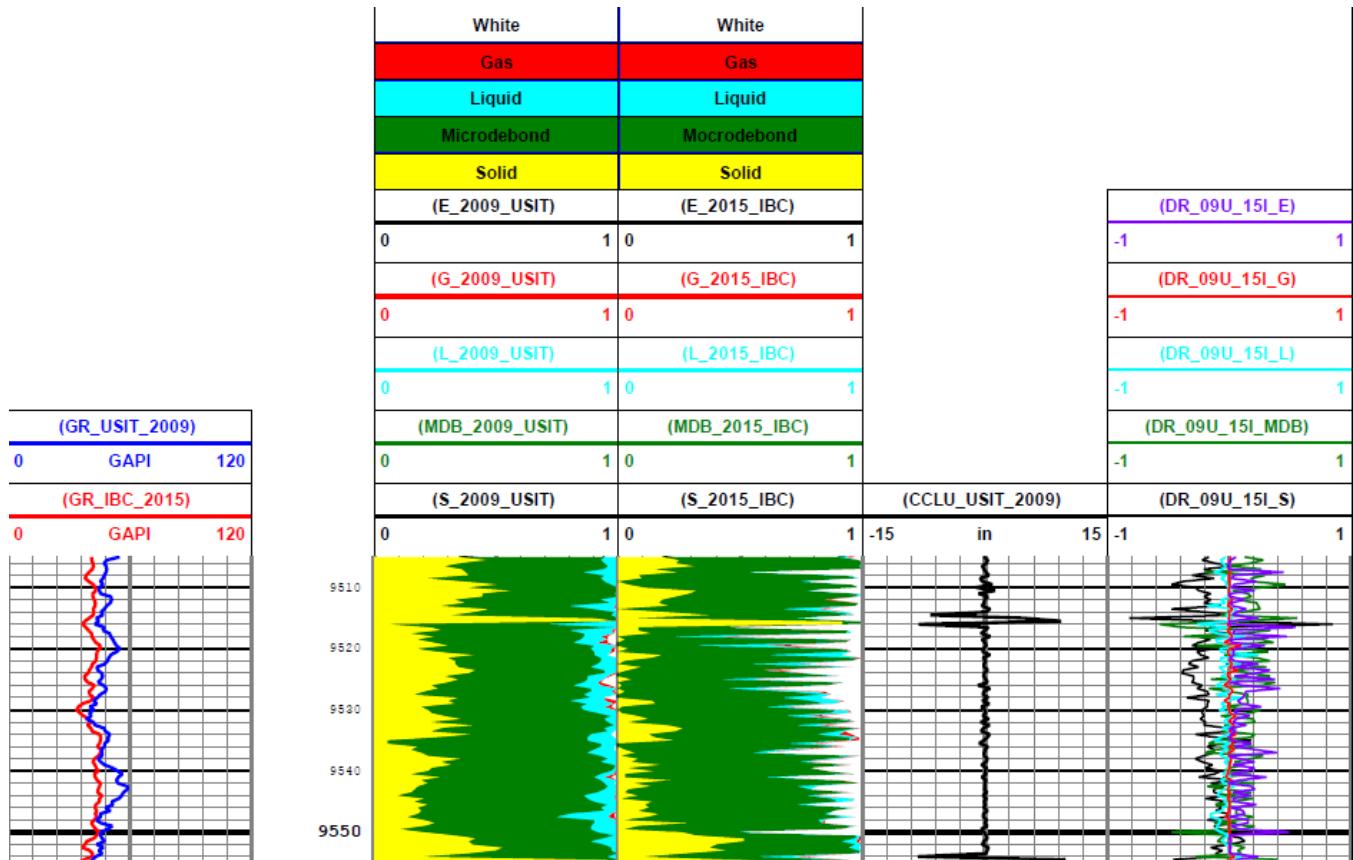
Figure 27 Comparison of ultrasonic data collected at 9530 ft in CFU31F-2. Note the 2009 data are denoted with USIT and the 2015 data are denoted with IBC.

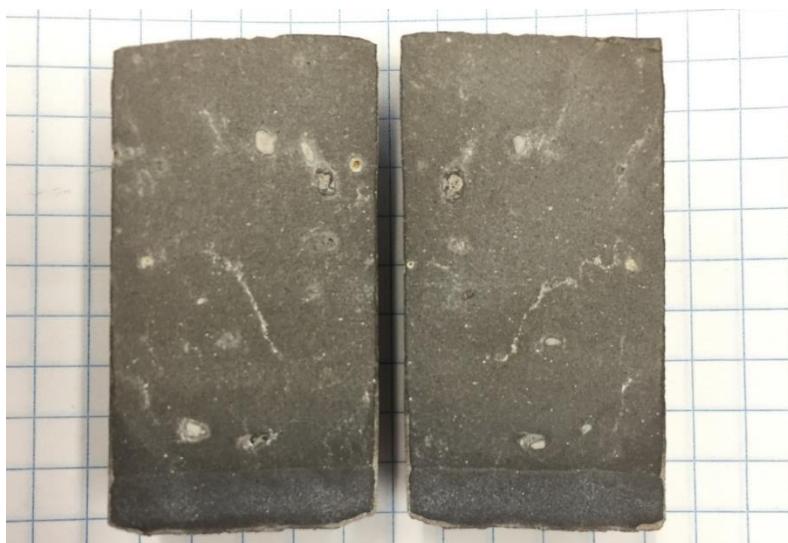
The sample was sectioned for further analysis using the micro-CT scan to select the best plane for sectioning. Visual analysis of the sectioned core showed that there is an approximately 0.5-mm-wide tan reaction front followed by an approximately 5.5-mm-wide grey reaction on the casing side of the core perpendicular to the long axis of the core (parallel to the casing in the well). Adjacent to the grey reaction front there is an approximately 0.5-mm-wide white front. Visual analysis also shows a filled in crack or fracture running diagonally across the sectioned surface of the core. ESEM analysis was not conducted on this sample.

**Figure 29 CFU31-F2 cement sample sectioned for further analysis**

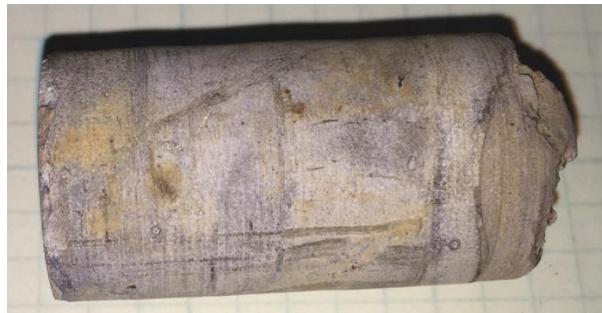
**Figure 39 Sidewall core collected at 9800 ft showing a discolored zone on the formation side (right). Note, the sidewall core is approximately 23mm in diameter.**

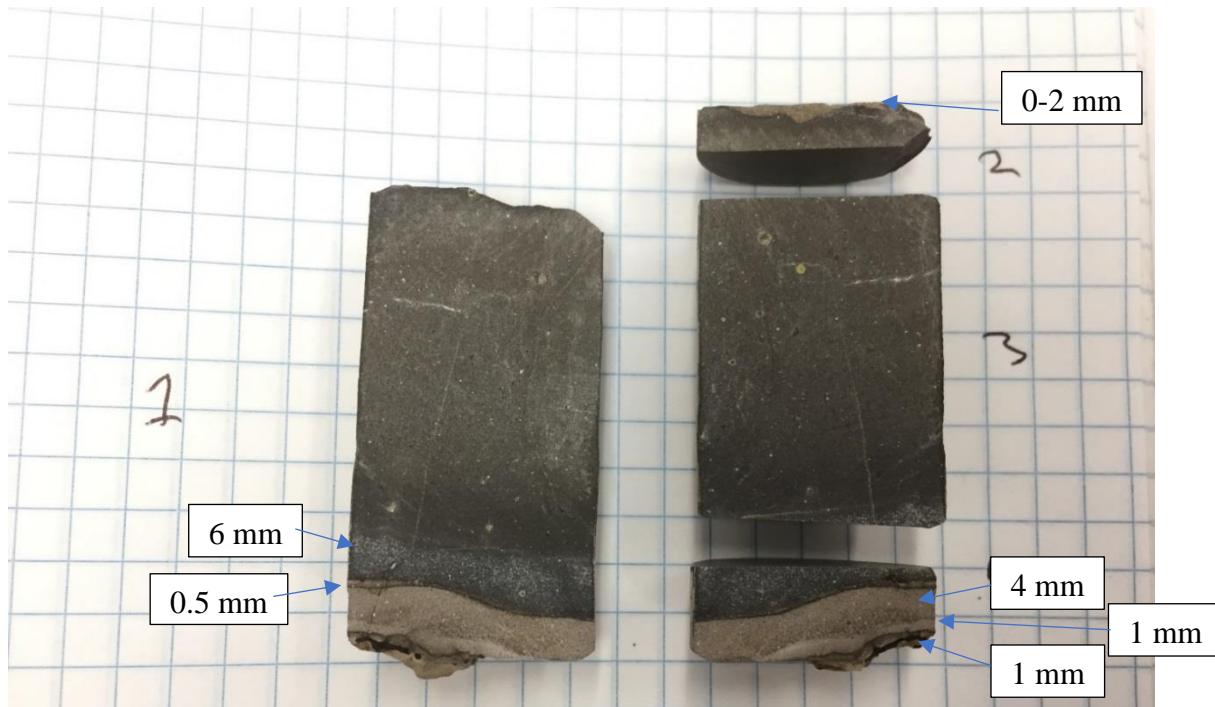
Visual analysis of the sectioned sample confirms multiple reaction fronts moving into the sample from the formation side. There are at least five fronts moving in from the formation side; four are tan. The inner-most front is light grey in color. Visual analysis of the sectioned sample also confirms the existence of a tan reaction front on the casing end of the sample. Figure 44 shows the sectioned sample and provides approximate widths of the reaction fronts. Also visible is a fracture that runs diagonally through the sample. The fracture is partially filled with white material and changes direction in the tan reaction fronts on the formation side, indicating that the fracture formed after the reactions were proceeding into the sample. Changes in material properties caused the direction of the crack to change.

**Figure 44 CFU31-F2 9800 ft cement sample sectioned for further analyses.**

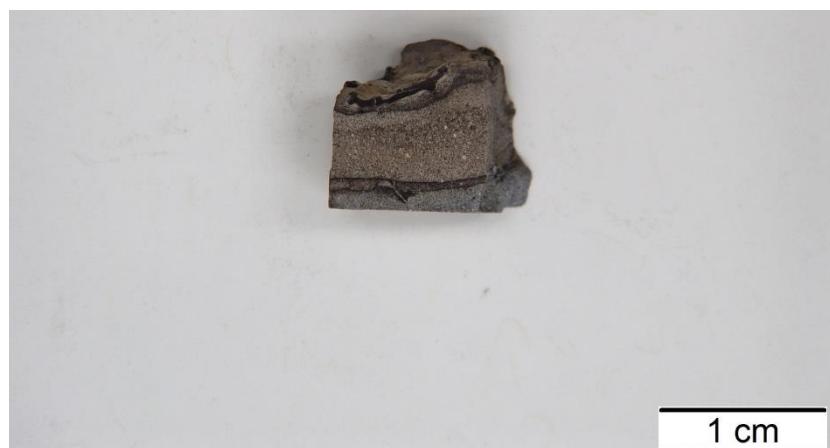
ESEM analyses were conducted on reacted zones on the formation-side of the sample (Figure 45) and the interior of the sample (Figure 49).

**Figure 45 Photograph showing the portion of the sample collected at 9800 ft used for ESEM analyses of the formation-side reaction fronts.**

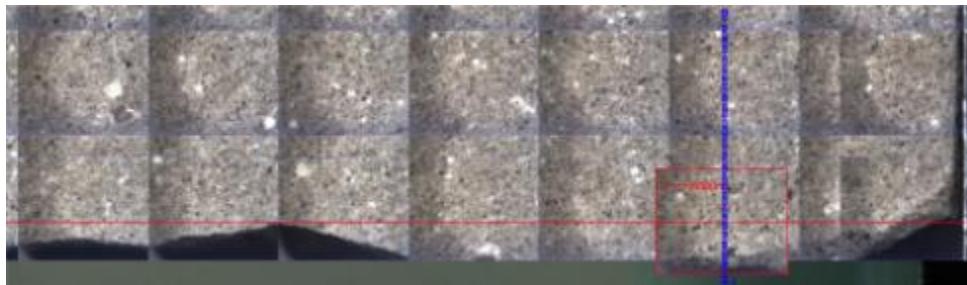
The sectioned sidewall core was used conducting LA-ICP-MS starting on the casing side and moving toward the formation side. The LA-ICP-MS scan line images and corresponding data are presented in Figure 51 through Figure 76. Line 1, moving into the sample across the reacted zone on the casing side shows an increase in ratios to about

100 microns for Ca/Si and Ca/Al and an increase in ratios for Ca/Fe to about 250 microns. After the initial increases the ratios remain fairly steady. Ca/Si remains around 1.5 to the end of the scan (Figure 52). Ca/Si slowly decreases over the next six lines (Figure 53 to Figure 62) where it reaches a value near 1 until crossing the fracture in the grey reacted zone (approximately 2000 microns into line 7, Figure 62) where Ca/Si jumps up to between 1.1 and 1.4. When the Line reaches the next front (approximately 4250 microns) Ca/Si increases again with two spikes around 1.6 and two spikes around 3.6. At the next transition to the light tan wide front, Ca/Si drops closer to 1 for the rest of the line. The Ca/Si increases moving into the grey zone with values as high as 2 and the decreases again by the end of the zone with values around 0.7 where the line transitions into the next reaction zone (approximately 3000 microns in Figure 64). In this zone Ca/Si increases to around 1.1 and then drops to around 0.4 around 3600 microns where the zone ends and the next zone begins. That zone is between 3600 and 4800 microns, it has several peaks and ranges between 0.5 and 1.2 Ca/Si. The next zone starts at 4800 microns and runs to around 5200 microns. The Ca/Si over this zone is smoother than the previous zone dropping from around 0.6 to 0.4 across the zone. In the last, outermost, reacted zone the Ca/Si rises to around 0.9 and then drops to around 0.2 at the end of the line, around 5550 microns. Figure 66 shows the behavior of the ratios across the grey zone without the crack. The Ca/Si behavior is smoother than across the crack. Figure 67 through Figure 76 show additional lines across the reaction fronts at on the formation side of the sample.

Figure 51 LA-ICP-MS Line 1 across the sample collected in CFU31-F2 at 9800 ft.

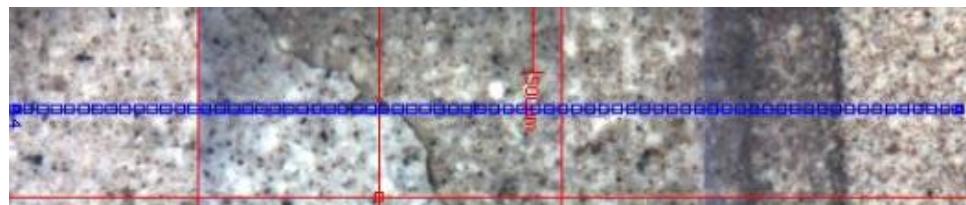
**Figure 62** LA-ICP-MS Line 7 results across the sample collected in CFU31-F2 at 9800 ft showing Ca/Si, Ca/Al, and Ca/Fe mole ratios.

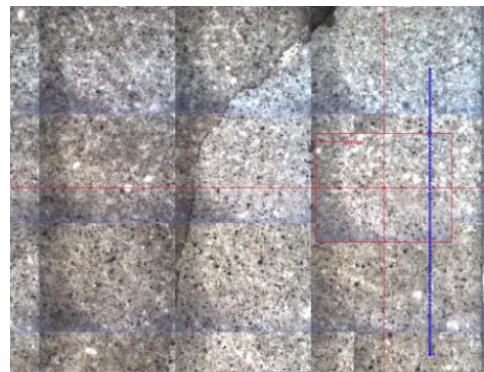
Figure 65 LA-ICP-MS Line 9 across the sample collected in CFU31-F2 at 9800 ft.

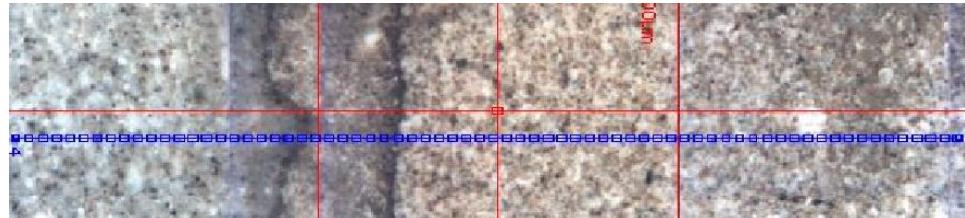
Figure 68 LA-ICP-MS Line 10 results across the sample collected in CFU31-F2 at 9800 ft showing Ca/Si, Ca/Al, and Ca/Fe mole ratios.

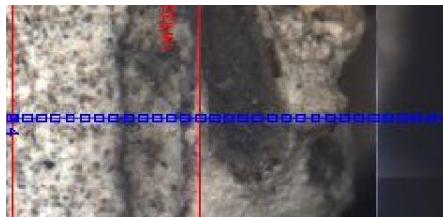
Figure 70 LA-ICP-MS Line 11 results across the sample collected in CFU31-F2 at 9800 ft showing Ca/Si, Ca/Al, and Ca/Fe mole ratios.

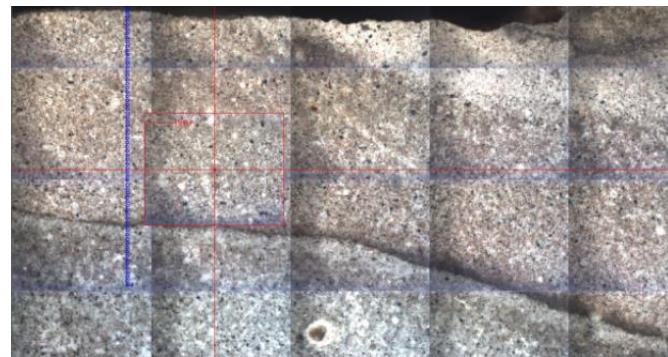
Figure 75 LA-ICP-MS Line 14 across the sample collected in CFU31-F2 at 9800 ft.

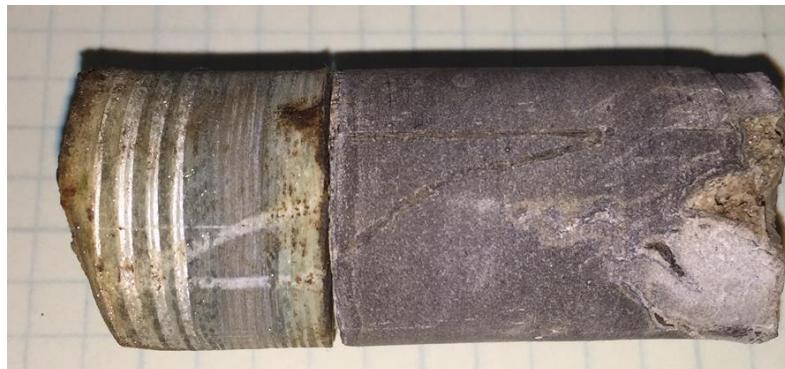
The core collected at 10268 ft consisted of solid cement and fiberglass casing (Figure 86). The core shows both light grey and tan discoloration or reacted zones on the formation side.

**Figure 86 Sidewall core collected in CFU31-F3 at 10268 ft. Note fiberglass casing is shown on the left side of the photo.**

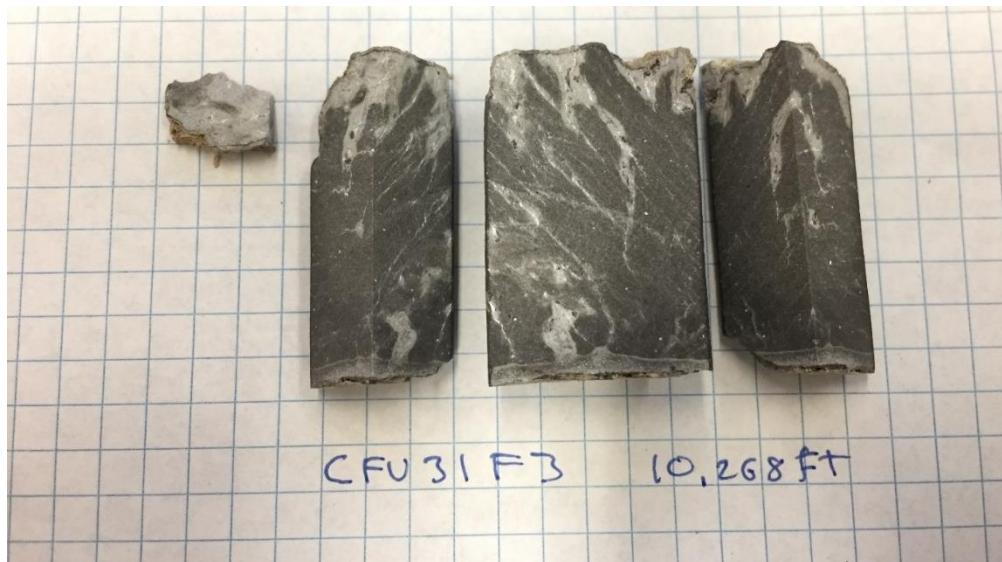
Sectioning of the sample (Figure 89) confirmed the existence of multiple diagonal (with respect to the long-axis of the sample) features that appear to be reacted zones and are lighter in color than the surrounding cement. There are also fronts on both ends of the sample. On the casing-side there is an approximately 1-mm-wide light tan front followed a 2- to 3-mm-wide light grey front. On the formation-side there is an approximately 1-mm-wide tan front.

**Figure 89 Cement sidewall core collected in CFU31-F3 at 102680 ft.**

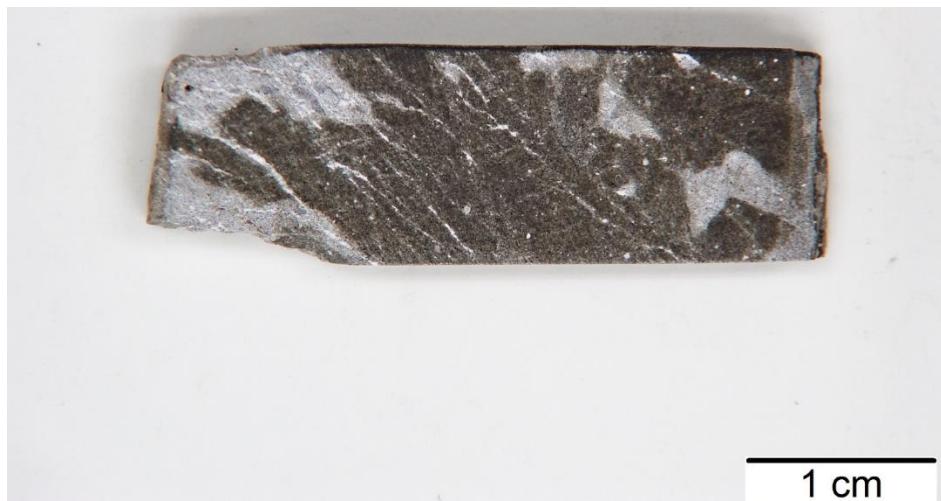
Portions of the sectioned sample were polished for ESEM imaging and EDS analysis (Figure 90). EDS analyses were conducted on the outer reacted zone of the sample on the formation side (Figure 91). The EDS analyses (Table 21) indicate atomic percentages for calcium are between 15.44 and 24.90 for the points selected and atomic percentages for silica are between 7.10 and 19.49. The Ca/Si ratios ranged between 0.74 and 2.70. Note the points with low Ca/Si ratios (0.74 and 0.79) are high in aluminum indicating areas where tricalcium aluminate was high in the initial cement powder.

**Figure 90** Portion of cement collected in CFU31-F3 at 10268 ft used for ESEM and EDS analysis.

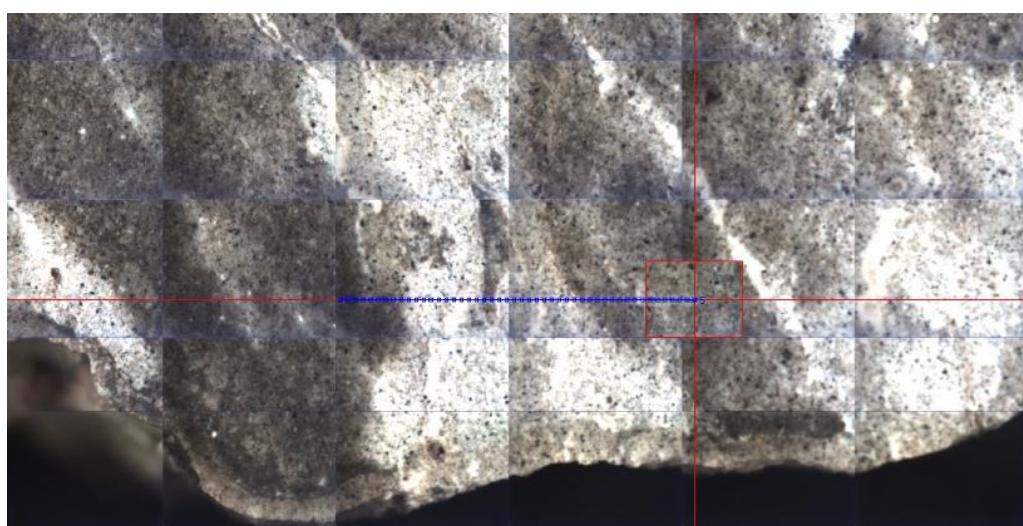
**Figure 113** LA-ICP-MS Line 11 across the sample collected in CFU31-F3 at 10268 ft.

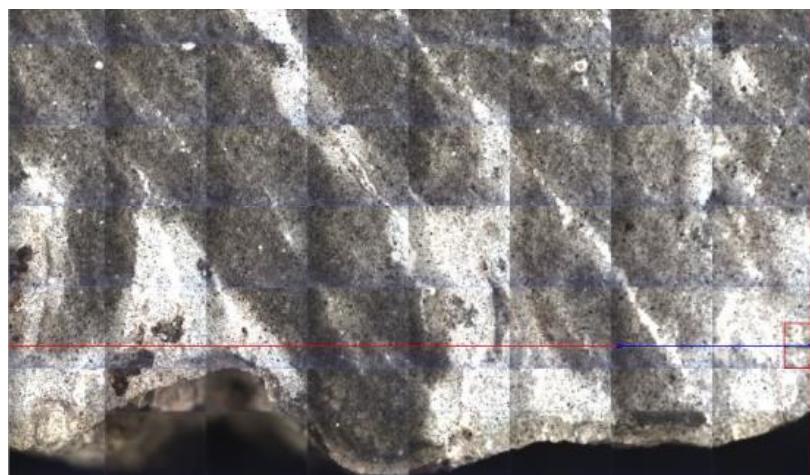
**Figure 115** LA-ICP-MS Line 12 across the sample collected in CFU31-F3 at 10268 ft.

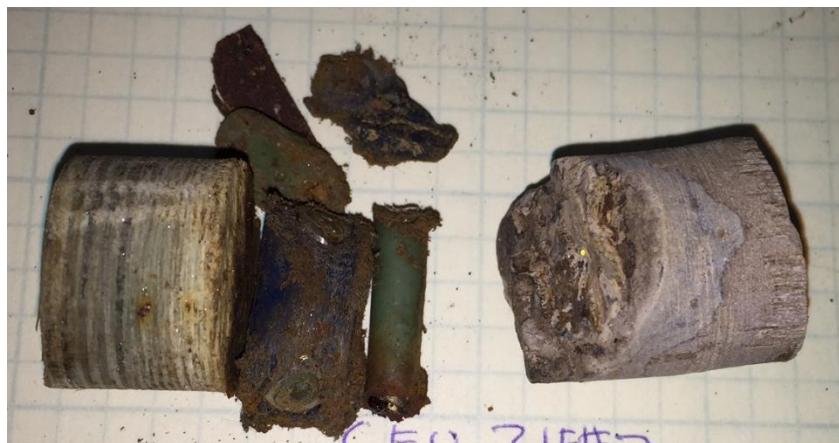
The core collected at 10380 ft consisted of solid cement, cable, lines, and sampling line, and fiberglass casing (Figure 117). The cement core shows both light grey and tan discoloration or reacted zones on the casing /cable side.

**Figure 117 Sidewall core collected in CFU31-F3 showing the fiberglass casing on the left, control lines in the center, and cement on the right.**

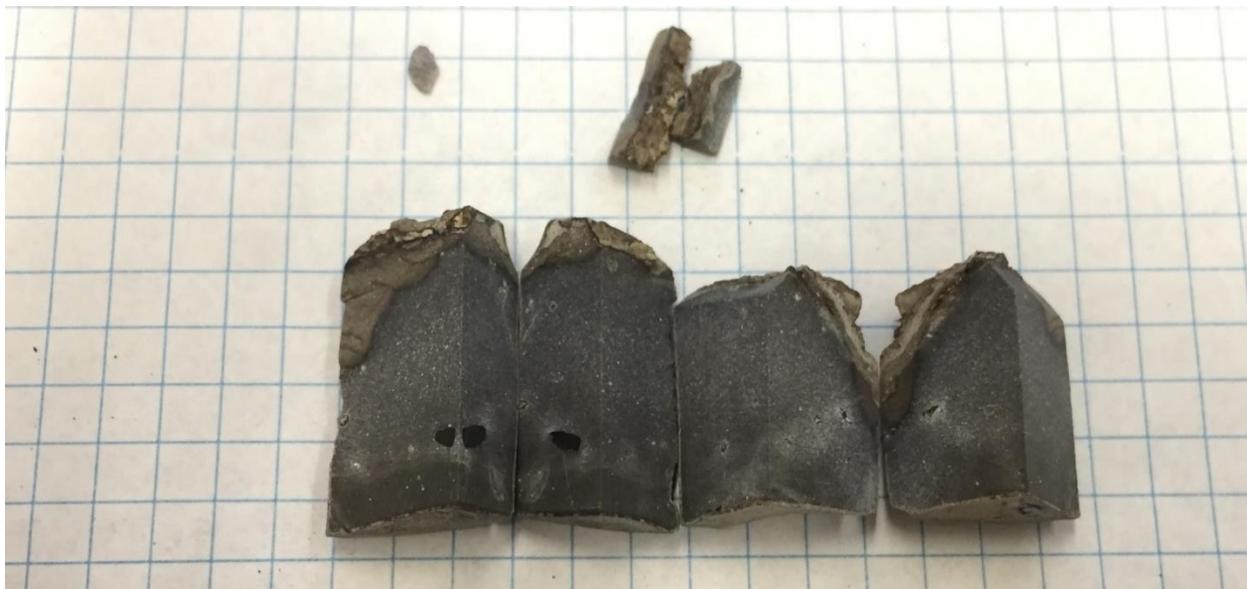
Sectioning of the sample (Figure 120) confirmed multiple fronts on the casing/cable side and a tan front on the formation side. Note the front on the formation side of the core continues on the outer side of the core sample, parallel to the long axis of the sample.

**Figure 120 Sectioned cement sidewall core collected in CFU31-F3 at 10380 ft.**

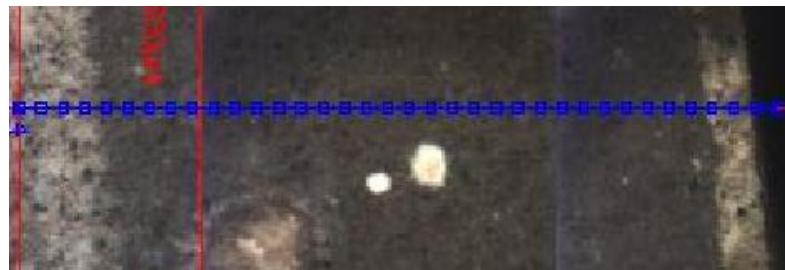
**Figure 132** LA-ICP-MS Line 5 results across the sample collected in CFU31-F3 at 10380 ft showing Ca/Si, Ca/Al, and Ca/Fe mole ratios.

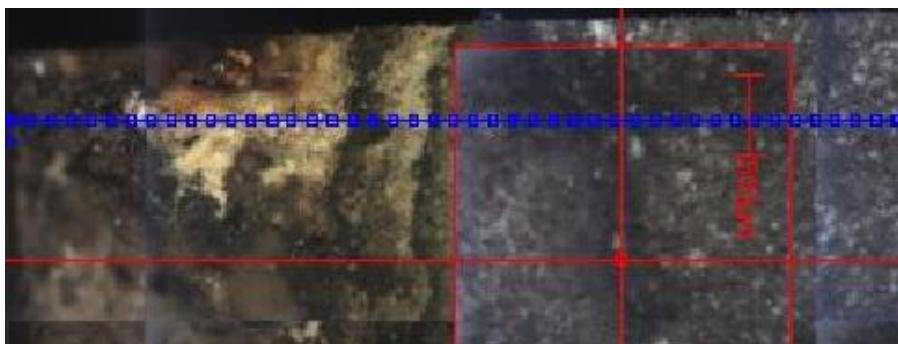
**Figure 136** LA-ICP-MS Line 7 results across the sample collected in CFU31-F3 at 10380 ft showing Ca/Si, Ca/Al, and Ca/Fe mole ratios.

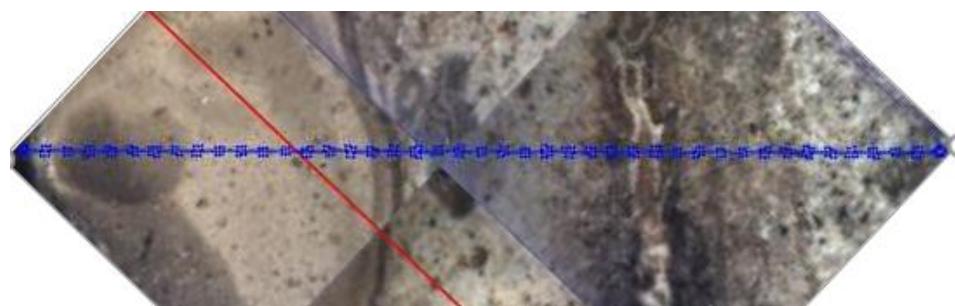
**Figure 138** LA-ICP-MS Line 8 results across the sample collected in CFU31-F3 at 10380 ft showing Ca/Si, Ca/Al, and Ca/Fe mole ratios.

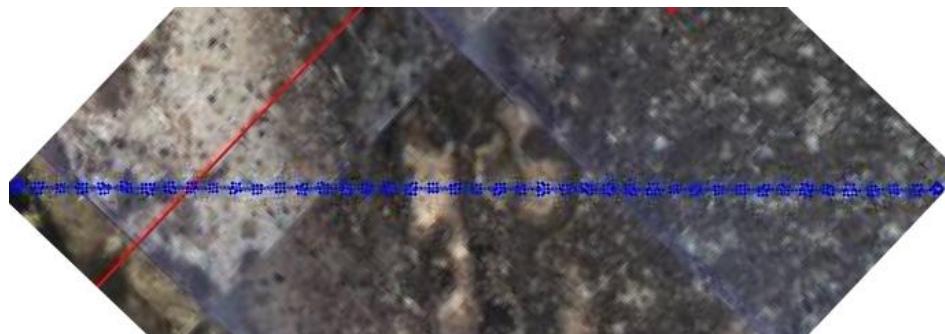
**Figure 140** LA-ICP-MS Line 9 results across the sample collected in CFU31-F3 at 10380 ft showing Ca/Si, Ca/Al, and Ca/Fe mole ratios.

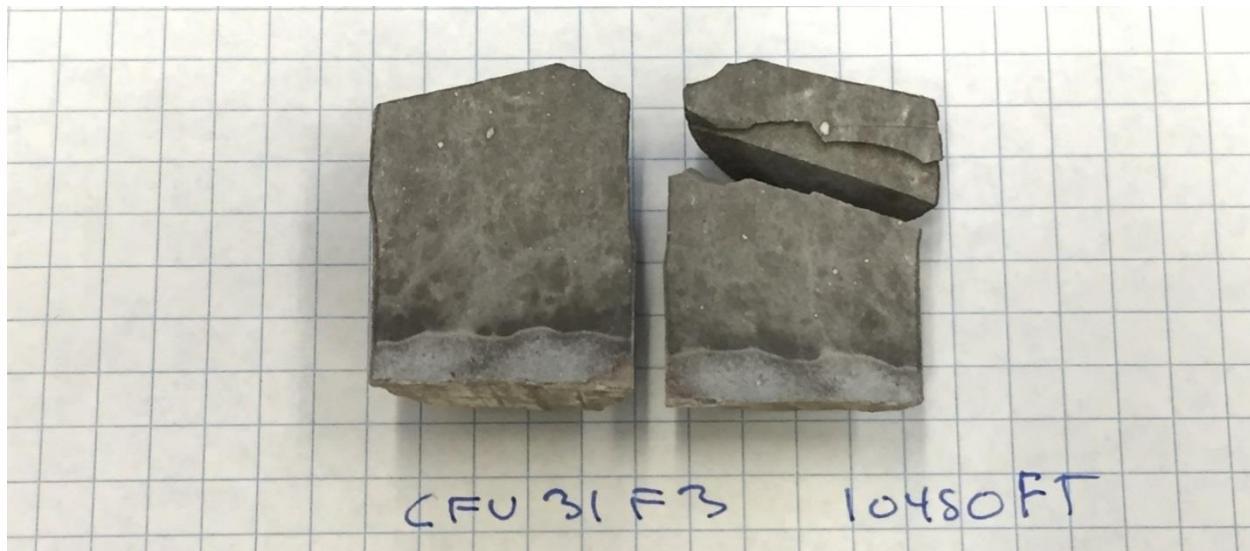
Sectioning of the sample (Figure 144) confirmed the fronts apparent in the micro-CT images. The fronts visible in the sectioned sample are a 4-mm-wide tan front followed by an 1/2-mm-wide light grey front.

**Figure 144 Cement sidewall core collected in CFU31-F3 at 10450 ft.**

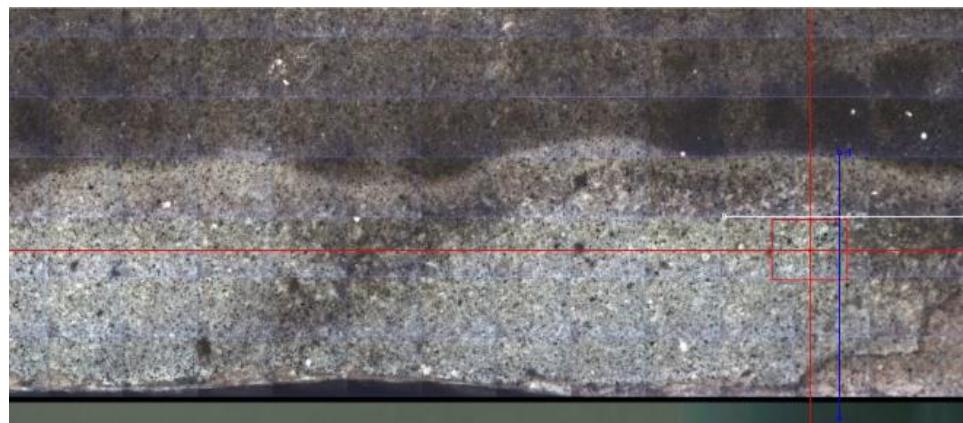
The sectioned sidewall core was analyzed using LA-ICP-MS starting on the formation side and moving toward the casing side of the sample. The LA-ICP-MS scan line images and corresponding data are presented in Figure 144 through Figure 159. The first line (Figure 145 and Figure 146) starts out measuring the tan zone (0 to 1300 microns) at the end of the casing side of the sample and then measures the light grey zone (1,300 to 5,200 microns). In the tan zone the Ca/Si has several peaks and ranges between 0.5 and 7. In the light grey zone the Ca/Si begins with a value around 1 and slowly rises to around 1.25. Line 2 (Figure 147 and Figure 148) shows Ca/Si slowly rises from around 1.3 to 1.5 over the length of the line. Lines 3 through 5 (Figure 149 to Figure 153) are generally flat with Ca/Si around 1.5. Line 6 (Figure 154 and Figure 155) is similar to Lines 3 through 5 from the beginning of the line to 3,480 microns where the Line meets the light tan front and Ca/Si jumps to around 3 and then drops off to 1.25 at the end of the sample. The last two lines in the sample are along a crack (Line 7; Figure 156 and Figure 157) and parallel to the crack (Line 8; Figure 158 and Figure 159). The Ca/Si over both scans is similar with values of Ca/Si around 1.6.

**Figure 145 LA-ICP-MS Line 1 across the sample collected in CFU31-F3 at 10450 ft.**

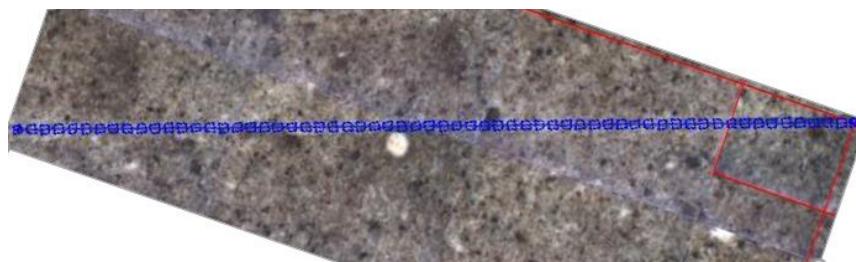
**Figure 157** LA-ICP-MS Line 7 results across the sample collected in CFU31-F3 at 10450 ft showing Ca/Si, Ca/Al, and Ca/Fe mole ratios.

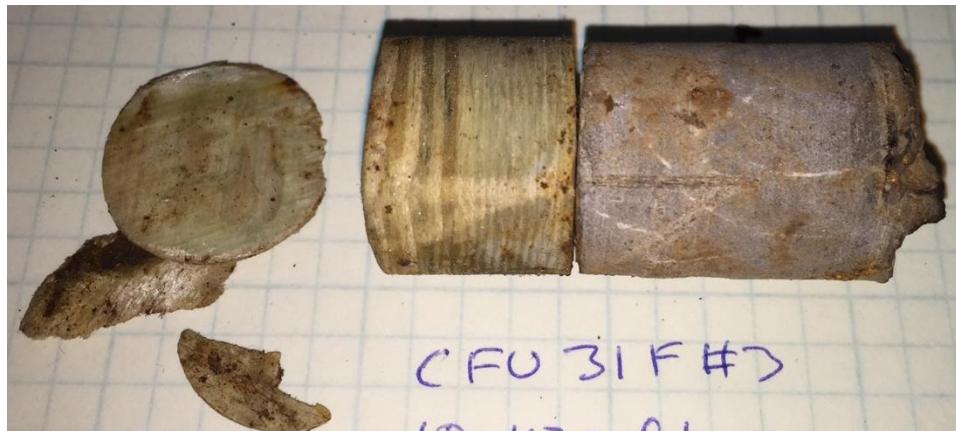
The core collected at 10470 ft consisted of solid cement and fiberglass casing (Figure 160). The cement core is uniform in color with no obvious fronts. The casing exhibited some delamination.

**Figure 160 Sidewall core collected in CFU31-F3 at 10470 ft showing fiberglass casing on the left and cement on the left.**

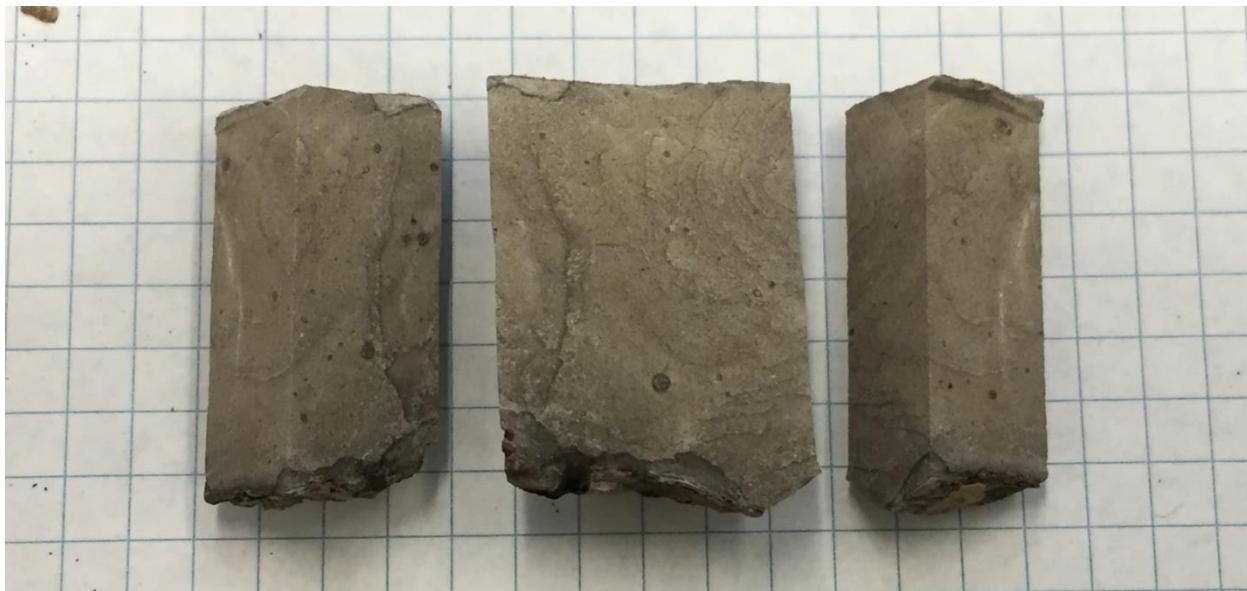
Sectioning of the sample (Figure 163) confirmed multiple fronts moving into or across the sample from ends moving along the long axis of the sample and in the center of the sample moving perpendicular to the long axis of the sample.

**Figure 163 Cement sidewall core collected in CFU31-F3 at 10470 ft.**

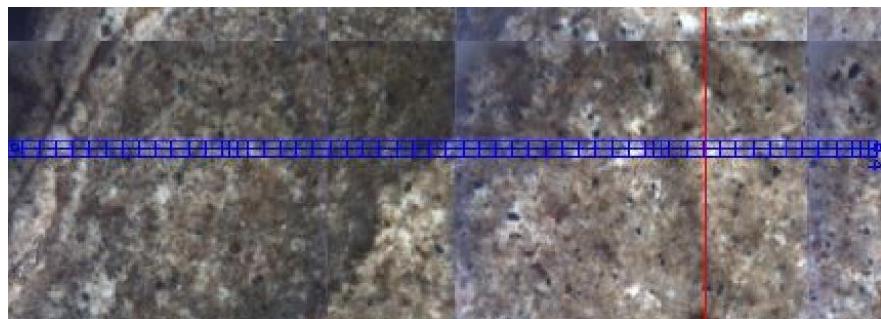
**Figure 165** LA-ICP-MS Line 1 results across the sample collected in CFU31-F3 at 10470 ft showing Ca/Si, Ca/Al, and Ca/Fe mole ratios.

The sectioned sidewall core was analyzed with LA-ICP-MS starting on the formation side and moving toward the casing side of the sample. The LA-ICP-MS scan line images and corresponding data are presented in Figure 164 through Figure 177. Lines 1 through 6 (Figure 164 through Figure 175) are parallel to the long-axis of the sample. These lines show variation in the elemental ratios throughout the sample with definite changes at transitions between fronts. Line 7 (Figure 176 and Figure 177) is a scan running perpendicular to the long-axis of the sample from the edge towards the center.

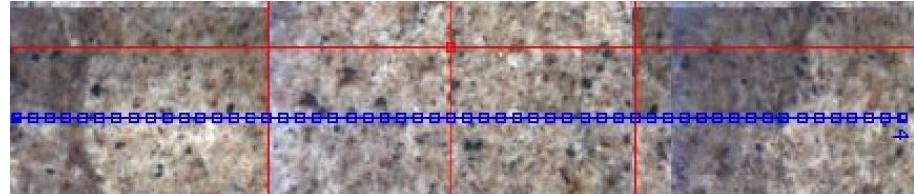
Figure 167 LA-ICP-MS Line 2 results across the sample collected in CFU31-F3 at 10470 ft showing Ca/Si, Ca/Al, and Ca/Fe mole ratios.

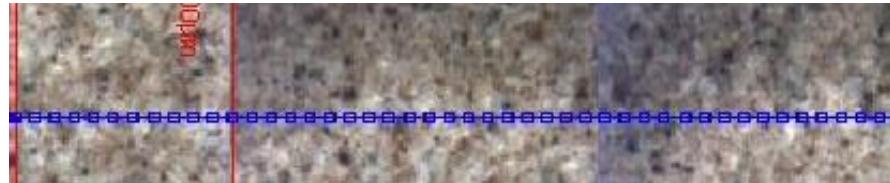
Figure 169 LA-ICP-MS Line 3 results across the sample collected in CFU31-F3 at 10470 ft showing Ca/Si, Ca/Al, and Ca/Fe mole ratios.

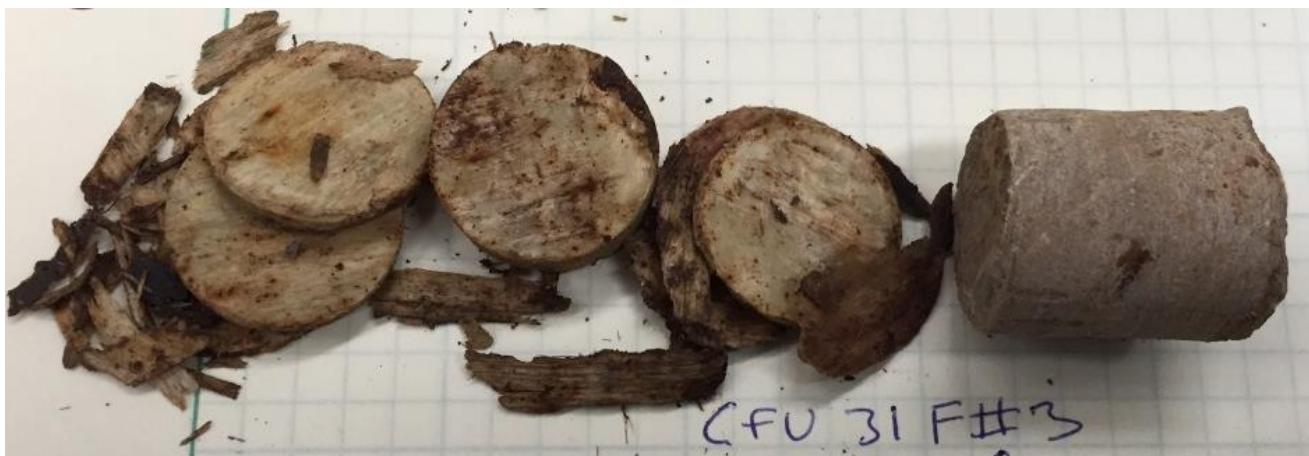
The core collected at 10477 ft consisted of solid cement and fiberglass casing (Figure 178). The cement core is uniform in color with no obvious fronts. The casing exhibited severe delamination.

**Figure 178 Sidewall core collected in CFU31-F3 at 10477 ft showing fiberglass casing on the left and cement on the left.**

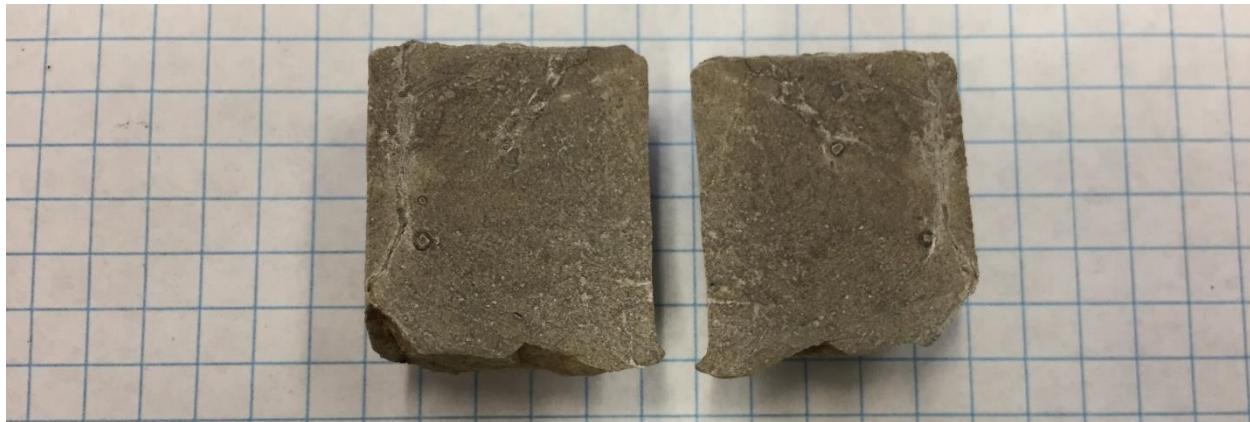
Sectioning of the sample (Figure 181) shows uniform material with cracks that have been filled on and multiple circular features ranging in size from around 10 to 1,000 microns.

**Figure 181 Cement sidewall core collected in CFU31-F3 and 10477 ft.**
